**Missouri
Department of
Natural Resources**

- History
- Recent Investigations and Waterline Replacement
- Planned Future Actions
- Questions

Presented by the Missouri Department
of Natural Resources

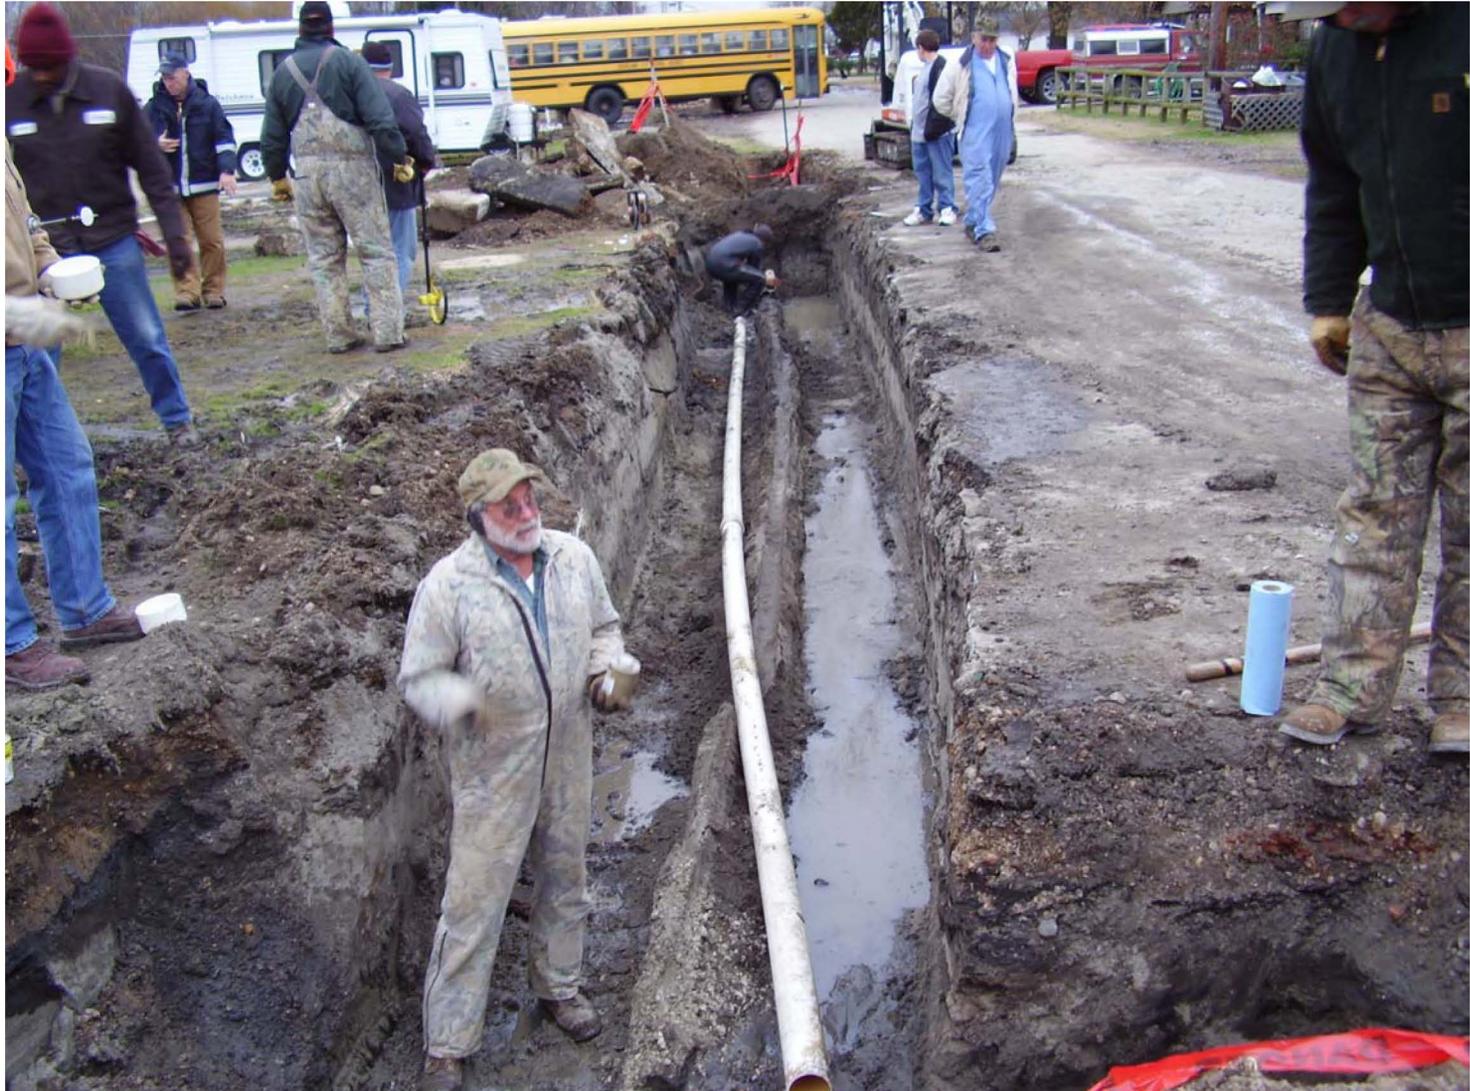
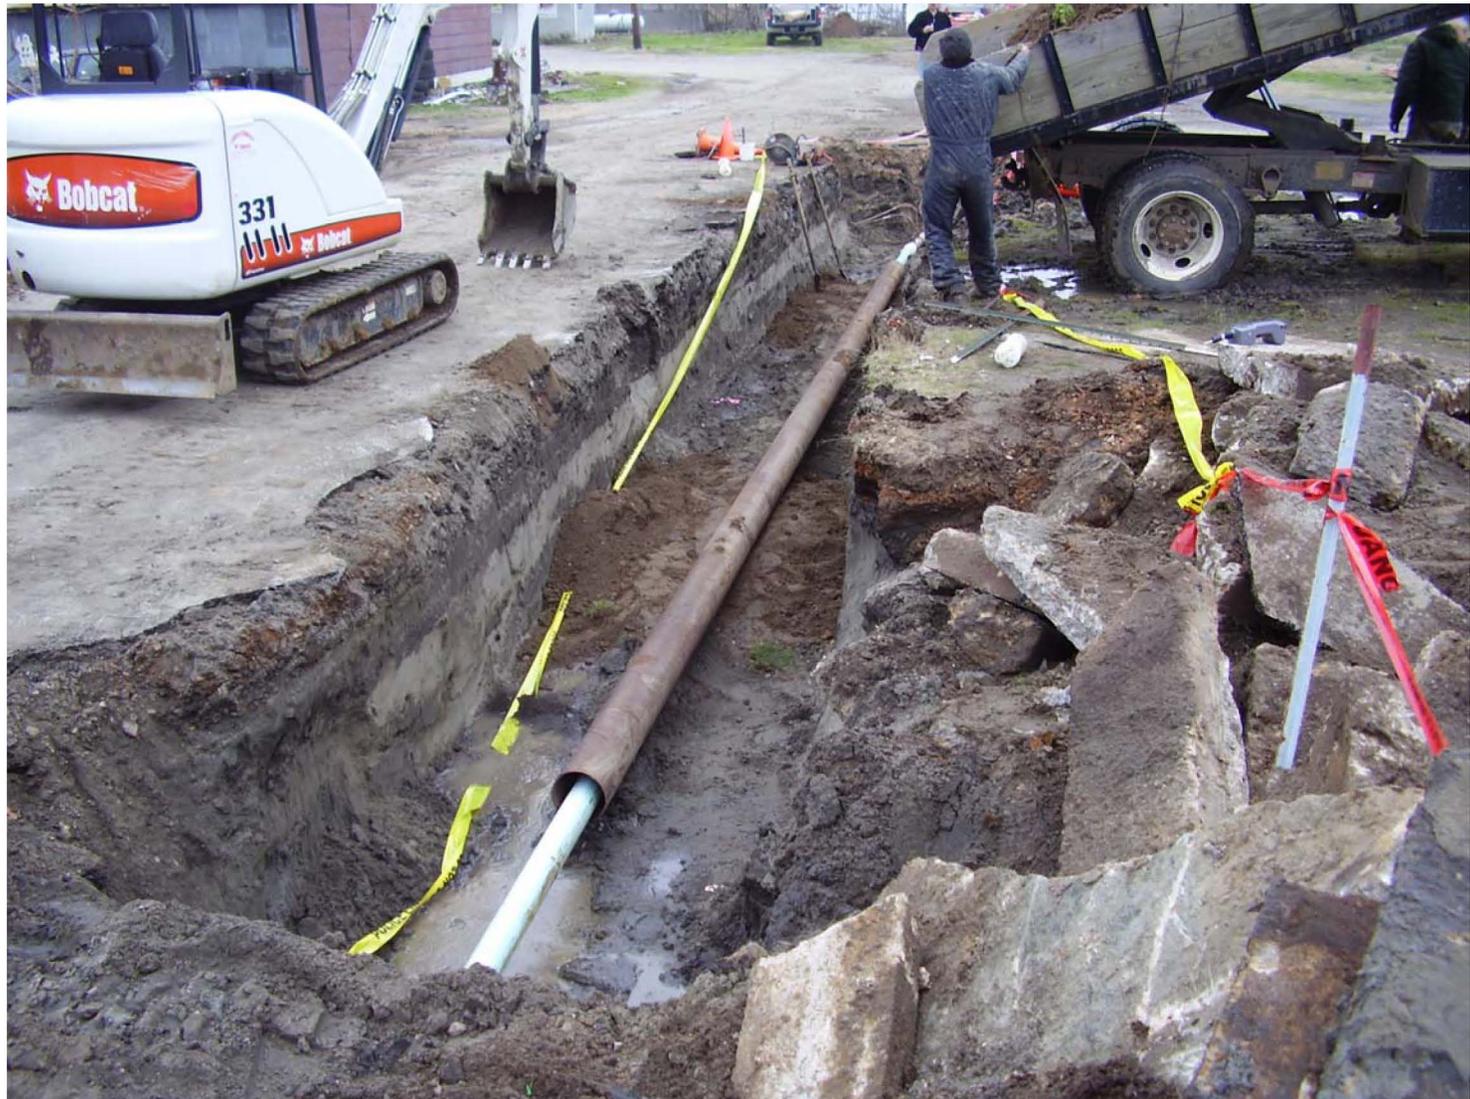
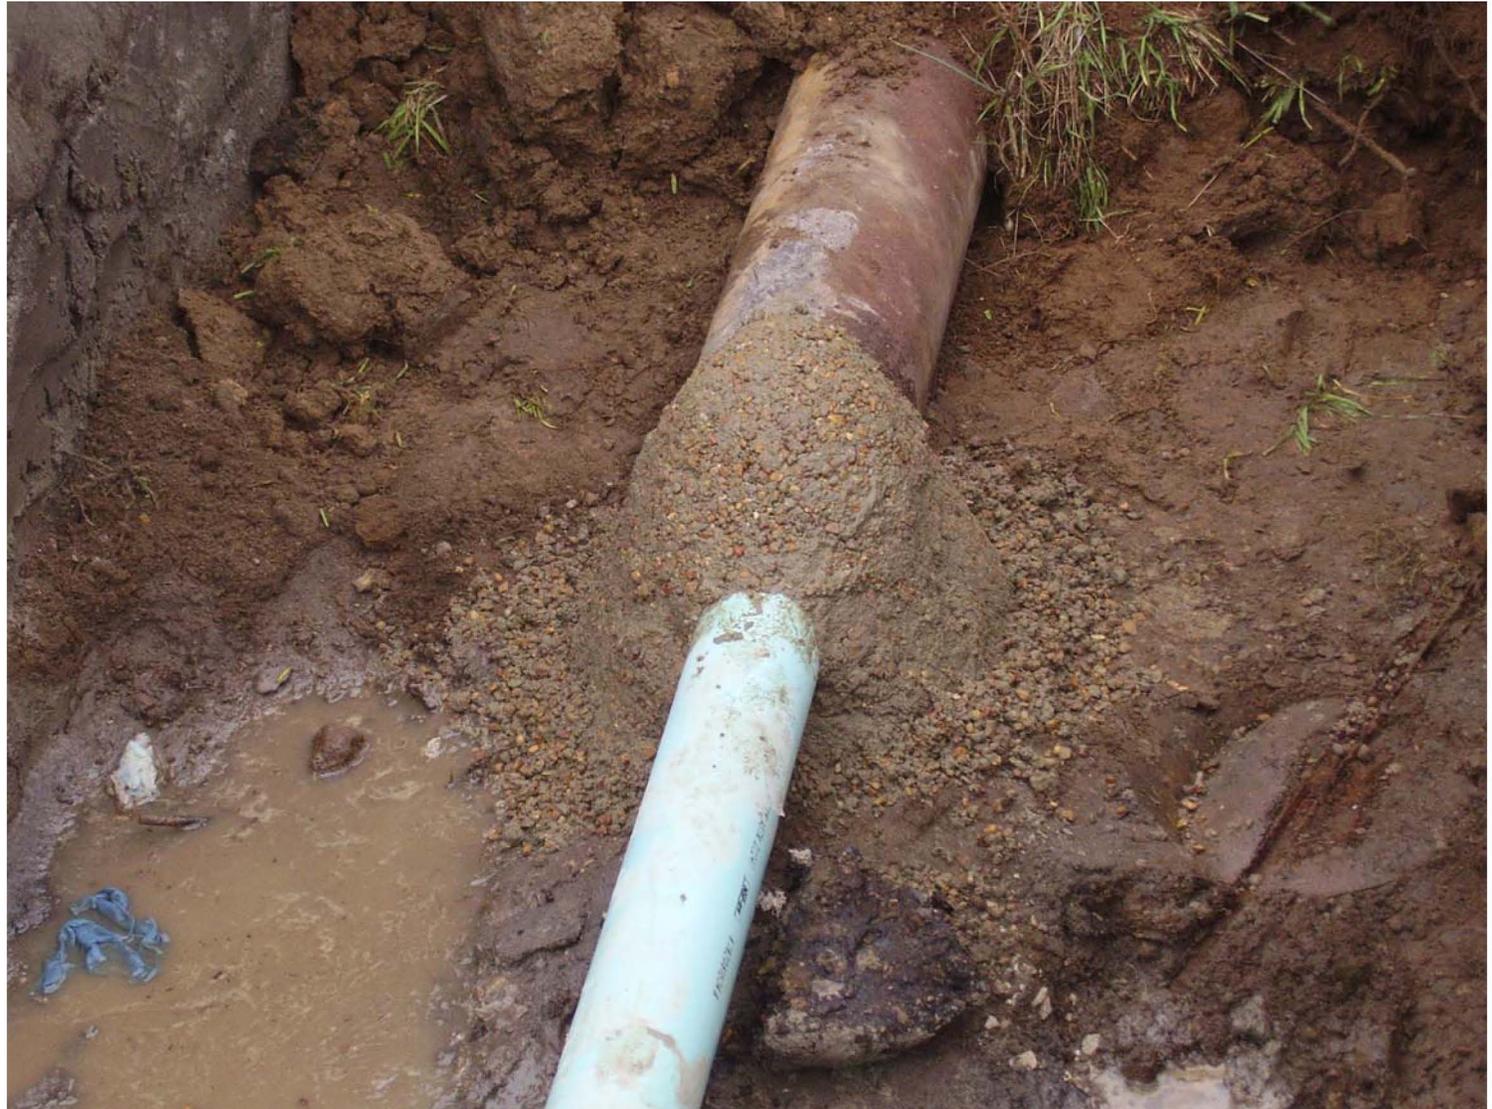
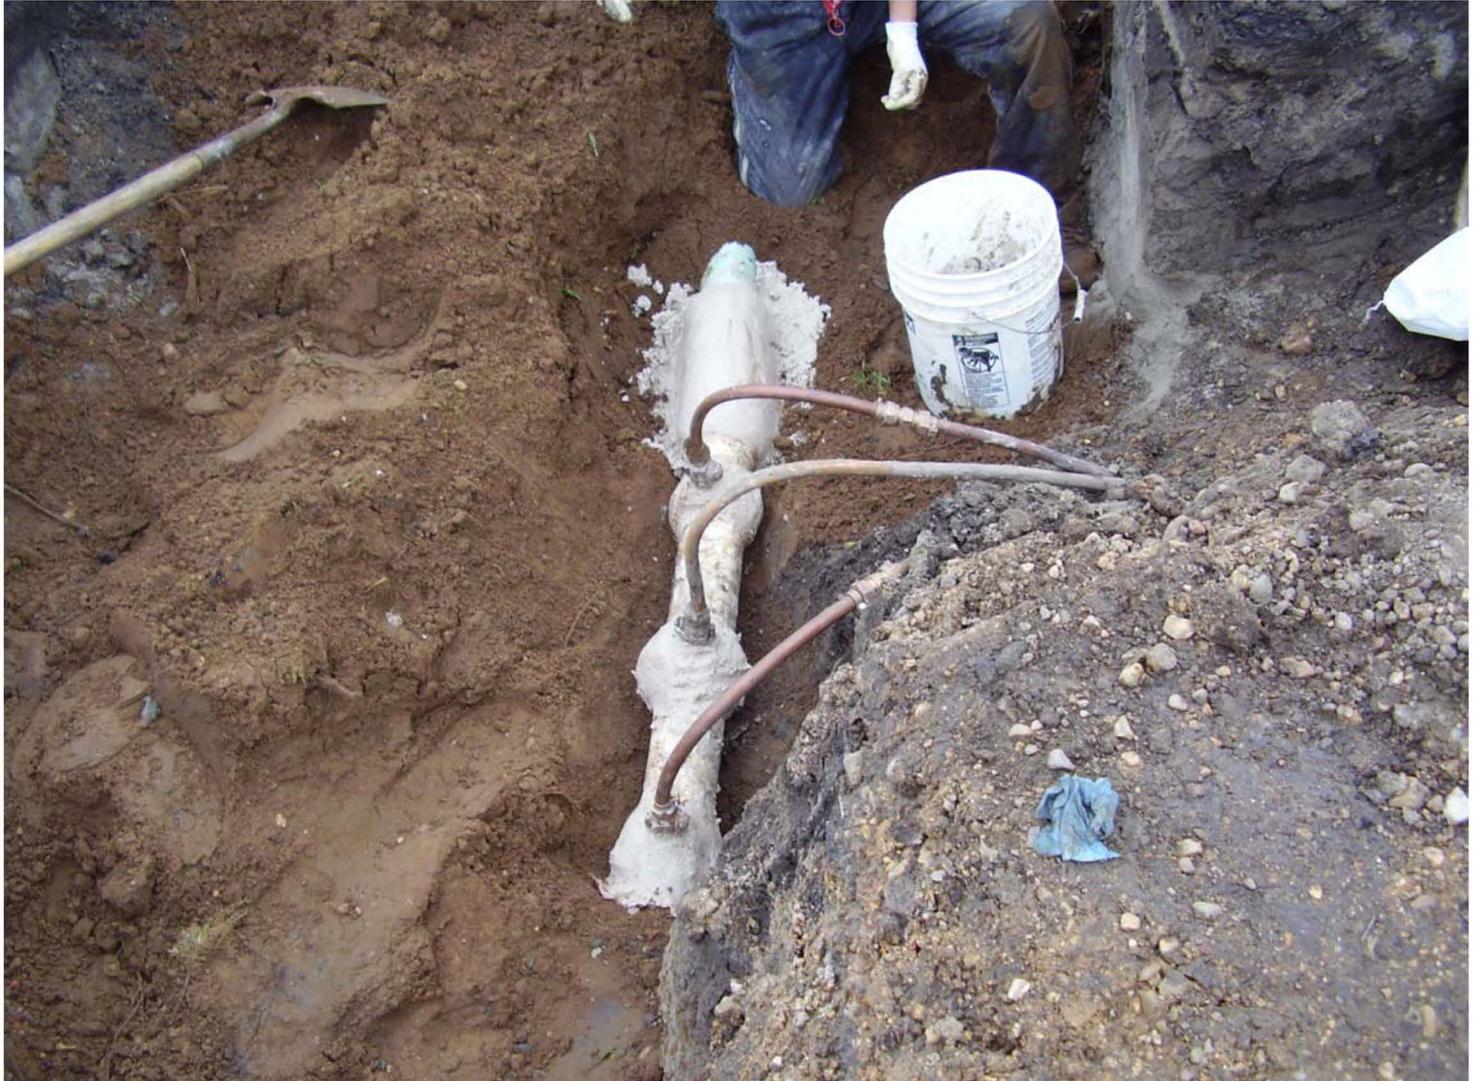
- Replaced approximately 51-feet of 4-inch PVC water main in contact with contaminated soil at the former Martin Oil Service Station on East Pool Street
- 40-feet of new PVC water main encased in steel pipe

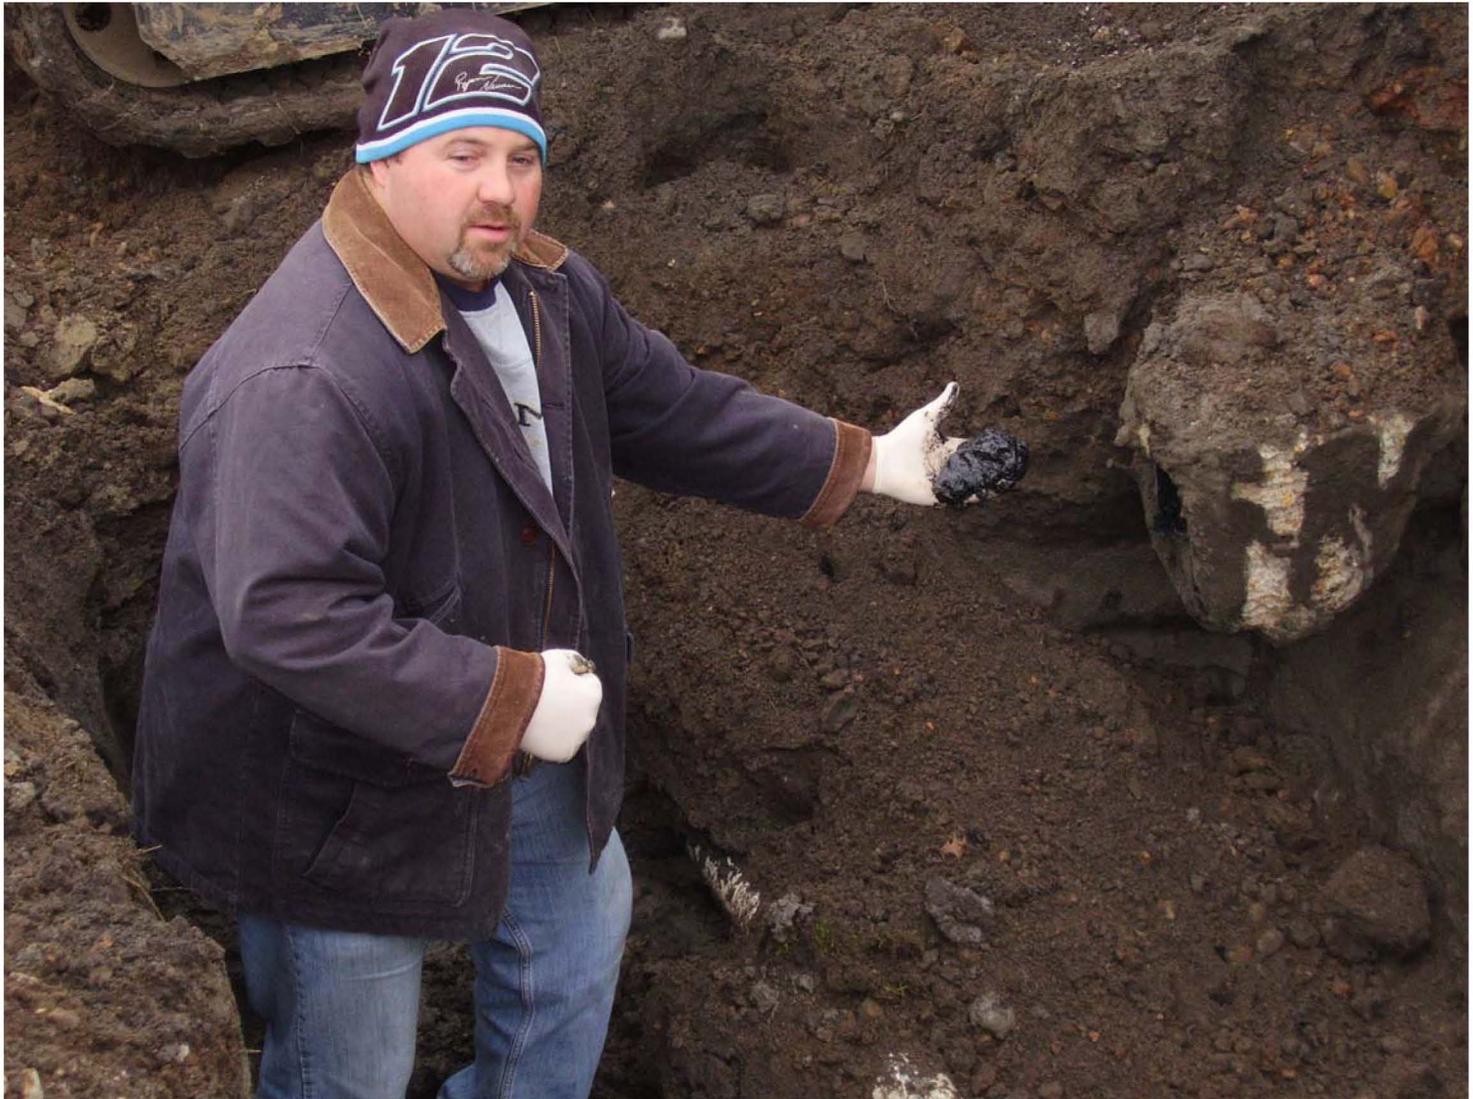
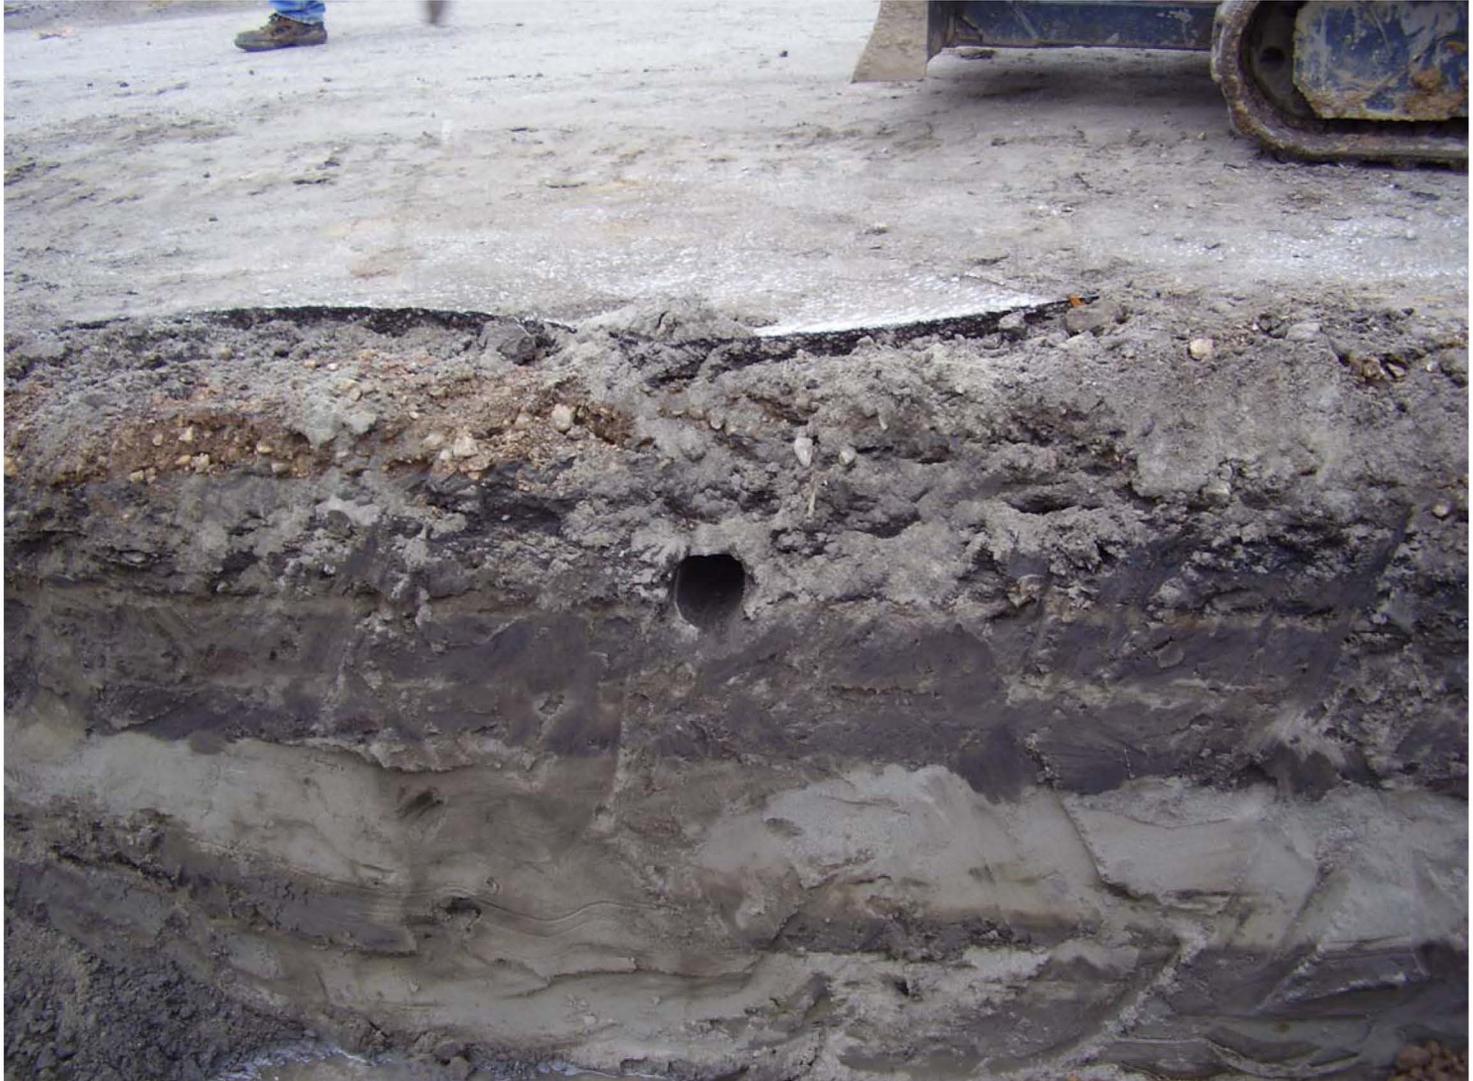
- Discovered two 4-inch cast iron drain pipes running from Martin Oil site under East Pool to 504 East Pool
- The drain pipes contained petroleum
- Further investigation is planned

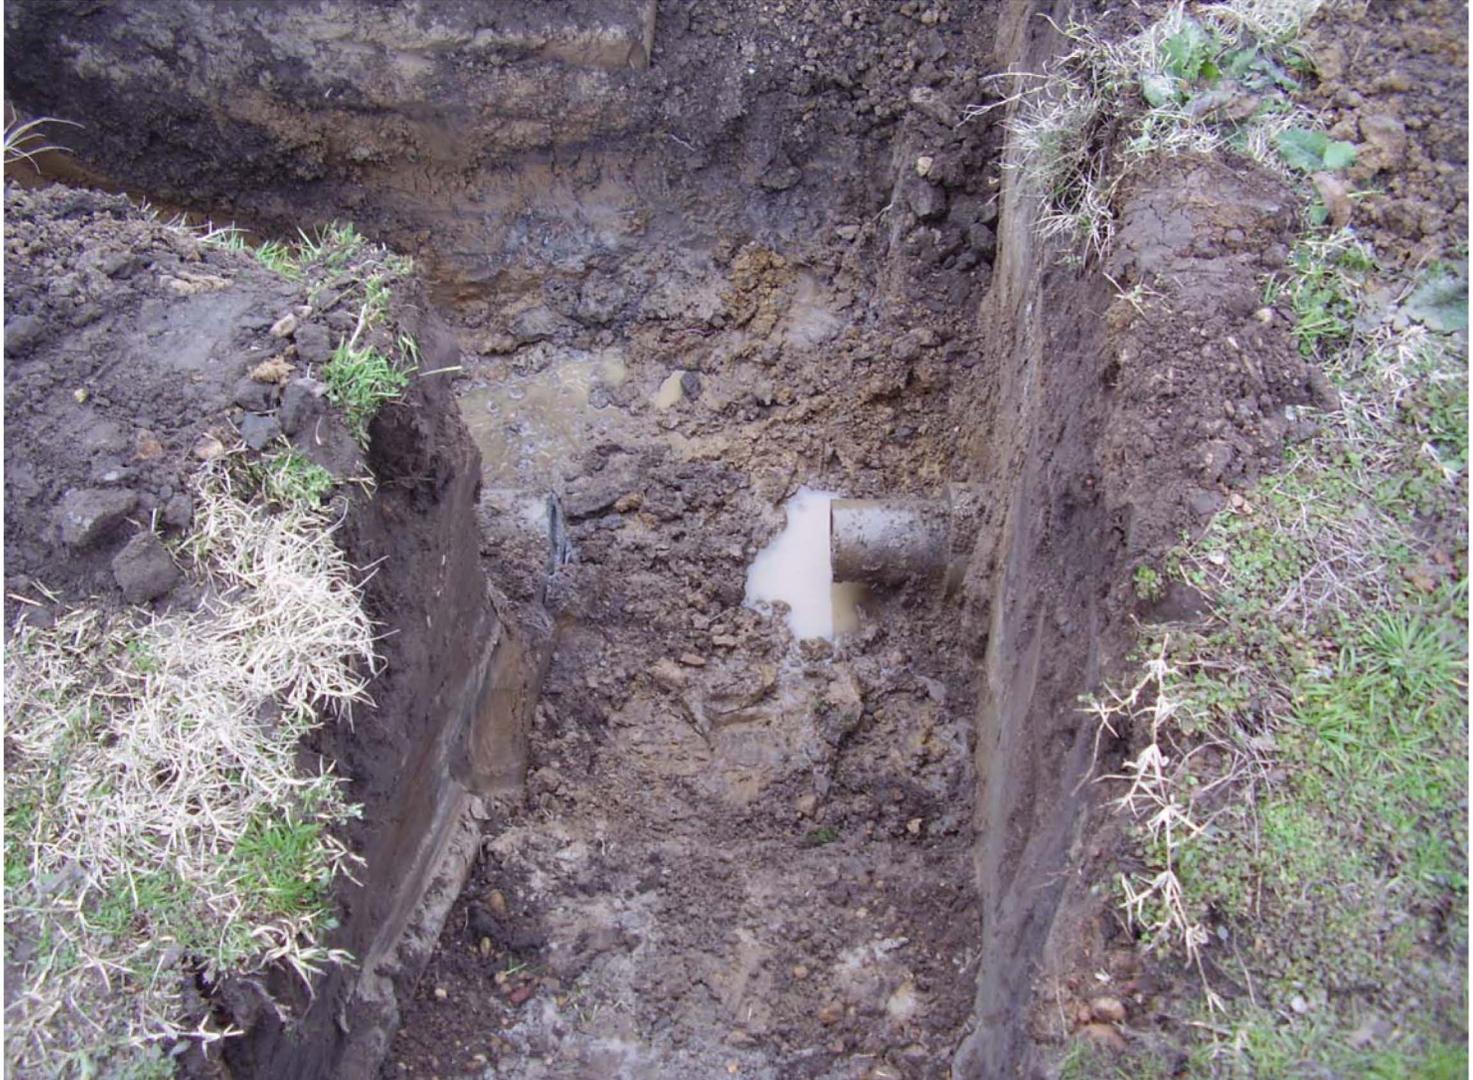
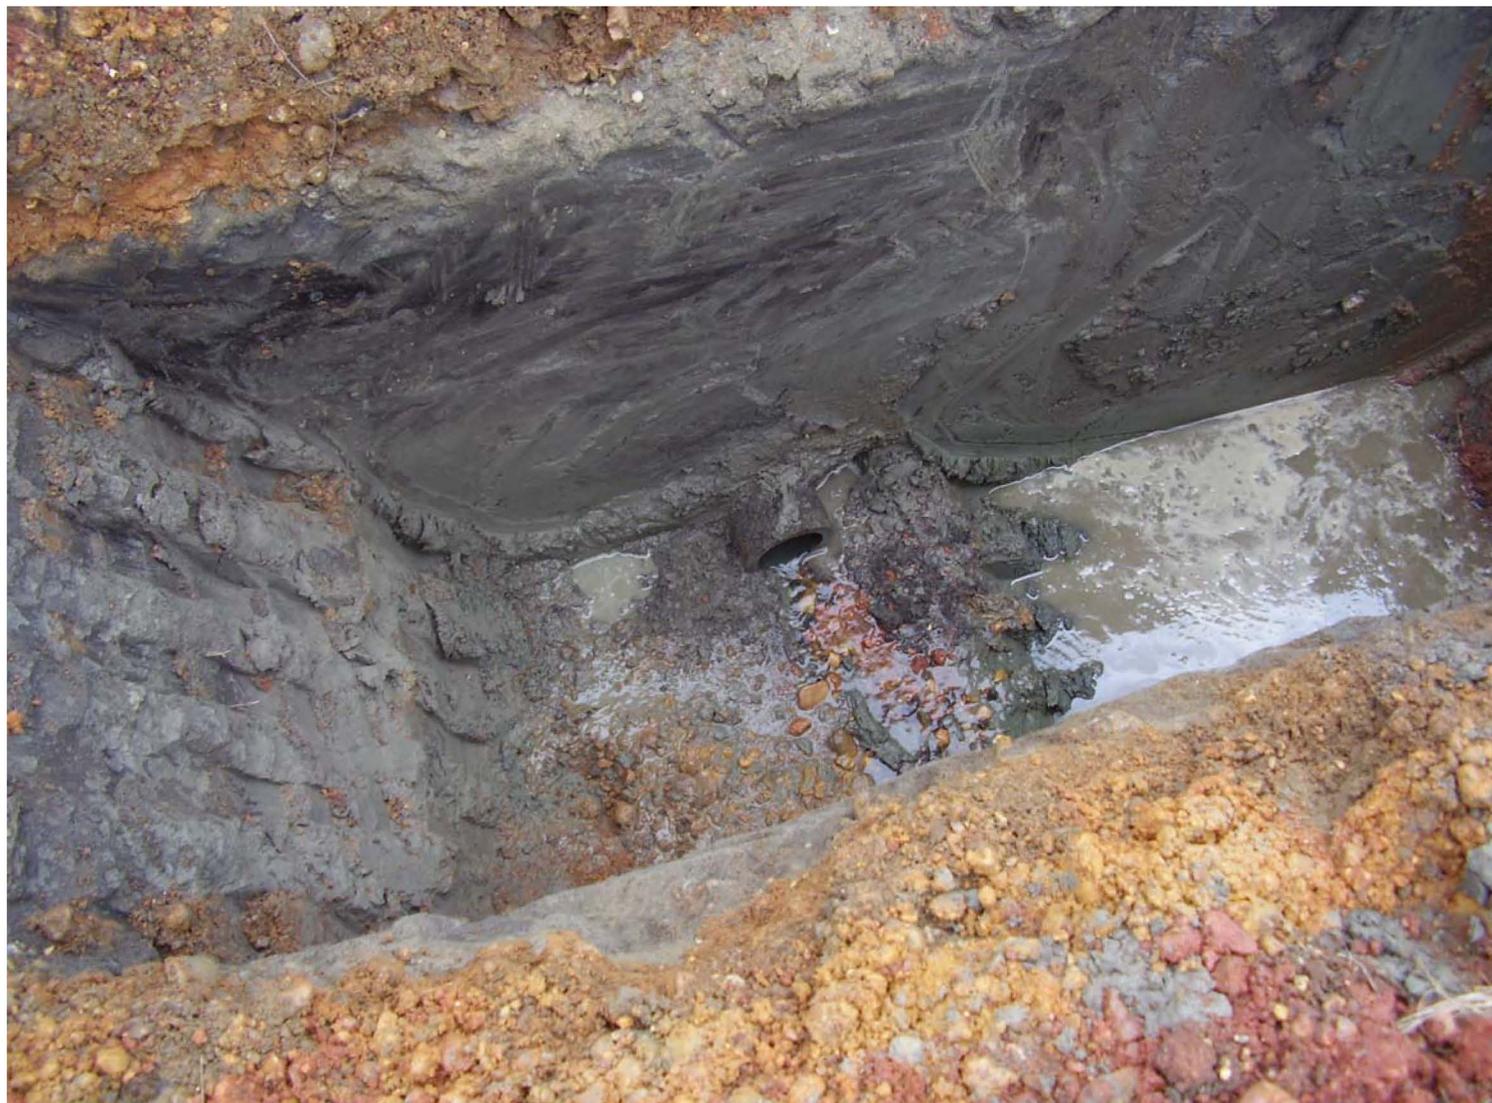
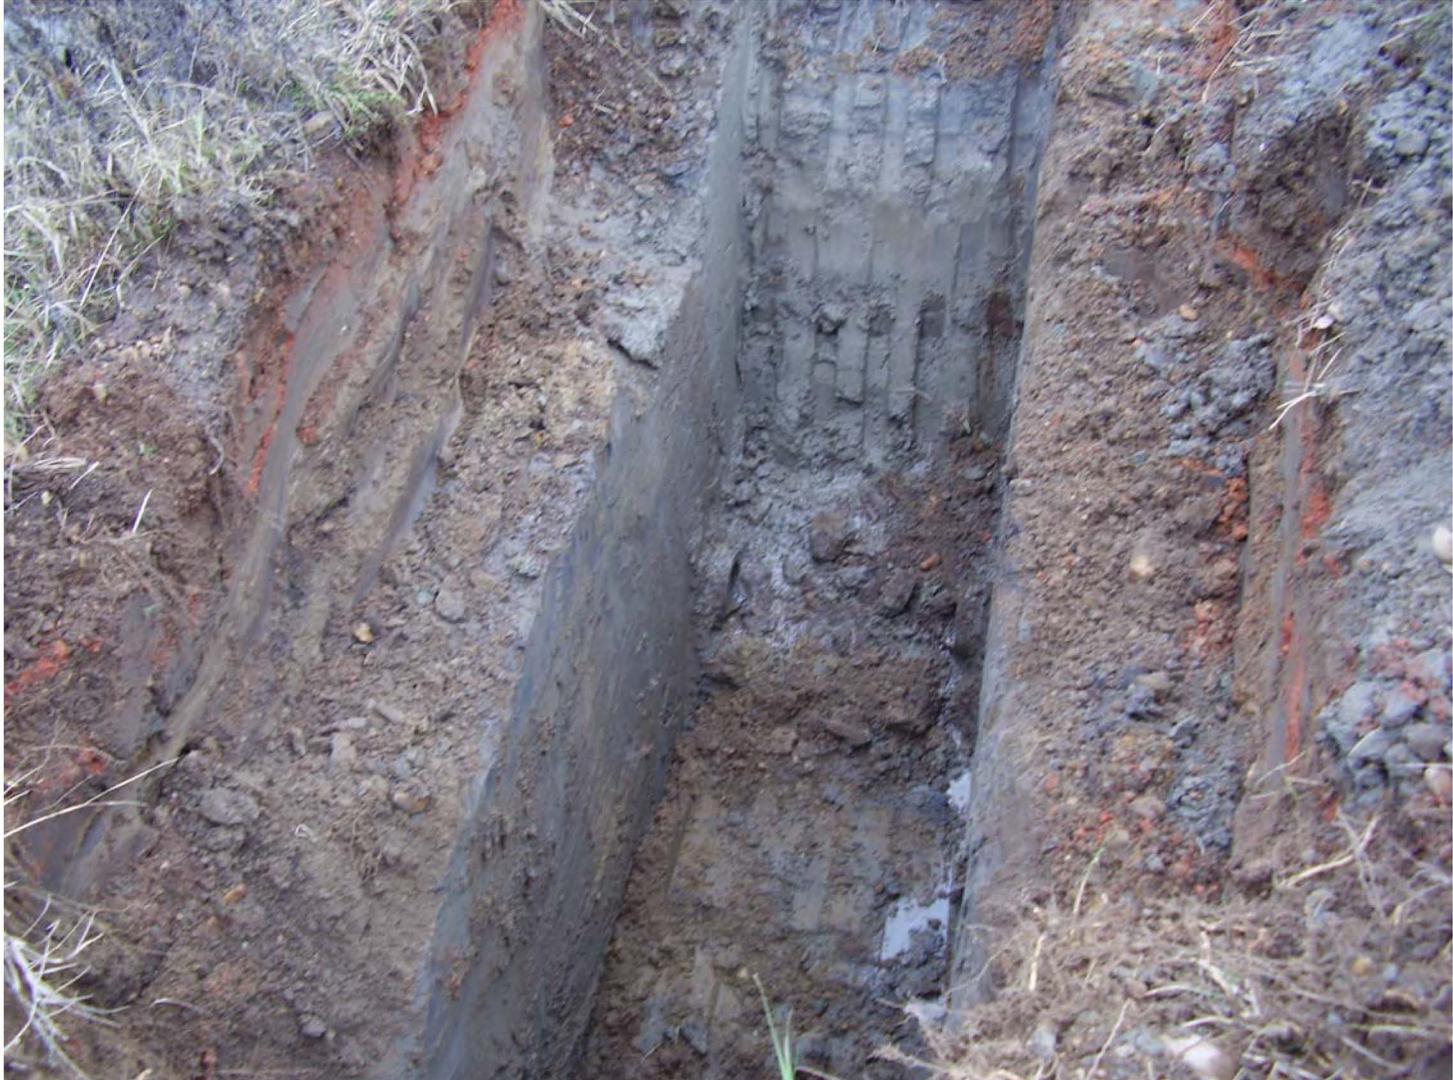
- At three points, cut and sealed transite water mains that serviced East Pool Street and locations south of the former South Bulk Plant
- Some of the transite mains passed through grossly contaminated soil at the South Bulk Plant

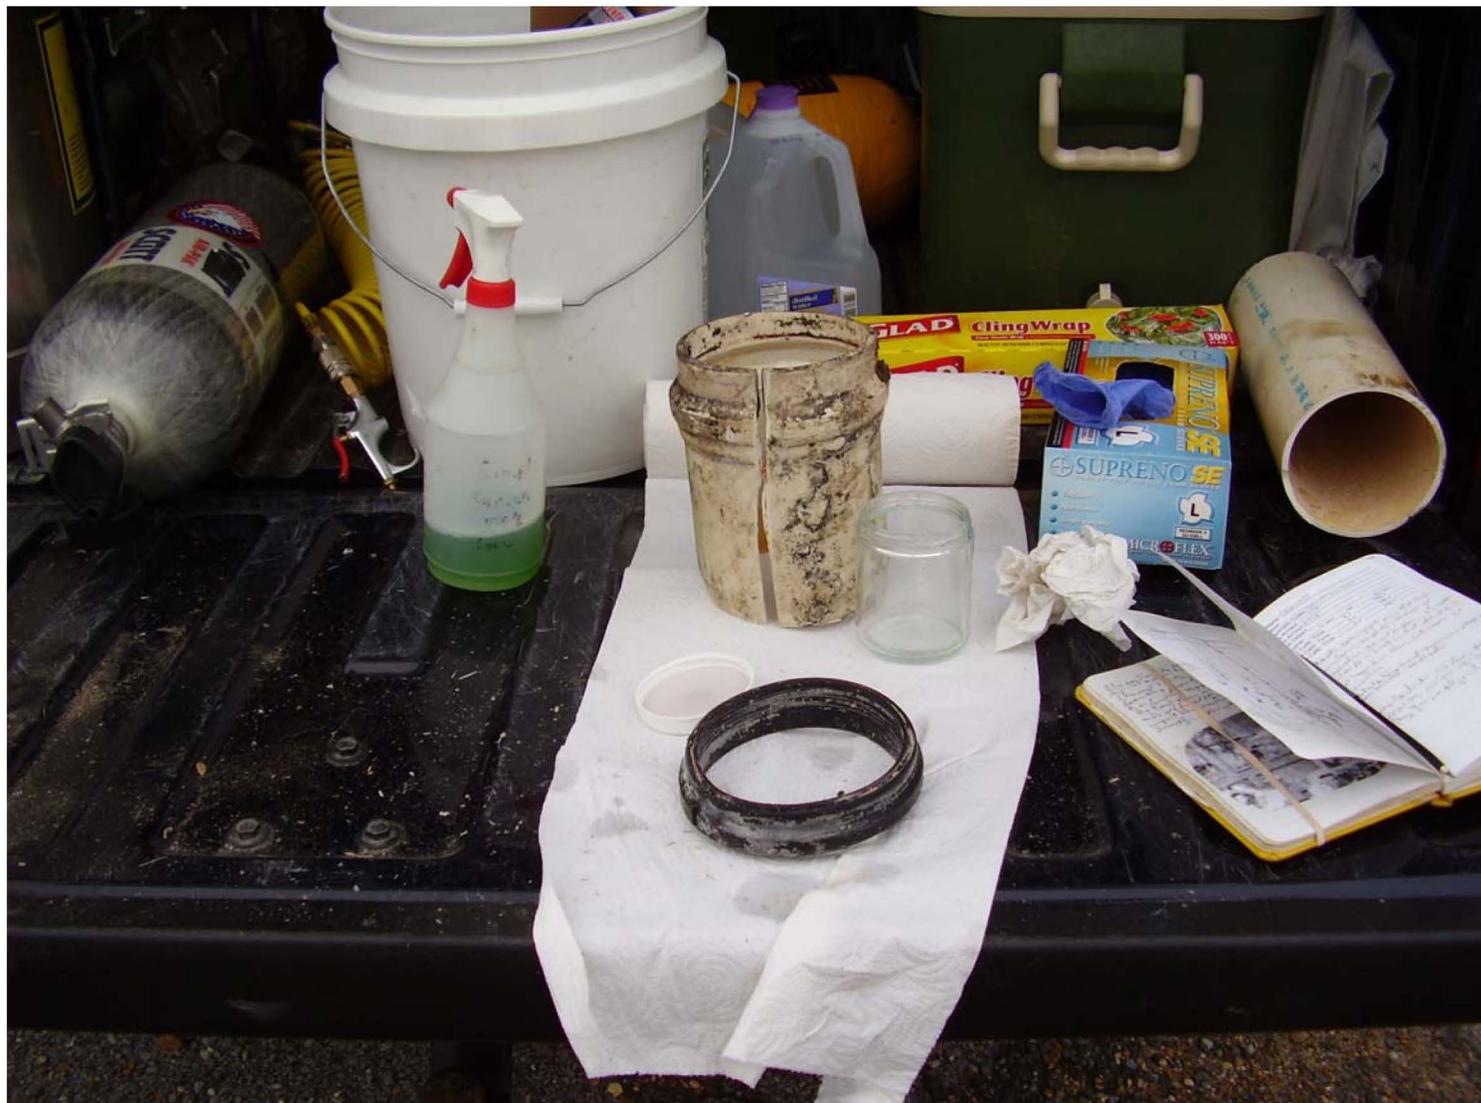
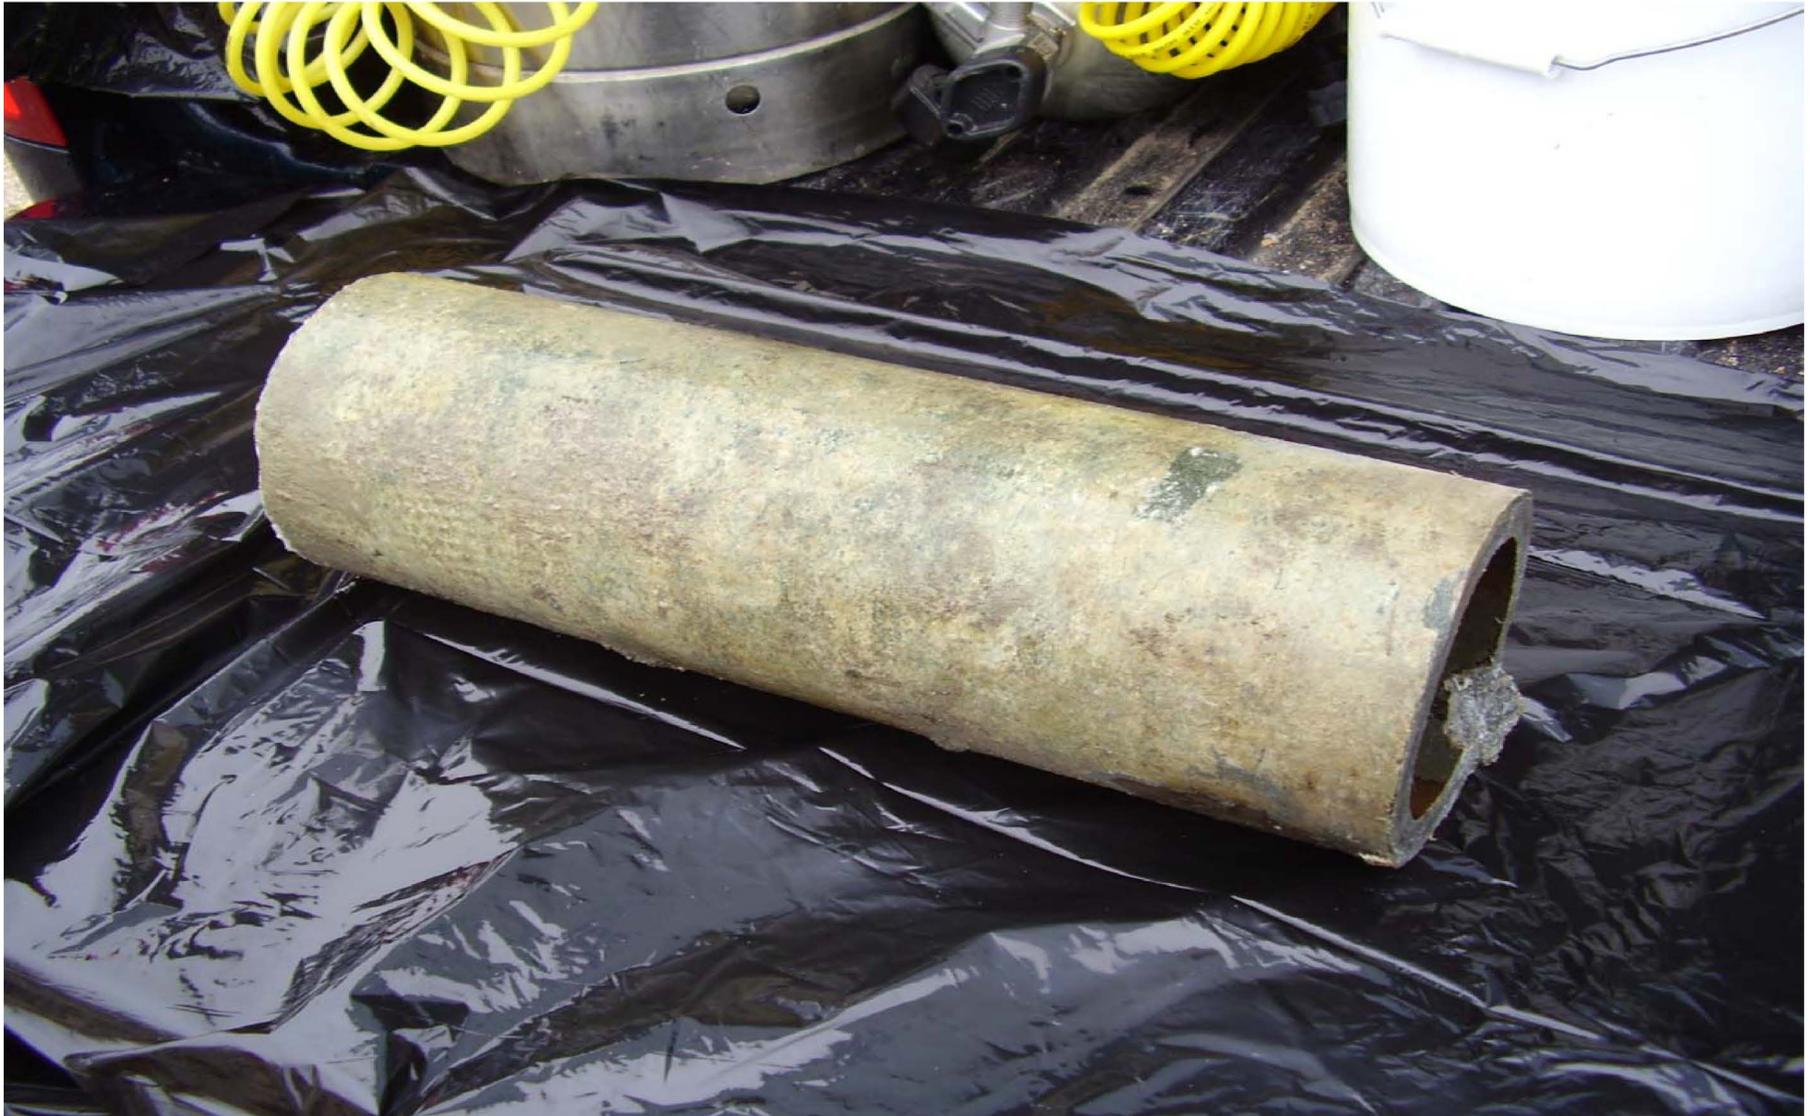
- To determine if petroleum might have permeated old distribution system
- Sections of the old PVC and transite water mains were collected, sealed, and filled with distilled water

- Desorption field test results confirm research from scientific literature, mainly that:
 - PVC is highly resistant to petroleum permeation
 - Transite, polyethylene waterlines, and rubber gaskets are vulnerable to permeation

- The PVC waterline at Martin Oil site was not permeated by petroleum
- Rubber gasket material was permeated
- Transite and polyethylene waterlines may have been permeated
- No current threats to the water service near 504 E. Pool St. from either PVC or Transite piping
