Re: Project 1712 Repair Outfall 002 CIPP Liner Repair  
Field Activity Project Summary

To: File 1010C5A – Storm Sewer  
From: M. E. Stites, D/SE1, OC48  
Date: May 27, 2011  
Re: **OUTFALL 002 INSPECTION**

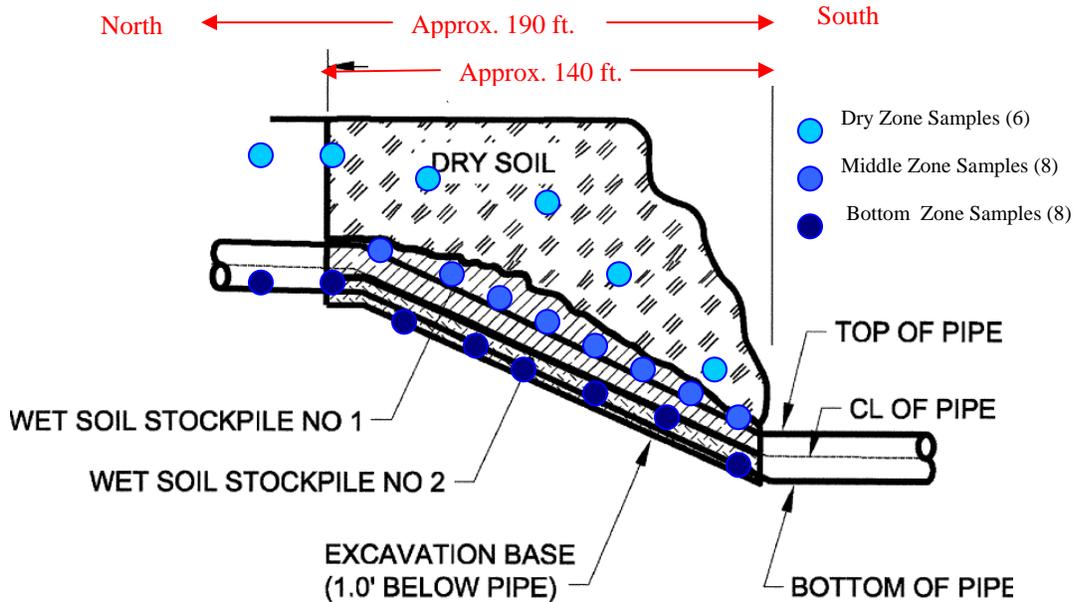
**Figure 1: MDNR Sampling Plan**

Figure 1 below summarizes the MNDR approved sampling plan which designates 22 soil samples for PCB analysis.

Based on Figure 1, three soil zones were identified for sampling as follows:

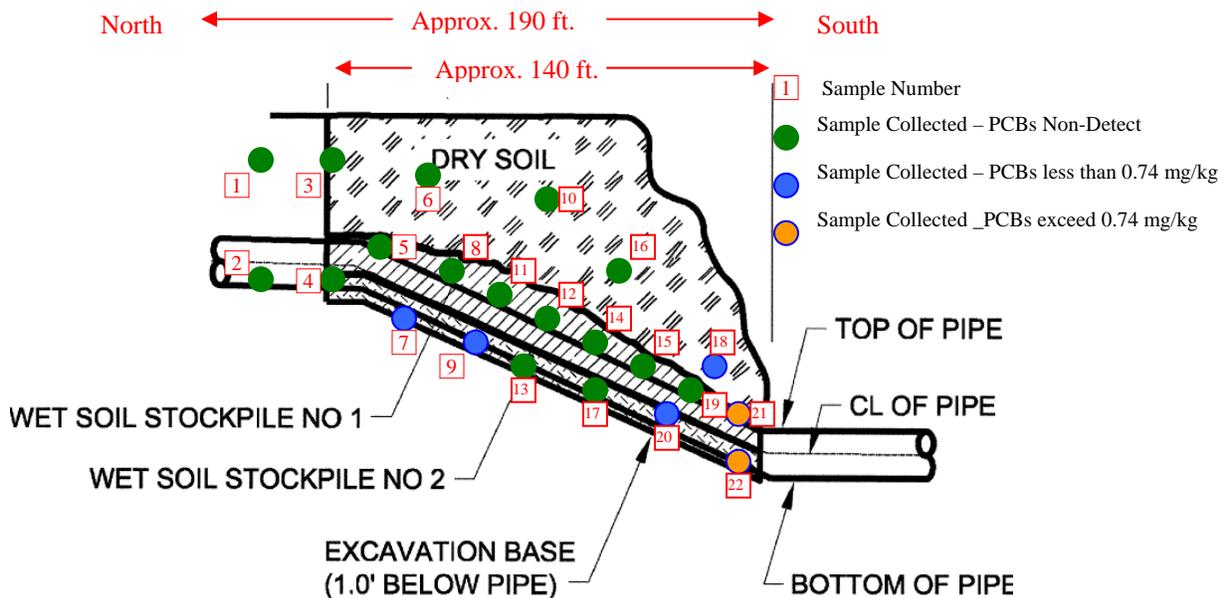
**Figure 2: Excavation Sampling Results**

Based on Table 1, several of the soil samples (7, 9, and 20) had detections of Aroclor 1260 which is potentially associated with asphaltic pipe mastic that had been applied as a construction material to the 66-inch host pipe joints. Upstream of the AICO Inlet/Manhole #2 area, there is no indication that PCBs associated with historic releases migrated outside the 66-inch pipe to surrounding soils. Joints occurred every 5 feet along the pipe length. Aroclors 1242/1248 were only detected in samples nearest the AICO inlet (samples 18, 21, and 22) and are consistent with Aroclors types associated with historic releases described in RCRA Facility Investigation report. Samples 21 and 22 were located just south of a former wing wall and concrete apron that were remnants of the former outfall structure to Indian Creek. Therefore, the low PCB levels are possibly the result of the historic releases at the former outfall (as opposed to exfiltration through the 66-inch concrete pipe to adjacent soils).

**Soil exceeding 0.74 mg/kg:** Soil samples 21 and 22 were collected from the zone where a replacement manhole was constructed. This area consisted of a 24-ft long by 14-ft wide trench box. All the soil from this area was stockpiled in a dedicated area on a double layer of 30-mil liner, then disposed as special waste at the Deffenbaugh facility. The 24-ft by 14-ft wide trench box yielded 314.3 tons of soil with minor amounts of concrete debris associated with a buried concrete apron associated with the former Indian creek outfall structure. Additional information on stockpile management and disposal quantities is provided in Sections 7.0 and 8.0 of this memo. Sample 22 was a biased sample in that soil selected was based on visual criteria deemed most likely to preferentially contain PCBs. The particular soil horizon was a small pocket of organic rich soil that appeared to be a marshy, decayed vegetation-rich material associated with the former Indian Creek stream bed/bank system. The organic-rich material would be expected to have preferentially adsorbed PCBs. This organic rich material and all adjacent soils were excavated in order to accommodate construction of the new manhole and concrete bulk head within the 24-ft long x 14-ft wide trench box.

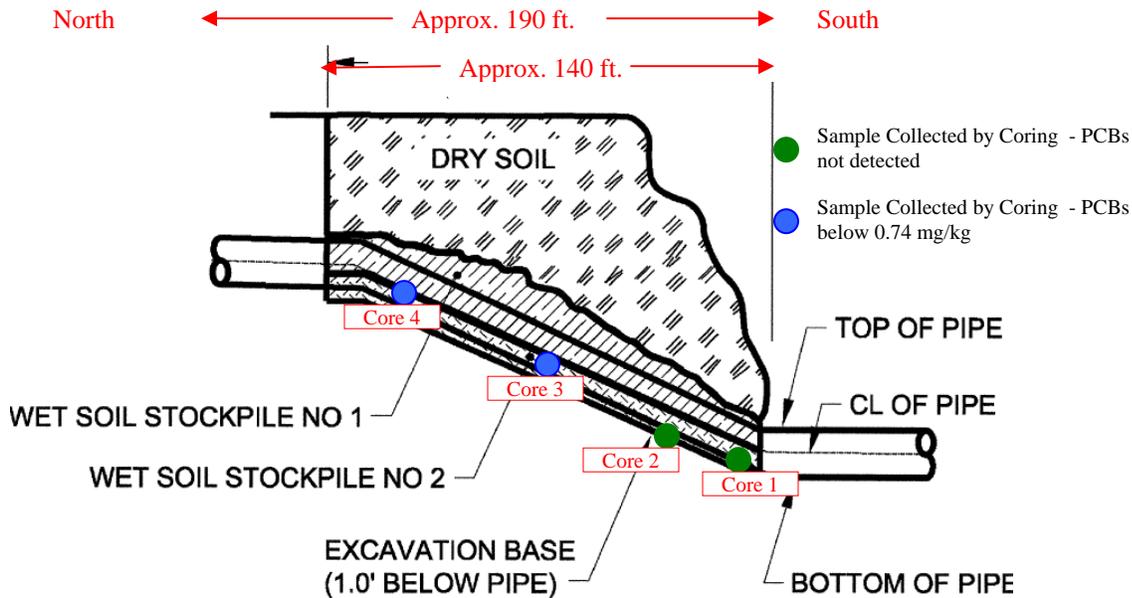
**Figure 3: Core sample locations through the 66-inch host pipe.**

Prior to start of excavation, samples were collected from soil located immediately adjacent to the 66-inch pipe at the ½ pipe diameter height (3 and 9 o'clock positions) and below (6 o'clock position). These samples were collected June 3 to 4, 2010. Table 1 Summarizes. Samples were collected by core penetration of the host pipe and collecting soil immediately adjacent to the pipe as part of the design. Figure 3 (below) also summarizes the PCB results for the cored locations. Aroclor 1260 was the only Aroclor detected and is potentially associated with construction materials such as mastic material that has been applied to the 66-inch host pipe joints. During the 66-inch pipe removal, a sample of mastic material associated with the host pipe was collected and analyzed with a result of 3.49 mg/kg PCBs (Aroclor 1260), indicating a potential source.

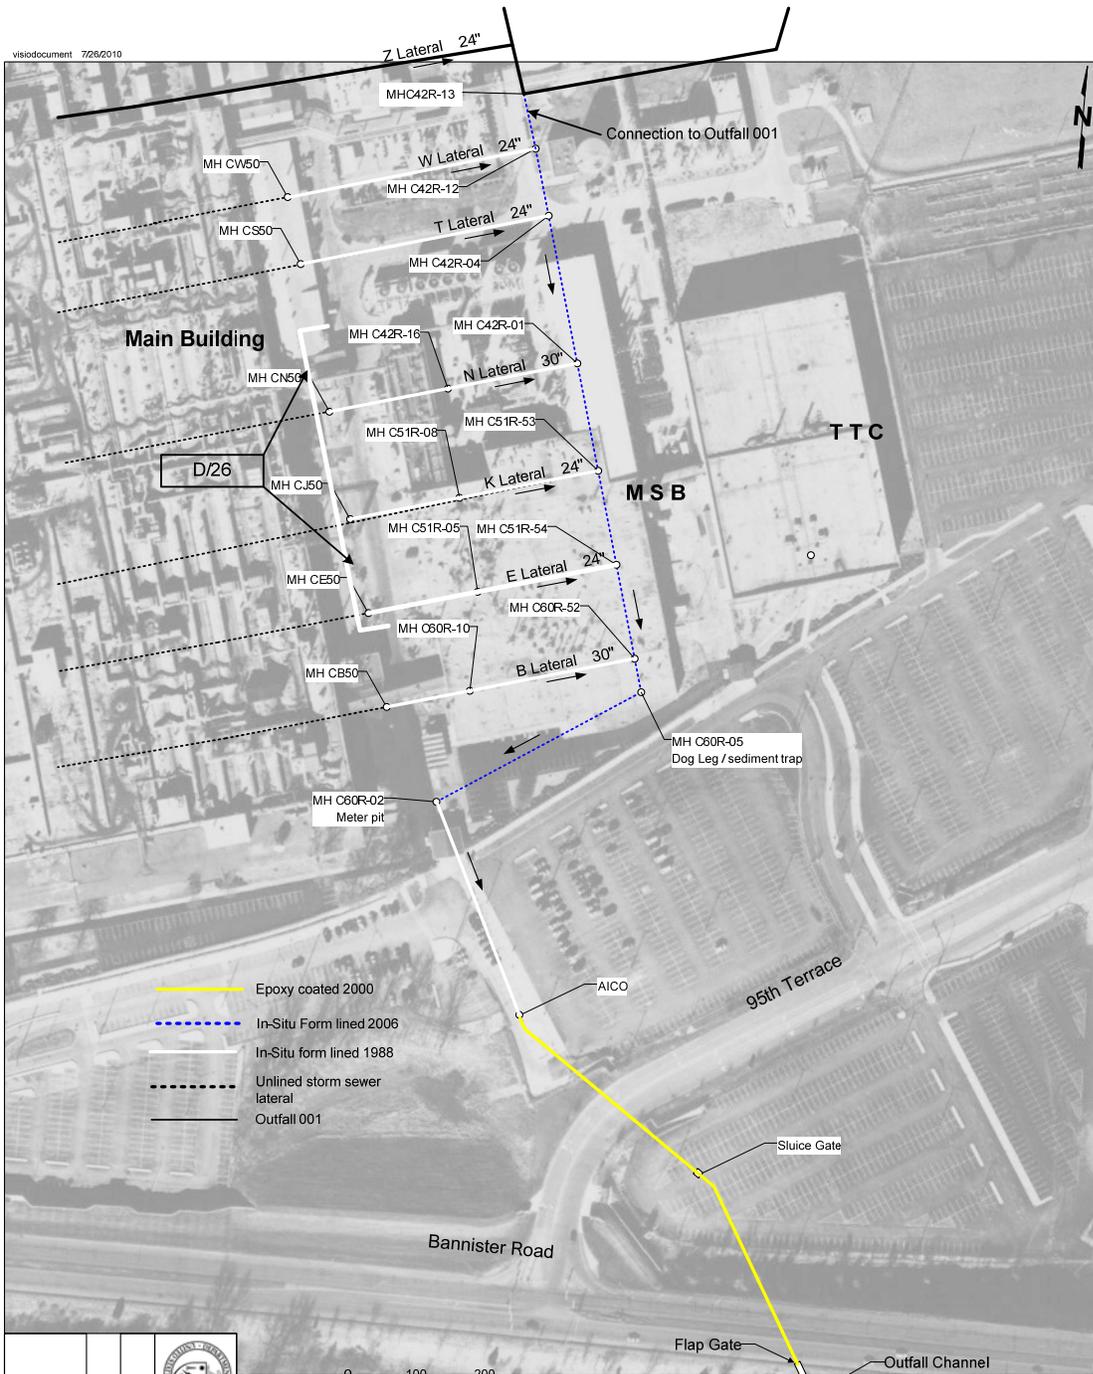
| | | | SEPTEMBER 2006 | FIGURE 1 |

As a result of completion of the 002 reroute system, base flow rates (i.e., non-rain event flows) in the 002 system downstream of the dog leg have been eliminated. The main purpose of this inspection was to review the recently completed work to repair the section of line between the AICO inlet and the meter pit manholes (Figure 1). Due to the above noted construction, cleaning of the main trunk line is not needed at this time.

The interior condition of the outfall piping is in excellent condition with no signs of infiltration or excessive sediment accumulation. The Outfall 002 reroute system continues to effectively reroute all base flow within the system resulting in no discharge during periods of no precipitation.

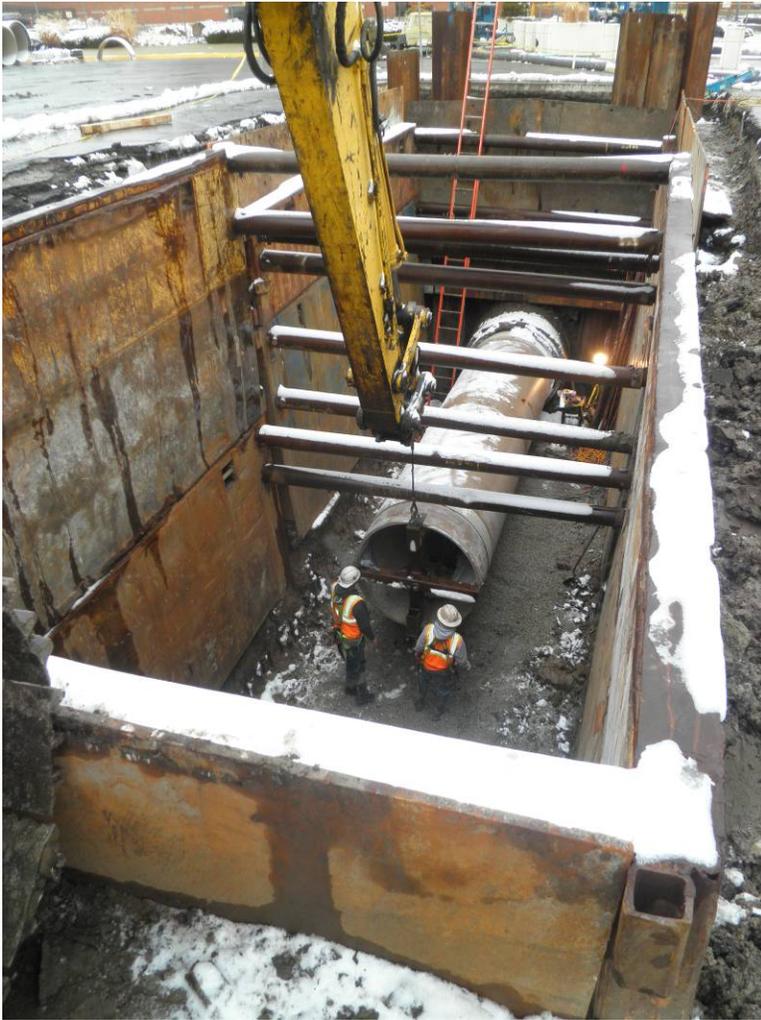
Section of new storm sewer piping being installed during Outfall 002 repair work.
