Memorandum

To: File 1010C5A – Storm Sewer
From: M. E. Stites, D/SE1, OC48
Date: December 15, 2011
Re: **OUTFALL 002 INSPECTION**

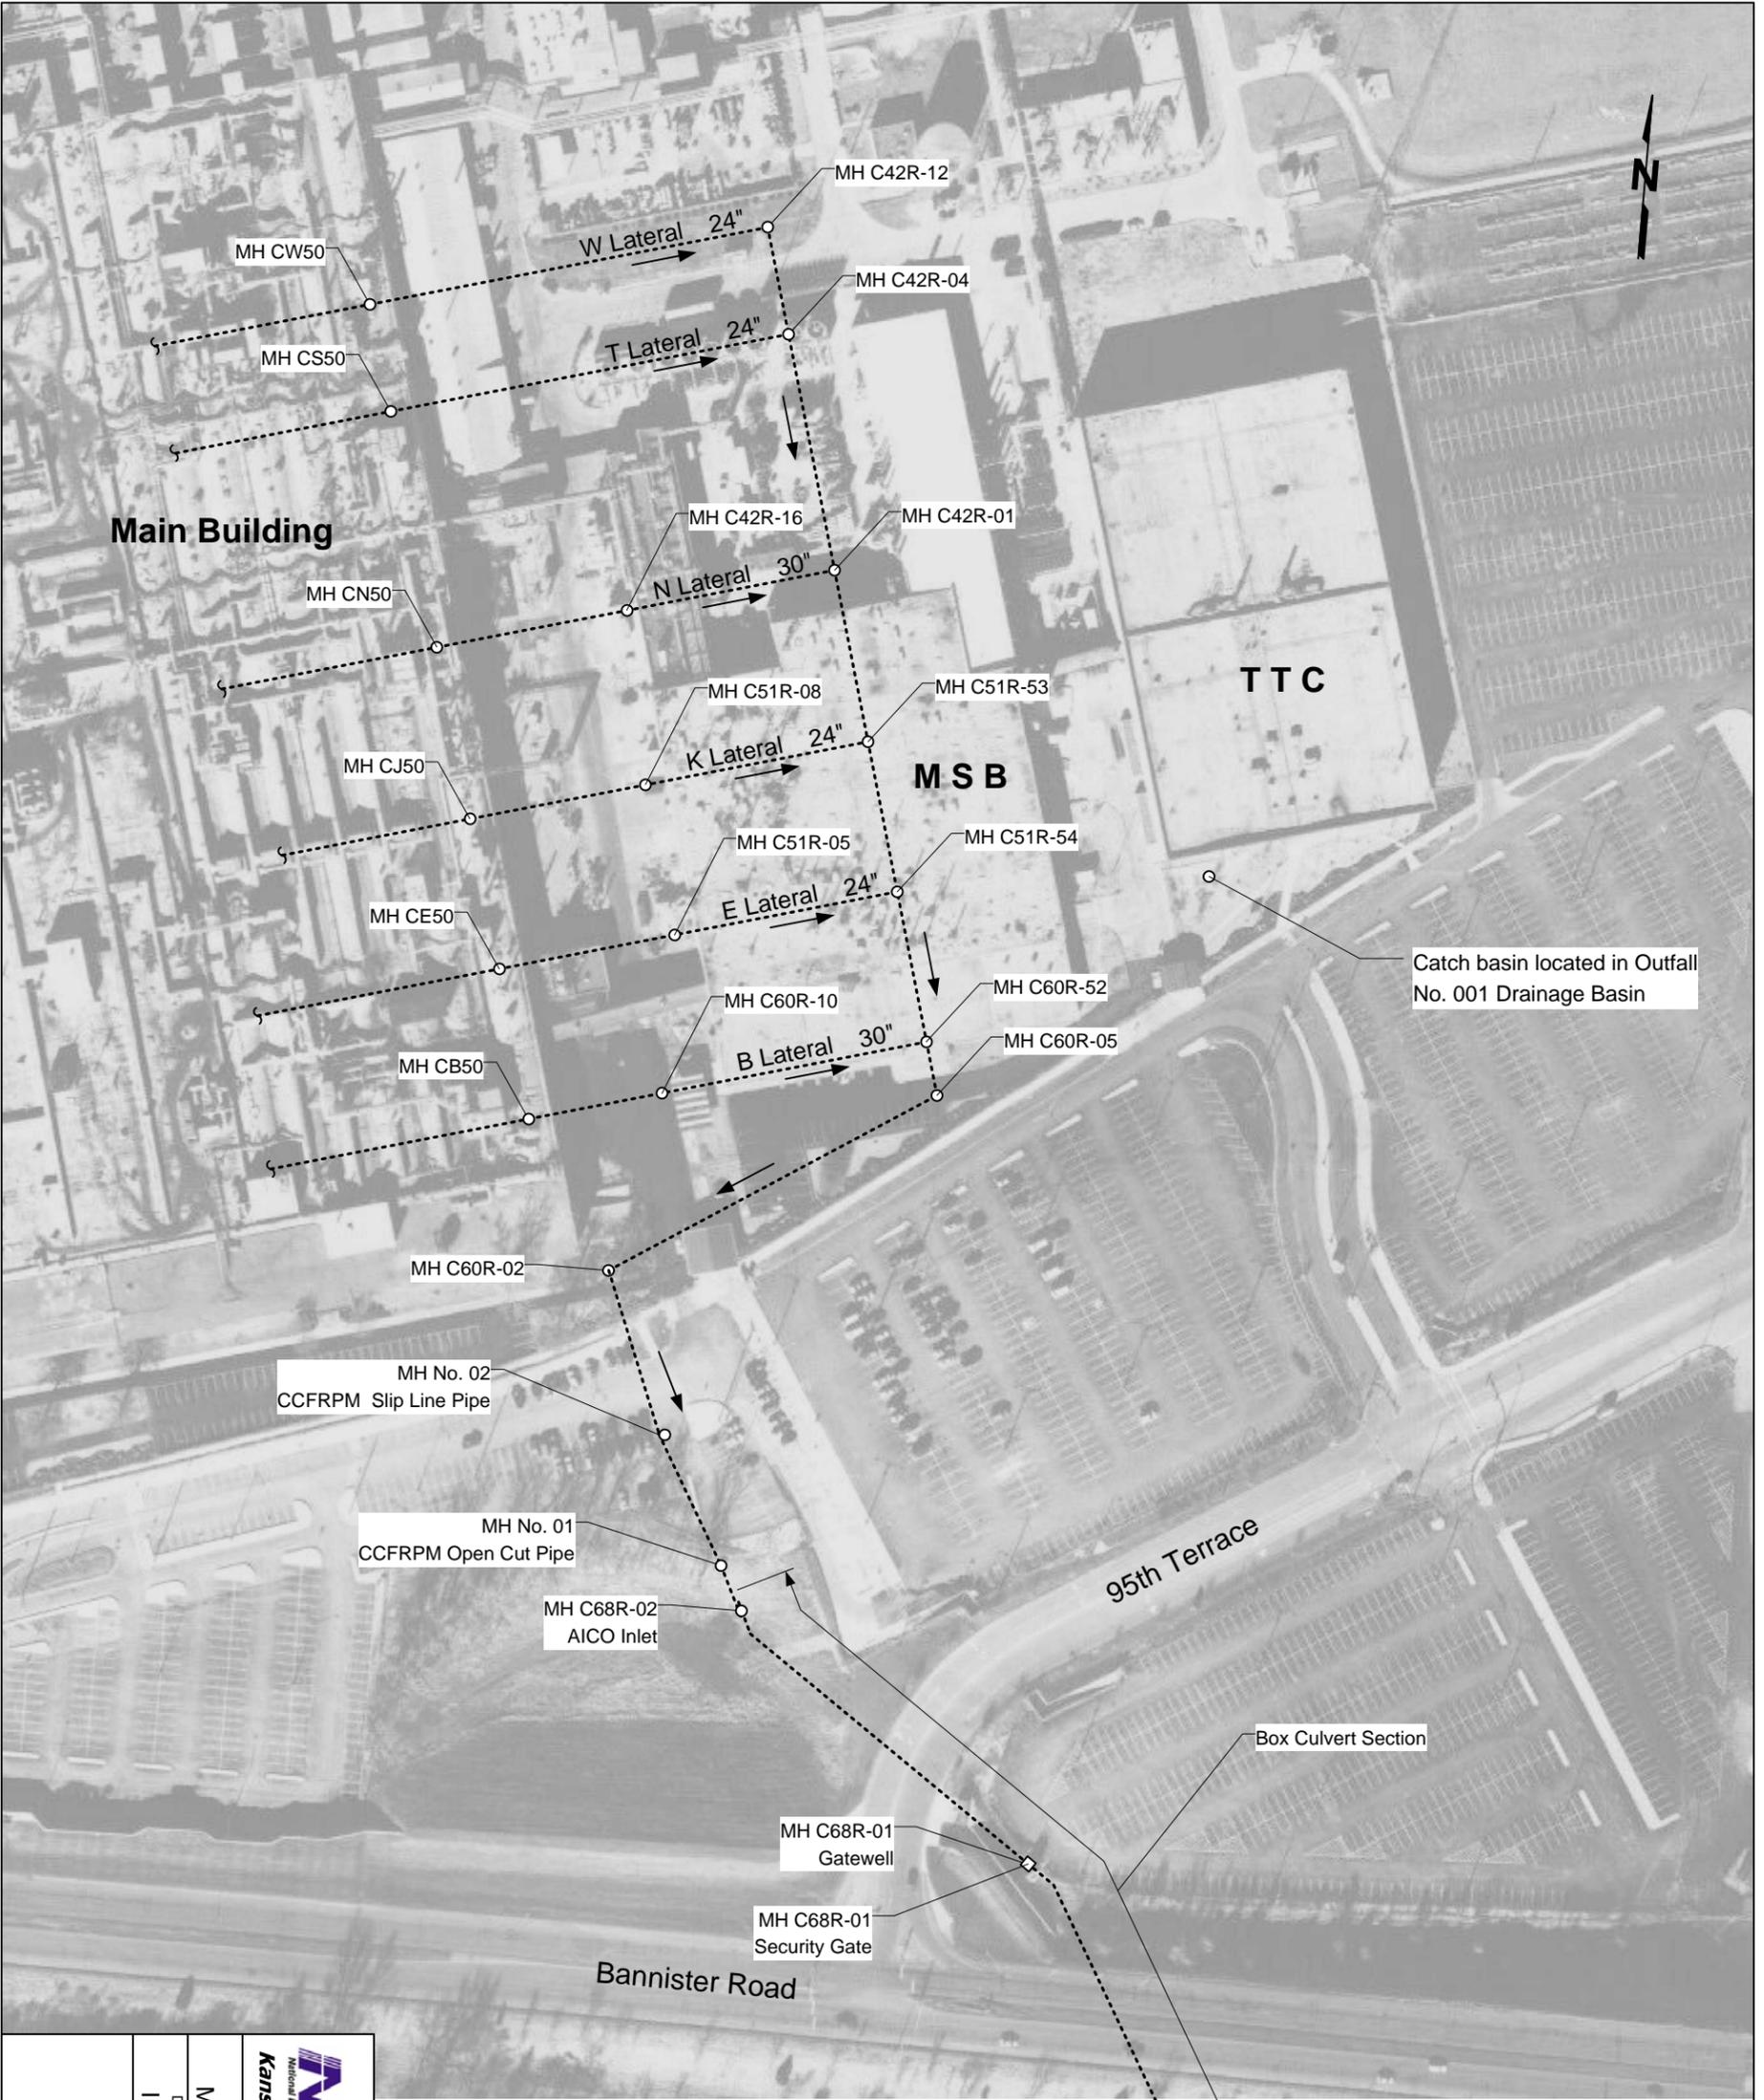
| Outfall 002 System Layout Storm Sewer Outfall 002 Inspection | Owner | Operator | Project Manager |

An interior inspection of the Outfall 002 system main trunk line was conducted on December 15, 2011 by Ernest Dibal (FES) and Colm Chomicky (Burns & McDonnell). Refer to Figure 1 for locations identified in this narrative. Elaine Brewer (FES) served as confined space attendant. The inspection team entered the 002 system at the Abandoned Indian Creek Outfall (AICO) drop inlet and proceeded south to the flap gate where the inspection was initiated. The team inspected the interval from the flap gate at Indian Creek north (upstream) to the meter pit, then east to the dog-leg, then north to the Outfall 001 crossover.

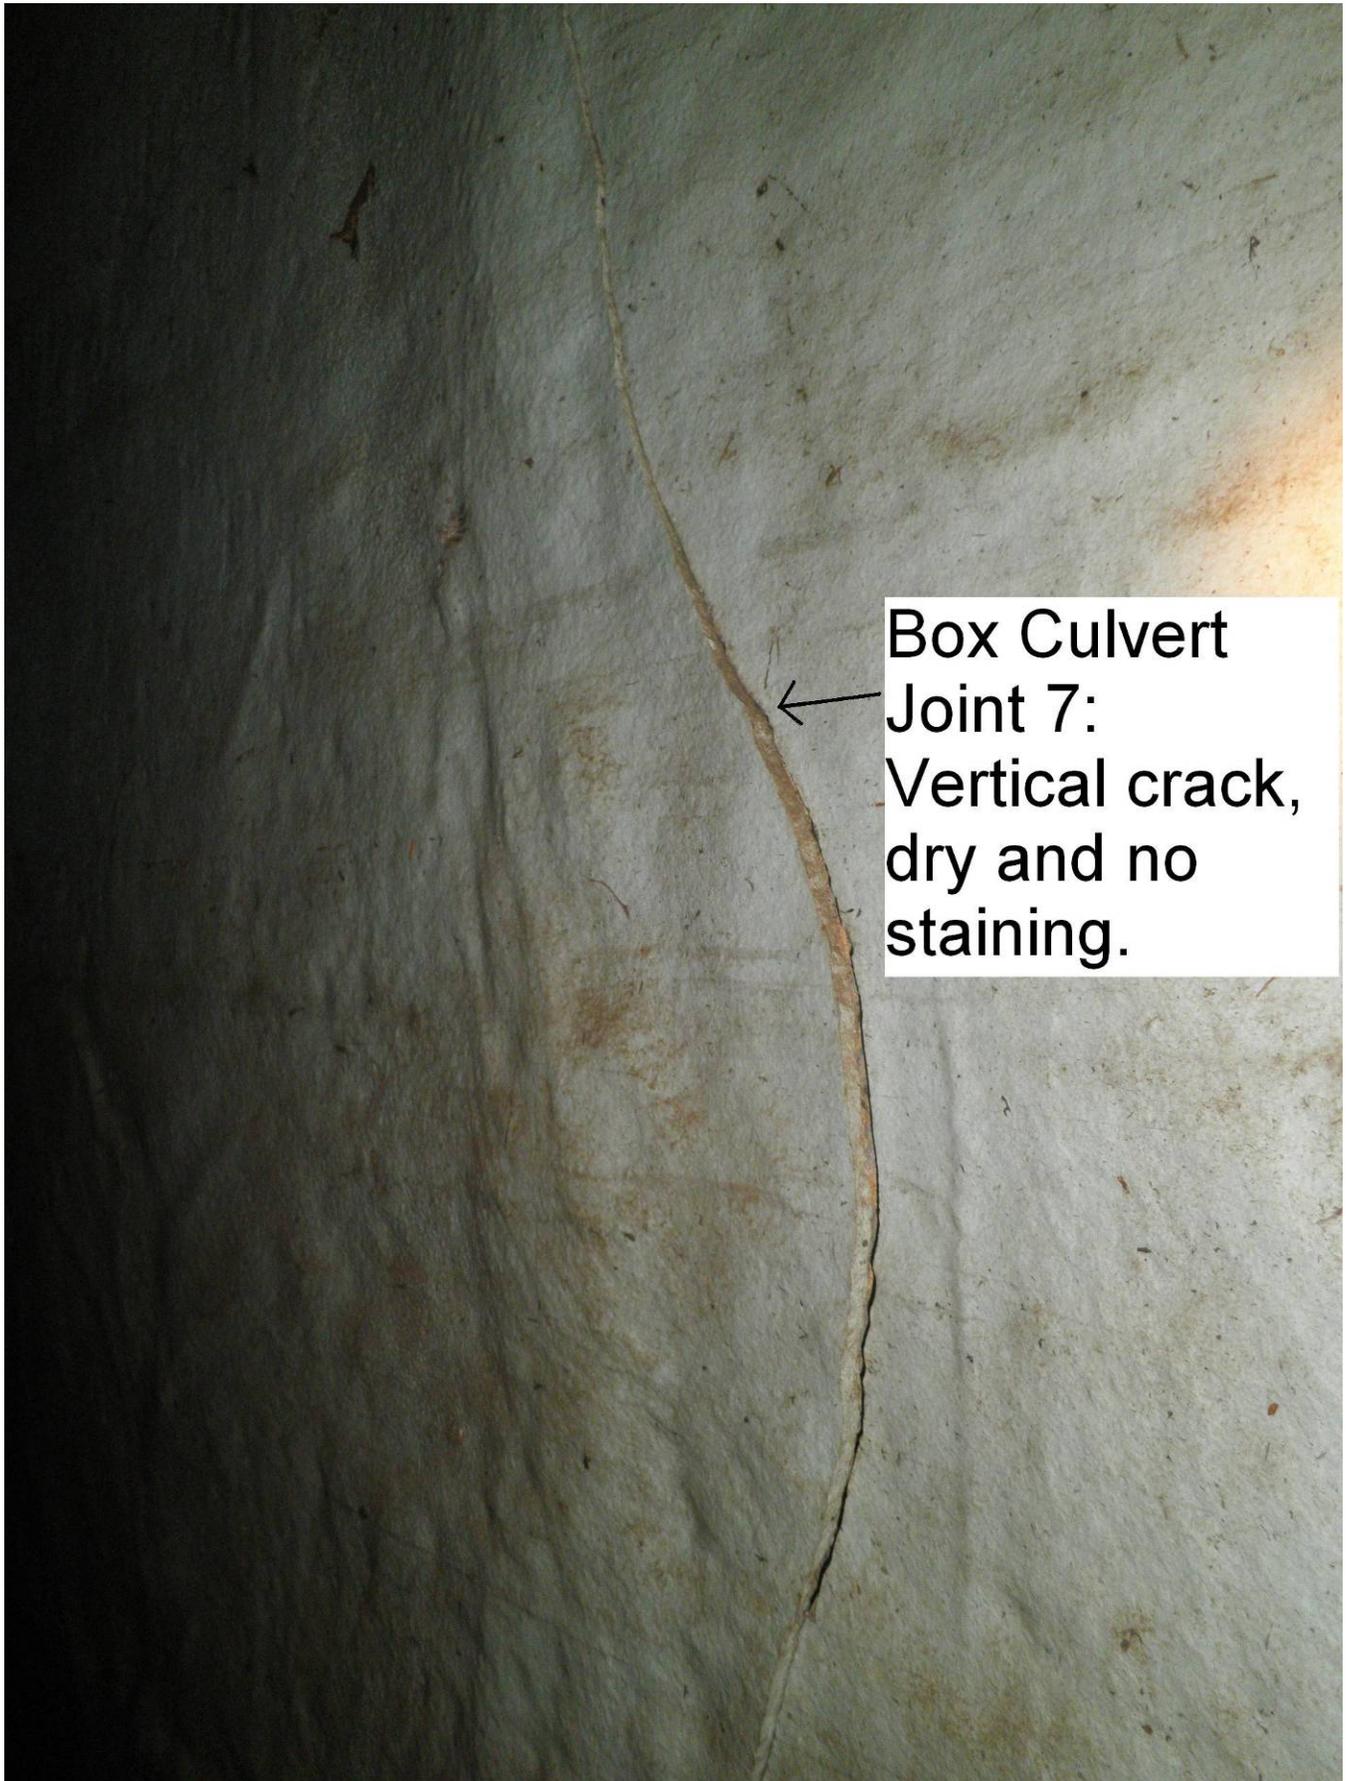
Minor flaking of patching material was observed at Joint 16 in the box culvert section and a crack was observed at Joint 7. No infiltration is observed at these joints. These joints will be evaluated for repair.

Box Culvert
Joint 7:
Vertical crack,
dry and no
staining.

The 5' x 7' box culvert section of piping begins at the AICO inlet and runs south to the termination of the box culvert at the flap gate structure. Only minor sediment deposits were observed in this interval. No active groundwater seeps were noted during the inspection. All joints in the box culvert have been grout-injected on the ceiling and sidewalls. In addition, floor joints were grout-injected during October 2008 and appeared in very good condition. Minor blemishes were observed at Joint 16 (loose patching, no seepage) and a crack at Joint 7 (dry crack with ¼-inch offset, no seepage). Blemishes and minor cracking at these pipe joints will continue to be evaluated during semi-annual interior pipe condition inspections. Joints 16 and 7 (although not leaking) will be evaluated for potential repairs prior to next inspection.

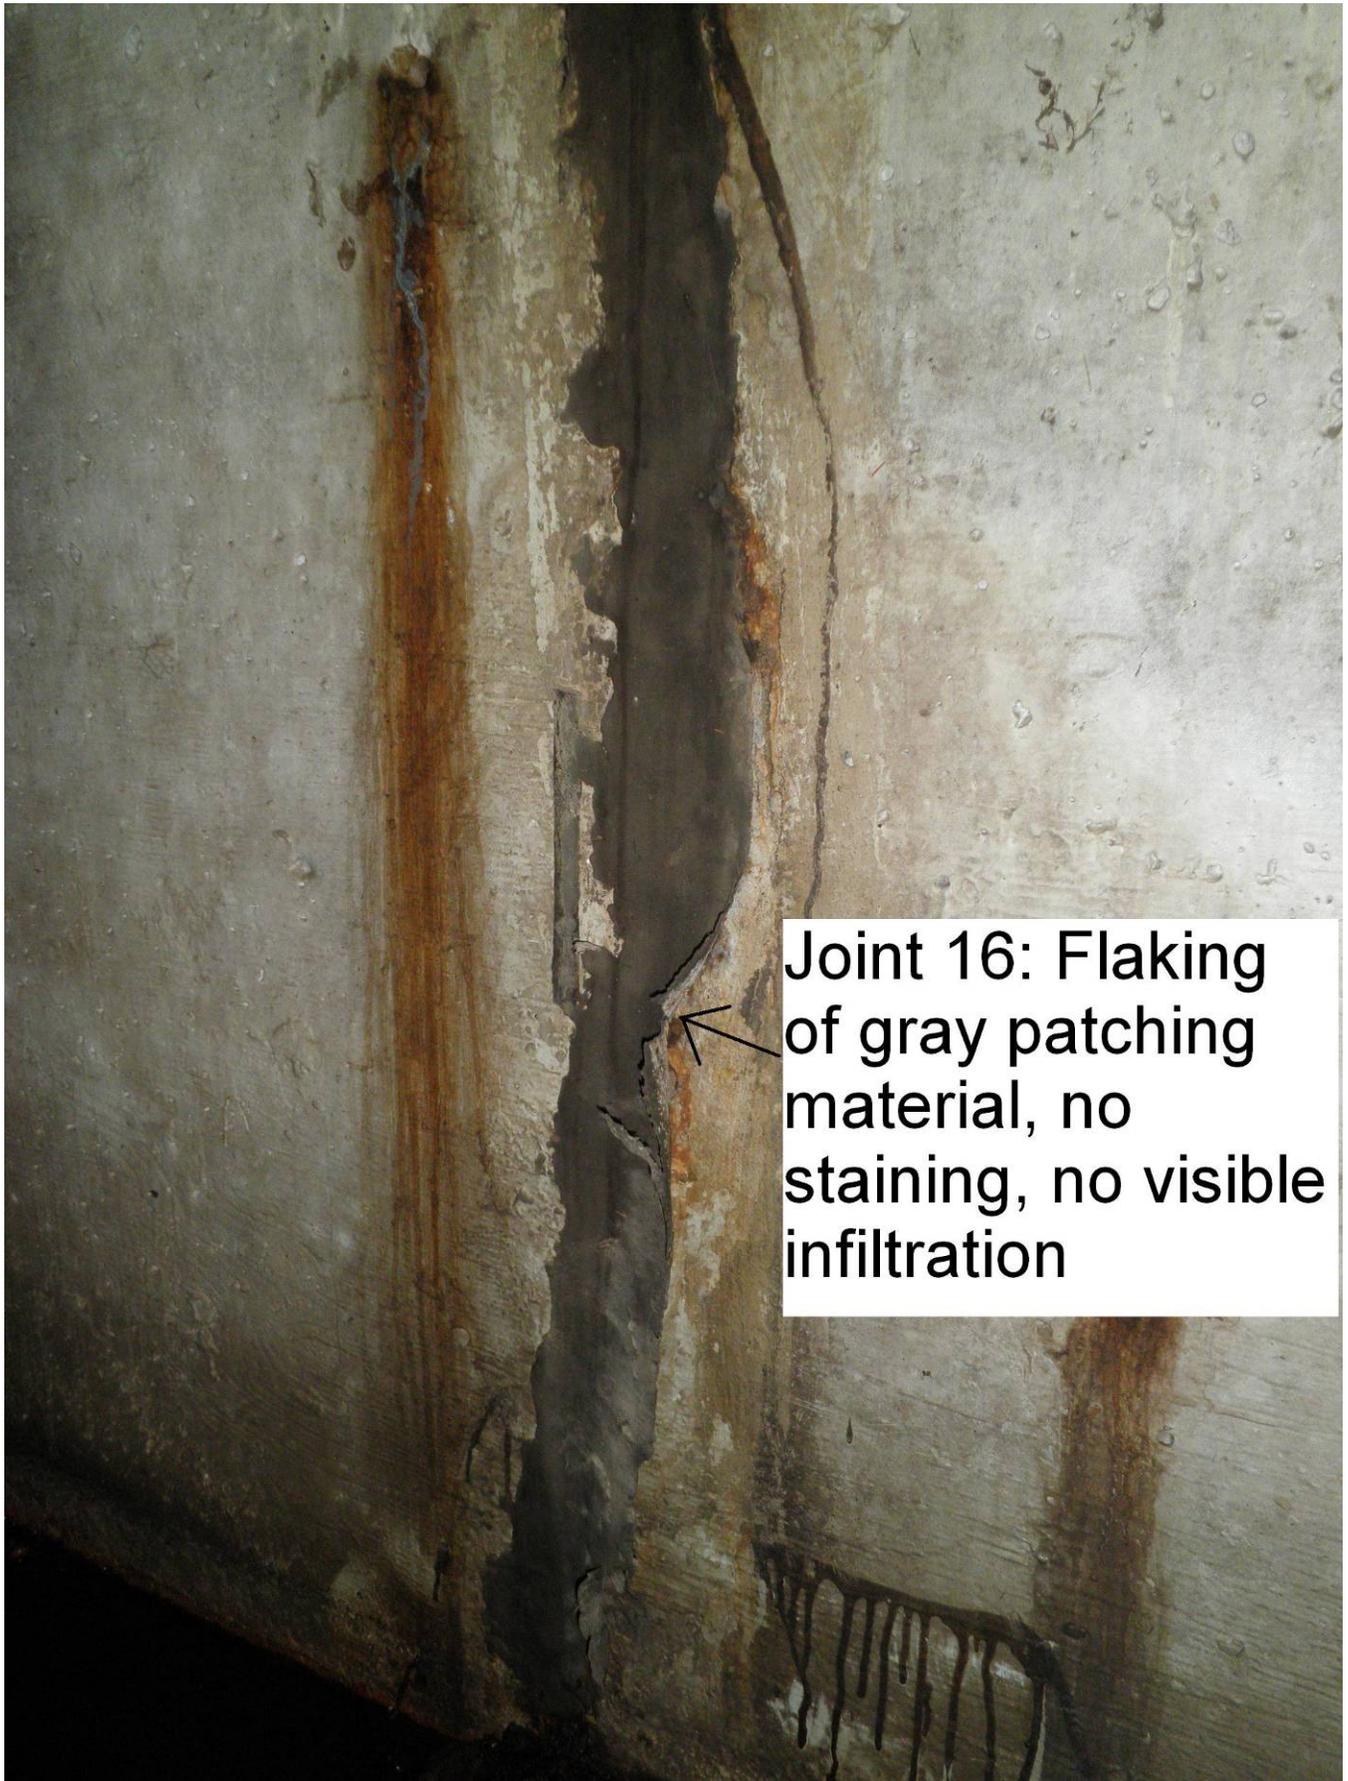
Joint 16: Flaking of gray patching material, no staining, no visible infiltration

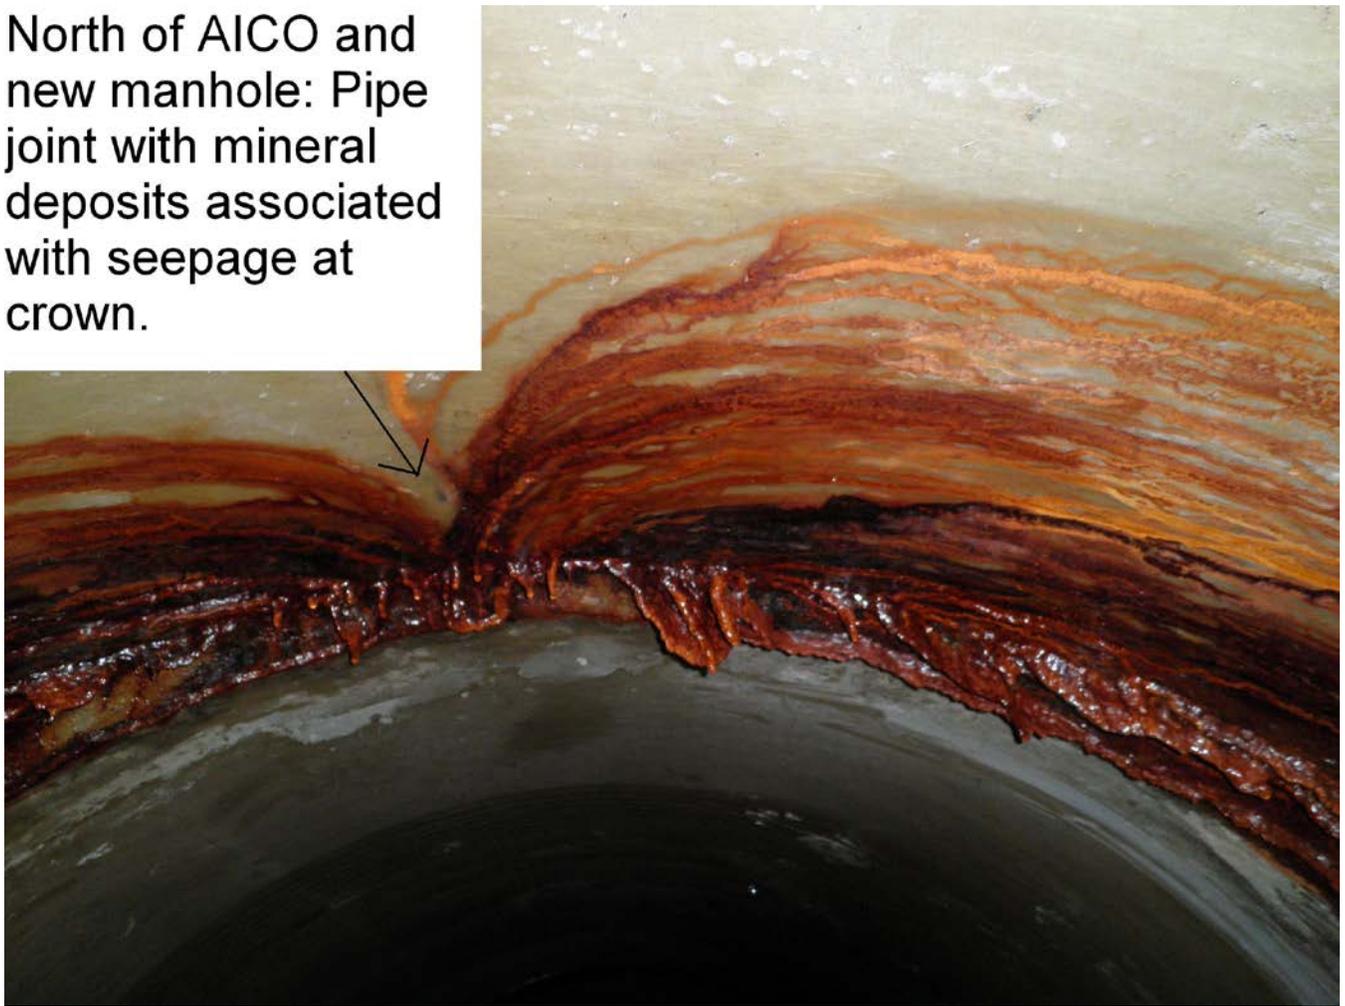
The December 2011 inspection of the new HOBAS pipe from near the AICO to the meter pit showed the new pipe and joints to be in excellent condition, with exception of infiltration staining at one joint adjacent (north) of a new manhole just upstream of the AICO inlet. This joint will be evaluated for repair.

New 60-inch HOBAS piping was installed just upstream of the AICO inlet to the meter pit. One joint shows evidence of infiltration. A repair will be evaluated for this joint.

North of AICO and new manhole: Pipe joint with mineral deposits associated with seepage at crown.
