Final Middle Fork Water Treatment Plant and Reservoir Condition Technical Memorandum

**U.S. Army Corps of Engineers
Kansas City District**

**Northwest Missouri Regional Water
Supply Transmission System Study
Phase V**

June 2012

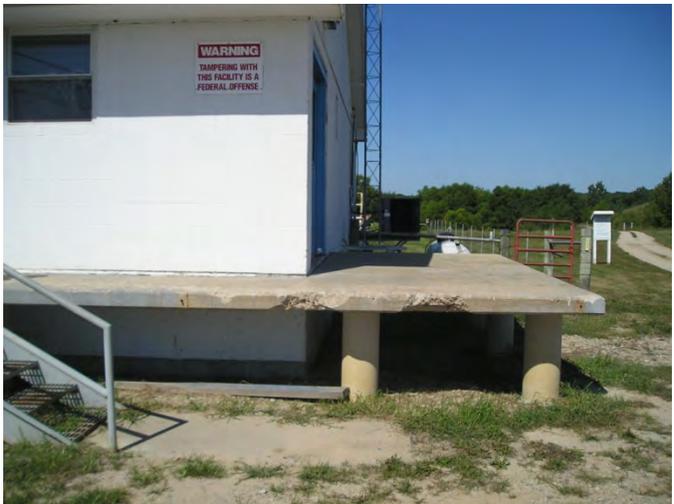
Structural reinforced concrete in the facility is generally in good condition, with two notable exceptions. Considerable damage to the loading dock face has occurred, exposing reinforcing steel. The concrete in this area should be scarified to remove loose material and patched to prevent further reinforcing steel corrosion. Dock bumpers should be installed to prevent further damage.

Treatment Building – From Southwest	Loading Dock – Note Damage
-------------------------------------	----------------------------

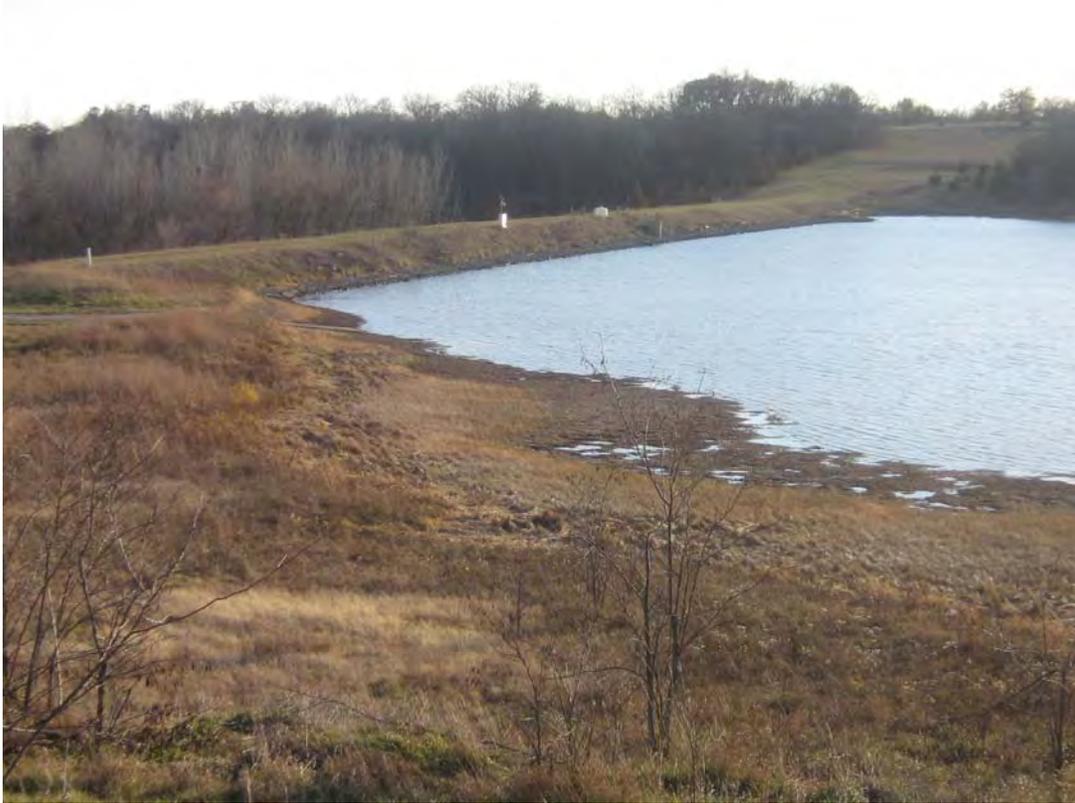
An erosion rill was observed on the downstream embankment slope, to the right of the primary spillway outlet (Photograph 26). In addition, a 6-inch-diameter animal burrow was observed on the slope left of the 6-foot-diameter primary spillway outlet pipe (Photograph 23 and 24). The abutment contacts appear to have a good transition into the natural topography (Photographs 1 and 7).

Photograph 1: Overview of dam from upstream

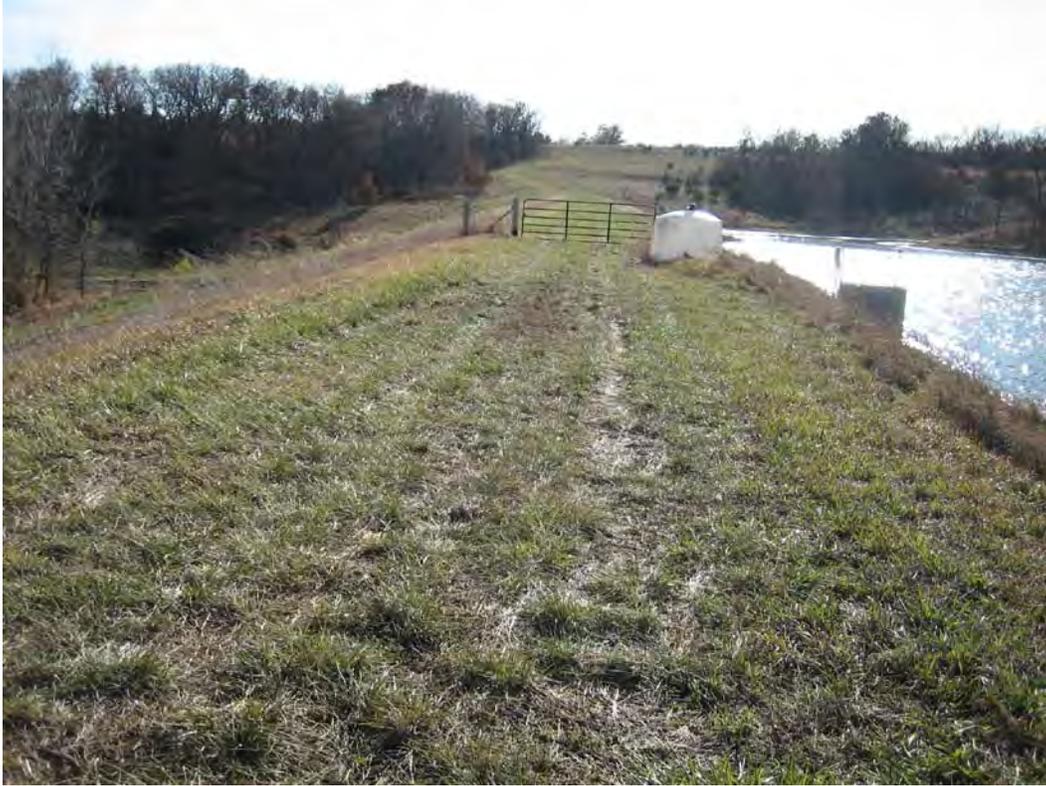
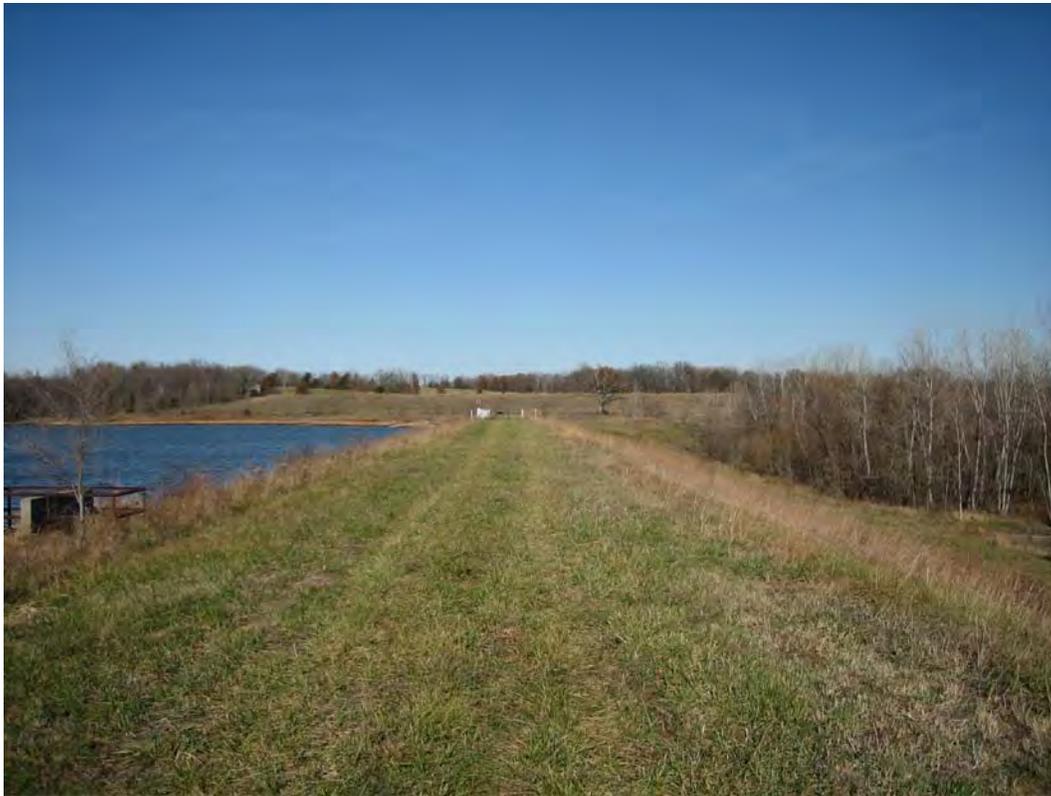
The majority of the crest (Photographs 5, 6, and 7) of the dam was straight with no signs of misalignment, sloughing, or settlement. The upstream slope (Photographs 8, 9, 12, and 15) generally appeared to be stable. Some brush was observed on the upstream slope, but it did not obstruct viewing the slope. The downstream slope (Photographs 4, 16, and 17) above El. 876.8 appeared to be approximately 3H:1V and was covered predominantly with tall brush and grass. A 15-foot-wide bench, at about El. 876.8, had extensive tire ruts, approximately 8 inches deep (Photographs 4, 18, 19, and 22). Otherwise, the bench was generally covered with well established grass. The downstream slope, below El. 876.8 was approximately 3H:1V and was generally overgrown with tall brush, grass, and trees up to 4 inches in diameter (Photograph 20). Several animal burrows were observed on the lower slope (Photograph 21).

Photograph 5: Crest looking south

Photograph 6: Crest looking north

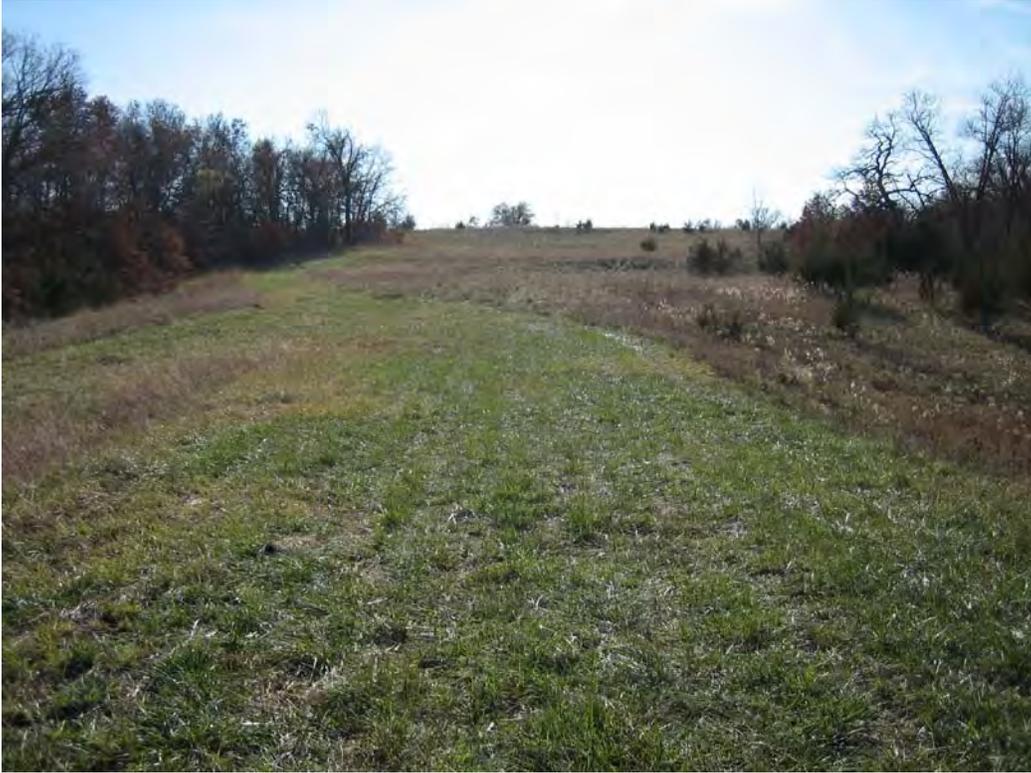
Photograph 7: Crest contact with right abutment.

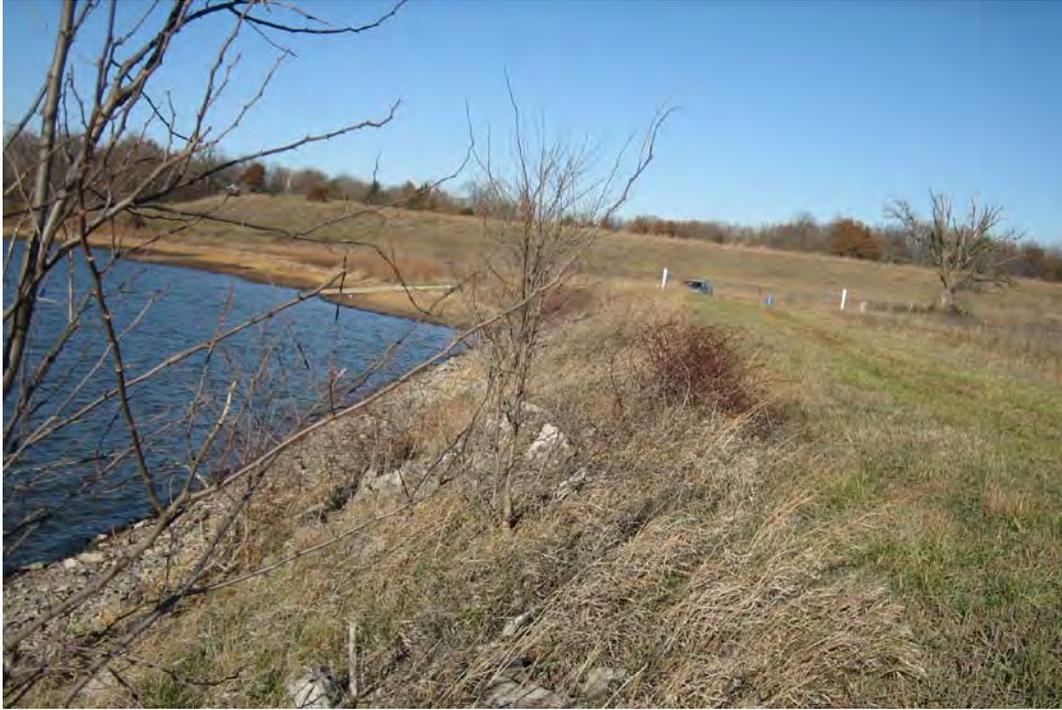
Photograph 9: Vegetation on upstream slope

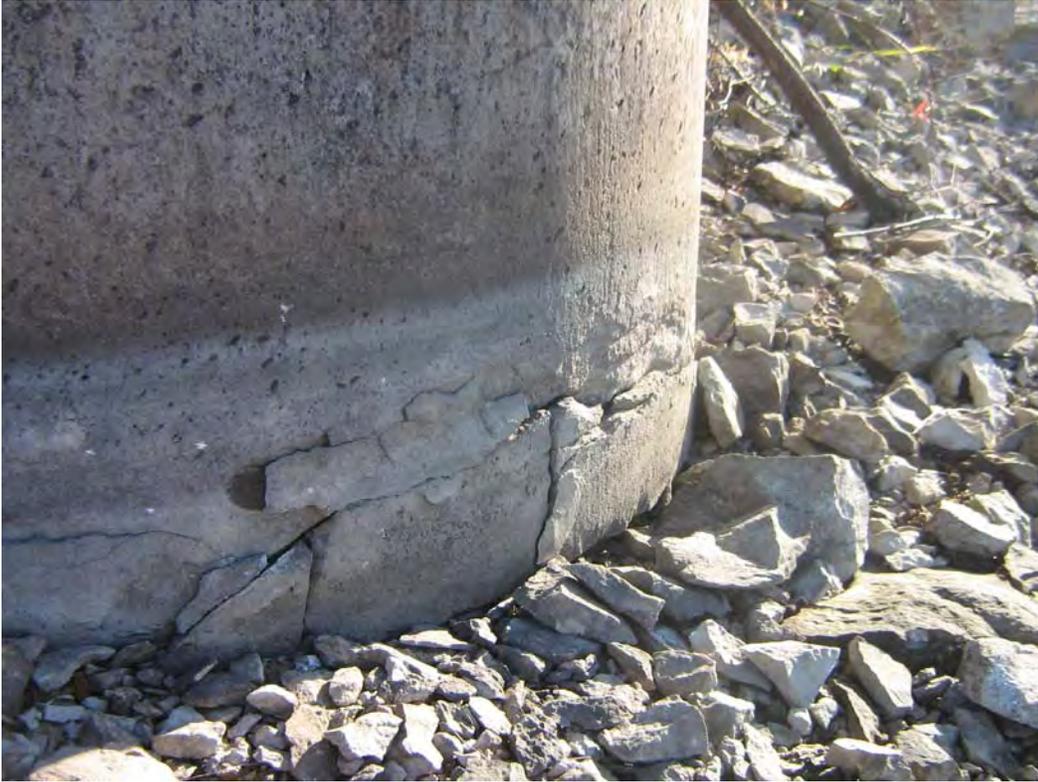
Photograph 11: Cracks at base of intake structure

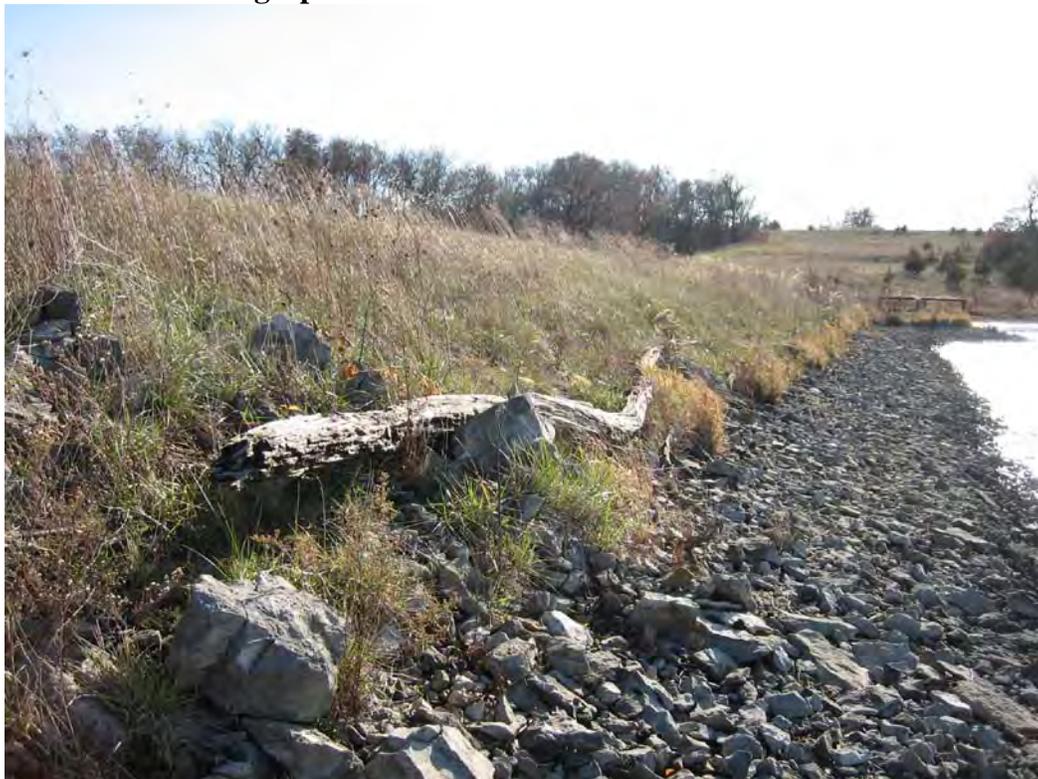
Photograph 12: Upstream slope, riprap and debris

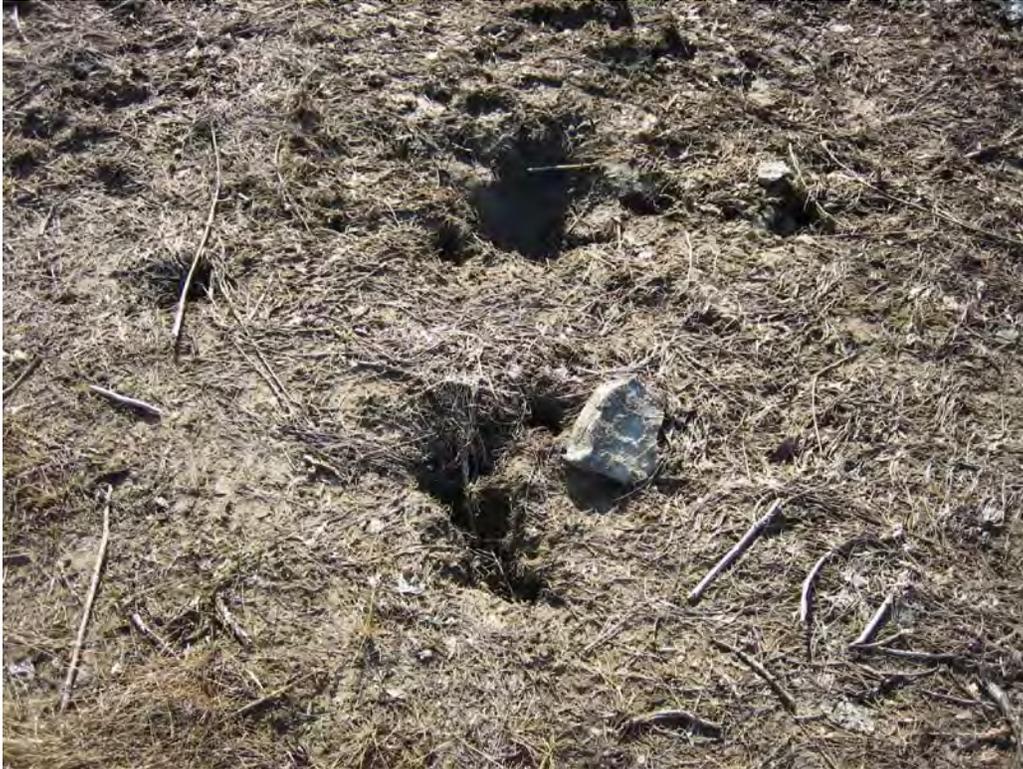
Photograph 15: Animal burrows on upstream slope

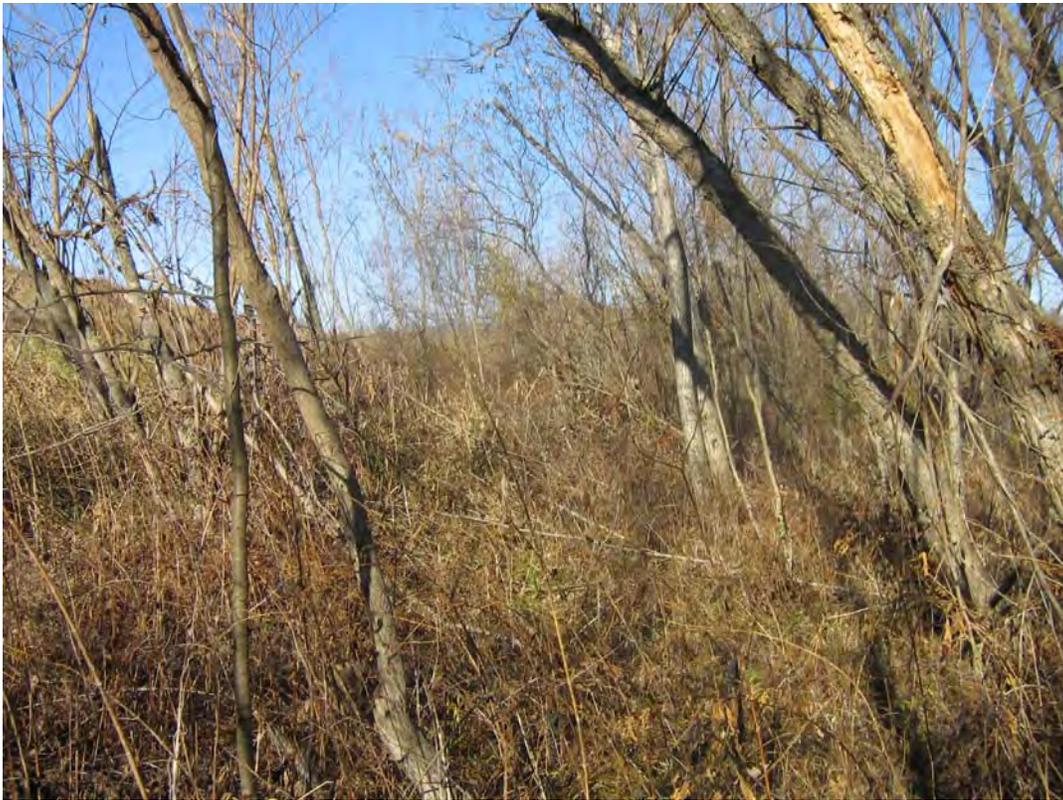
Photograph 20: Vegetation on lower downstream slope

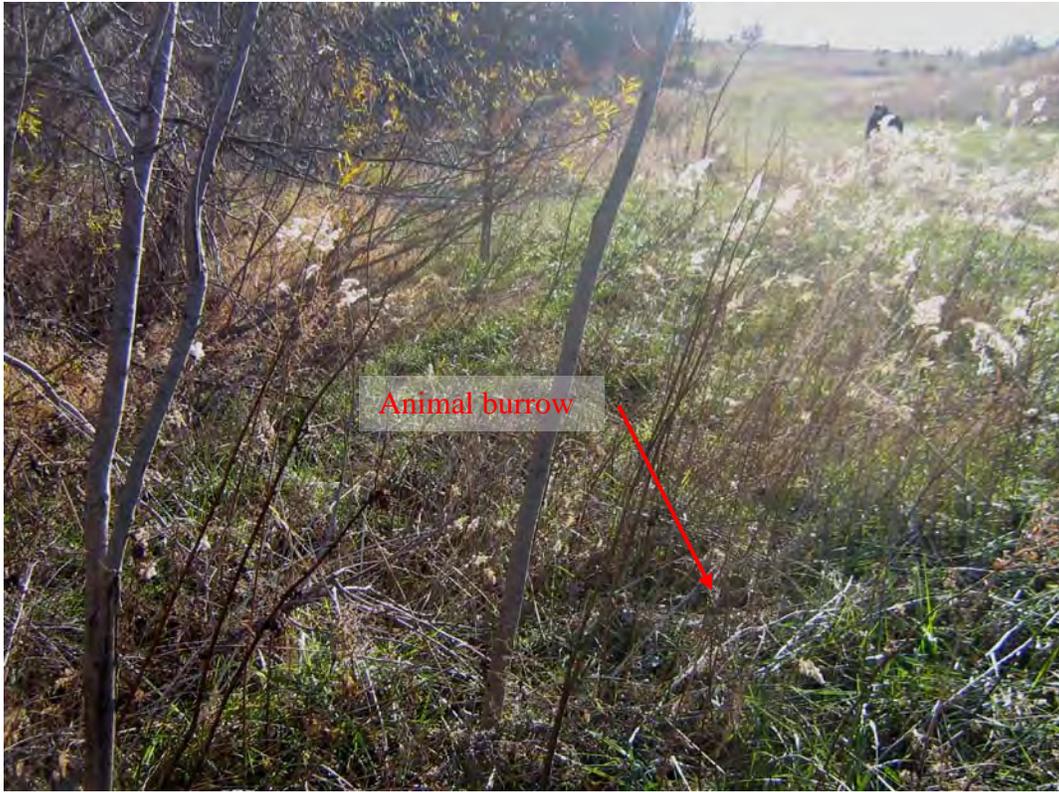
Photograph 21: Animal burrow on lower downstream slope

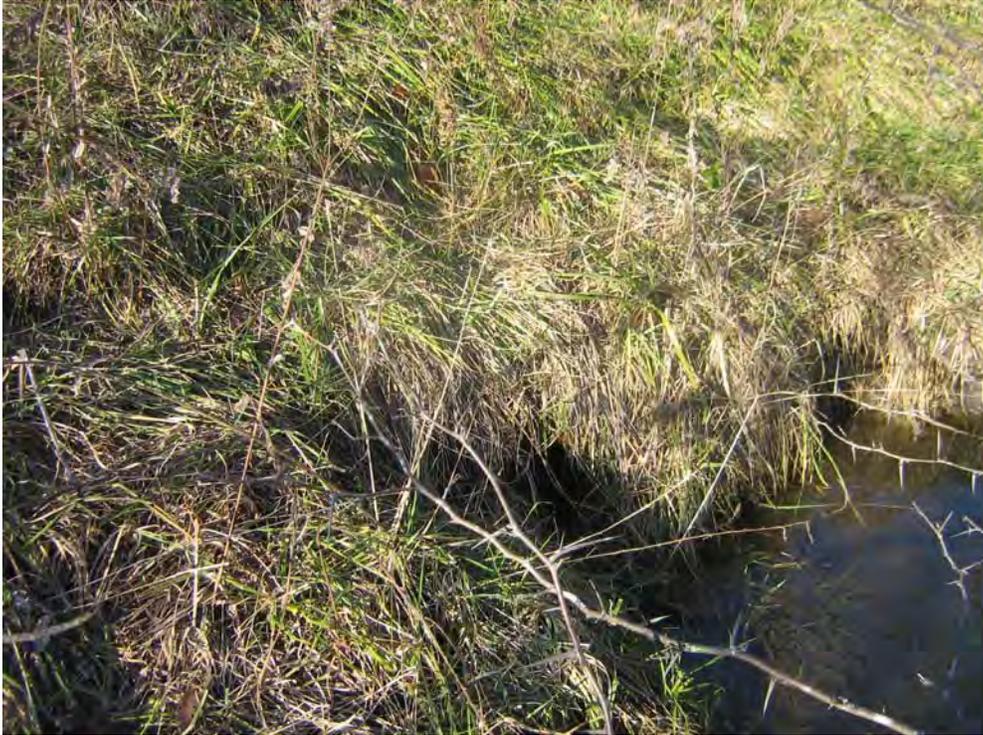
Photograph 25: Animal burrow in embankment

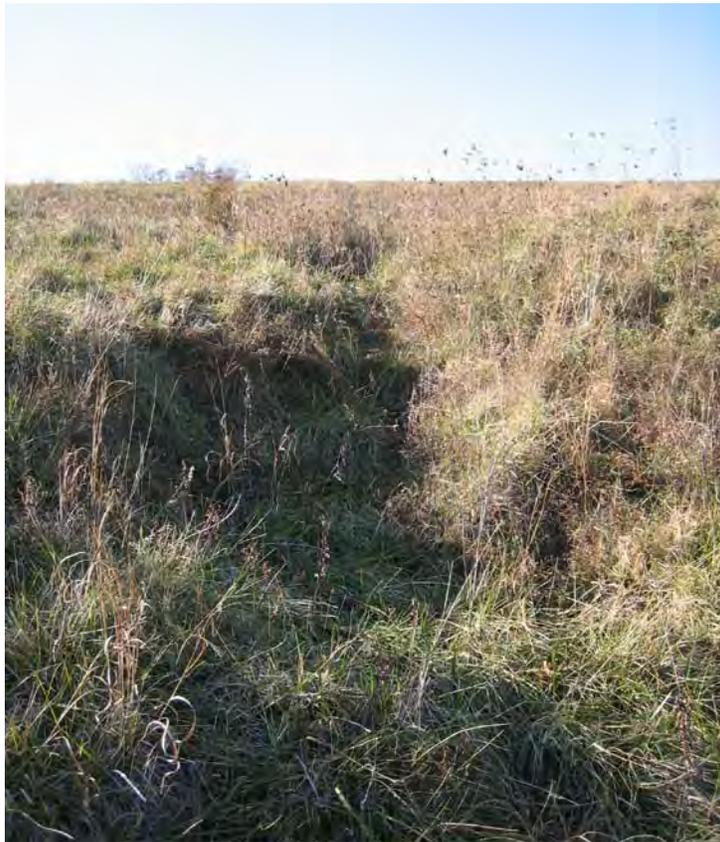
Photograph 26: Erosion rill in downstream slope above plunge basin

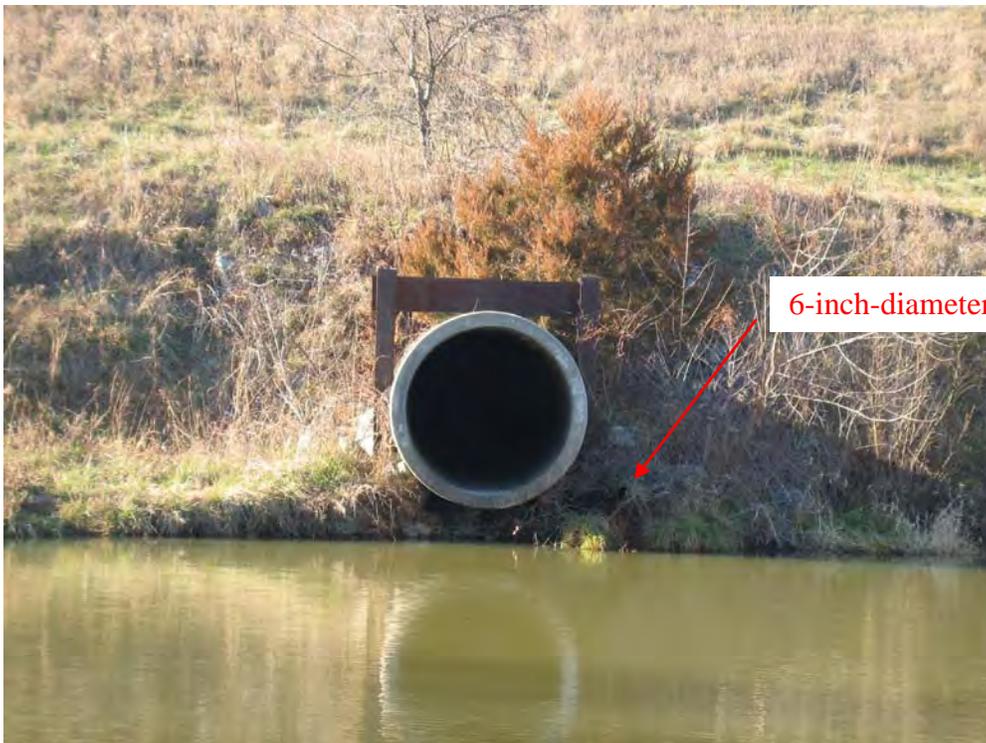
The caretaker reported the 6-inch-diameter foundation drain installed along the length of the toe of the downstream slope and the pipe from the filter diaphragm discharge adjacent to the primary spillway outlet pipe. The caretaker indicated that limited water flows have been observed discharging from the pipe intermittently. The foundation drain discharges to the plunge basin, left of the primary spillway discharge pipe (Photograph 28). The drain pipe was not observed during the inspection.

Photograph 28: Foundation drain discharge
