# Sources and Causes of Leaks

# Sources and Causes Underground Storage Tanks (UST)

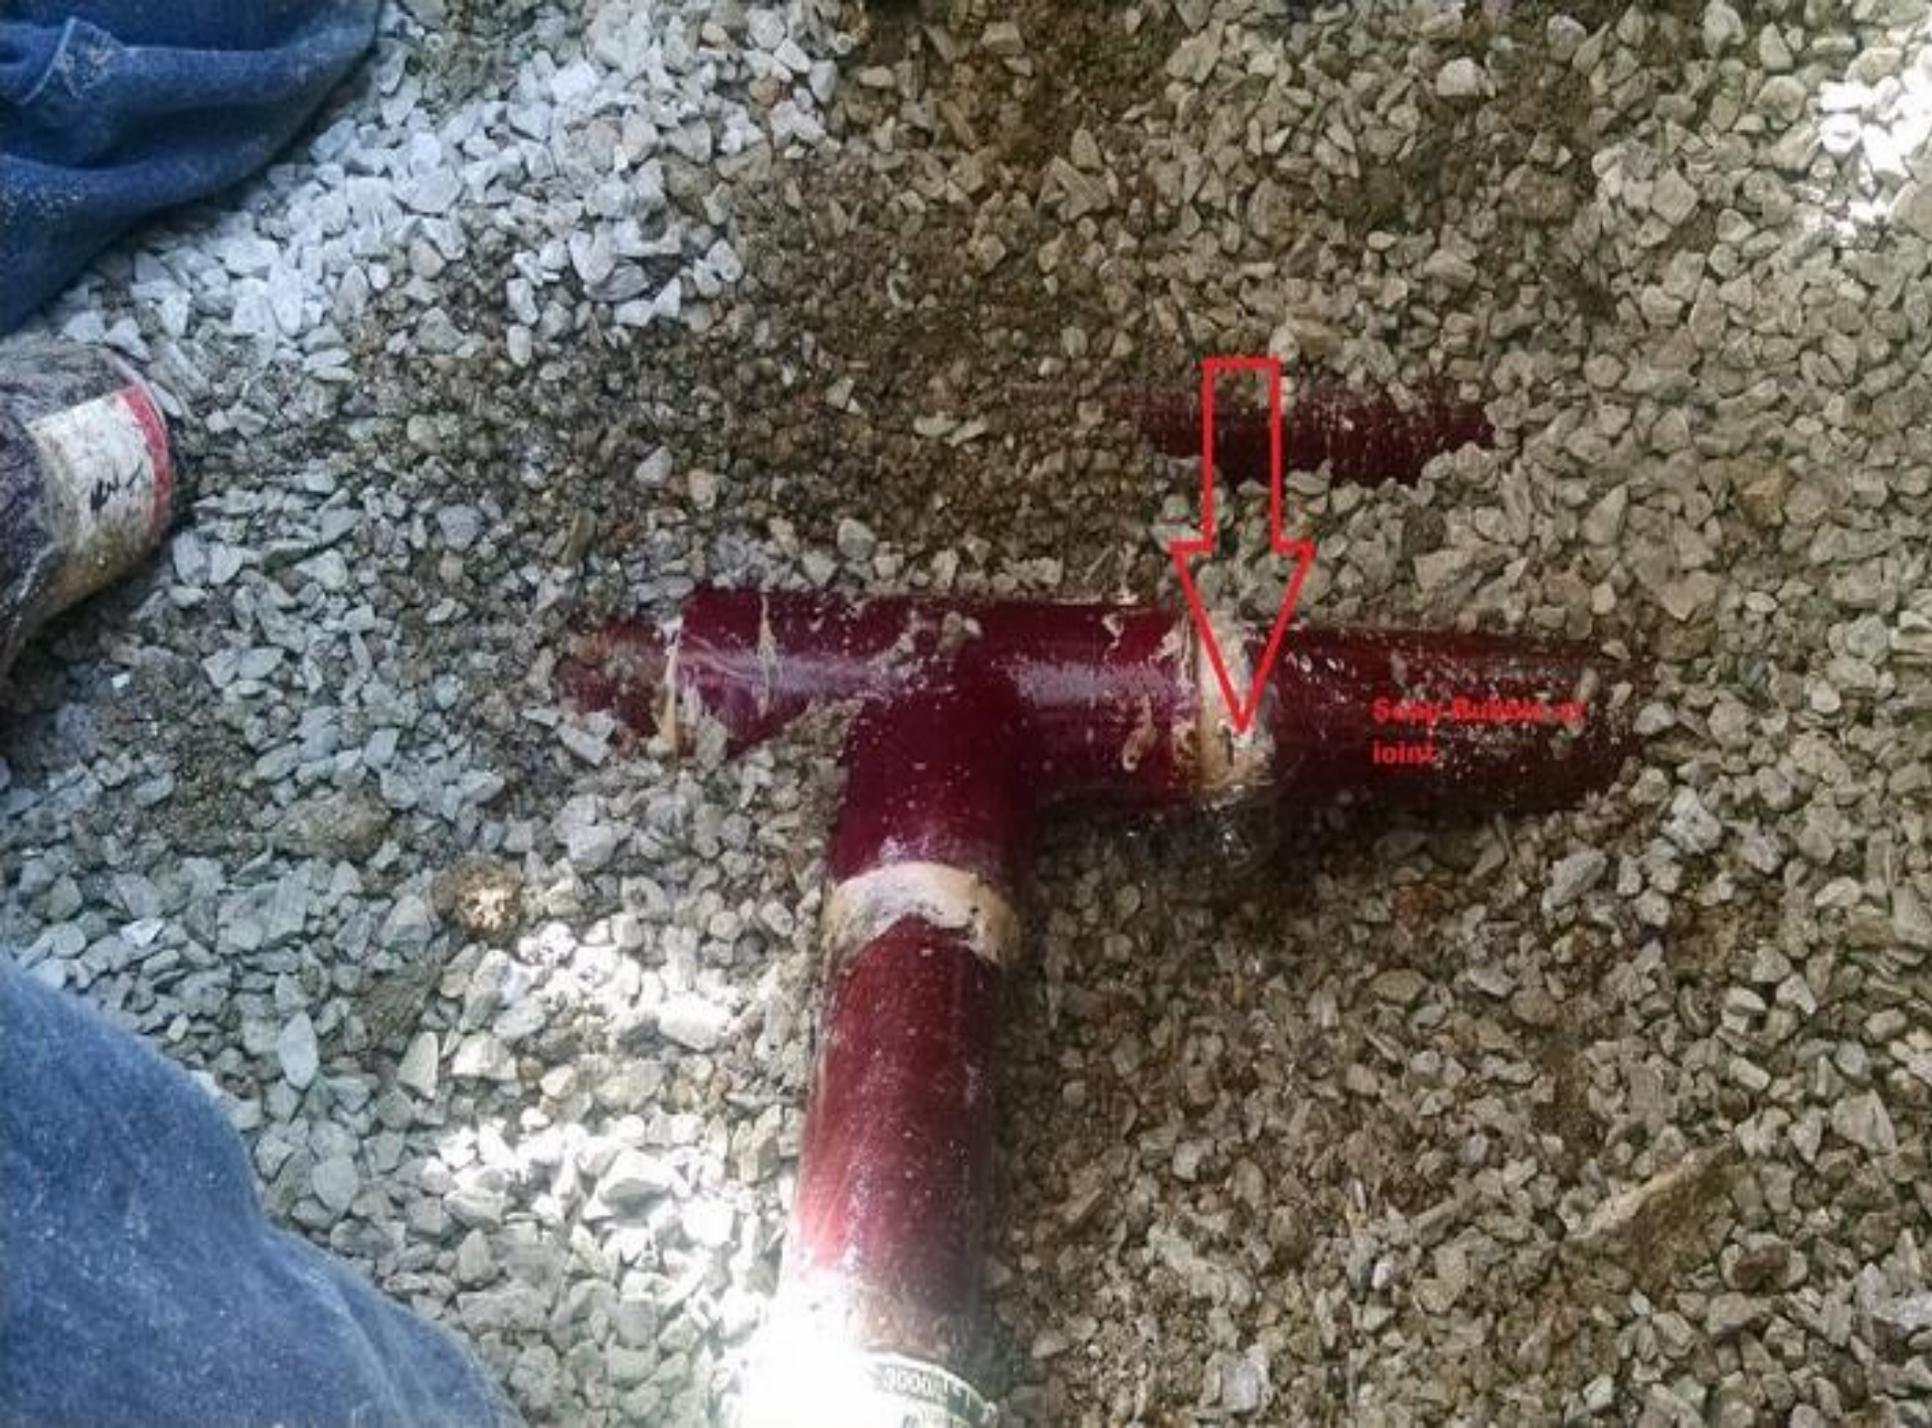
- Environmental Emergency Response (EER) notified of strong vapors in sewer
  - Some manways pegged the air monitor
- Electronic monitoring system alarms
- Premium line tightness test fail
- Helium test confirm premium fail
- Line excavated- failure at fiberglass elbow

Soft Bubble at joint

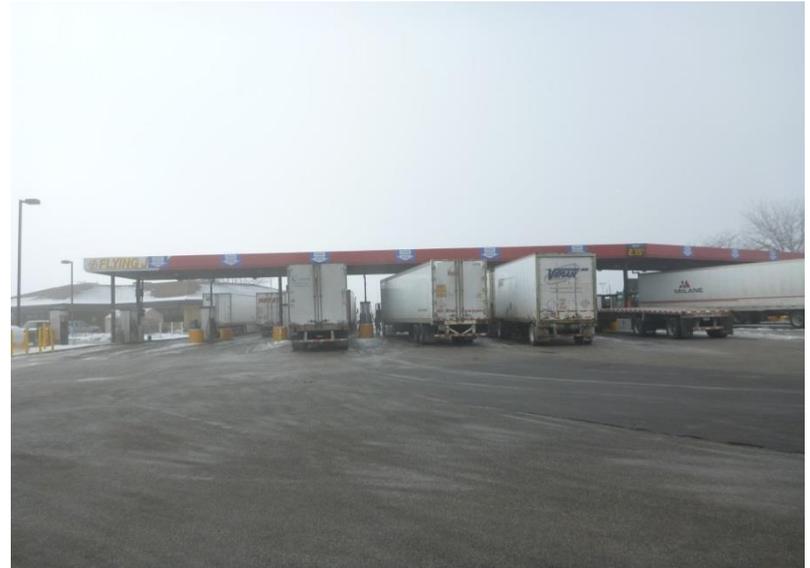
- Source – Dispenser
- Cause – Physical or mechanical damage
- Quantity – Approx. 1200 gallons according to inventory records
- Truck hit dispenser
- Site characterization
- Free product recovery

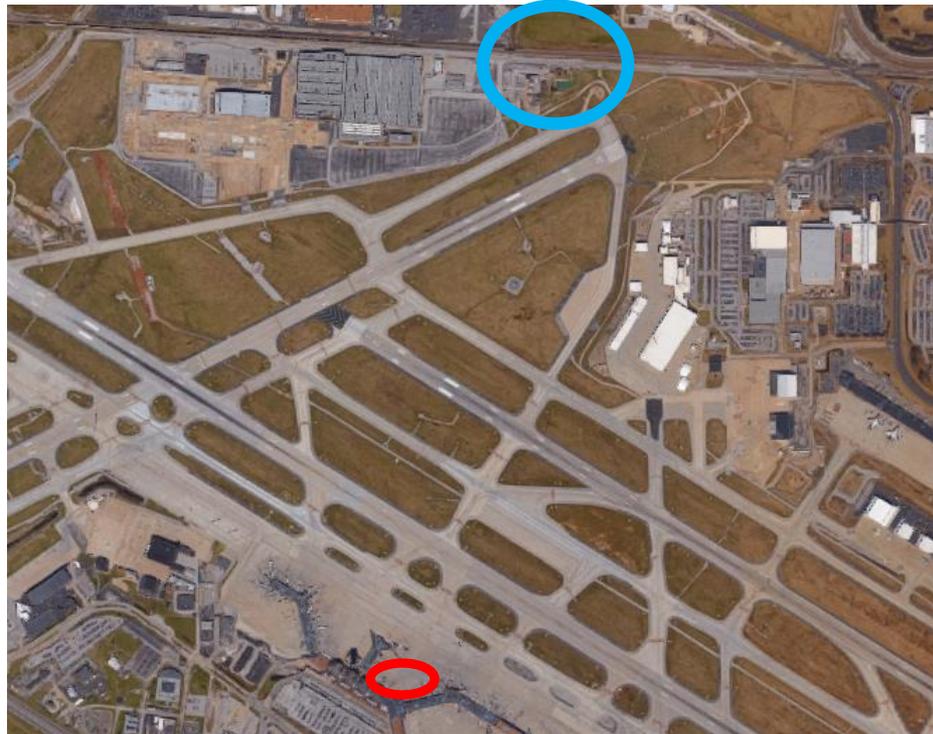
- Product sheen in nearby creek
- Airport responded
- Booms at creek
- Started testing lines
- Active remediation
- Site characterization

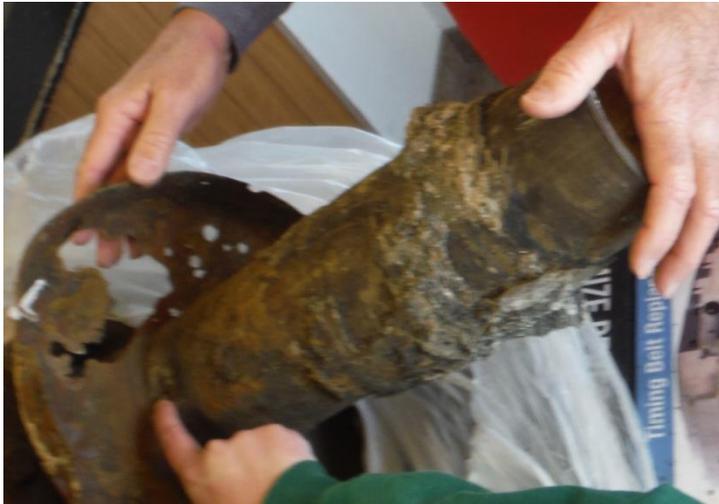
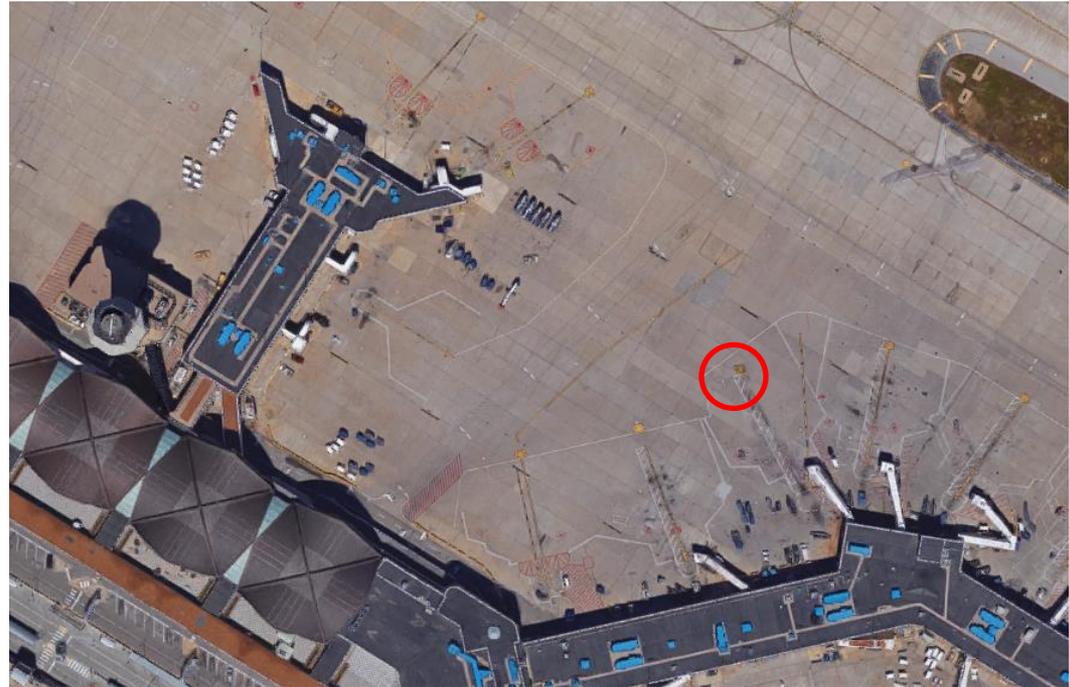
- Fuel hydrant system
- Flange rusted - corrosion

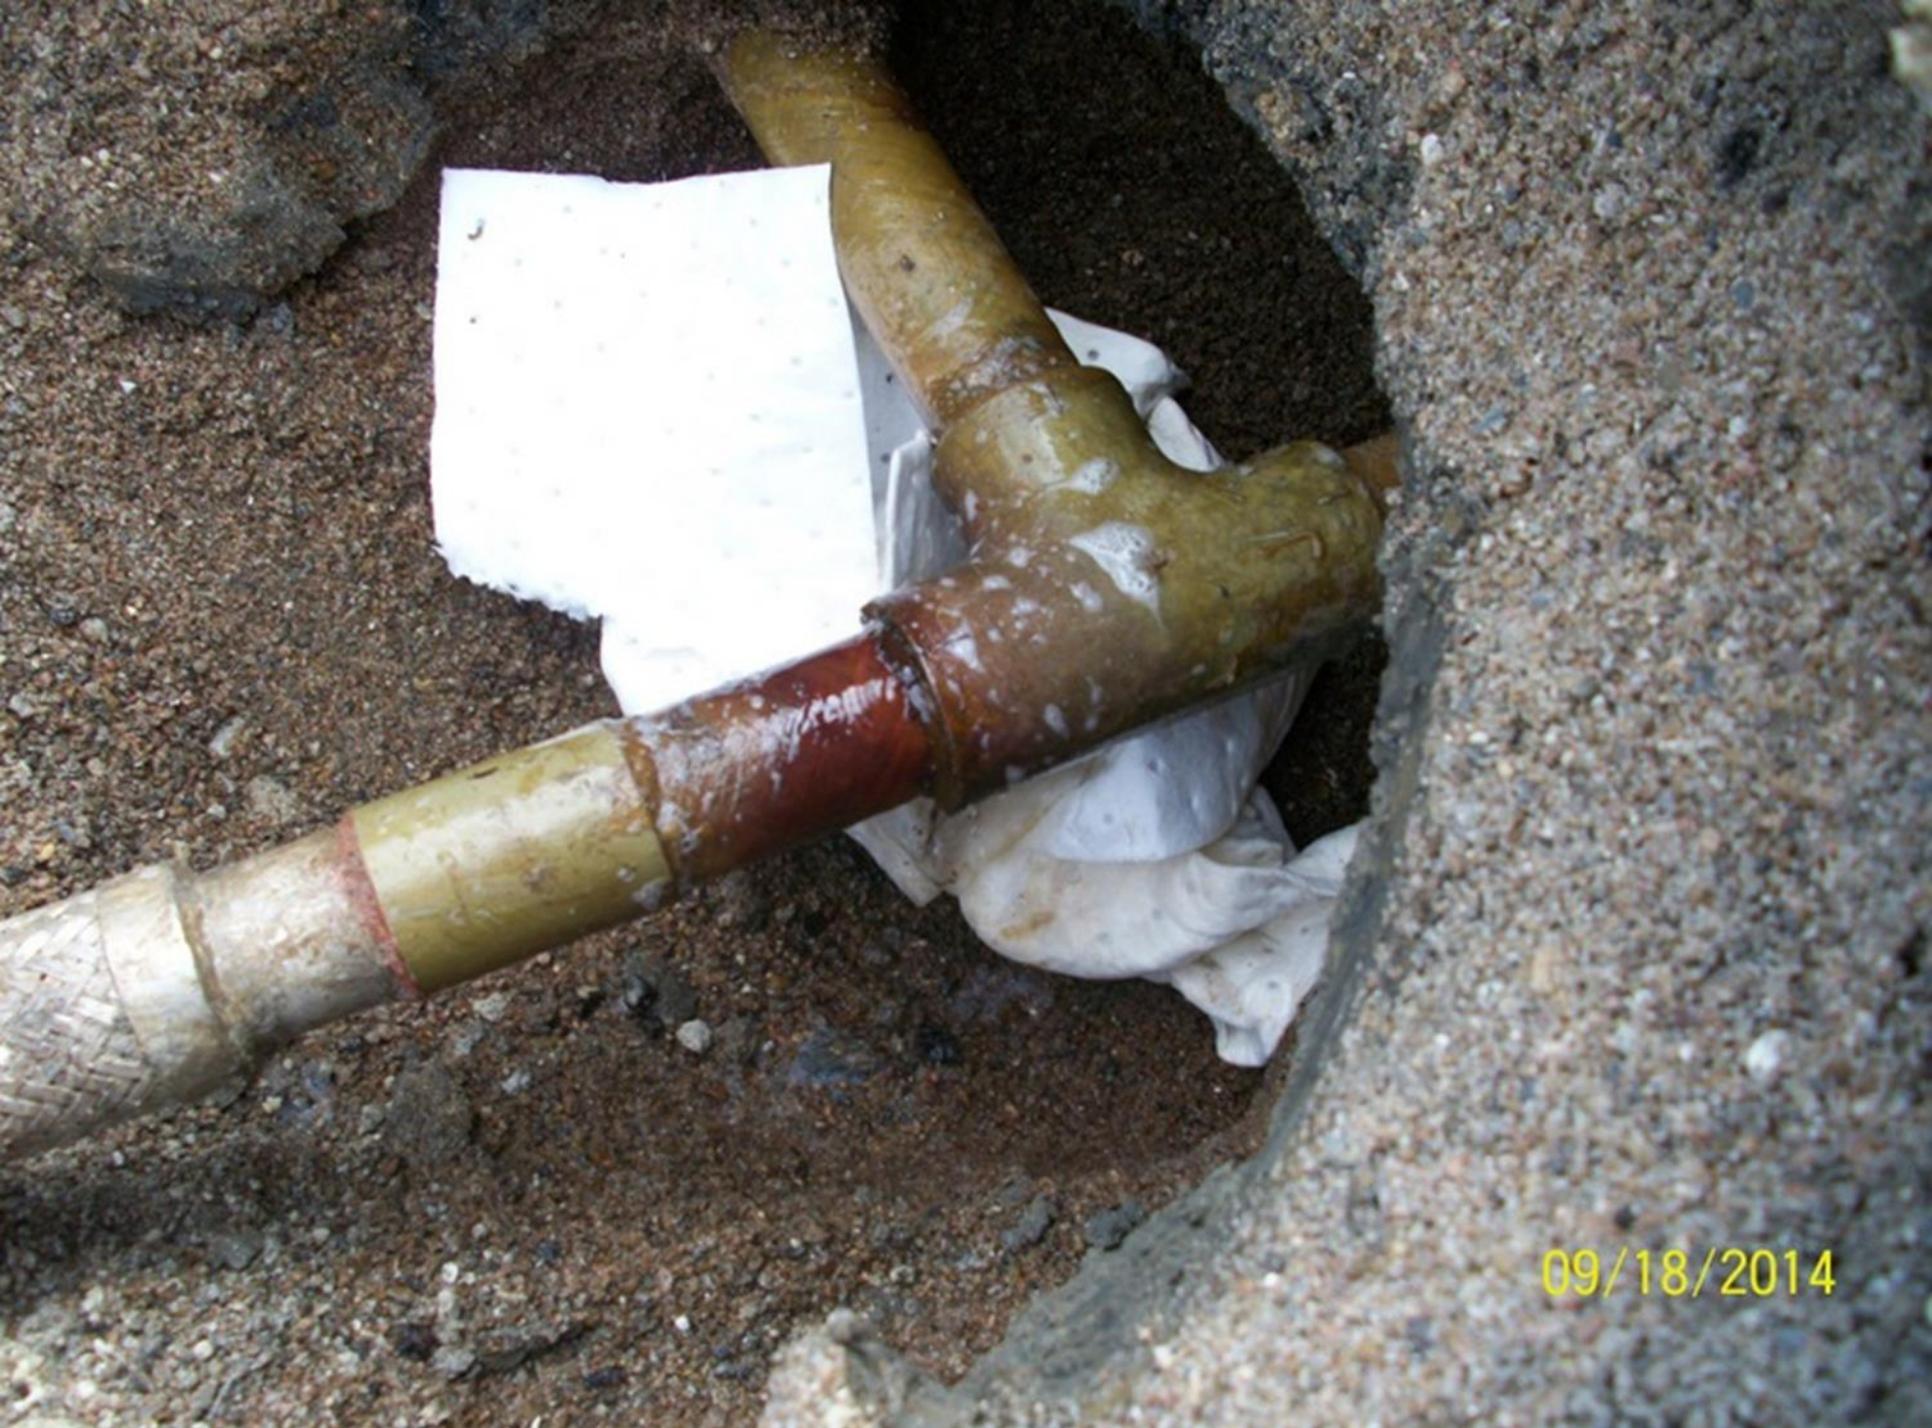
- EER contacted- vapors in sewer
- Nearby station investigated
- Product found in wells
- Tank and line tightness testing conducted
- Piping on unleaded system failed test
- Free product recovery, site characterization ongoing

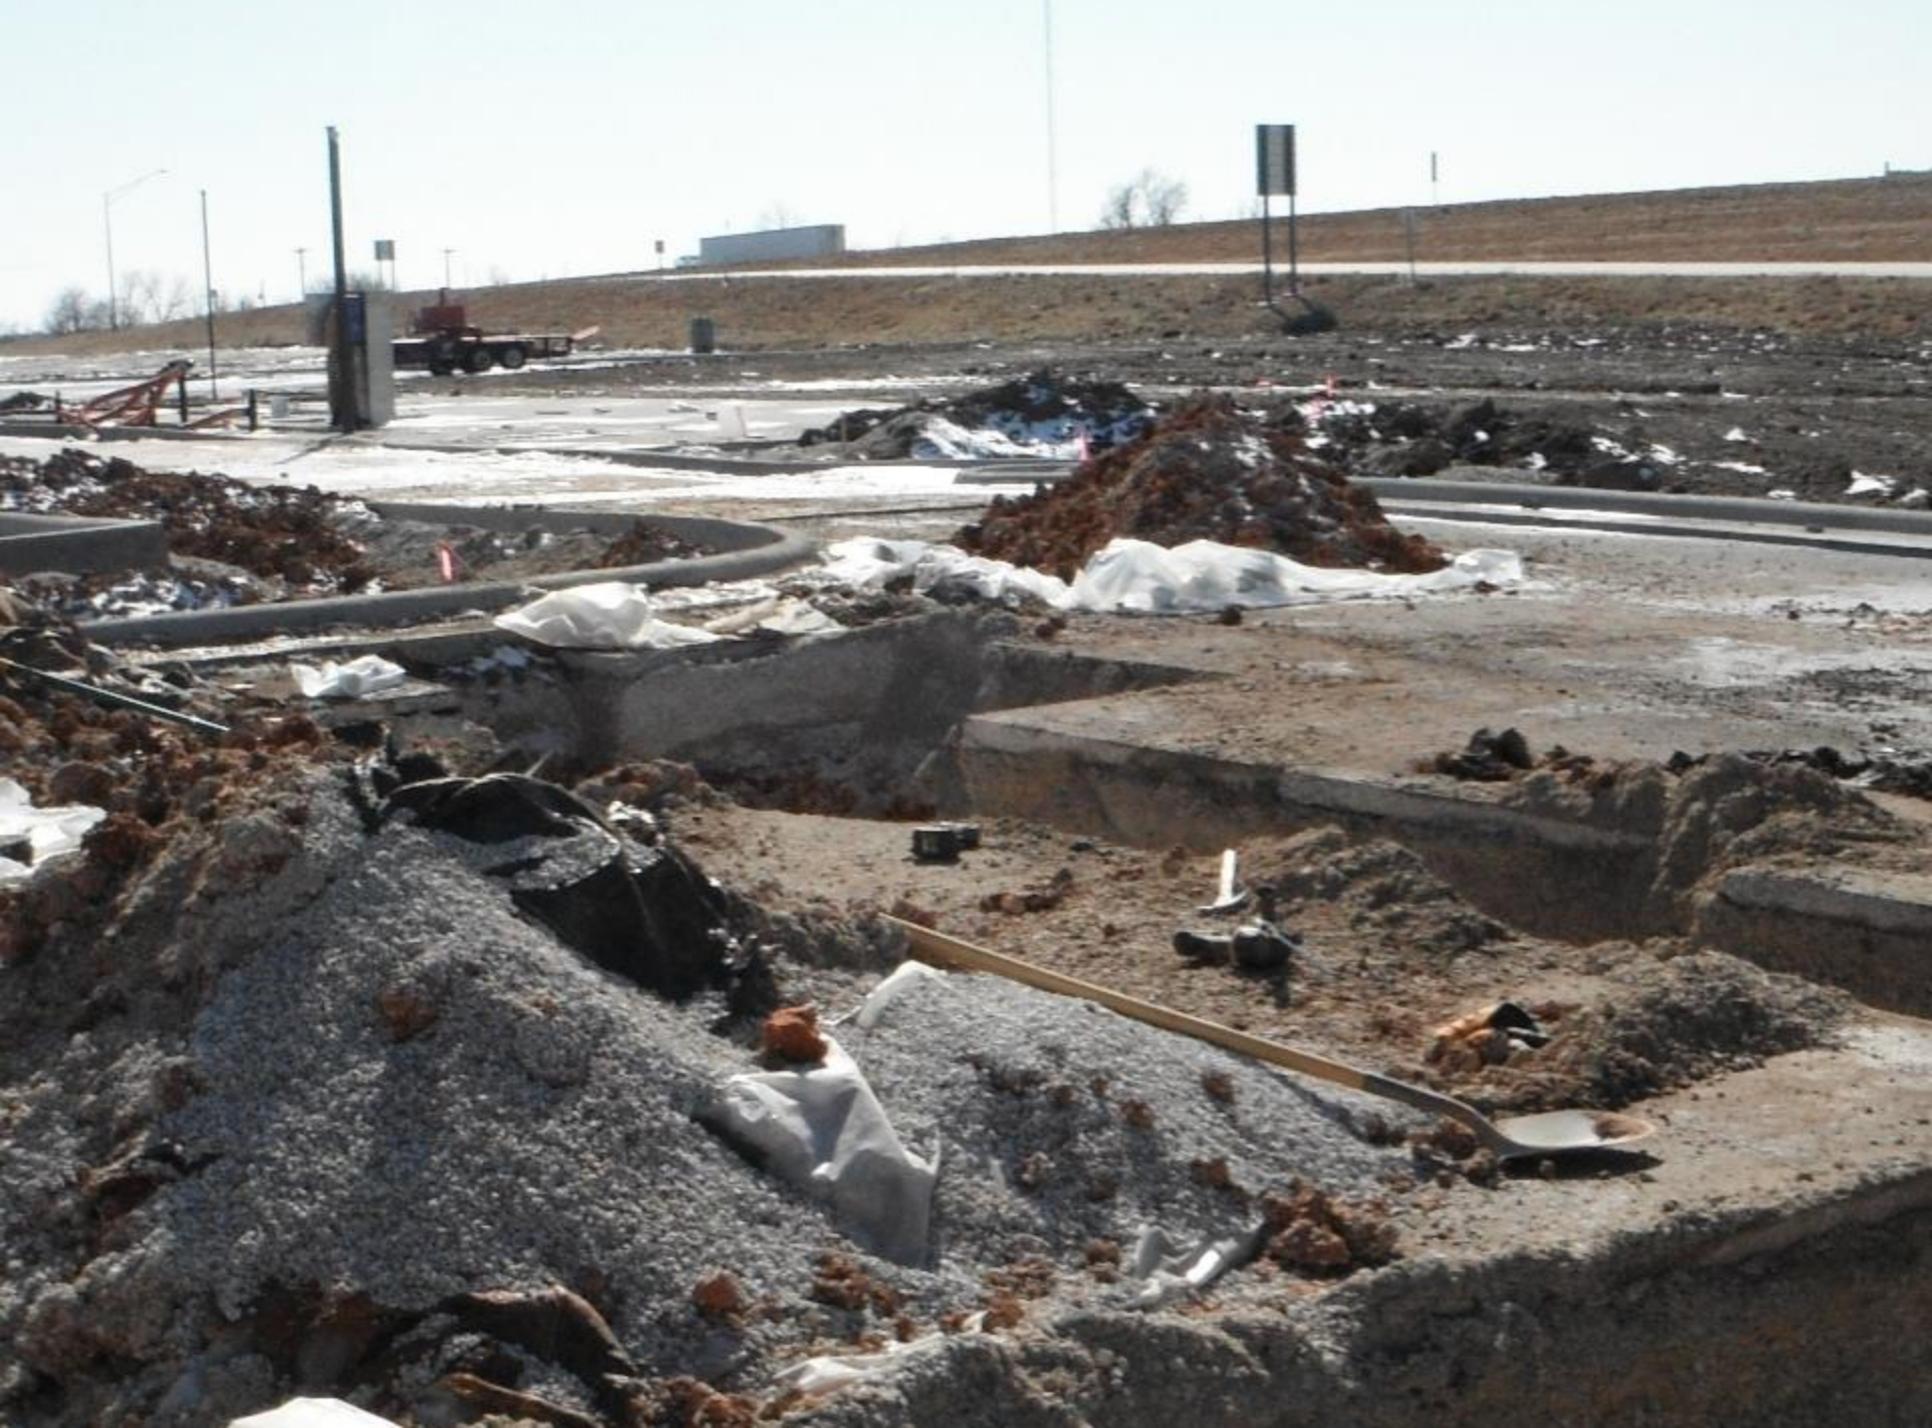
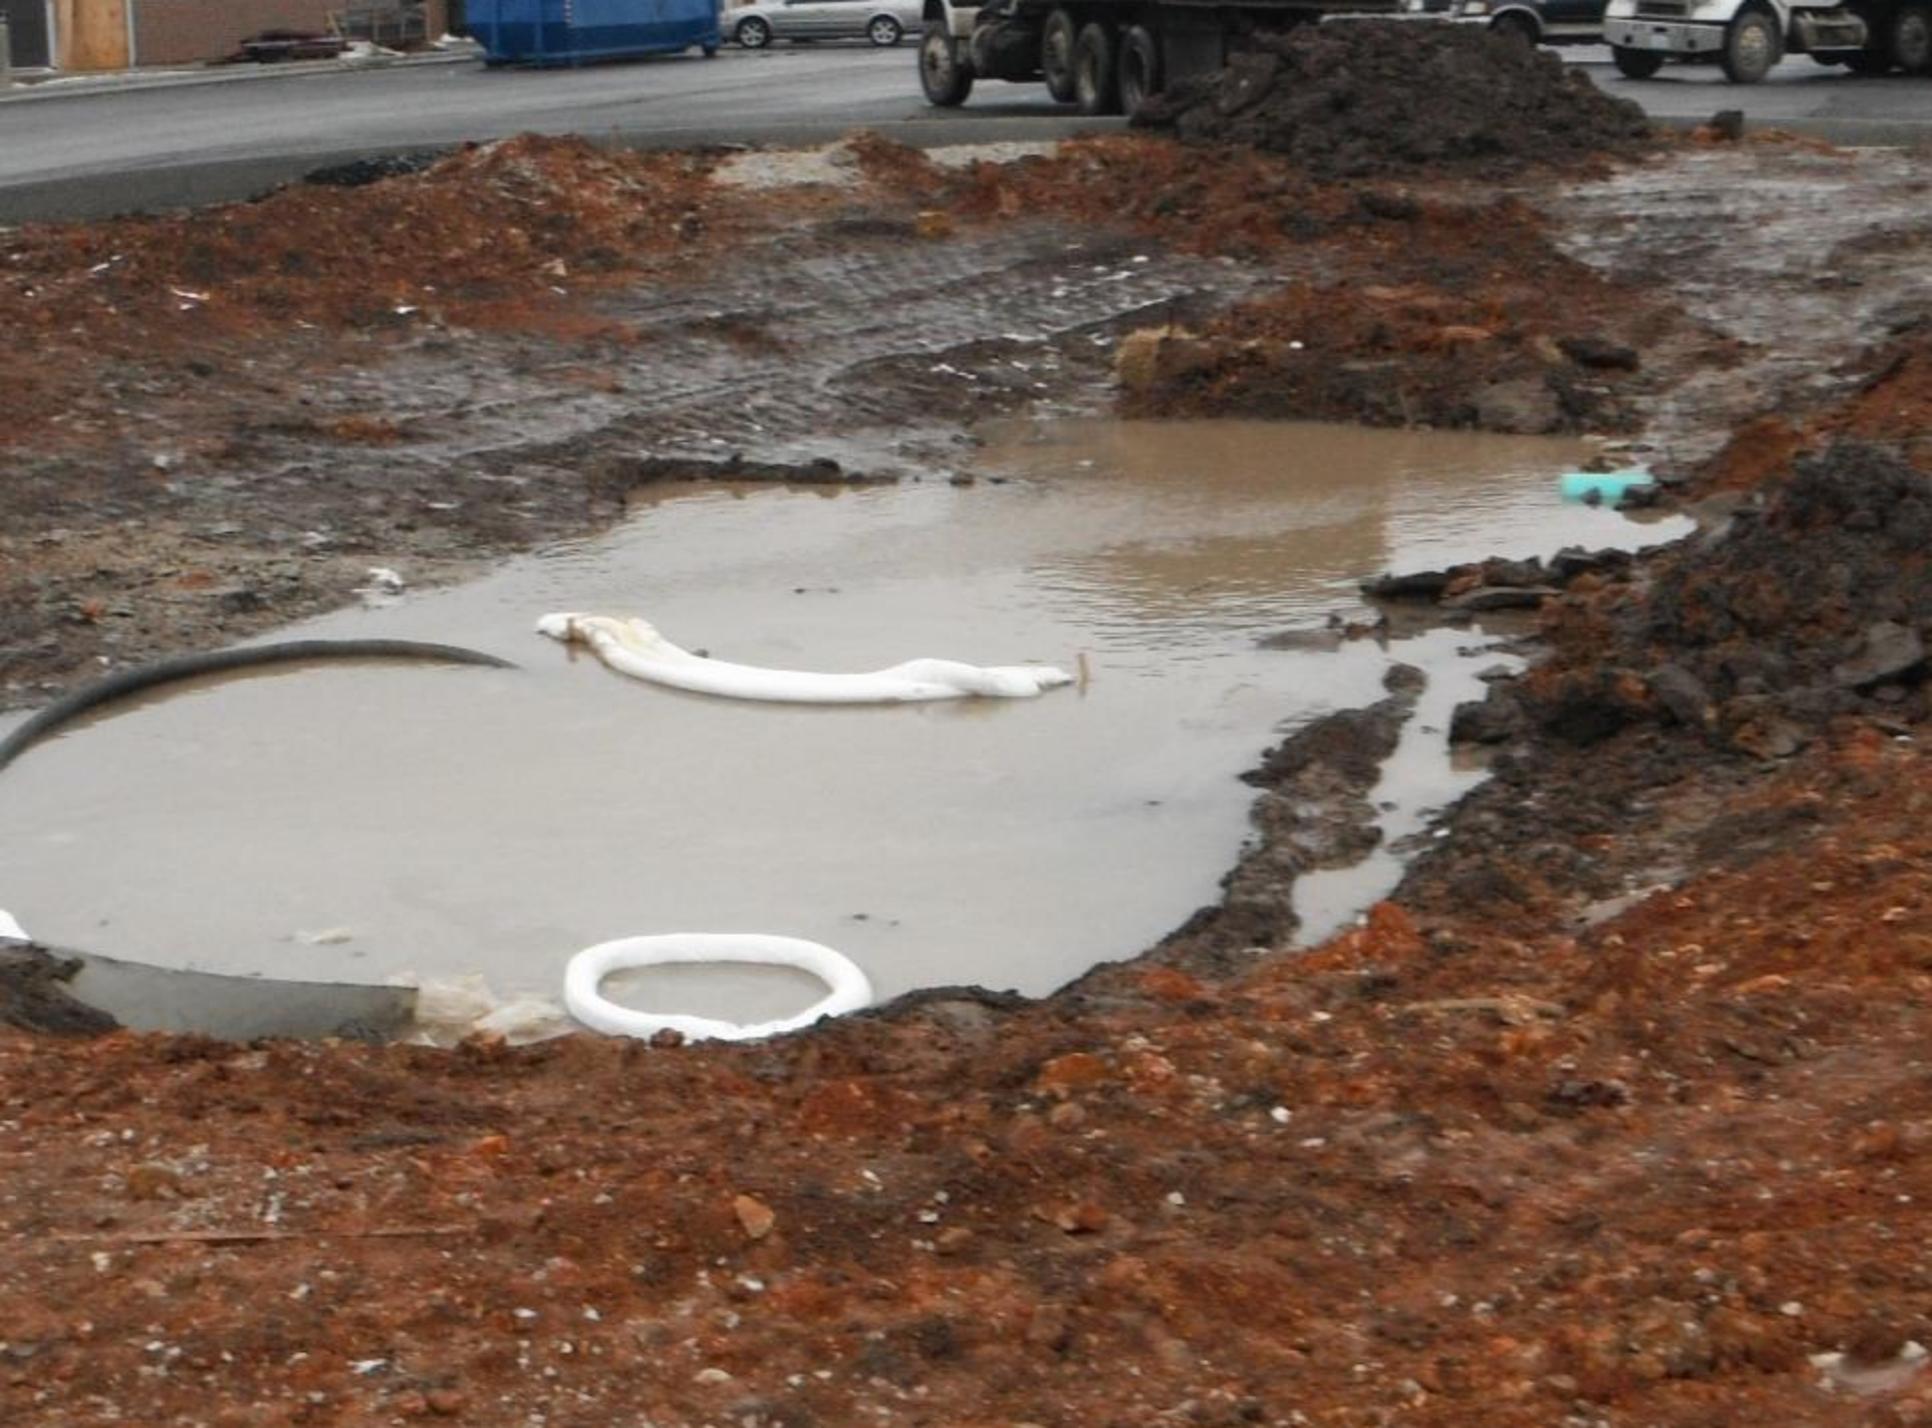
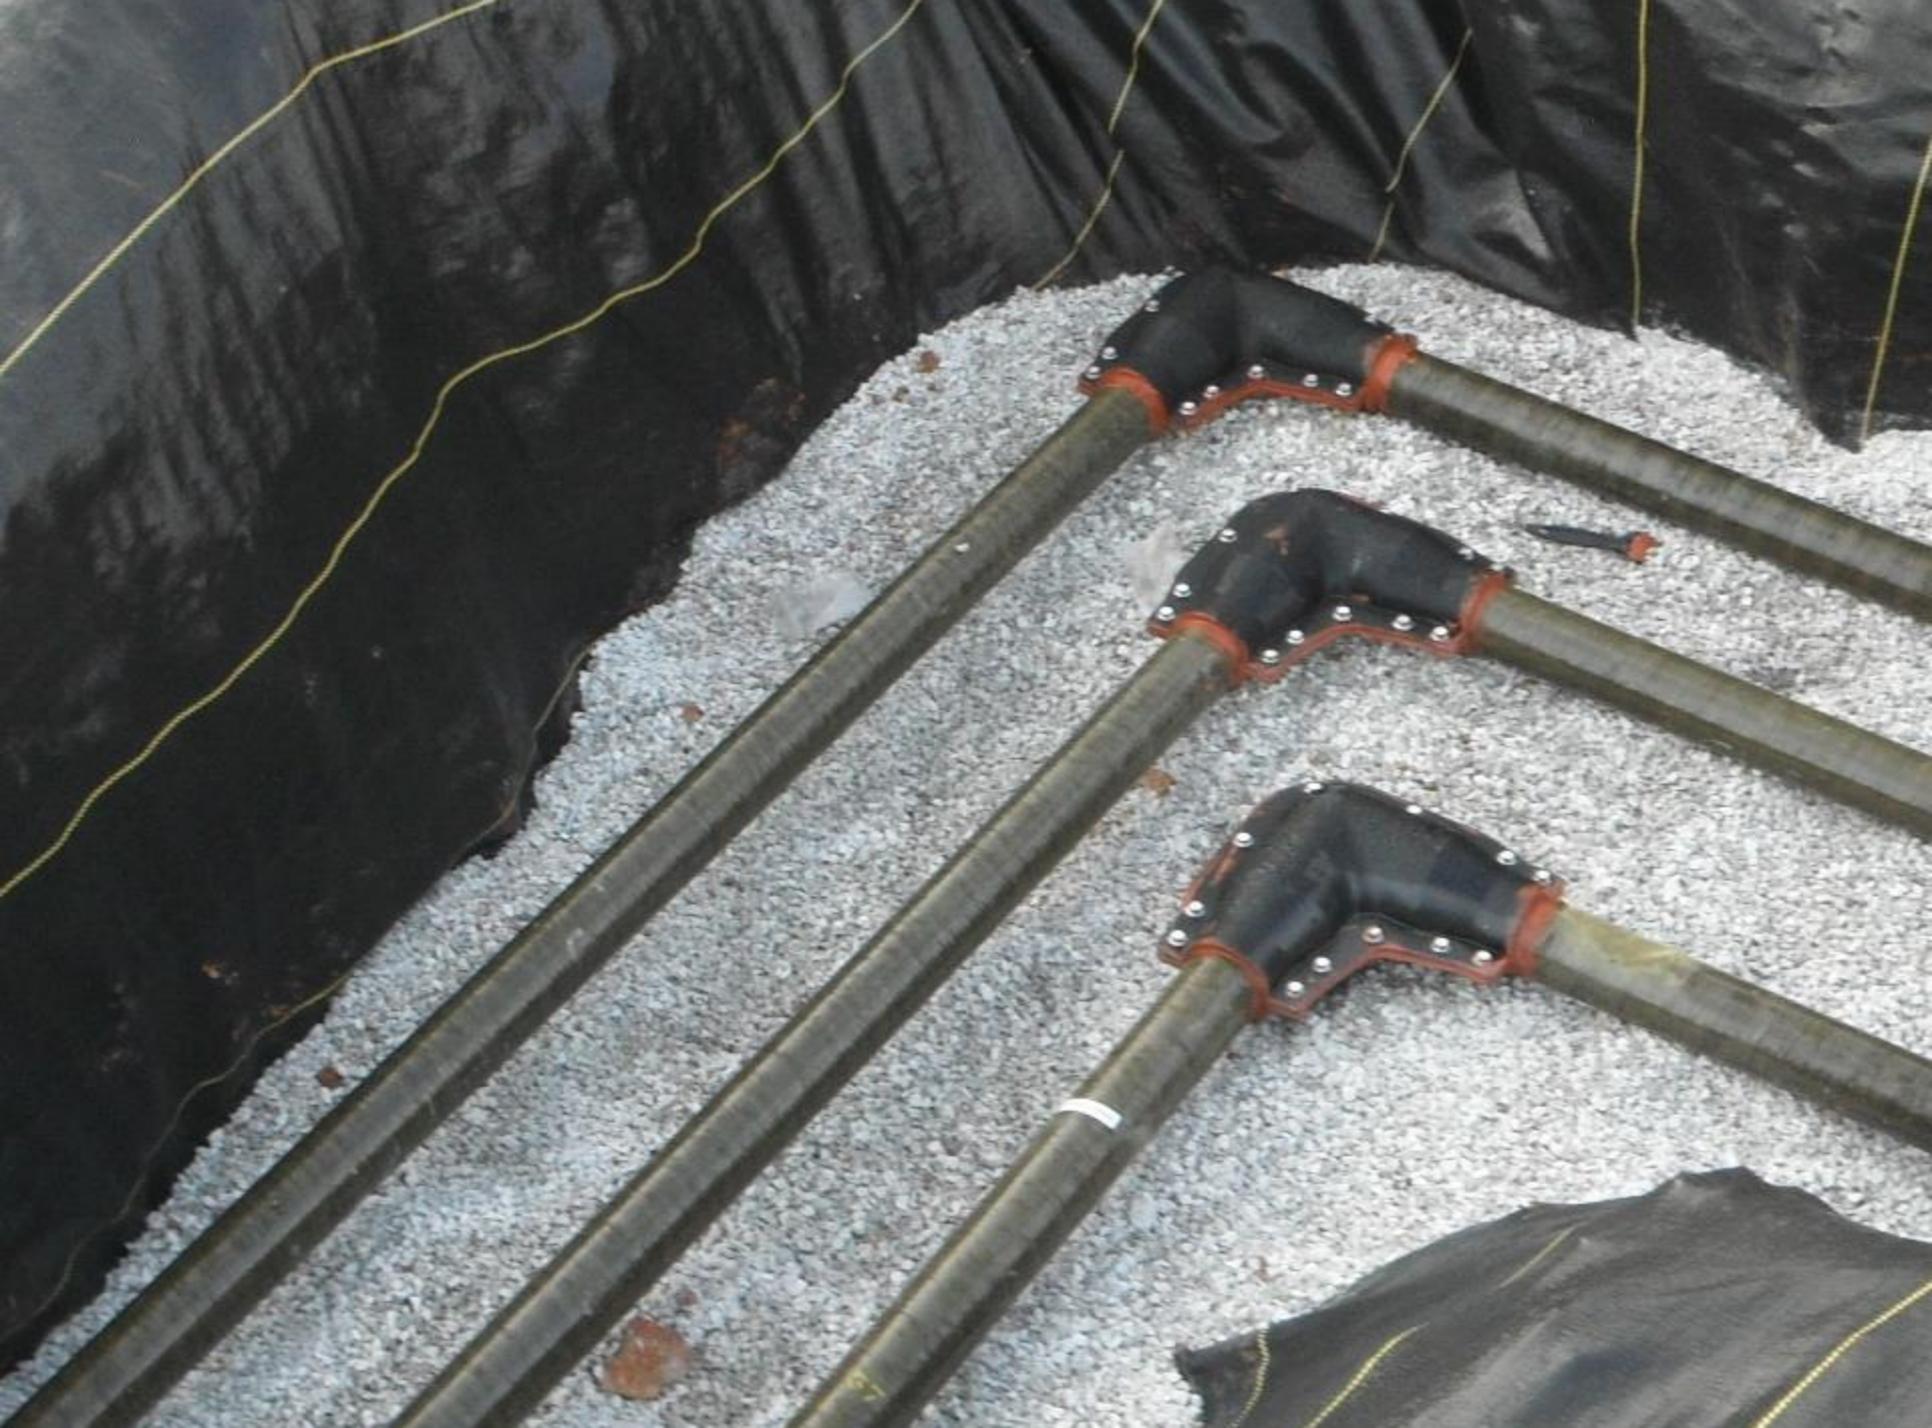
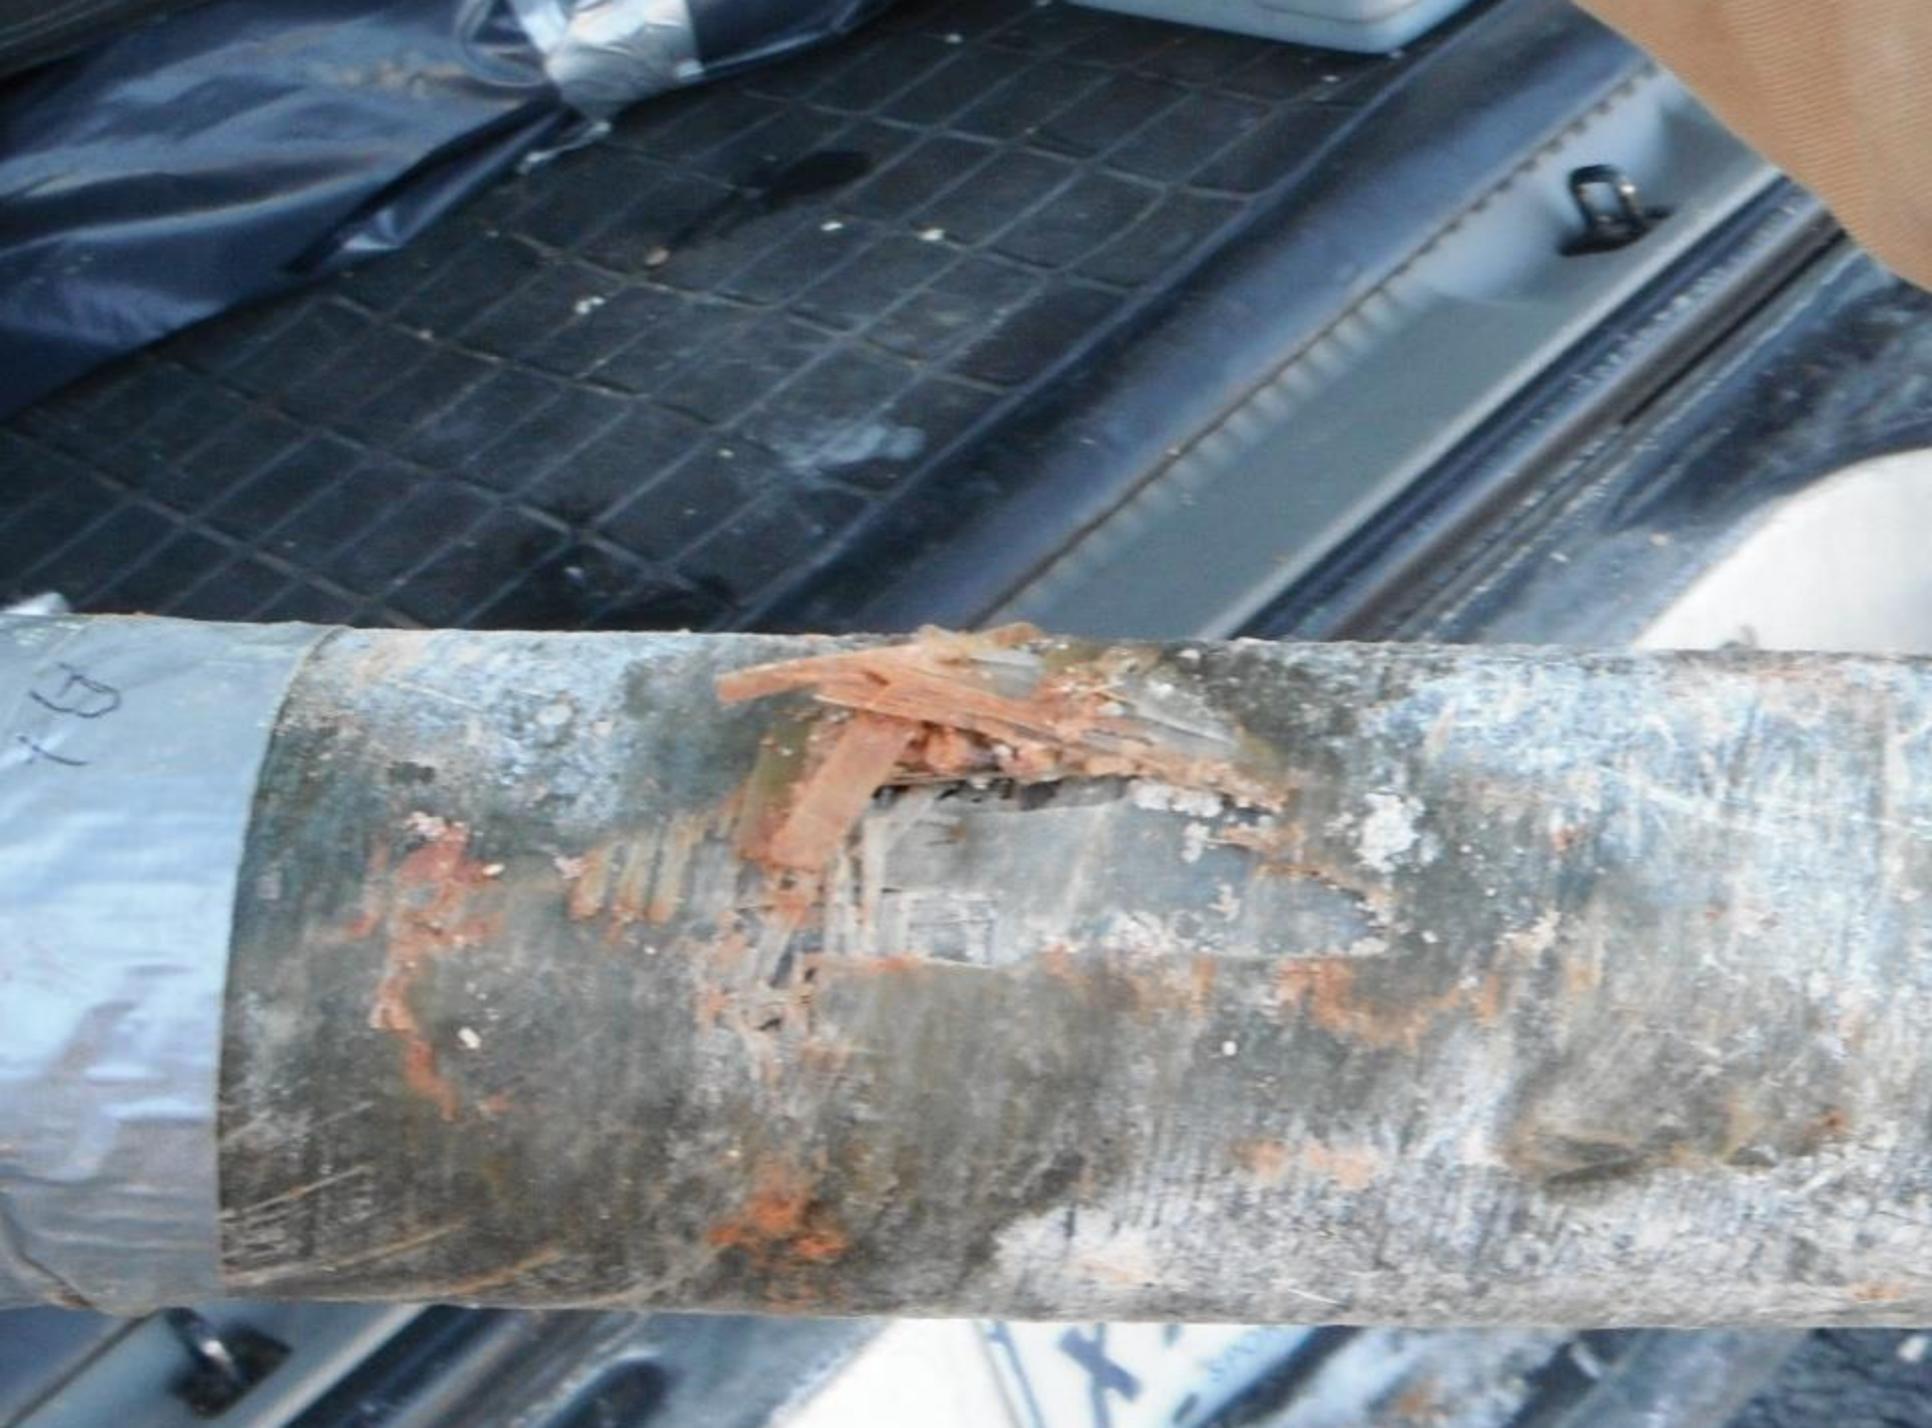
- Newly installed piping
- Damaged by backhoe
- Damage not reported
- Line pressurized- damage unknown
- Approx. 6000 gallons of product released
- NFA issued in June 2015

Conduit  
a rea  
Orien Denton  
March - 6

Pipe at  
Curb  
a rea  
Orien Denton  
March - 6
