# Sources and Causes of Leaks

# Sources and Causes Underground Storage Tanks (UST)

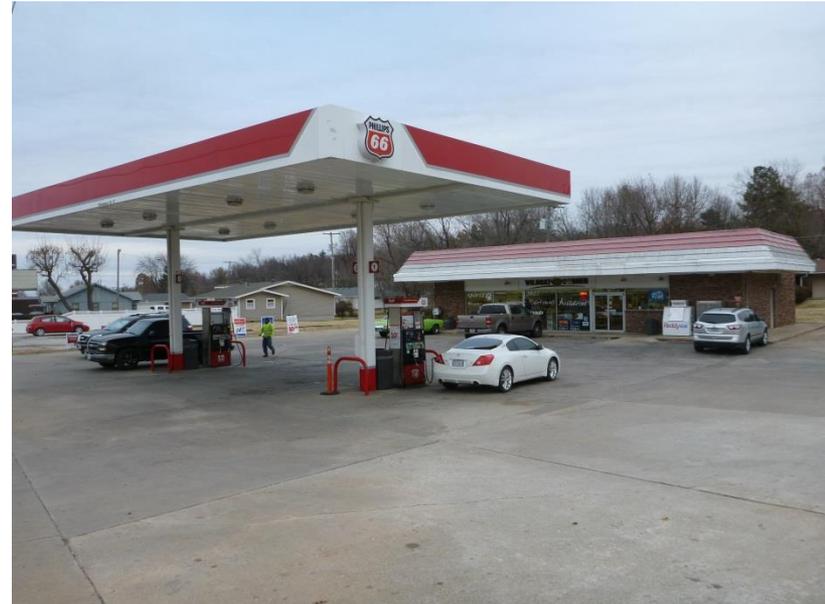
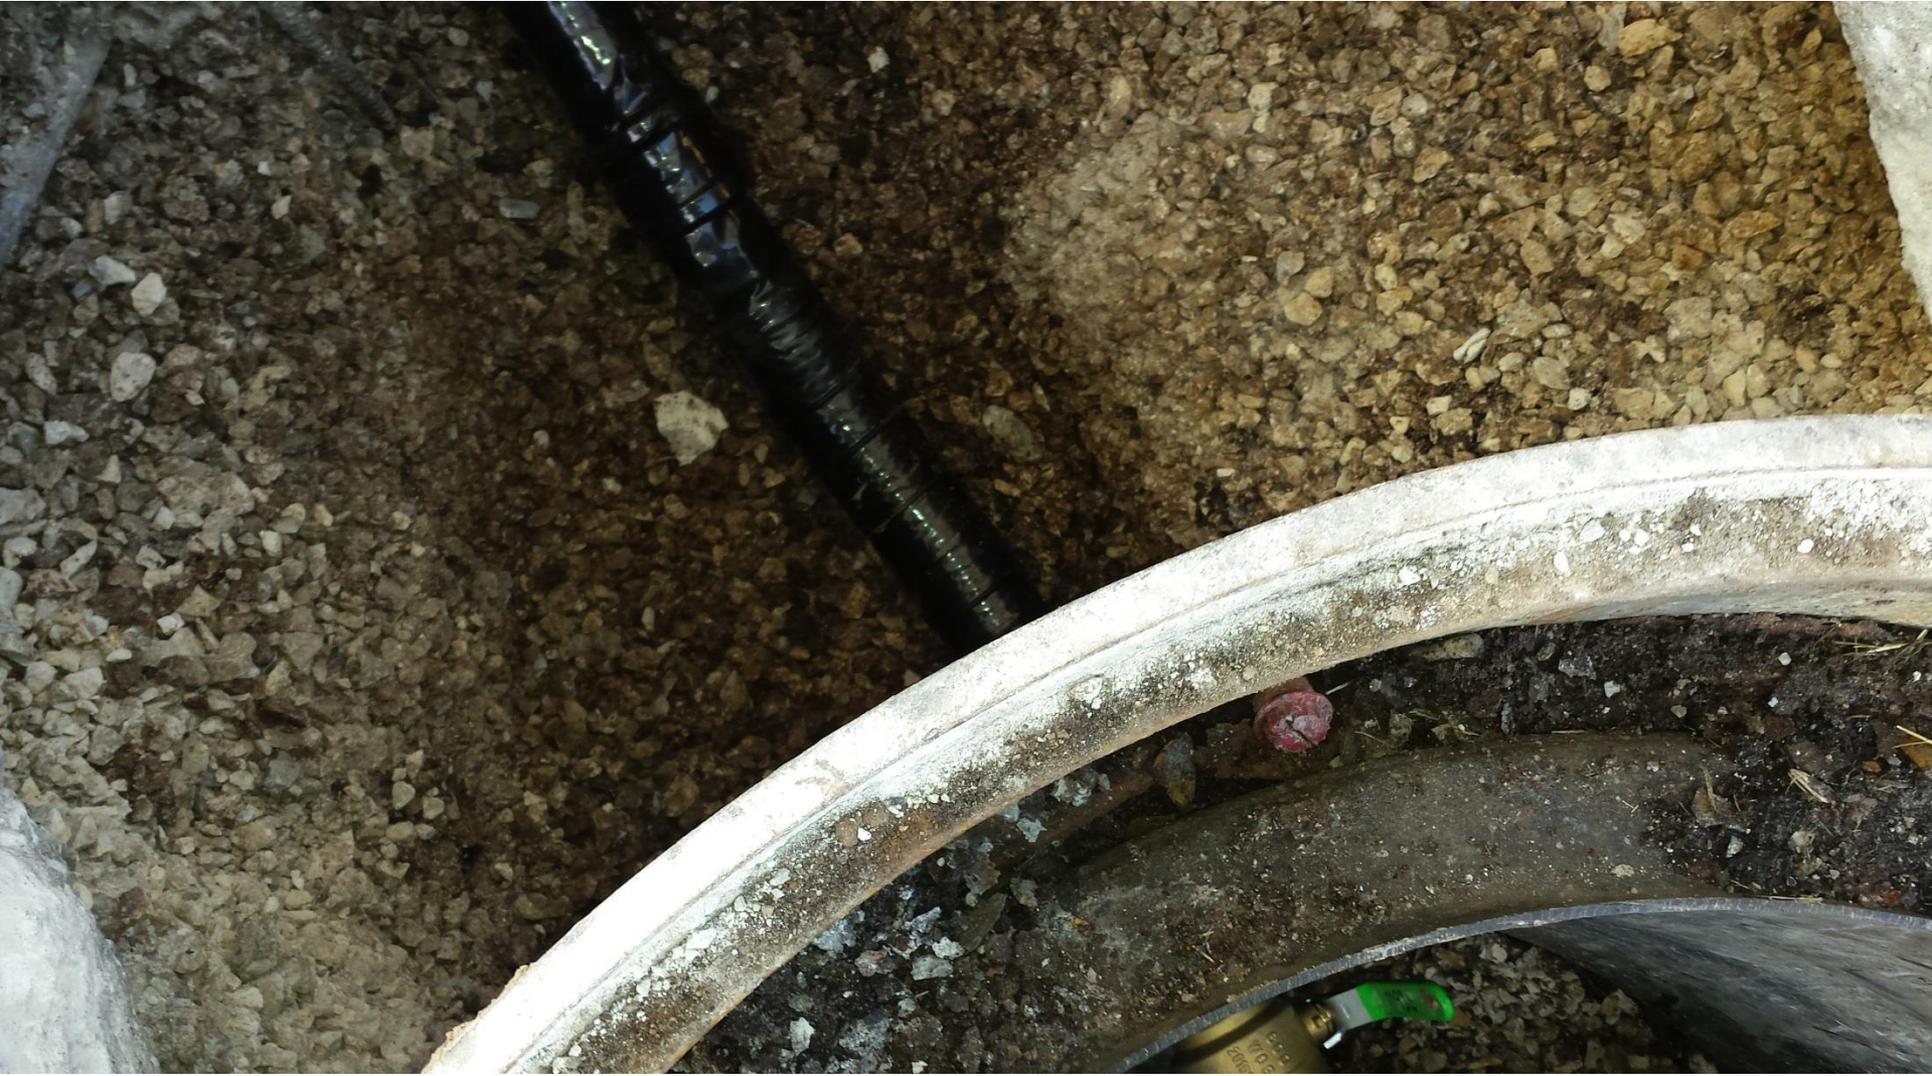
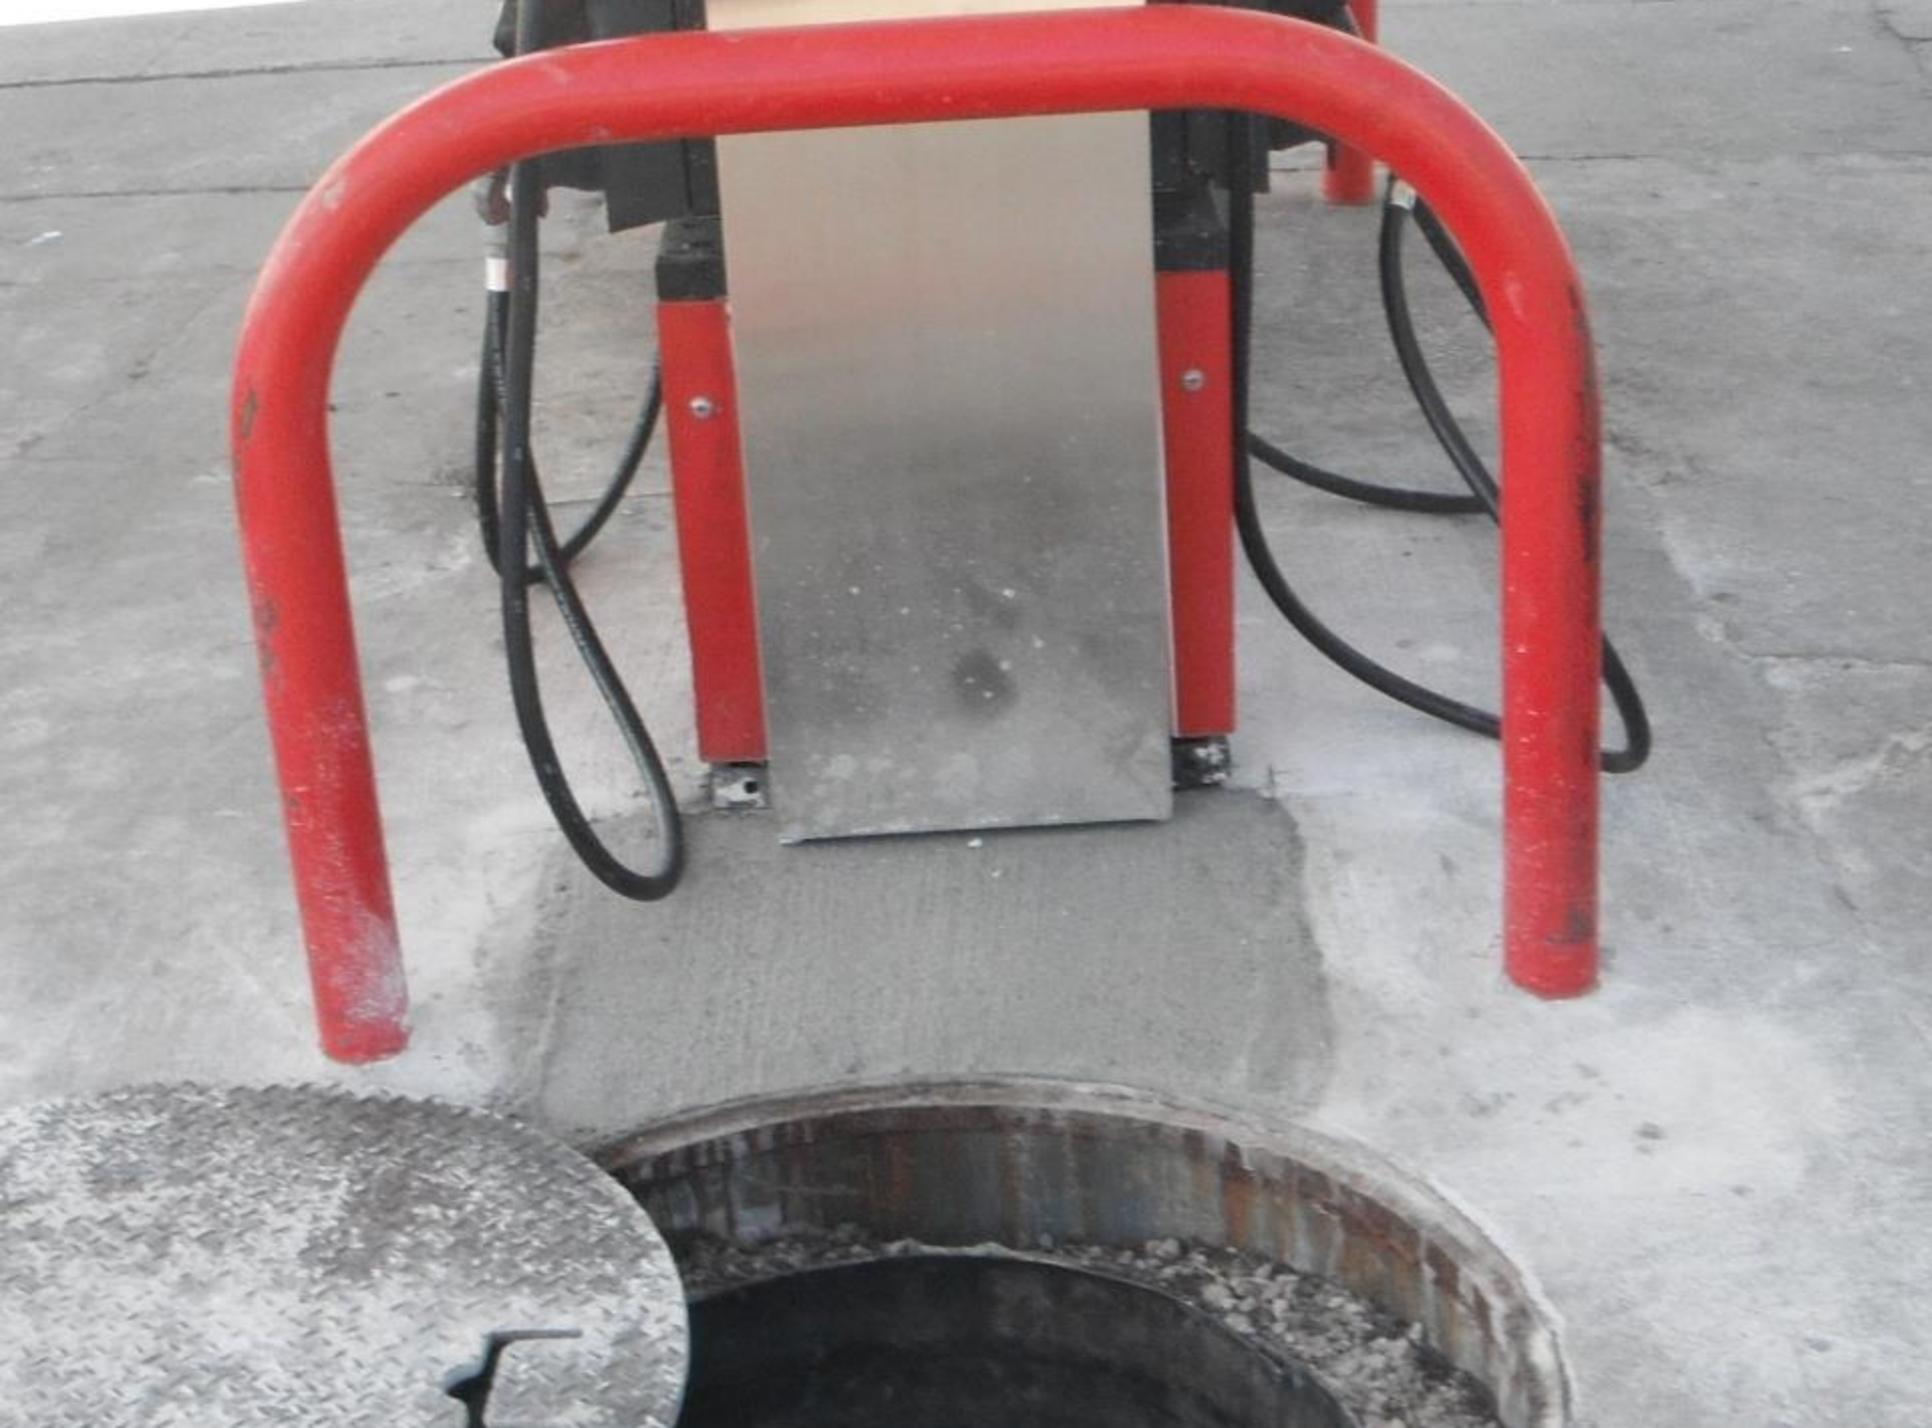
- Owner called in failing line tightness test
- Found leak- replaced flexible connector leaking threads
- Conducted sampling
- Results submitted
- Site characterization
- Free product recovery

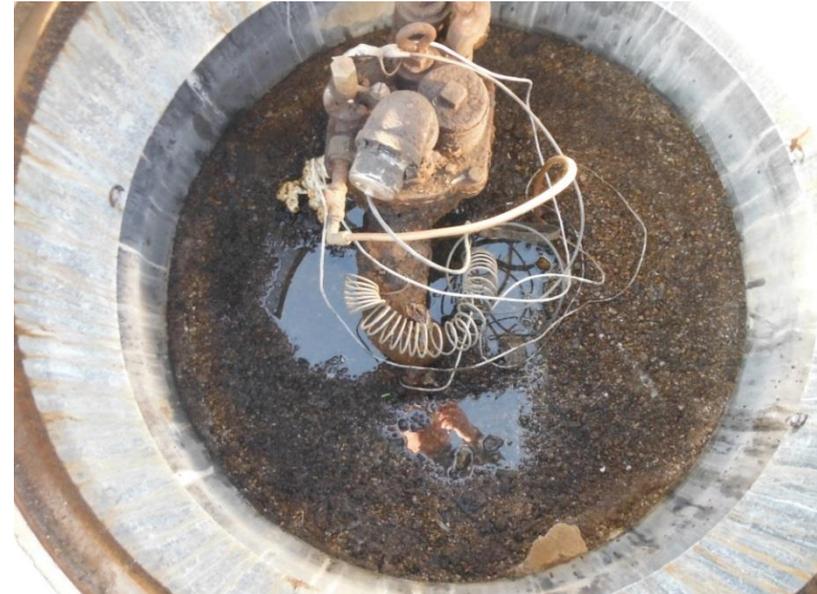
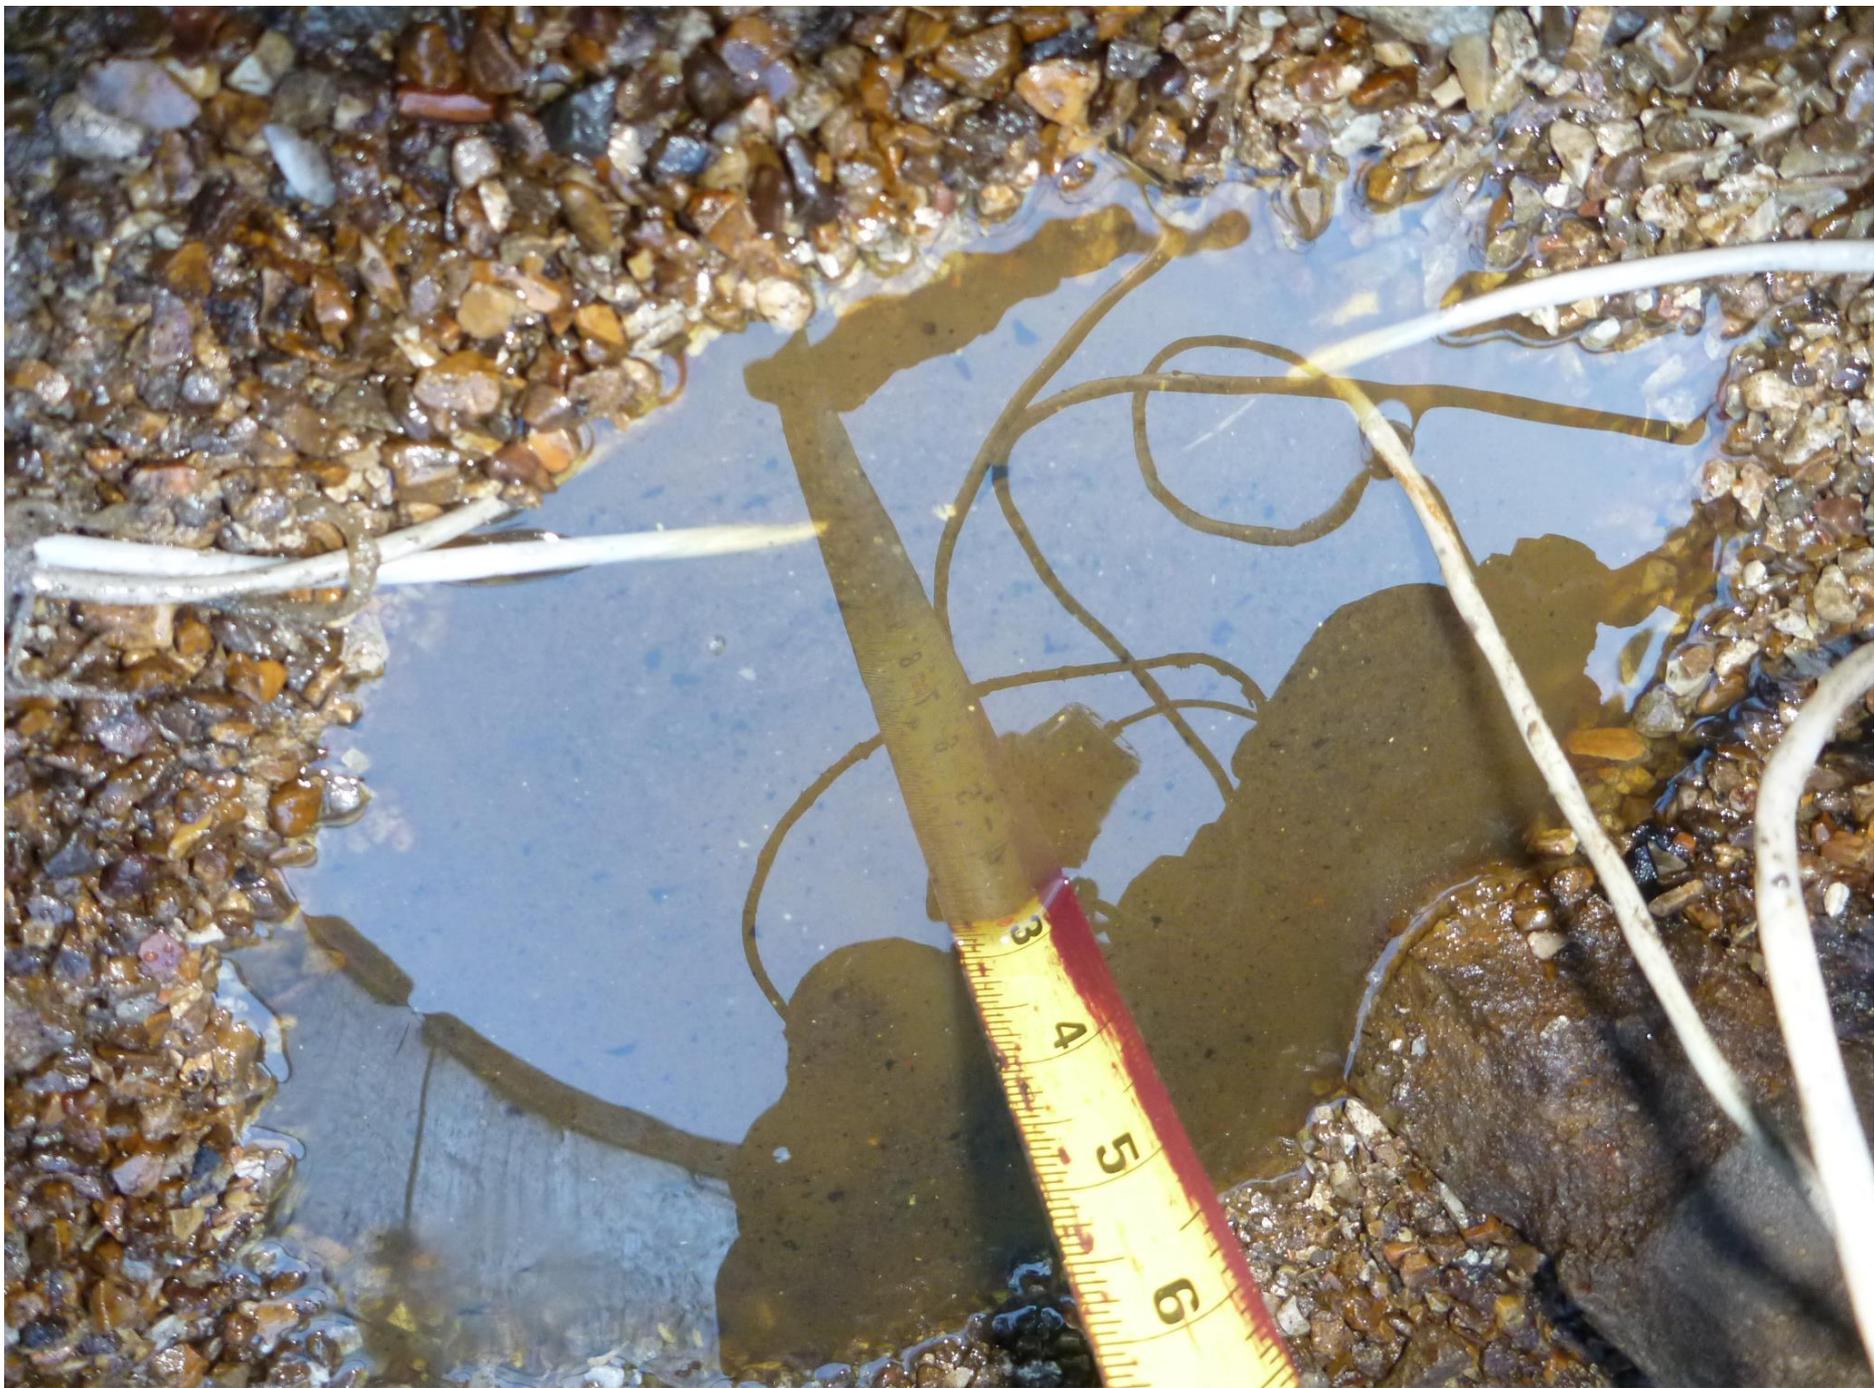
- Product noted in two tank top areas during Oct. 29, 2014, inspection
- Feb. 4, 2015, re-inspection to check areas
  - Product again found
- The department requested investigation

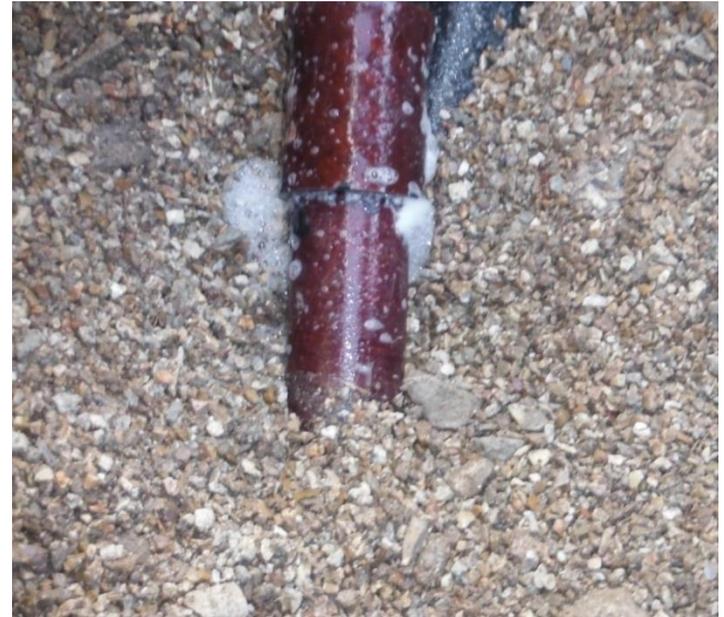
- Feb. 12, 2015- The department, contractor and owner on-site
- Small leak found at FRP coupling
- Repairs made
- Sampling conducted
  - Above DTLs
- Site characterization needed

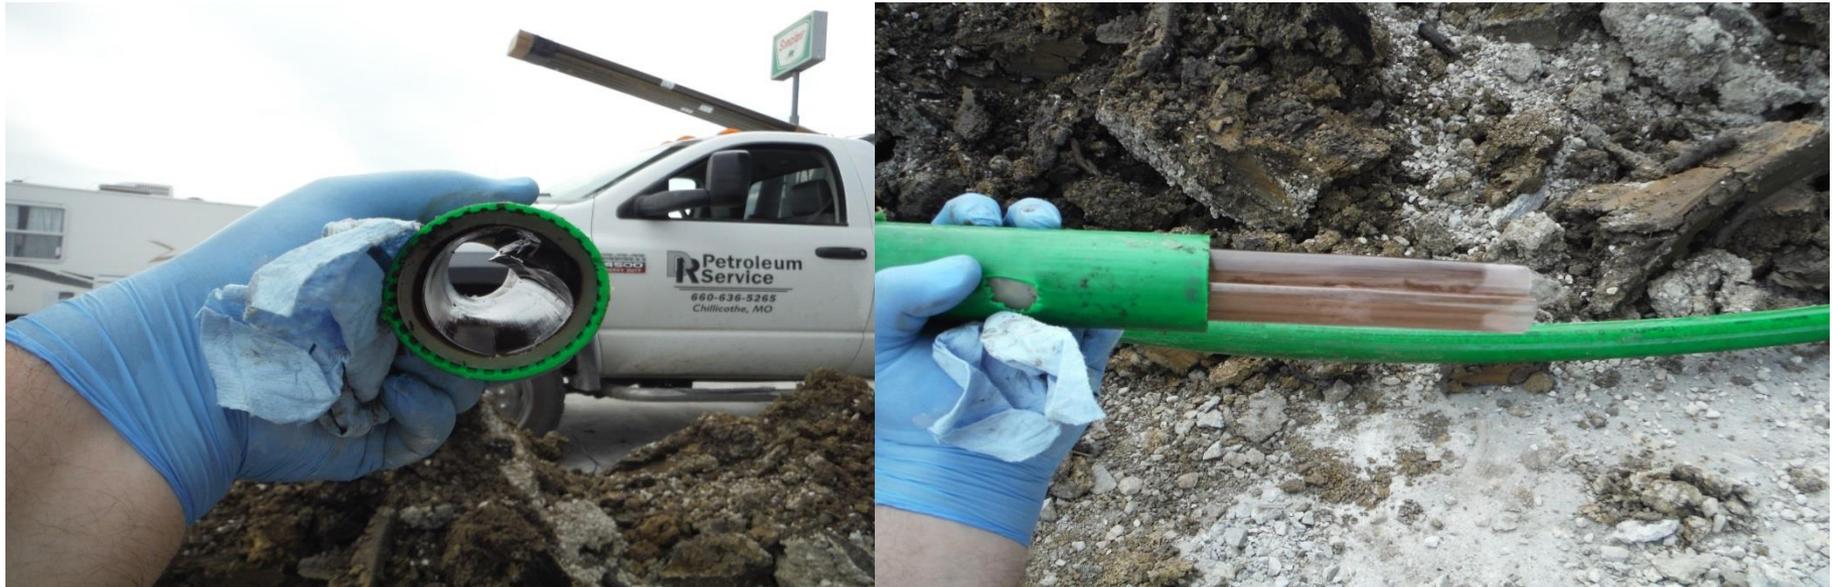
- Piping in contamination
- Delamination/deterioration
- Site characterization needed

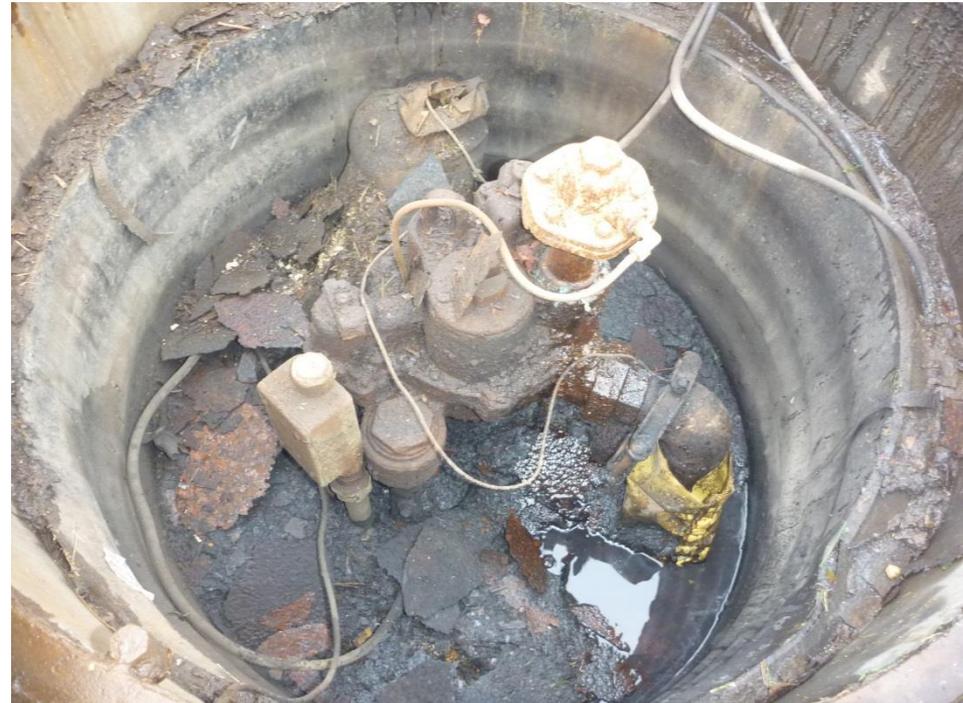
- Leak found during Oct. 9, 2014, inspection (video provided)
- Product in well
- Pumped well
- Sheen in well
- Sampling required
- Site characterization ongoing

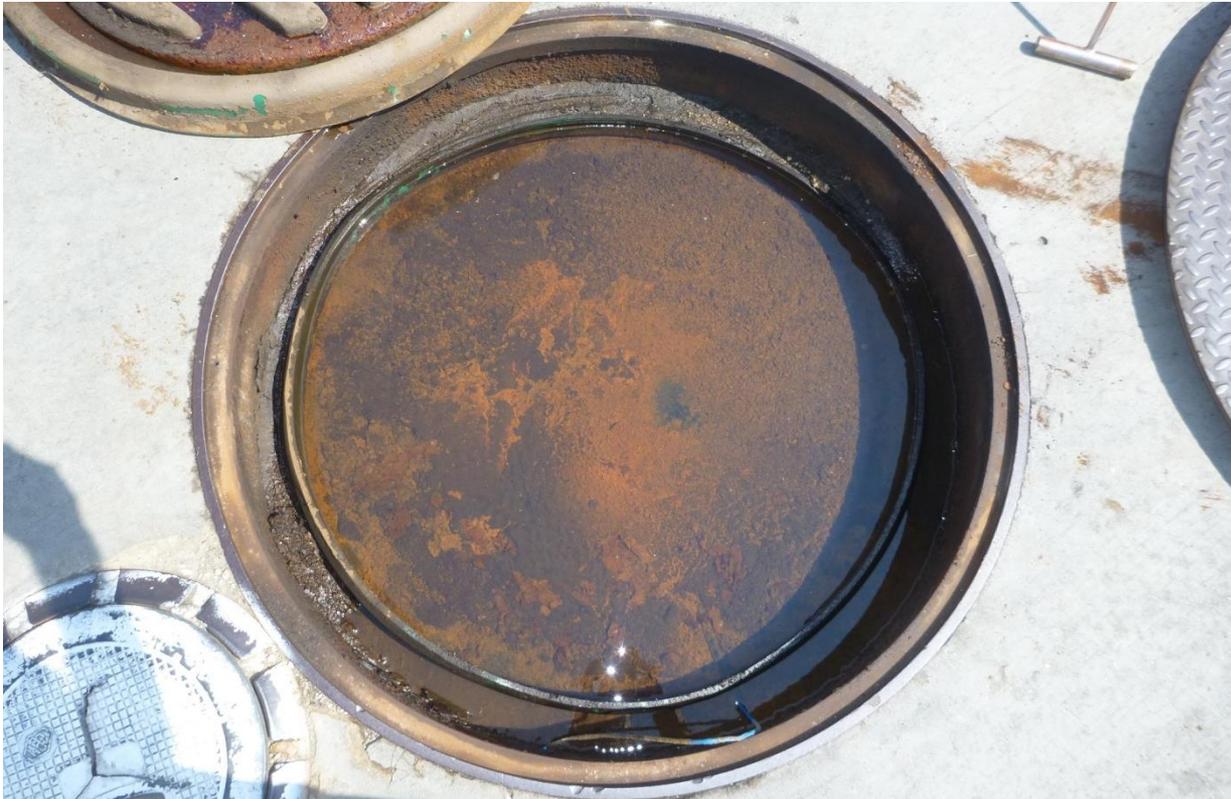
- Inspection Sept. 4, 2015 - found product bubbling up through water filled sump

- Owner immediately contacted contractor
- Pumped out sump
- Found pinhole leak in flex connector
- Replaced within hours of inspection
- Sampling requested
- Free product recovery and site characterization work plan needed

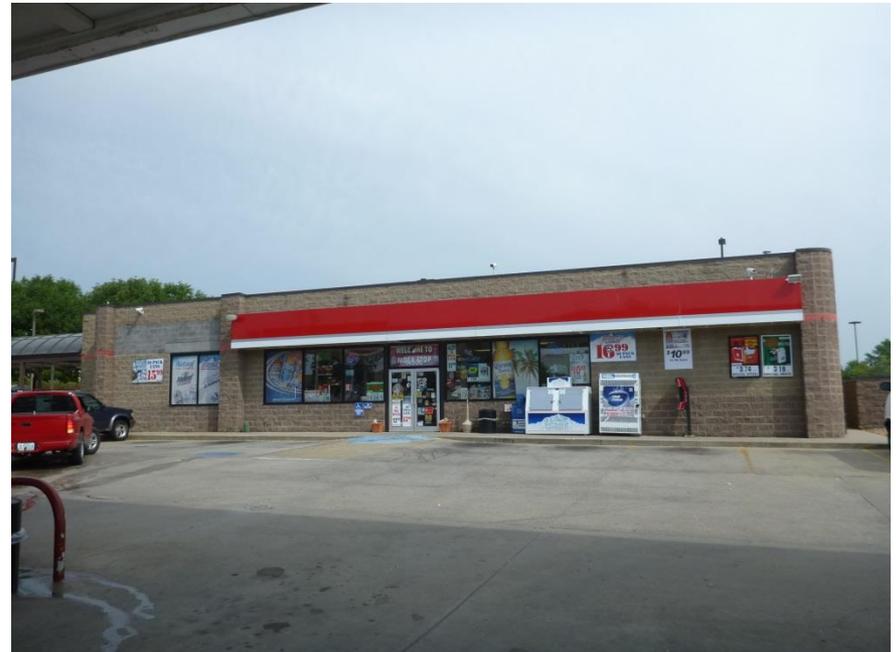
- Spill/overflow of approx. 700 gallons
- Sampling conducted
- Contamination found
- Site characterization  
risk assessment  
underway

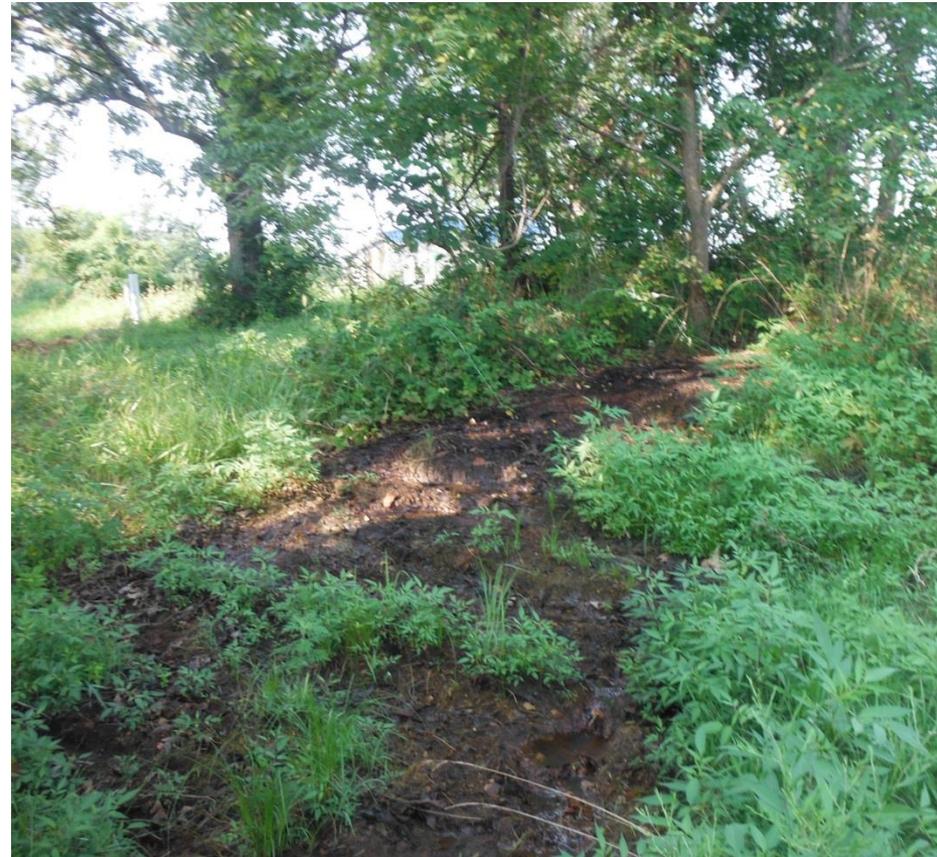
- Complaint called in
- Dead vegetation
- Pipe from tank pit to back of property
- Owner will conduct sampling

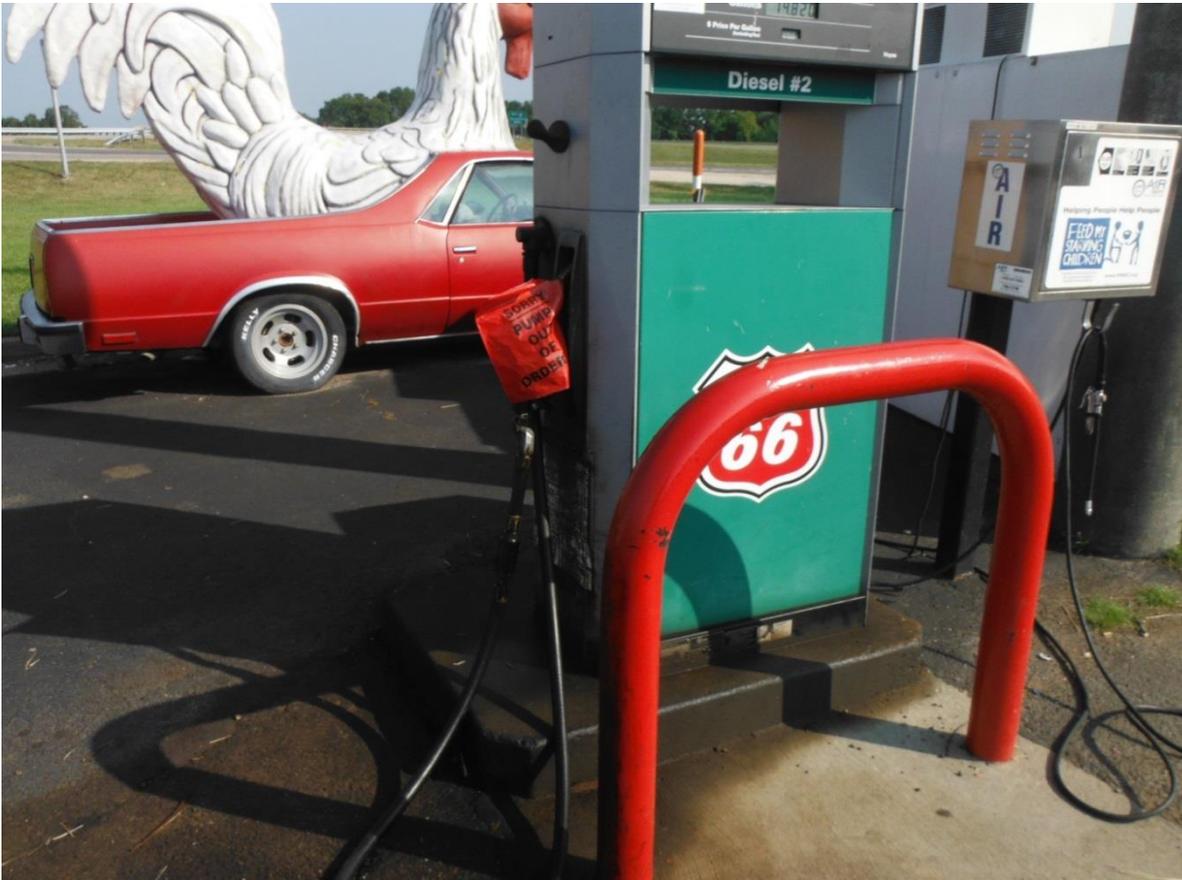
- Some staining
- Uncertain if it was the source
- Excavation of soils approved

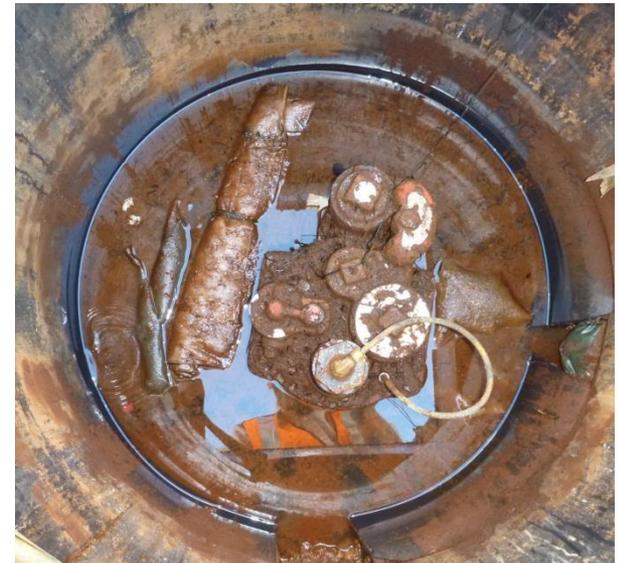
- Small weeps in 2009- fixed
  - Vent tube at line leak detector
- Jan. 27, 2012, inspection noted small leak at line leak detector
  - Feb. 23, 2012, re-inspection found clear water in area and no signs of a leak

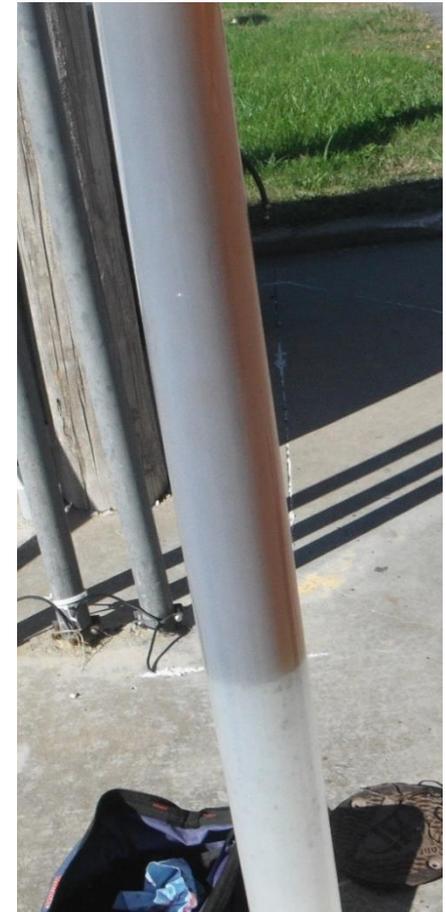
- Oct. 20, 2014, inspection
  - Product in tank top area
  - Absorbent pads in tank top area
- Oct. 21, 2014, the department's re-inspection
  - 12 inch product (weathered) in well
  - Absorbent materials in a well
  - Did not observe off-site impacts
- Required sampling

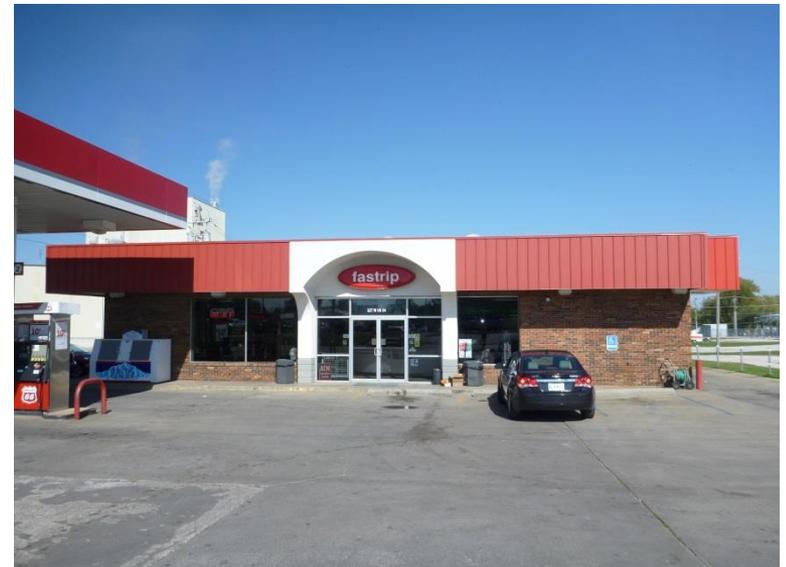
- Passing tank and line tightness tests
- Passing release detection
- Not requiring additional system check *at this time*
- Required sampling
- Site characterization, free product recovery
