**APPENDIX B**  
**PHOTOGRAPHS**

Photograph Log  
Shapiro Brothers Salvage Site  
Site Inspection/Removal Site Evaluation

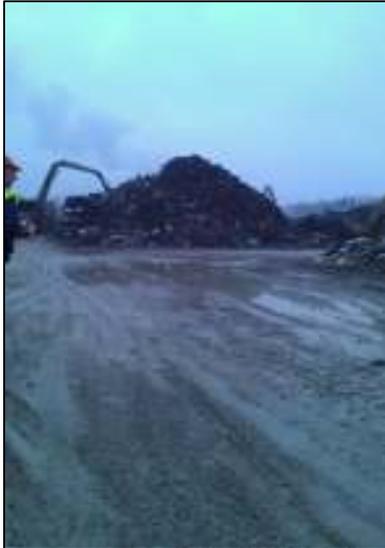
Photograph 1  
Taken April December 20,  
2012

Gravel surface in facility  
materials processing area.  
View looking north.

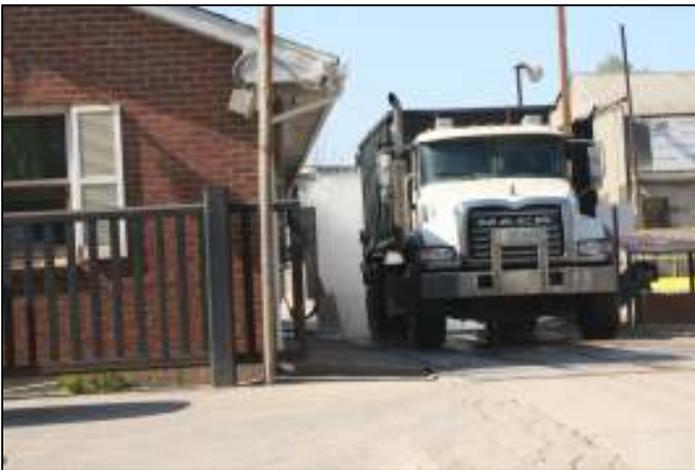
Photograph 2  
Taken April 9, 2012

Main facility entrance/exit  
onto 9<sup>th</sup> Street showing  
truck wash station in  
operation. View looking  
north.

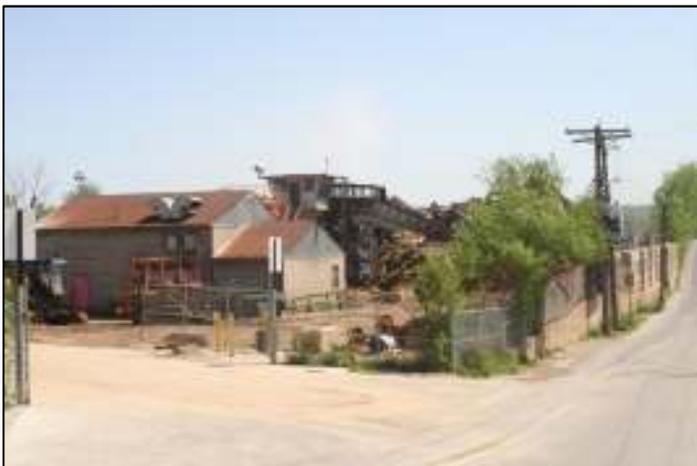
Photograph 3  
Taken April 10, 2012

Northern facility  
entrance/exit onto Vine  
Street. View looking  
southeast.

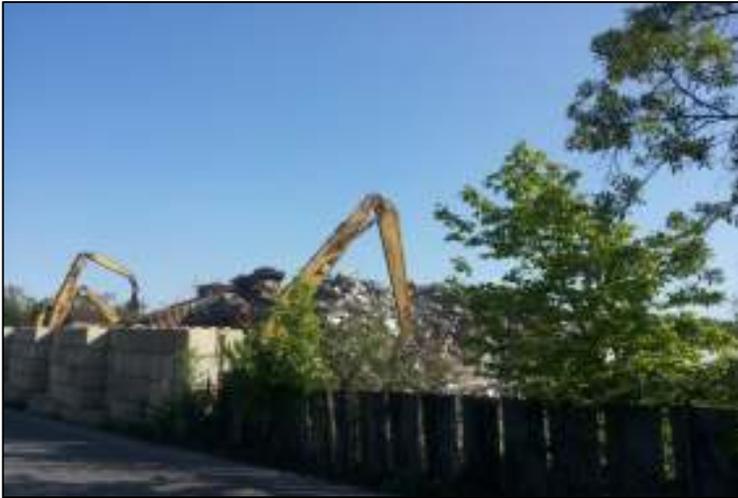
Photograph 4  
Taken April 9, 2012

Scrap handling operation  
along Vine Street. View  
looking northeast.

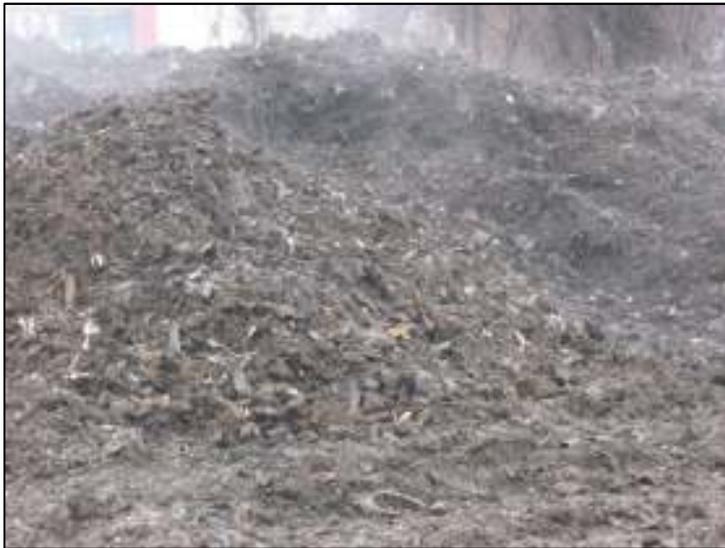
Photograph 5  
Taken December 20, 2012

Shredder fluff pile releasing  
steam. View looking east.

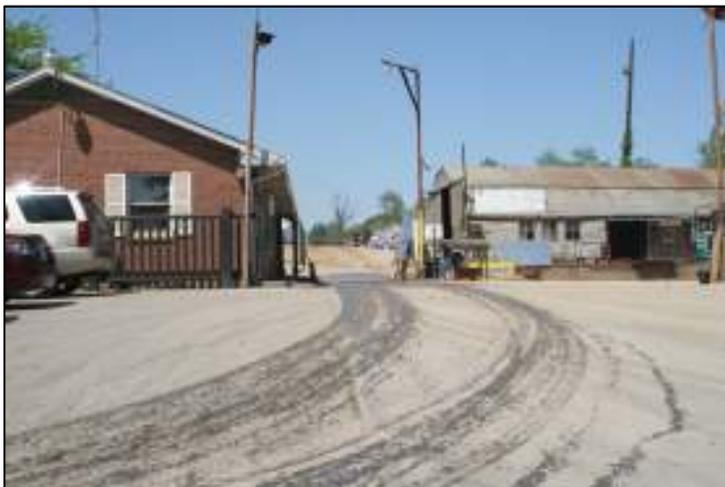
Photograph 6  
Taken April 10, 2012

Main facility entrance/exit  
onto 9<sup>th</sup> Street showing  
truck tracks.

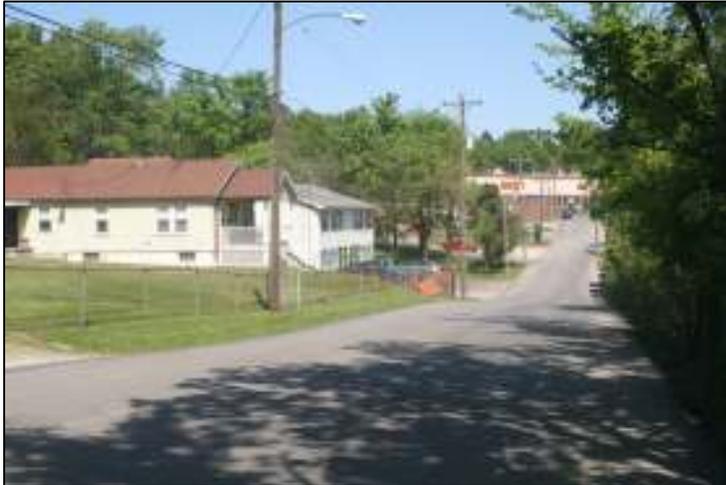
Photograph 7  
Taken April 10, 2012

View along Vine Street looking north. The facility is on the right (east) side of the photo.

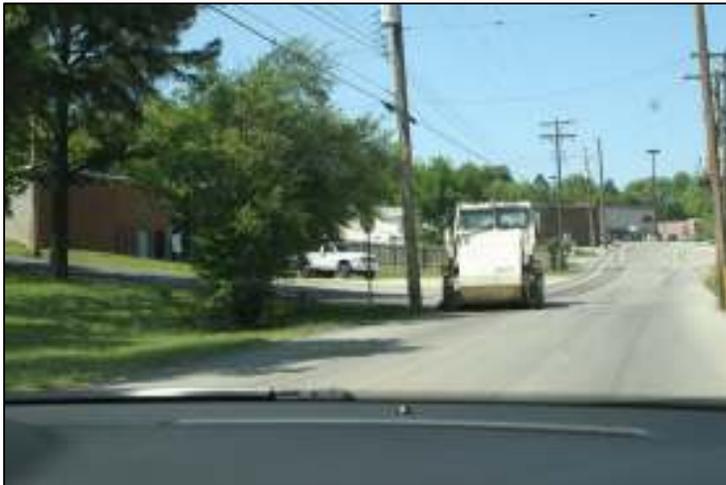
Photograph 8  
Taken April 10, 2012

Street sweeper operated by the facility traveling along Vine Street near the north facility entrance. View looking North.

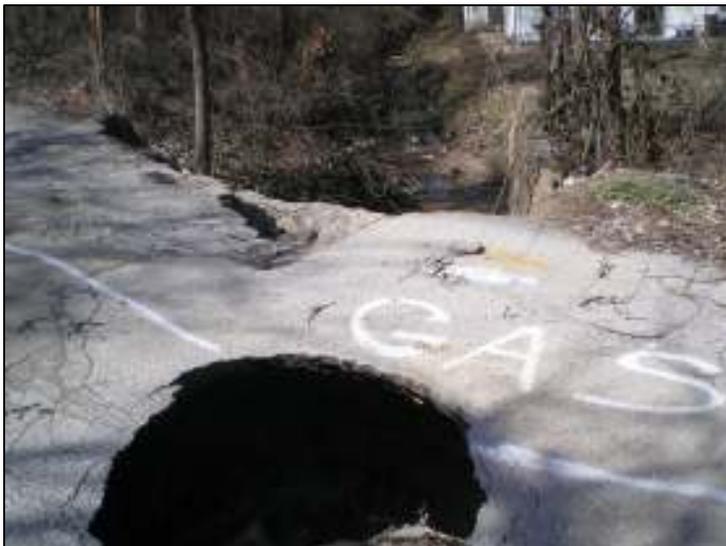
Photograph 9  
Taken April 10, 2012

Failure of the 12<sup>th</sup> Street culvert/road collapse near the southeast corner of the facility.

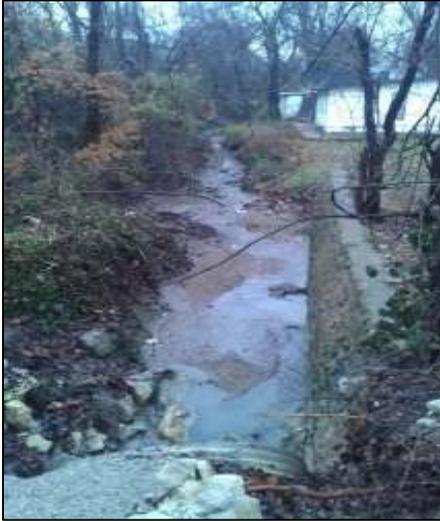
Photograph 10  
Taken December 20, 2012

Unnamed tributary of  
Platin Creek looking  
upstream to the north from  
the 12<sup>th</sup> Street culvert near  
the southeast corner of the  
facility.

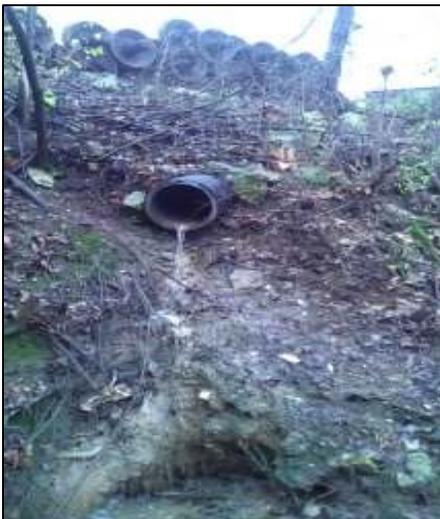
Photograph 11  
Taken December 20, 2012

Discharge from the facility  
to the unnamed Platin  
Creek tributary along the  
eastern facility boundary.

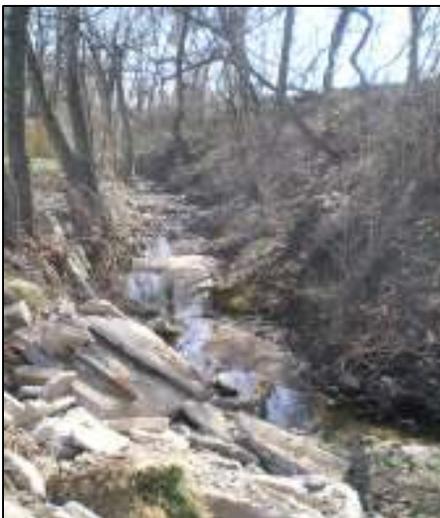
Photograph 12  
Taken December 20, 2012,

View of the unnamed  
Platin Creek tributary from  
the northeastern facility  
corner. View looking  
downstream to the south.

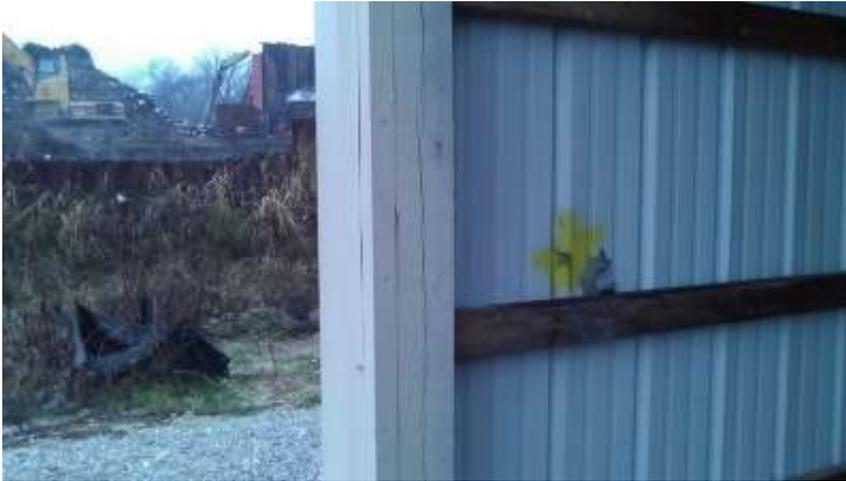
Photograph 13  
Taken December 20, 2012

One of the holes in Joachim  
Plattin Ambulance District  
Building directly across  
from the facility shredder  
(viewed in background).

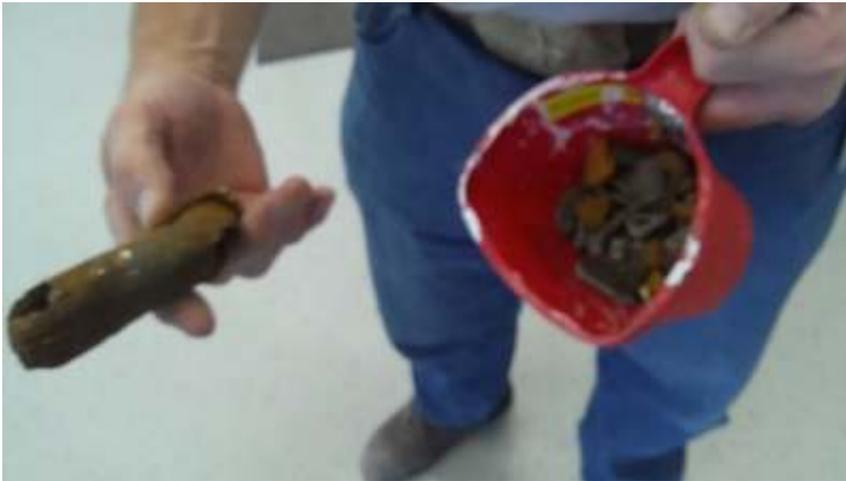
Photograph 14  
Taken December 20, 2012

Some of the material  
ejected from the facility  
shredder which has been  
collected at the Joachim  
Plattin Ambulance District  
building

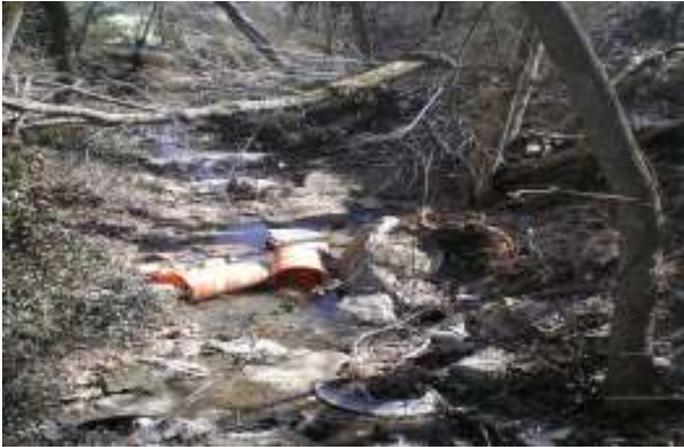
Photograph 18  
Taken April 9, 2012

Plattin Creek tributary  
along eastern boundary of  
the facility showing metal  
debris in stream bed.

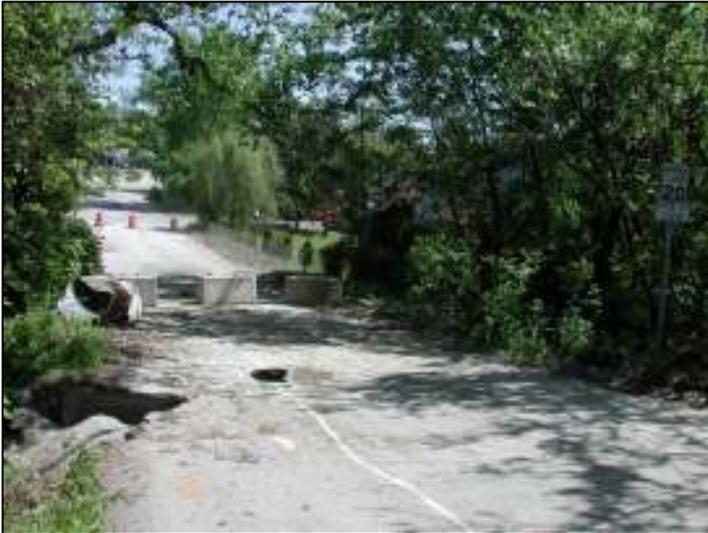
Photograph 19  
Taken April 9, 2012

Surface water and sediment  
sampling location at 12<sup>th</sup>  
Street bridge (SW01/SD02).  
View looking east.

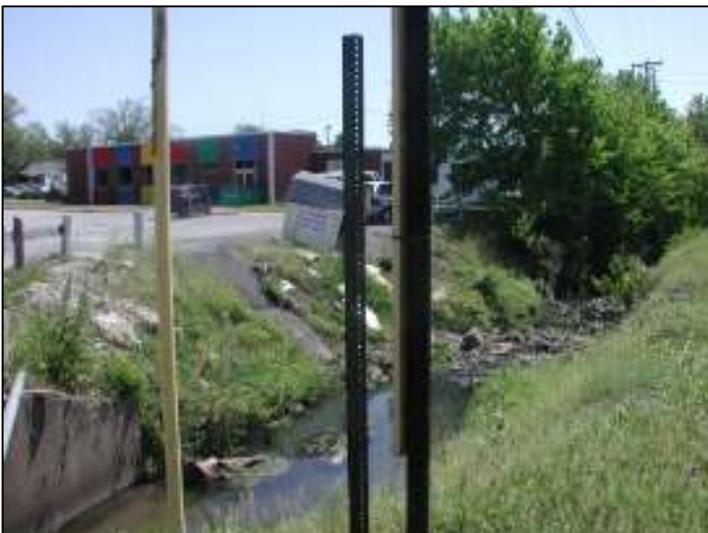
Photograph 20  
Taken April 9, 2012

Surface water and sediment  
sampling location at Bailey  
Road bridge(SW03/SD03).  
View looking south.

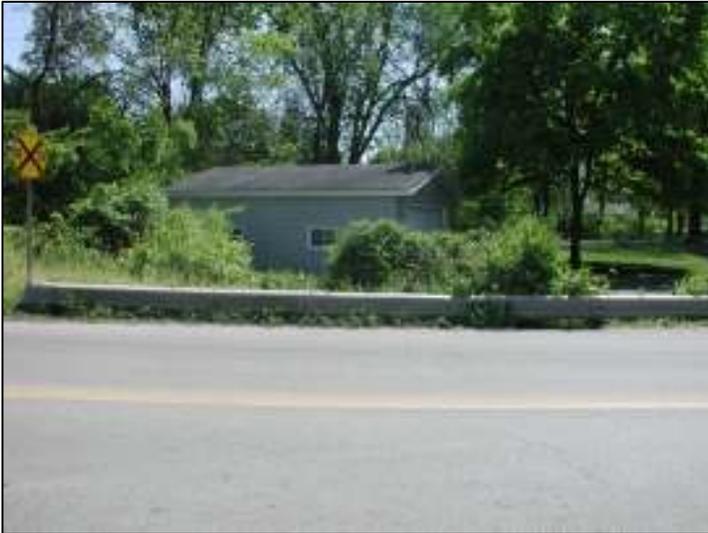
Photograph 21  
Taken April 9, 2012

Surface water and sediment  
sampling location at 6<sup>th</sup>  
street bridge (SW02/SD02).  
View looking south.

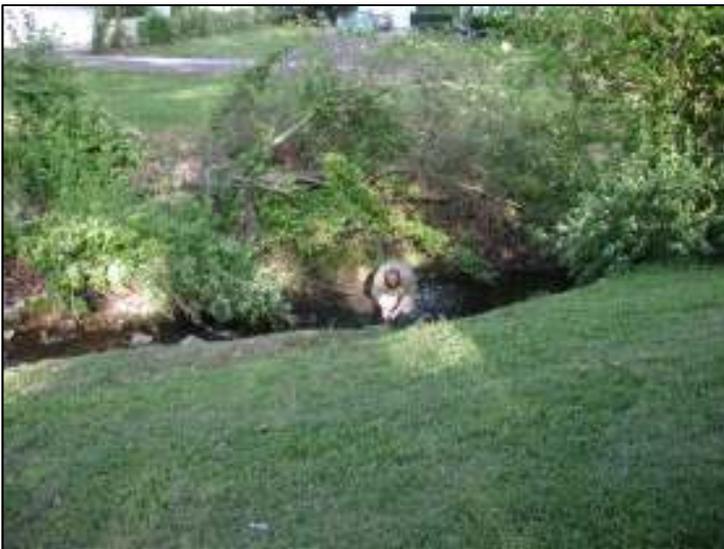
Photograph 22  
Taken April 9, 2012

Surface water and sediment  
sampling location at Sunset  
Park (SW04/SD04). View  
looking east.
