Memo

Re: Outfall 002 Joint Inspection North of AICO inlet area.

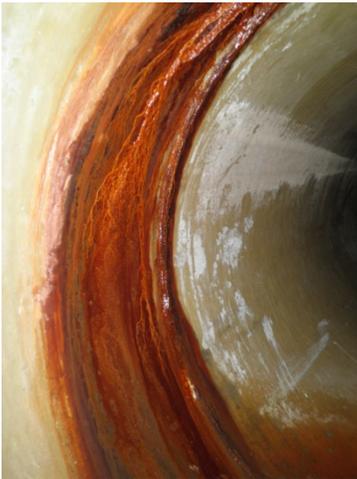
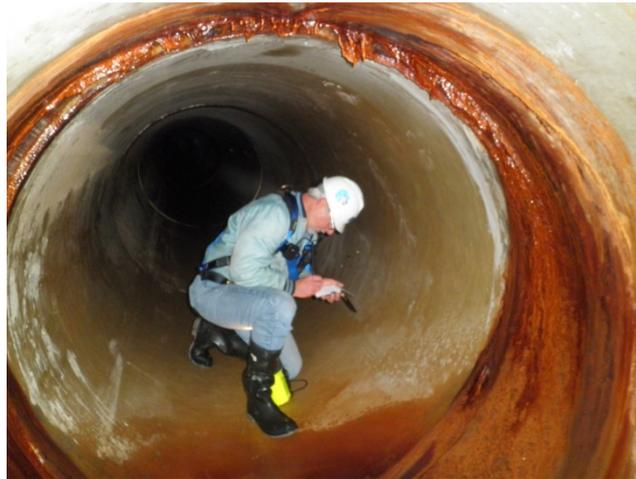
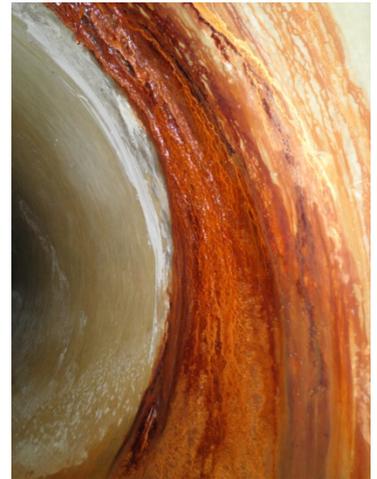
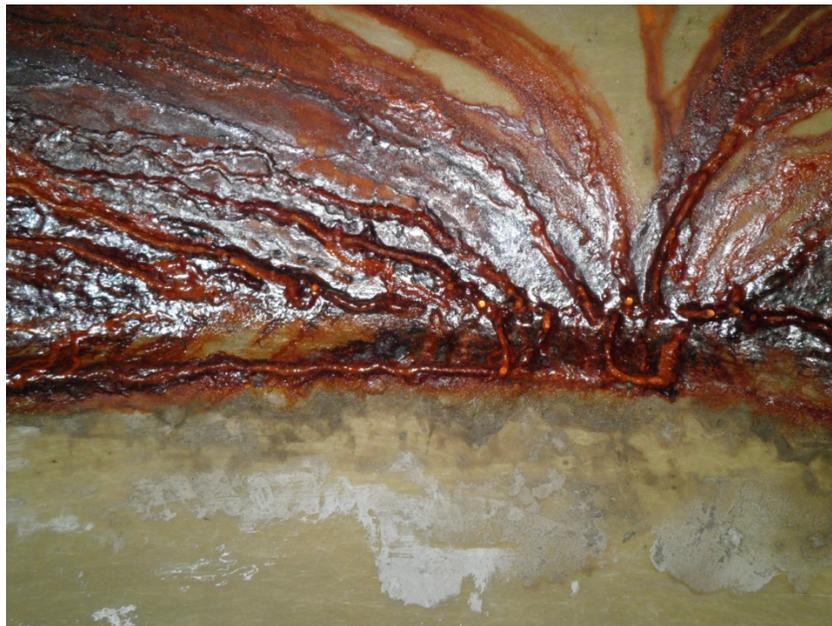
1.0 Background: During the Outfall 002 inspection (December 15, 2011 by Ernie Dibal and Colm Chomicky), seepage was observed north of the AICO inlet where the new manhole joins the 60-inch Hobas pipe. Water was dripping from the pipe crown at the joint between the new Hobas pipe and new manhole (north, upstream side of manhole). Rust-colored staining associated with the seepage was also observed. Below are several photos of the seepage

2.0 Inspection by Kissick Construction 01/04/2012: Kissick Construction was notified of the need for warrantee repair on January 02, 2012 by Elaine Brewer. Kissick arrived at the AICO area at 9:00 am on January 4, 2012 and performed confined space entry to inspect the seepage. The inspection lasted approximately 10 minutes. Kissick stated that they will notify HOBAS, the manhole manufacturer and their local general pipe supplier to evaluate possible solutions.

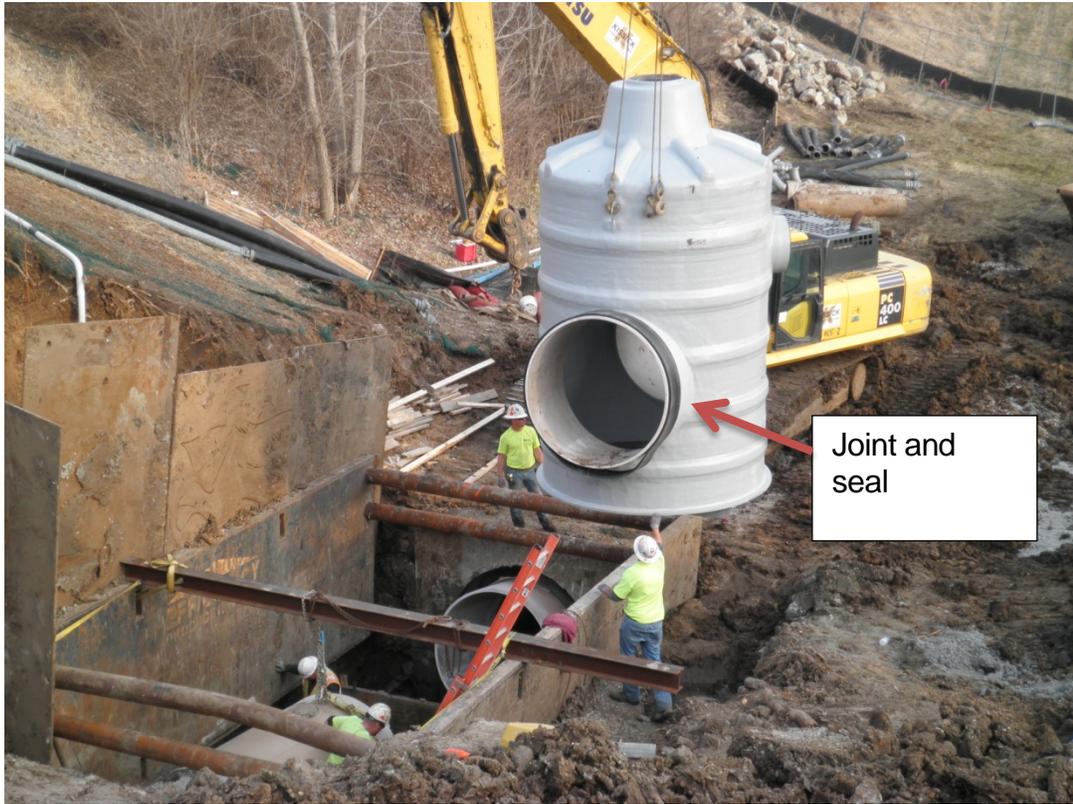
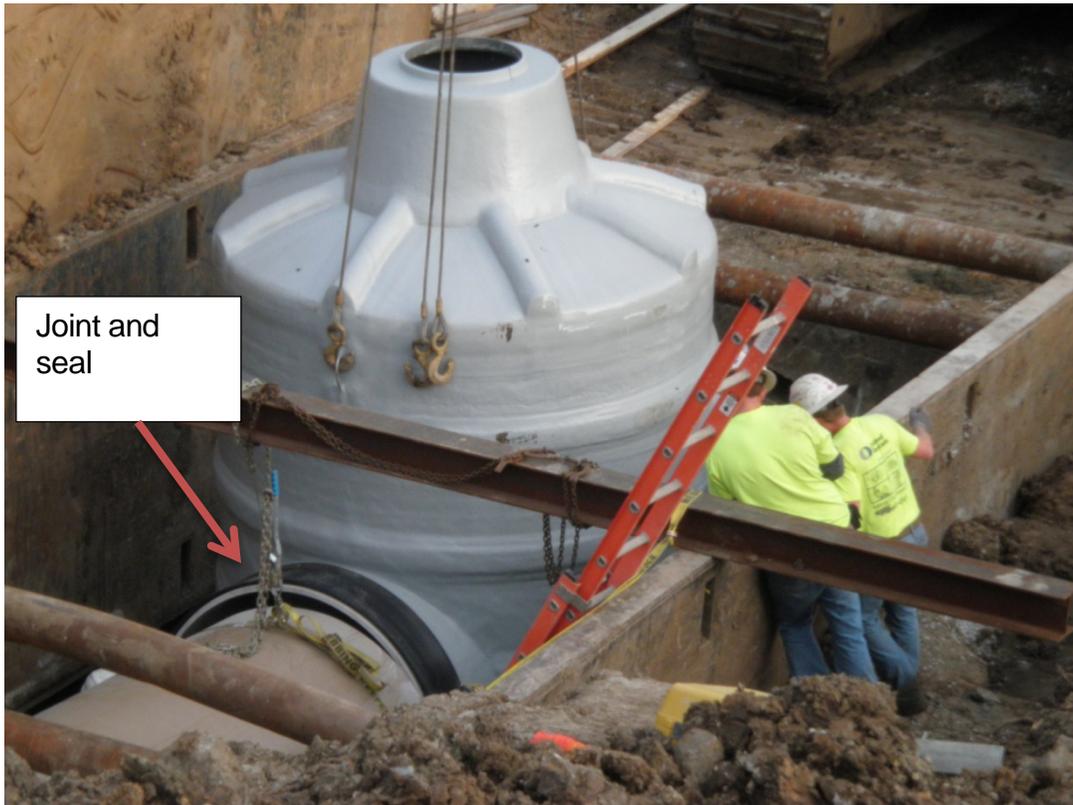
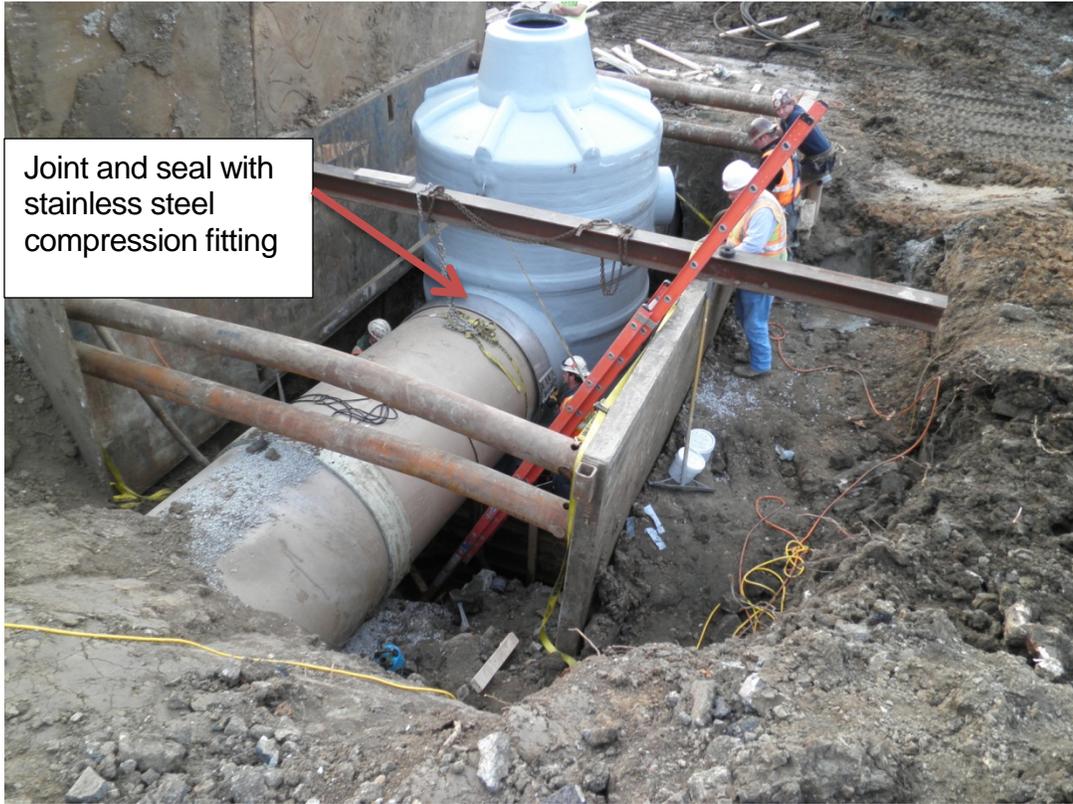
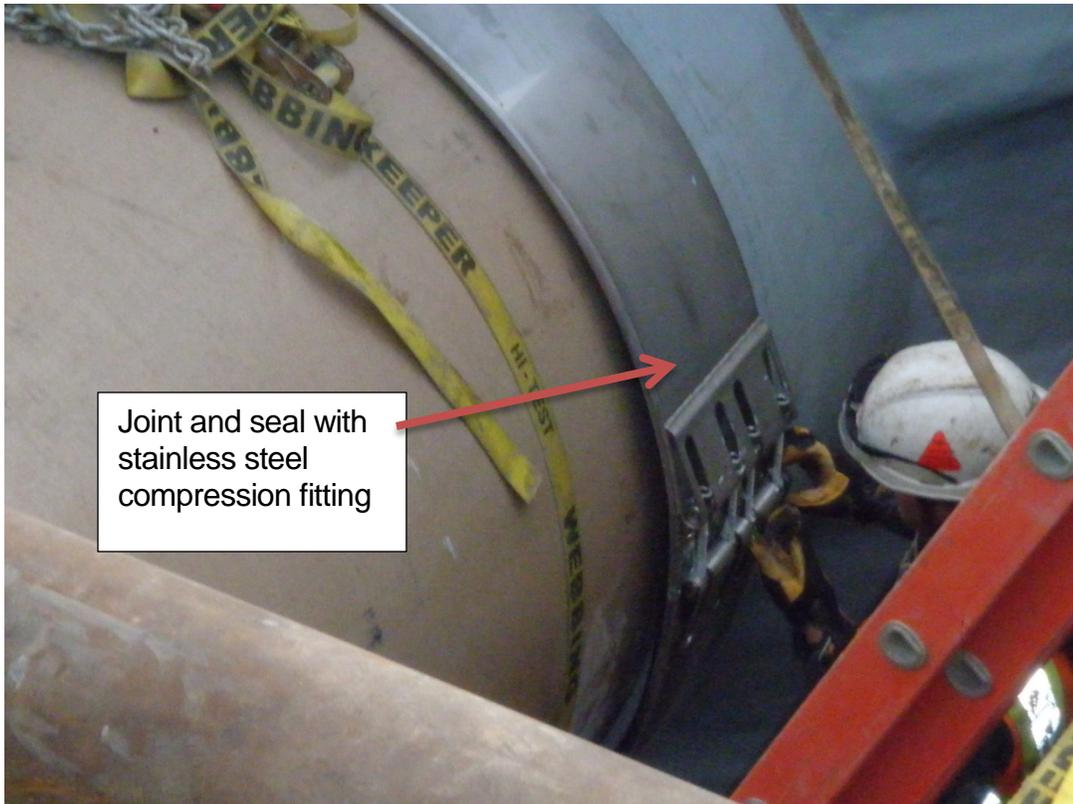
Additional Photos below are exterior views of the joint during construction
