To: SECOR, Inc.
From: Mary Lou Goodpaster
CC: George F. Jamison, Environmental Operations, Inc.
Date: April 9, 2004
Re: Former Hulett Lagoon, Camdenton, MO: Environmental Resource Site Review

1. Site Name: Former Hulett Lagoon
Location: West of West Mulberry Lane and east of Dawson Street
County: Camden City: Camdenton State: MO

SITE AREA TOPOGRAPHIC MAP SHOWING
 MONITORING WELL LOCATIONS
 FORMER HULETT LAGOON
 HAMILTON SUNDSTRAND
 CAMDEN, MISSOURI

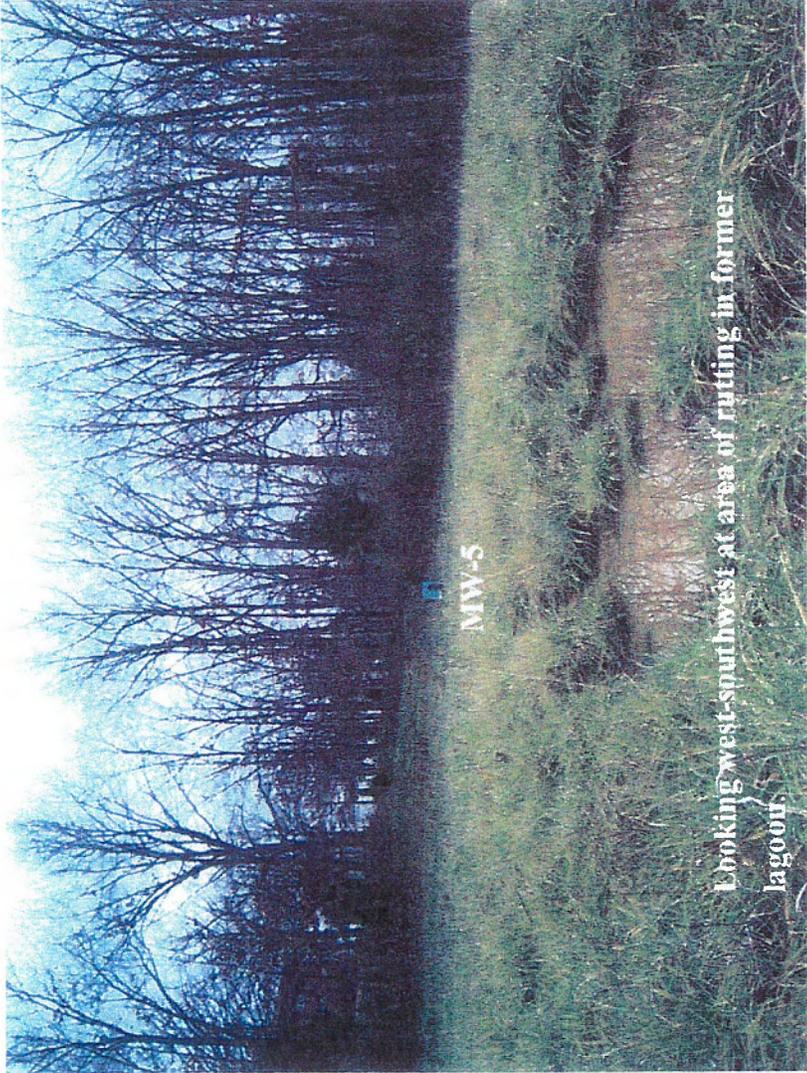
Looking west-southwest at area of rutting in former lagoon.

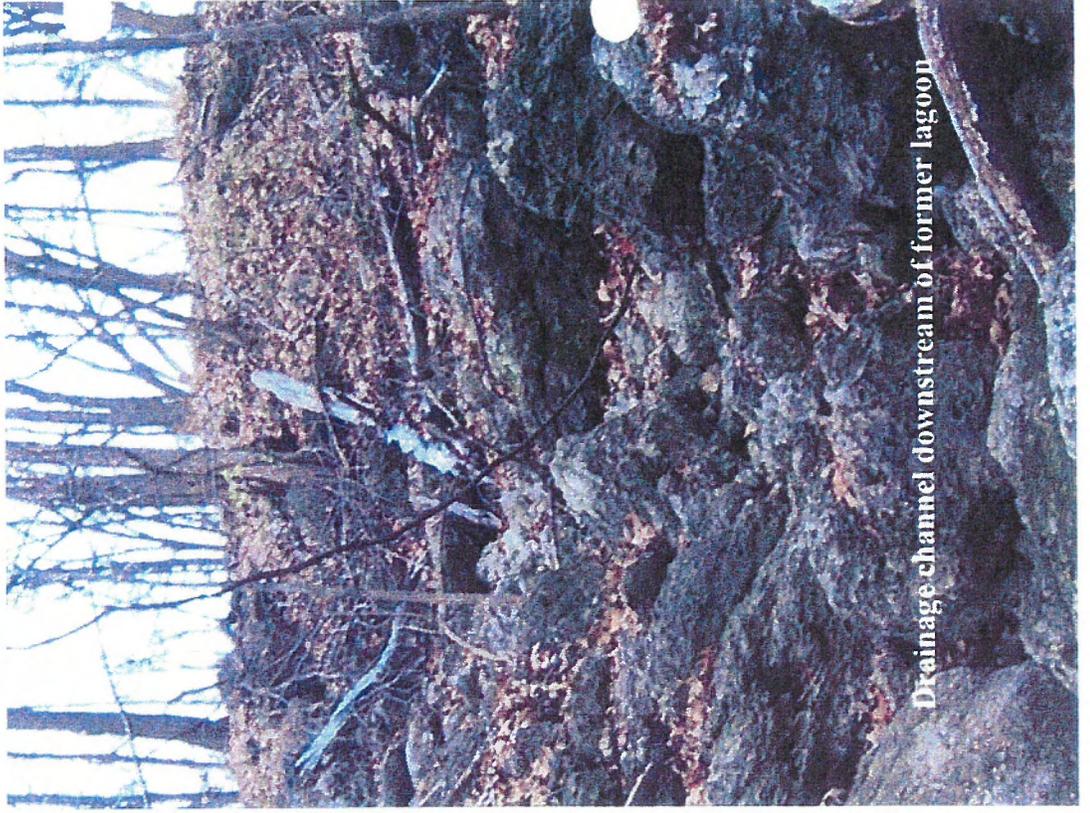
Drainage channel downstream of former lagoon

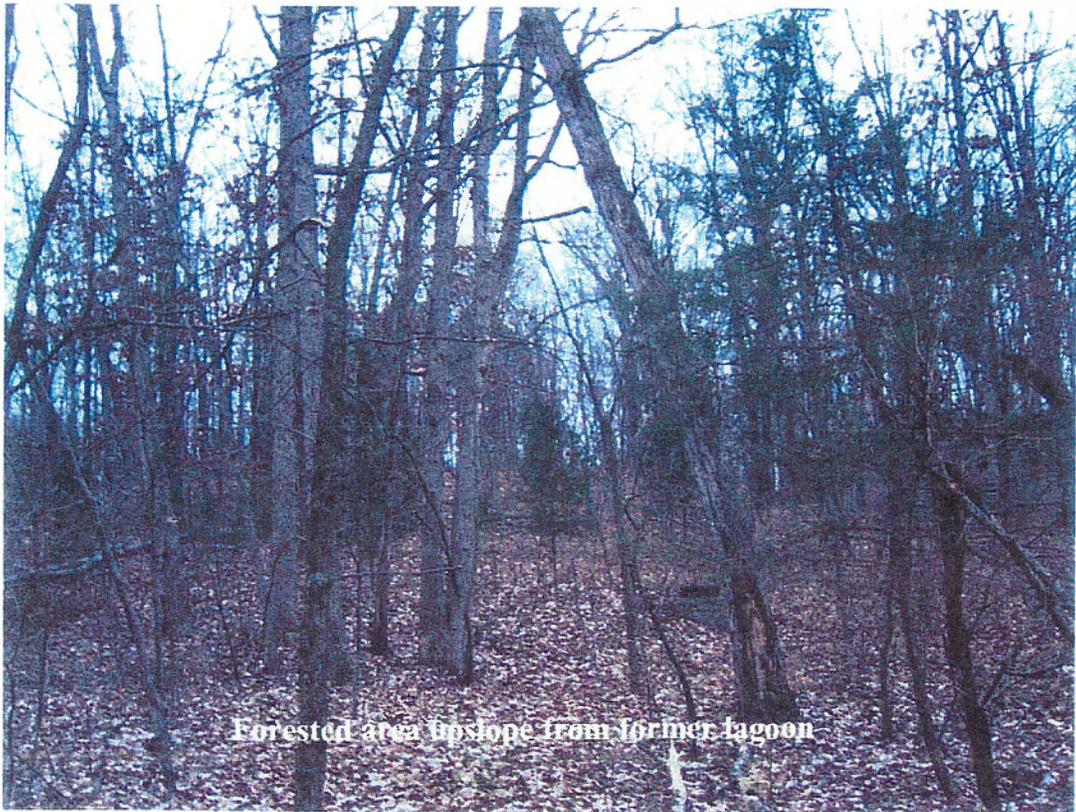
Forested area upslope from former lagoon

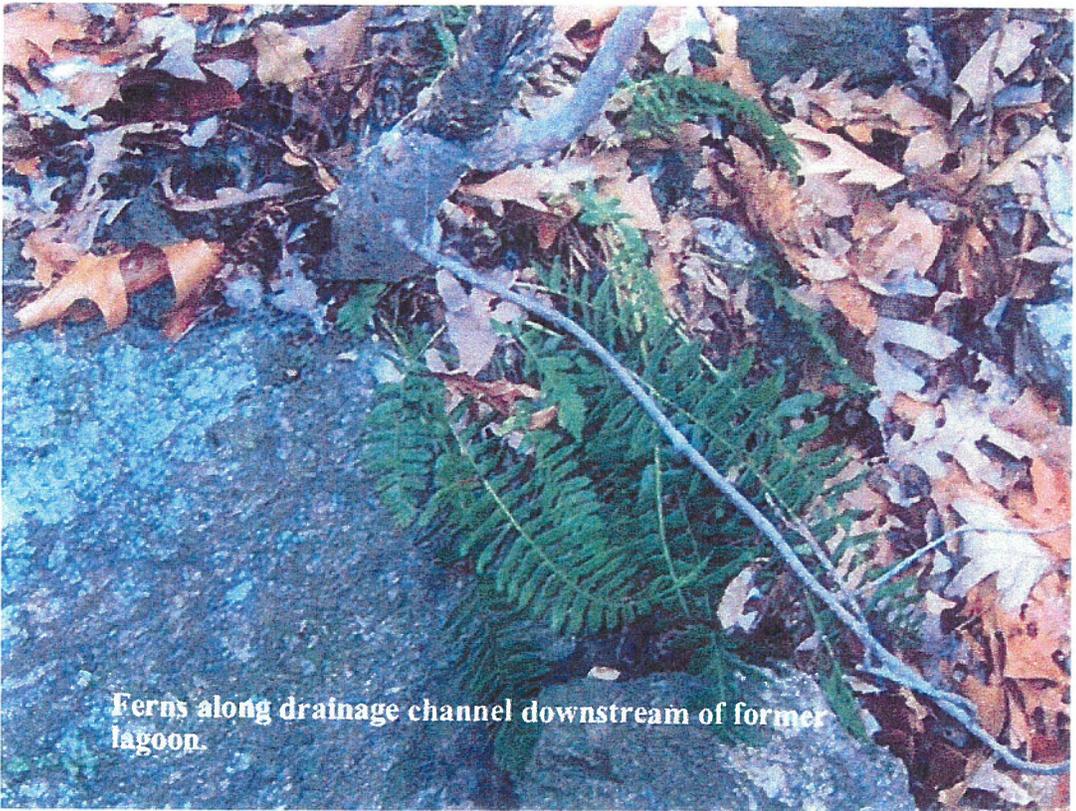
Ferns along drainage channel downstream of former lagoon.

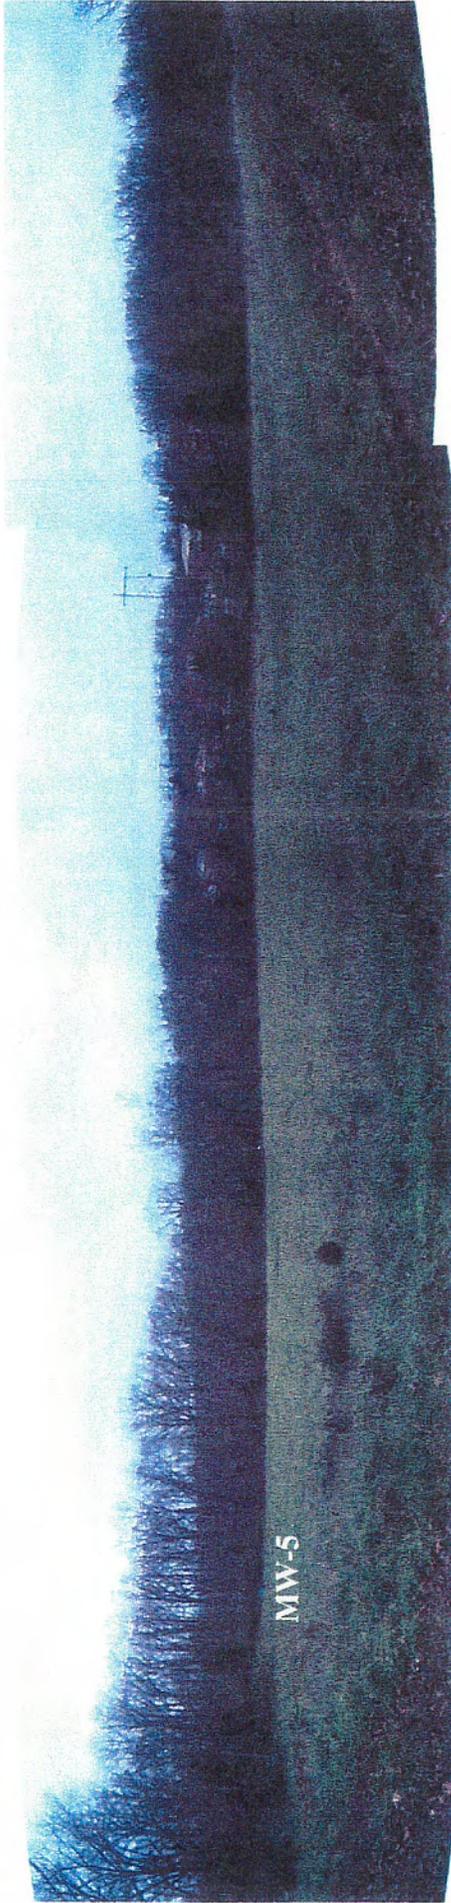
Looking over former lagoon area towards northwest.

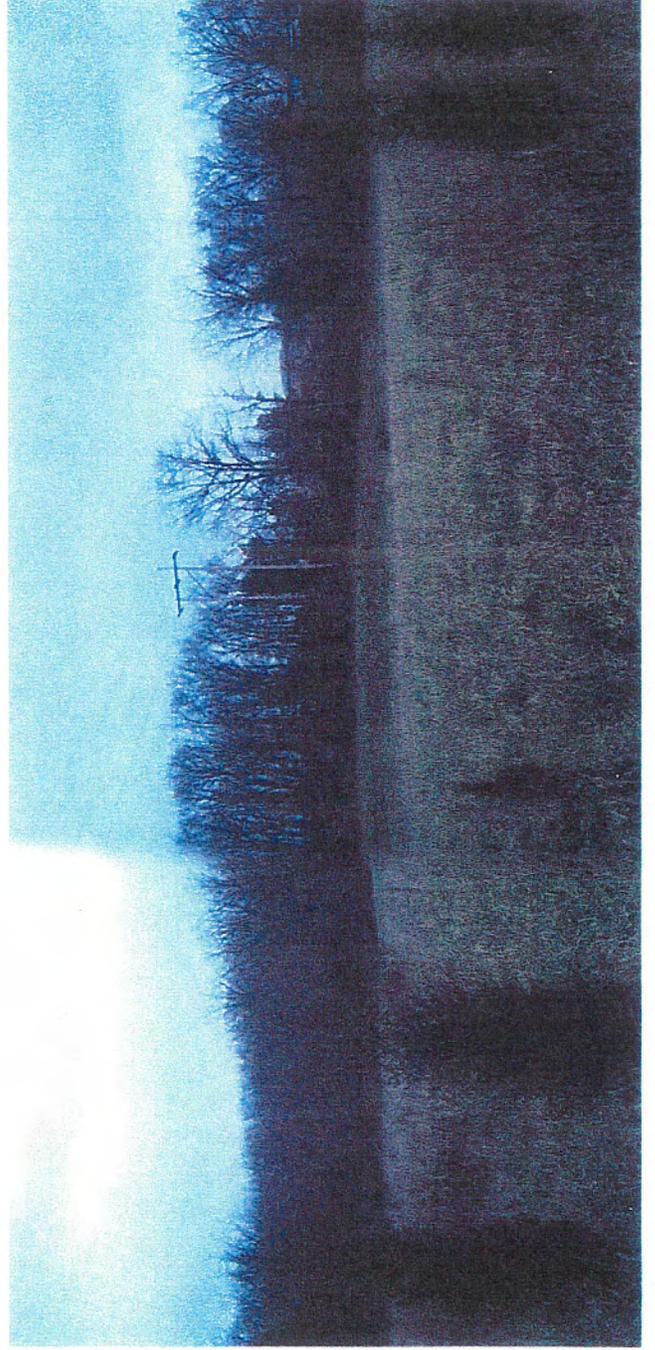
View over former lagoon area towards southeast.

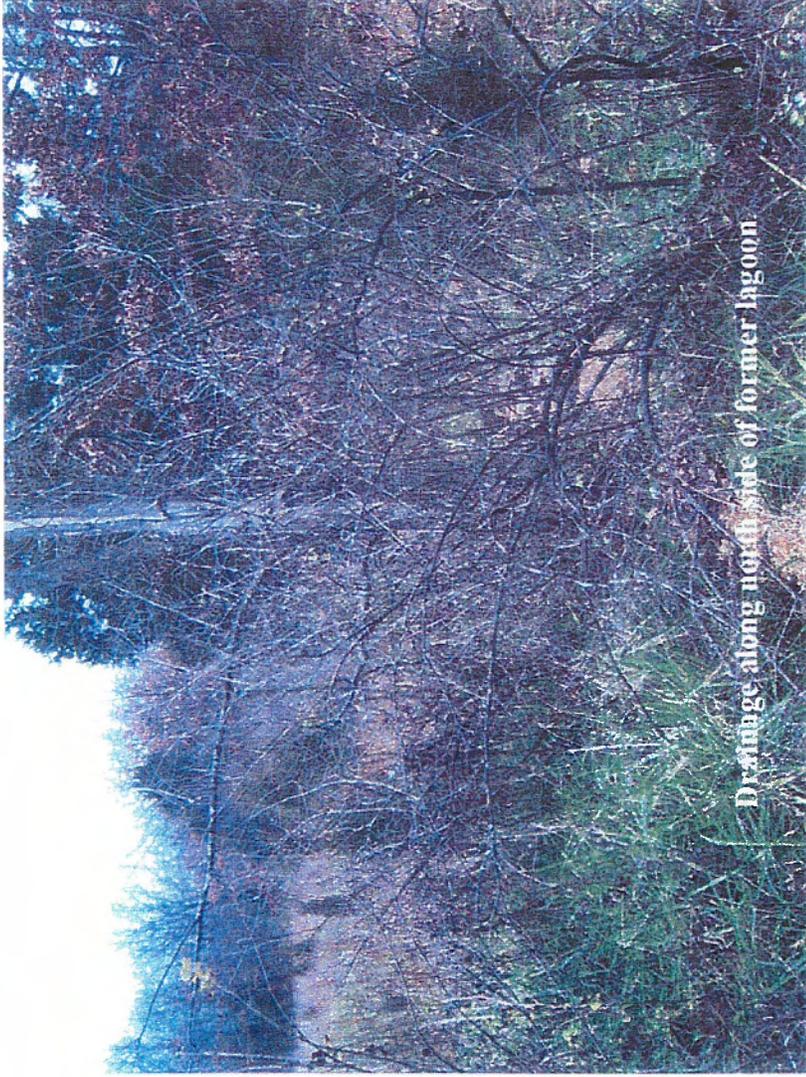
Drainage along north side of former lagoon.

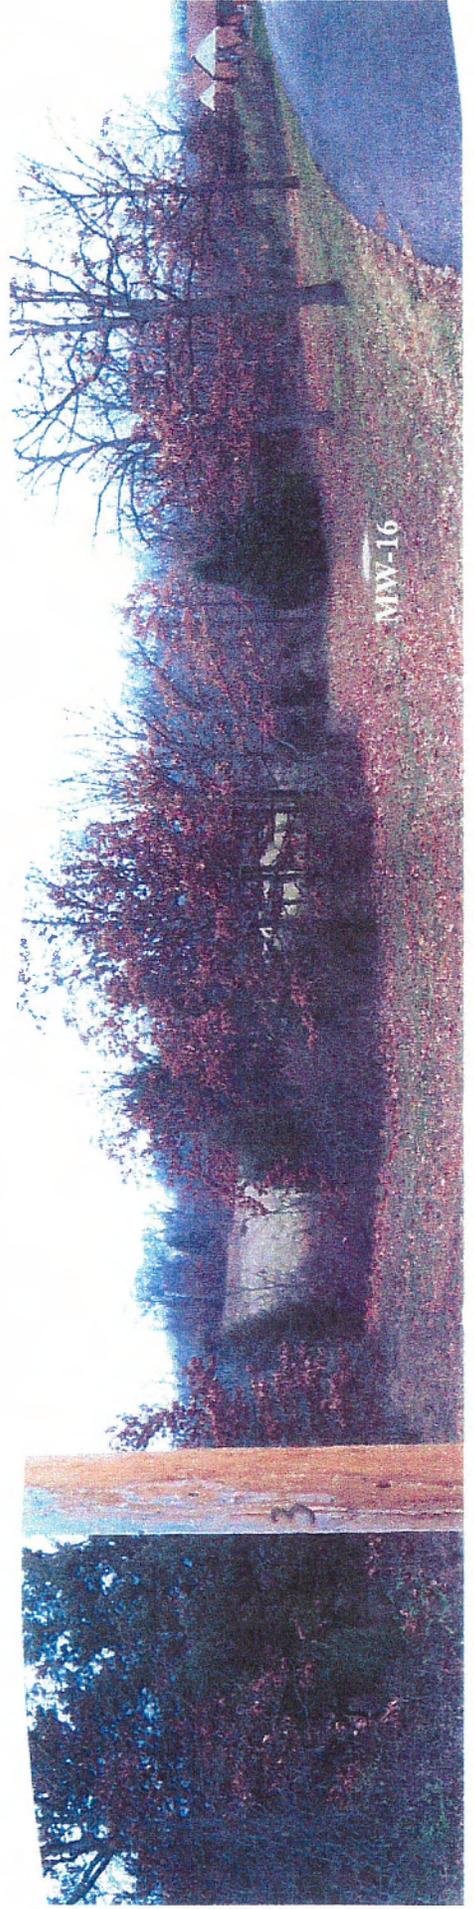
View of former lagoon from driveway for adjacent apartment
