STORMWATER MANAGEMENT EVALUATION REPORT
FOR
BRIDGETON LANDFILL
LOCATED AT
13570 SAINT CHARLES ROCK ROAD, BRIDGETON, MISSOURI 63044

BRIDGETON LANDFILL, LLC

CIVIL & ENVIRONMENTAL CONSULTANTS, INC.
4848 PARK 370, SUITE F
HAZELWOOD, MISSOURI 63042

Date: DECEMBER 2018

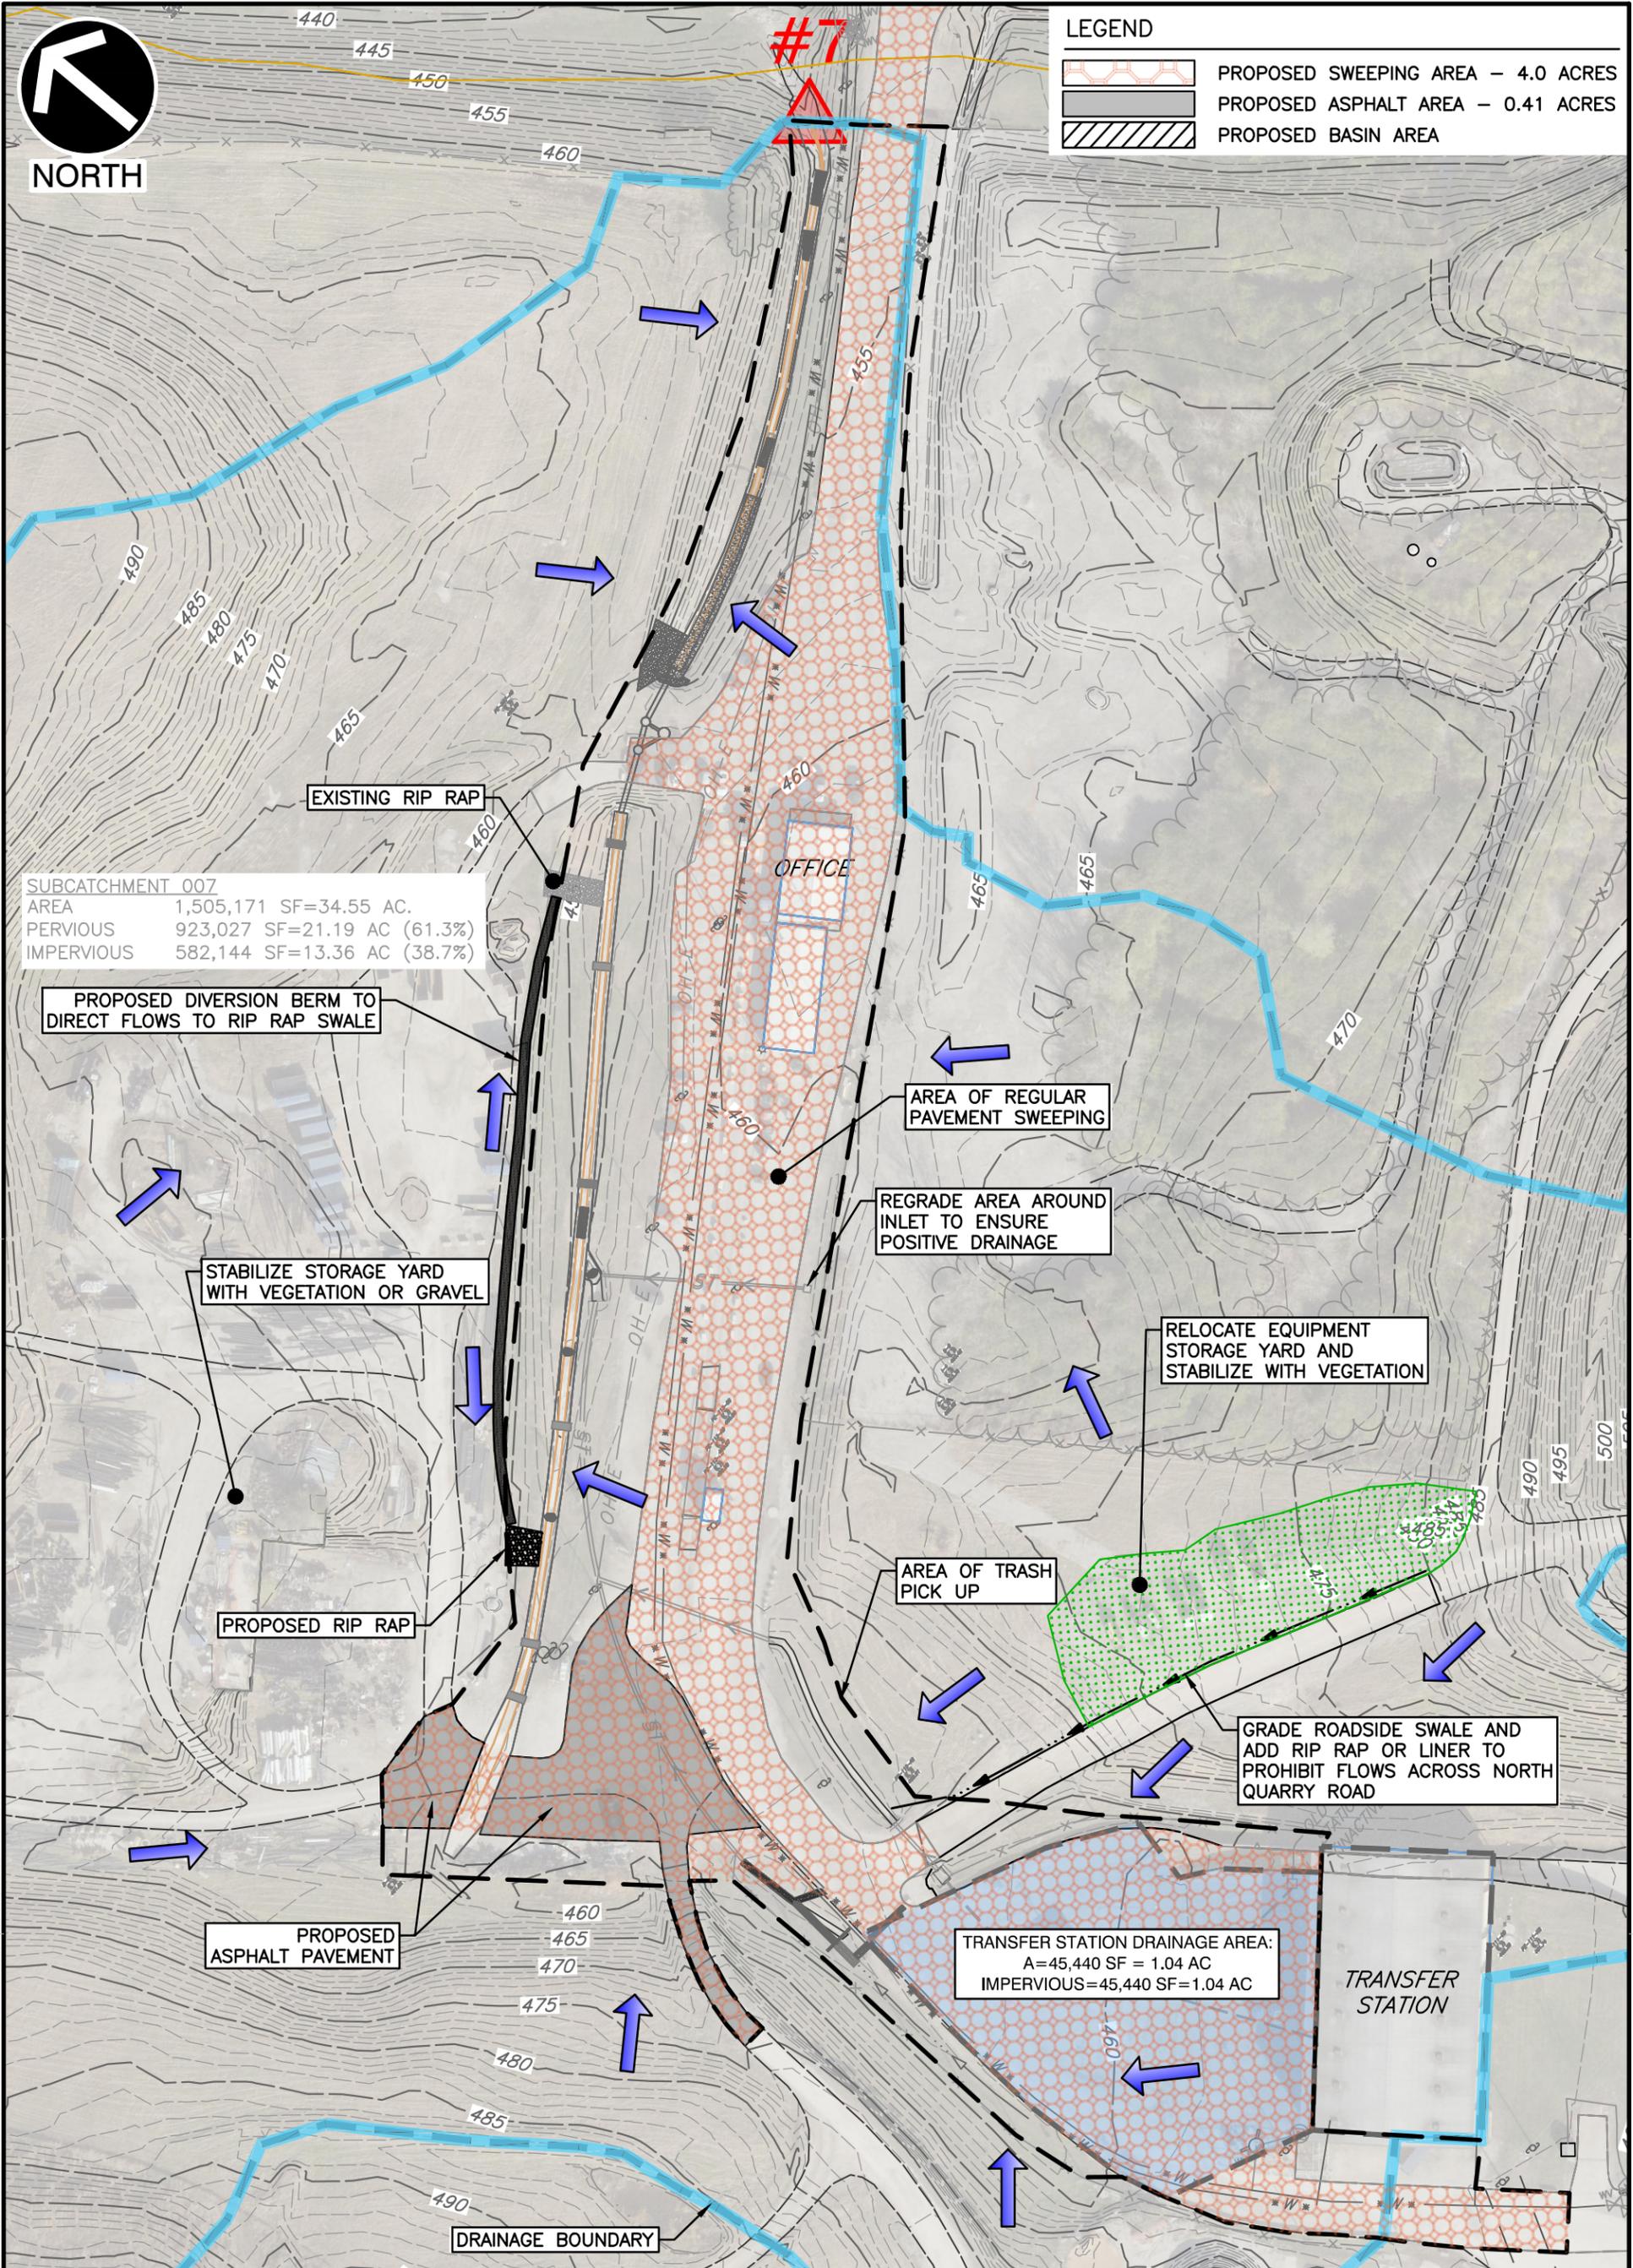
**STORMWATER OUTFALL #7
 PROPOSED IMPROVEMENTS**

This outfall is experiencing several recurring NPDES exceedances including biochemical oxygen demand (BOD), chemical oxygen demand (COD), TSS, Chlorides and Sulfates. The two main contributing factors to these exceedances are the transfer station pad runoff and some eroded non-vegetated tributary areas. To bring this outfall into compliance, we recommend four ways to improve the effectiveness of the existing BMPs:

- a. Implement a daily manual trash pickup – Once per day (minimum), someone walks the entire 6.6-acre area to pick up debris and trash. This 6.6-acre area is shown on the enclosed *Figure 2* and extends from the transfer station to the entrance at St Charles Rock Road.

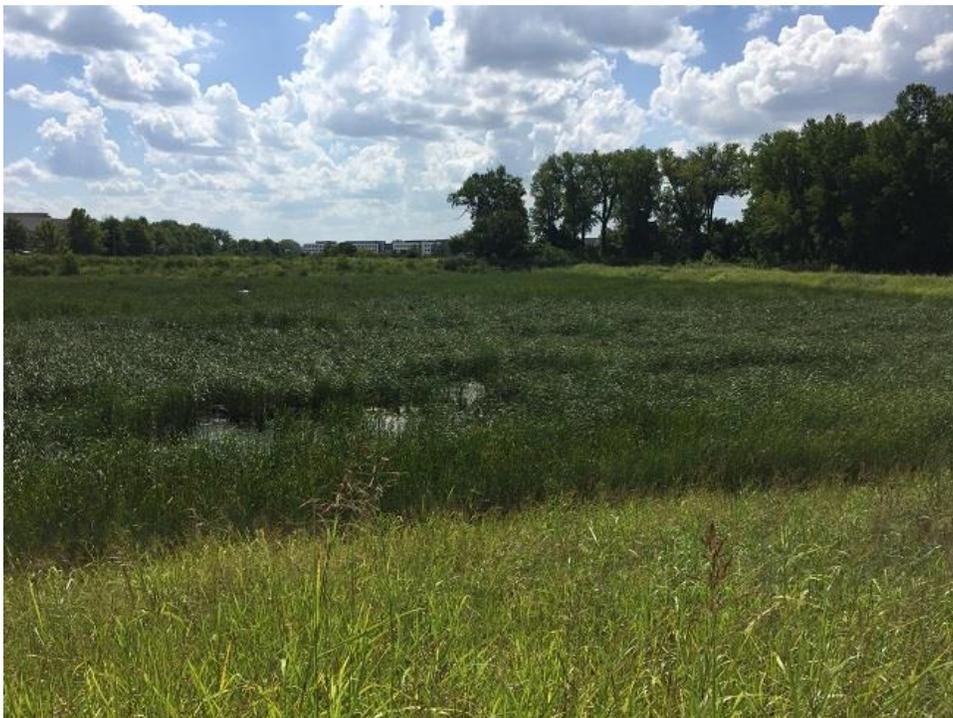
Photograph Number: 1
Description: Outfall 003:
Retention Pond with
vegetation

Some routine maintenance is needed including sediment removal in the upstream lined channels and swales. The berms require periodic inspection to confirm no new animal dams or burrows are being constructed by muskrats or beavers. Maintenance should be coordinated with Outfall #005 as the pumped stormwater can also contain sediment contributing to potential exceedances.

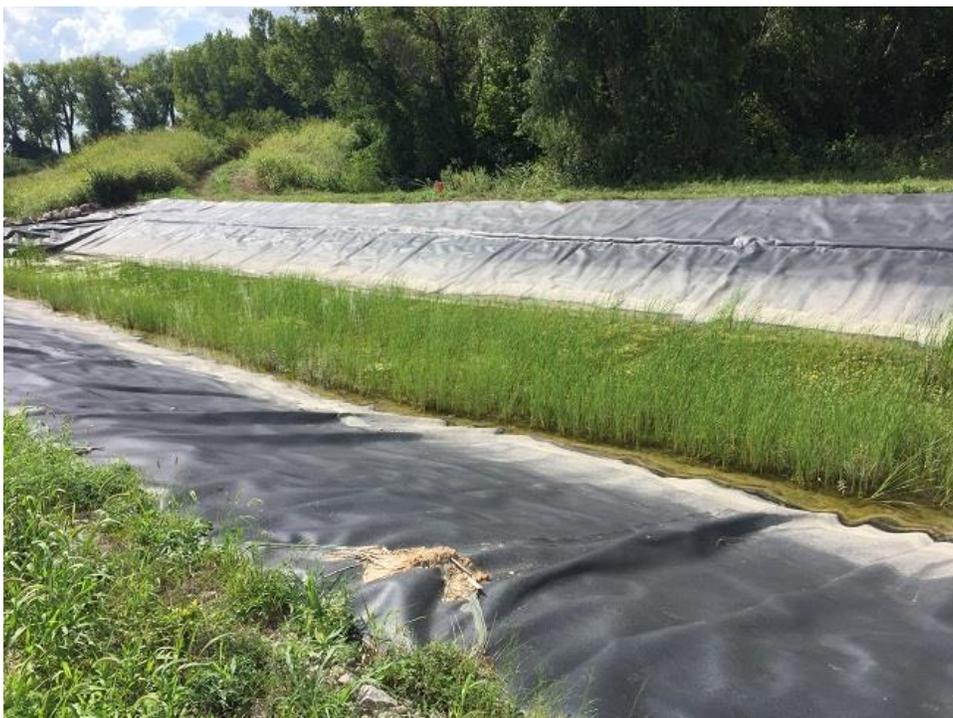
Photograph Number: 2
Description: Outfall 003:
Sediment and vegetation
within upstream lined
drainage channel

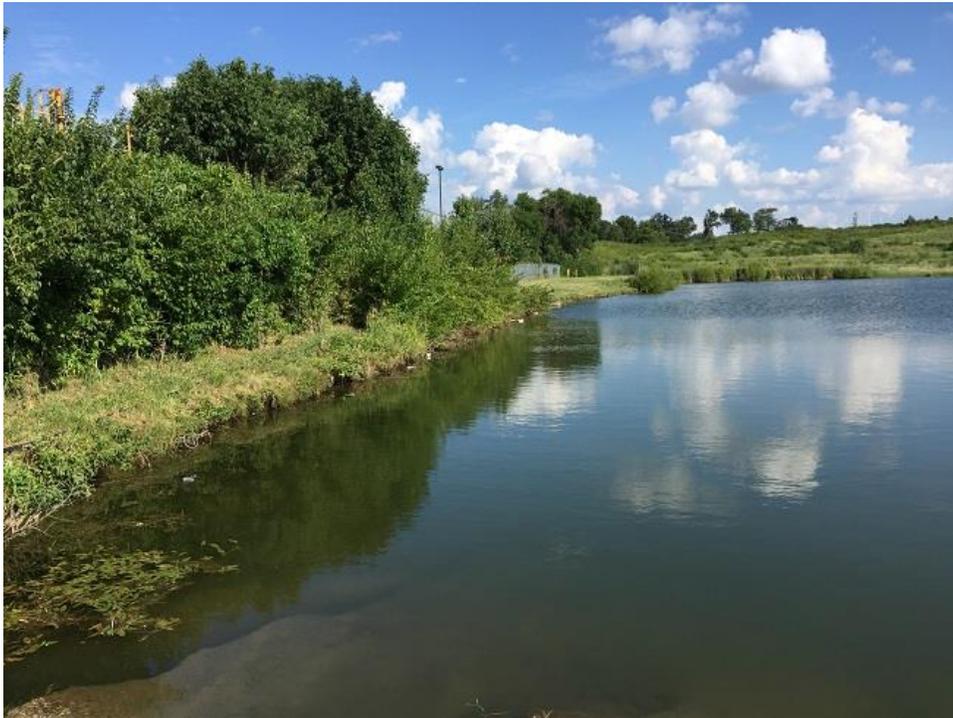
Periodic aluminum and total suspended solids (TSS) exceedances have occurred recently. An exceedance spike in 2017Q3 appears related to the work at the earthen borrow area and north quarry cap project when the ground was bare and not lined or vegetated during the ongoing construction process. CEC, Inc. recommends stabilizing work areas when not in operation and during construction efforts to prevent further silt loading in the pond and downstream channel.

Photograph Number: 3
Description: Outfall 004:
Retention Pond

In addition, we propose an emphasis on routine housekeeping with the downstream offsite channel. This channel allows some stormwater to pool and sediment to gather due to a very flat longitudinal slope. Recommend clearing this sediment annually to prevent backwater conditions and stagnant pooling.

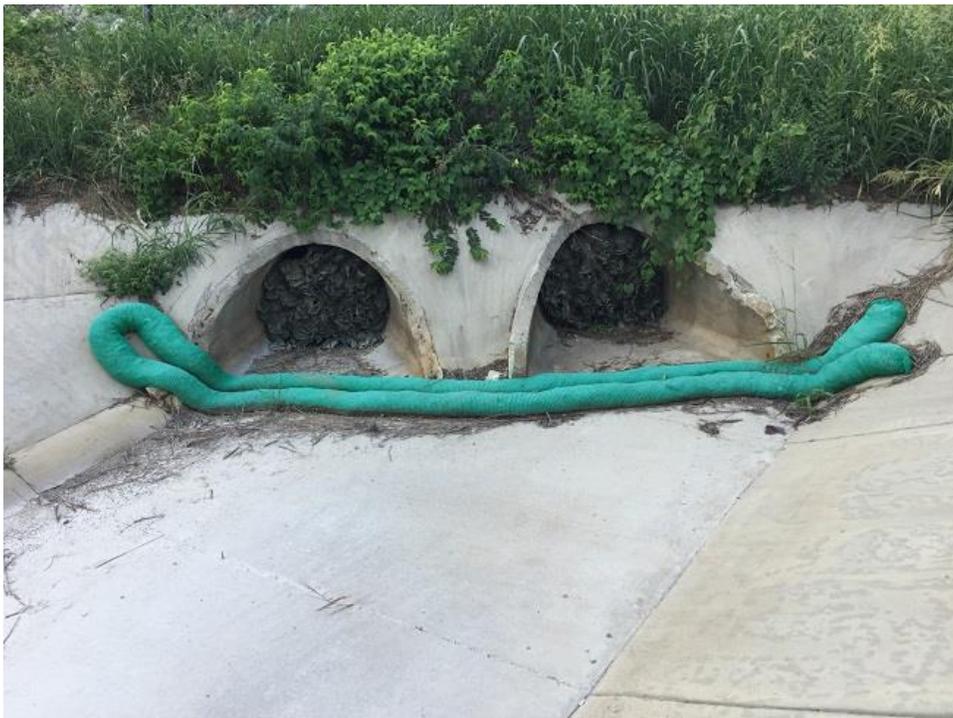
However, sand bags were placed in the inlet and outlet of the pipe in 20173Q to close the outfall. Since this time, rain events are being managed by a pumping system, diverting flow to Outfall #003 to allow sediment to drop out during the longer residence time within the facility's stormwater management system, and no discharges or exceedances have occurred. The normal operating procedures are to pump from the lined inner east ditch to a lined swale along the south quarry landfill cap to drain to Outfall #003. When the lined inner east ditch fills and gets to the invert of a passive interconnected pipe, this pipe allows flow to travel to the lined outer east ditch. This lined outer east ditch has a knife gate that prevents flow to Outfall #005.

Photograph Number: 4
Description: Outfall 005:
Sand bags in outfall piping
system.

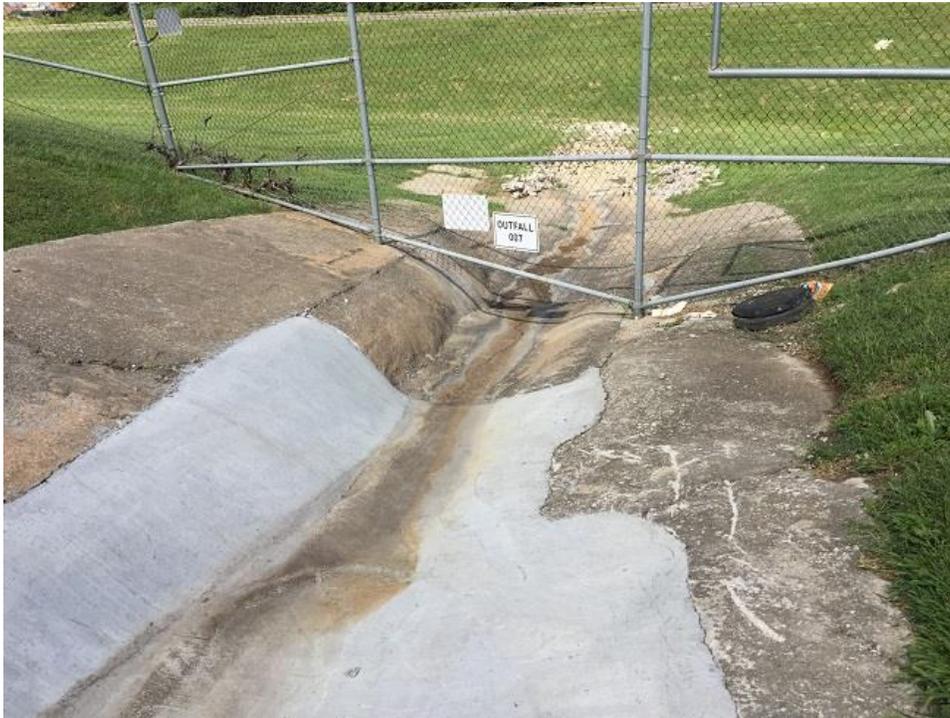
Photograph Number: 5
Description: Outfall 007:
Outfall swale at property
fence line

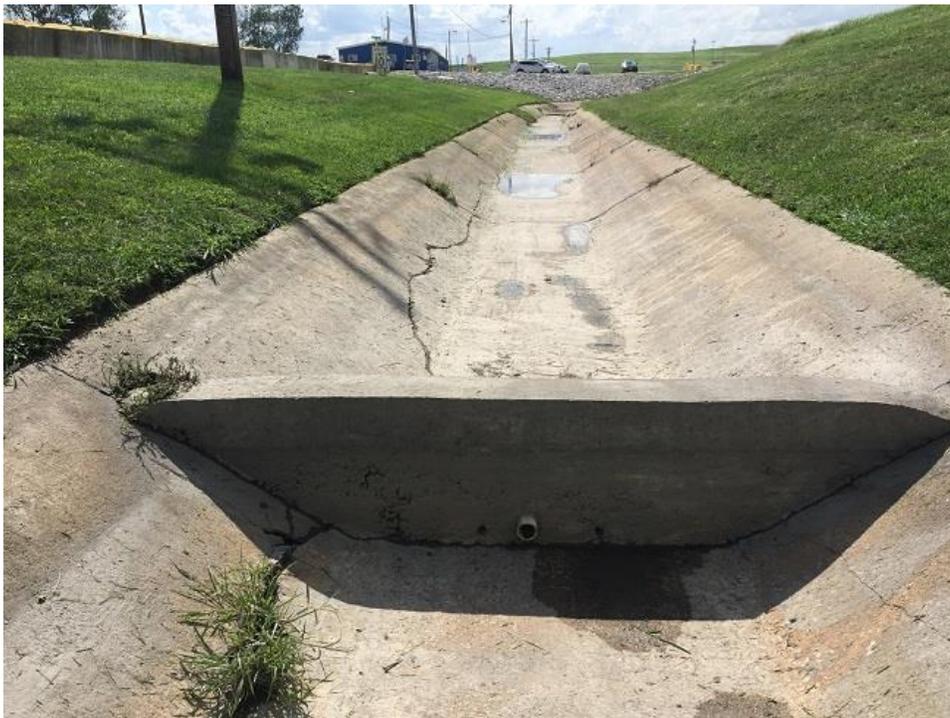
Photograph Number: 6
Description: Outfall 007:
Concrete weir upstream of
the property fence line.

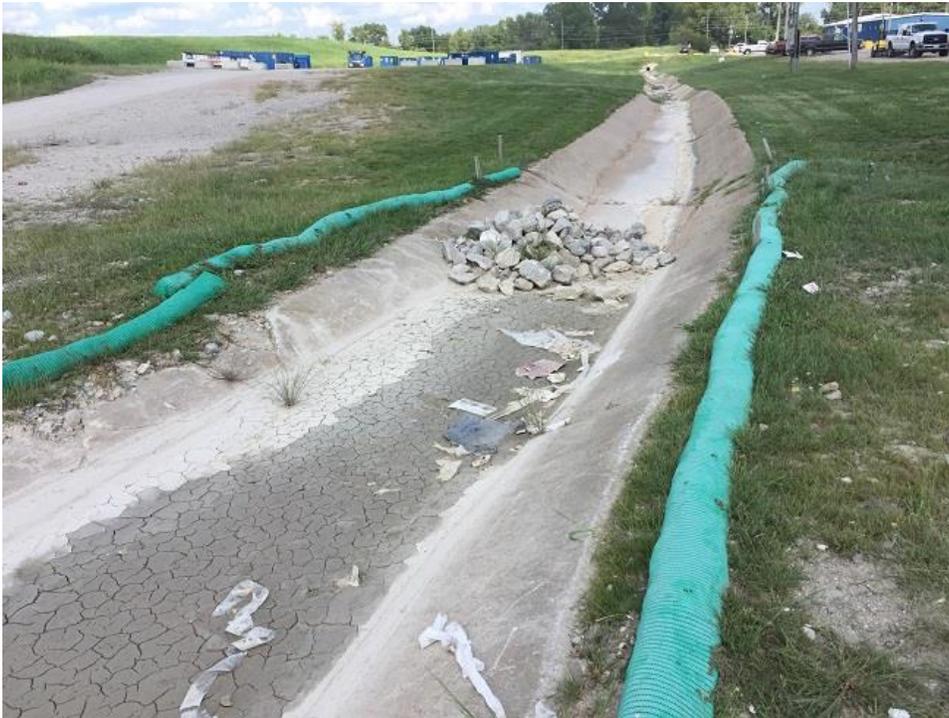
Photograph Number: 7

Description: Outfall 007: Check dam in concrete swale with sediment. Recommend reshaping the rock check dams to allow runoff to spill through the center rather than near the ends of the dam – see detail in Appendix B.

- a. Routine repair and maintenance of the rock check dams shall be done quarterly. The check dams should be constructed with the spillway in the center of the check dam to prevent flows from channeling around the outside edges of the rock and scouring and eroding the earthen hillside – see detail in *Appendix B*. In addition, sediment shall be cleared from the check dams during routine maintenance intervals. Filter socks shall also continue to be implemented to capture sediment and reduce sediment loading into the swales.

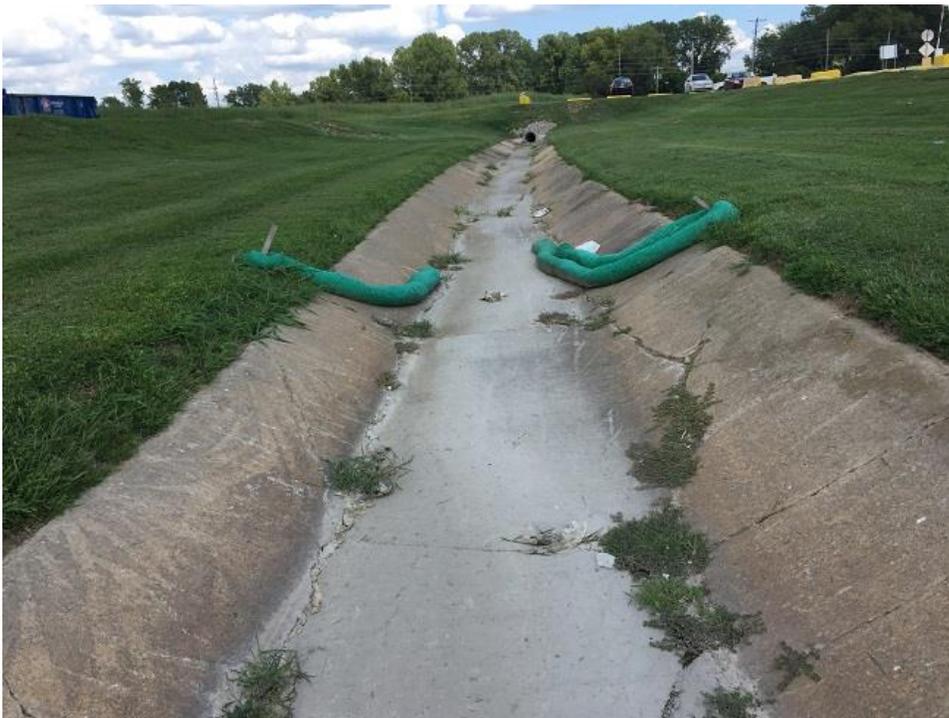
Photograph Number: 8

Description: Outfall 007: Concrete swale with silt sock and minor sediment.

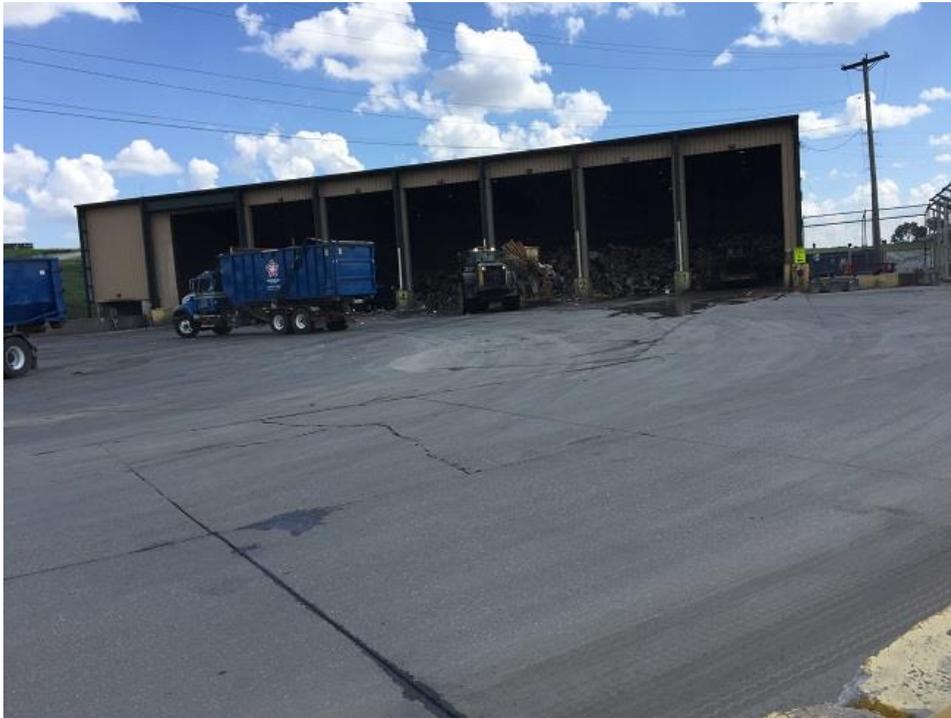
Photograph Number: 9
Description: Outfall 007:
Transfer station and
concrete pad.

- b. Purchase a new sweeper with a pressurized water sprayer and vacuum system to better clean the concrete pad area in front of the transfer station. This sweeper should be used several times per day to regularly clean the concrete pad of debris. This new sweeper could be outfitted on existing equipment to replace the current brush sweeper that does not appear to collect and remove debris from the pad or drainage area. For details see *Appendix B*.

- c. Contract with a sweeping company to weekly use an industrial sized vacuum sweeper on the entire 6.6-acre area from the transfer station and along the outbound lane for transfer trucks. See *Appendix B* for details.

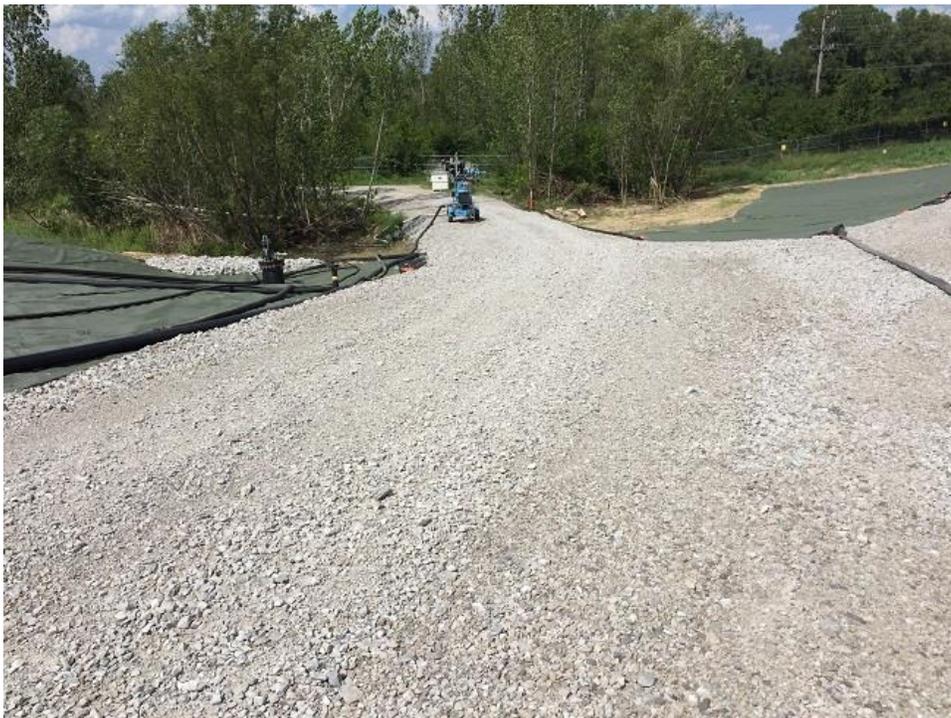
Currently, there is a low area upstream of the outfall that is collecting runoff and allowing it to temporarily store. A pump and conveyance pipe are set adjacent to this low area to convey flows back uphill to a lined storage basin which then gravity drains to Outfall #004. In extreme rain events, the pump has not kept up and has periodically (2015 and 2017) allowed a discharge of stormwater through the fence restricting access to Area 1 and along the St Charles Rock Road right-of-way. These rain events were when Outfall #008 was proposed and had not been formalized in the permit, but did lead to flows high in TSS, iron and aluminum. Subsequent to these two significant rain events, the site has set up an additional stormwater pump and conveyance pipe to collect stormwater internal to the North Quarry perimeter access road to increase pumping capacity to manage high-flow and high-intensity storm events. We suggest constructing an enlarged stormwater settling basin to allow greater storage of the high-flow and high-intensity storm events. An enlarged basin will help to eliminate or reduce frequency of discharges to the newly permitted Outfall #008.

Photograph Number 9
Description: Outfall 008:
Low area with pump and
force main to send flows to
a lined storage basin
tributary to Outfall 004.

A recent north quarry liner project has recently been completed which has helped to limit sediment loading to this outfall. We suggest routine housekeeping to ensure the cap is maintained and continues to provide positive drainage to the constructed low area.
