Remedial Investigation / Feasibility Study Work Plan – Final Revision 2.0

Hardesty Federal Complex
607 Hardesty Avenue
Kansas City, Jackson County, Missouri

March 13, 2013
Terracon Project No. 02107147

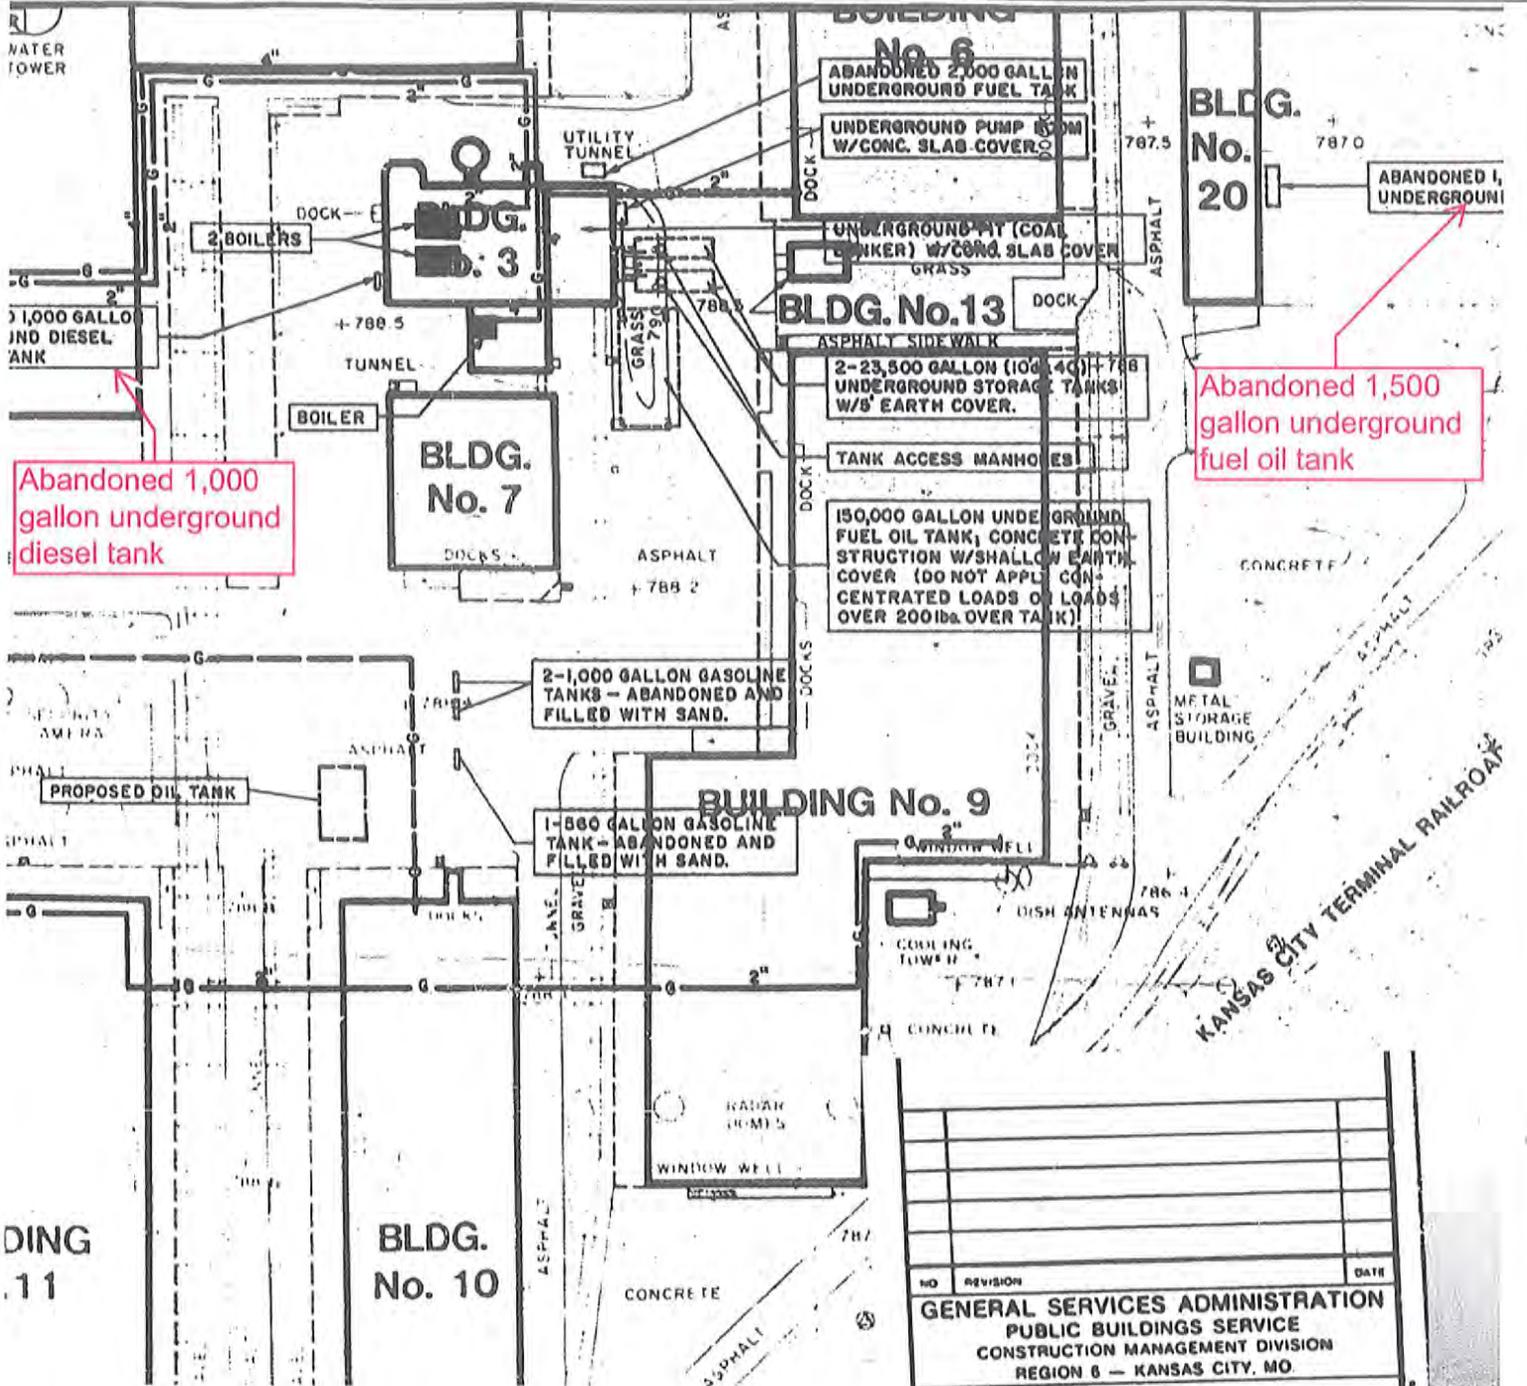
Abandoned 1,000 gallon underground diesel tank

Abandoned 1,500 gallon underground fuel oil tank

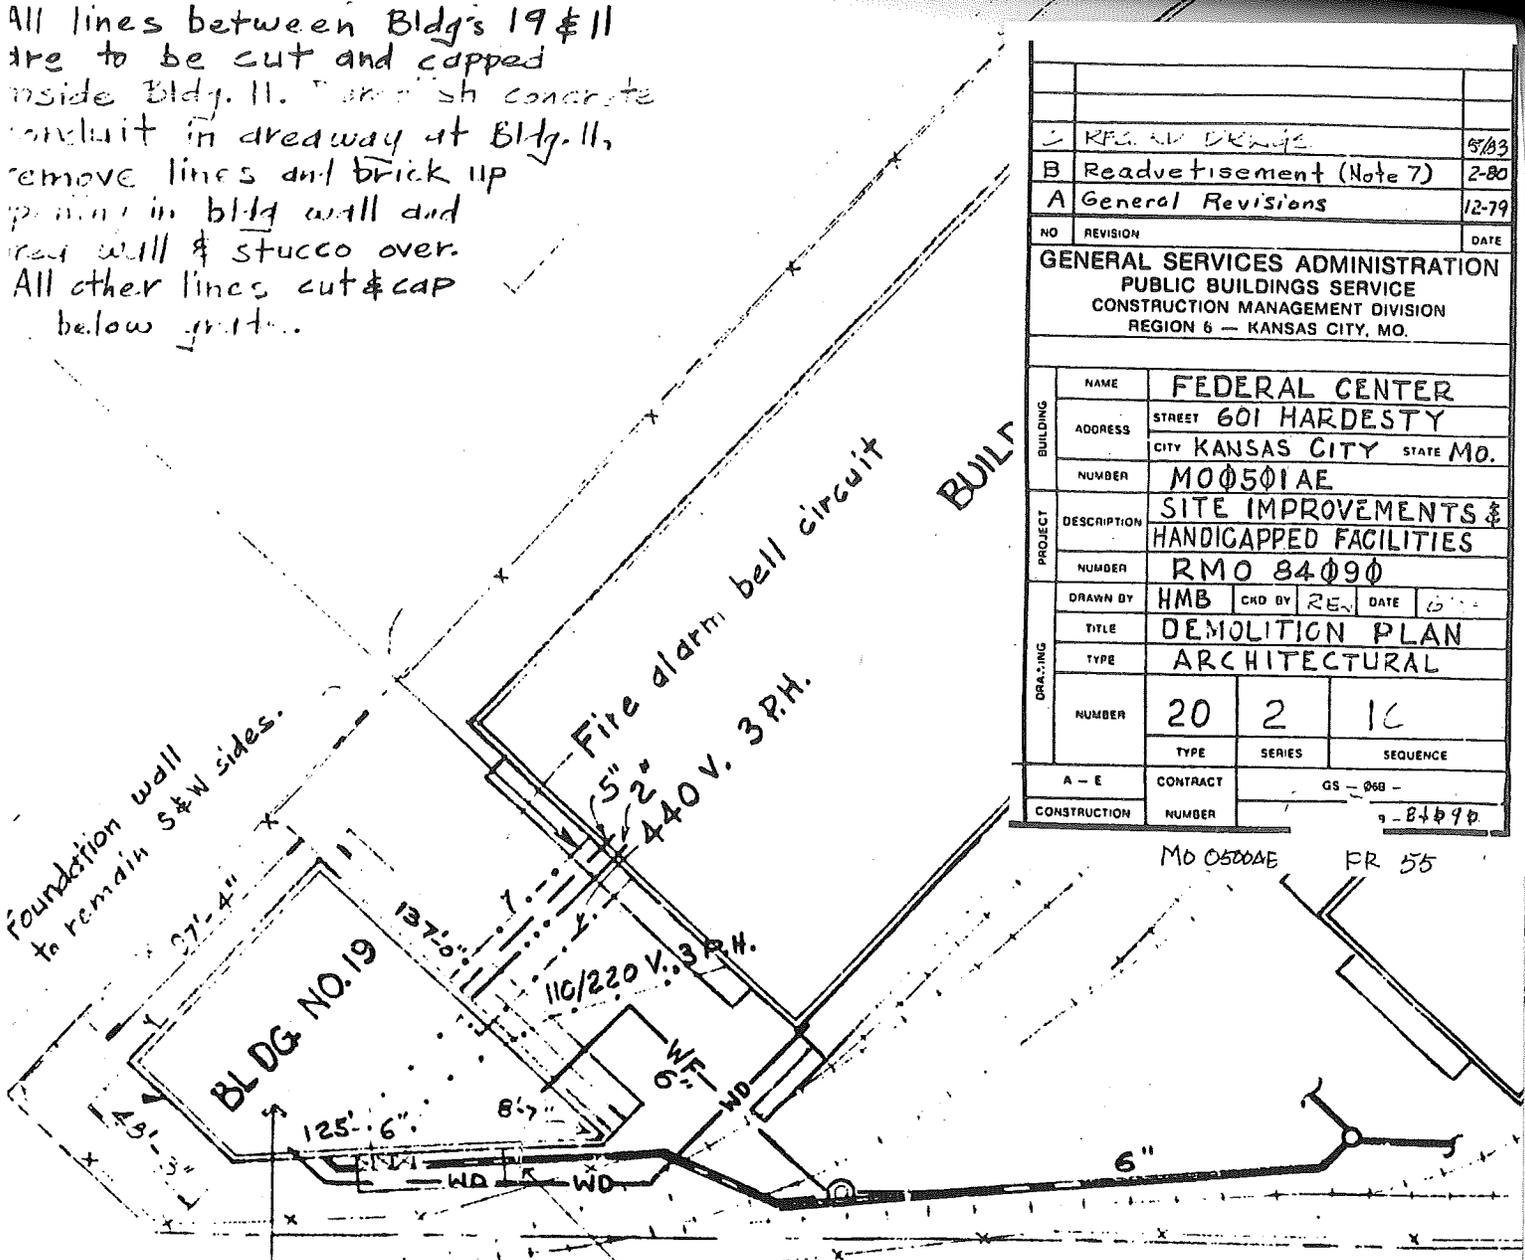
Remove 6 Ft. diameter tank & fill hole.

Bldg. 19. Demolish all walls, piers, pedestals & docks, except west & south walls, to 2'-0" below grade. West & south walls are to be demolished in existing concrete foundation wall (4 1/2" above floor line) & foundation wall left as retaining wall. Bldg. const. is conc. to floor line, conc. block exterior walls, interior wood columns & roof structure. Grade site to drain to the north, slope to be 0.5% to 1%. Repair disturbed asphalt paving. Topsoil and seed remaining earth surface. Fill material removed from below the floor slab may be used as fill material under dock slabs of Bldg. No. 9.

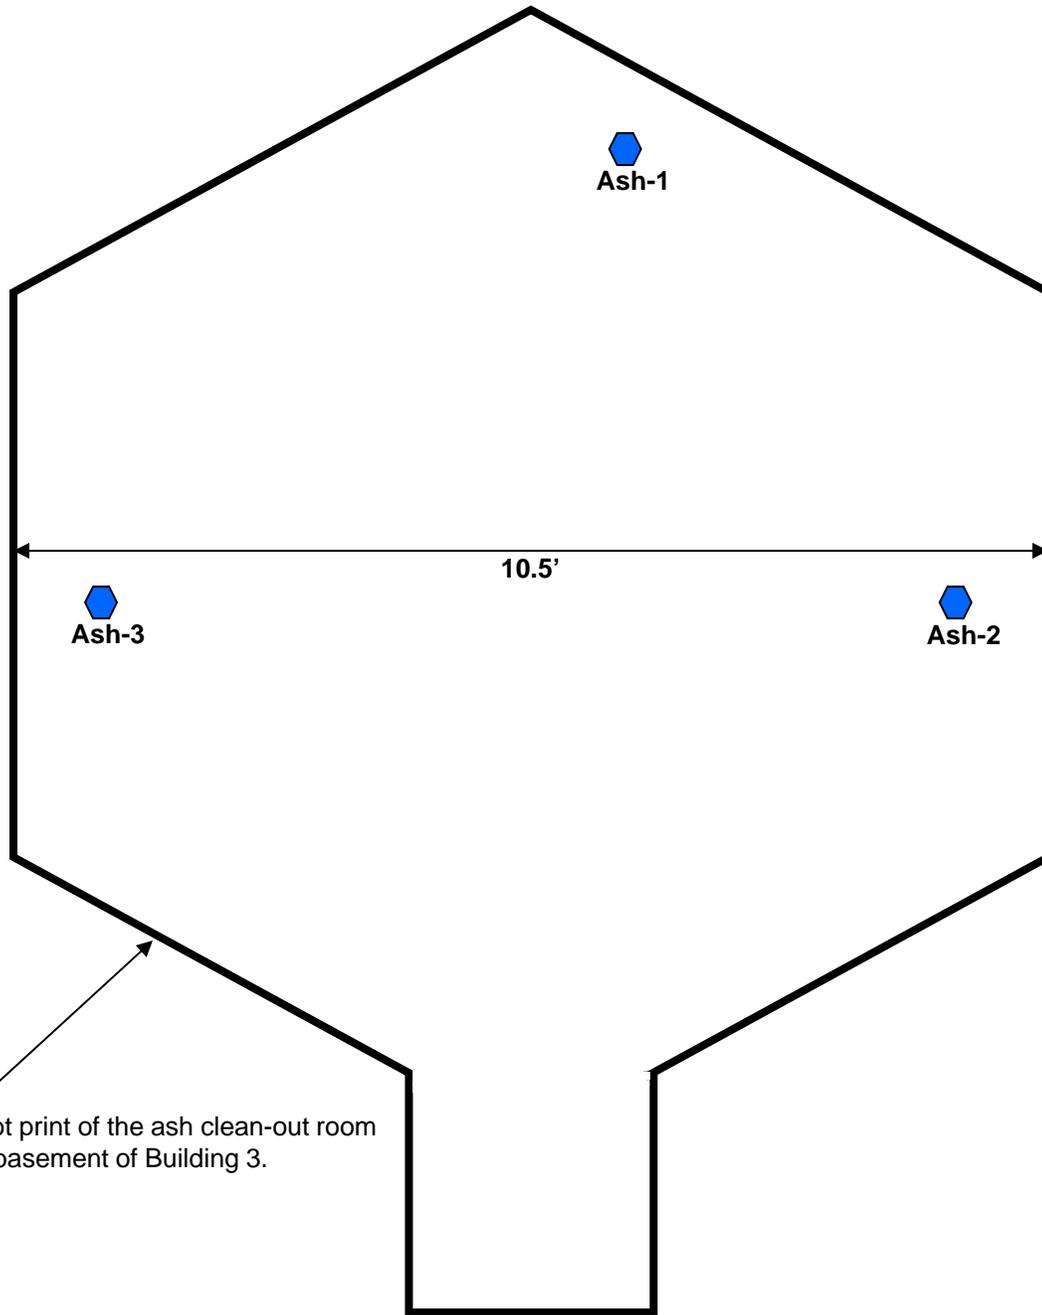
Approximate foot print of the ash clean-out room in the basement of Building 3.

- Smokestack Ash. Ash was observed in the ash clean-out room under the smokestack in the basement of Building 3. Reportedly, the boilers in Building 3 were previously operated with coal and fuel oil.

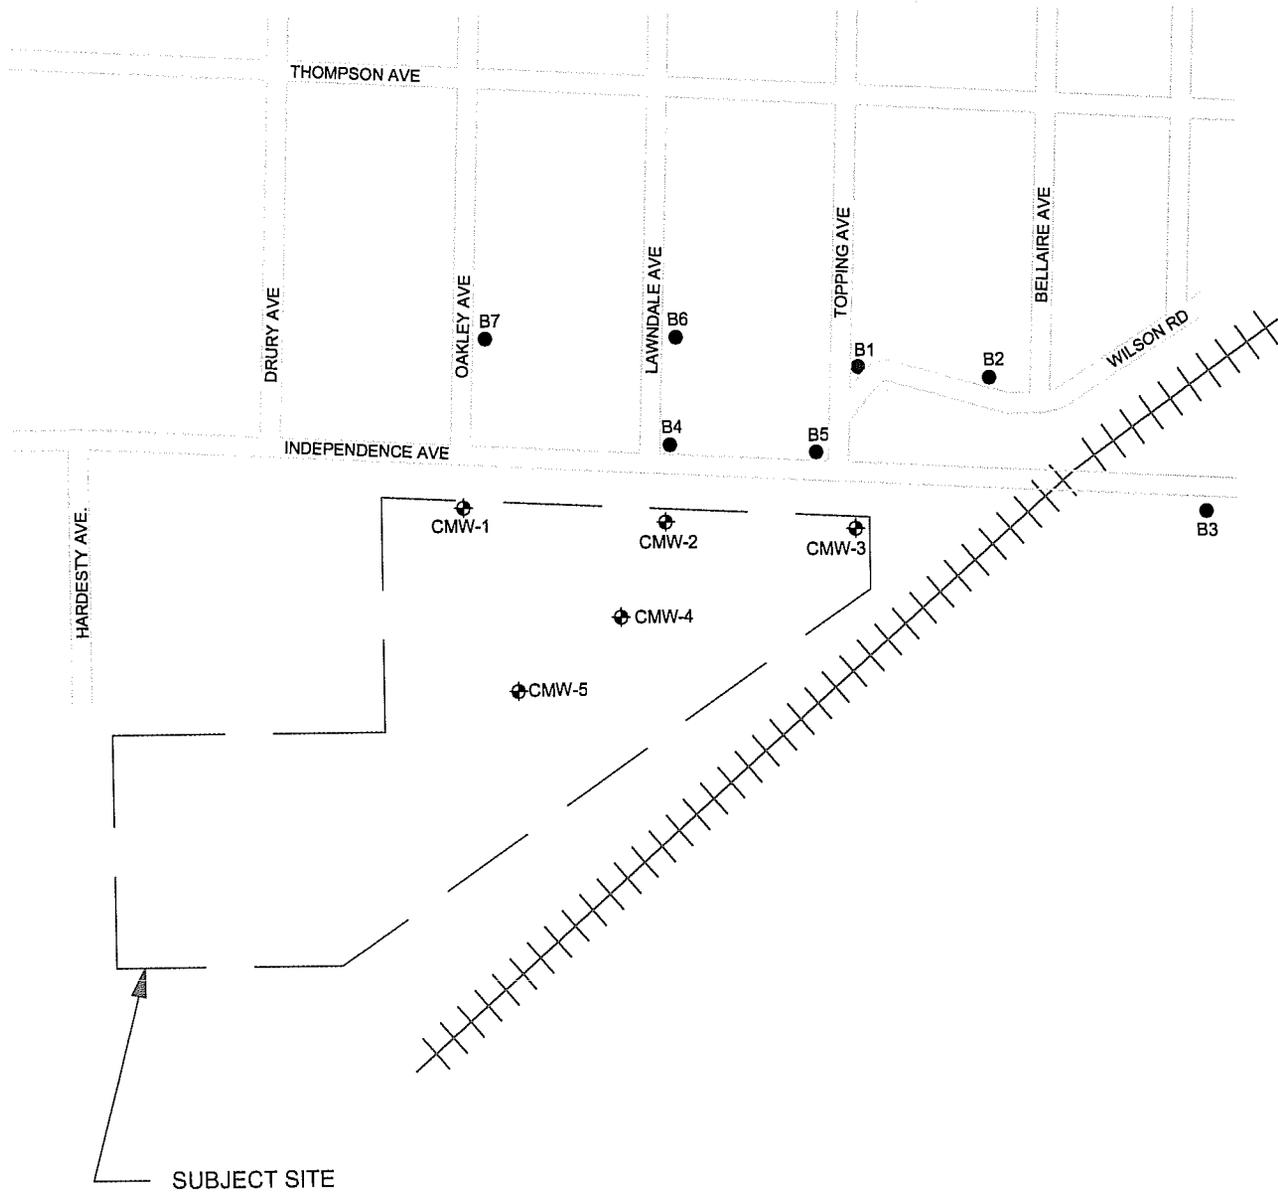
- OFF-SITE BORING LOCATIONS
- ⊕ MONITORING WELL CLUSTERS

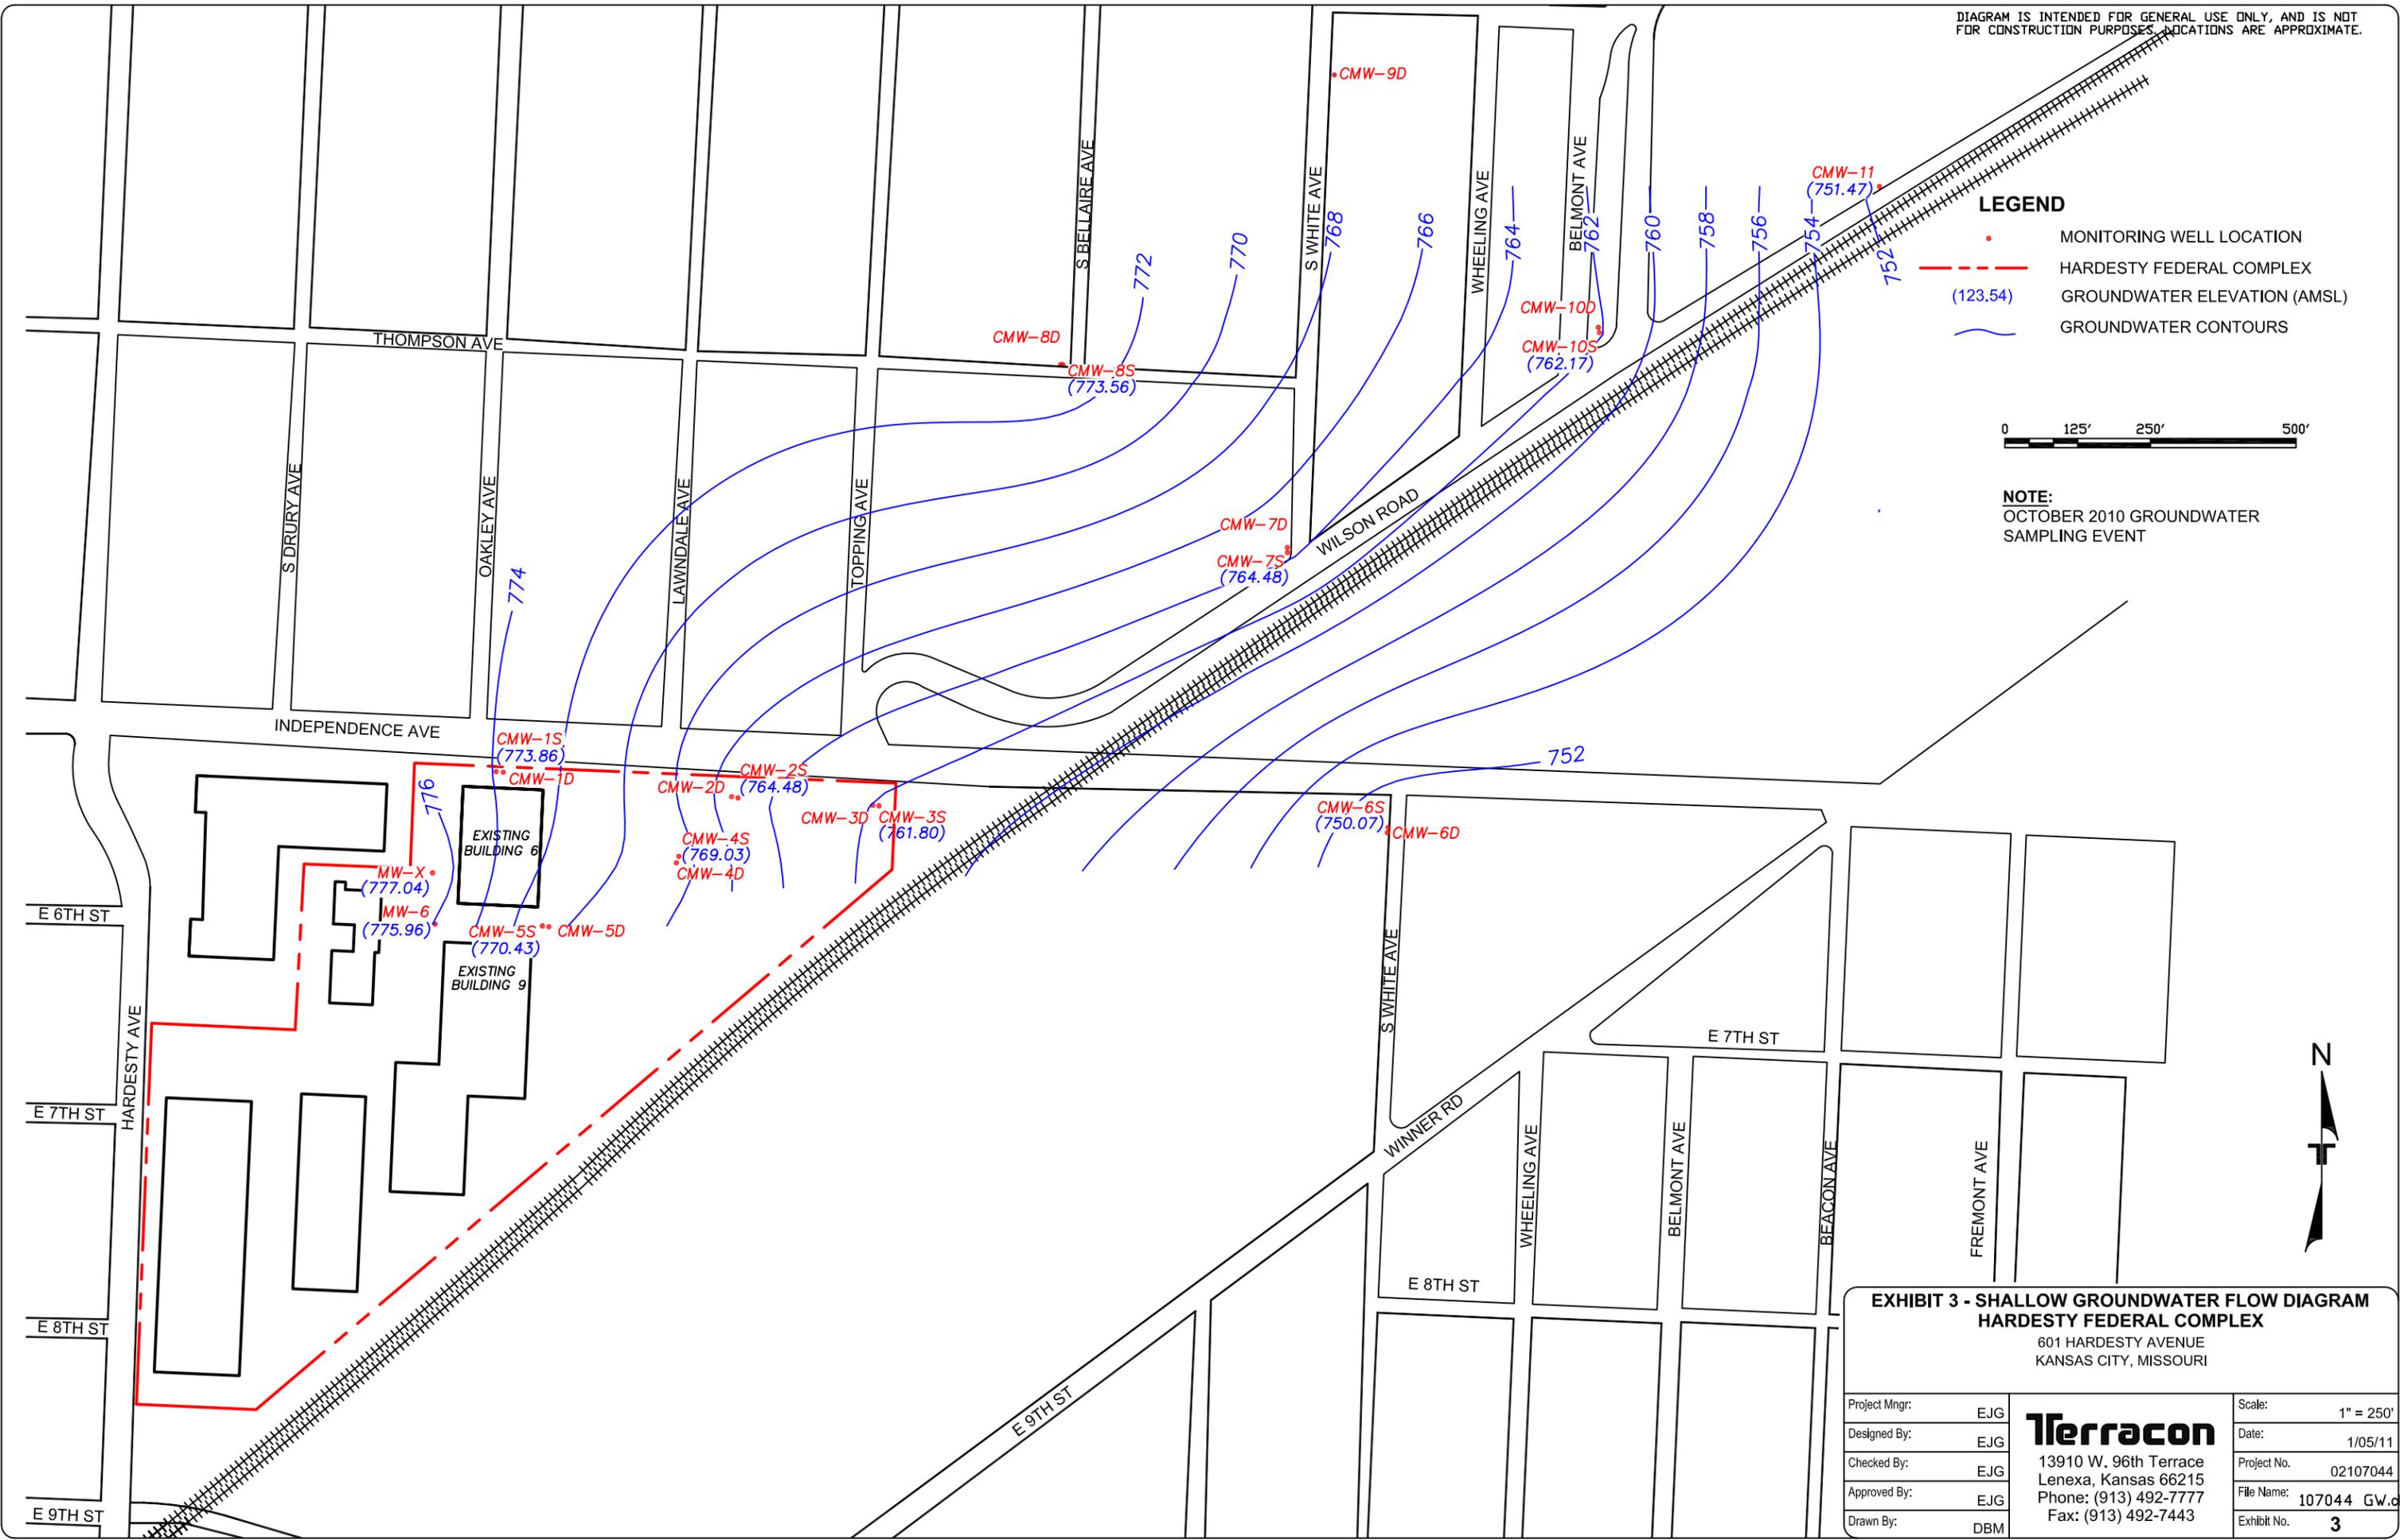
**EXHIBIT 3 - SHALLOW GROUNDWATER FLOW DIAGRAM
HARDESTY FEDERAL COMPLEX**
601 HARDESTY AVENUE
KANSAS CITY, MISSOURI

NOTE:
OCTOBER 2010 GROUNDWATER SAMPLING EVENT

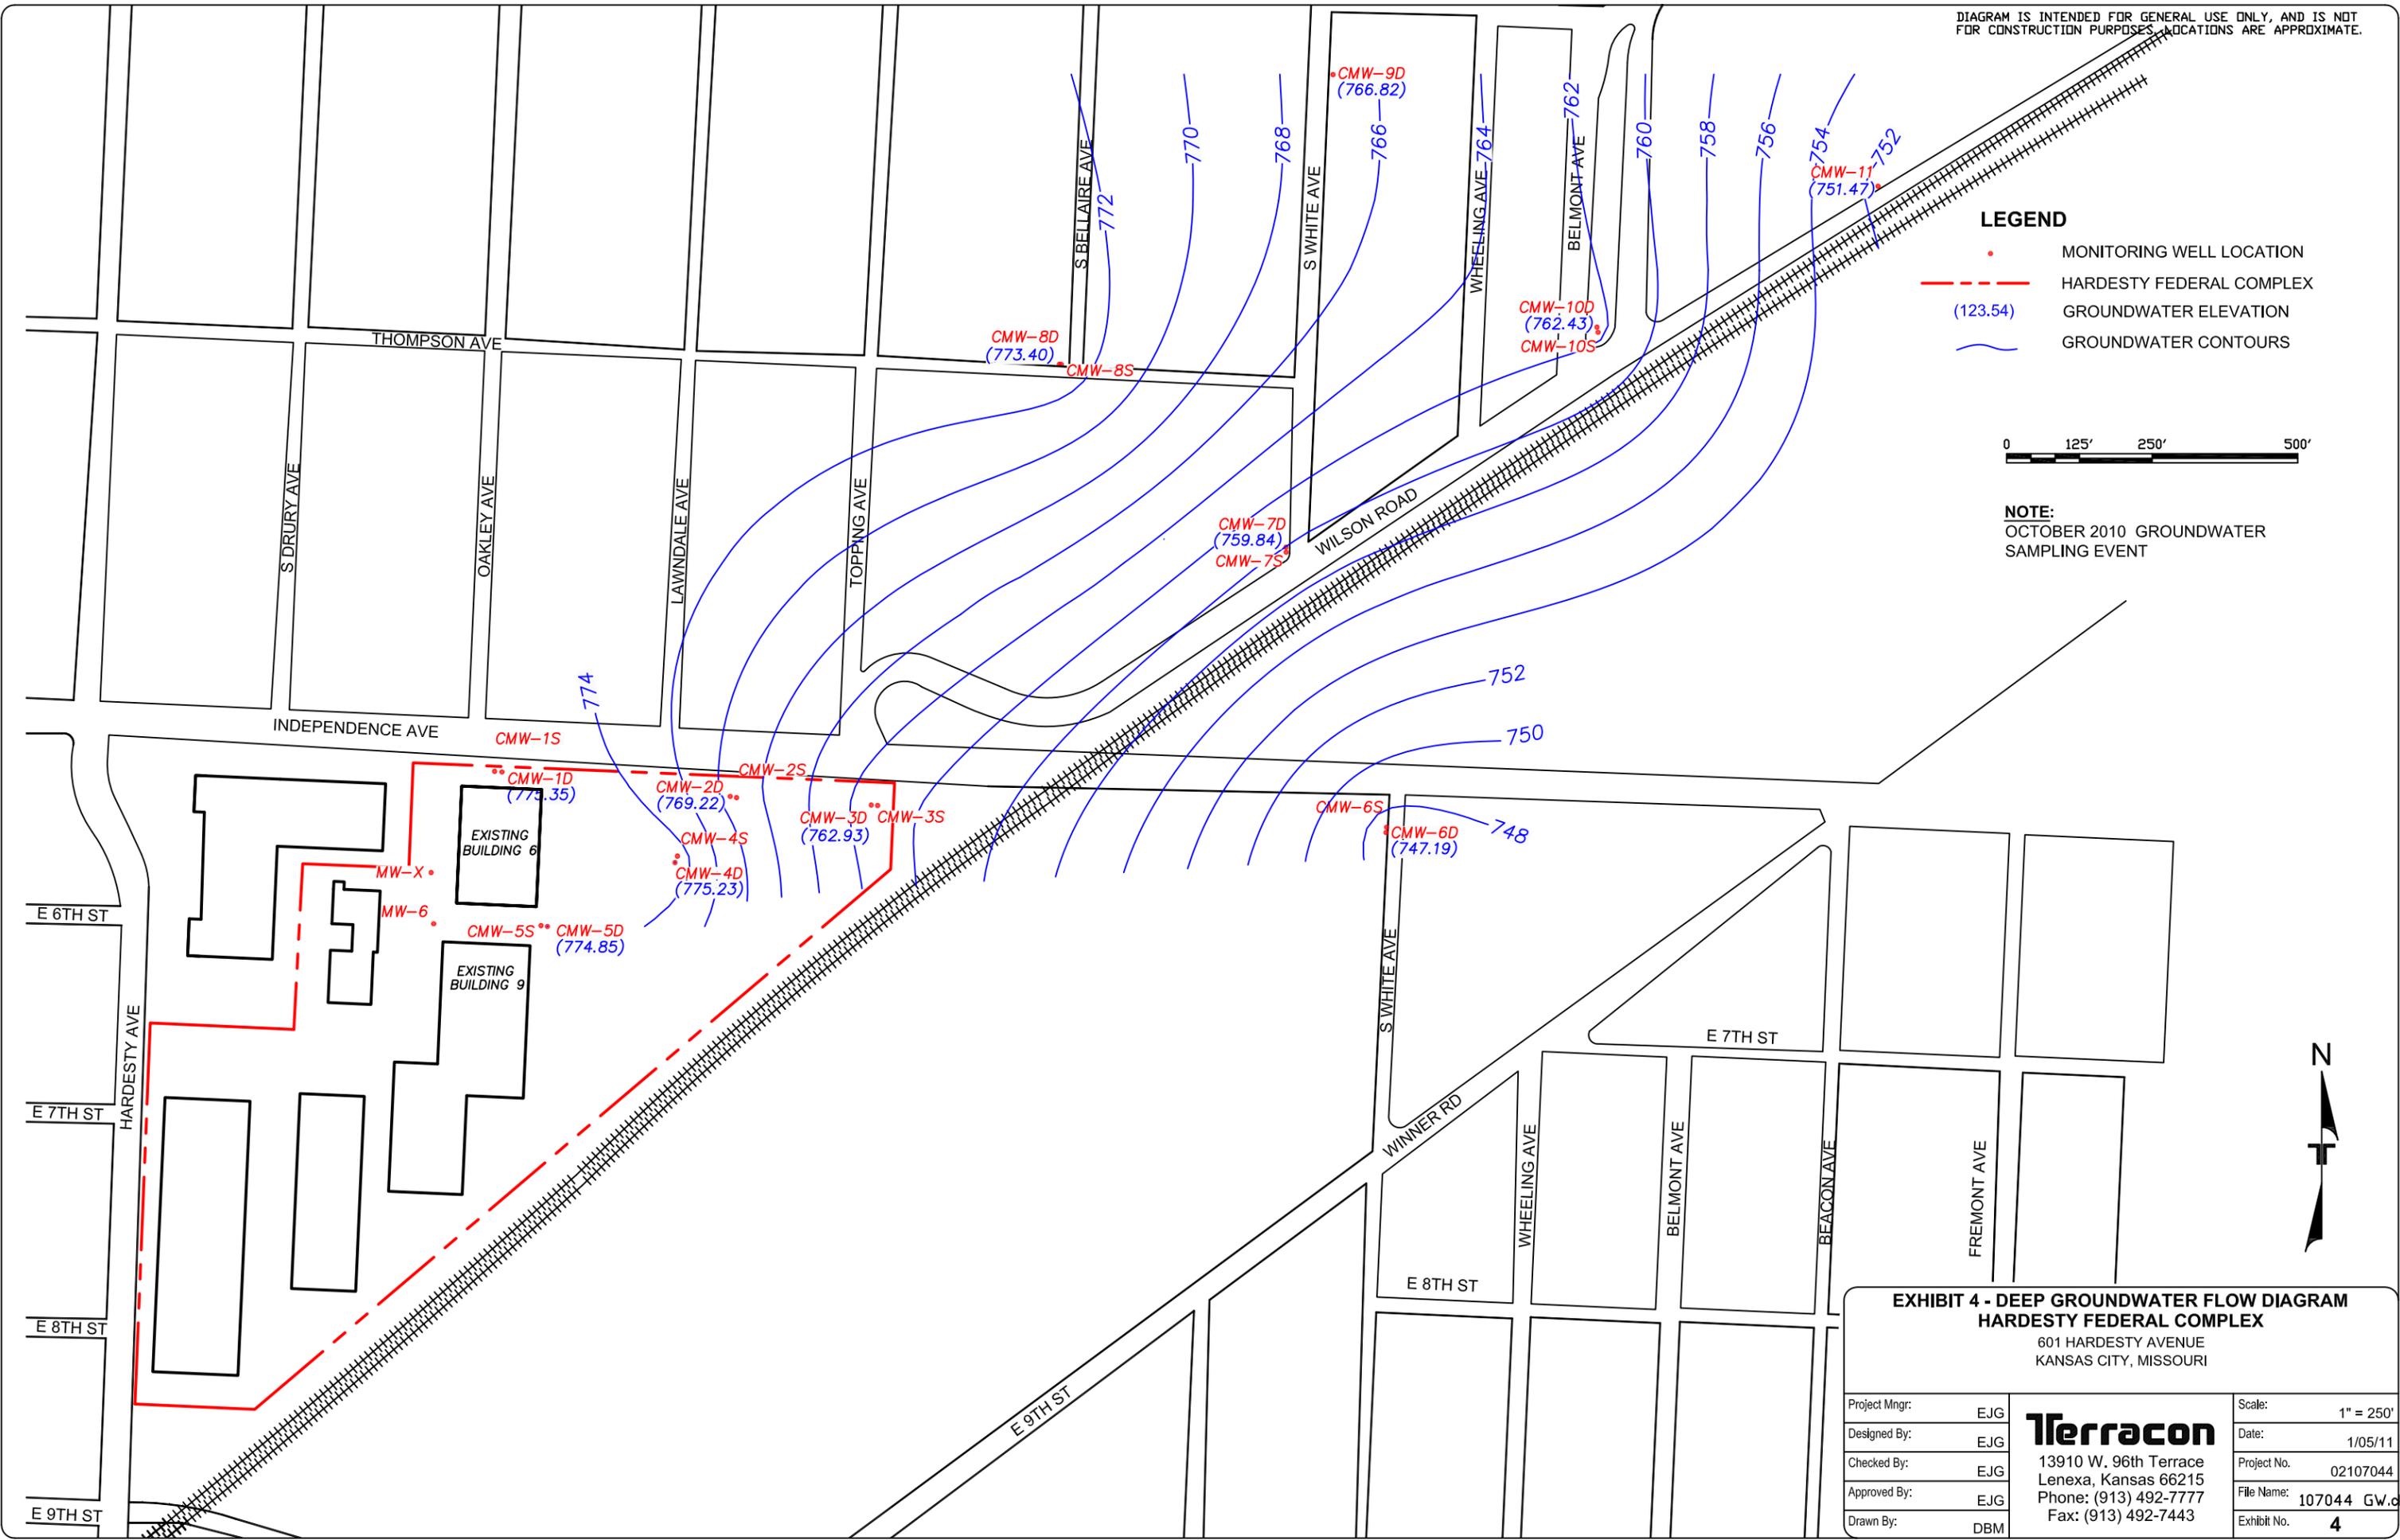
**EXHIBIT 4 - DEEP GROUNDWATER FLOW DIAGRAM
HARDESTY FEDERAL COMPLEX**
601 HARDESTY AVENUE
KANSAS CITY, MISSOURI

NOTE:
OCTOBER 2010 GROUNDWATER SAMPLING EVENT

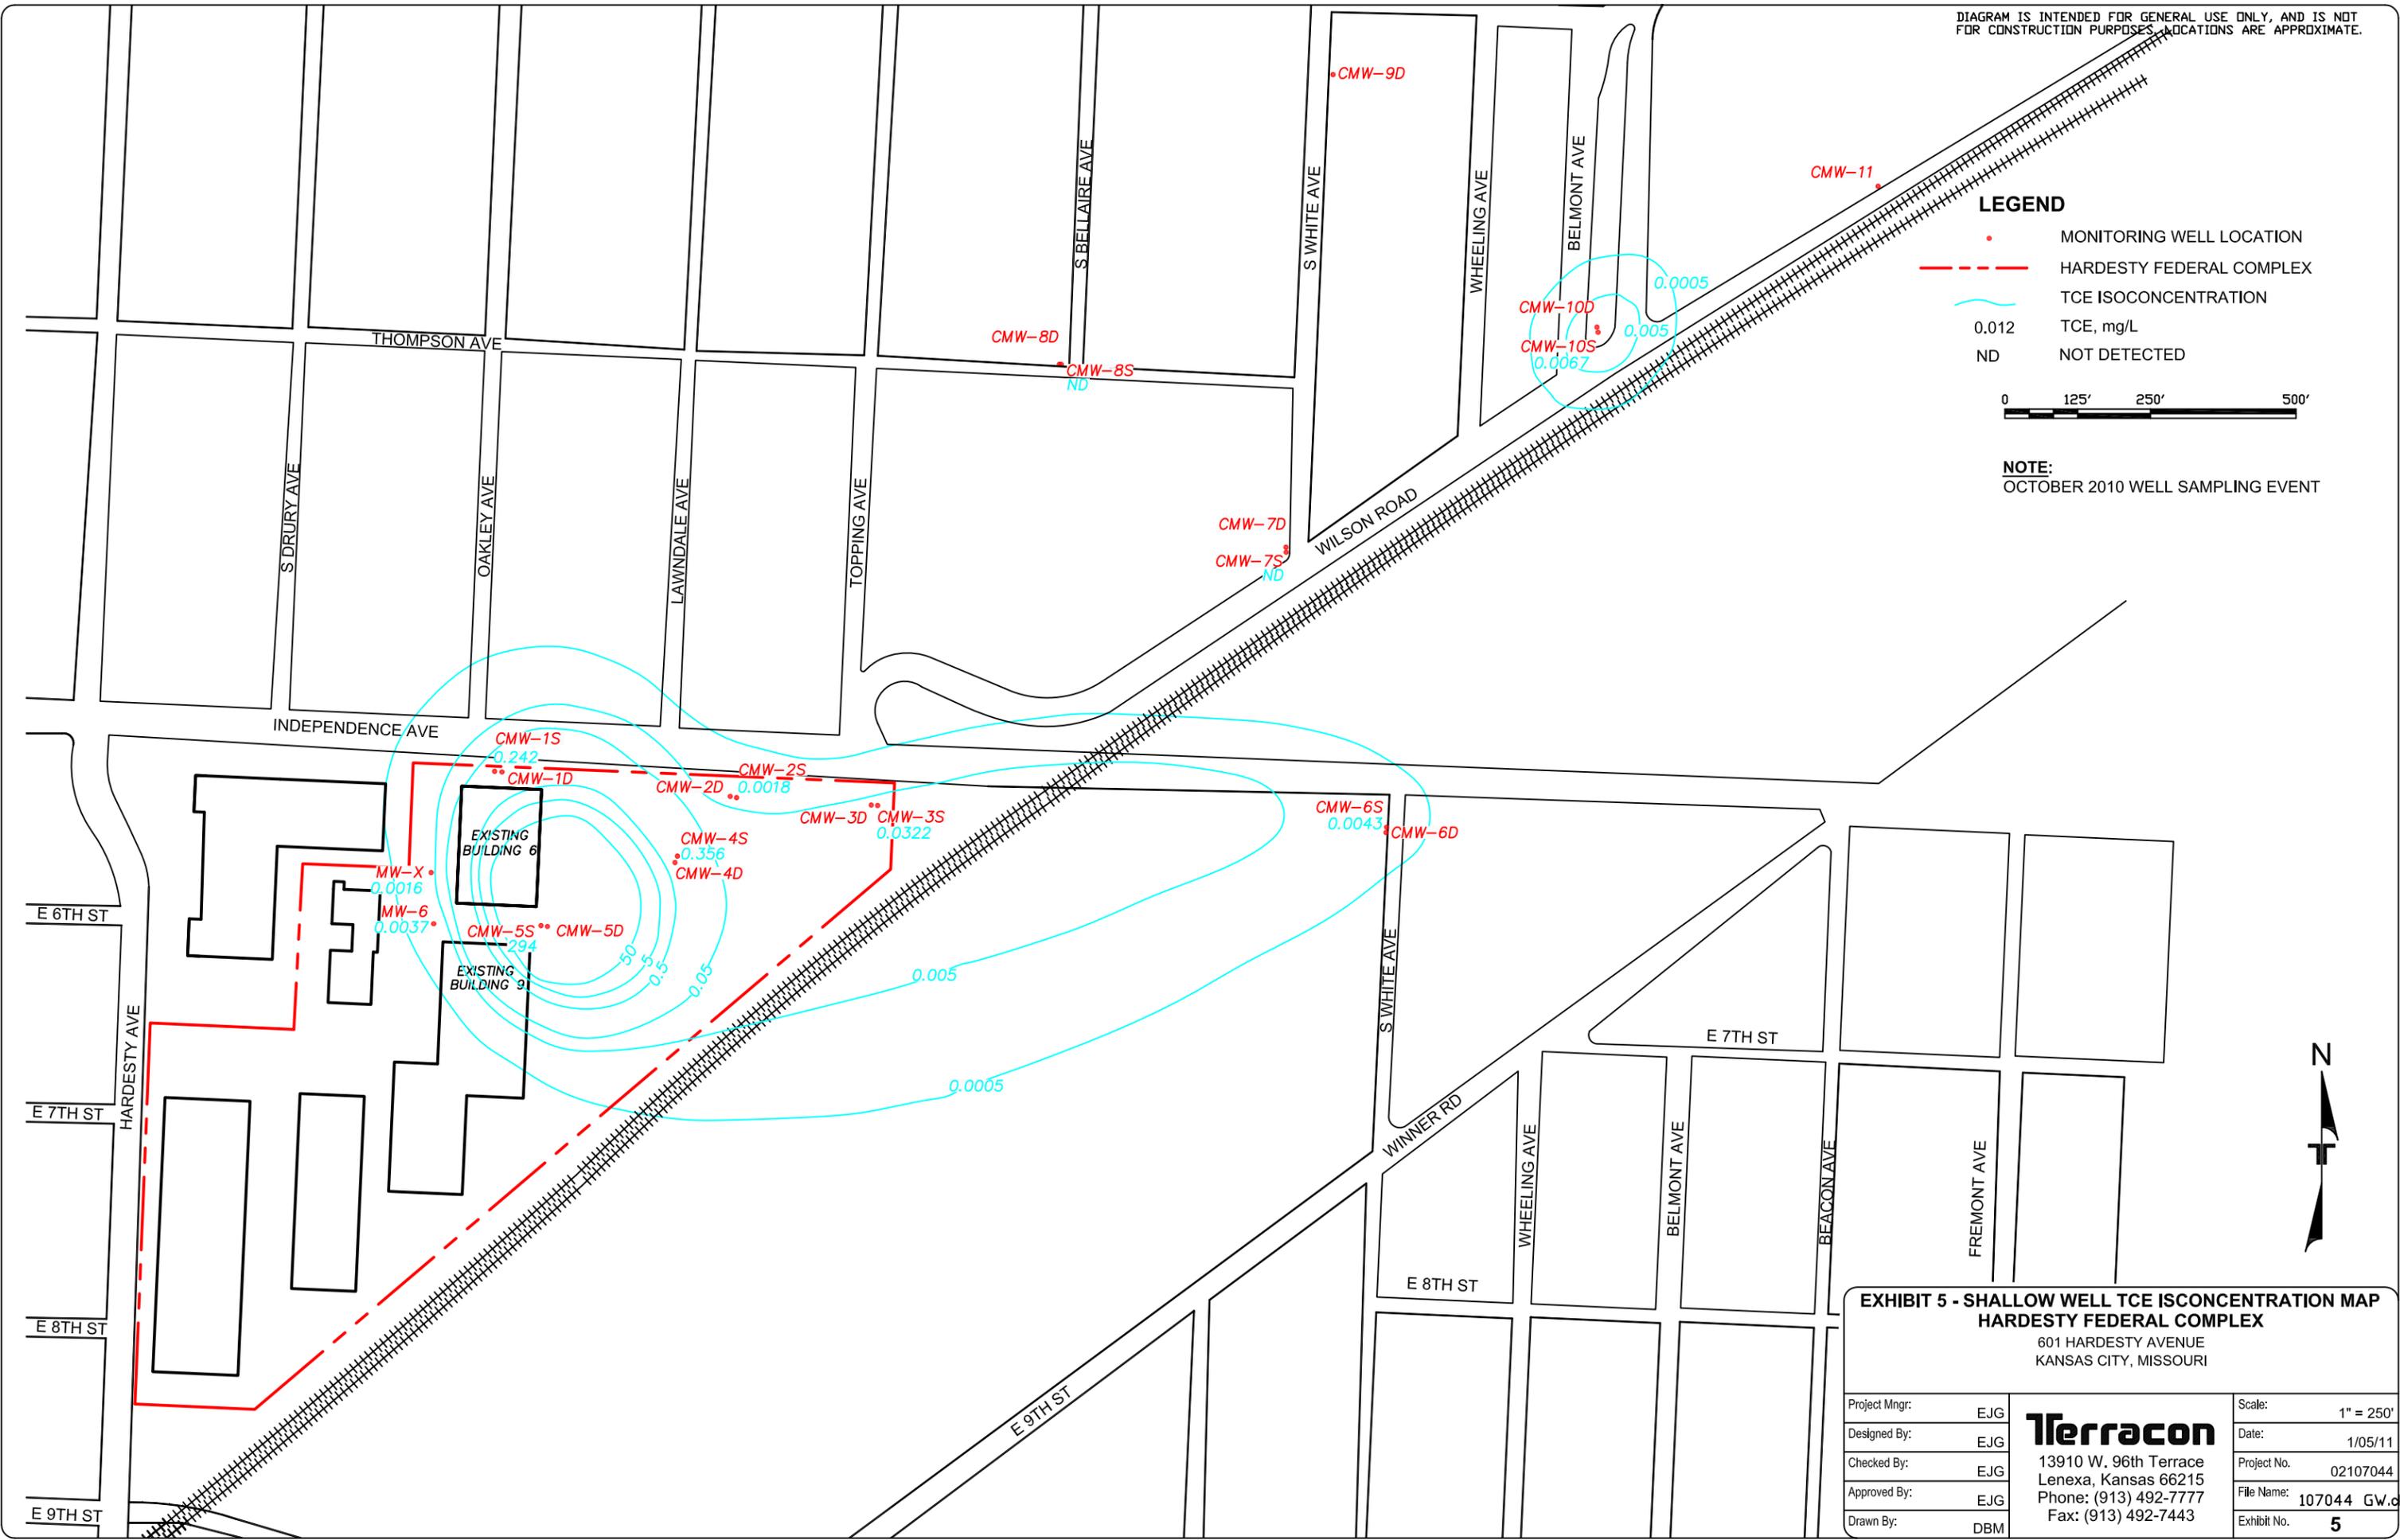
**EXHIBIT 5 - SHALLOW WELL TCE ISOCONCENTRATION MAP
HARDESTY FEDERAL COMPLEX**
601 HARDESTY AVENUE
KANSAS CITY, MISSOURI

NOTE:
OCTOBER 2010 WELL SAMPLING EVENT

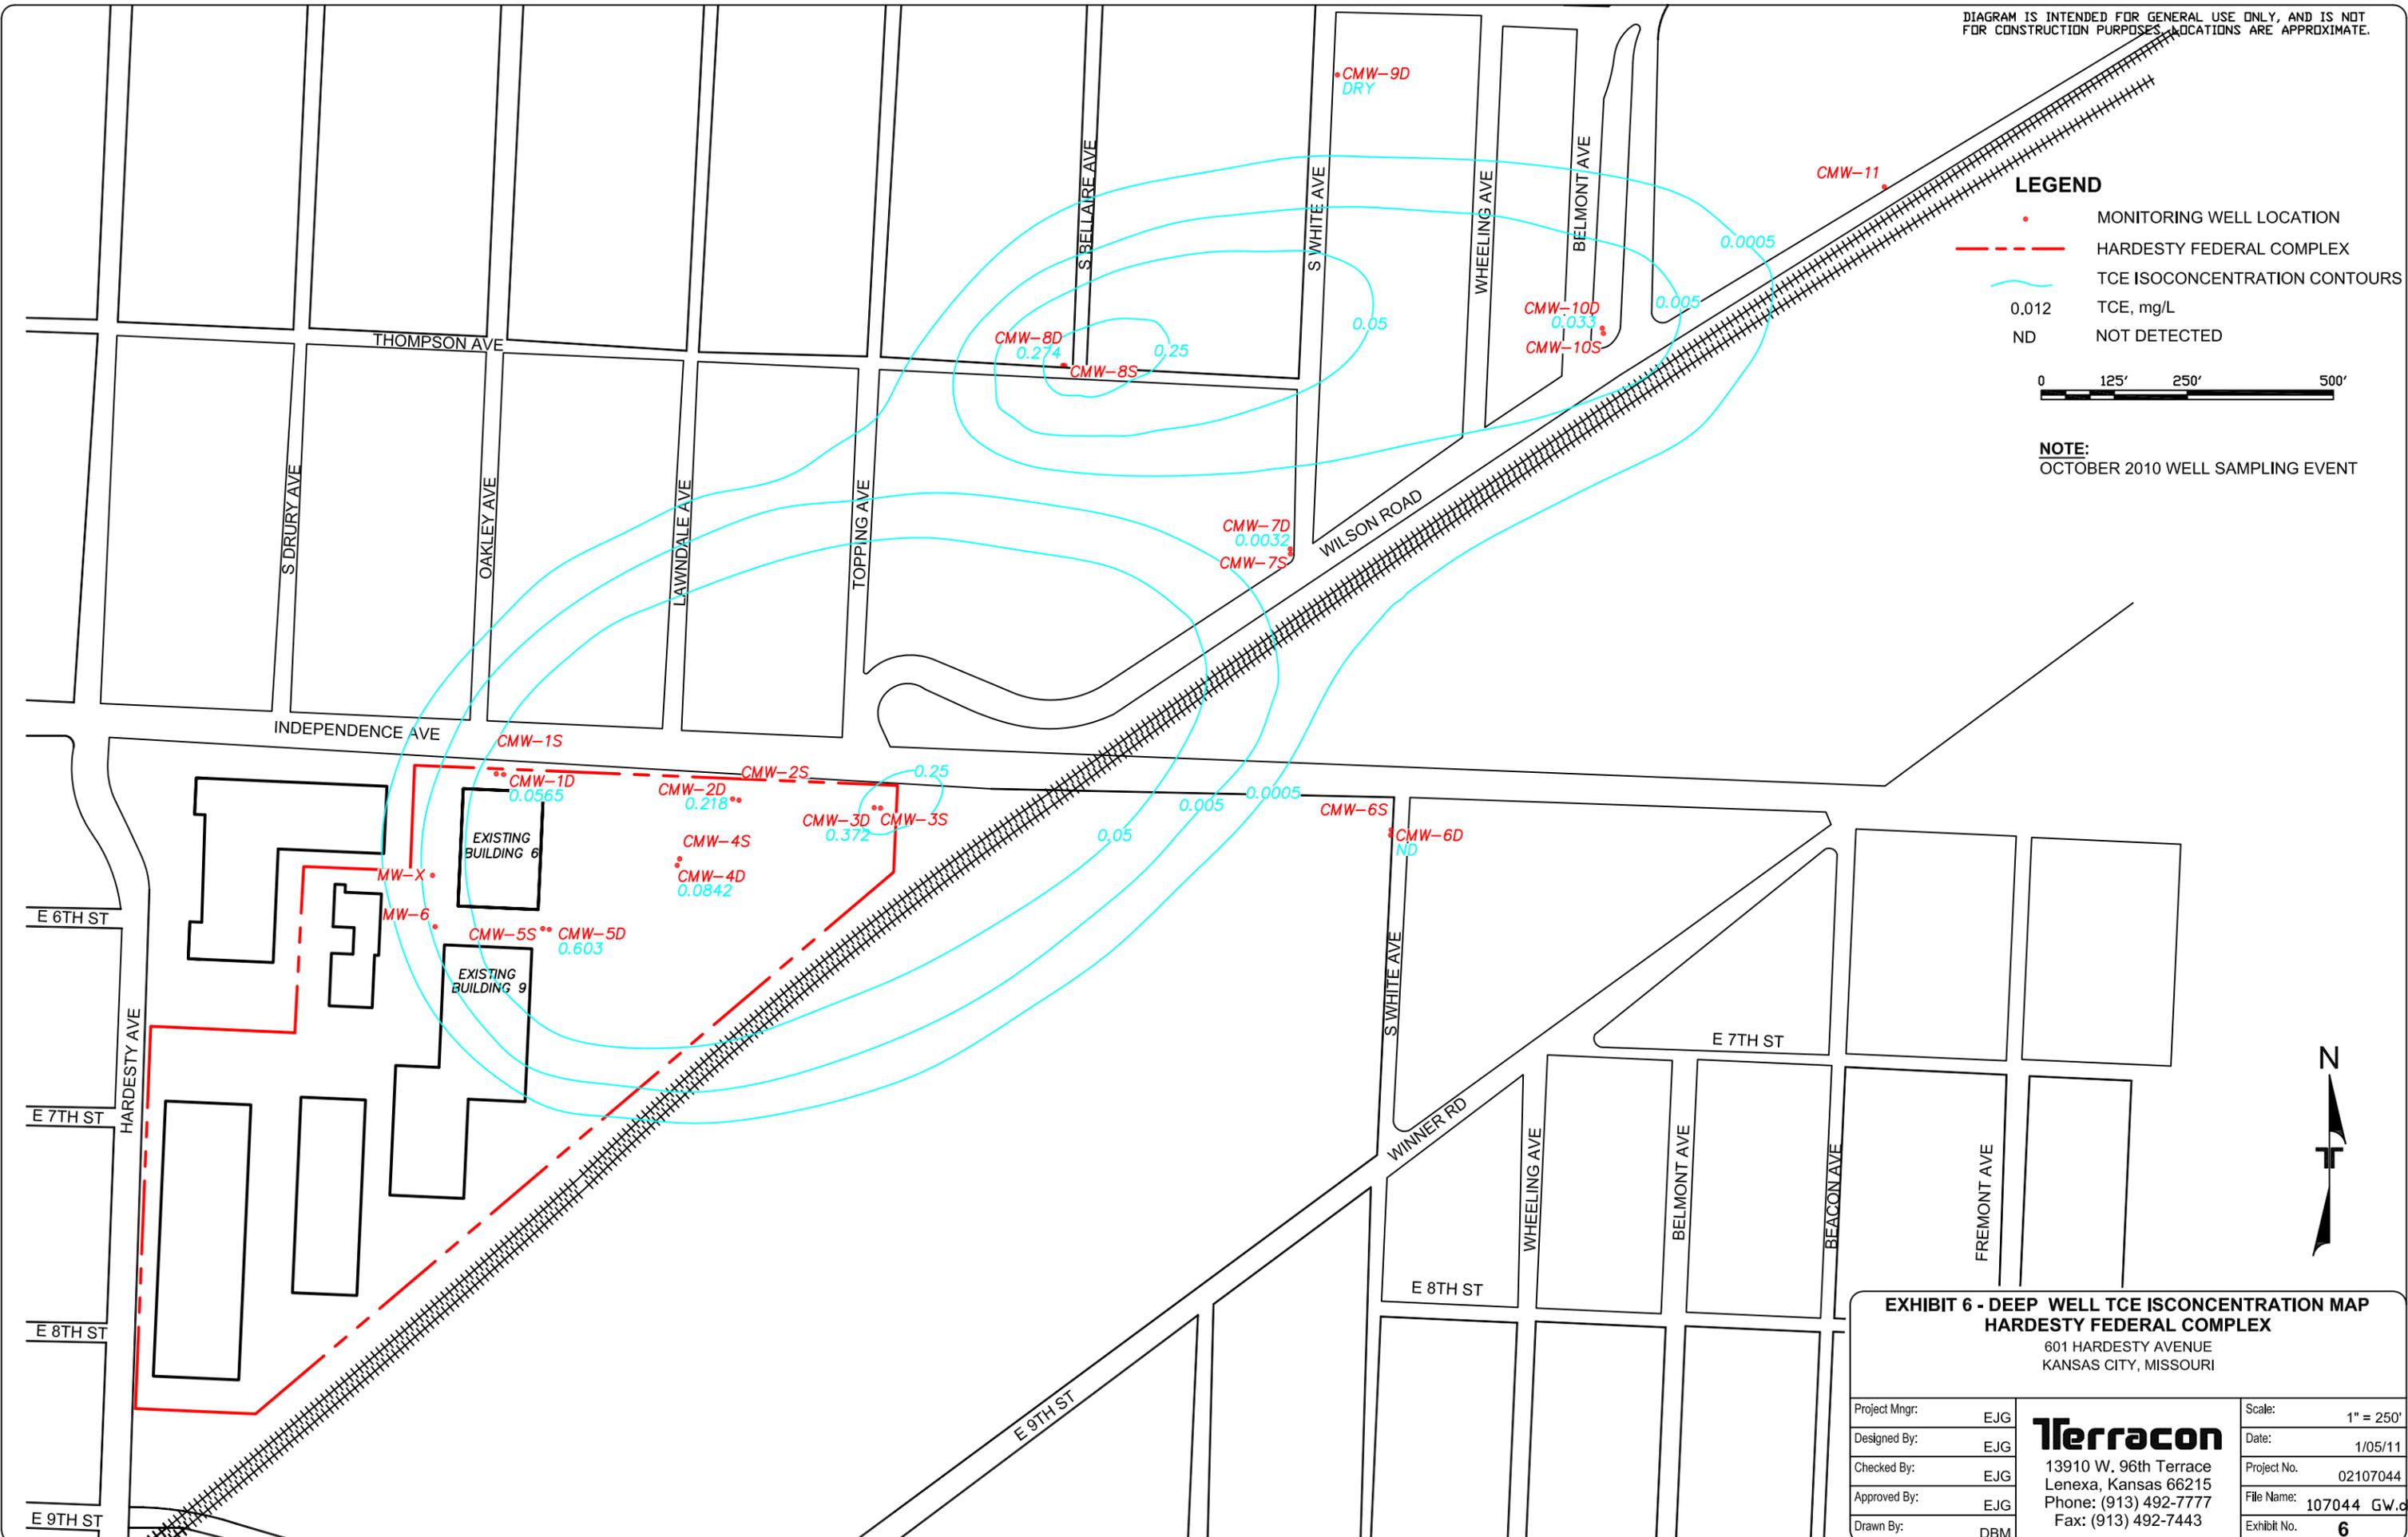
**EXHIBIT 6 - DEEP WELL TCE ISOCONCENTRATION MAP
HARDESTY FEDERAL COMPLEX**
601 HARDESTY AVENUE
KANSAS CITY, MISSOURI

NOTE:
OCTOBER 2010 WELL SAMPLING EVENT
