Remedial Investigation / Feasibility Study Work Plan – Final Revision 2.0

Hardesty Federal Complex
607 Hardesty Avenue
Kansas City, Jackson County, Missouri

March 13, 2013
Terracon Project No. 02107147

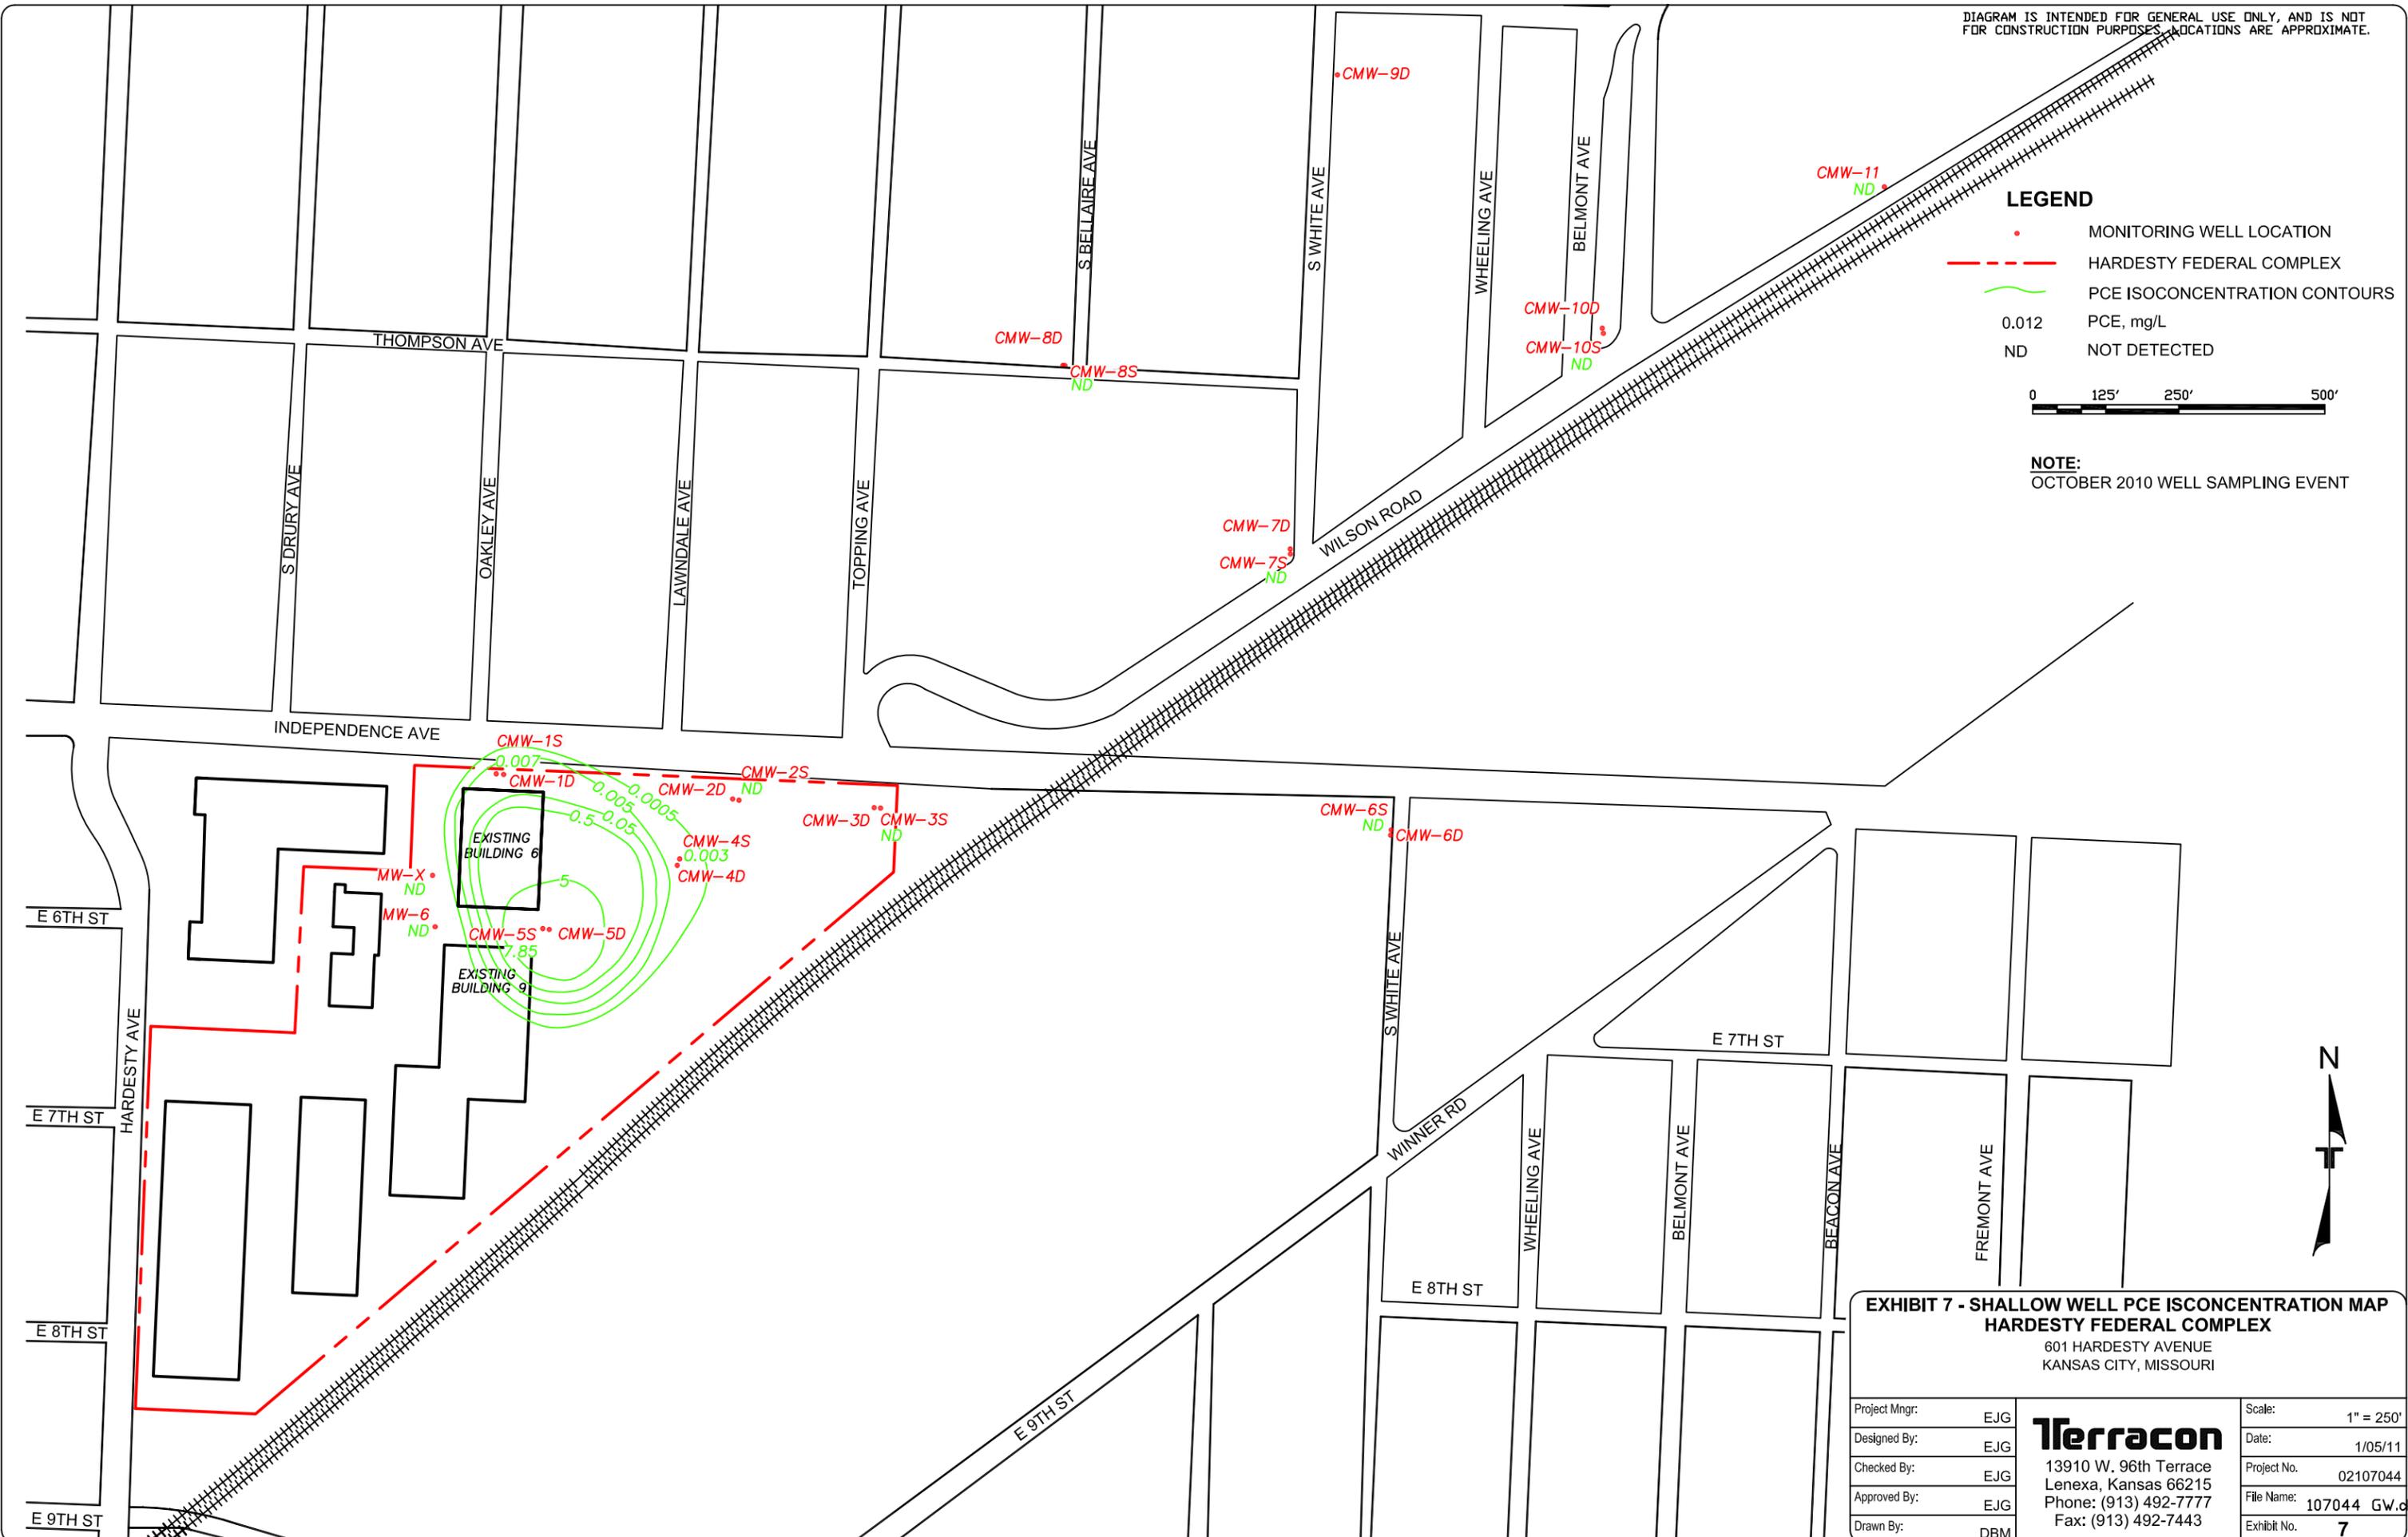
**EXHIBIT 7 - SHALLOW WELL PCE ISOCONCENTRATION MAP
HARDESTY FEDERAL COMPLEX**
601 HARDESTY AVENUE
KANSAS CITY, MISSOURI

NOTE:
OCTOBER 2010 WELL SAMPLING EVENT

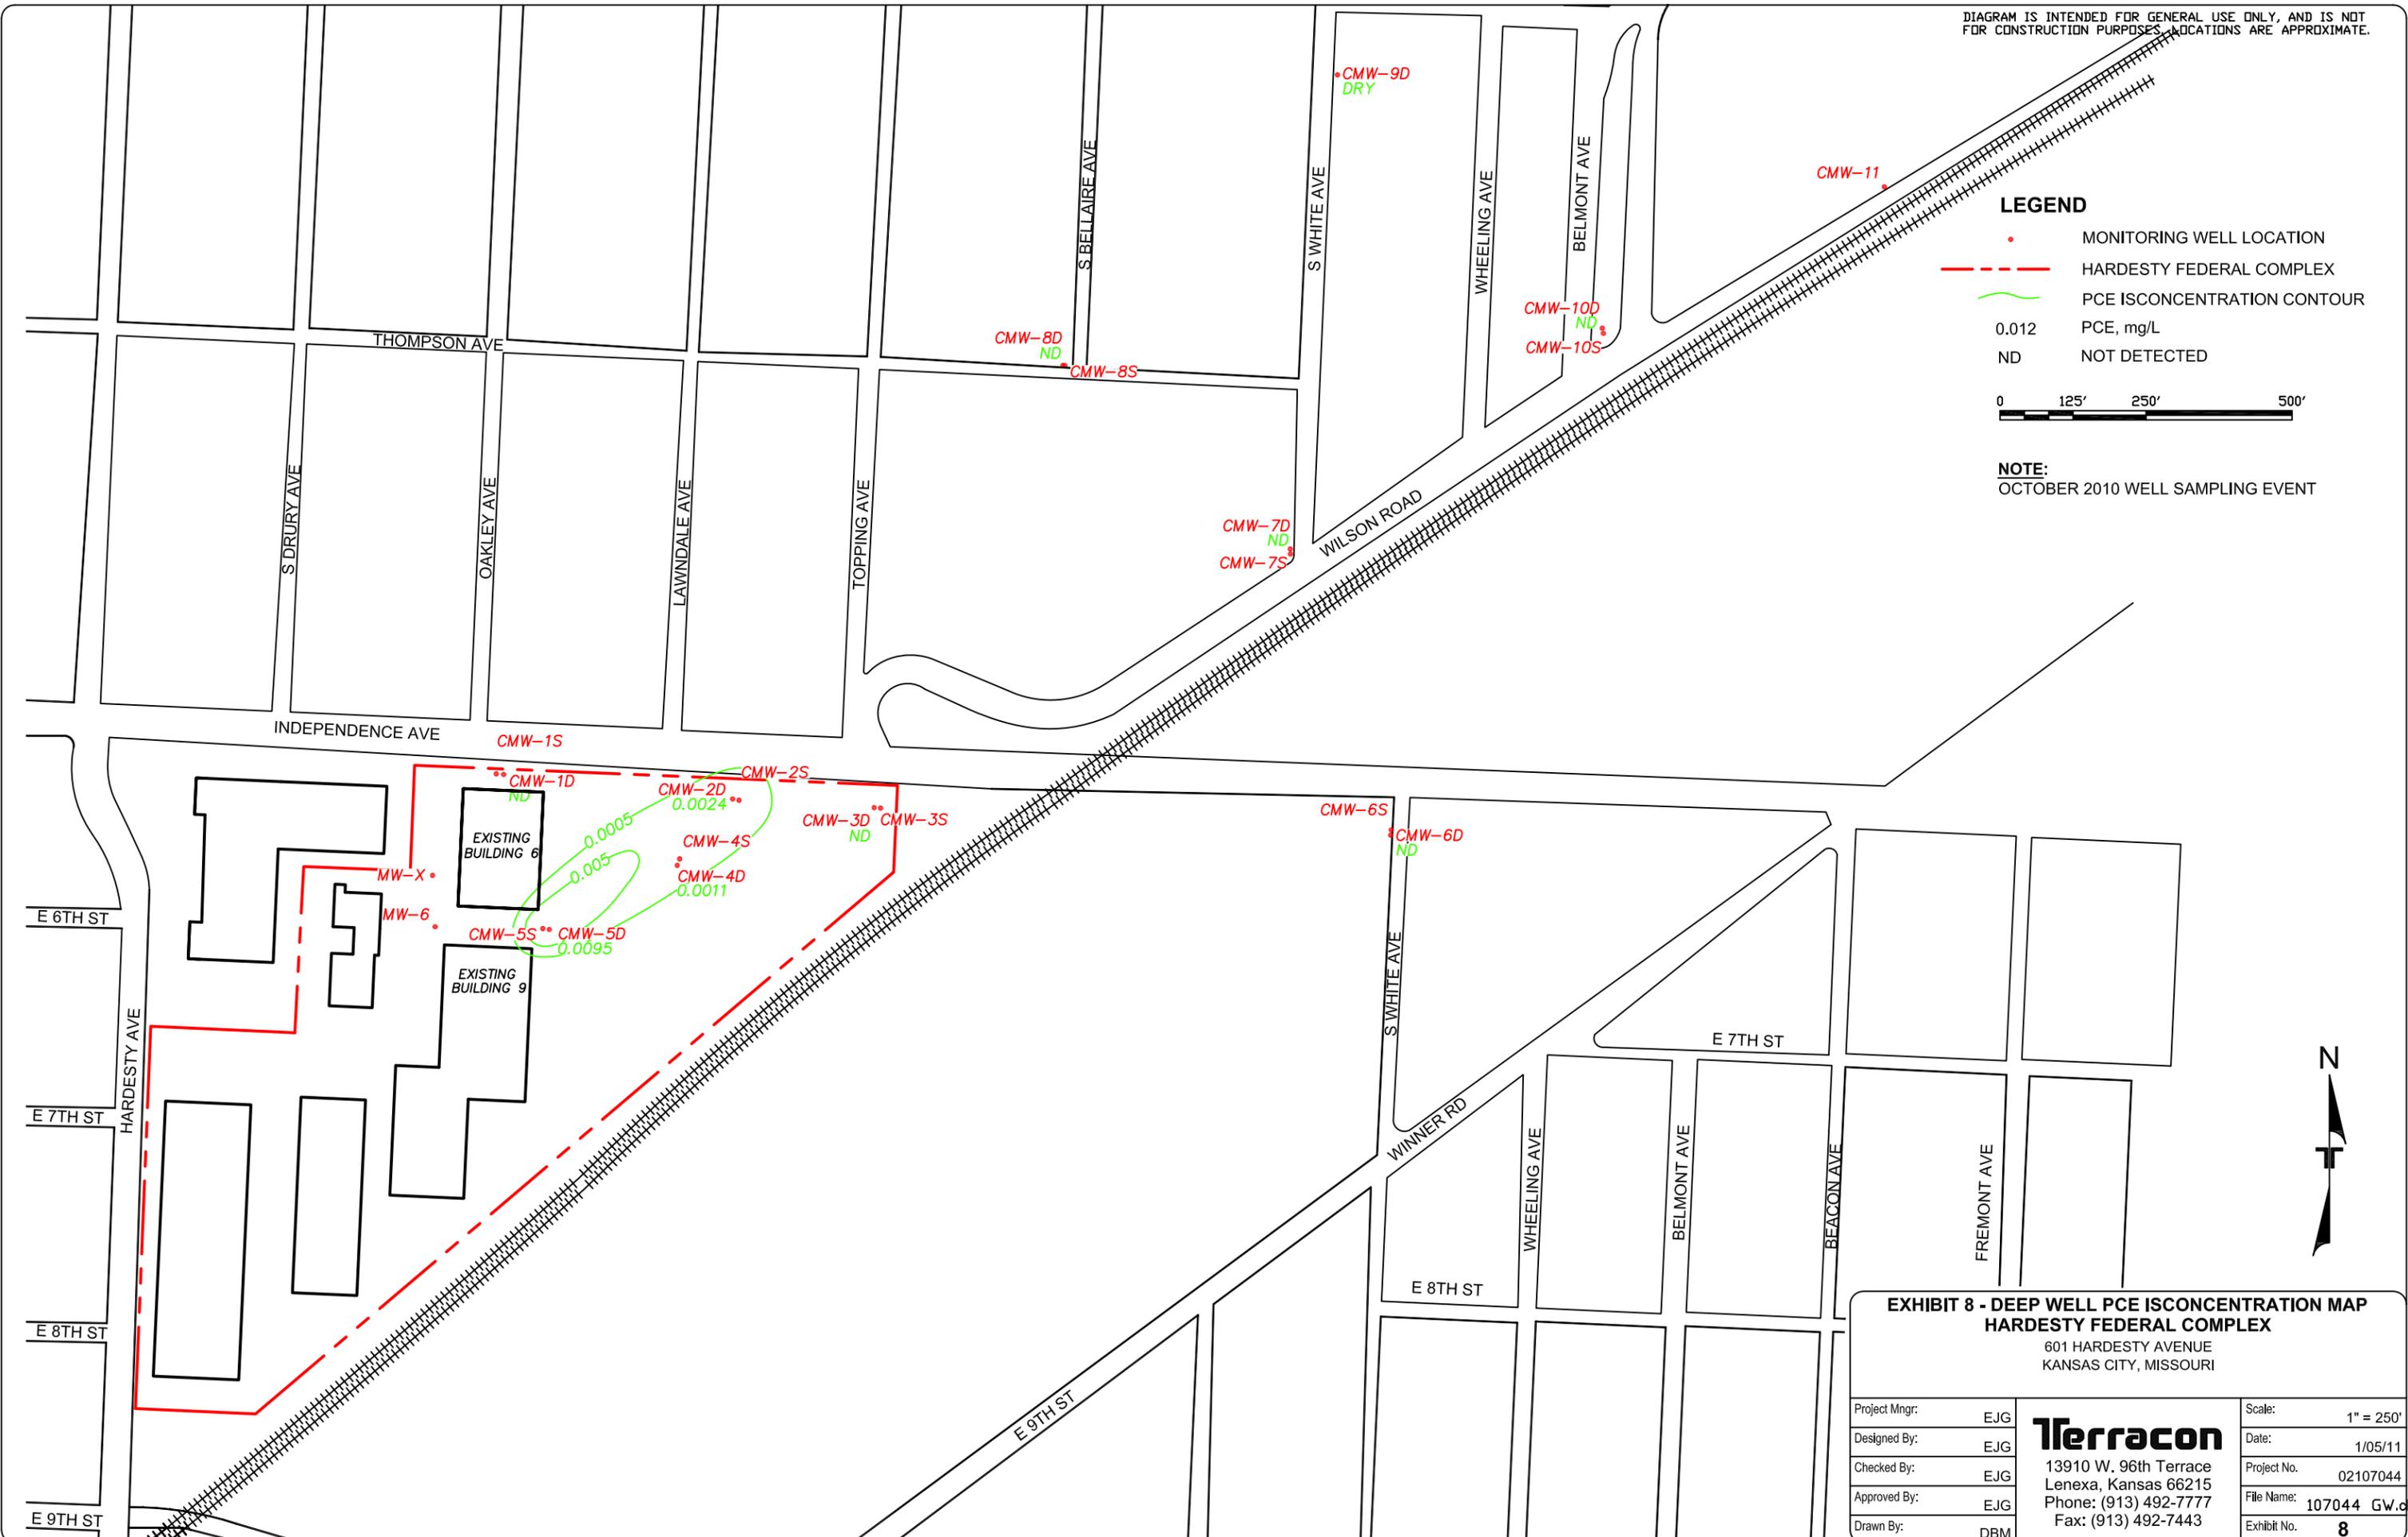
**EXHIBIT 8 - DEEP WELL PCE ISCONCENTRATION MAP
HARDESTY FEDERAL COMPLEX**
601 HARDESTY AVENUE
KANSAS CITY, MISSOURI

NOTE:
OCTOBER 2010 WELL SAMPLING EVENT

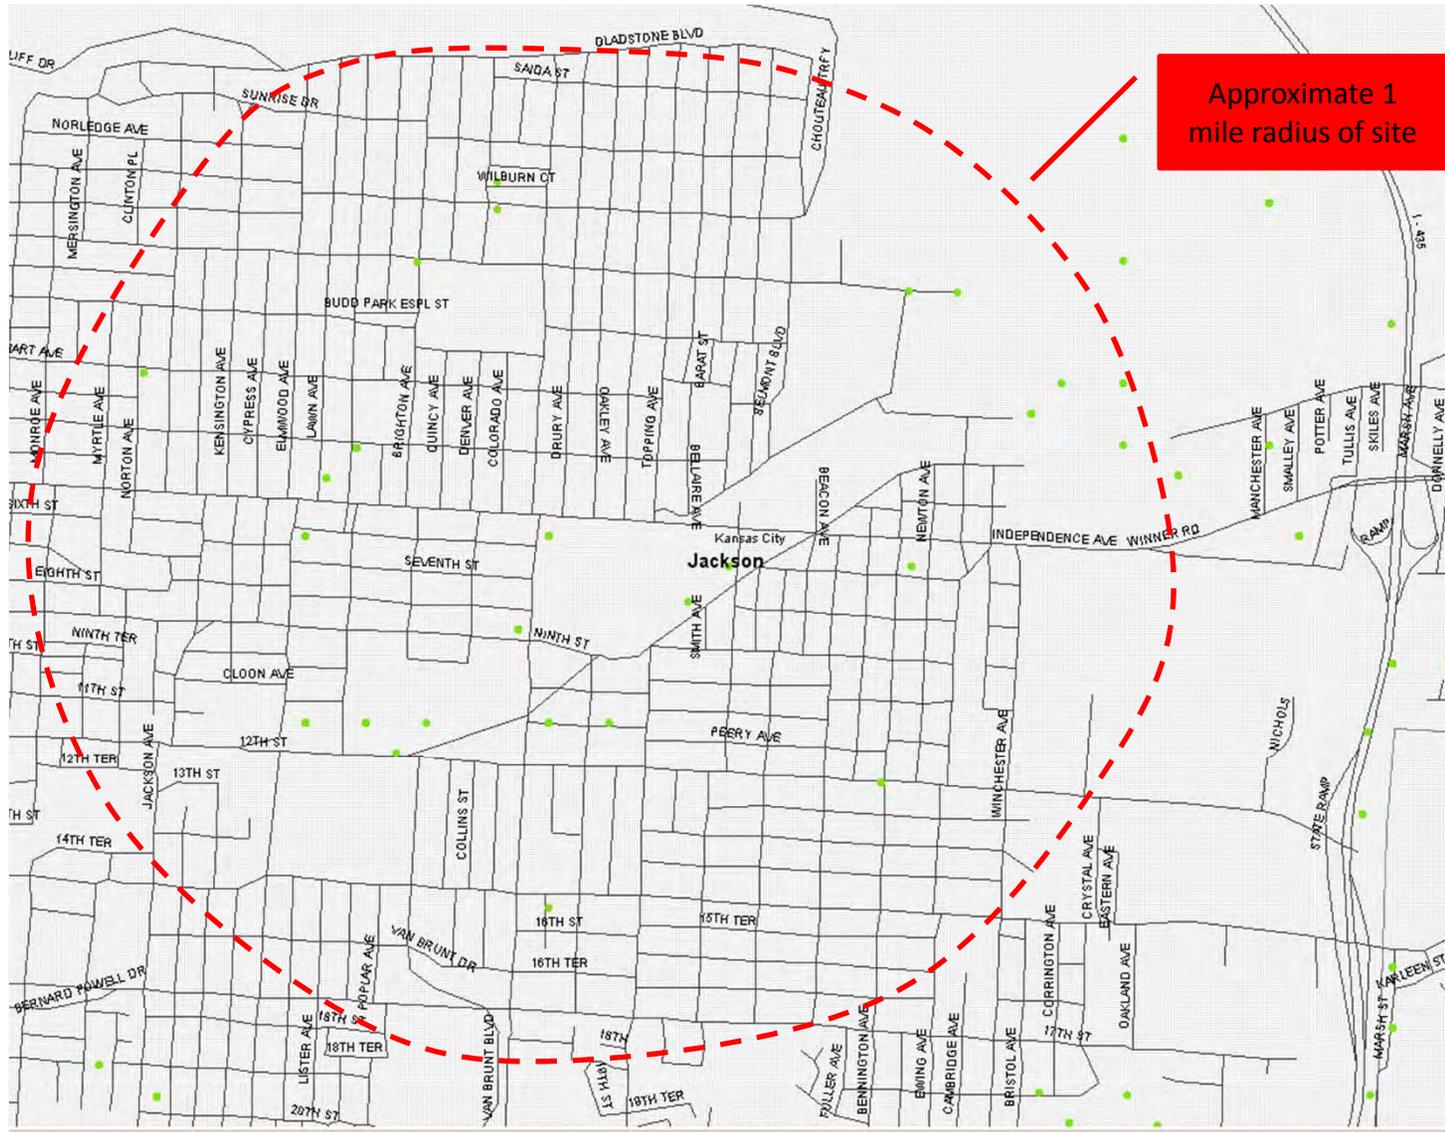
MEGA 2007 Water Well Search

● Private Well ● Public Well

Information obtained from Missouri Department of Natural Resources (MDNR) Geological Survey and Resource Assessment Division (GSRAD) Missouri Environmental Geology Atlas (MEGA), 2007.
