Use Attainability Analysis

WBID 0715 Richland Creek

Submitted by
SES, Inc.

Date Received: June 3, 2007

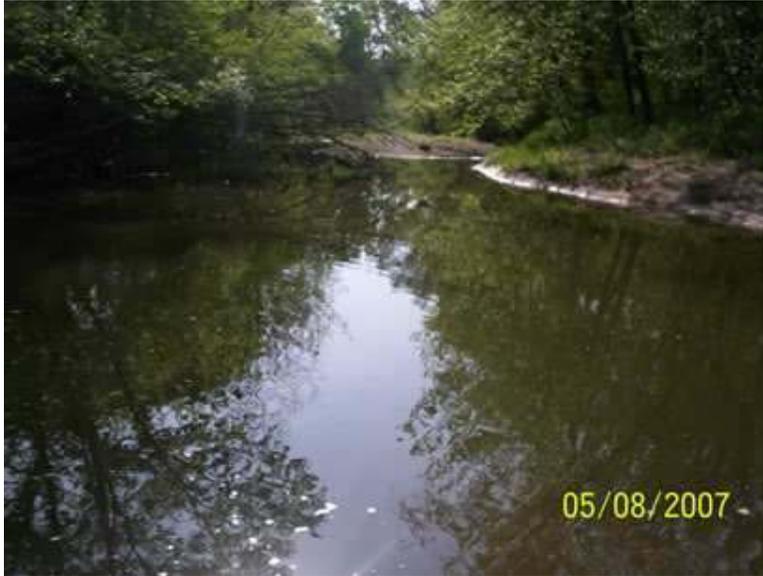
Site# 1 Photo ID# 3, Downstream

% Cobble	% Gravel	% Sand	% Silt
50	40	5	5
% Mud/Clay	% Bedrock		
0	0

Carex, rushes, grasses along banks and in gravel. Minimal aquatic vegetation

Odor Sewage Musky Chemical **None** Other
 Color **Clear** Green Gray Milky Other
 Bottom Deposit Sludge Solids Fine Sed. **None** Other
 Surface Deposit Oil Scum **Foam** None Other

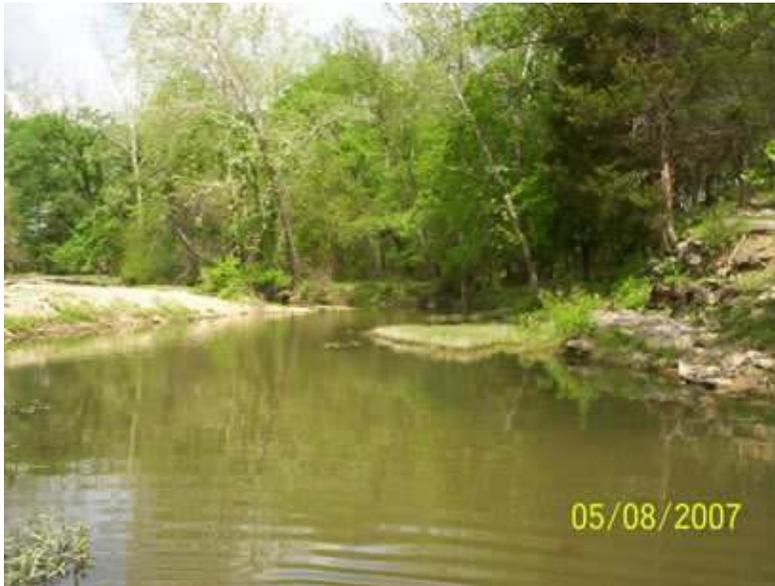
Site# 2 Photo ID# 4, Upstream

% Cobble	% Gravel	% Sand	% Silt
50	40	5	5
% Mud/Clay	% Bedrock		
0	0

Some floating aquatic vegetation. Carex, rushes, grasses along bank and in gravel

Odor Sewage Musky Chemical **None** Other
 Color **Clear** Green Gray Milky Other
 Bottom Deposit Sludge Solids Fine Sed. **None** Other
 Surface Deposit Oil Scum Foam **None** Other

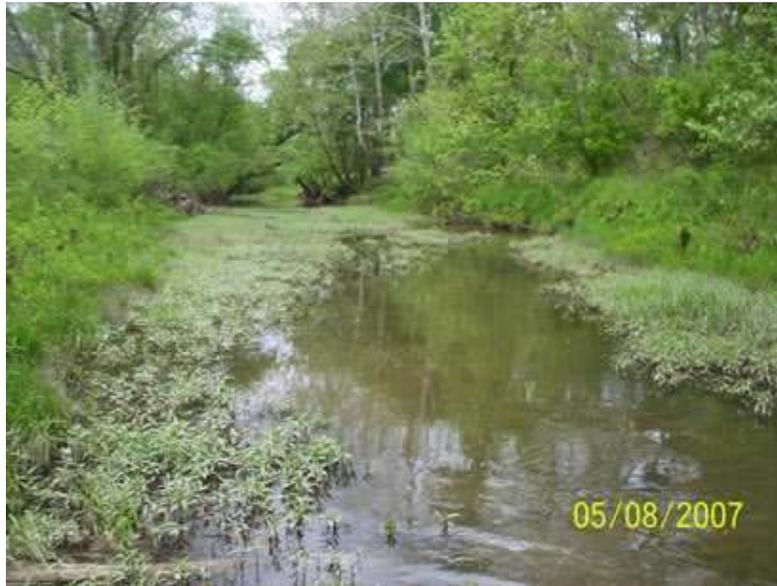
Site# 3 Photo ID# 6, Upstream

% Cobble	% Gravel	% Sand	% Silt
50	40	5	5
% Mud/Clay	% Bedrock		
0	0

Present in areas. 90% coverage in areas. Algae on rocks.

Odor Sewage Musky Chemical **None** Other
 Color **Clear** Green Gray Milky Other
 Bottom Deposit Sludge Solids Fine Sed. **None** Other
 Surface Deposit Oil Scum **Foam** None Other
