Use Attainability Analysis

WBID 0747 Fowler Creek

Submitted by

Missouri Department of Natural Resources

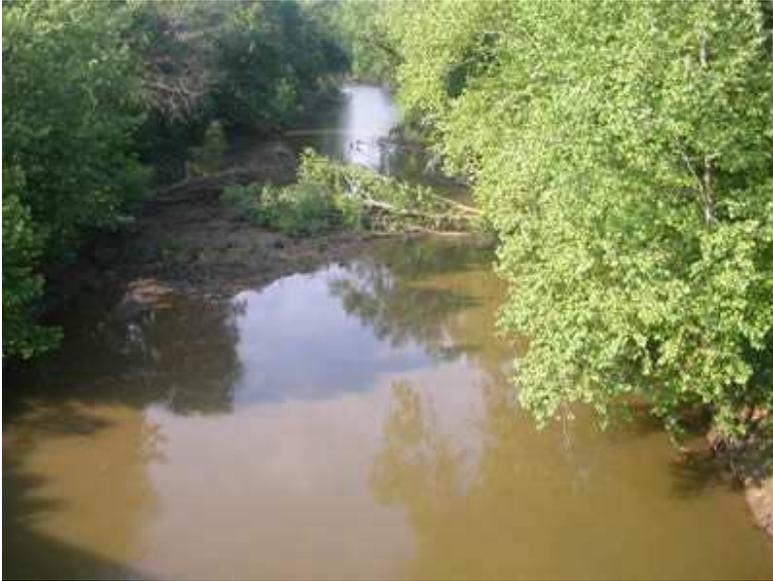
Site# 1 Photo ID# 149, Upstream

WBID 747
 Site # 1

Site Location (e.g. road crossing) At HWY Y road crossing

Upstream Photo 149 Downstream Photo 148

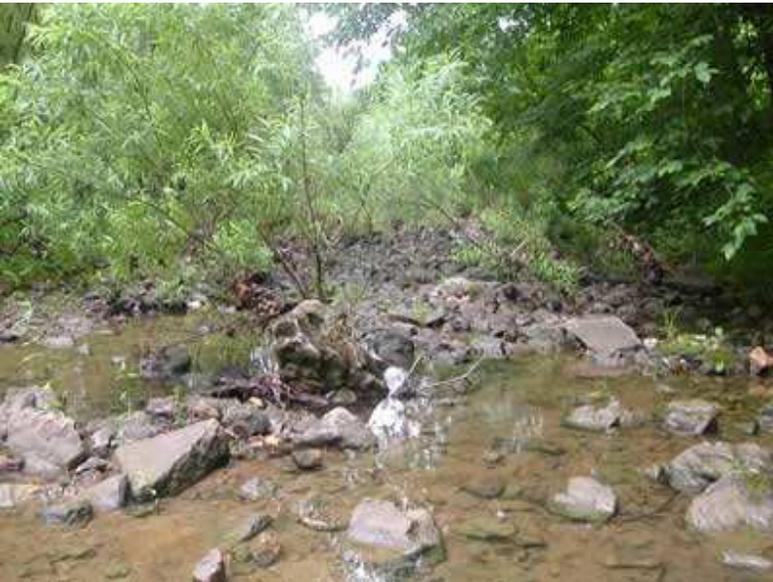
Site# 2 Photo ID# 151, Upstream

WBID 747
 Site # 2

Site Location (e.g. road crossing) .75 miles downstream of HWY Y road crossing

Upstream Photo 151 Downstream Photo 150

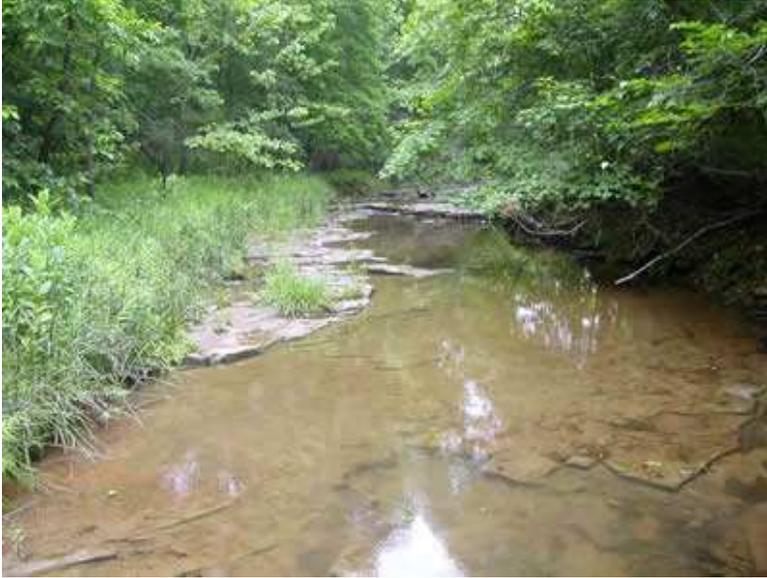
Site# 3 Photo ID# 153, Upstream

WBID 747
 Site # 3

Site Location (e.g. road crossing) 1.5 miles downstream

Upstream Photo 153 Downstream Photo 152
