Use Attainability Analysis

WBID 0829 Rising Creek

Submitted by  
SES, Inc.

To  
Missouri Department of Natural Resources  
Water Protection Program

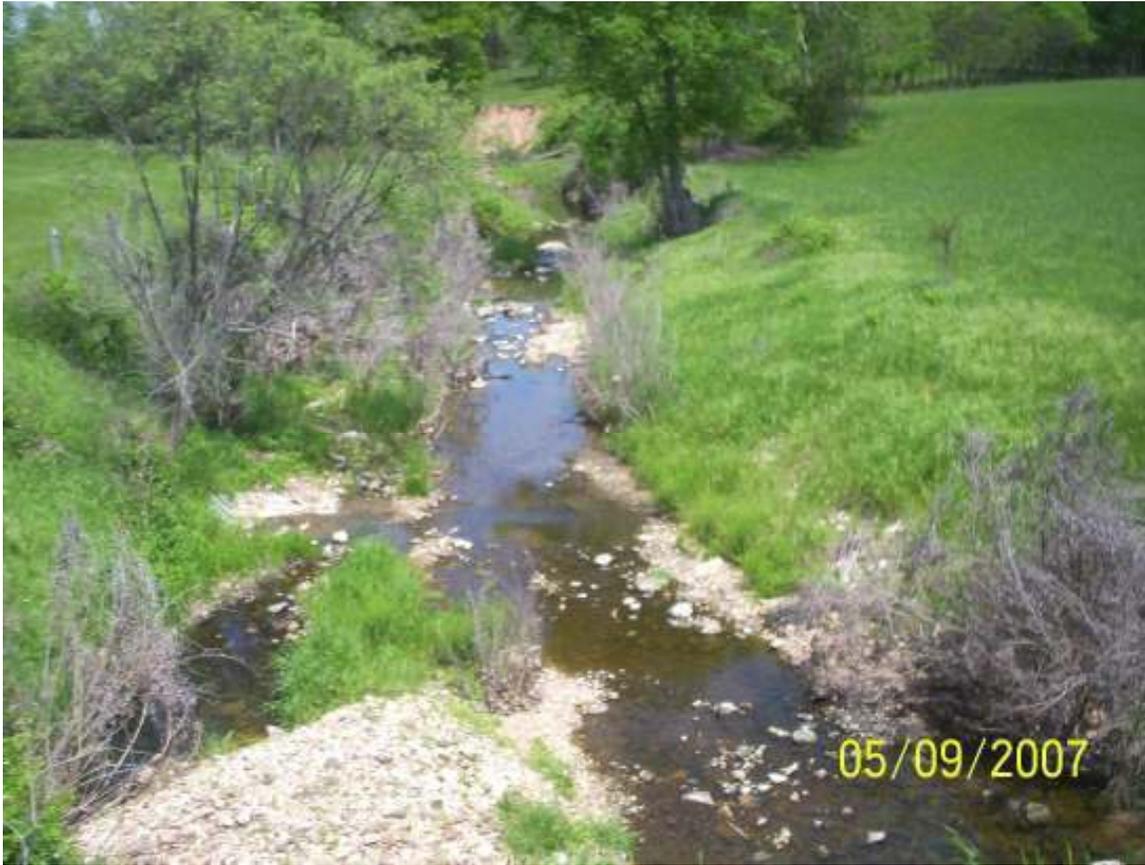
Site 1 Downstream Photo 21 WBID# 0829

**Downstream View's Physical Dimensions:** Is there any water present at this view?      yes

If so, is there an obvious current?

Substrate:

% Cobble	% Gravel	% Sand	% Silt
20	50	30	0
% Mud/Clay	% Bedrock		
0	0

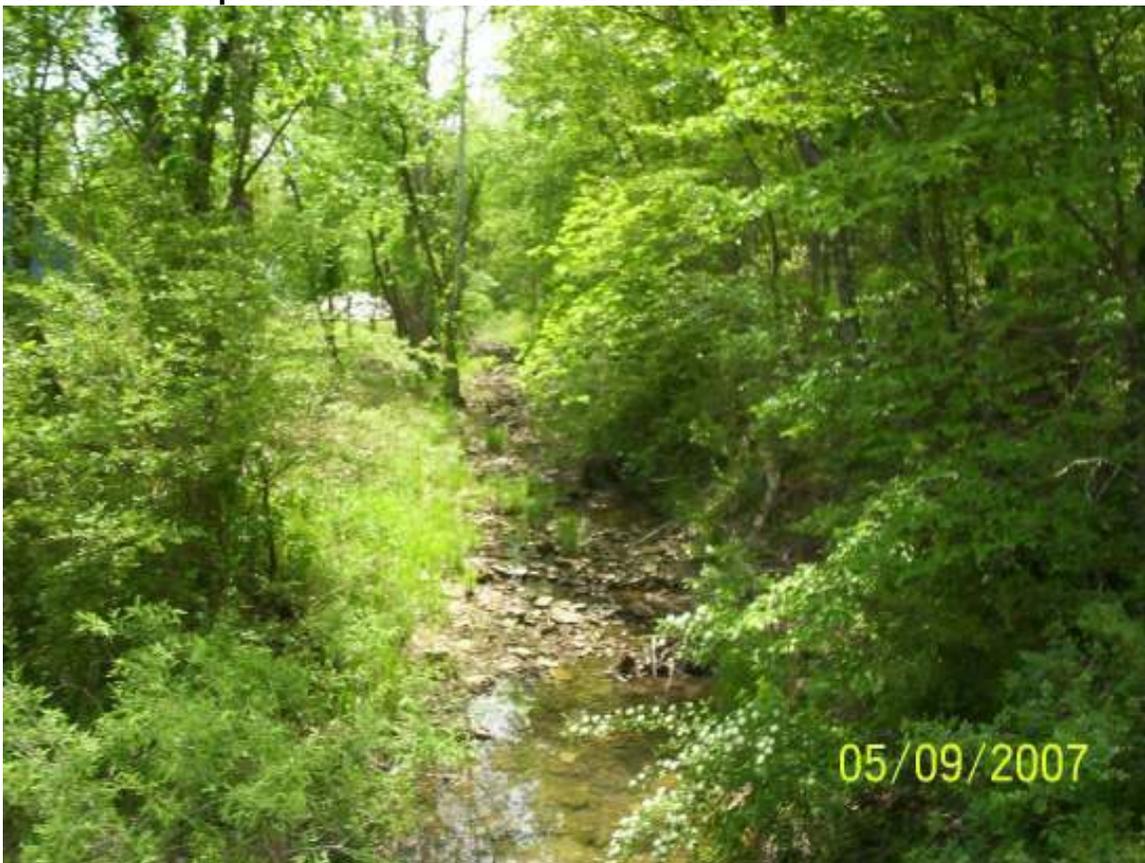
Site 1 Upstream Photo 20 WBID# 0829

**WBID #** 829                      **Site #** 1  
**Mark #** 13                      **Dissolved Oxygen (ppm)** 10.2  
**Upstream Views Physical Dimensions:** Is there any water present at this view?      yes

Riffle	0				
Run	0				
Pool	100

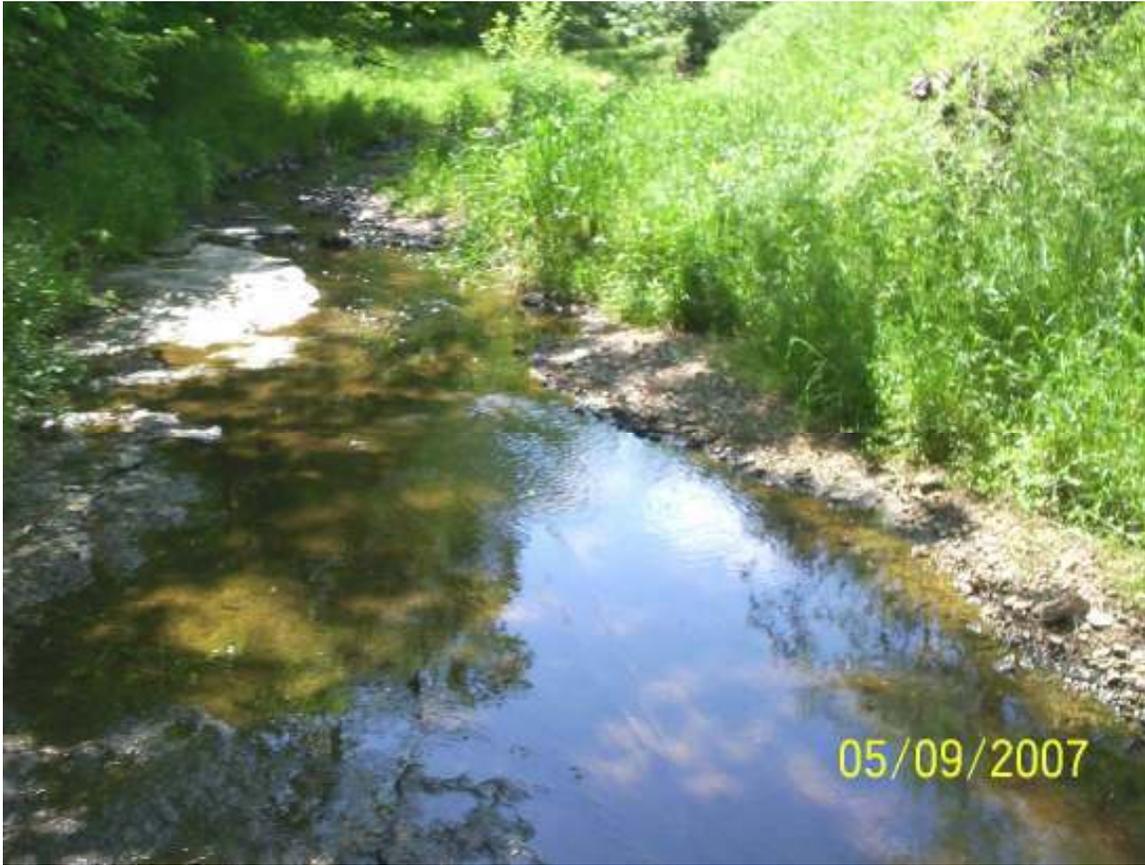
Photo 23

**Downstream View's Physical Dimensions:** Is there any water present at this view?      yes

% Cobble	% Gravel	% Sand	% Silt
20	70	0	0
% Mud/Clay	% Bedrock		
0	10

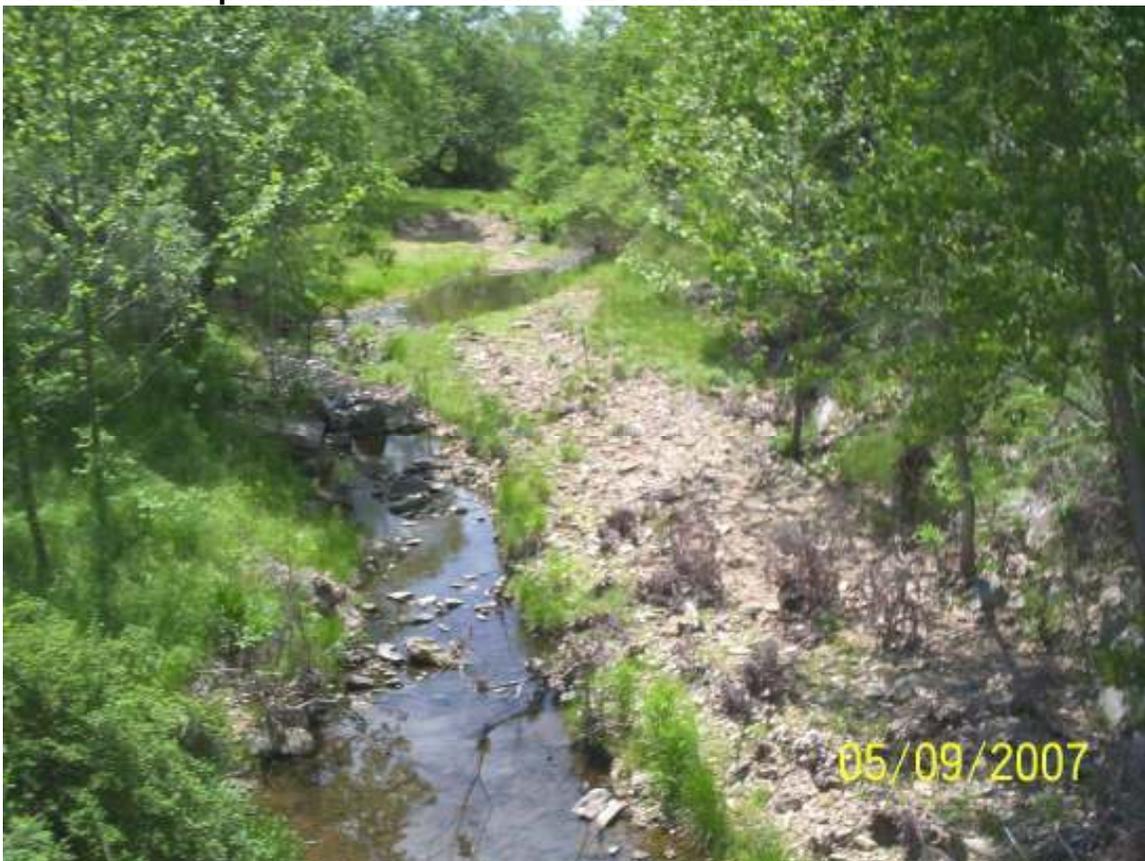
Photo 22

**WBID #** 829      **Site #** 2  
**Mark #** 14      **Dissolved Oxygen (ppm)** 10.6  
**Upstream Views Physical Dimensions:** Is there any water present at this view?      yes

Riffle	10				
Run	0				
Pool	90

Algae on bedrock.

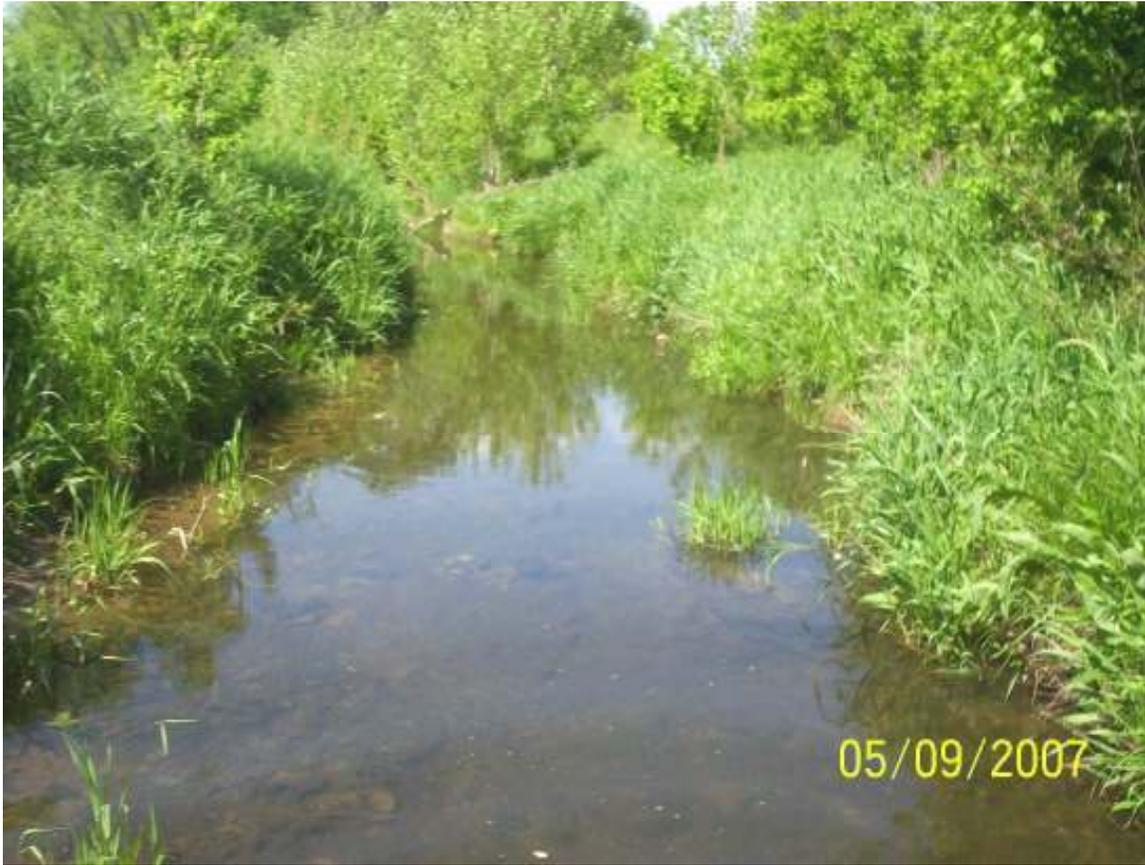
Photo 25

**Downstream View's Physical Dimensions:** Is there any water present at this view? Yes

% Cobble	% Gravel	% Sand	% Silt
10	10	60	20
% Mud/Clay	% Bedrock		
0	0

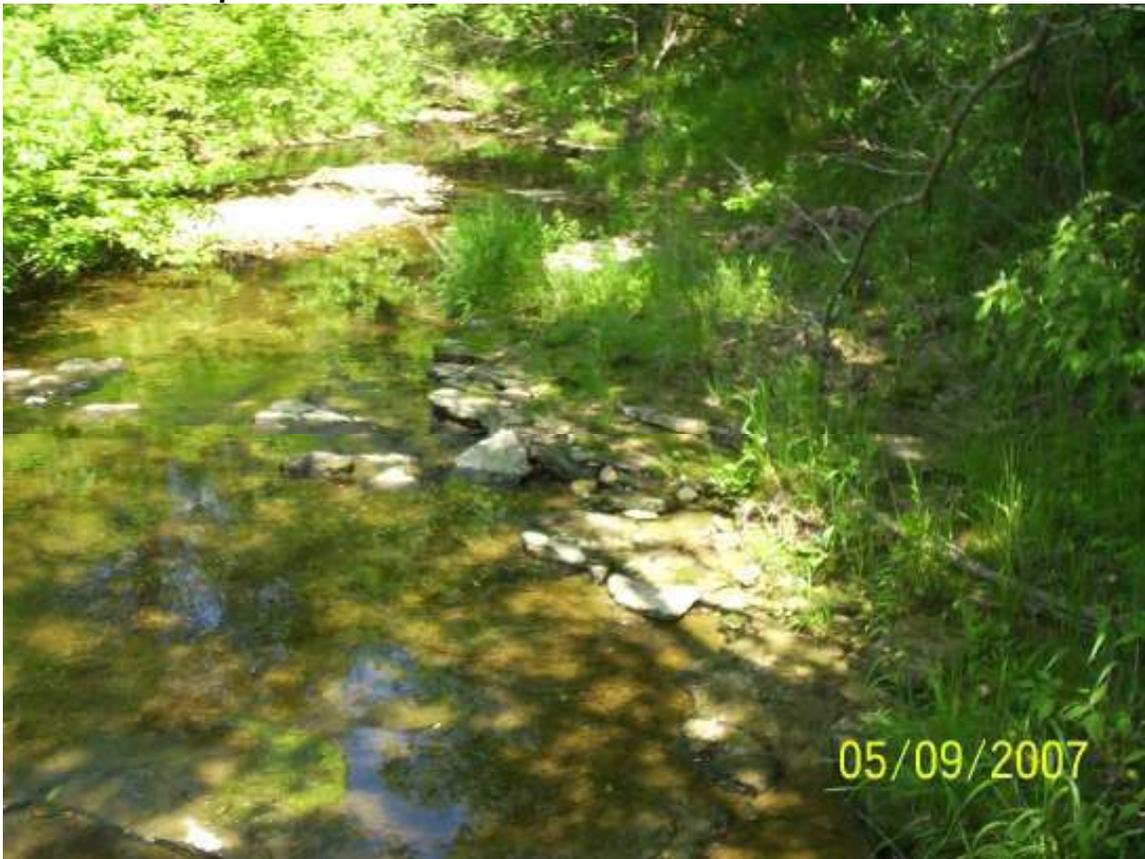
Photo 24

**WBID #** 829                      **Site #** 3  
**Mark #** 15                      **Dissolved Oxygen (ppm)** 11.1  
**Upstream Views Physical Dimensions:** Is there any water present at this view? Yes

Riffle	10				
Run	0				
Pool	90

Alge on rocks.
