**Use Attainability Analysis**  
**for**  
**Water Body Identification # 0833**  
**Linn Creek**

**Conducted by:**  
**Environmental Resources Coalition**

**To:**  
**Missouri Department of Natural Resources**  
**Water Protection Program**

**Submitted: November 21, 2005**

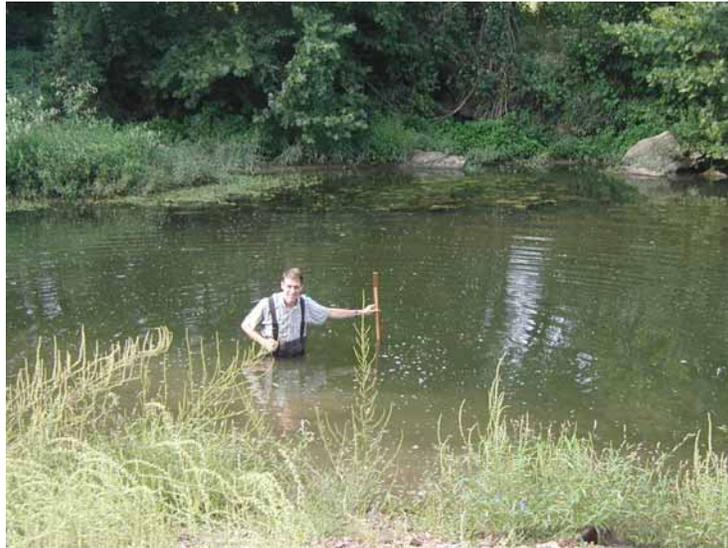
### Upstream View of the Pool

**09/01/05 - Assessors could not cross the stream at this location. Depths greater than 140 cm were measured with actual maximum pool depth likely to exceed 200 cm. Footprints and several alcohol bottles were noticed on the gravel bar adjacent to the pool.**

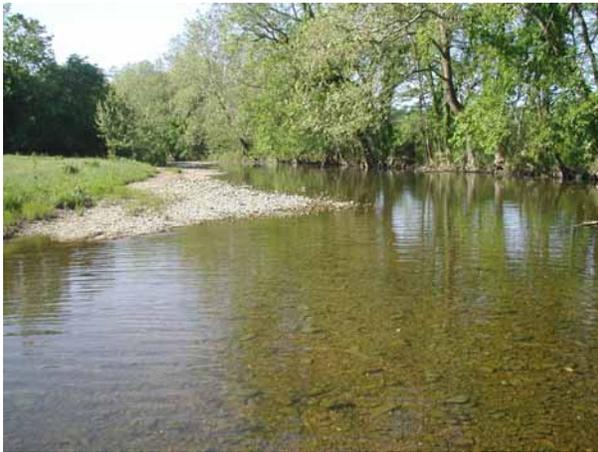
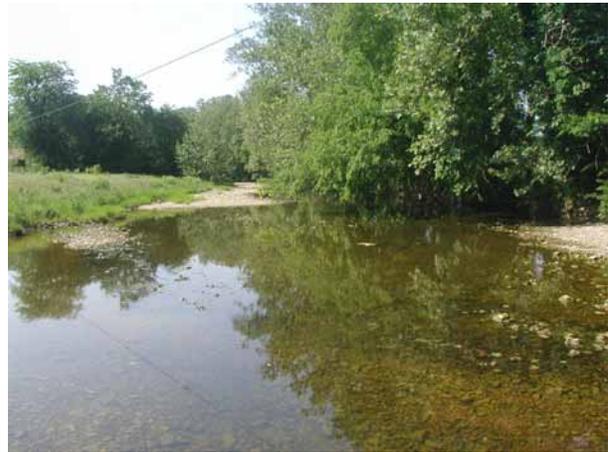
### Upstream Views

**Site #2:** Site #2 of Linn Creek is located just off Highway W before the stream and highway curve away from each other. The surroundings at this site include wooded area, pasture land, and a low water crossing. The stream is very wide and shallow at this location.

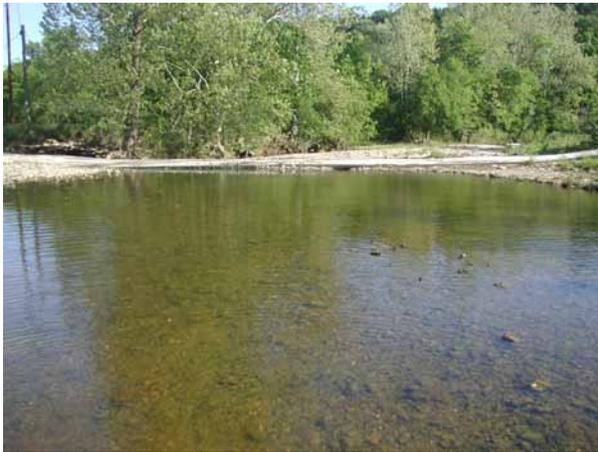
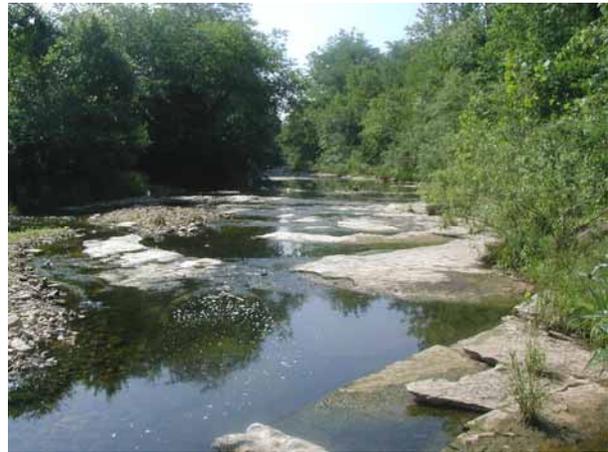
### Upstream Views

**Site #3:** Site #3 of Linn Creek is located just off Highway W by the roadside pull off on the east side of the highway. The assessment site is surrounded by wooded areas and Highway W. Access to stream is easily accomplished by a small footpath from the highway pull off to the edge of the stream. At this location, trash lines the banks of the stream. It is the opinion of the assessment team that the path is likely used for dumping trash rather than whole body contact recreation. This site is located approximately 0.9 of a mile below the WWTF.

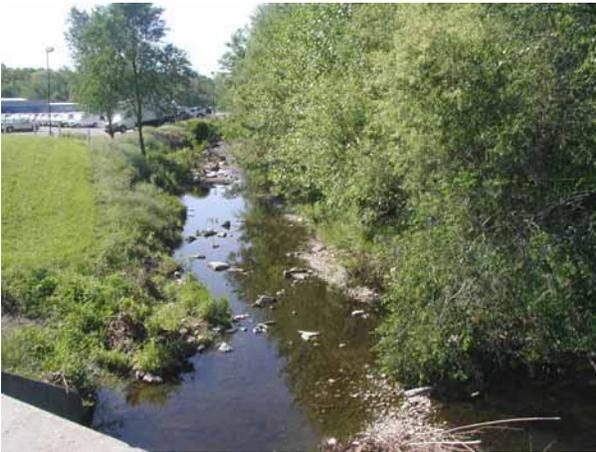
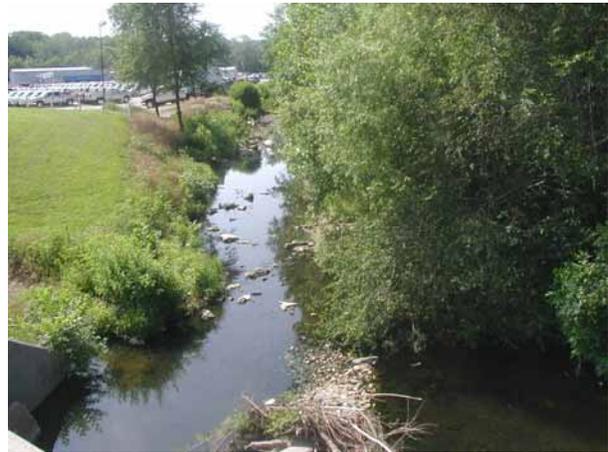
### Upstream Views

**Site #4:** Site #4 is located just off Hwy 50 near the concrete plant and is the uppermost assessment site on Linn Creek. This site located approximately 0.4 of a mile downstream of the WWTF. Surrounding conditions include; a concrete plant, a car dealership, Highway 50, and some wooded areas. During the assessment on 05/17/05 approximately 2.5 miles of the stream was assessed between Site #2 and Site #4.
