Use Attainability Analysis

WBID 1010 North Fork Grindstone Creek

Submitted by
SES, Inc.

Date Received: June 3, 2007

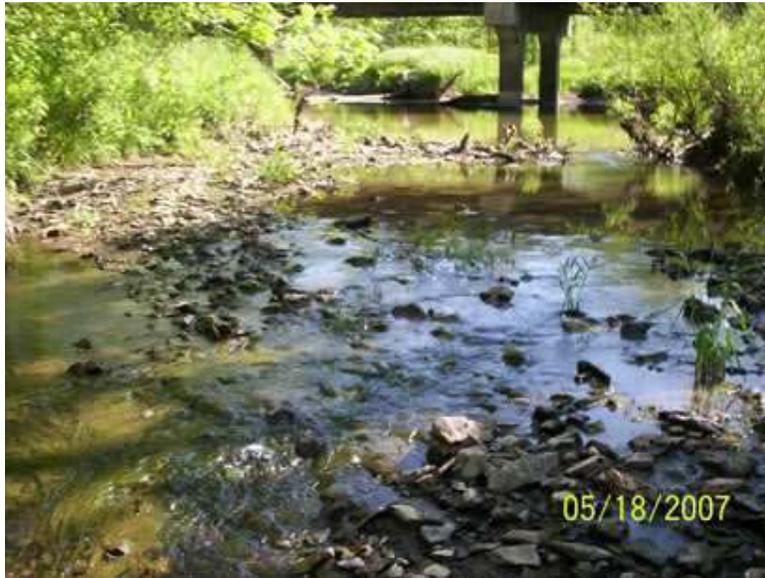
Site# 1 Photo ID# 99, Upstream

Upstream Photo 99 Downstream Photo 98

Depth
Transect 1	0.00
Substrate:	0.00
cobble	0.00
Water Clarity:	0.05
clear	0.05
Channel Feature:	0.10
riffle	0.10
Channel Width:	0.10
2 yards	0.05
0.05	0.05
Transect 2	0.10
Substrate:	0.00
cobble	0.05
Water Clarity:	0.10
clear	0.10
Channel Feature:	0.10
riffle	0.05
Channel Width:	0.05
4 yards	0.00
0.05	0.00
Transect 3	0.15
Substrate:	0.40
cobble/bedrock	0.40
Water Clarity:	0.40
clear	0.35
Channel Feature:	0.20
pool	0.15
Channel Width:	0.20
6 yards	0.50
0.38	0.45
Transect 4	0.00
Substrate:	0.10
cobble/bedrock	0.25
Water Clarity:	0.30
cloudy	0.35
Channel Feature:	0.35
pool	0.30
Channel Width:	0.20
6 yards	0.10
0.23	0.15

Site Median	Site Maximum
0.15	0.50

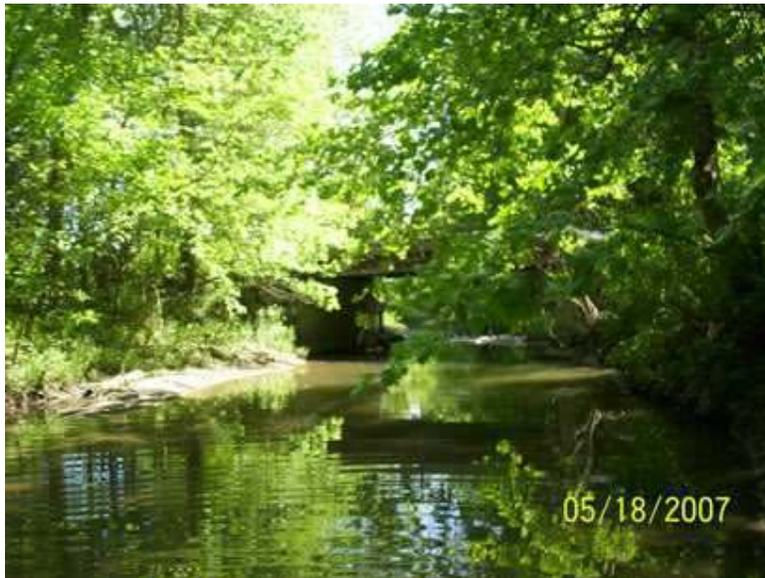
Site# 2 Photo ID# 101, Upstream

Upstream Photo 101 Downstream Photo 100

0.10	0.10	0.10	0.00	0.05	0.05
Transect 4	0.00	Transect 8	0.05	Site Median	Site Maximum
Substrate:	0.00	Substrate:	0.25	0.10	0.55
cobble	0.00	bedrock	0.20		
Water Clarity:	0.05	Water Clarity:	0.25		
clear	0.10	clear	0.20		
Channel Feature:	0.10	Channel Feature:	0.15		
riffle	0.05	pool	0.00		
Channel Width:	0.10	Channel Width:	0.00		
3 yards	0.10	8 yards	0.00

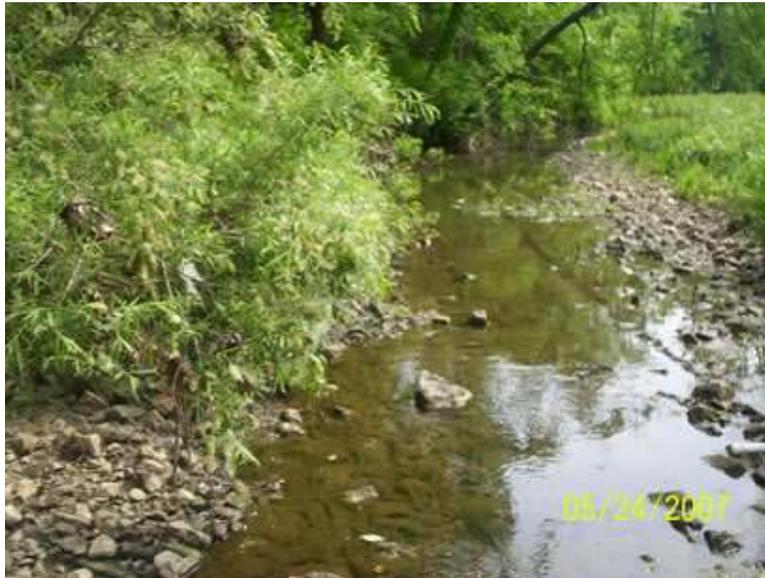
Site# 3 Photo ID# 49, Upstream

Upstream Photo 49 Downstream Photo 48

0.28	0.30	0.03	0.05	0.03	0.00
Transect 4	0.00	Transect 8	0.00	Site Median	Site Maximum
Substrate:	0.00	Substrate:	0.00	0.05	0.50
cobble/gravel	0.00	cobble/sand	0.00		
Water Clarity:	0.00	Water Clarity:	0.10		
clear	0.00	clear	0.05		
Channel Feature:	0.00	Channel Feature:	0.05		
riffle	0.05	pool	0.05		
Channel Width:	0.05	Channel Width:	0.05		
3 yards	0.05	7 yards	0.10

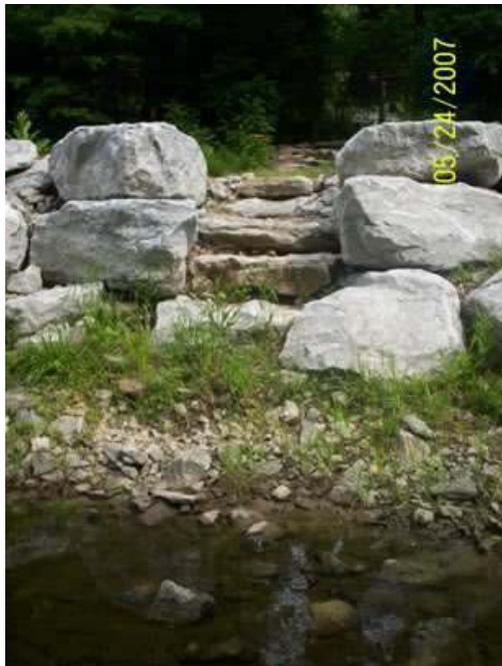
Site# 3 Photo ID# 50, Stairs/walkway

City/county parks	Playgrounds	MDC conservation lands	Urban areas
Campgrounds	Boating accesses	State parks	National Forests
Nature trails	Stairs/walkway Pic #50	No trespass sign	Fence
Steep slopes	None of the Above	Other: bench - Pic #51
