Use Attainability Analysis

WBID 1475 Brush Creek

Submitted by
SES Inc.

Missouri Department of Natural Resources
Water Protection Program

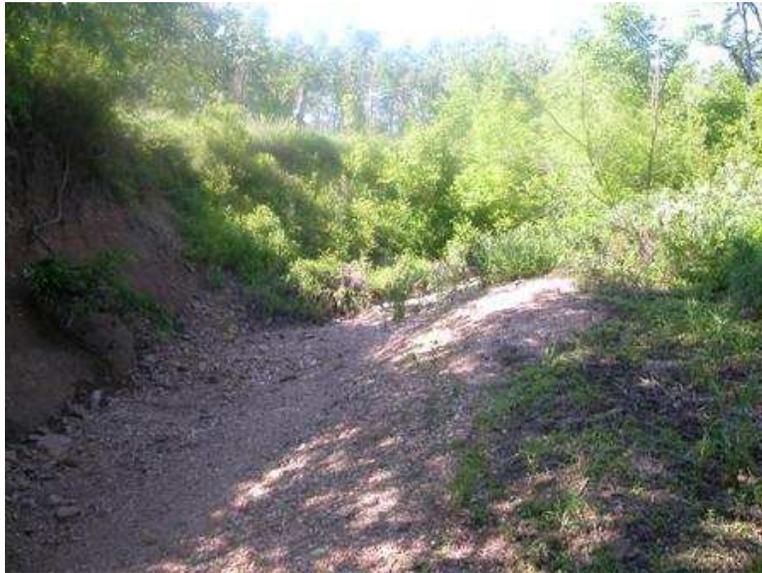
Site# 1 Photo ID# 60, Upstream

WBID # 1475 **Site #** 1
Mark # 30 **Dissolved Oxygen (ppm)** N/A
Upstream Views Physical Dimensions: Is there any water present at this view? no
 If so, is there an obvious current? no

Heavy vegetation in stream beds. Algae on rocks and in pools. No floating algae in pools. Vegetation along banks.
