Use Attainability Analysis

WBID 1784 Tributary to Bois Brule Ditch

Submitted by
Olsson Associates

On
October 14, 2008

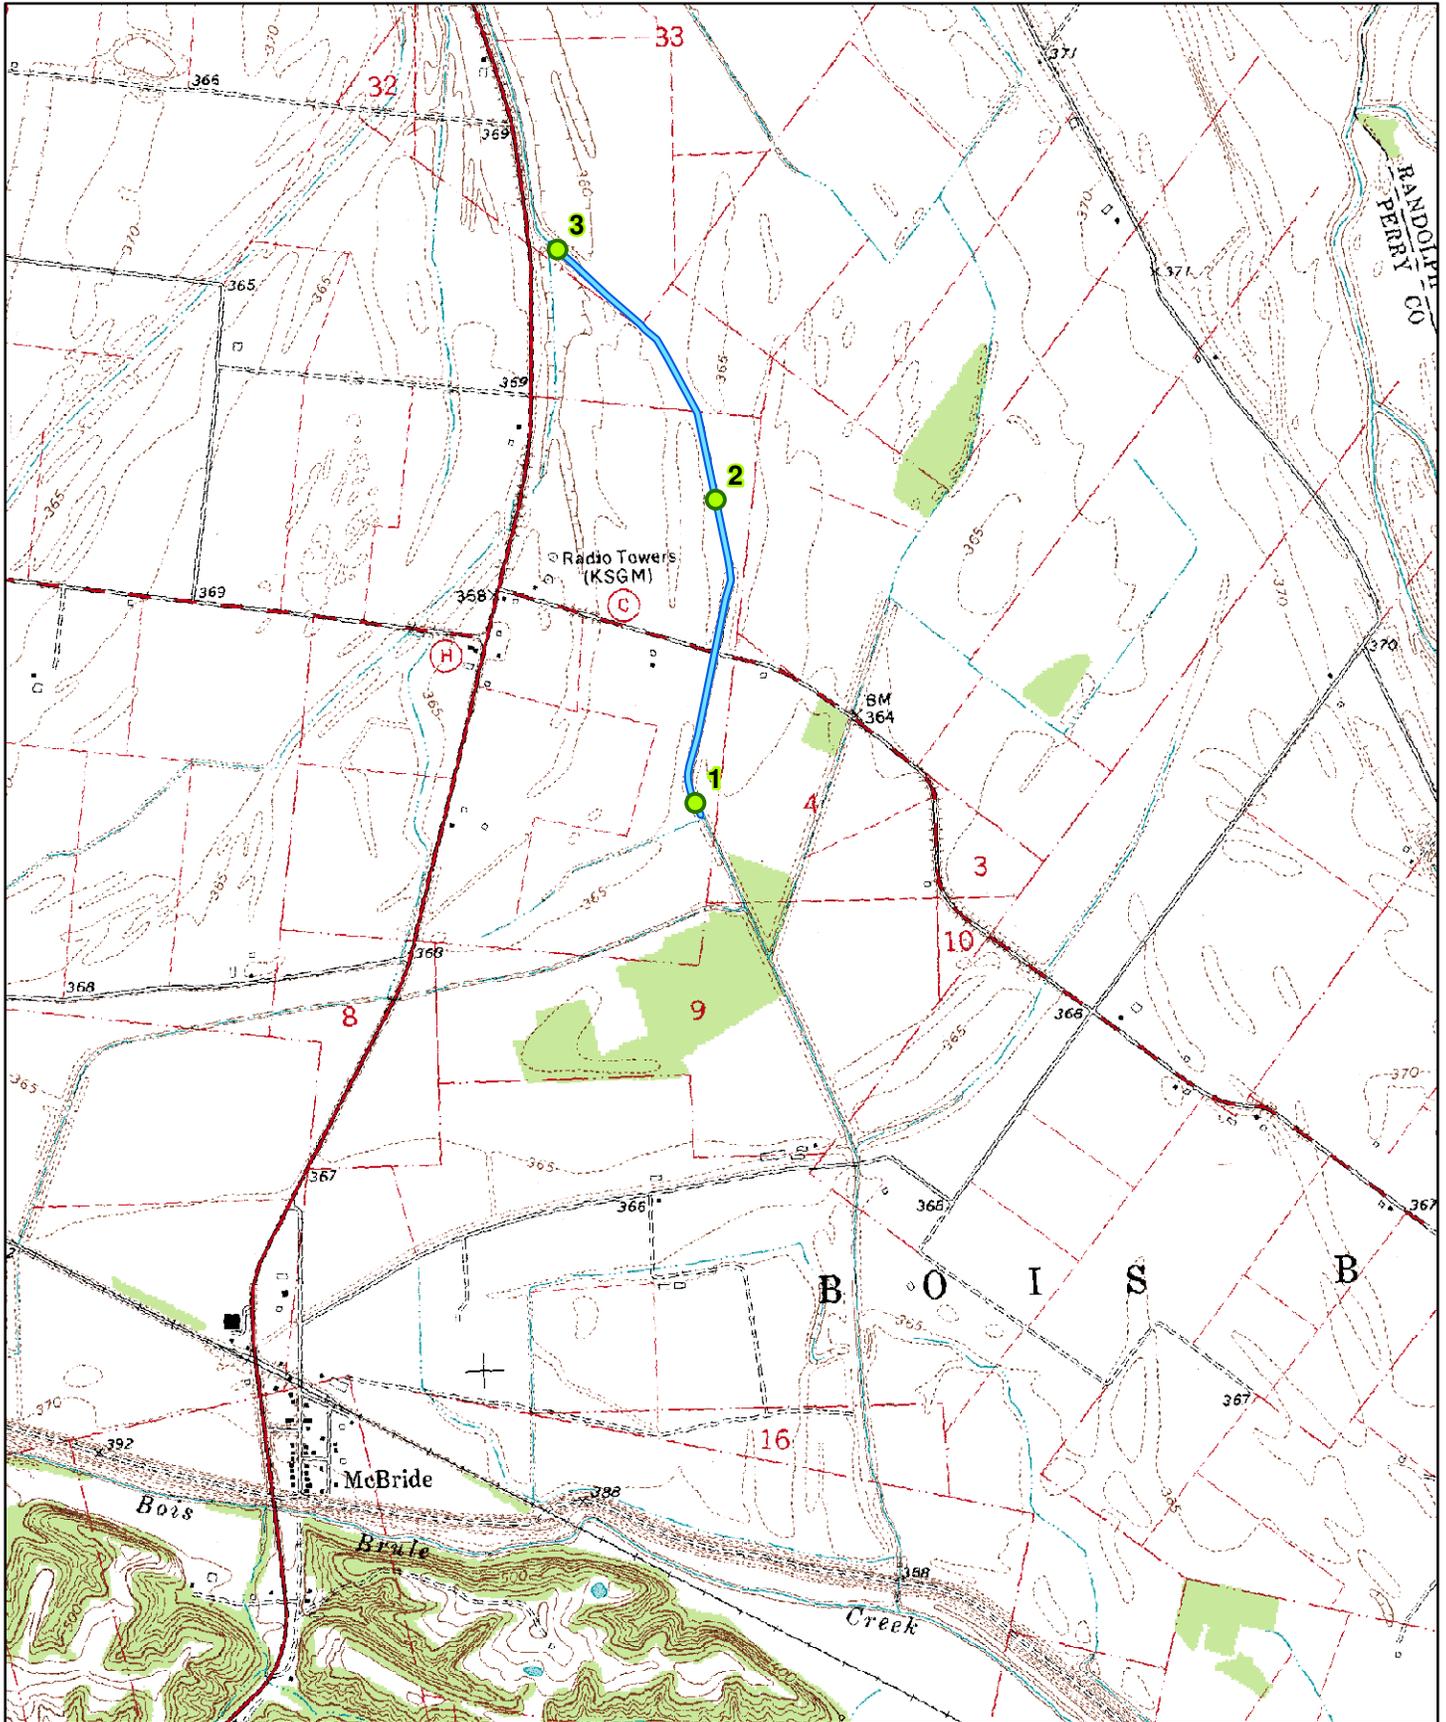
**MISSOURI RECREATIONAL
USE ATTAINABILITY ANALYSIS**

Stream: Trib. to Bois Brule Ditch
WBID:1784

Map Sheet:1/1
County: Perry

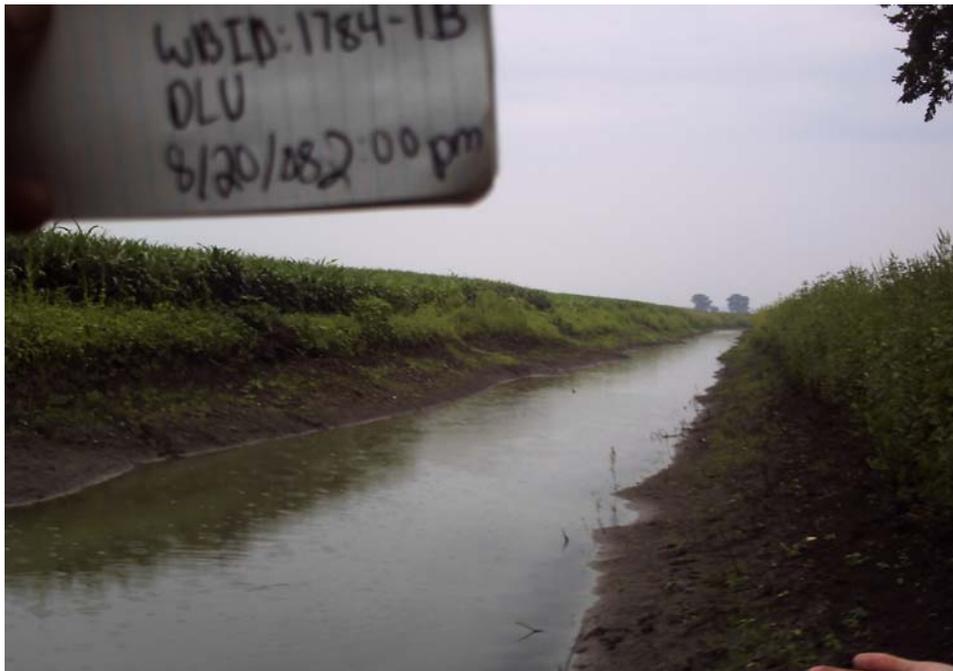
Photo ID#	Photo Purpose	Photo ID#	Photo Purpose	Photo ID#	Photo Purpose
1784-1-A	Upstream looking down	1784-1-B	Downstream looking up		
Photo ID#	Photo Purpose	Photo ID#	Photo Purpose	Photo ID#	Photo Purpose
Photo ID#	Photo Purpose	Photo ID#	Photo Purpose	Photo ID#	Photo Purpose

Water way is an irrigation ditch with deep (+1 foot) mud banks and bottom
Access only through farm fields.

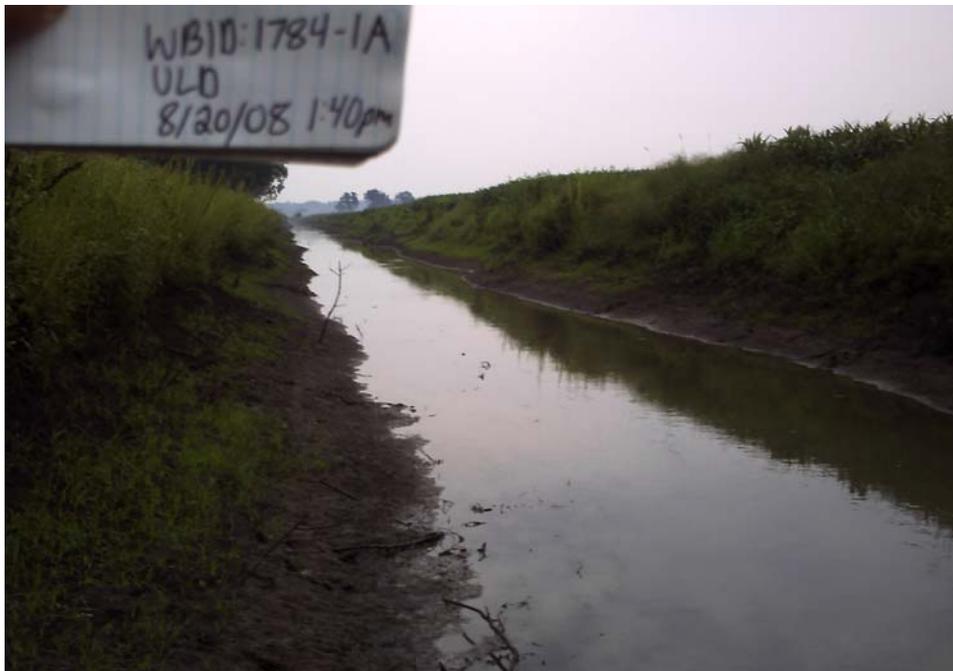
Photo ID#	Photo Purpose	Photo ID#	Photo Purpose	Photo ID#	Photo Purpose
1784-2-A	Upstream looking down	1784-2-B	Downstream looking up		
Photo ID#	Photo Purpose	Photo ID#	Photo Purpose	Photo ID#	Photo Purpose
Photo ID#	Photo Purpose	Photo ID#	Photo Purpose	Photo ID#	Photo Purpose

Waterway is an irrigation ditch with deep (+foot) mud banks and bottom.
 Access only through farm fields.

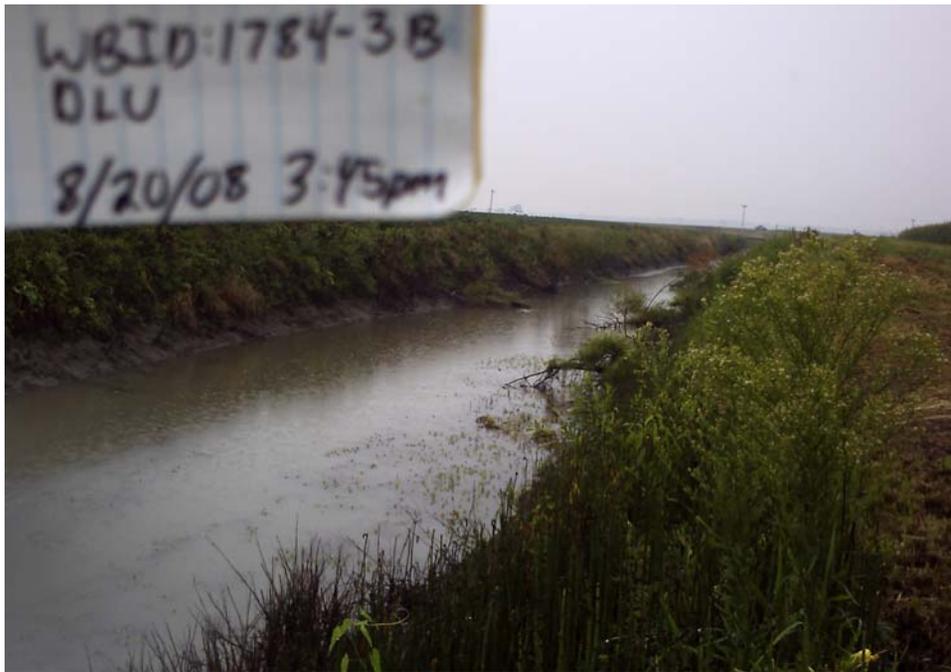
Photo ID#	Photo Purpose	Photo ID#	Photo Purpose	Photo ID#	Photo Purpose
1784-3-A	Upstream looking down/bridge	1784-3-B	Downstream looking up		
Photo ID#	Photo Purpose	Photo ID#	Photo Purpose	Photo ID#	Photo Purpose
Photo ID#	Photo Purpose	Photo ID#	Photo Purpose	Photo ID#	Photo Purpose

Waterway is an irrigation ditch with deep (+/-1 foot) mud banks and bottom.
Access by way of tractor road into field.
