Use Attainability Analysis
for
Waterbody Identification # 2618
Ditch # 2

Conducted by:
Environmental Resources Coalition

To:
Missouri Department of Natural Resources
Water Protection Program

Submitted: December 22, 2005

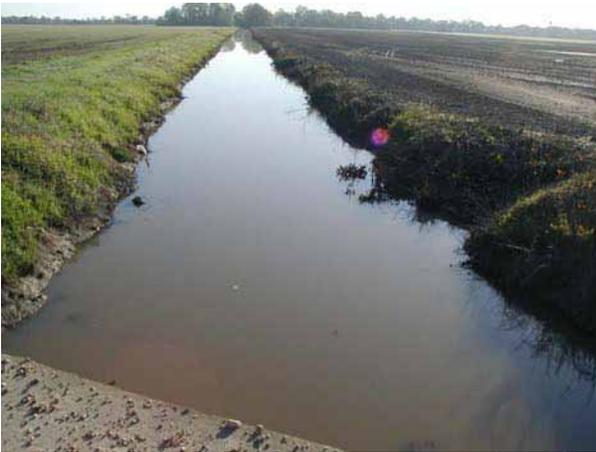
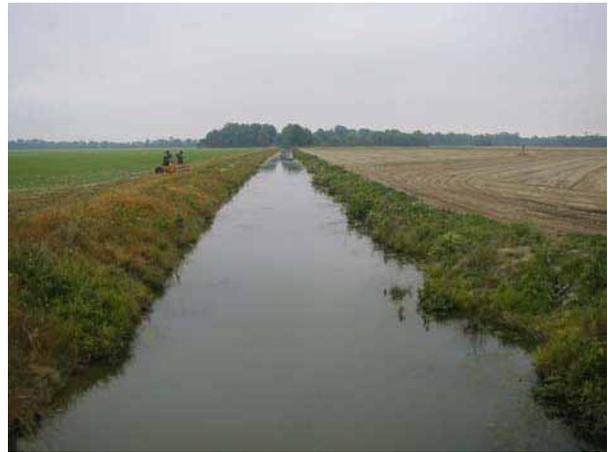
Upstream Views

Uses Observed	None	None
Evidence of Human Use (WBCR)	None	None
Aquatic Vegetation	Macrophytes - coontail (~20% coverage)	Floating mats of algae
<i>Water Characteristics</i>		
Odor	Sulfurous gas expelled from sediment	Sulfurous gas
Color	Turbid	Very turbid
Bottom Deposits	8 to 10 inches of fine sediment	Fine Sediment
Surface Deposits	None	Small amounts of foam

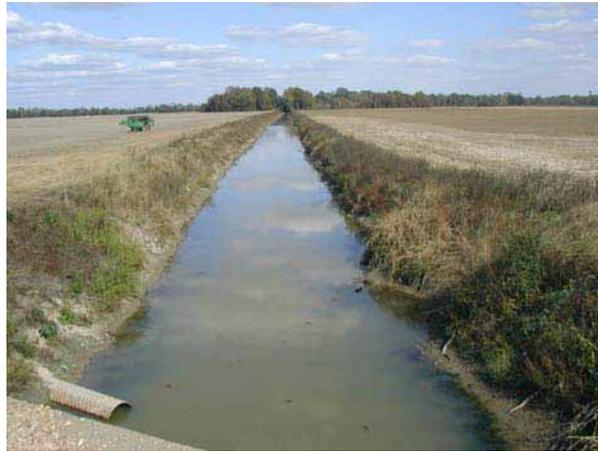
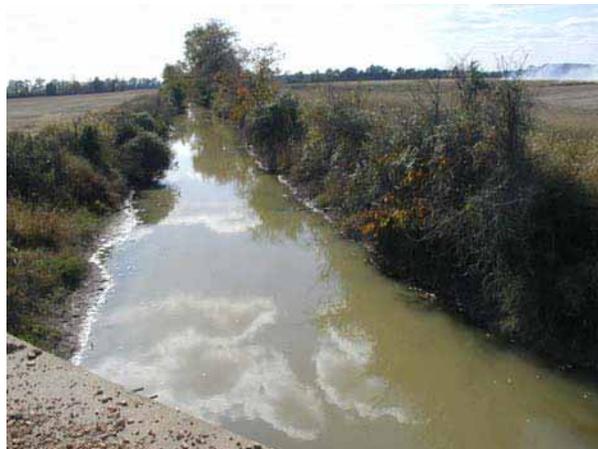
**Upstream View
10/26/05**

Odor	Sulfurous gas	Sulfurous gas
Color	Turbid	Turbid
Bottom Deposits	None	None
Surface Deposits	None	None

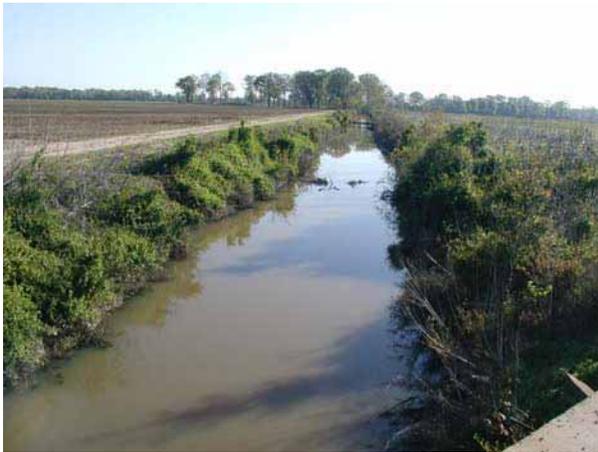
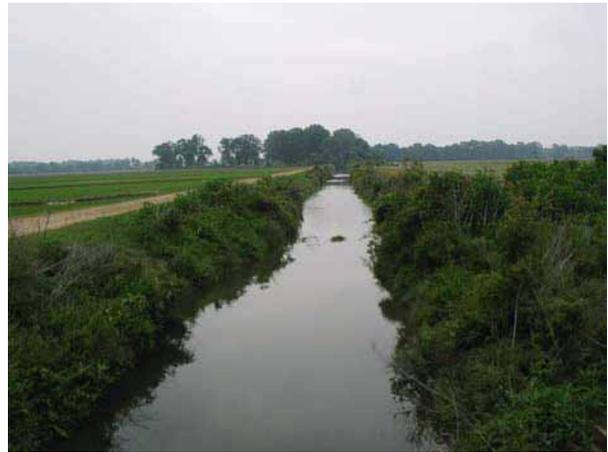
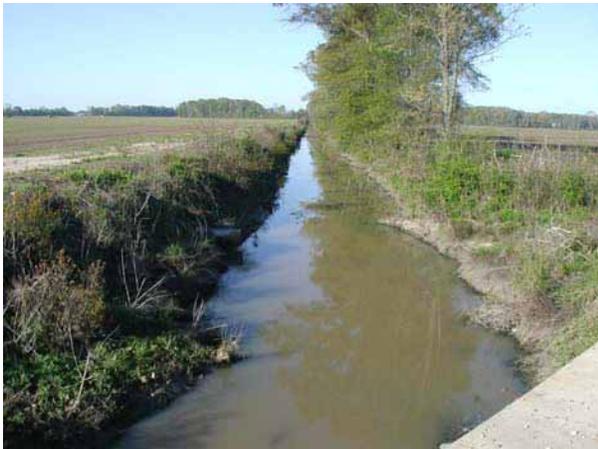
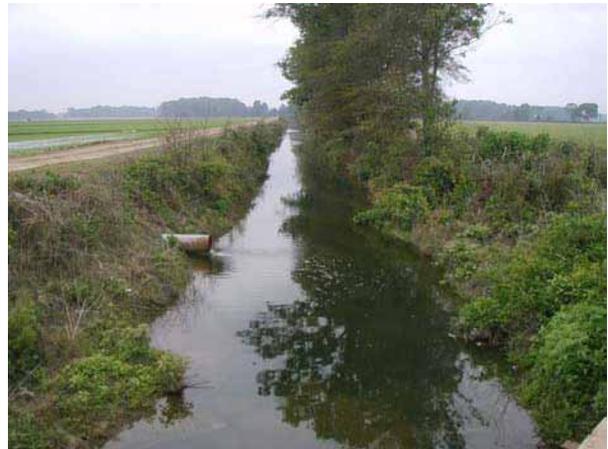
Upstream Views

Site #2: Site #2 of Ditch # 2 is located off County Road II-1. Farm fields entirely surround the area. The stream has steep banks that are brush covered making access to the stream difficult. The bed of the waterbody at this site contained a lot of trash including broken glass, tires, several appliances and some old fencing material.

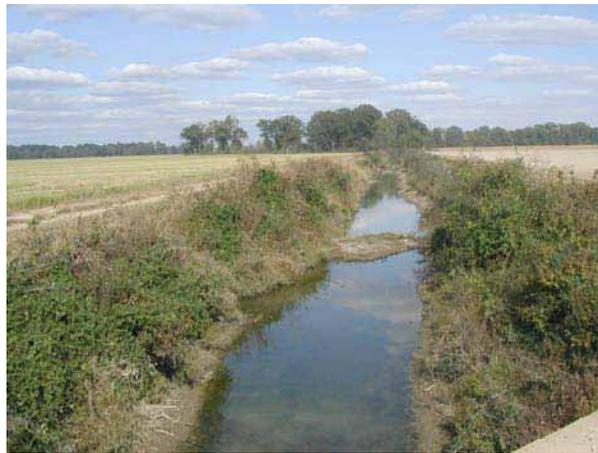
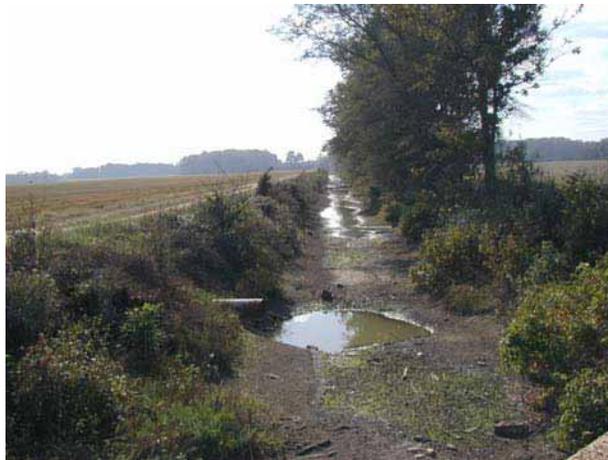
**Upstream View
10/26/05**

Uses Observed	None	None
Evidence of Human Use (WBCR)	None	None
Aquatic Vegetation	Bottom algae, < 5 % macrophyte coverage	None
<i>Water Characteristics</i>		
Odor	None	None
Color	Turbid	None
Bottom Deposits	None	None
Surface Deposits	None	None

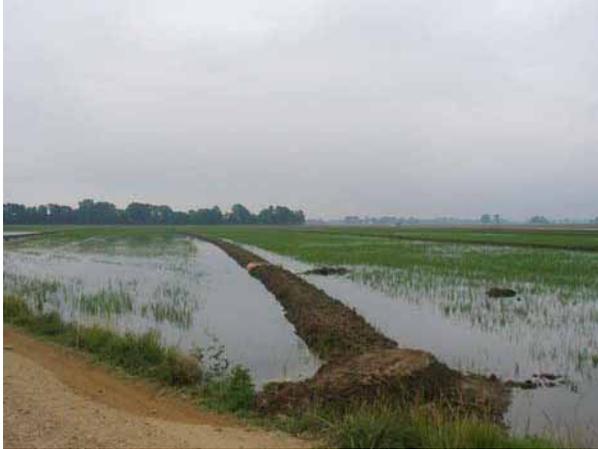
Irrigation of crops caused increased water level in Ditch # 2

Picture # 1 – rice field near Ditch # 2 –water runoff

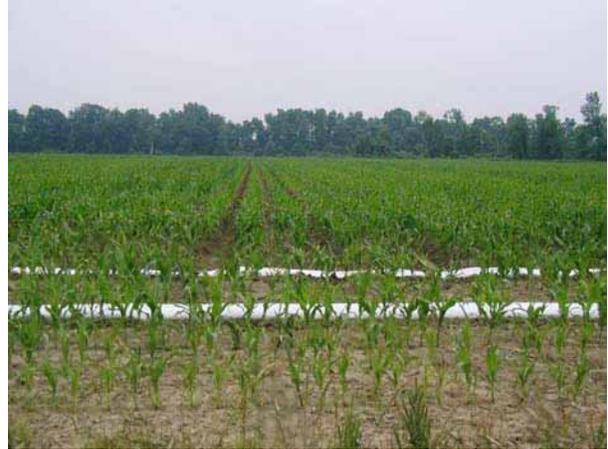
Picture # 2 – white irrigation tubes in field –watering corn

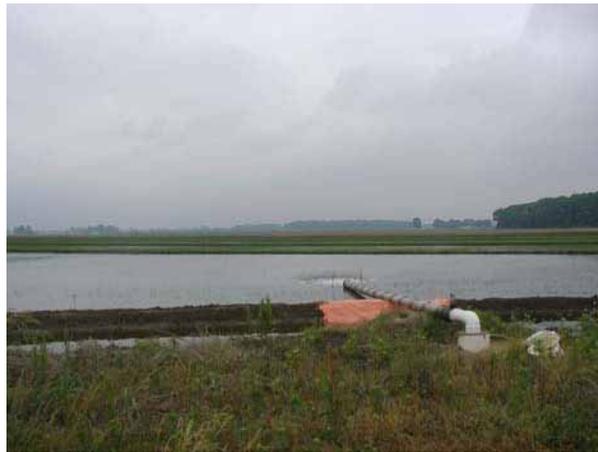
Picture # 3 – flooding of rice fields adjacent to Ditch # 2

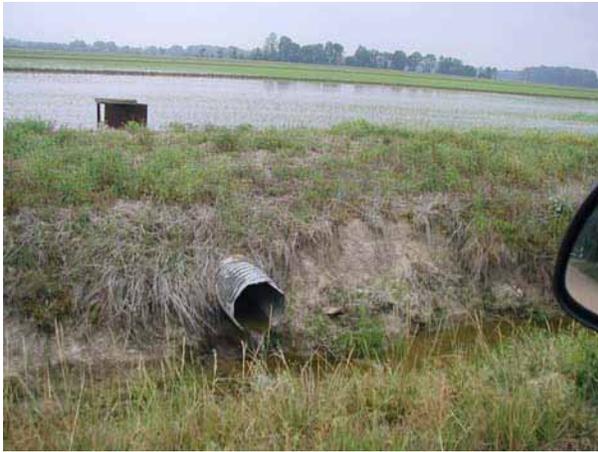
Irrigation of crops caused increased water level in Ditch # 2

Picture # 1 – overflow pipe from rice field to ditch that runs into Ditch # 2

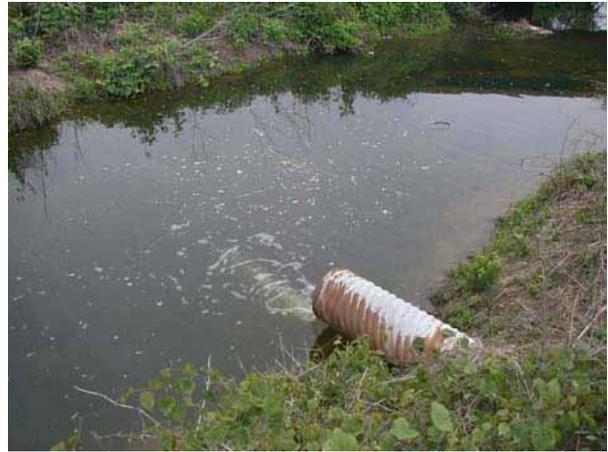
Picture # 2 – drainage pipe emptying into Ditch # 2

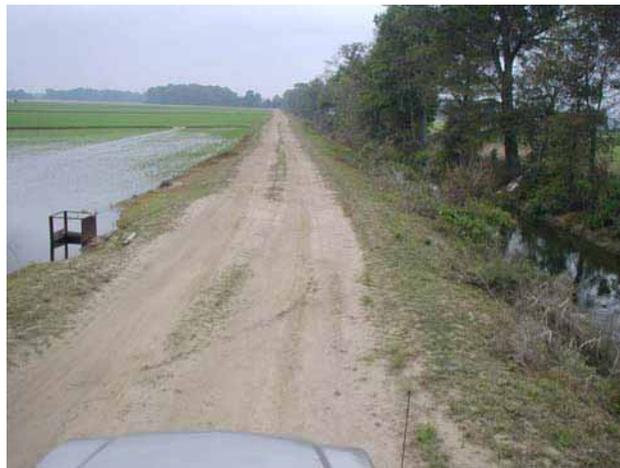
Picture # 3 –example of drainage pipe and Ditch # 2 in same picture

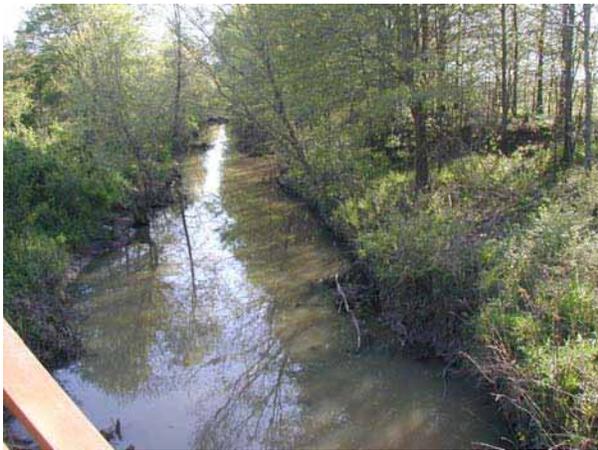
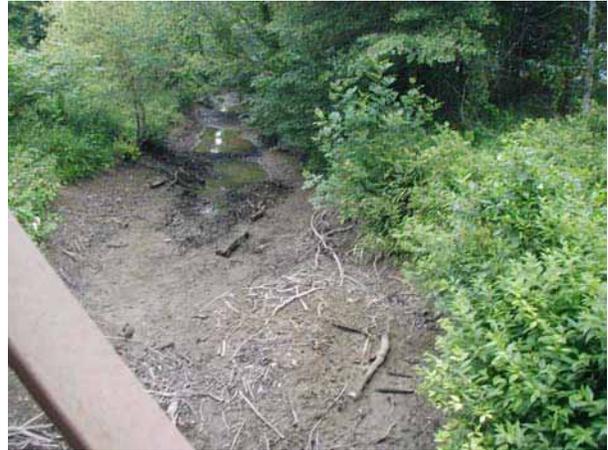
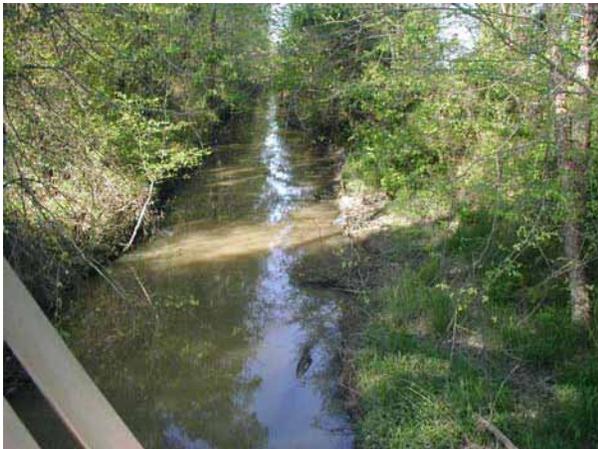
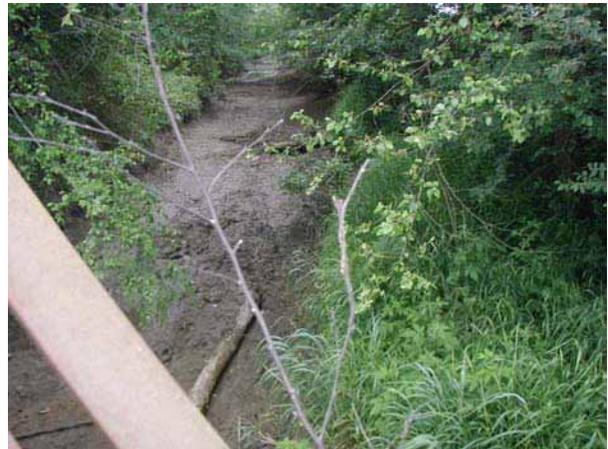
Upstream Views

06/02/05 –no water in ditch (except for puddles) – several debris dams upstream

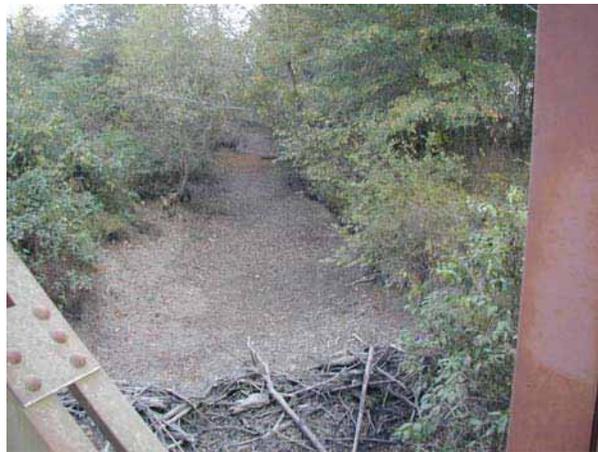
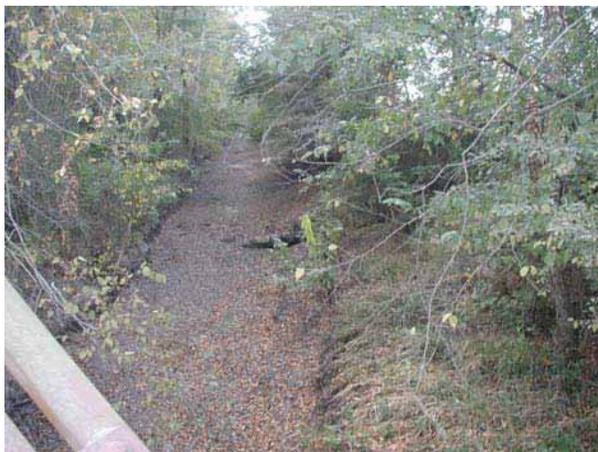
**Upstream View
10/26/05**

10/26/05	10/26/05
Assessment Location	Upstream	Downstream
Time	2:45 PM	2:45 PM
Stream Type	Run	Run
Width (m)	Dry	Dry
Length (m)	60.96	60.96
Avg. Depth (cm)	Dry	Dry
Maximum Depth (cm)*	Dry	Dry
Flow Present	No	No
Flow (cfs)	-	-

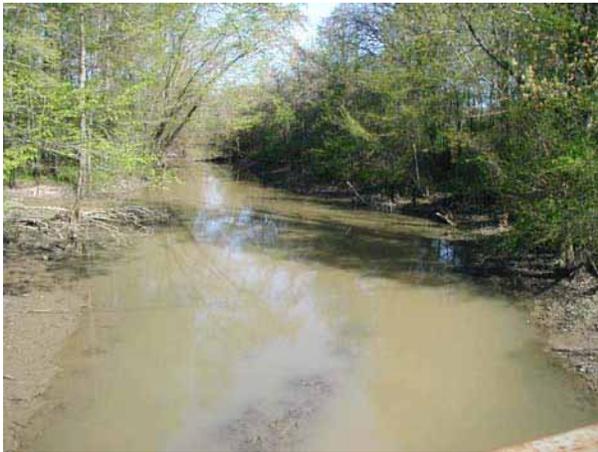
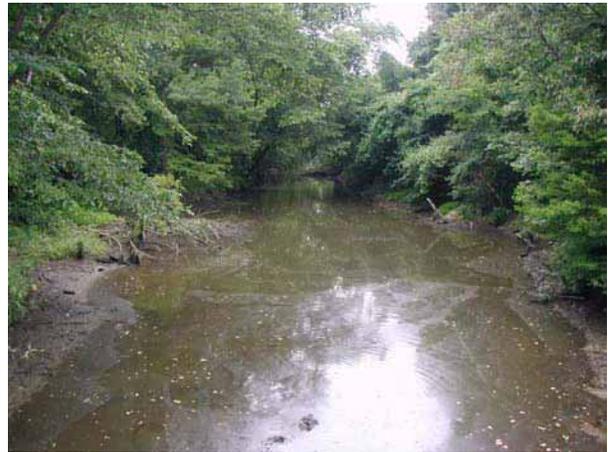
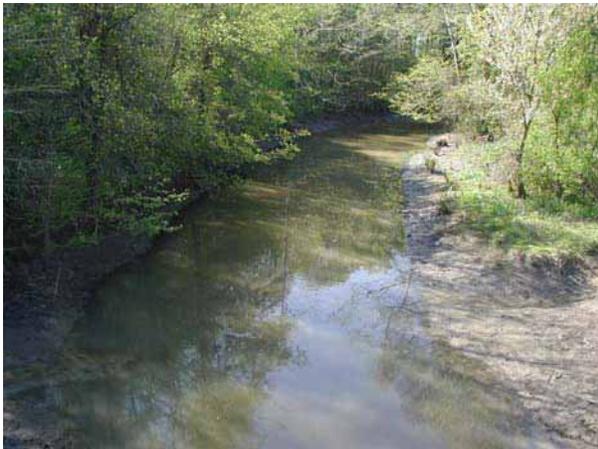
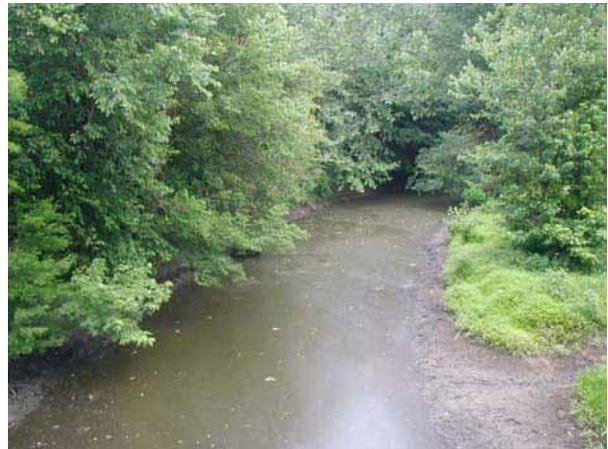
Upstream Views

Uses Observed	None	None
Evidence of Human Use (WBCR)	None	None
Aquatic Vegetation	None	None
<i>Water Characteristics</i>		
Odor	None	None
Color	Turbid	Very turbid
Bottom Deposits	Deep fine sediment	None
Surface Deposits	None	Thick oily film

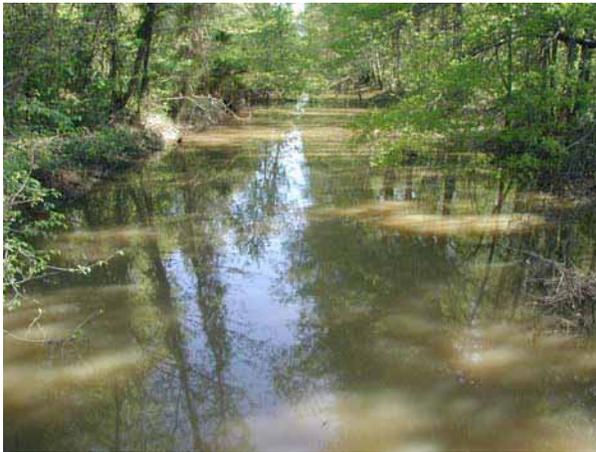
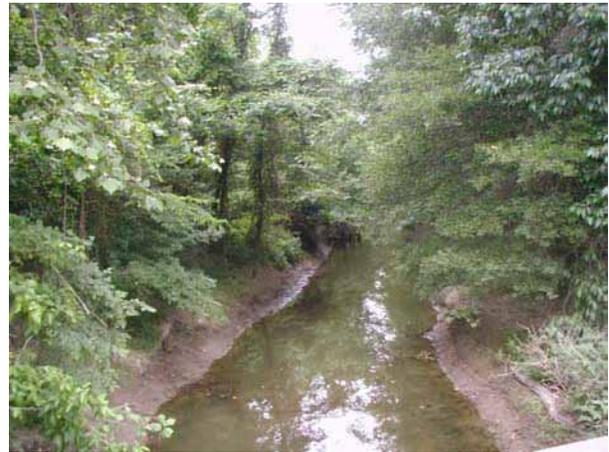
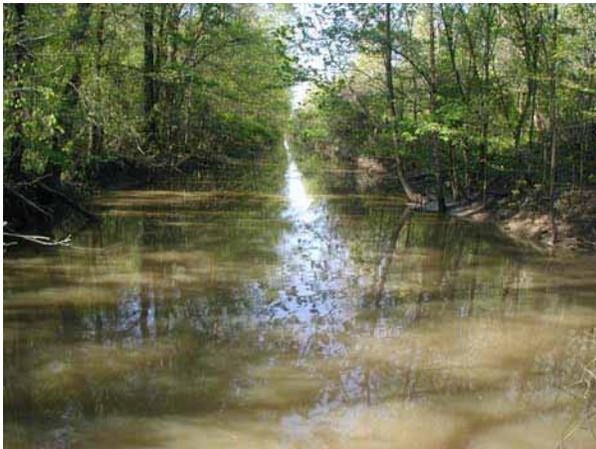
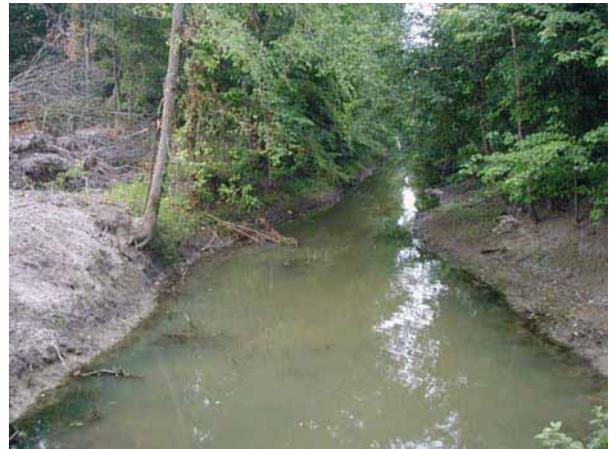
Upstream Views

06/02/05 – water significantly lower than previous visit, some trees have been cleared out on downstream side of stream since previous visit

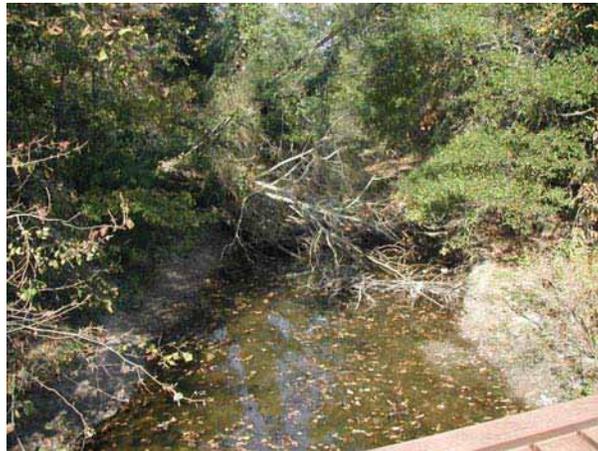
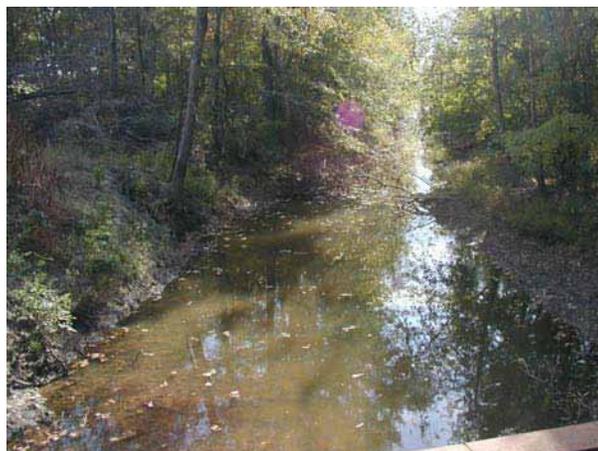
**Upstream View
10/26/05**

Uses Observed	None	None
Evidence of Human Use (WBCR)	None	None
Aquatic Vegetation	Some benthic algal growth	Some benthic algal growth
Water Characteristics		
Odor	Sulfurous gas expelled from sediment	Sulfurous gas expelled from sediment
Color	Turbid/clear	Turbid/clear
Bottom Deposits	None	None
Surface Deposits	None	None
