Use Attainability Analysis
for
Water Body Identification # 3113
Lateral Ditch #2

Conducted by:
Environmental Resources Coalition

Stream Description - WB ID: 3113 – Lateral Ditch #2

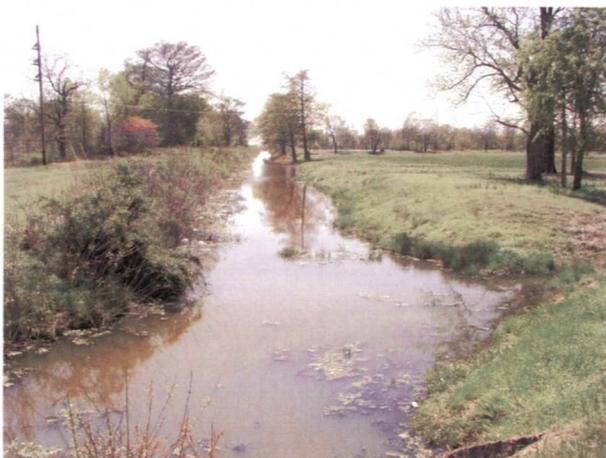
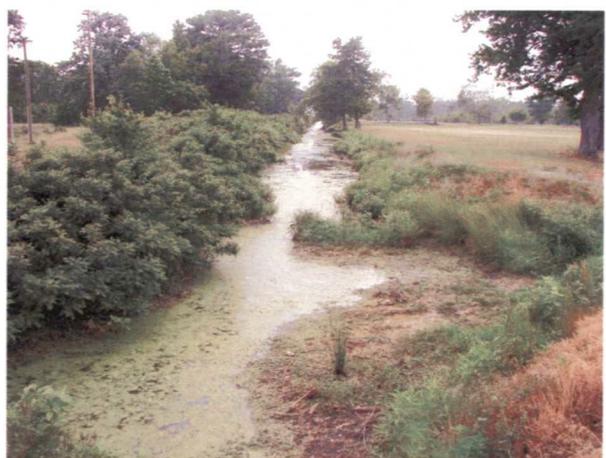
Downstream Views

04/15/05	06/02/05
Assessment Location	Downstream	Downstream
Time	11:55AM	2:21PM
Stream Type	Run	Run
Width (m)	7.47	3.05
Length (m)	91.44	91.44
Ave Depth (cm)	32.36	9.55
Maximum Depth (cm)*	48.5	16.0
Flow Present	No	No
Flow (cfs)	-	-

Uses Observed	None	None
Evidence of Human Use (WBCR)	None	None
Aquatic Vegetation	30-40% cover (coontail) Duckweed (wolfia sp.)	95% cover Duckweed
<i>Water Characteristics</i>		
Odor	None	None
Color	Clear	Green (top cover)
Bottom Deposits	None	None
Surface Deposits	None	None

Site #1: Site #1 of Lateral Ditch #2 is located on Highway J in the city limits of Malden, and is the uppermost site of the reach. The banks were mowed due to city or nearby residence. This site is upstream of the Waste Water Treatment Facility (WWTF).

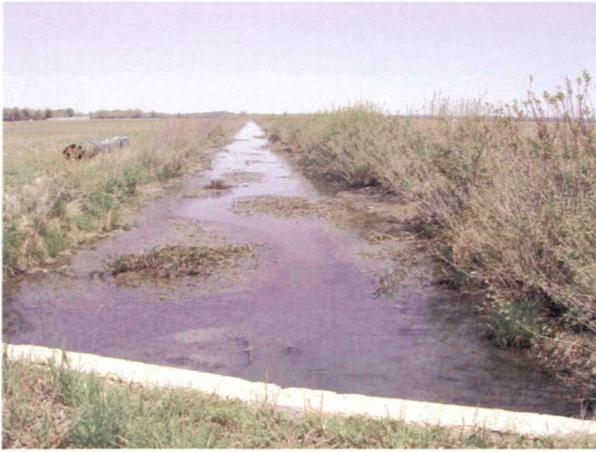
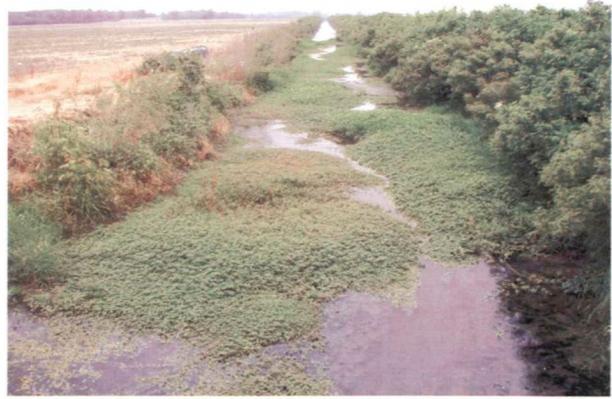
Upstream Views

04/15/05	06/02/05
Assessment Location	Downstream	Downstream
Time	12:15PM	2:31PM
Stream Type	Run	Run
Width (m)	5.79	4.27
Length (m)	91.44	91.44
Ave Depth (cm)	17.95	16.27
Maximum Depth (cm)*	38.0	35.0
Flow Present	No	No
Flow (cfs)	-	-

Uses Observed	None	None
Evidence of Human Use (WBCR)	None	None
Aquatic Vegetation	80% cover sub- and emergent, large mats of floating algae	60% cover sub- and emergent plants
<i>Water Characteristics</i>		
Odor	Strong sulfur smell	Sewage/trash
Color	Clear	Clear/murky
Bottom Deposits	Soft fluffy sediment/sludge	Spongy sediment
Surface Deposits	None	None

Site #2: Site #2 of Lateral Ditch #2 is located on County Road 239 and is surrounded by farm fields. There were numerous bags of trash on the banks as well as in the water body. When conducting the cross-section, the assessor sank approximately 2-2.5 feet due to soft bottom deposits, causing anoxic gases to emerge. After the assessor crossed the water body, the water appeared black due to resuspended bed material.

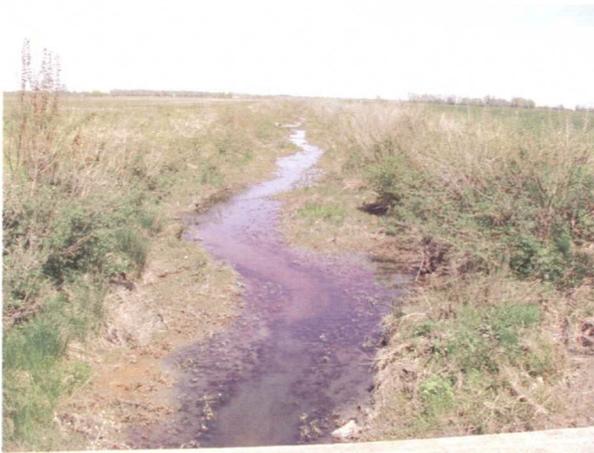
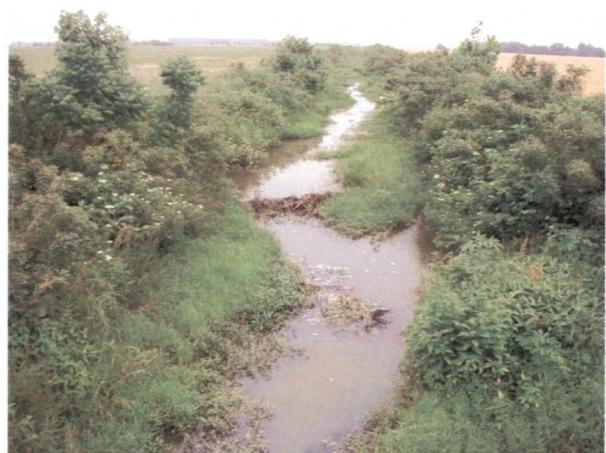
Upstream Views

04/15/05	06/02/05
Assessment Location	Upstream	Upstream
Time	1:00 PM	3:05 PM
Stream Type	Run	Run
Width (m)	3.05	3.66
Length (m)	182.88	182.88
Ave Depth (cm)	21.67	21.31
Maximum Depth (cm)*	43.0	38.0
Flow Present	No	No
Flow (cfs)	-	-

Uses Observed	None	None
Evidence of Human Use (WBCR)	None	None
Aquatic Vegetation	40-60% emergent plants	50% emergent plants
<i>Water Characteristics</i>		
Odor	None	None
Color	Murky	Turbid
Bottom Deposits	None	None
Surface Deposits	None	Foam

Site #3: Site #3 of Lateral Ditch #2 is located off Country Road 239, at which point it empties into Main Ditch. The banks of the stream are moderately steep, 6 to 8 feet and vegetated. There were several bags of trash at the site. Local residents frequent the site to shoot guns, which was evident in the numerous shotgun shells present. During the April 15th visit, a path from Lateral Ditch #2 to Main Ditch was visible, but was overgrown with plant growth by the second visit.
