Use Attainability Analysis

WBID 3190 Opossum Creek

Submitted by
SES Inc.

Missouri Department of Natural Resources
Water Protection Program

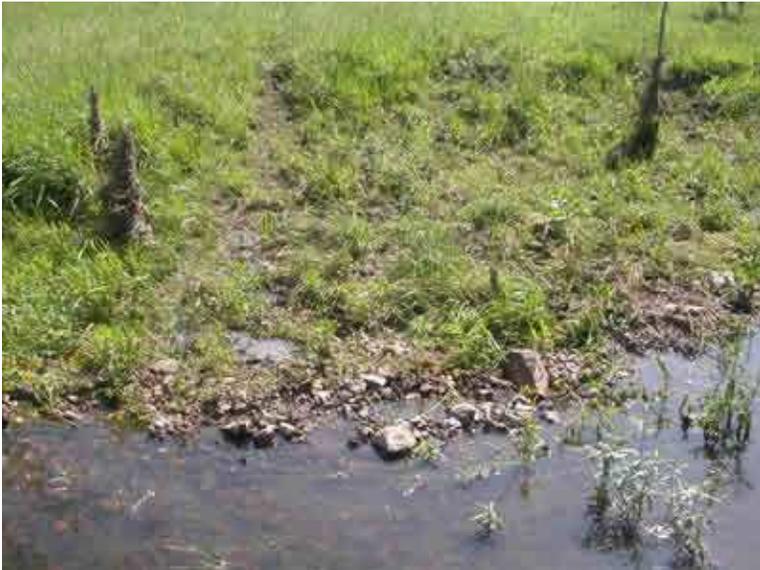
Roads	Rope swings	Foot paths/prints	Dock/platform
Livestock Watering Pic #16	RV/ATV Tracks	Camping Sites	Fire pit/ring
NPDES Discharge	Fishing Tackle	Other:

Site# 1 Photo ID# 16, Livestock watering

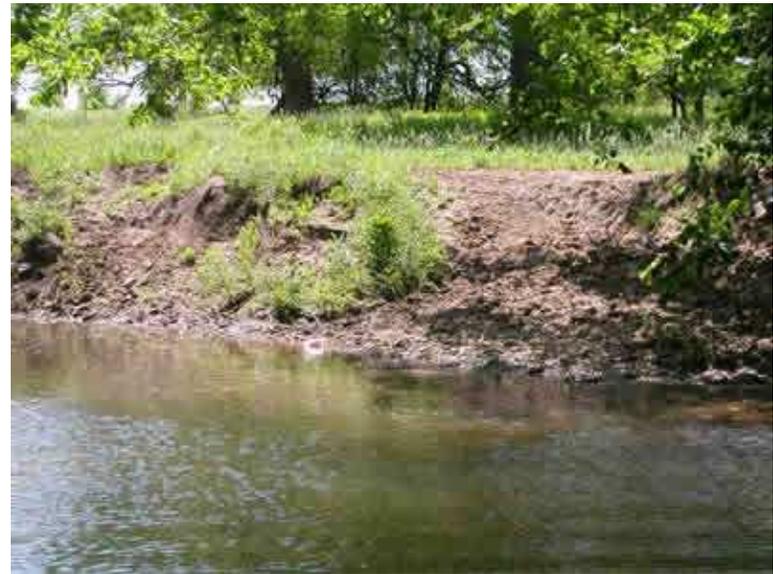
Roads	Rope swings	Foot paths/prints	Dock/platform
Livestock Watering Pic #22	RV/ATV Tracks	Camping Sites	Fire pit/ring
NPDES Discharge	Fishing Tackle	Other:

Site# 3 Photo ID# 22, Livestock watering

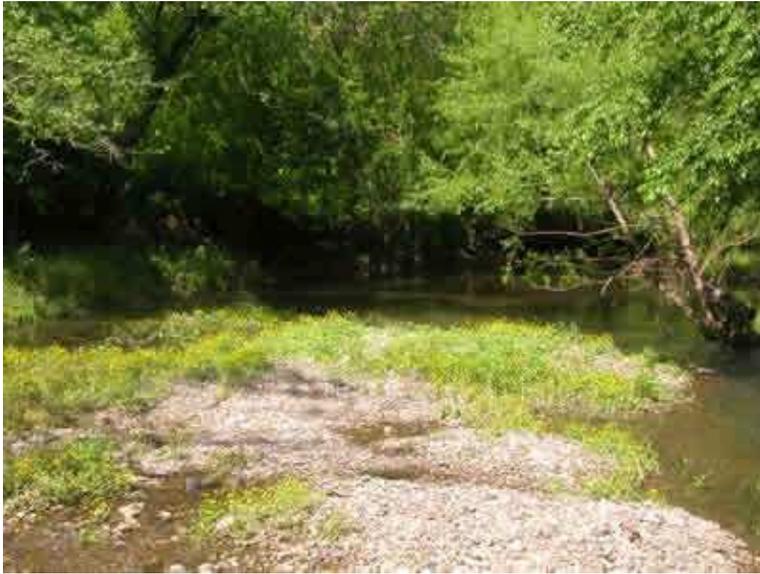
Roads	Rope swings	Foot paths/prints	Dock/platform
Livestock Watering Pic #17	RV/ATV Tracks	Camping Sites	Fire pit/ring
NPDES Discharge	Fishing Tackle	Other:

Site# 2 Photo ID# 17, Livestock watering
