*Pilot Study of the VOC Eater
Technology*

ABS – VOCEATER™
PILOT STUDY REPORT

Prepared by Nic Korte

December, 2011

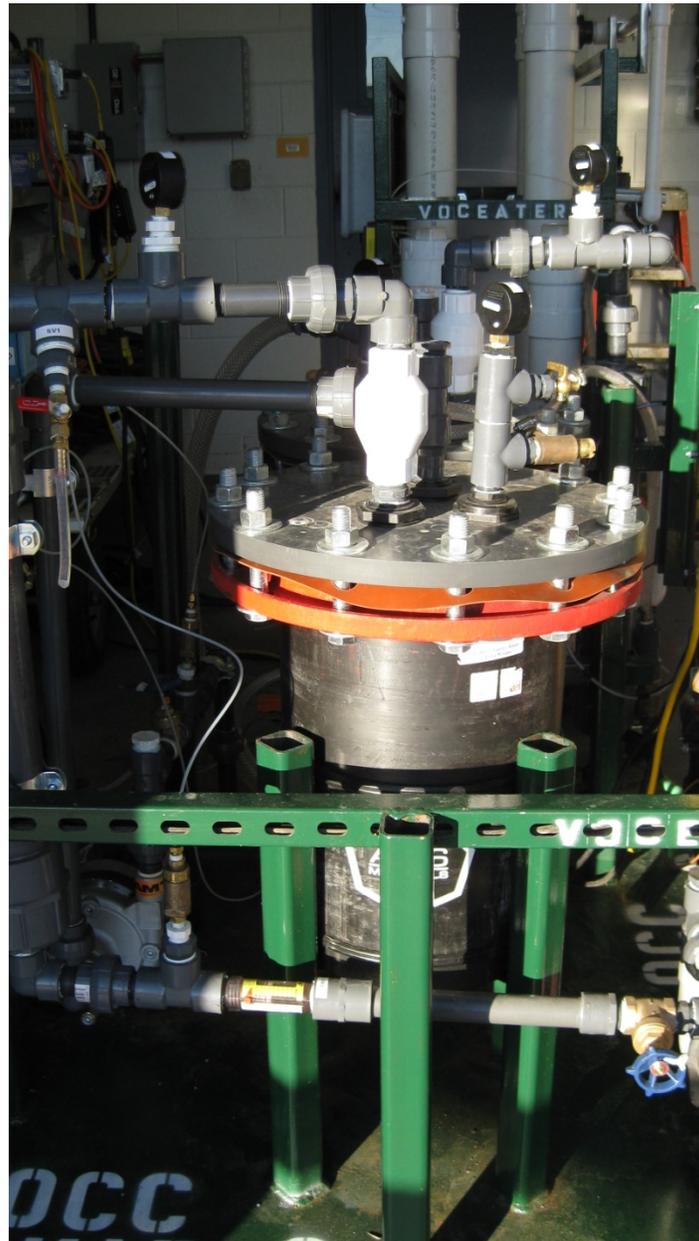
The unit consisted of two sections. The first portion employed two large columns and was called the OCC unit (Figure 1). Within this unit were 3 kg of Pd-Osorb at 35-60 mesh. This small mesh

Figure 1. Initial, larger, educator-containing tanks employed for ~75% chlorinated contaminant removal.

(high surface area) material was retained within conical screen (100-mesh) filters. Within the tanks were two eductors used to circulate the solution. (Eductors use a Venturi design that enables small pumps to circulate large volumes of liquid in order to provide efficient agitation

/mixing. Eductors are typically capable of circulating four to five gallons of solution for each gallon pumped.) In this application, the eductors mix Osorb with the incoming water. These two larger tanks which comprise the OCC were expected to remove 75-80% of the contaminants.

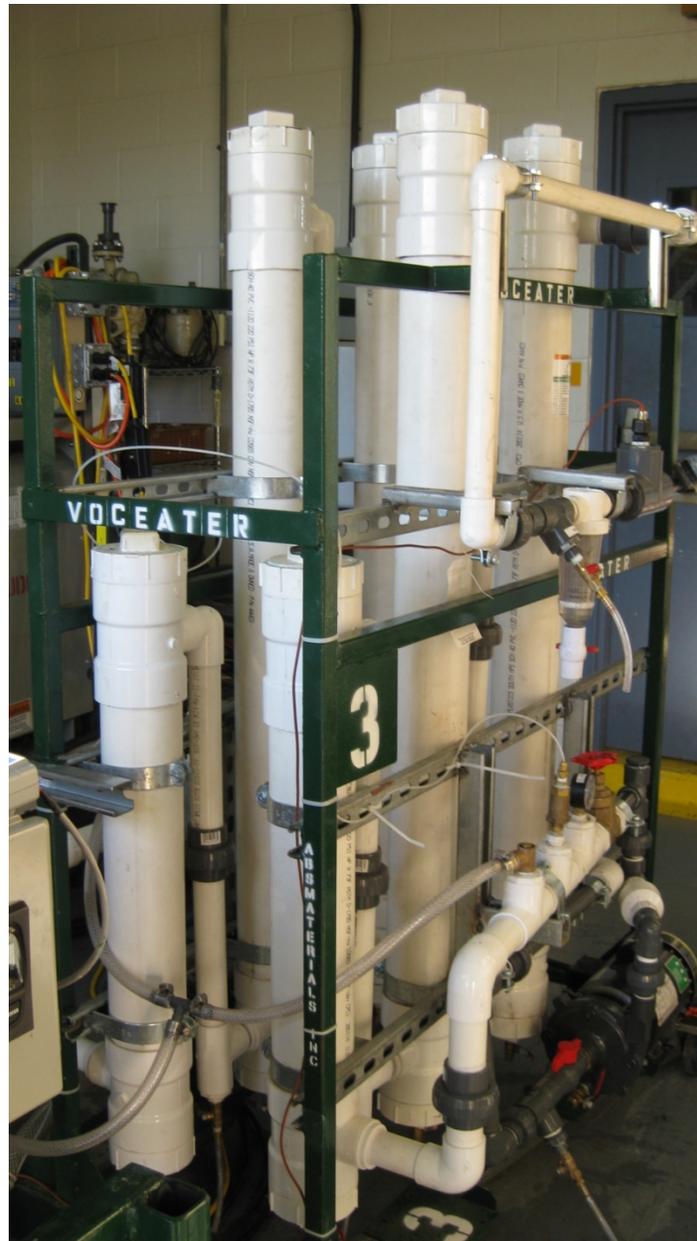
The second part of the pilot unit, known as the VOCEater™, was expected to remove the remainder of the chlorinated contaminants. The VOCEater™ consisted of four packed columns containing 18kg of 5-20 mesh Osorb (Figure 2). It was noted that the media within

Figure 2. Fixed bed columns of 5-20 mesh Osorb.

these tanks could be stirred with a rod held with two fingers. Hence, the media is apparently more slurry-like than like a packed column.

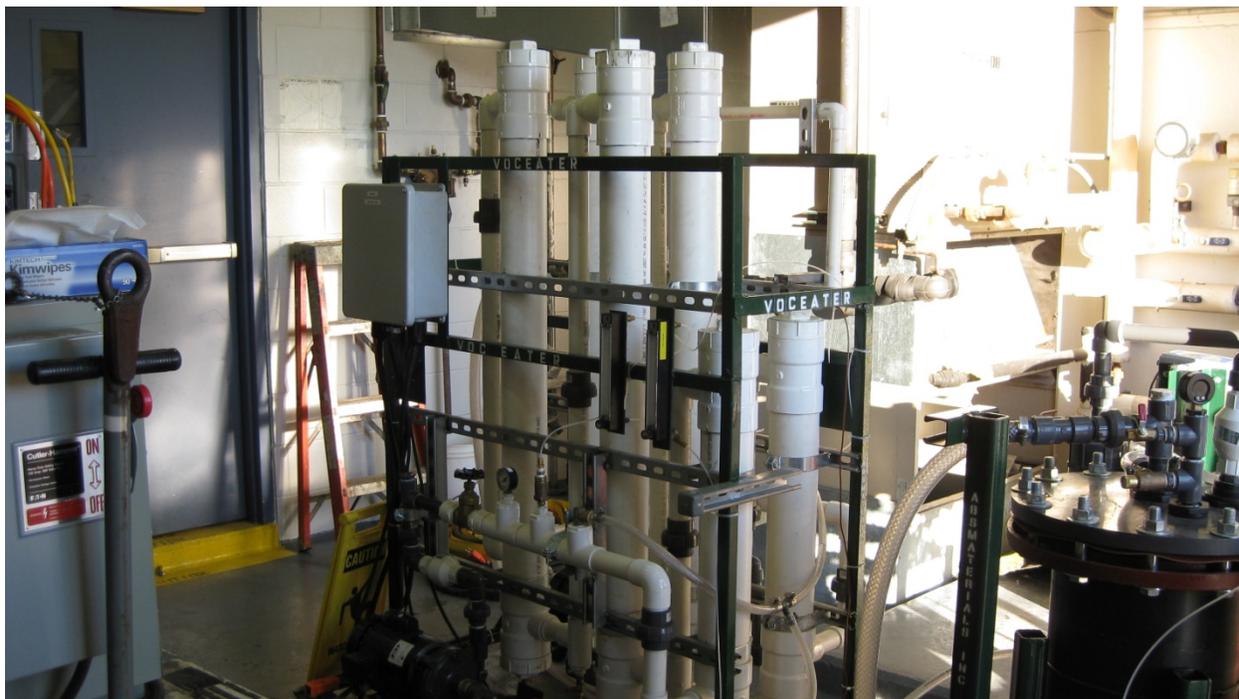
The OCC and VOCEater™ components were hooked in series as shown in Figure 3.

Figure 3. OCC unit on far right, VOCEater™ in center, hooked in series, comprised the Pilot Unit tested at the KCP.

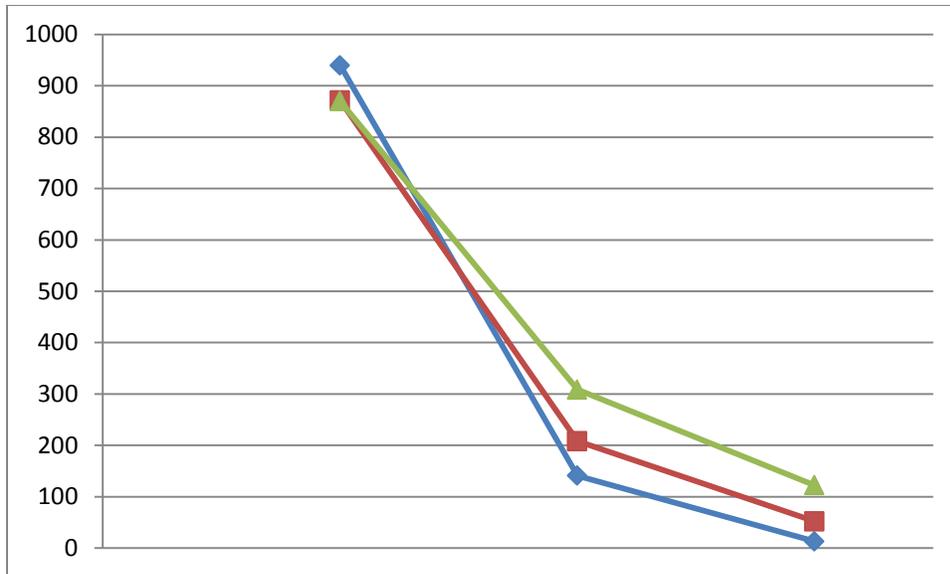
Figure 4. Treatment efficiency for the first three samples collected during the pilot study. (Water was acidified. Y-axis shows µg/L of chlorinated solvents. Each line shows concentration in the influent [first point], post-OCC (middle point) and post-treatment [last point]. Blue line shows sample at 1 hour, red line at three hours and green line at 6.25 hours.)

Unfortunately, treatment efficiency began to decrease. The second sample had 94% treatment (~52 µg/L remaining) which reduced further to 86% (122 µg/L remaining) by the end of the day on Oct 12 (Figure 4). No samples were sent to the laboratory on Oct 13 as the unit was inspected and re-tightened for leaks.

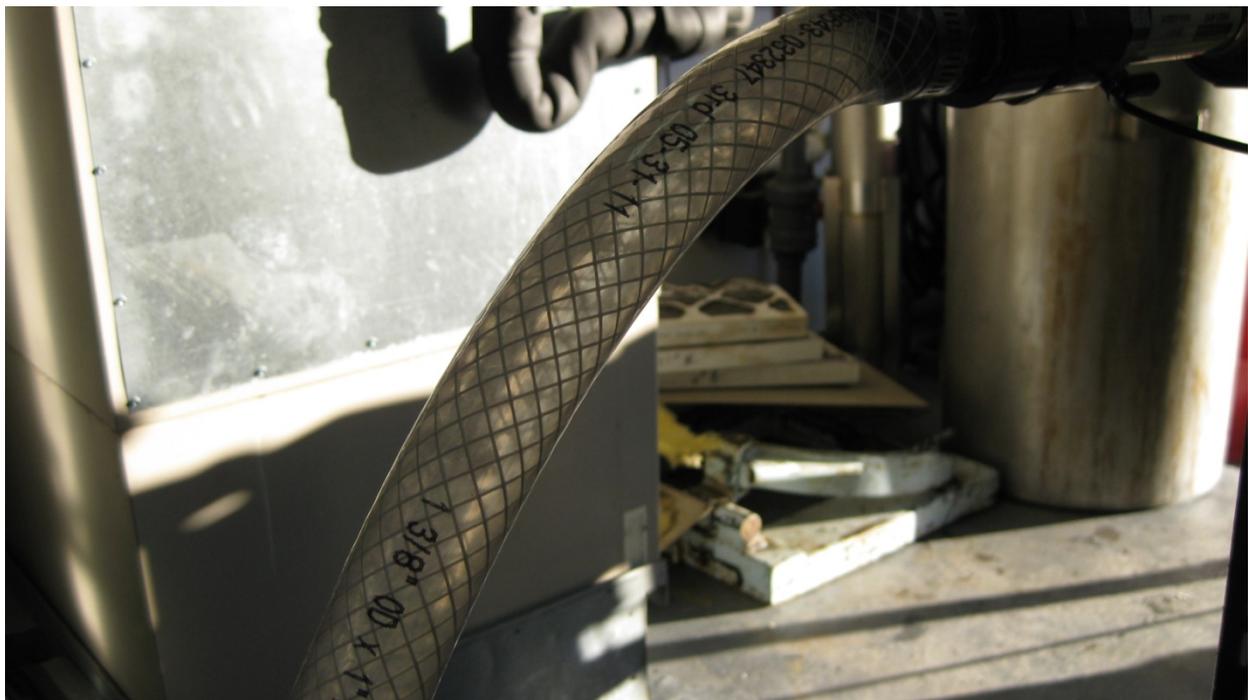
It was noted, however, that a large amount of bubbles were in the effluent line (Figure 5). The

Figure 5. There were a large amount of bubbles in the effluent line.

ABS technician on-site was unable to explain the origin of the bubbles. The hydrogen was shut off briefly to determine whether the amount of de-gassing varied but over the few minutes of this test; there was little evident change.

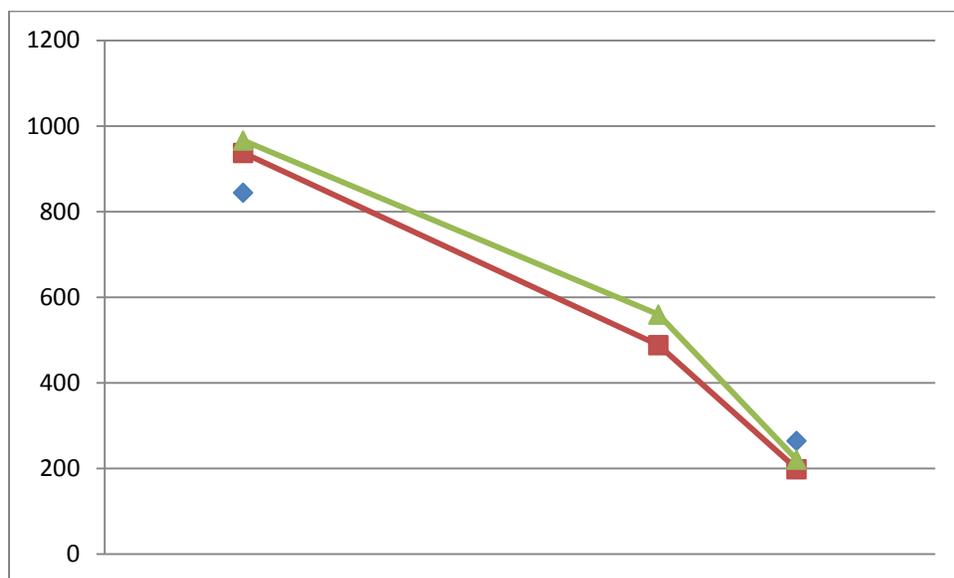
Because of the unexplained bubbles and the decrease in treatment efficiency, unacidified water was supplied on October 14. A single sample was collected. Although there were no longer bubbles in the treatment lines, overall treatment efficiency was only 69% (~264 $\mu\text{g/L}$ remaining) (Figure 6).

Figure 6. Treatment efficiency with unacidified water. (Y-axis shows $\mu\text{g/L}$ of chlorinated solvents. Blue points show samples (no post-OCC sample was collected) from October 14, red line from October 17 and green line from October 18.)

Unfortunately, treatment efficiency did not improve and remained <80% (198 and 200 $\mu\text{g/L}$ remaining) for two subsequent samples. It was at this time that the vendor informed KCP personnel that iron in the influent was now responsible for the decreased treatment. The vendor did not specify whether the iron poisoned the palladium catalyst or physically hindered treatment by precipitating within the columns. (In follow up conversations, the vendor noted that “the Pd-Osorb that had been affected by the process water was returned and rinsed with deionized water. Rinsing led to a return in catalytic performance in the laboratory as measured in a bench-top reactor vessel. It is likely adsorbed iron blinded the glass. Currently, an effort is being made to determine what form of iron leads to this blinding effect.”)

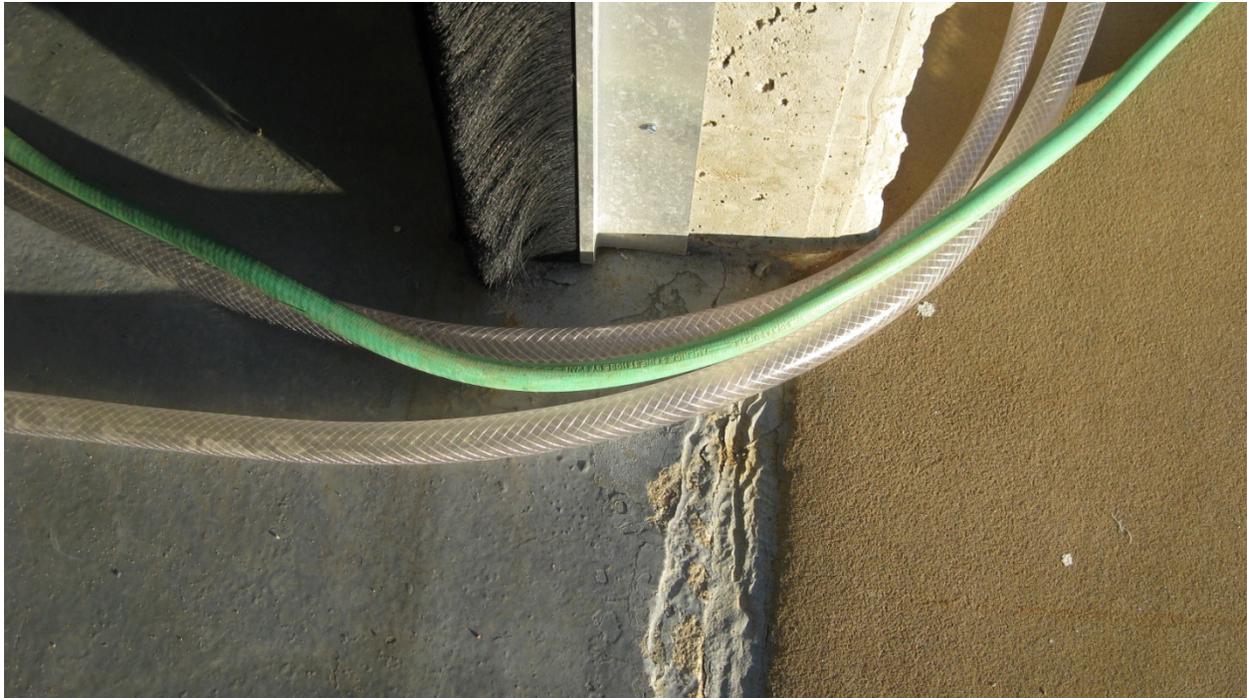
Even when the water was acidified, oxidized iron was evident in the influent line (Figure 7). Although not visually striking in Figure 7, it is apparent that there is a slight brown tinge in

Figure 7. Comparison of color of influent line (bottom) and effluent line (top), showing greater clarity in the effluent.

the bottom tubing (influent), whereas the top (effluent) is crystal clear. Based on knowledge of the water at the KCP, it is believed that the brown stain in the influent signifies the presence of minute particles or complexes of oxidized (ferric or Fe^{+3}) iron. Data collected indicates that iron was not retained within the ABS pilot unit when the water was acidified. Two samples of influent collected during this portion of the test contained 21,000 and 21,300 $\mu\text{g/L}$ of iron respectively. The associated effluent samples contained 26,000 and 22,000 $\mu\text{g/L}$. Sampling and laboratory variability probably accounts for the differences in the influent/effluent measurements rather than any changes within the ABS unit. The clear effluent shown in Figure 7 indicates that the low pH in conjunction with the extreme reducing conditions in the VOCEaterTM reduced all of the iron to the ferrous (Fe^{+2}) state which readily dissolves in water.

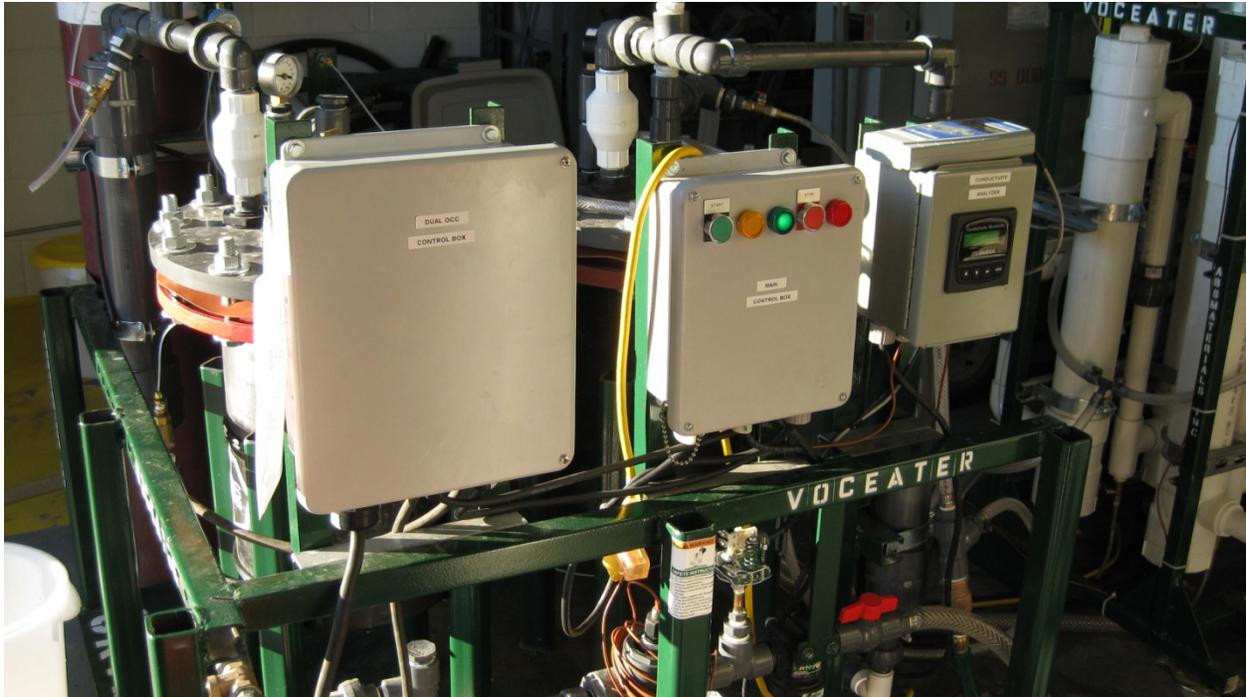
Initial comments from site personnel were mostly related to the large number of valves, gauges and pipe connections on the unit (Figures 8 and 9). The site water plant staff all expressed

Figure 8. Control Panel for the ABS Pilot System.

skepticism that the unit could operate automatically for extended time periods without developing leaks and suffering from periodic clogging. Concern was expressed because there were four pumps and numerous mechanical valves and pressure switches. Indeed, there were a few minor leaks during the test. Another comment was that a unit made of schedule 40 PVC “would never last.”

It is noted, however, that subsequent discussion with ABS personnel indicate that the unit at the KCP was only for pilot testing purposes. Full-scale units would employ different materials and be PLC controlled—presumably eliminating many of the concerns regarding ease-of-use and reliability. The vendor has stated that “full scale units will be PLC driven. We have one pilot unit deployed that is PLC driven and allows for remote retrieval of conductivity data via a telephone line. The water flow is intermittent at this site and features to turn the system ‘on and off’ according a preset water level in a surge is in place.”

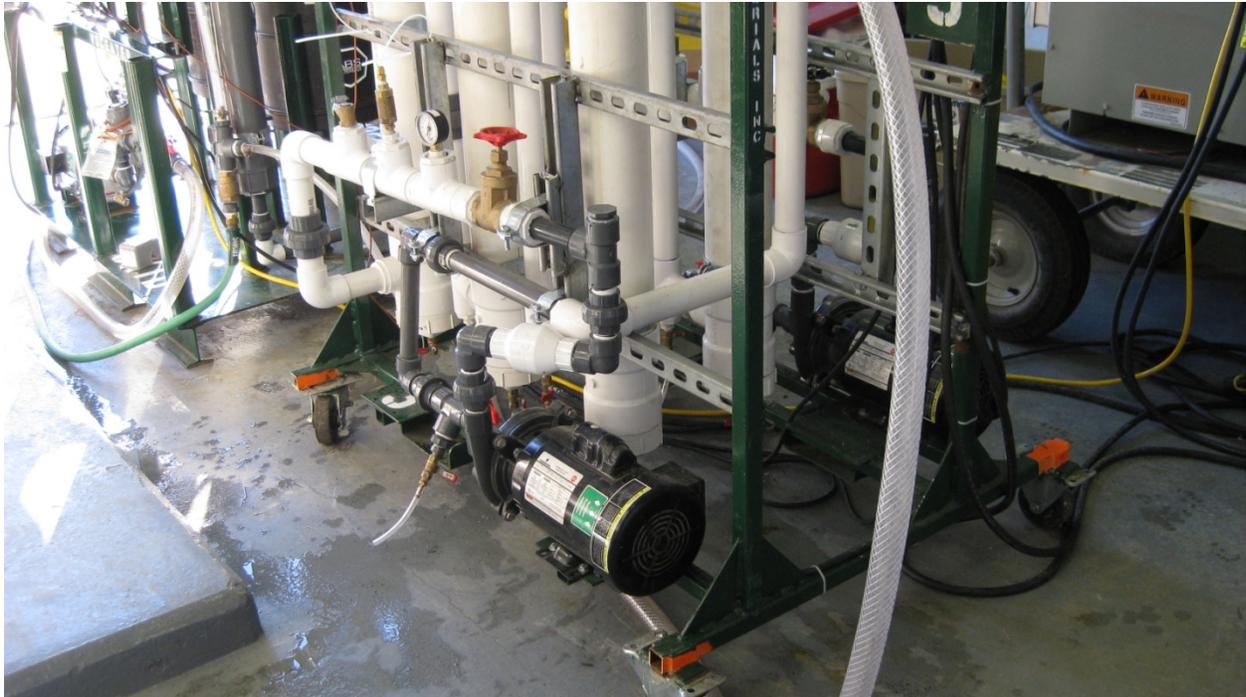
Figure 9. View showing many of the valves, meters and connections on the pilot system.
