ATTACHMENT 13 - AURORA SURVEY NOTES MAY 9, 2007

Oak and Sycamore Sample Locations (SL) - Aurora and Baldwin Park

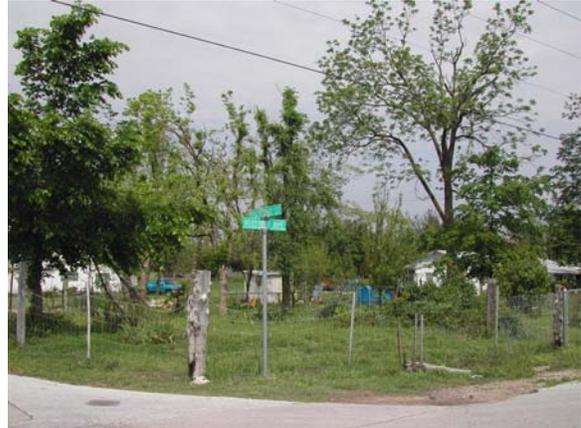
Photo A1

SL A1 (Imagery indicated Sycamore)

Black Walnut, Elm & Maple on corner of residential area.

No Oak or Sycamore.

#6 Soil in ditch Pb 333 / Zn 4700

#7 Yard under trees Pb 124.89 / Zn 2790

#8 Edge of pavement Pb 165 / Zn 3740

#9 Pavement Pb 38 / Zn 741

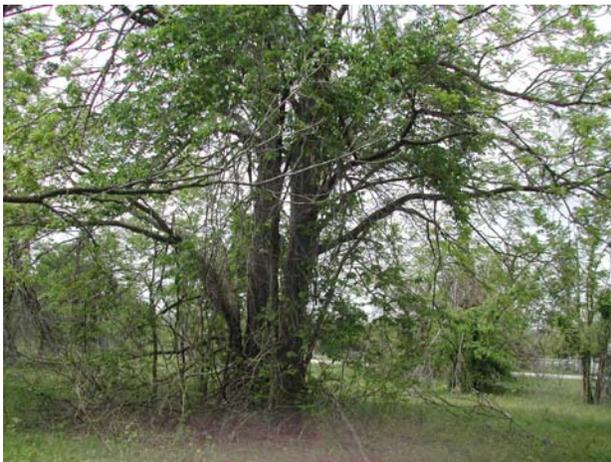
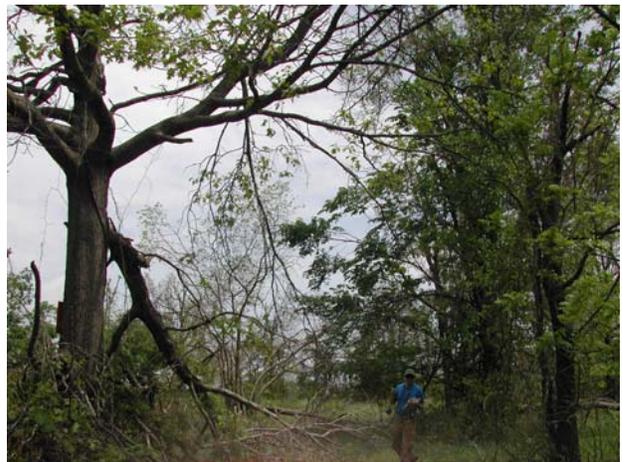
Photo A2 & 3

SL A2 (Imagery indicated Oak)

Black/Red Oak, Black Walnut & Black Cherry.

Leaves A2 - Black Oak

Leaves A3 - Black Walnut

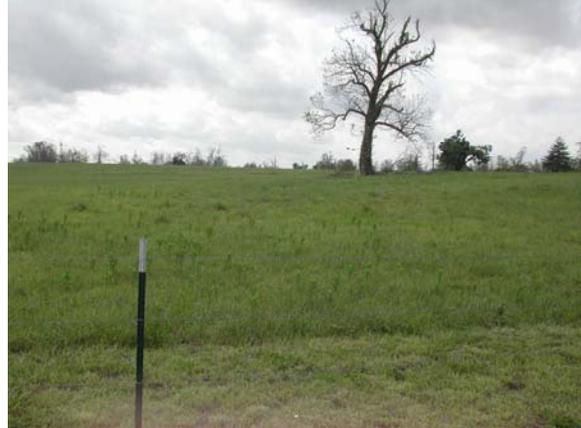
SL A4 (Imagery indicated Sycamore)
Milkweed in field
Leaves A4 - Milkweed
XRF 20070509 (ug/cm²)
#20 Stack of leaves Pb ND / Zn ND
Photo A4

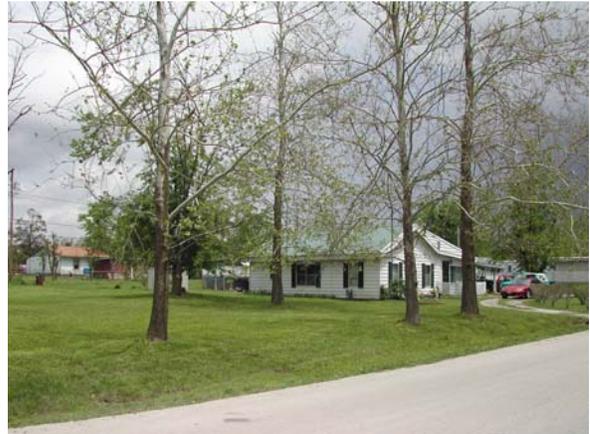
SL A5 (Imagery indicated Oak)
Several Sycamore trees in yard near street.
Leaves A5 - Sycamore
[Lat 36.977655445 Long -93.714769083]
XRF 20070509 (ug/cm²)
#21 Live leaves Pb ND / Zn ND
Photo A5

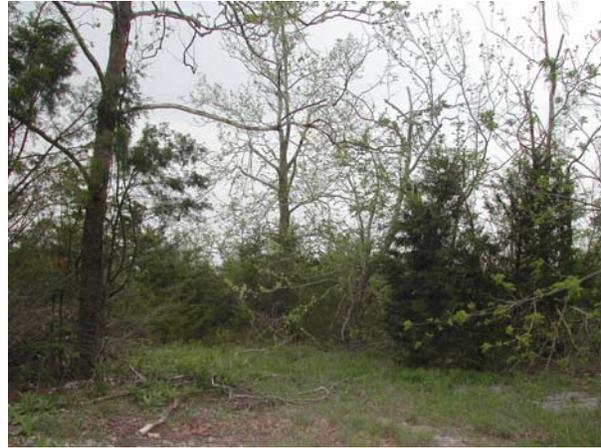
Photo A6

SL A9 (Imagery indicated Sycamore)

Sycamore tree as plotted

XRF 20070509 (ppm)
#27 Soil near Sycamore Pb 867.5 / Zn 14,421.0
#28 Soil near Sycamore Pb 55.34 / Zn 4,410.7
#29 Retest Soil near Sycamore
Pb 70.07 / Zn 1,581.4

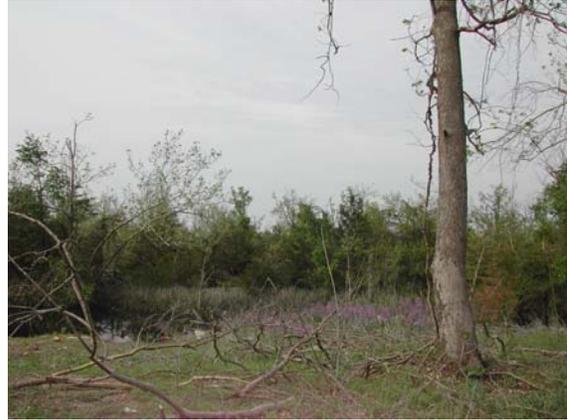
SL A12 (Imagery indicated Oak)
Contaminated Sycamore near Pond in mining area.
Ponds in Baldwin Park mining area had no apparent aquatic life or algae, and a strange dark color.
No samples taken
Photo A7

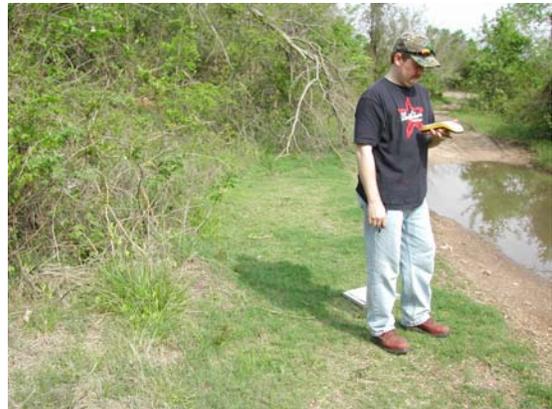
SL A13
Bermuda grass around pond in mining area.
Grass A13- Bermuda
XRF 20070509 (ug/cm²)
#52 Live grass stacked Pb ND / Zn 33.31
#33 In-situ grass Pb 13.53 / Zn 404.13
Soil mode (ppm)
#53 Live grass stacked Pb ND / Zn 268.45

Soil
XRF 20070509 (ppm)
#12 Soil in grass area Pb 375.06 / Zn 15,429.0
Photo A8
