SITE REASSESSMENT REPORT

Shapiro Brothers Salvage
Jefferson County, Missouri

EPA ID: MON000706345

September 30, 2013

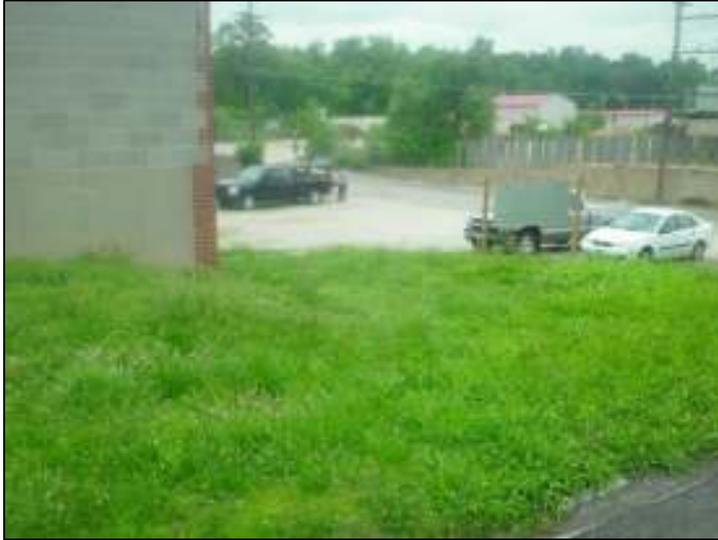
Photograph 1
Taken June 13, 2013
by Michael Stroh, DNR

Commercial Property
Location ID 400, view
looking northeast. Grassy
area and gravel lot sampled
as separate sampling units.

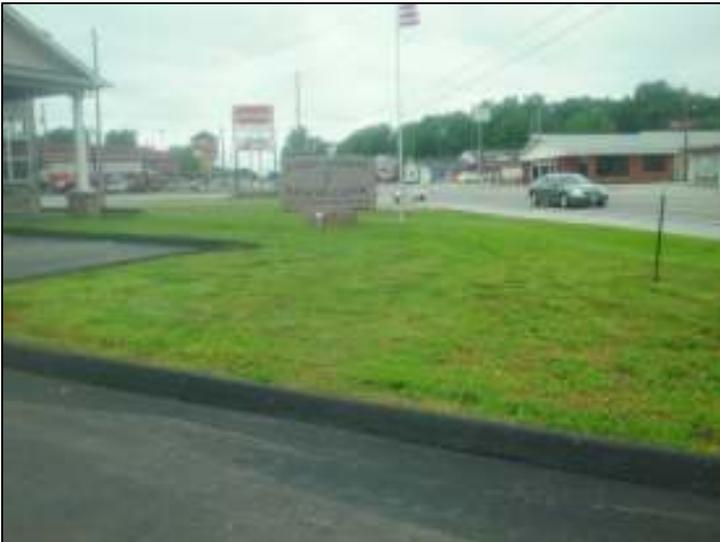
Photograph 2
Taken June 13, 2013
by Michael Stroh, DNR

Commercial Property
Location ID 401, view
looking northeast. Grassy
area near Truman Blvd.
sampled together with
grassy area in Photo. 3.

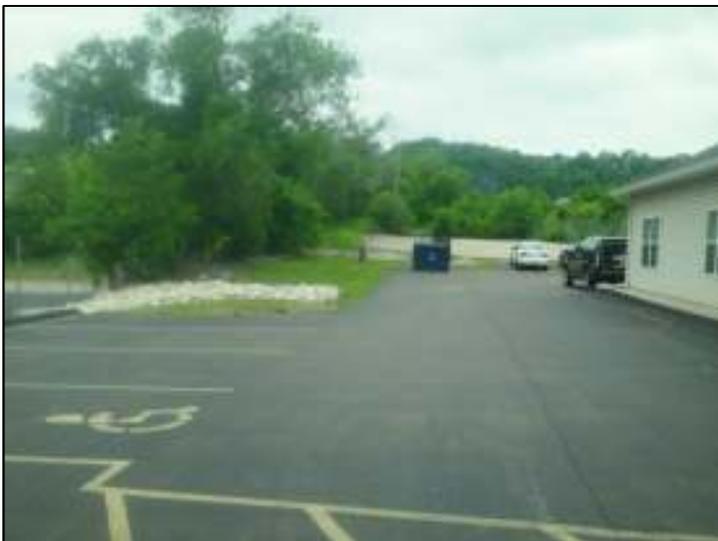
Photograph 3
Taken June 13, 2013 by
Michael Stroh, DNR

Commercial Property
Location ID 401, view
looking west. Grassy area
south of building sampled
together with grassy area in
Photo 2.

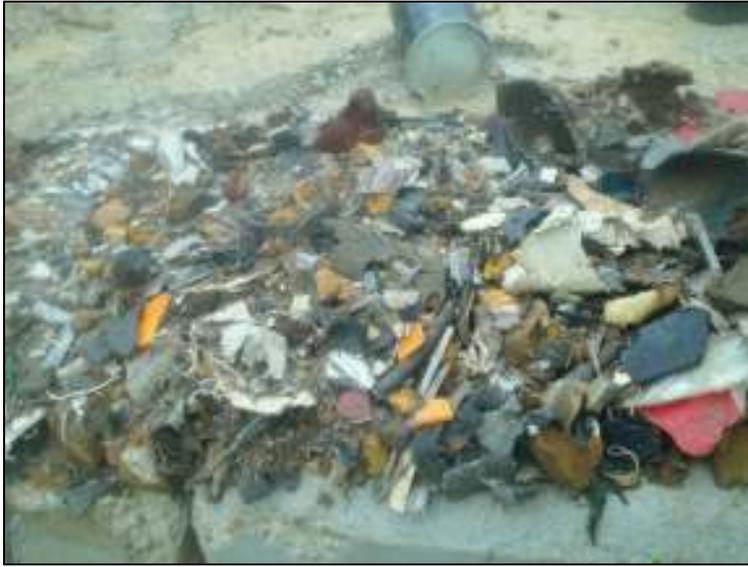
Photograph 4
Taken June 13, 2013 by
Michael Stroh, DNR

Commercial Property
Location ID 401. Foam,
plastic and metal debris on
top of a low concrete block
retaining wall located along
western property boundary
adjacent to Shapiro Salvage
yard.

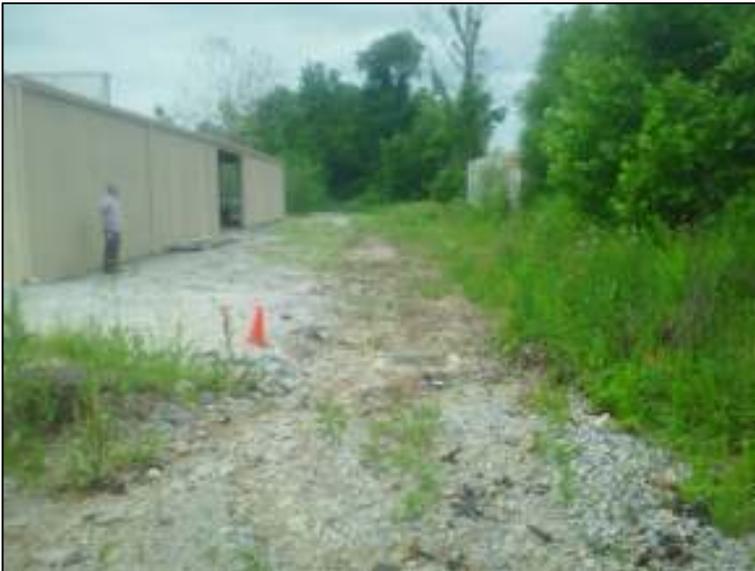
Photograph 5
Taken June 13, 2013 by
Michael Stroh, DNR

Commercial Property
Location ID 402. Mixed
gravel/vegetation sampling
area along western property
boundary adjacent to
Shapiro Salvage yard.

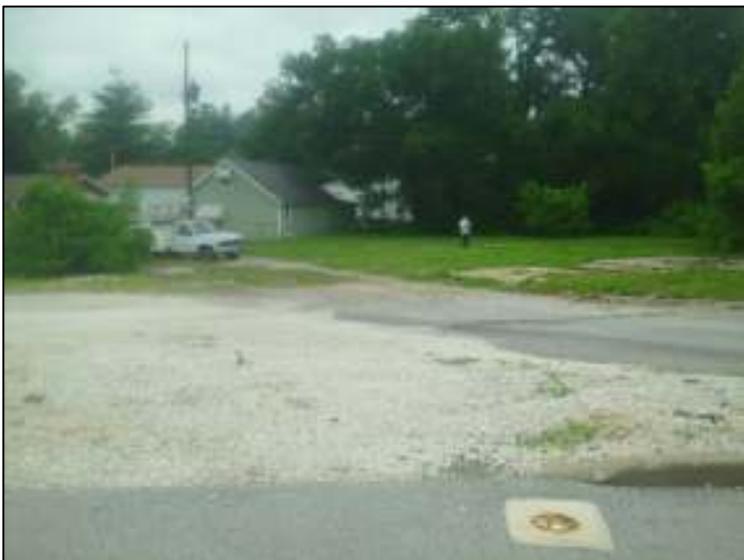
Photograph 6
Taken June 13, 2013 by
Michael Stroh, DNR

Commercial Property
Location ID 403. Grassy
area on western property
boundary sampled together
with grassy area in
Photograph 7.

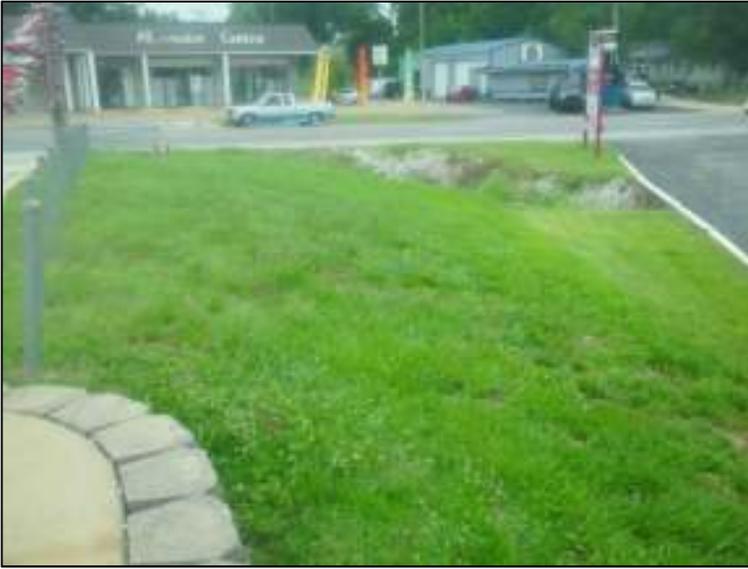
Photograph 7
Taken June 13, 2013 by
Michael Stroh, DNR

Commercial Property
Location ID 403. Grassy
area on eastern property
boundary sampled together
with grassy area in
Photograph 6.

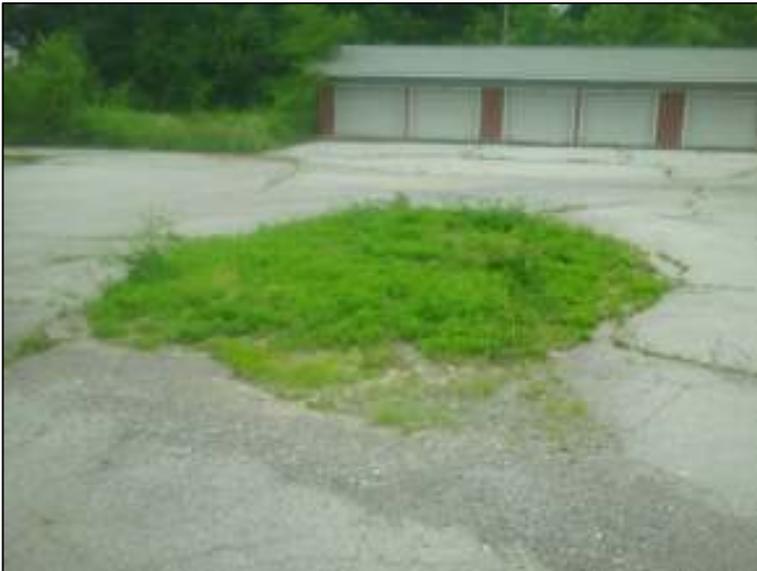
Photograph 8
Taken June 13, 2013 by
Michael Stroh, DNR

Commercial Property
Location ID 404. Grassy
area near center of property
sampled together with
grassy areas in Photographs
9 & 10.

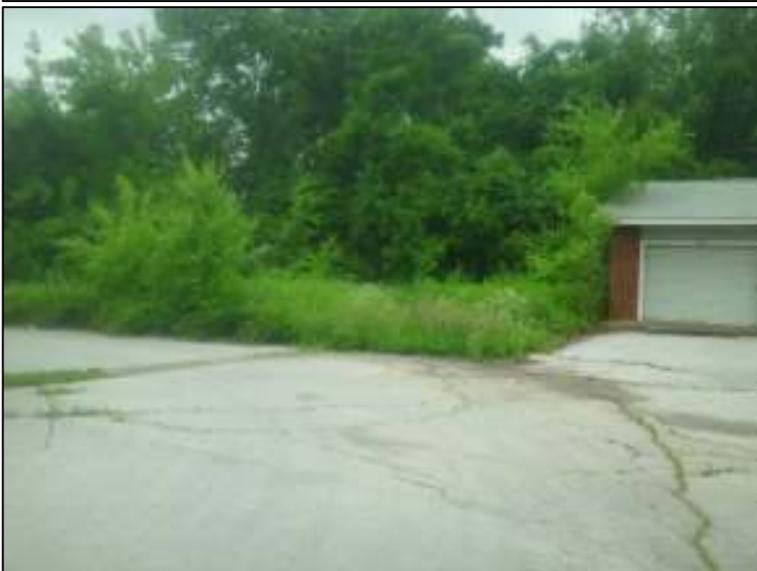
Photograph 9
Taken June 13, 2013 by
Michael Stroh, DNR

Commercial Property
Location ID 404. Grassy
area along southwest
boundary of property
sampled together with
grassy areas in Photographs
8 & 10.

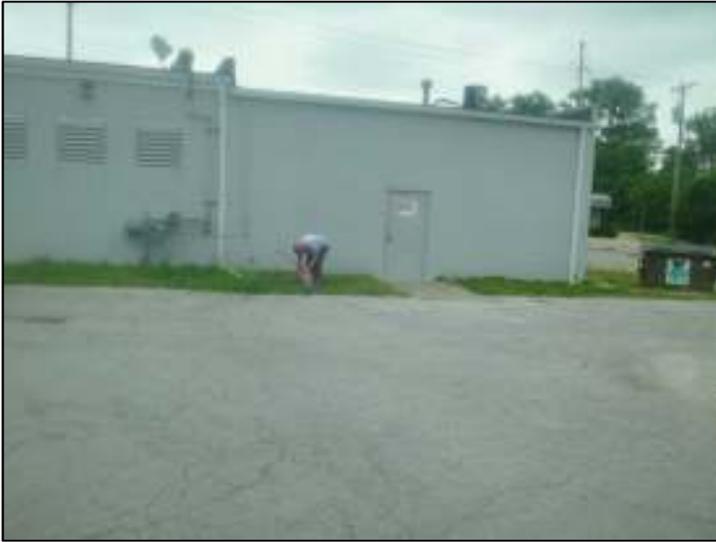
Photograph 10
Taken June 13, 2013 by
Michael Stroh, DNR

Commercial Property
Location ID 404. Grassy
area behind building
sampled together with
grassy areas in Photographs
8 & 9.

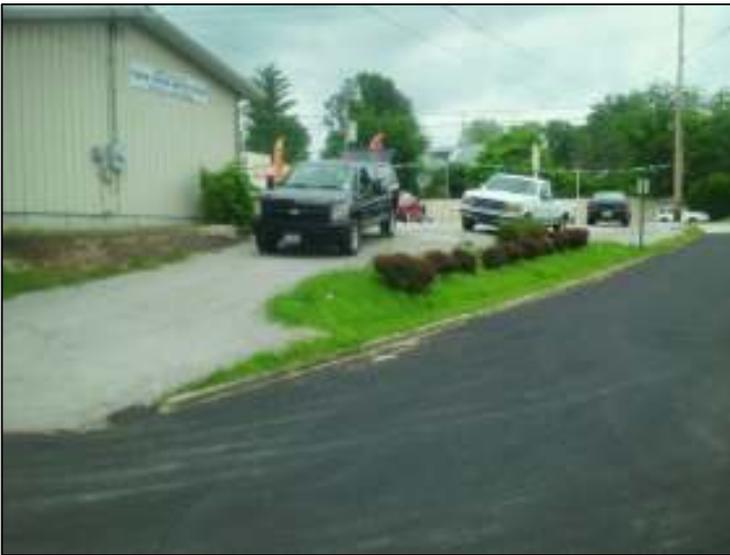
Photograph 11
Taken June 13, 2013 by
Michael Stroh, DNR

Commercial Property
Location ID 406. Grassy
area along south side of
building sampled together
with grassy area in
Photograph 12.

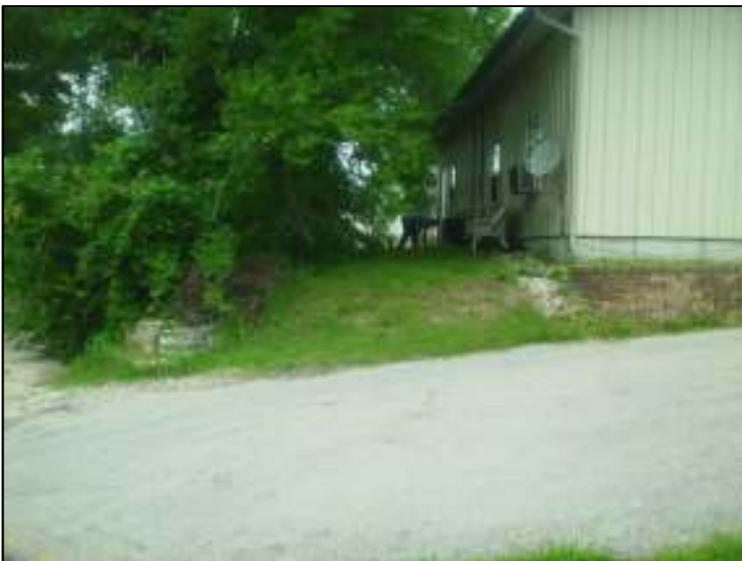
Photograph 12
Taken June, 13, 2013 by
Michael Stroh, DNR

Commercial Property
Location ID 406. Grassy
area west of building
sampled together with
grassy area in Photograph
11.

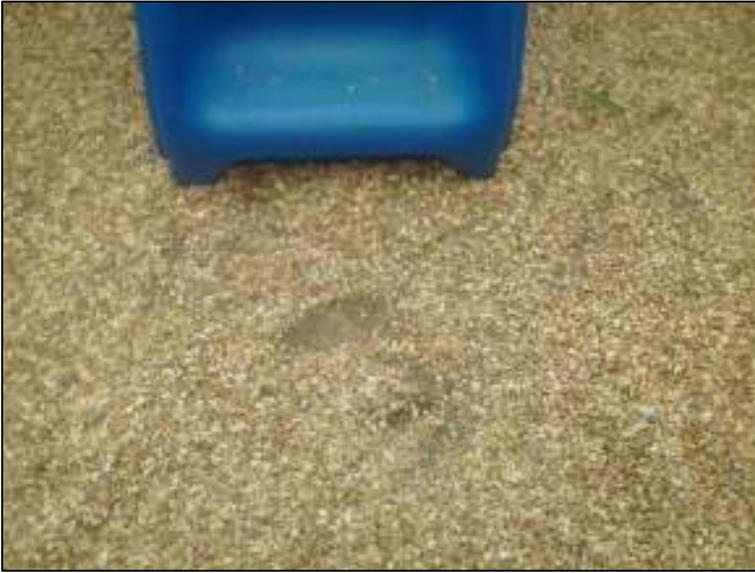
Photograph 13
Taken June 13, 2013 by
Michael Stroh, DNR

Commercial Property
Location ID 405. Daycare
play area showing 0-1”
depth of pea gravel beneath
the slide.

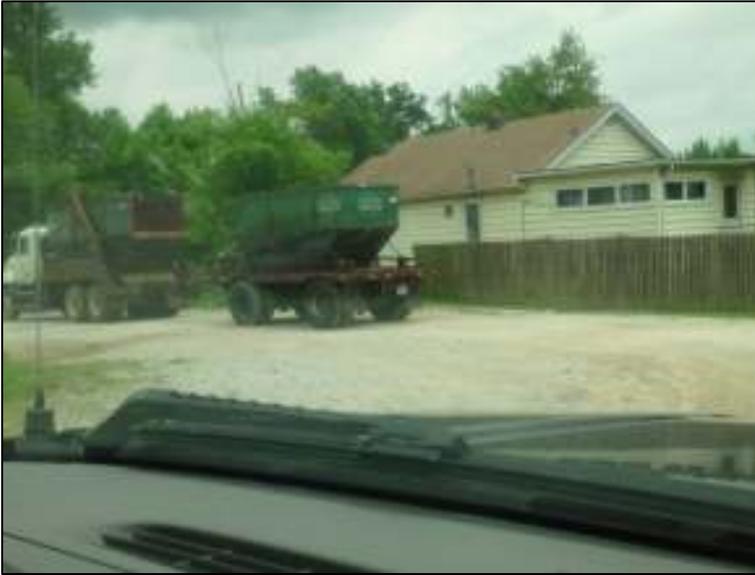
Photograph 14
Taken June 13, 2013 by
Sean Counihan, DNR

Scrap metal haul truck
parked at property owned
by M. W. Recycling
located at southwest corner
of 9th and Delmar.
Residential Location ID
143 visible behind wood
fence in background. View
looking southeast.

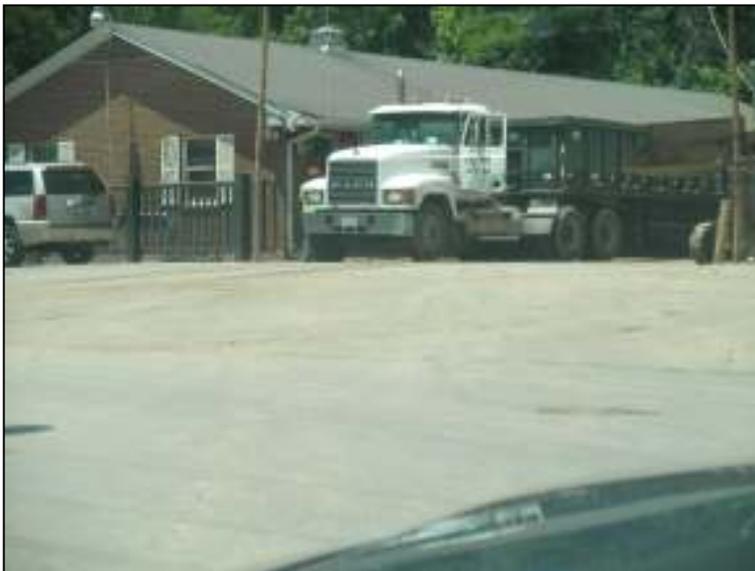
Photograph 15
Taken June 28, 2013 Sean
Counihan, DNR

Truck exiting Shapiro
facility without passing
through the truck wash,
then turning north onto
Vine Street.

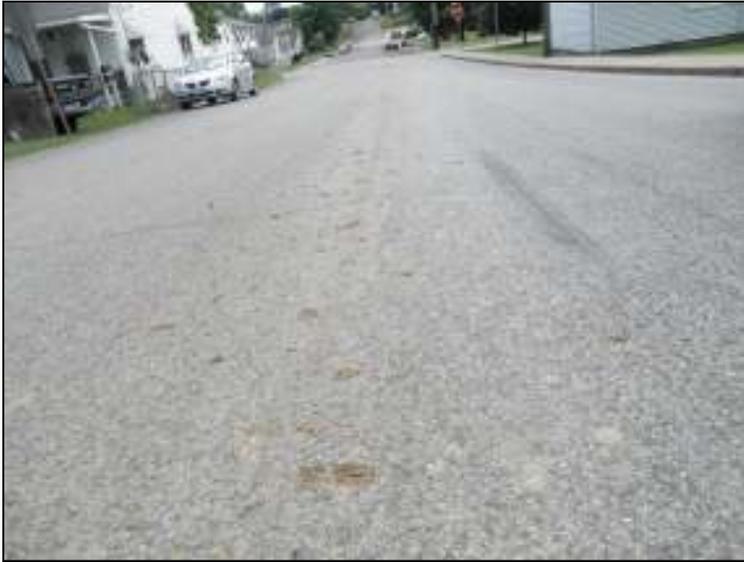
Photograph 16
Taken June 28, 2013 Sean
Counihan, DNR

Trail of soil track-out deposits in roadway. Vine Street facing south, stop sign is at 9th Street. Sample collected from roadway at this location.

Roadway track-out was observed by department personnel as part of this investigation (Appendix B, Photograph 16). During a site visit on June 28, 2013, department personnel observed trucks leaving the facility through the south gate without passing through the truck wash station (Appendix B, Photograph 15) (MDNR, 2013b). A sample of the roadway track-out material was collected from Vine Street on June 28, 2013. A second sample was collected of the roadway dust from Delmar Avenue a few houses south of the facility entrance. Both samples were submitted for total lead analysis. The sample from Vine Street was also submitted for TCLP lead analysis. Results are summarized in Table C1. The Delmar Avenue sample contained 1,240 mg/kg lead, and the Vine

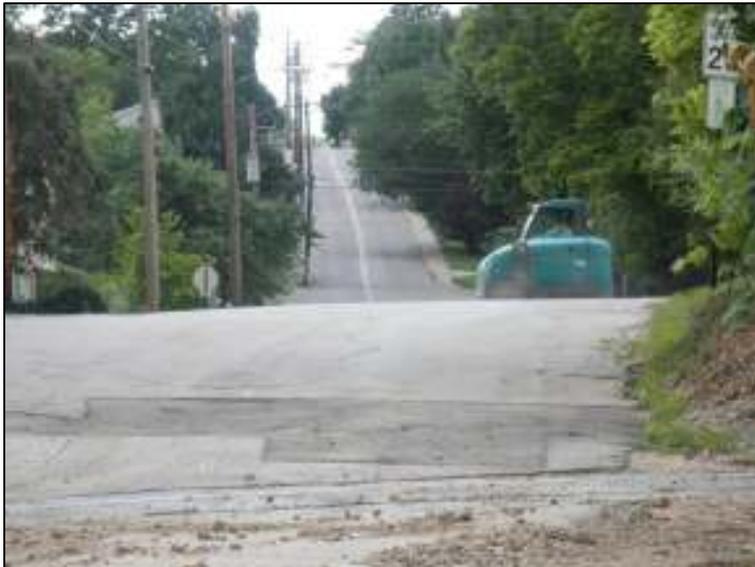
Photograph 17
Taken June 28, 2013 Sean
Counihan, DNR

Shapiro facility street sweeper operating on residential street near the facility. Dust cloud can be observed.

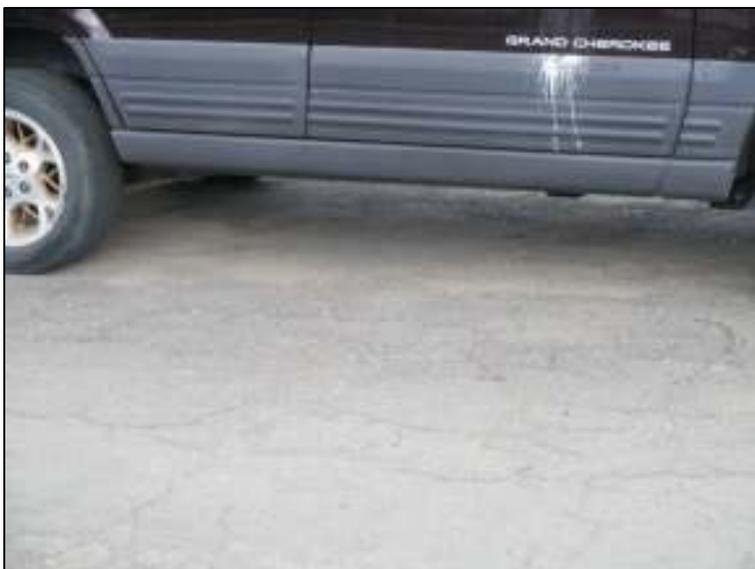
Photograph 18
Taken June 28, 2013 Sean
Counihan, DNR

Layer of dust/soil observed beneath vehicles parked along east and west sides of Delmar Avenue where street sweeper is unable to pass.

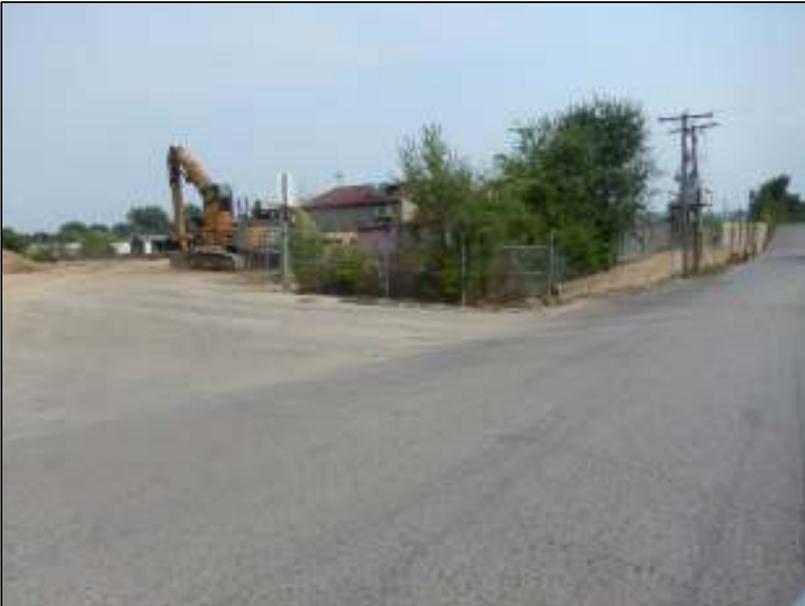
Photograph 19
Taken August 22, 2013
Michael Stroh, DNR

Southeastern view of the Shapiro facility northern entrance showing soil track-out from trucks.

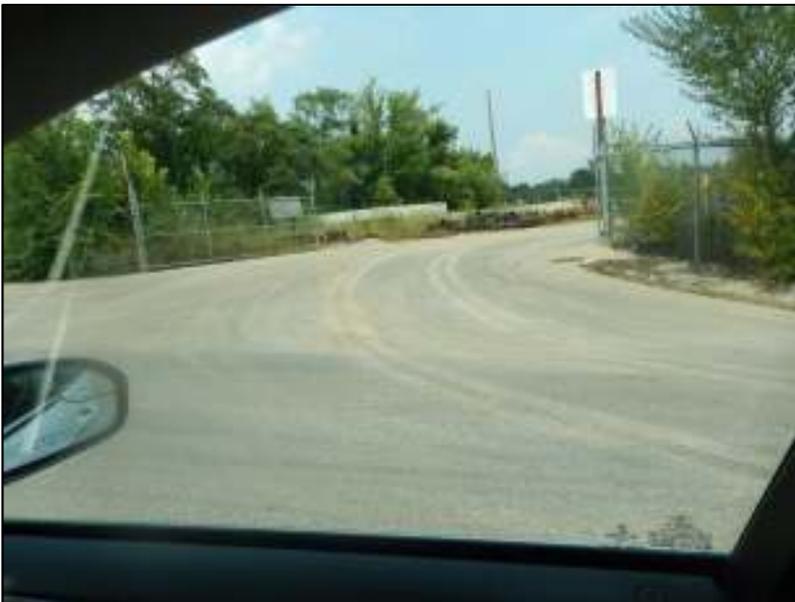
Photograph 20
Taken August 22,
2013 Michael Stroh, DNR

Eastern view of the Shapiro facility northern entrance showing soil track-out from trucks.

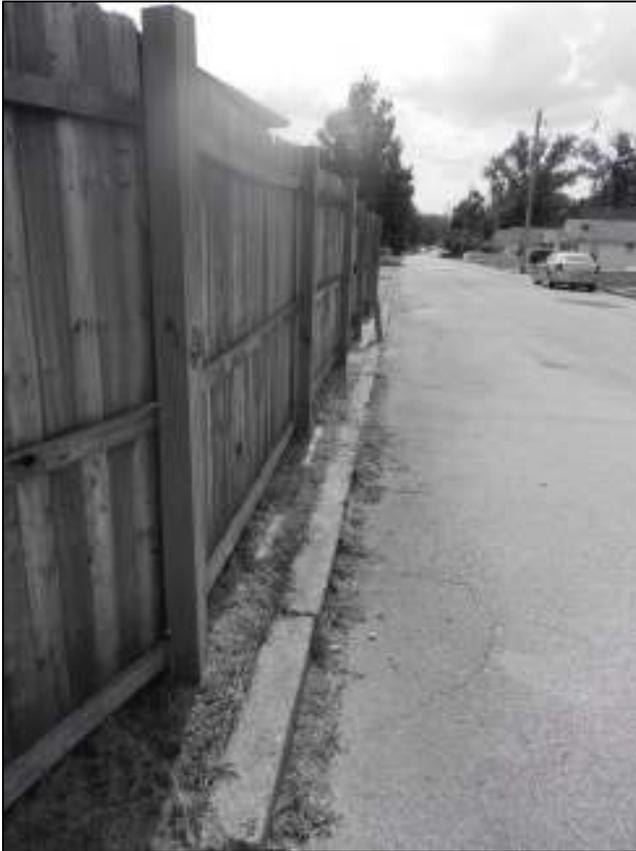
Photograph 21
Taken August 22,
2013 Michael Stroh, DNR

Commercial Property
Location ID 405. Grassy
area between fence and
Kenner Street. View
looking south.

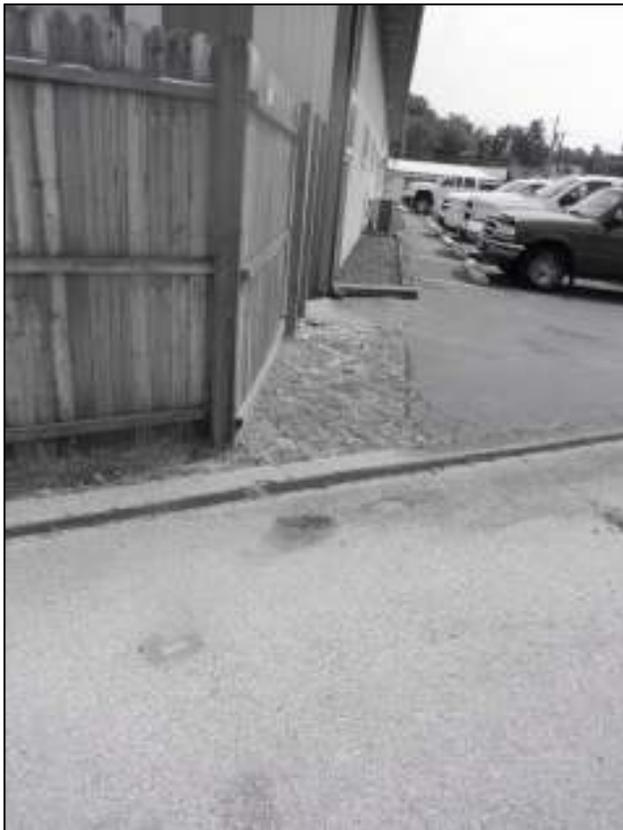
Photograph 22
Taken August 22,
2013 Michael Stroh, DNR

Commercial Property
Location ID 405. Grassy
area between fence and
Kenner Street. View
looking east.

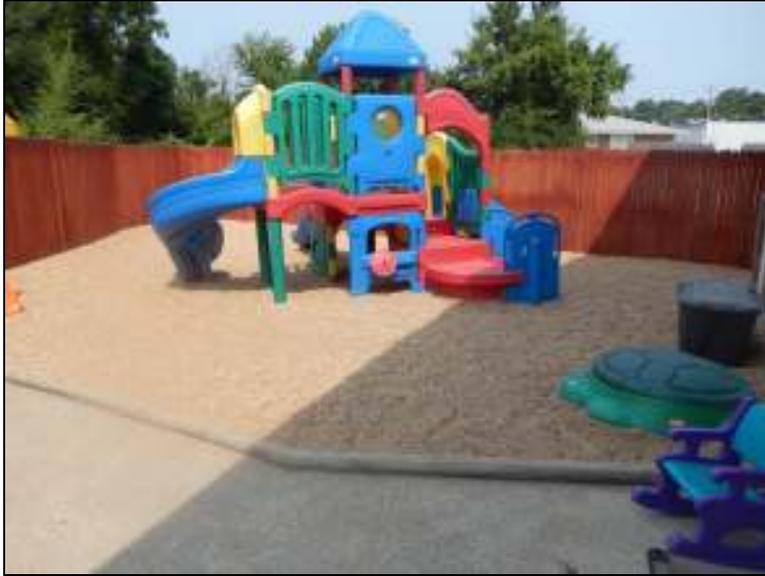
Photograph 23
Taken August 22,
2013 Michael Stroh, DNR

Commercial Property
Location ID 405. Main
play area sampled as
separate sampling unit.

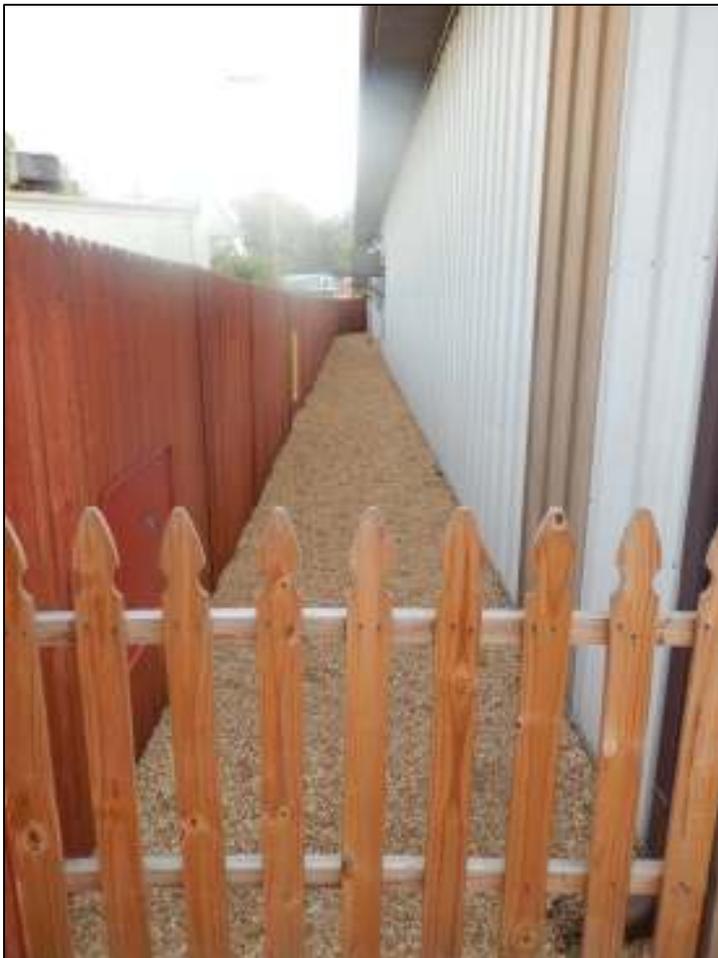
Photograph 24
Taken August 22,
2013 Michael Stroh, DNR

Commercial Property
Location ID 405. Walkway
along north side of daycare
building leading into the
main play area. Sampled as
separate sampling unit.

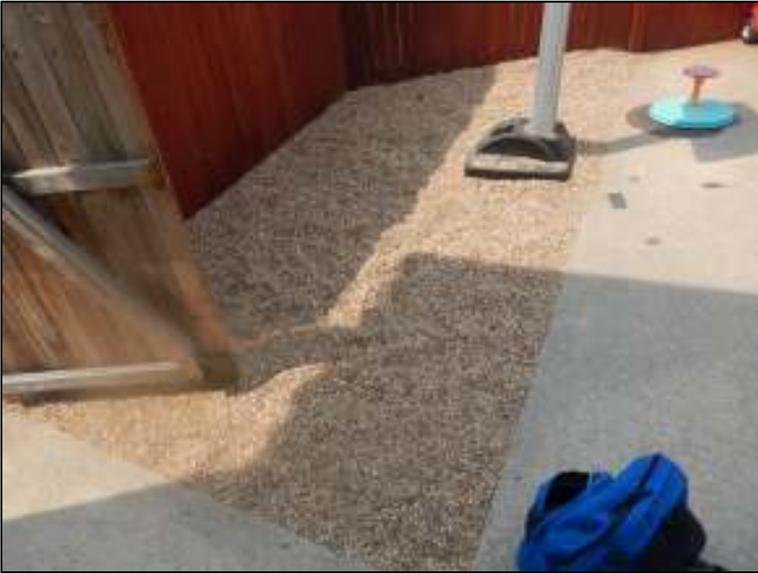
Photograph 25
Taken August 22,
2013 Michael Stroh, DNR

Commercial Property
Location ID 405. Southern
portion of play area
proposed to be covered
with concrete. Sampled as
separate sampling unit.

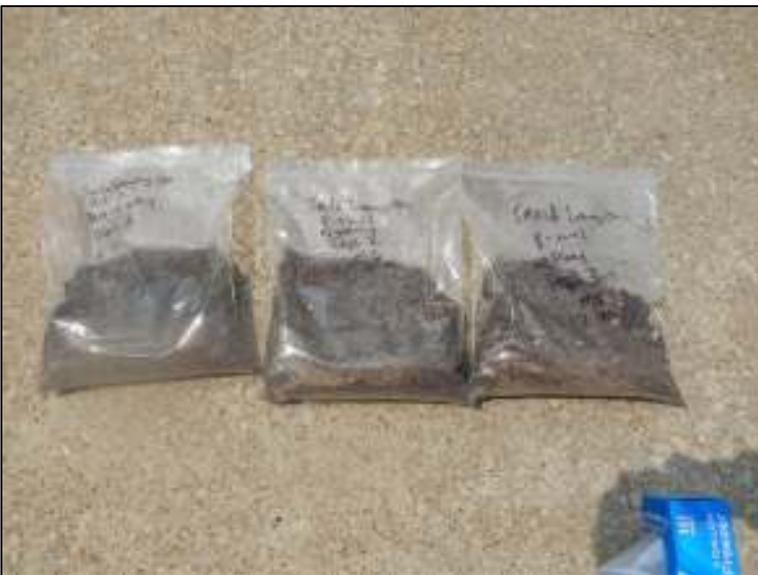
Photograph 26
Taken August 22,
2013 Michael Stroh, DNR

Commercial Property
Location ID 405. Three
replicate incremental
composite samples
collected from walkway
sampling unit.

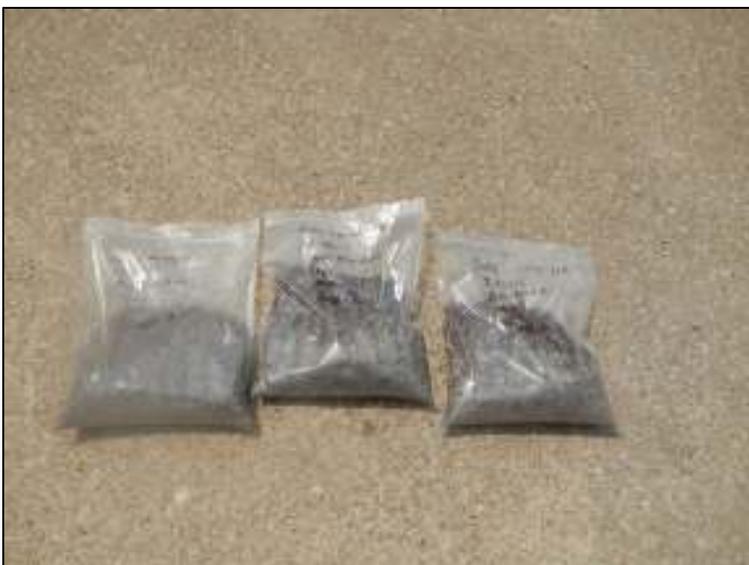
Photograph 27
Taken August 22,
2013 Michael Stroh, DNR

Commercial Property
Location ID 405. Three
replicate incremental
composite samples
collected from main play
area sampling unit.

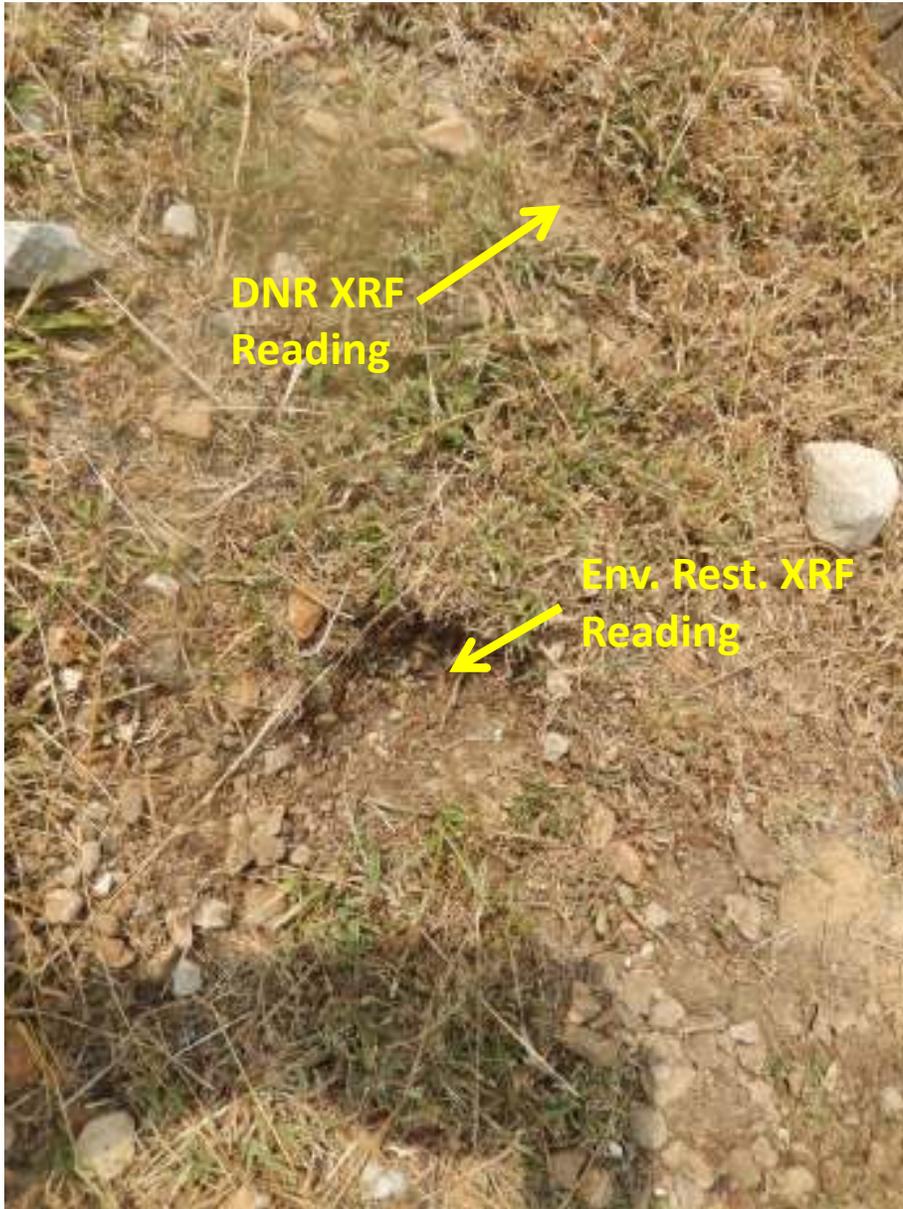
Photograph 28
Taken August 22,
2013 Michael Stroh, DNR

Commercial Property
Location ID 405. Grassy
area between the fence and
Kenner Street showing
divot where an in-situ XRF
reading was taken by
Environmental Restoration
personnel and the location
where an in-situ XRF
reading was taken by DNR
staff.

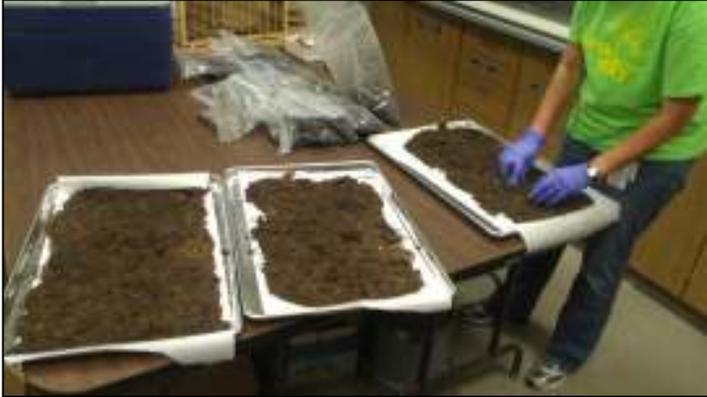
Photograph 29
Taken August 19,
2013 Michael Stroh, DNR

Incremental composite soil samples collected from commercial properties being spread out to air dry in the laboratory.

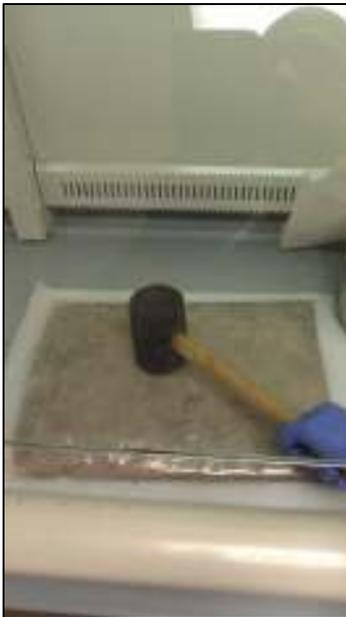
Photograph 30
Taken August 19,
2013 Michael Stroh, DNR

Disaggregation of an air-dried incremental composite soil sample prior to sieving in the laboratory.

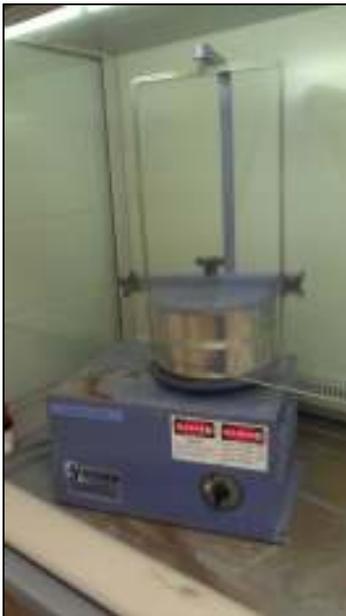
Photograph 31
Taken August 19,
2013 Michael Stroh, DNR

Sieving an air-dried, disaggregated soil sample in the laboratory prior to XRF analysis.

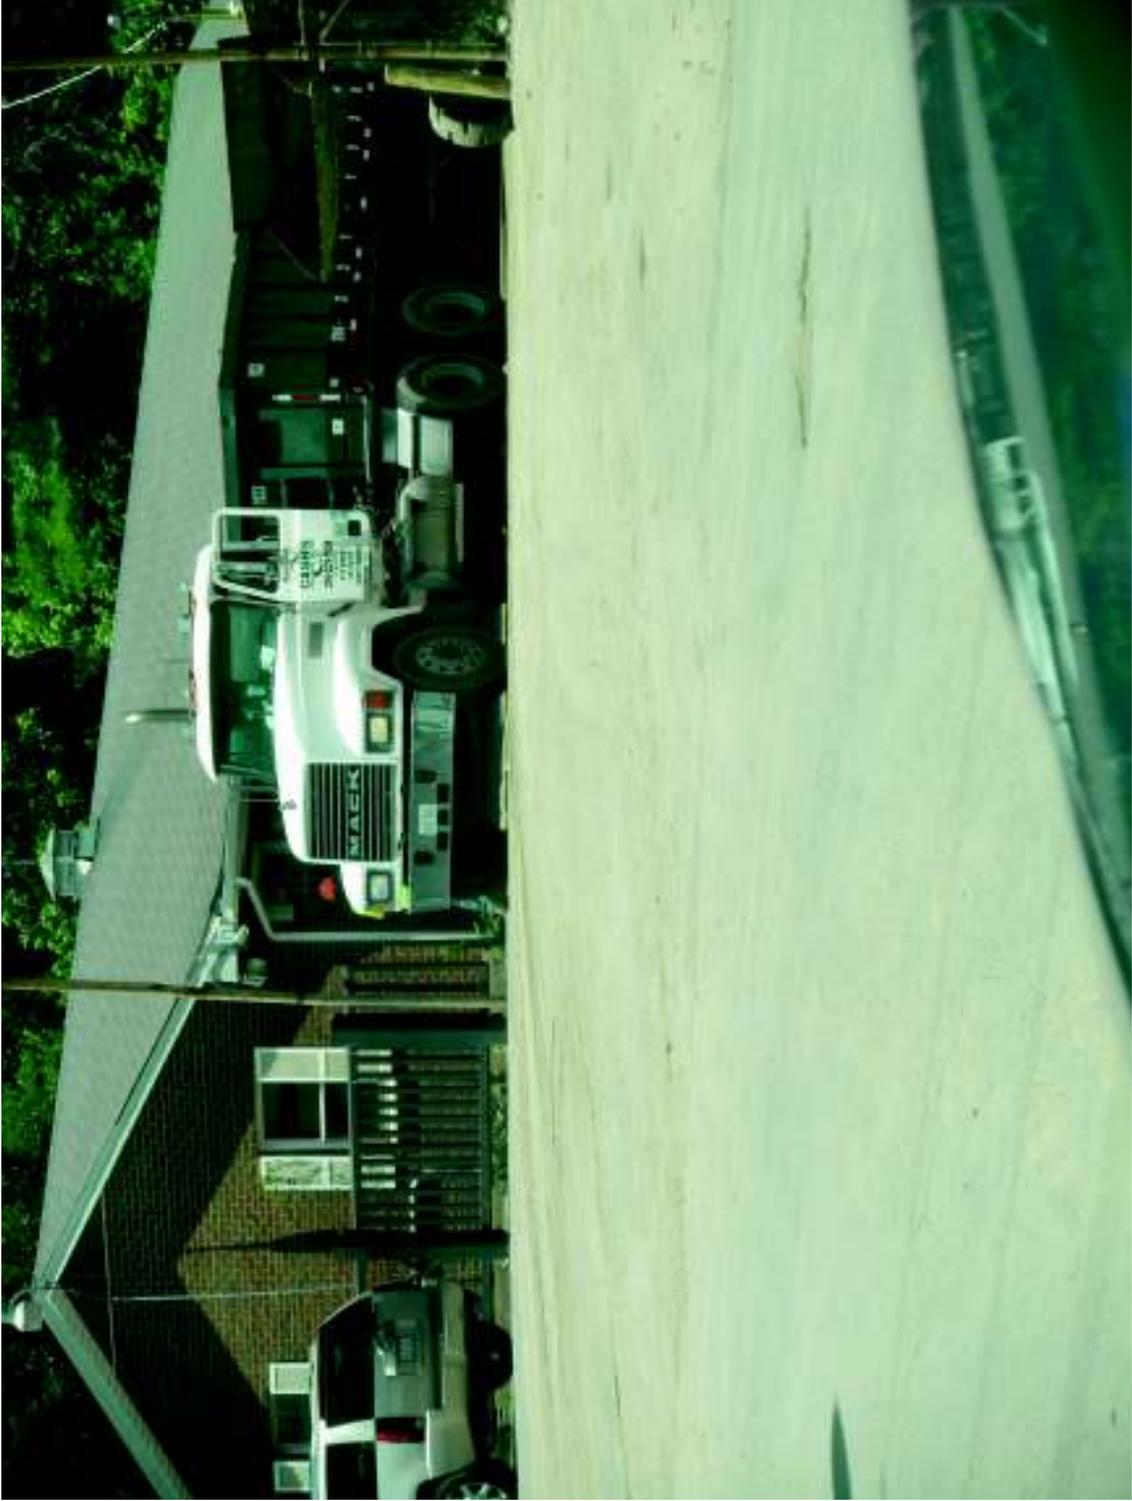
Photograph 1 - Truck exiting south entrance left (west) onto (9th St.), no wash, then turning right (north) onto Vine St.

Other allegations of the trucks entering and leaving the facility without passing through the truck wash were also confirmed (Photograph 1). Two trucks were observed exiting the facility through the 9th St. location. The truck exited onto 9th St. west and turned north onto Vine Street. Tracks of soil were observed leading out of the facility at the 9th St. location and heading north on Vine. The second truck observed leaving the facility pulled partially out until the driver spotted the State vehicle, then slowly backed the truck back through the entrance, back into the facility. The truck wash was not in operation during the exiting of these trucks.

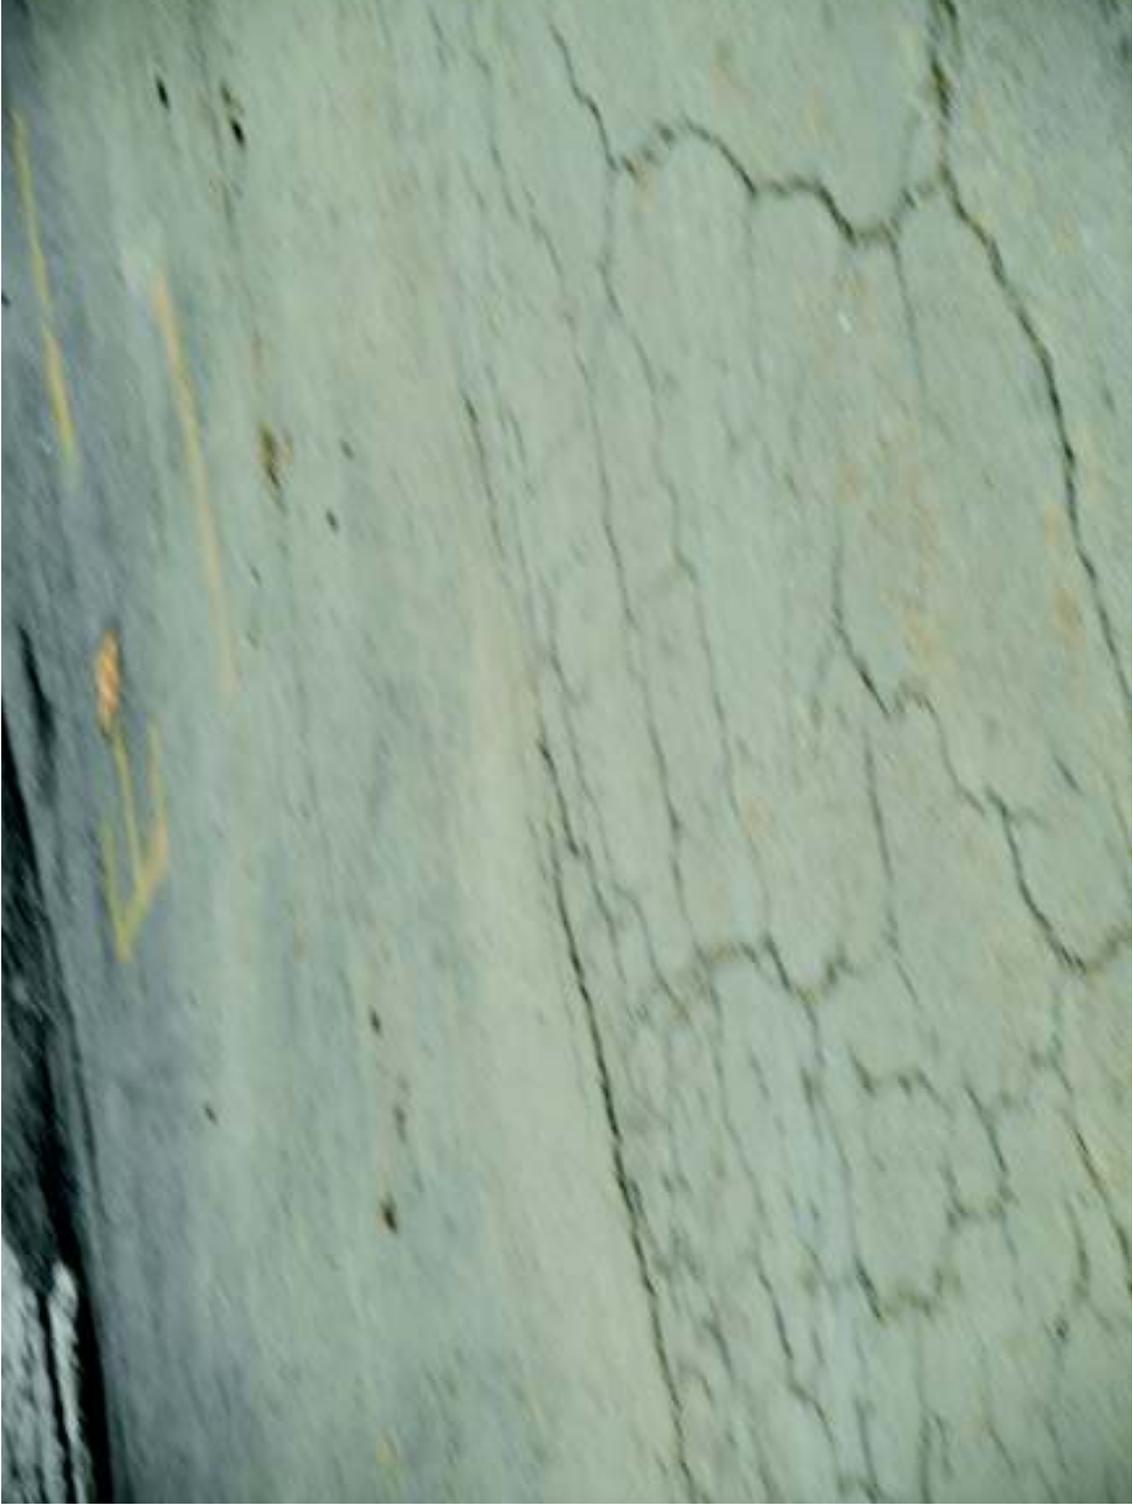
Photograph 2 - Soil deposits left in the roadway (9th St.) by trucks leaving the facility. Picture taken by Sean Counihan, 6/28/2013

Significant amounts of soil were observed tracked out onto the road. A soil sample was collected from the soil deposits in the roadway along Vine St (Photographs 2-5). The sample was collected from the middle of the roadway where the tracks leading from the facility were located.

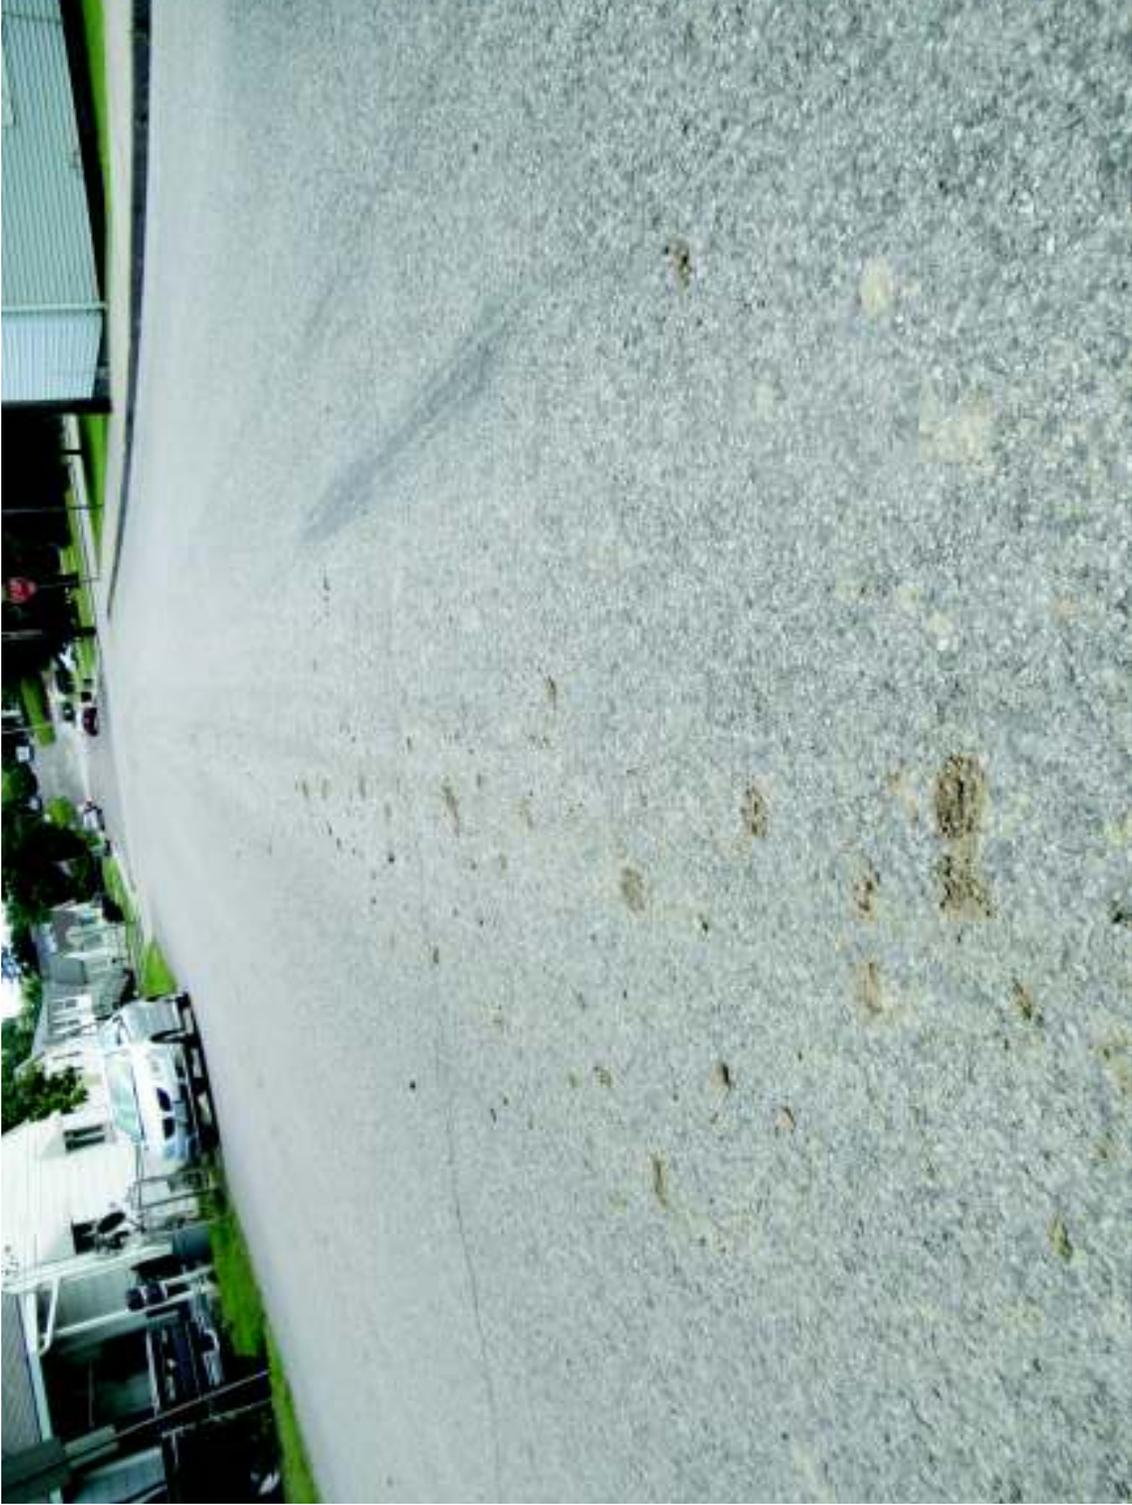
Photograph 3 - Trail of soil deposits in roadway (Vine St. facing south, stop sign is 9th. St.) Sample collected from these soil deposits in the road.

Street sample contained 7,480 mg/kg lead. TCLP analysis of the Vine Street sample resulted in 65 mg/l lead, documenting that the roadway material is a characteristically hazardous waste.

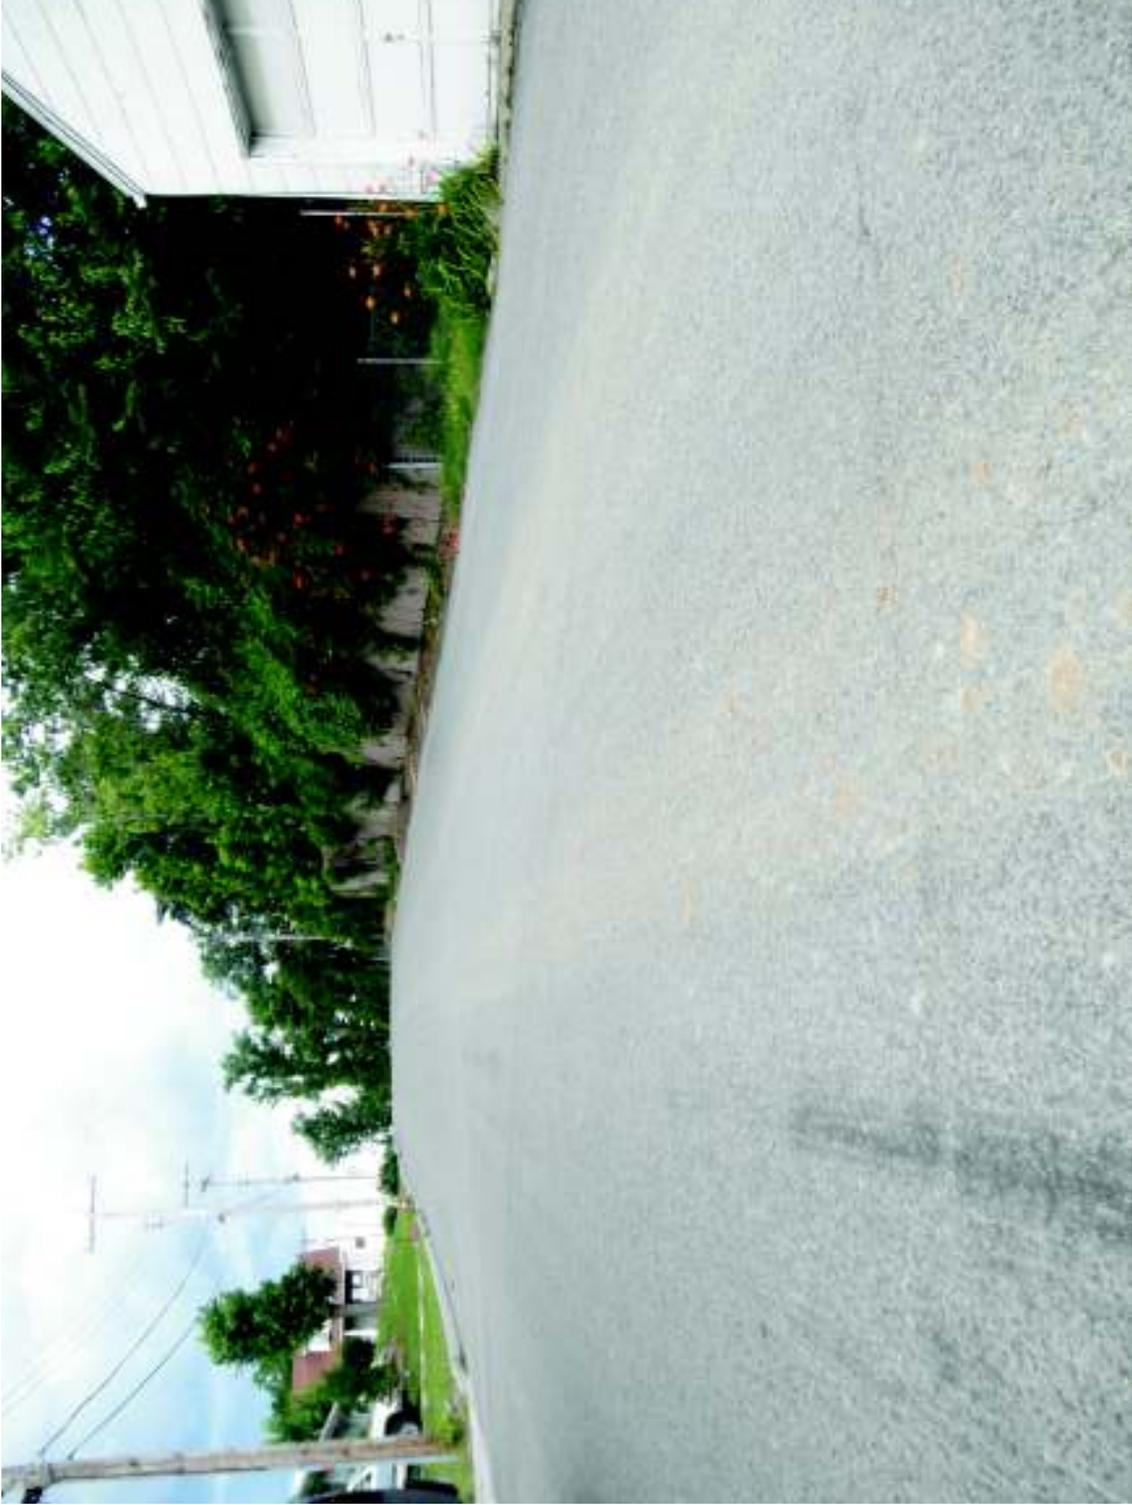
Photograph 4 - Tracks in road (Vine St. facing north)
Picture taken by Sean Counihan, 6/28/2013
