SITE REASSESSMENT REPORT

Shapiro Brothers Salvage
Jefferson County, Missouri

EPA ID: MON000706345

September 30, 2013

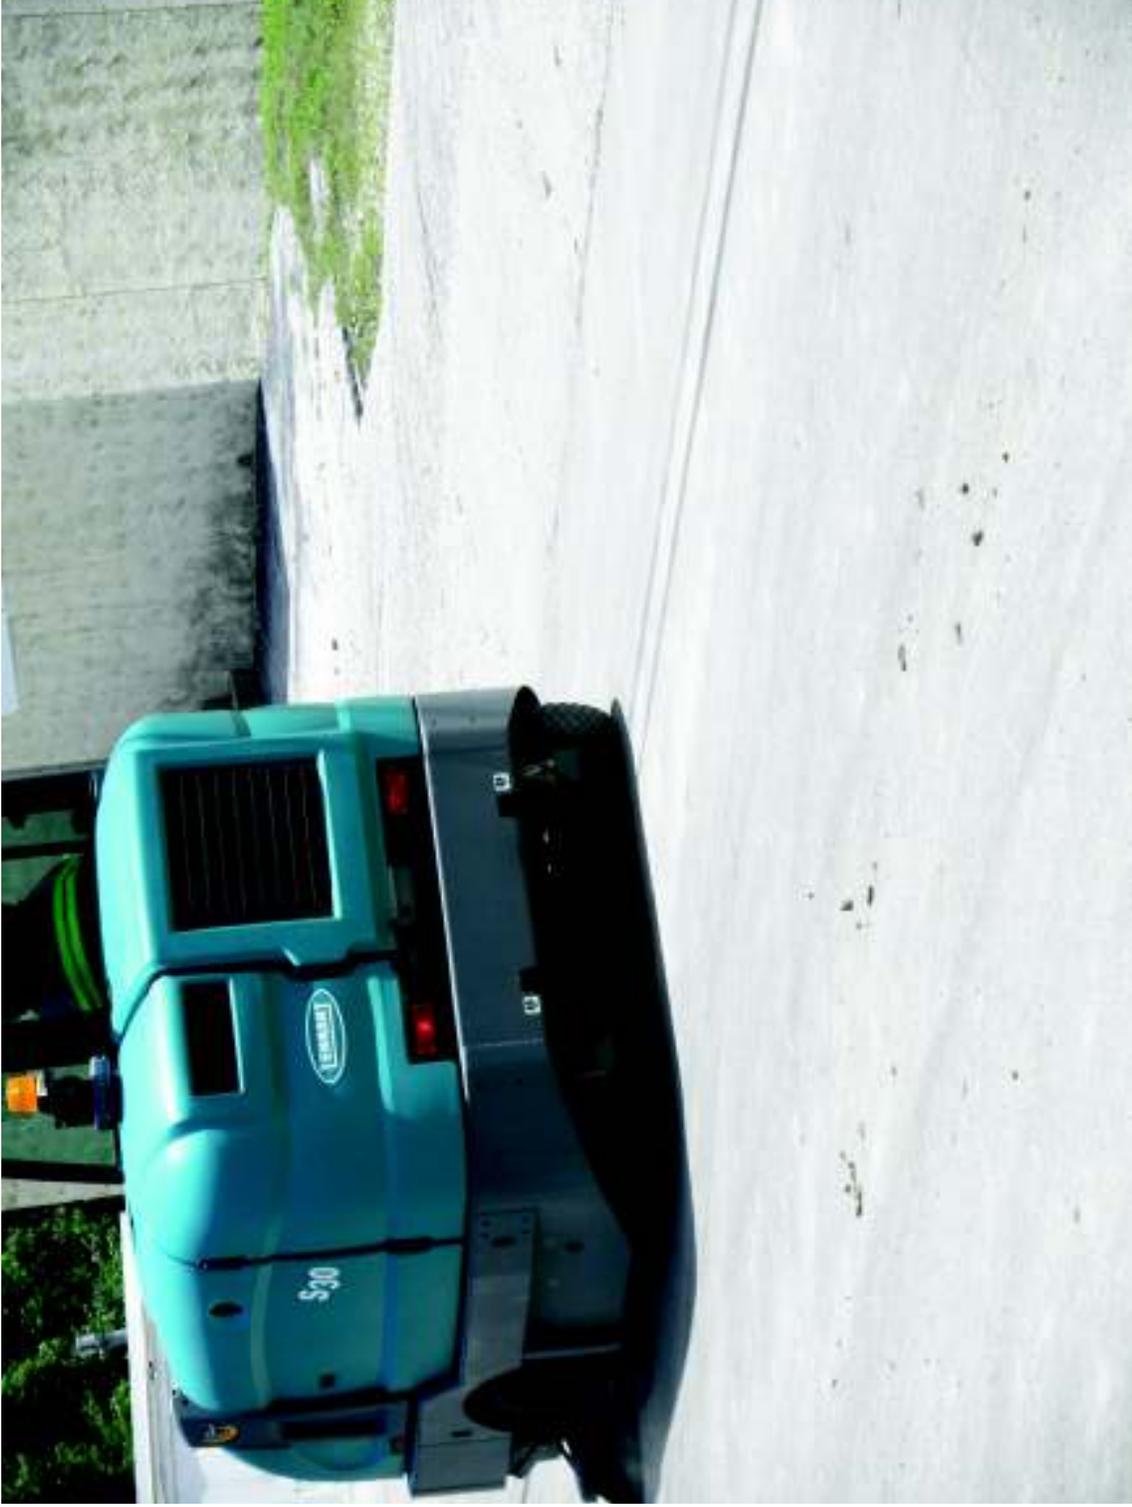
Photograph 5 - Street sweeper (on 9th St.) Operator would stop the machine any time I went by.

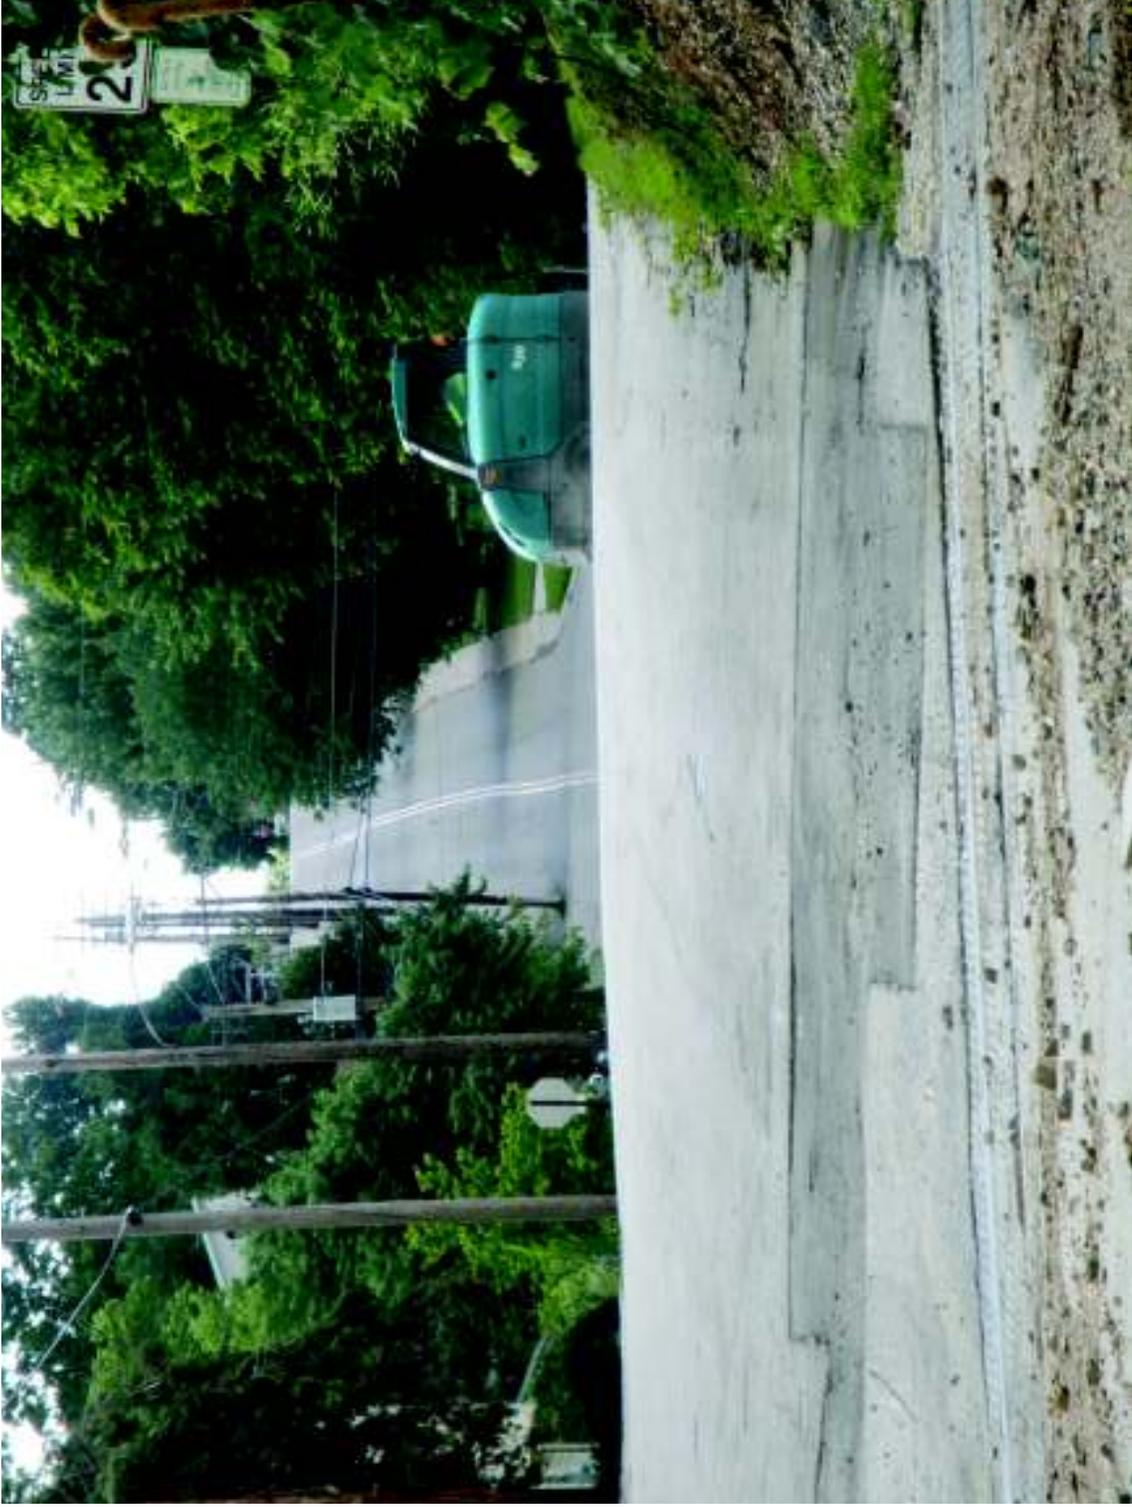
Photograph 6 - Street sweeper from a distance (dust cloud can be observed)

Allegations, by residents, that the street sweeper, used by PSC Metals was creating a dust cloud in an effort to clean the road were confirmed with photographs taken by the ESP representative. The street sweeper was observed operating on 06/28/13 along 9th St. and Vine. However, there was no water being used in the cleaning process, and the brushes on the front of the machine did create a visible dust cloud (Photograph 6). Any time the State vehicle was spotted by the

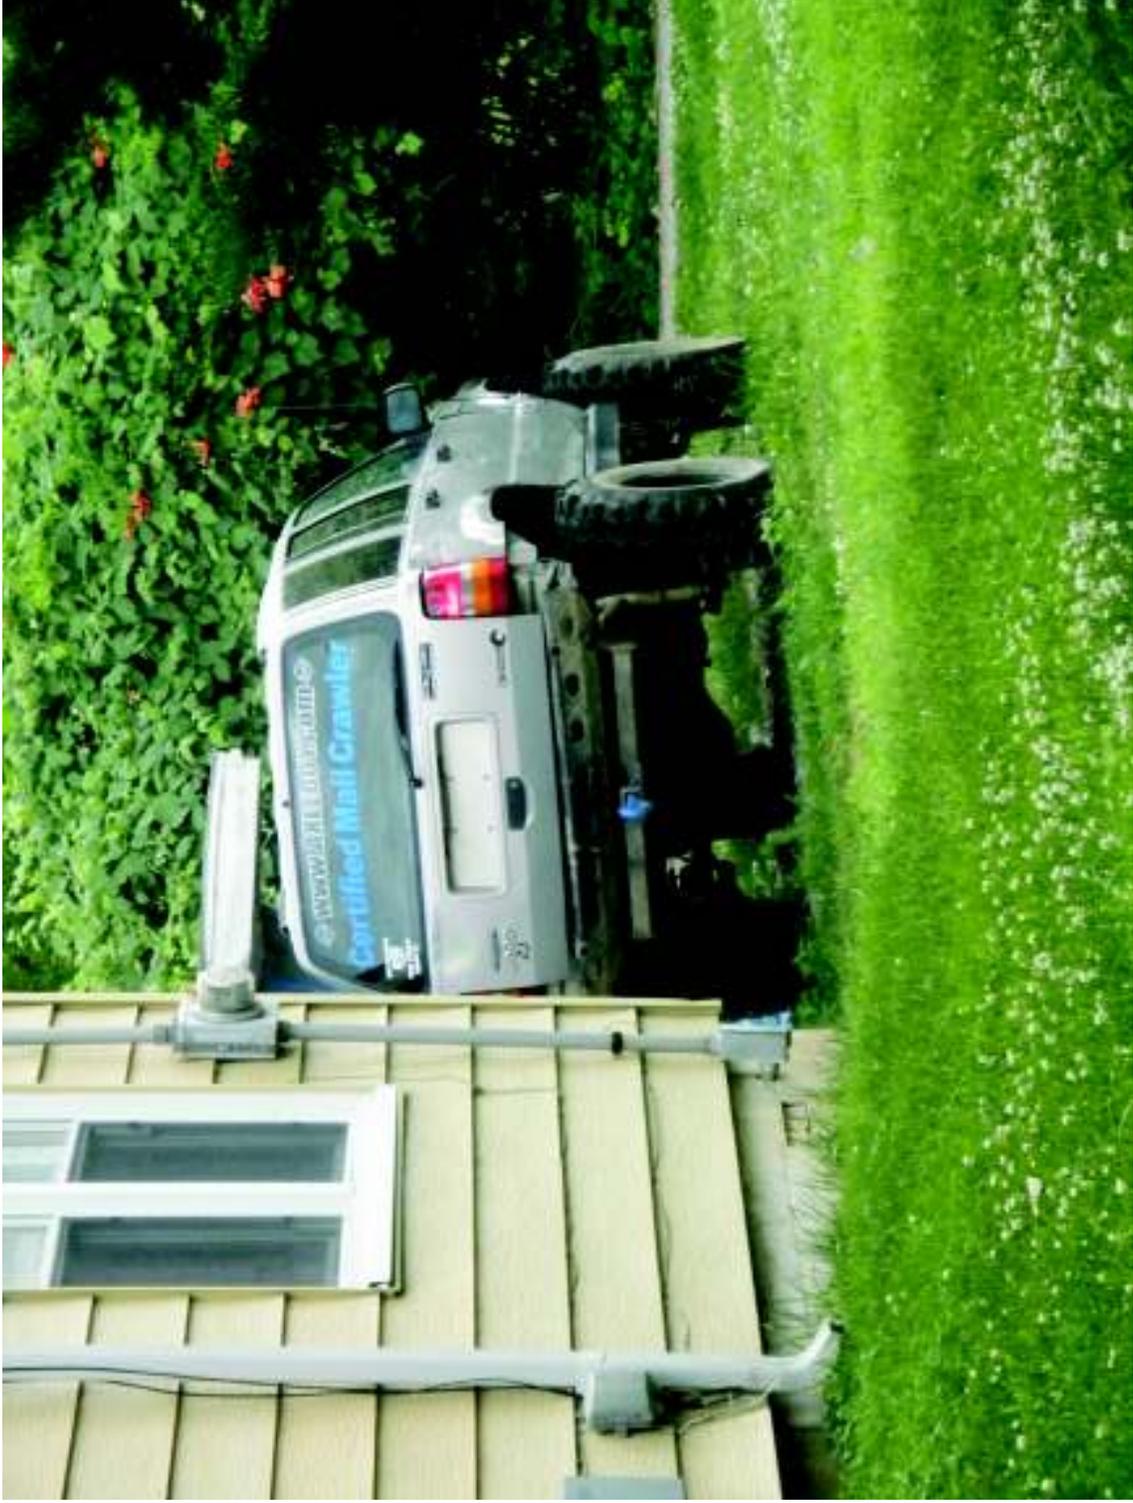
Photograph 7 - [“Monster Truck” at residence three doors south of facility on west side (851 Delmar)of Delmar Avenue. No appreciable soil in front of this residence.

ESP personnel also investigated an allegation by PSC metals that a resident along Delmar Avenue is contributing to the roadway contamination by washing a “monster truck” and several ATVs in the street on Delmar Ave. A Jeep Cherokee with a lift kit and larger than normal tires was observed in the back yard of a residence on the west side of Delmar near the facility entrance (Photograph 7). There did not appear to be any appreciable amount, or larger amount of soil/dust in front of this location than was observed on the rest of Delmar Avenue. This location is near the 9th St. exit of PSC and is also near the base of the down slope of Delmar Ave. from both the north and the south and most likely collects street debris during heavy rain events. A small amount of sand/silt was observed near the residence (at the bottom of the down slope) north of the driveway in the street. A sample of this material was collected for XRF analysis.

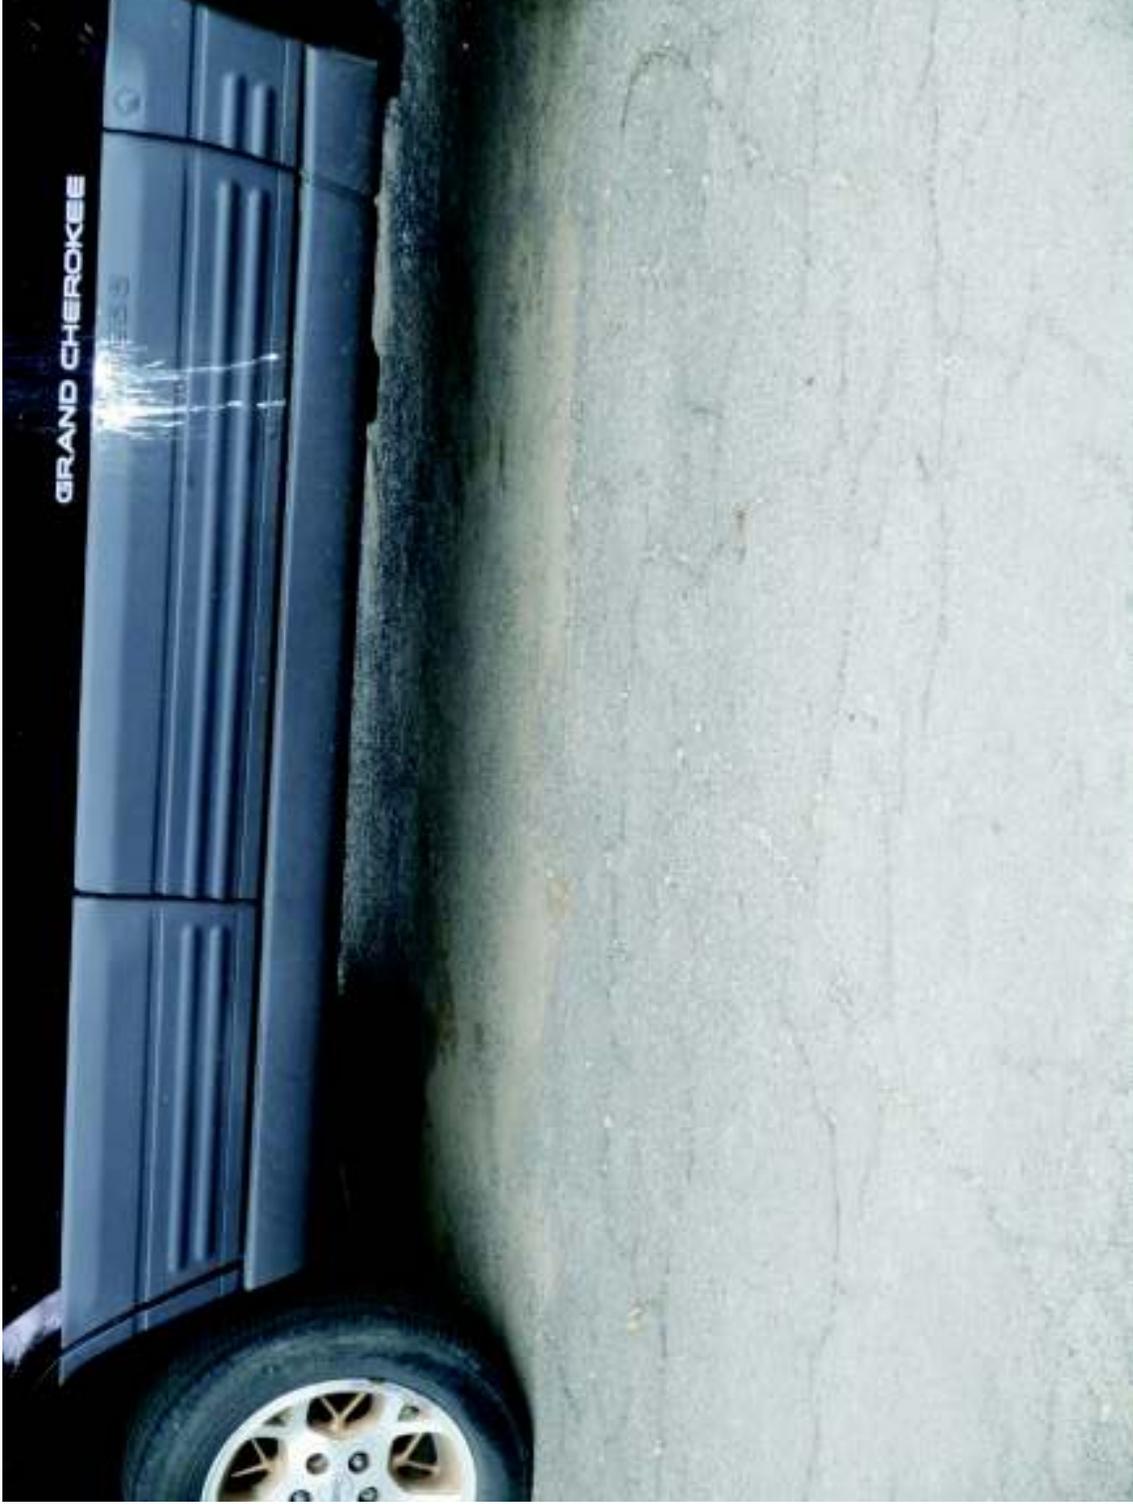
Photograph 8 - Layer of soil/dust can be observed under vehicles and along east and west sides of road on Delmar Avenue.

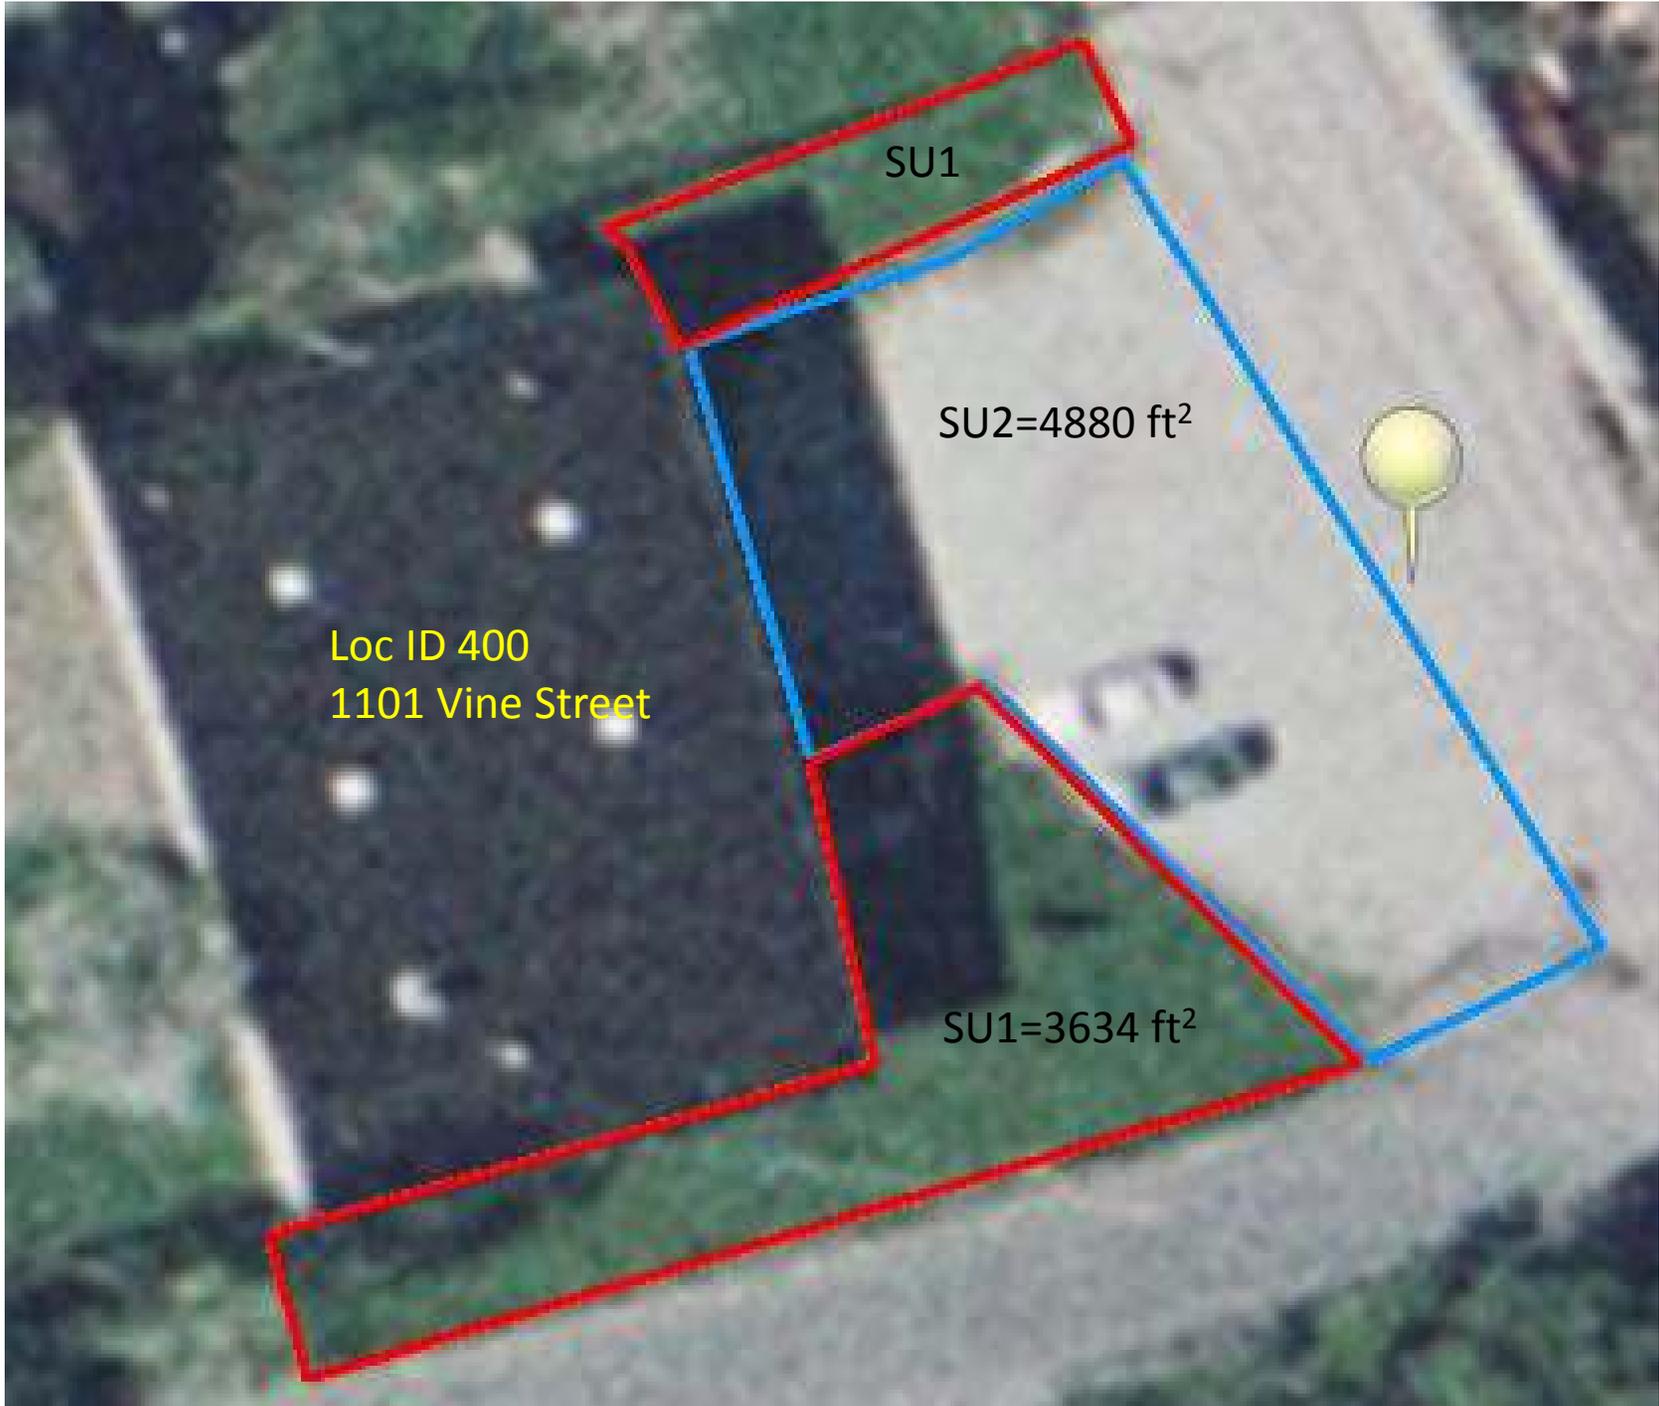
Loc ID 400
1101 Vine Street

SU1

SU2=4880 ft²

SU1=3634 ft²

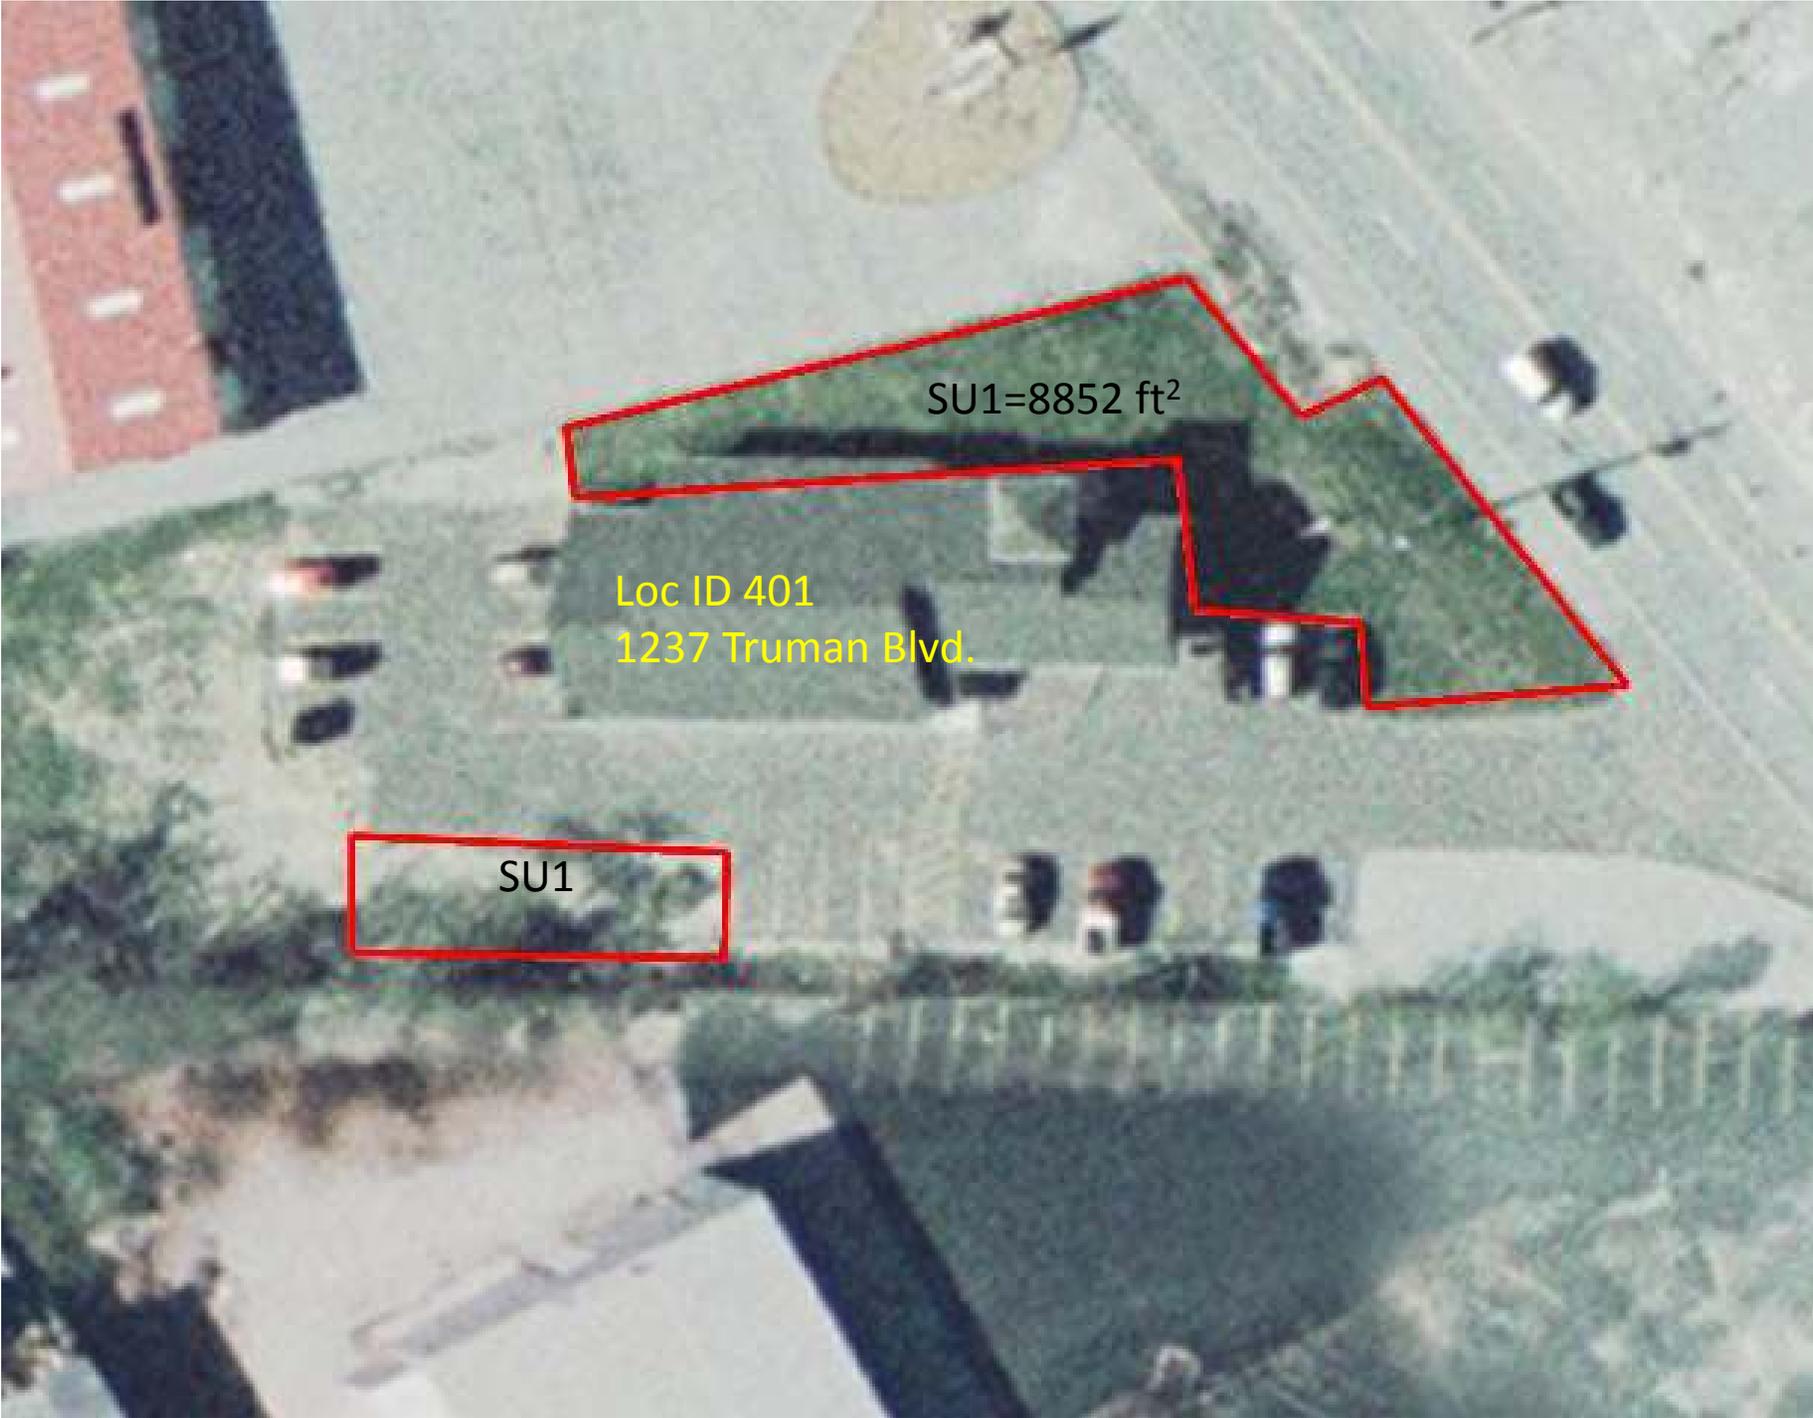
Loc ID 401
1237 Truman Blvd.

SU1=8852 ft²

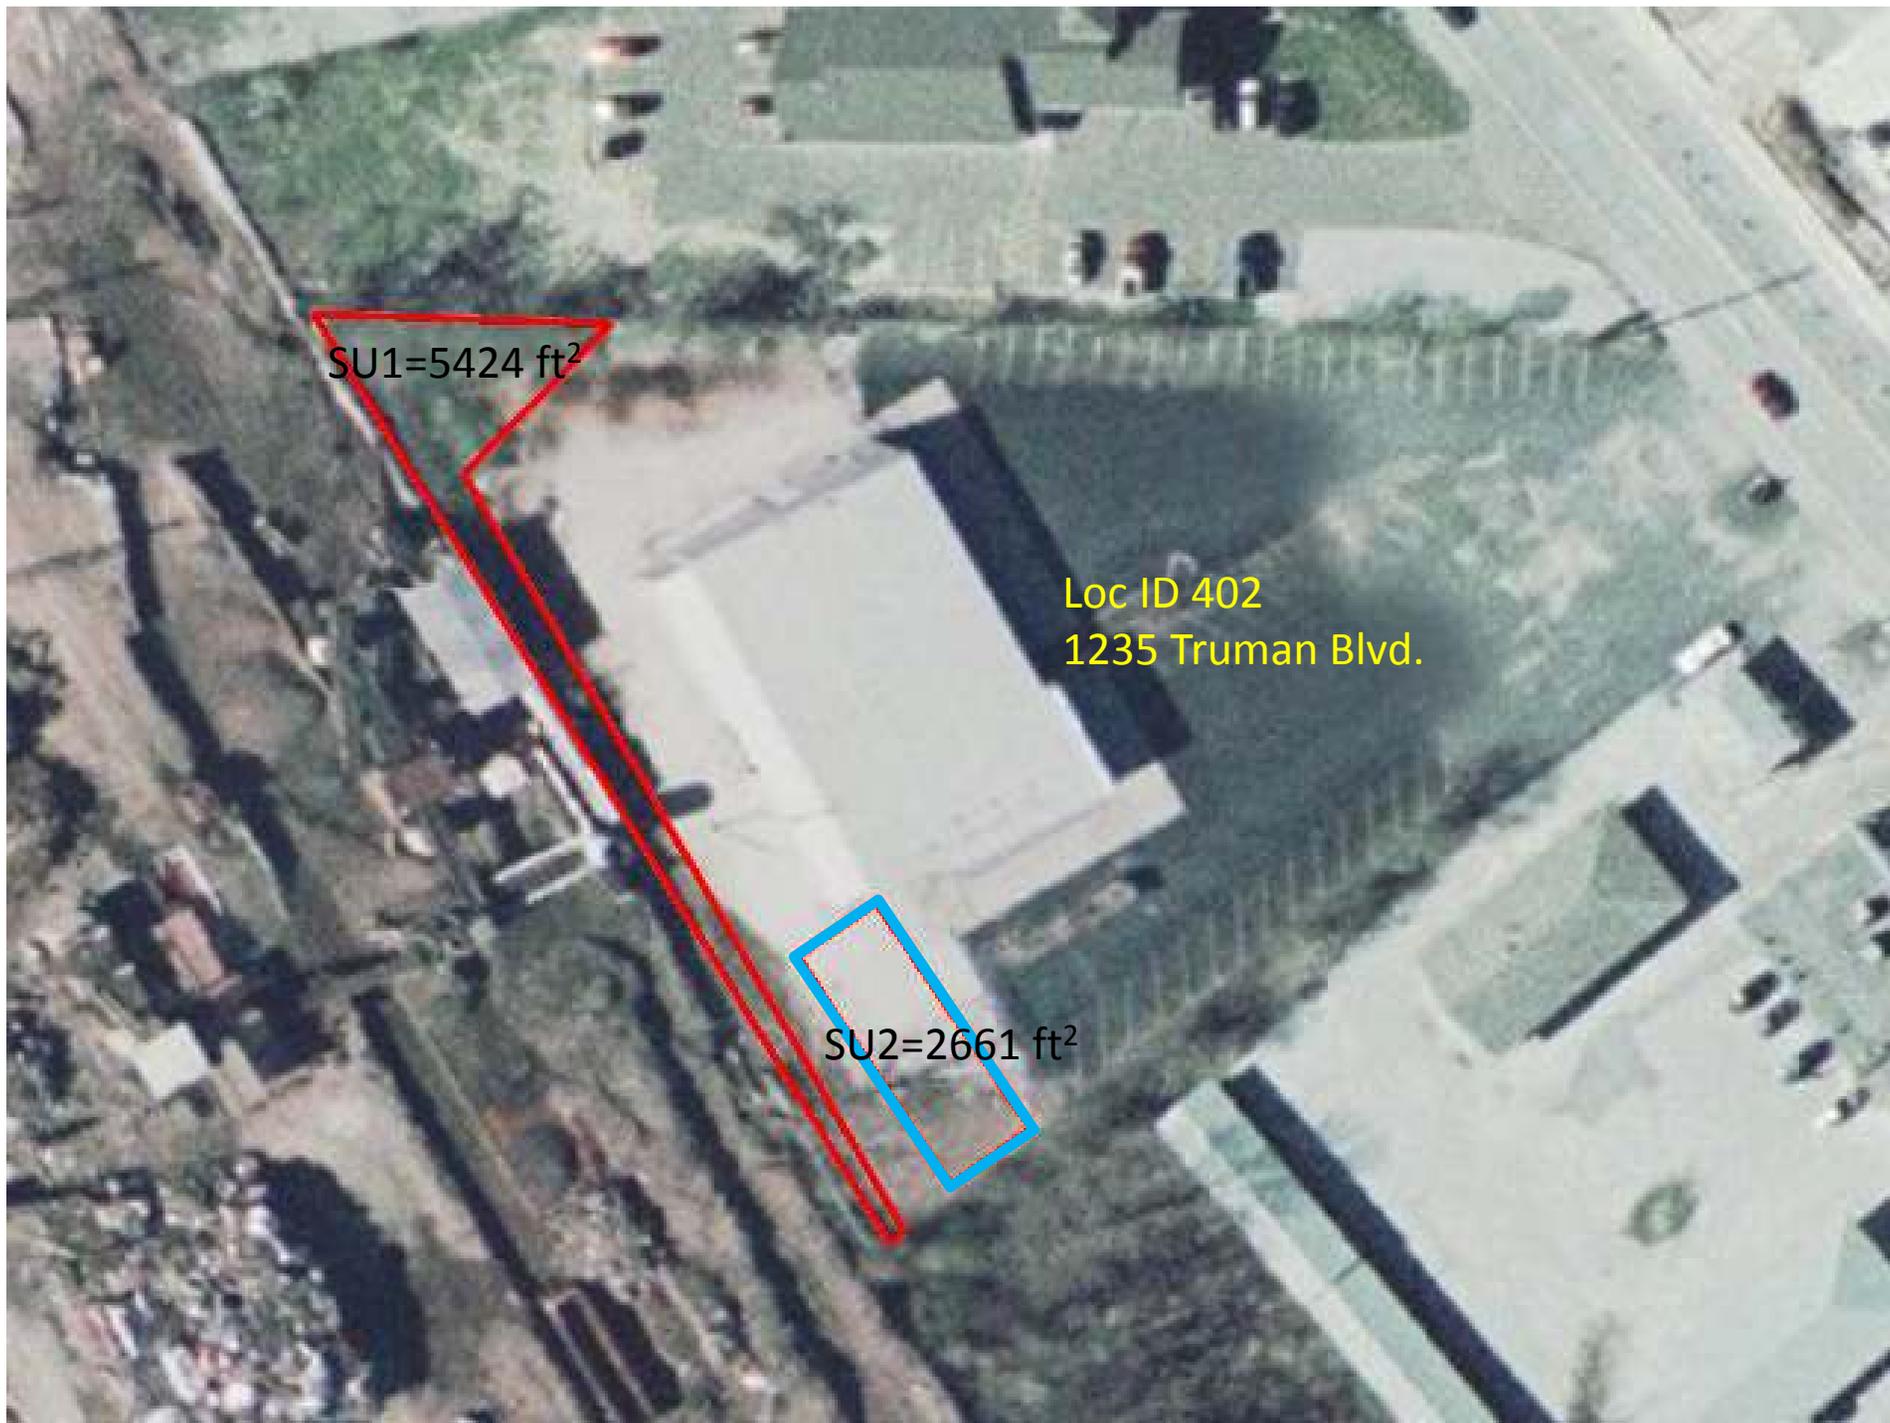
Loc ID 402
1235 Truman Blvd.

SU1=5424 ft²

SU2=2661 ft²

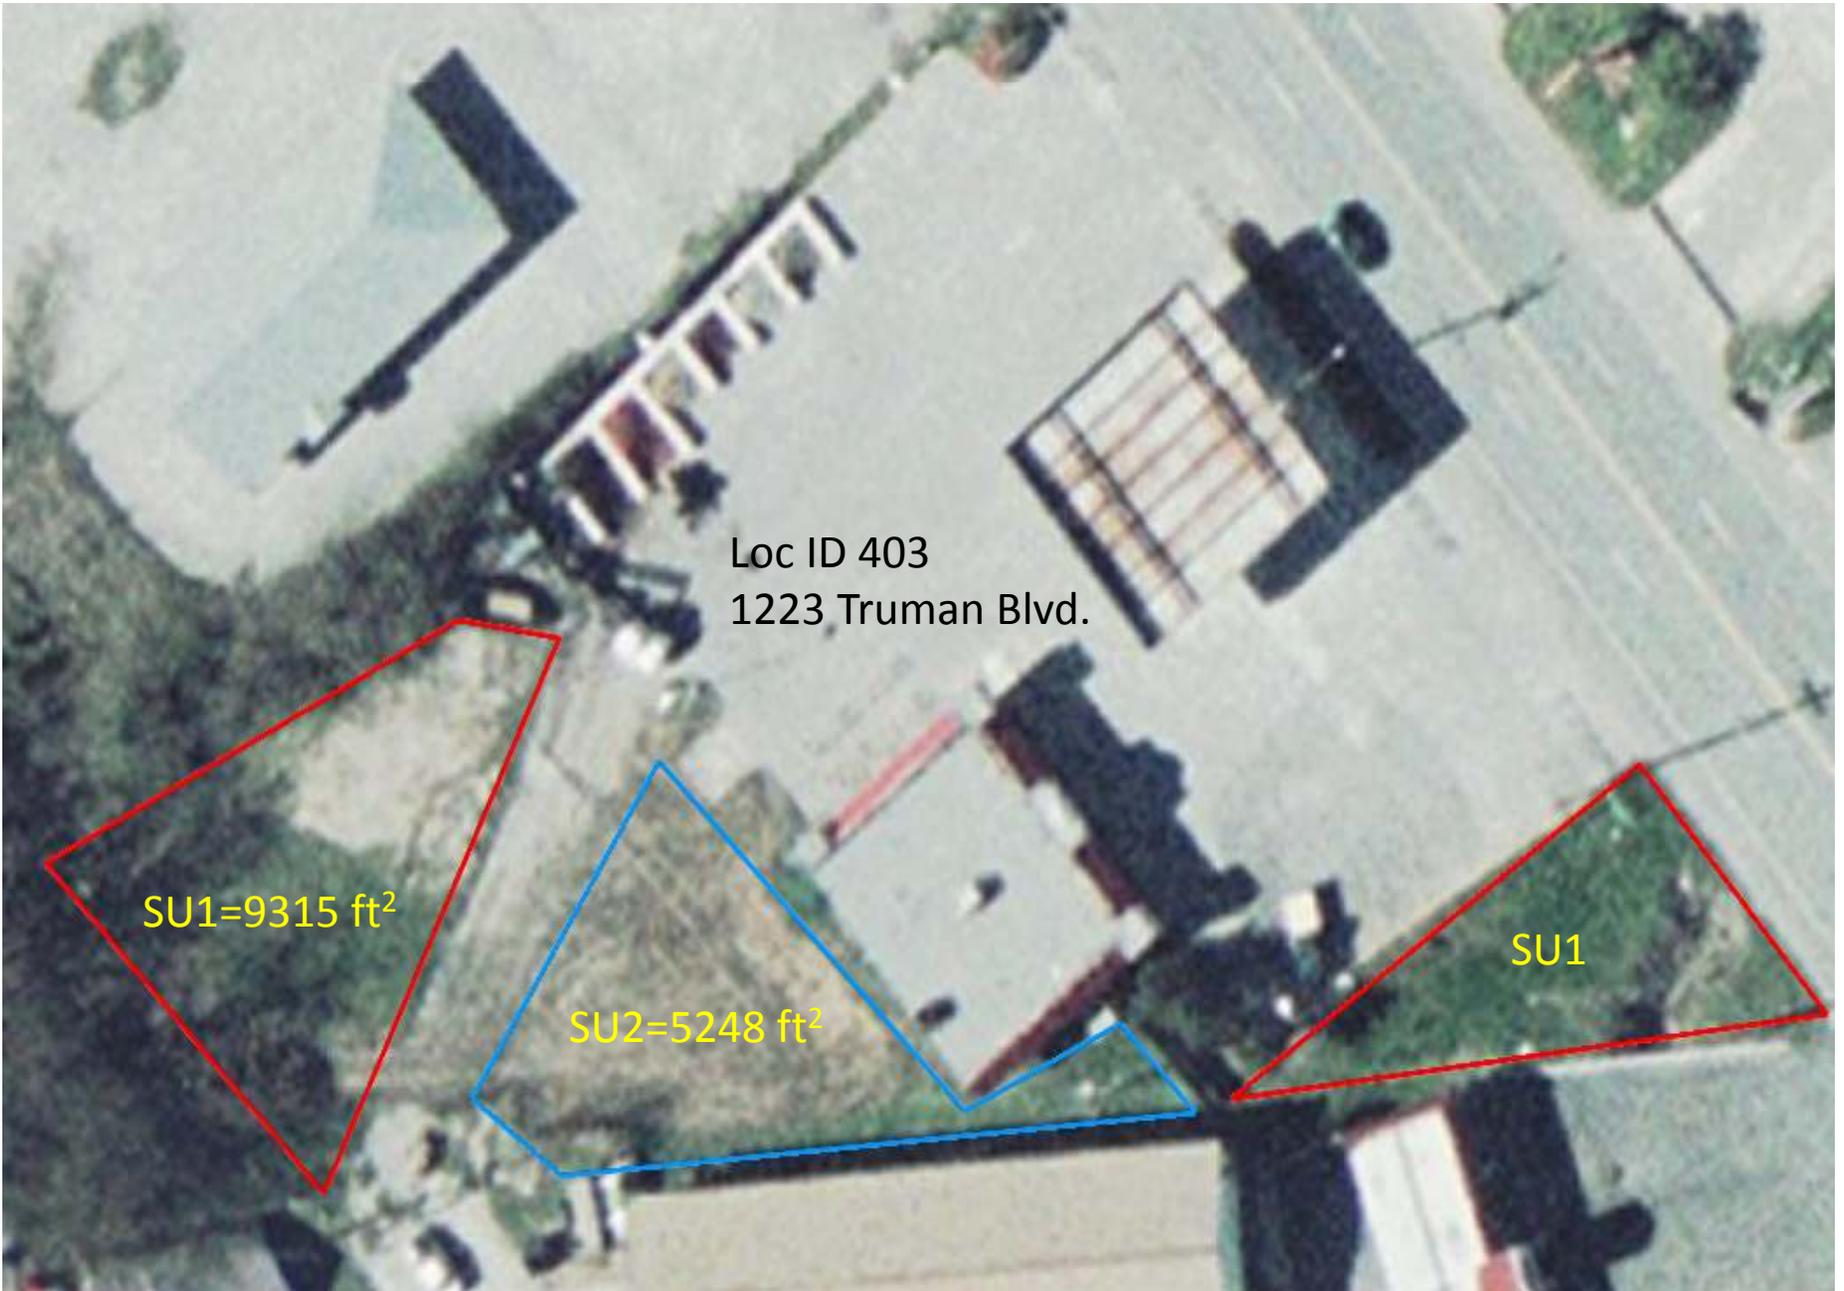
Loc ID 403
1223 Truman Blvd.

SU1=9315 ft²

SU2=5248 ft²

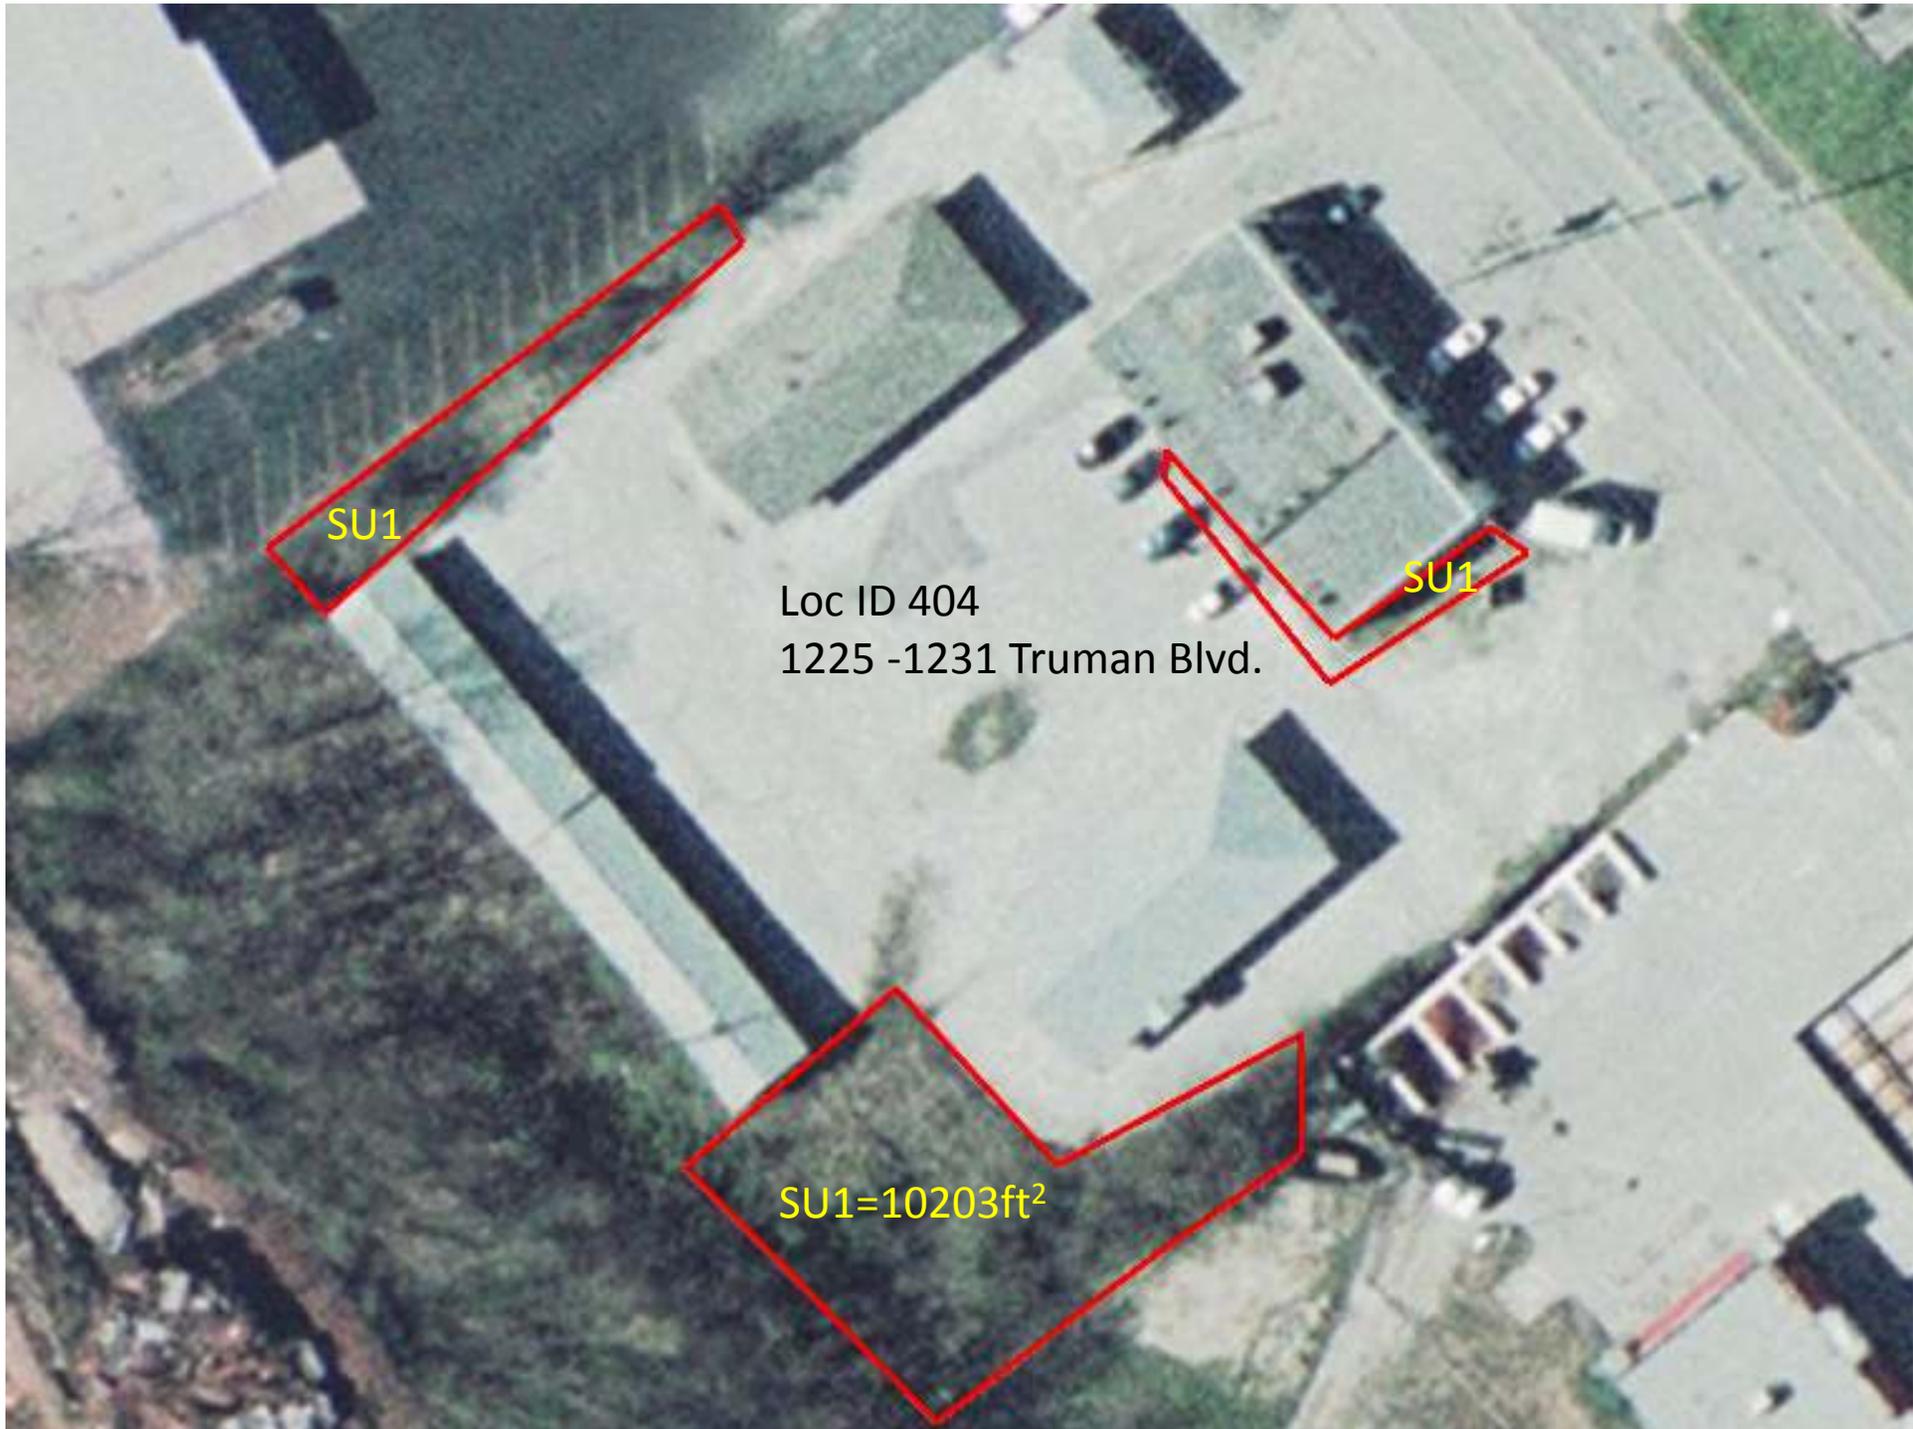
Loc ID 404
1225 -1231 Truman Blvd.

SU1=10203ft²

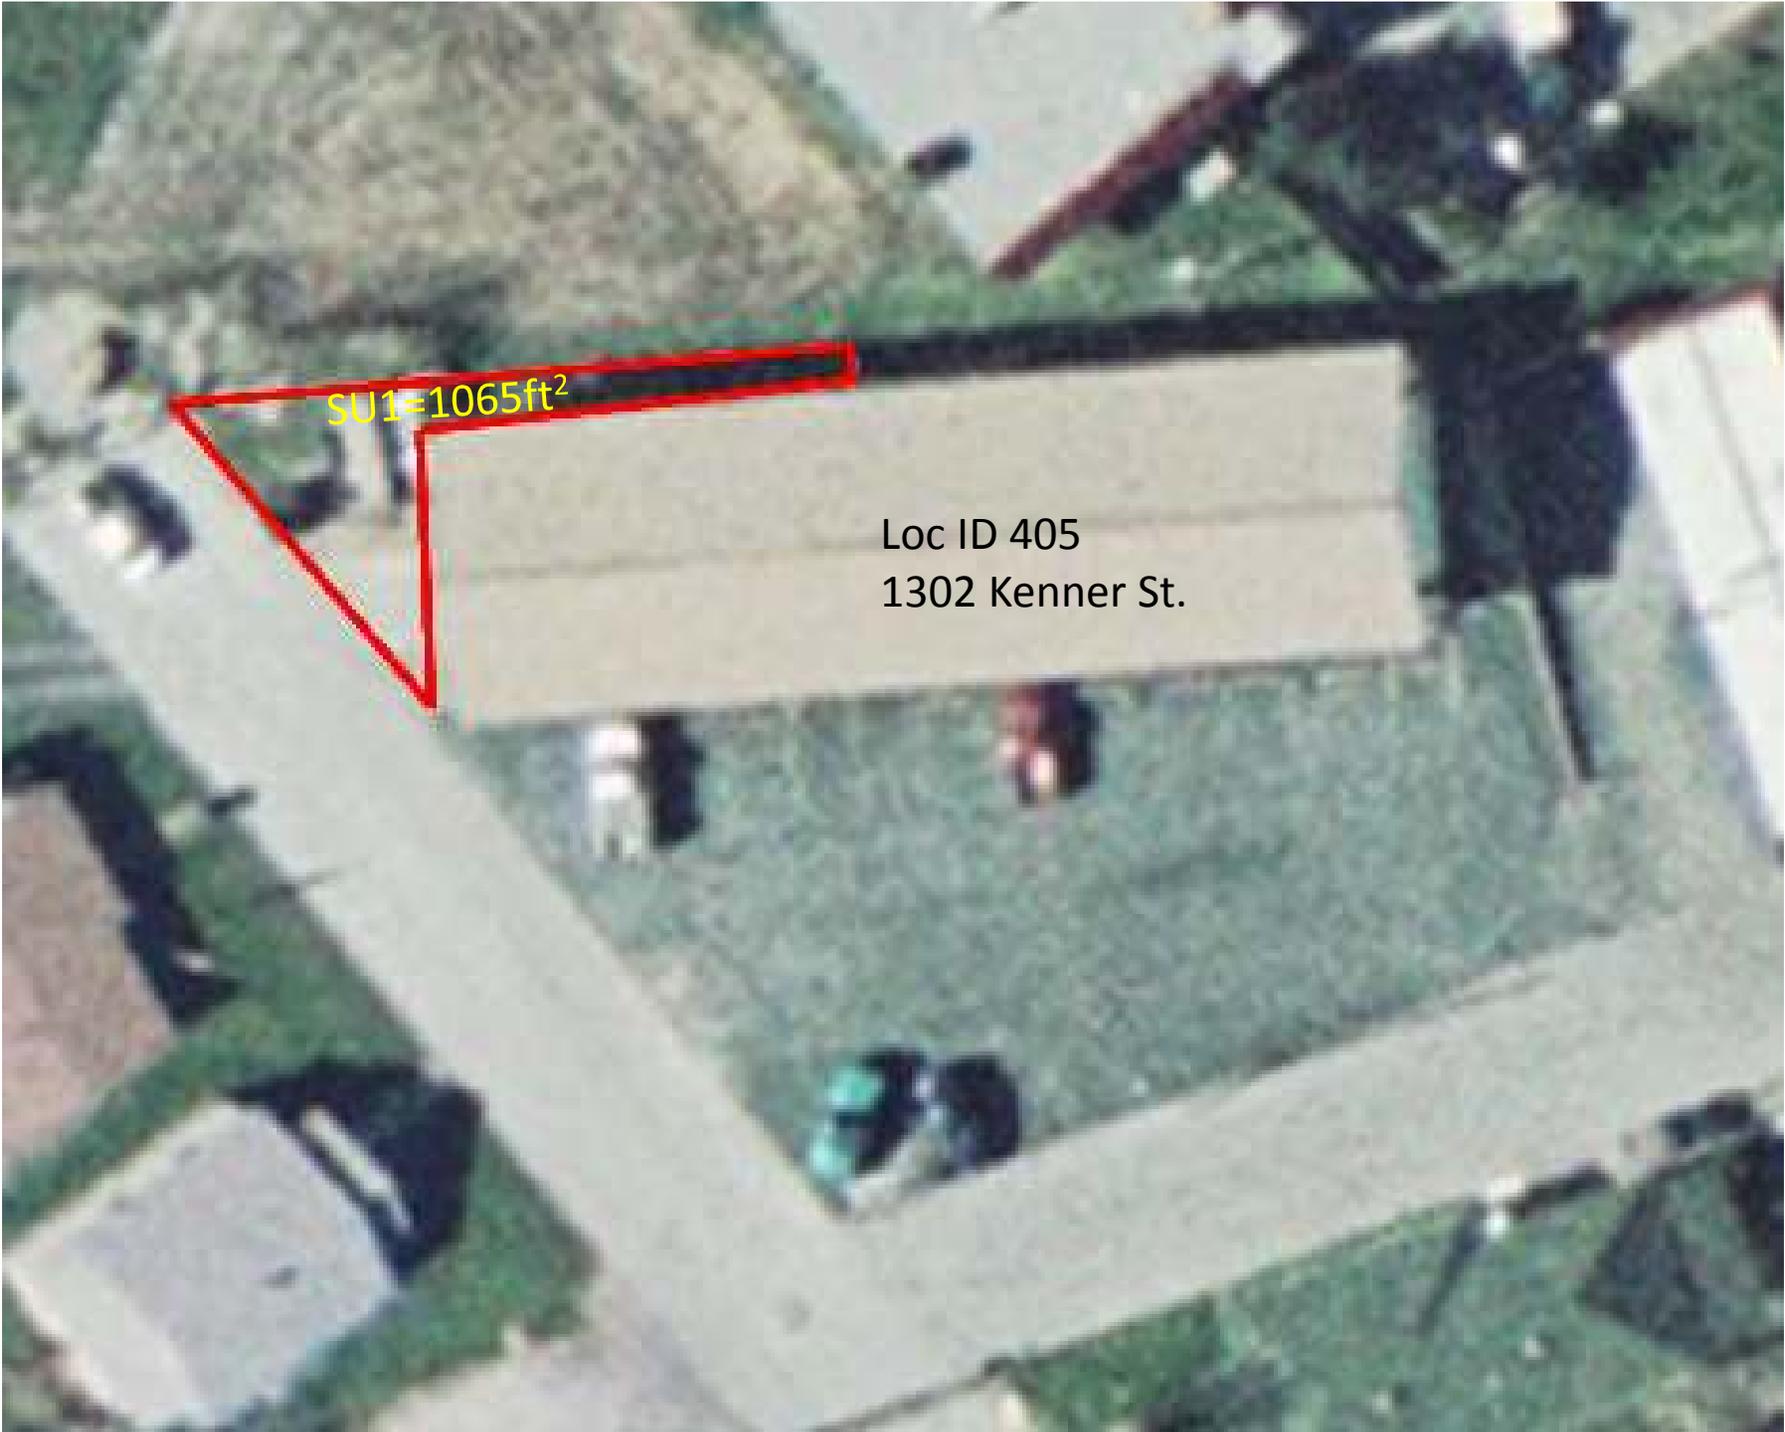
Loc ID 405
1302 Kenner St.

SU1=1065ft²
