SITE REASSESSMENT REPORT

Shapiro Brothers Salvage
Jefferson County, Missouri

EPA ID: MON000706345

September 30, 2013

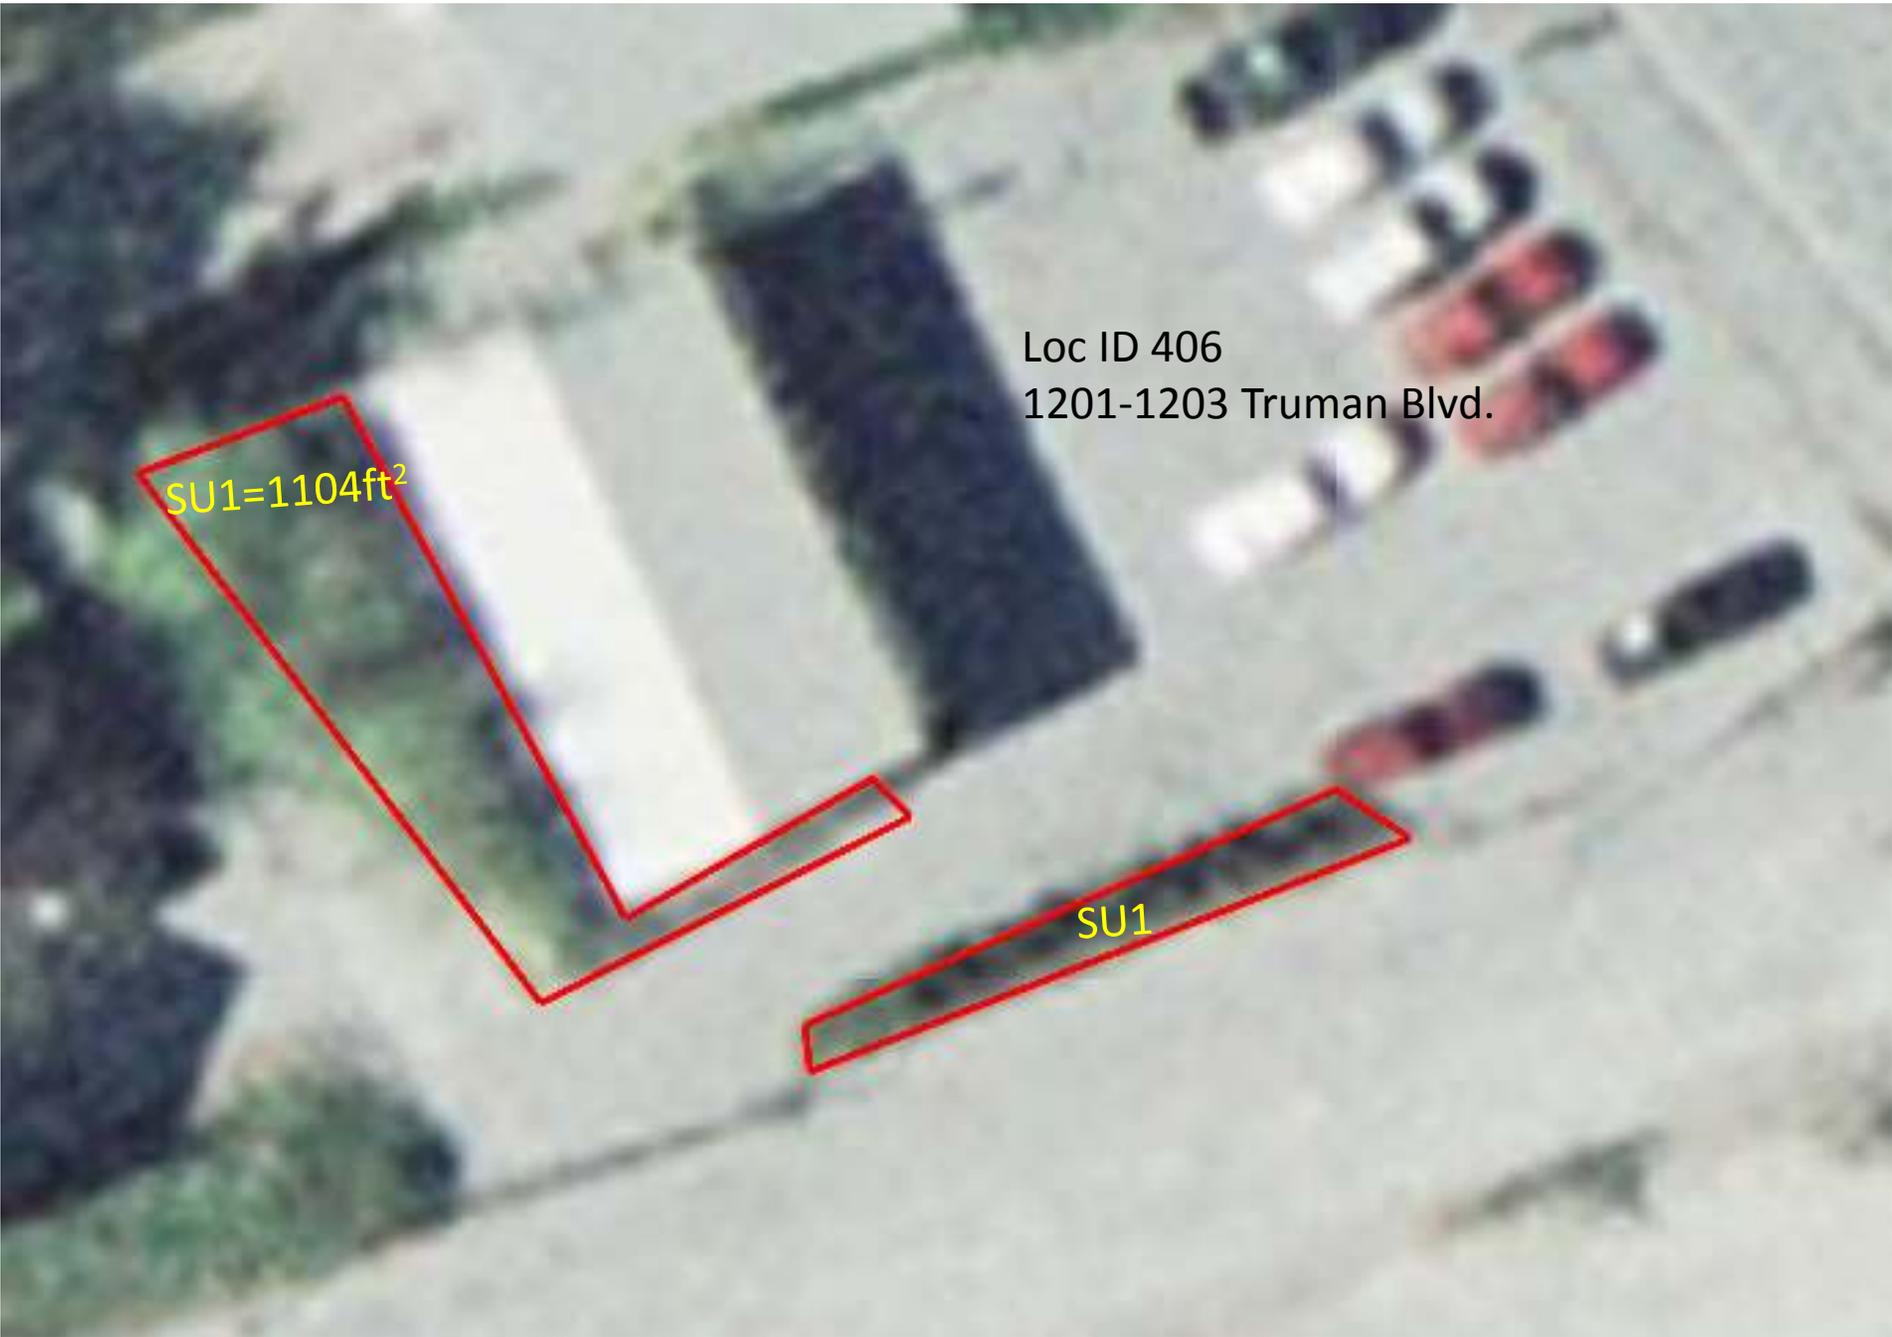
Loc ID 406
1201-1203 Truman Blvd.

SU1=1104ft²

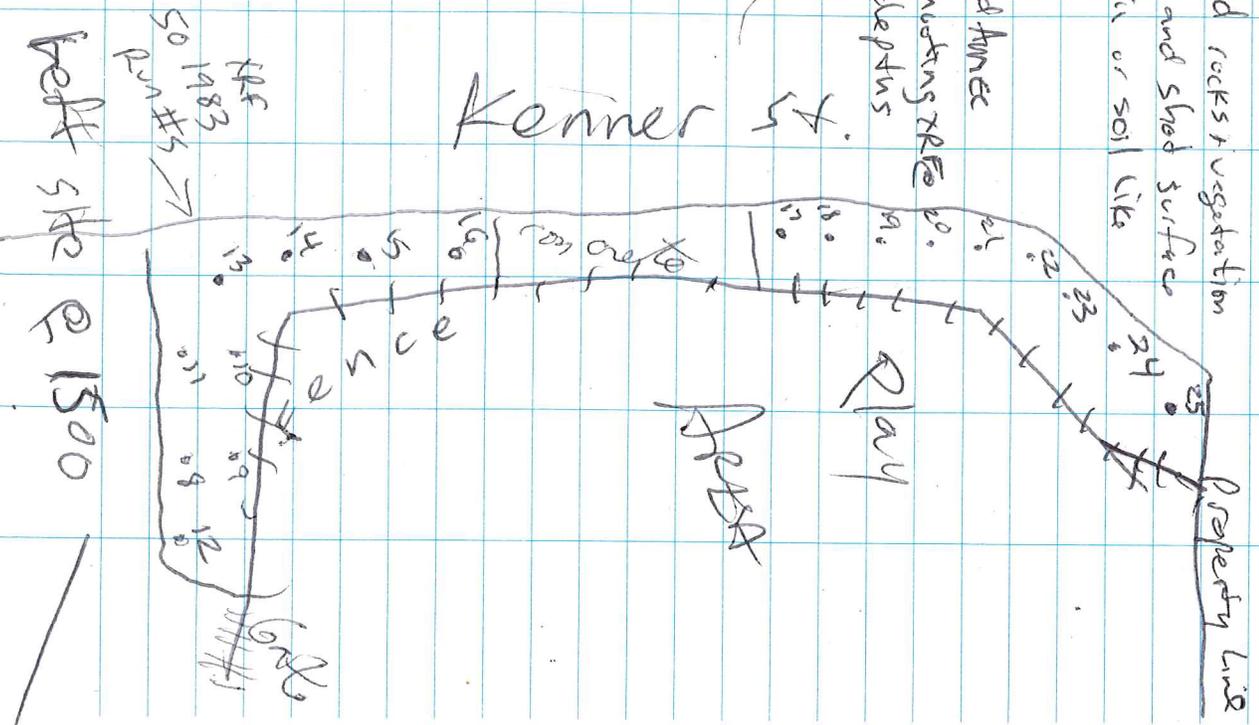
In-Situ XRF Analyses Conducted at Location ID 405 Between Fence and Curb

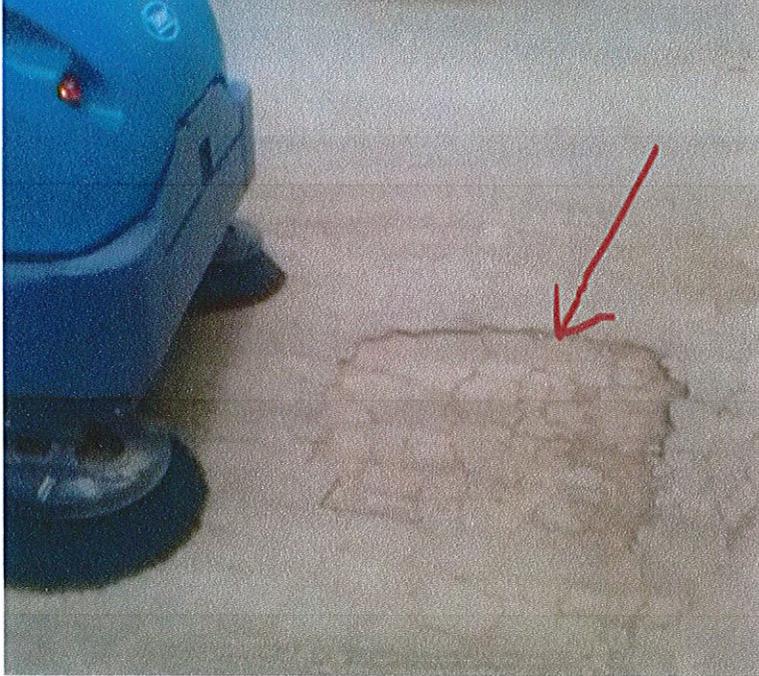
Photo 1 – Broken Pavement

Photo 1 titled "pavement broken" provides an example of an uneven surface. This uneven surface is from the parking lot of the location, however along the side street heading towards the houses there is a large volume of this broken asphalt. In contrast the street in front of the scale is a very flat, even surface with minor cracks. The sweeper cleans this surface with the highest level of success, as can be seen in Photo 2.

The canister for the sweeper was cleaned prior to the sweeper being used on the day of the visit. It appears that when the sweeper seems to be blowing dust, the canister needs cleaning, and this will be a focus of the sweeper operators going forward. A sweeper inspection and operation log has been developed and will be completed daily by the operator effective June 28, 2013.
