Missouri
Department of
Natural Resources

Use Attainability Analysis

WBID 0034 Birkhead Branch

Field Data Sheets for Recreational Use Stream Surveys

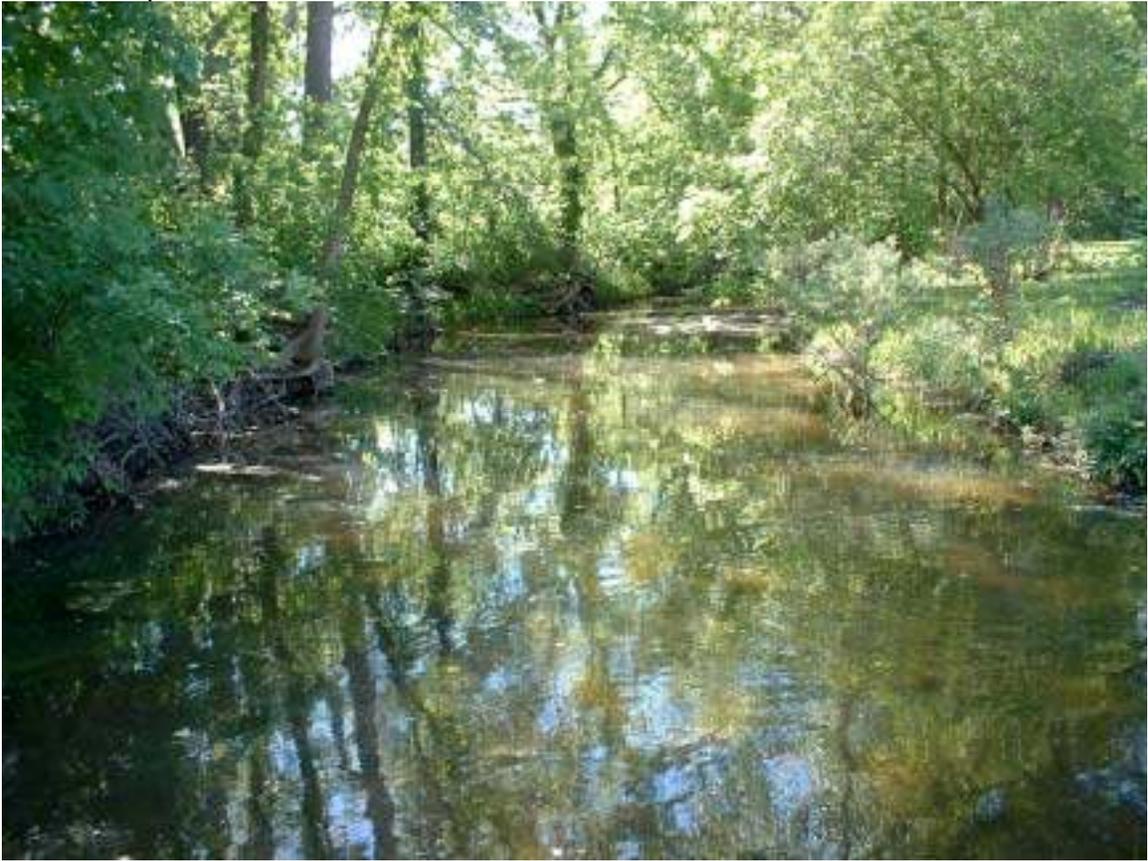
0034-01-up

<input type="checkbox"/> Riffle	Width (ft):	Length (ft):	Avg. Depth (ft):	Max. Depth (ft):
<input type="checkbox"/> Run	Width (ft):	Length (ft):	Avg. Depth (ft):	Max. Depth (ft):
<input checked="" type="checkbox"/> Pool	Width (ft): <u>25</u>	Length (ft): <u>100</u>	Avg. Depth (ft): <u>1</u>	Max. Depth (ft): <u>2.5</u>
<input type="checkbox"/> Flow Present?	<input checked="" type="checkbox"/> Yes <input type="checkbox"/> No		Estimated (ft ³ /sec):

Comments: Please attach additional comments (including information from interviews) to this form.
Water backing up from stone dam someone built. 50 minnows observed
 *This information is not to be used solely for removal of a recreational use designation but rather is to provide a more comprehensive understanding of water conditions. Consequently, this information is not intended to directly influence a decision on the recreation use analysis but may point to conditions that need further analysis or that effect another use.

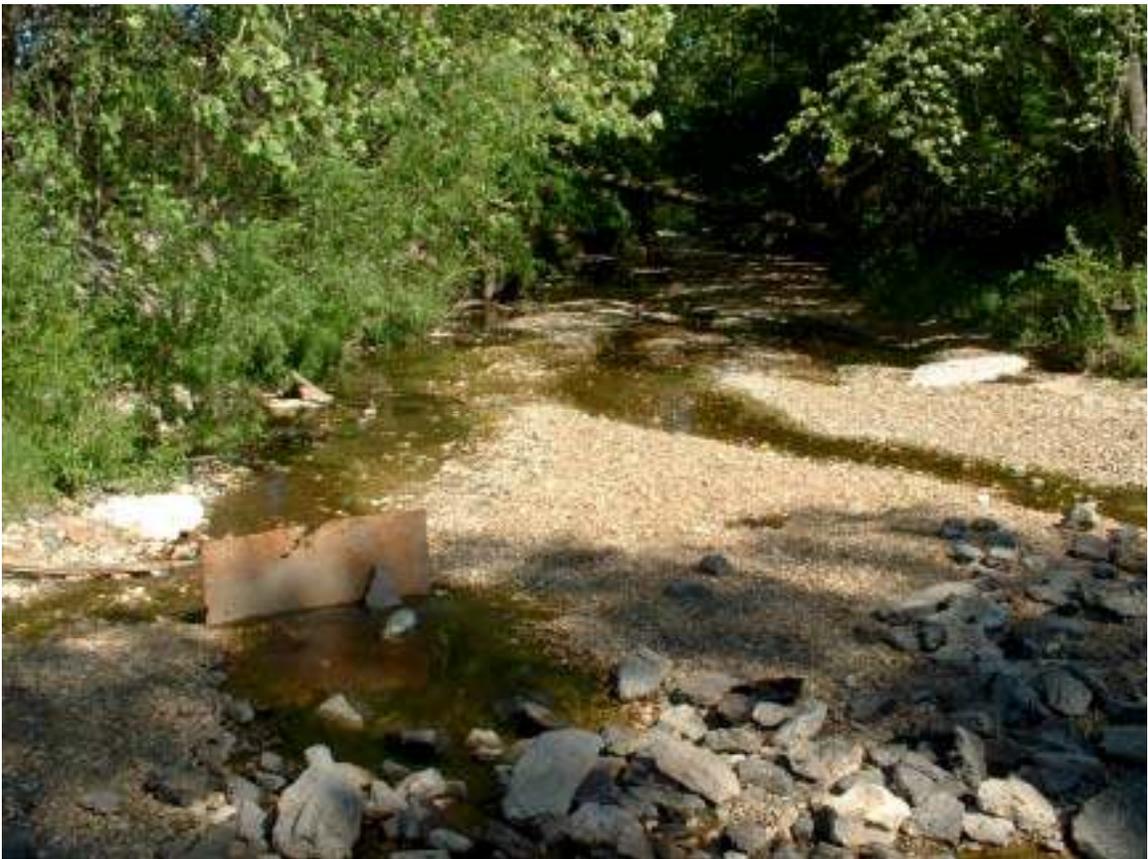
0034-01-ds

<input type="checkbox"/> Riffle	Width (ft):	Length (ft):	Avg. Depth (ft):	Max. Depth (ft):
<input checked="" type="checkbox"/> Run	Width (ft): <u>10</u>	Length (ft): <u>20</u>	Avg. Depth (ft): <u>0.25</u>	Max. Depth (ft): <u>0.5</u>
<input type="checkbox"/> Pool	Width (ft):	Length (ft):	Avg. Depth (ft):	Max. Depth (ft):
<input type="checkbox"/> Flow Present?	<input checked="" type="checkbox"/> Yes <input type="checkbox"/> No		Estimated (ft ³ /sec):

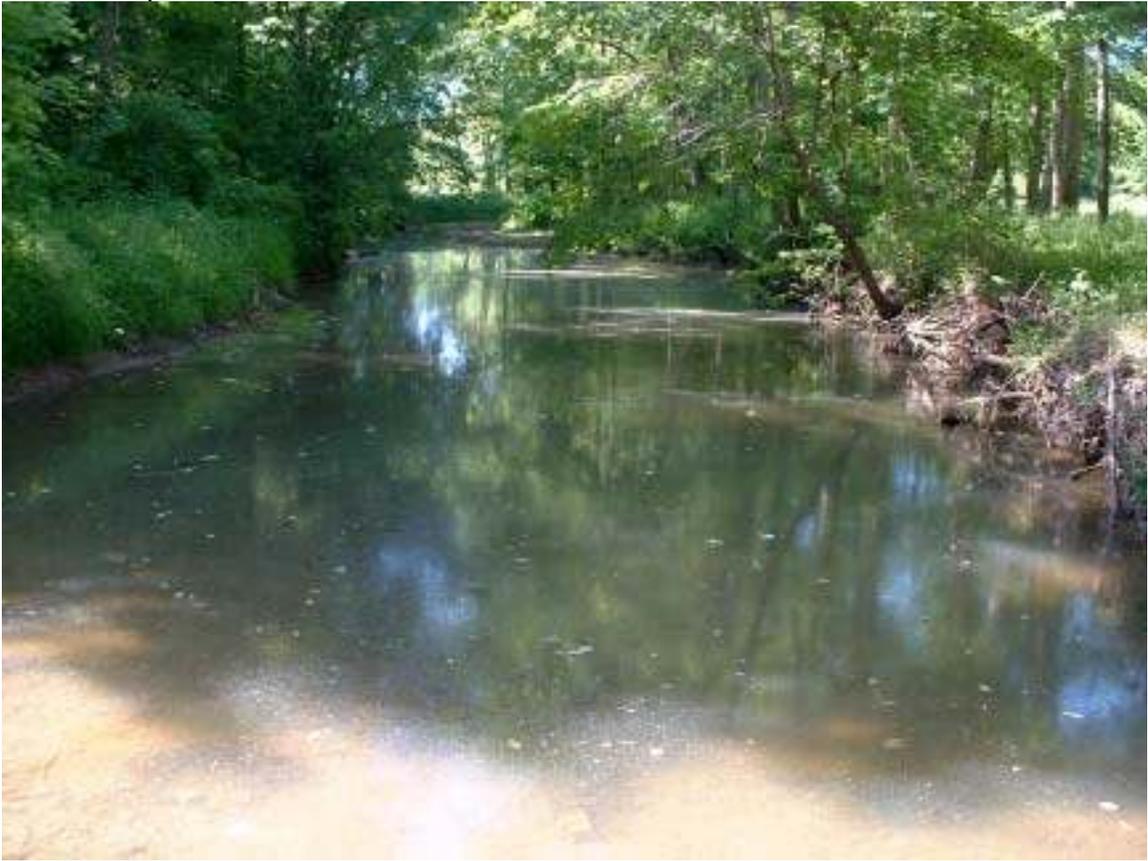
0034-02-up

<input type="checkbox"/> Riffle	Width (ft):	Length (ft):	Avg. Depth (ft):	Max. Depth (ft):
<input type="checkbox"/> Run	Width (ft):	Length (ft):	Avg. Depth (ft):	Max. Depth (ft): 2.5
<input checked="" type="checkbox"/> Pool	Width (ft): <u>25</u>	Length (ft): <u>100</u>	Avg. Depth (ft): <u>1.0</u>	Max. Depth (ft): <u>2.5</u>
<input type="checkbox"/> Flow Present?	<input checked="" type="checkbox"/> Yes <input type="checkbox"/> No		Estimated (ft ³ /sec):

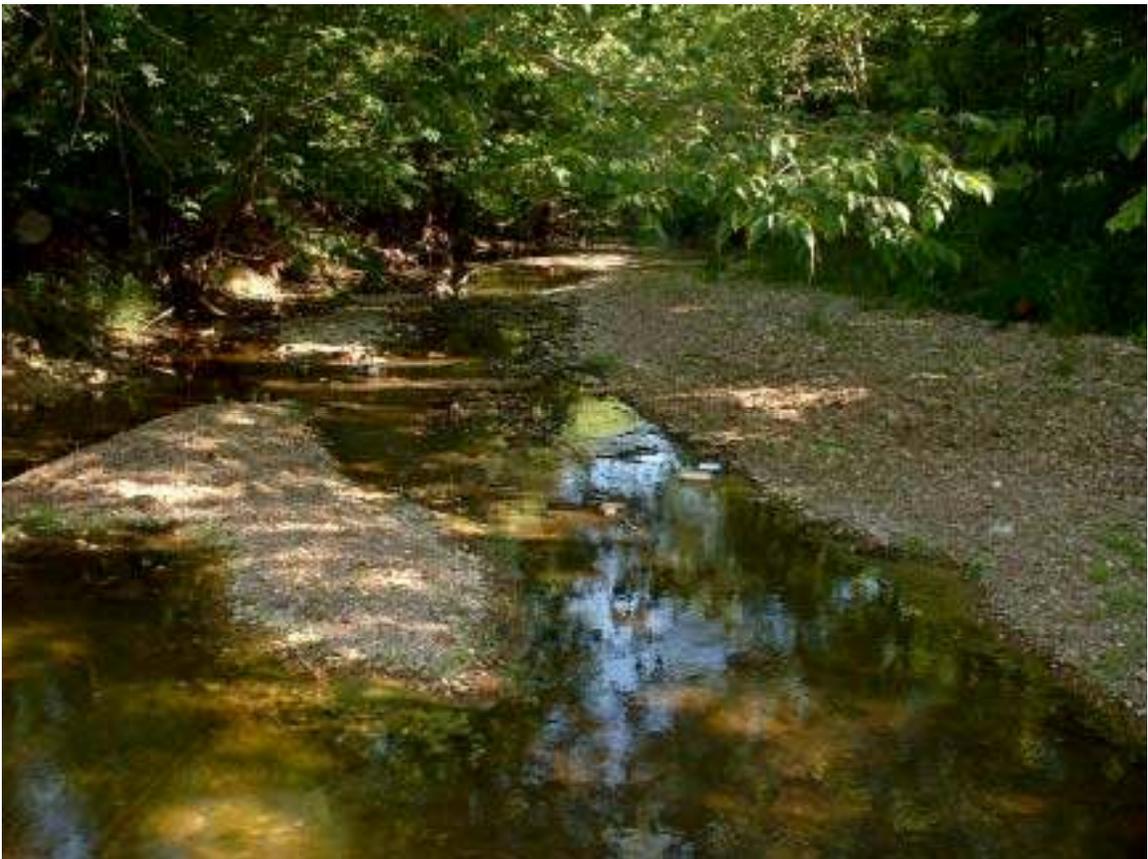
0034-02-ds

<input type="checkbox"/> Riffle	Width (ft):	Length (ft):	Avg. Depth (ft):	Max. Depth (ft):
<input checked="" type="checkbox"/> Run	Width (ft): <u>6</u>	Length (ft): <u>20</u>	Avg. Depth (ft): <u>0.5</u>	Max. Depth (ft): <u>0.75</u>
<input type="checkbox"/> Pool	Width (ft):	Length (ft):	Avg. Depth (ft):	Max. Depth (ft):
<input type="checkbox"/> Flow Present?	<input checked="" type="checkbox"/> Yes <input type="checkbox"/> No		Estimated (ft ³ /sec):

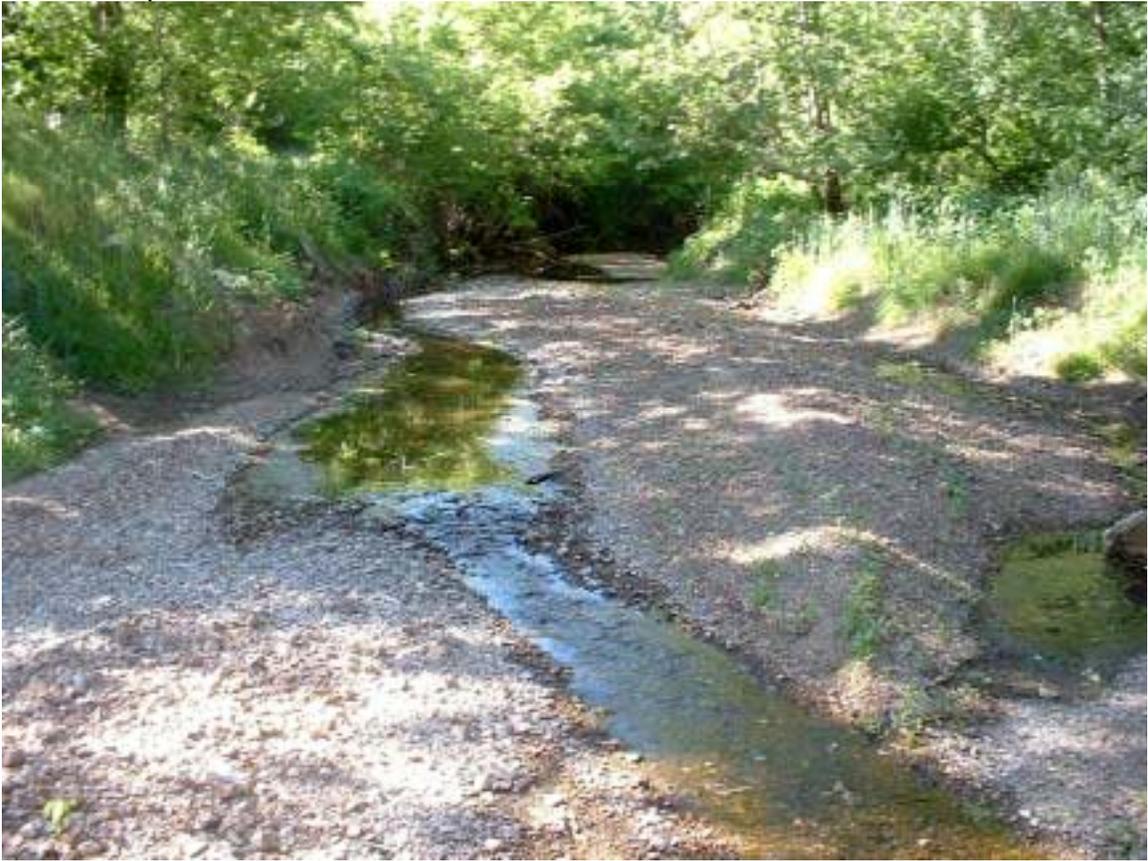
0034-03-up

<input type="checkbox"/> Riffle	Width (ft):	Length (ft):	Avg. Depth (ft):	Max. Depth (ft):
<input checked="" type="checkbox"/> Run	Width (ft): 5	Length (ft): 15	Avg. Depth (ft): 0.5	Max. Depth (ft): 0.75
<input type="checkbox"/> Pool	Width (ft):	Length (ft):	Avg. Depth (ft):	Max. Depth (ft):
<input type="checkbox"/> Flow Present?	<input checked="" type="checkbox"/> Yes <input type="checkbox"/> No		Estimated (ft ³ /sec):

50 minnows observed, tire

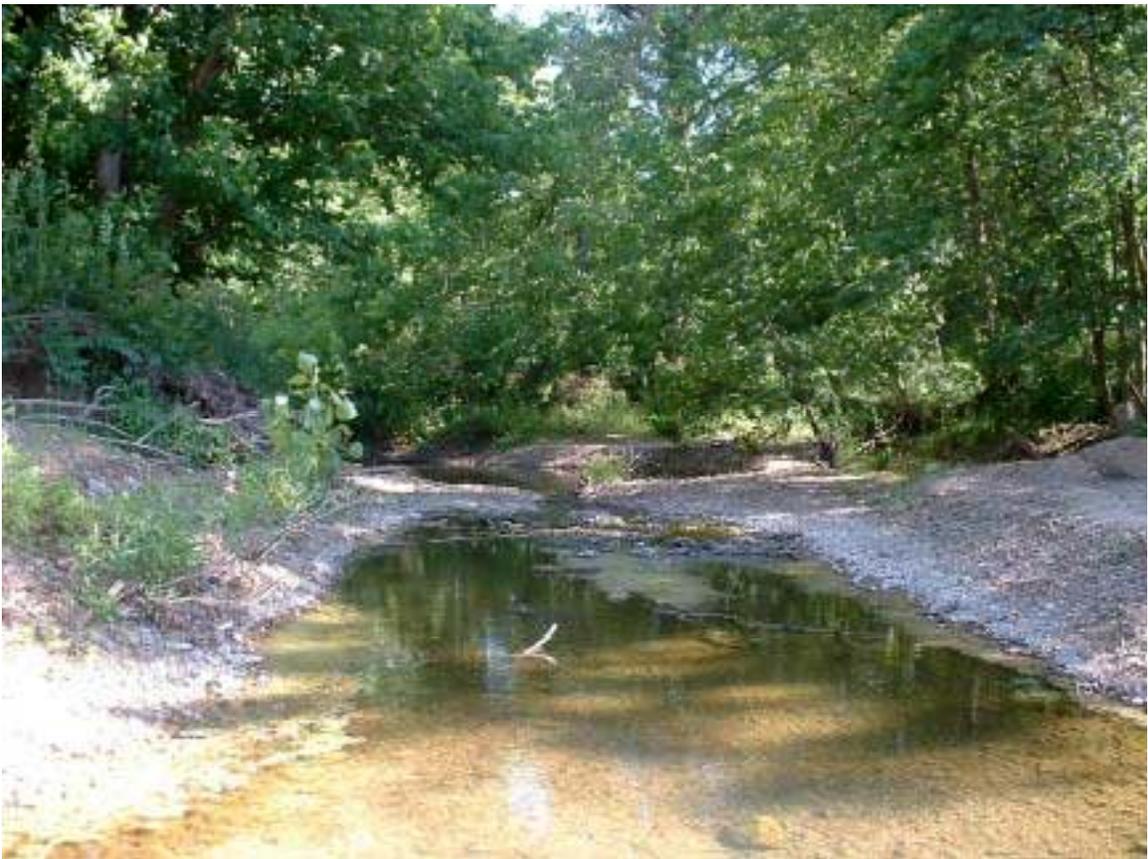
0034-03-ds

<input type="checkbox"/> Riffle	Width (ft):	Length (ft):	Avg. Depth (ft):	Max. Depth (ft):
<input type="checkbox"/> Run	Width (ft):	Length (ft):	Avg. Depth (ft):	Max. Depth (ft):
<input checked="" type="checkbox"/> Pool	Width (ft): 15	Length (ft): 15	Avg. Depth (ft): 1.5	Max. Depth (ft): 3.5
<input type="checkbox"/> Flow Present?	<input checked="" type="checkbox"/> Yes <input type="checkbox"/> No		Estimated (ft ³ /sec):
