**Muddy Creek
Recreational Use Attainability Analysis**

July 2005

MEC WATER RESOURCES, INC.
1000 North College Avenue, Suite 4
Columbia, Missouri 65201

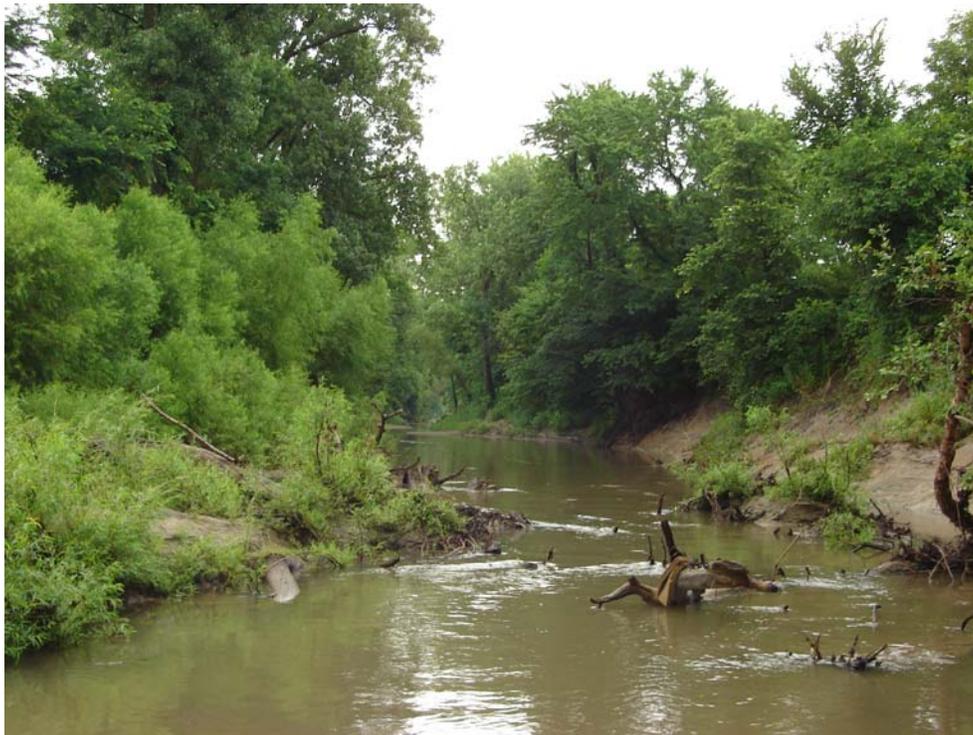
Figure 3. Muddy Creek Site 1 Upstream View

Mean depth along a 1,000 ft. assessment reach was 0.46 ft. as determined from 10 transects (Appendix B). The maximum depth observed at this location was 1.49 ft. MEC staff measured streamflow as 17.15 cfs.

The landscape near the Trenton WWTF is mostly row crop with some lightly forested areas. The banks are steeply sloping and are mostly covered with sand and some grass and small shrubs (Figures 2 and 3). Riparian areas are narrow and are composed of trees and shrubs. Channel substrate is predominately sand.

MEC staff did not observe any direct or indirect evidence of WBCR at Site 1. MEC staff concludes that WBCR is neither an existing nor an attainable use at this site based on no public access due to fencing, steep slopes, absence of observed WBCR uses, and shallow conditions.

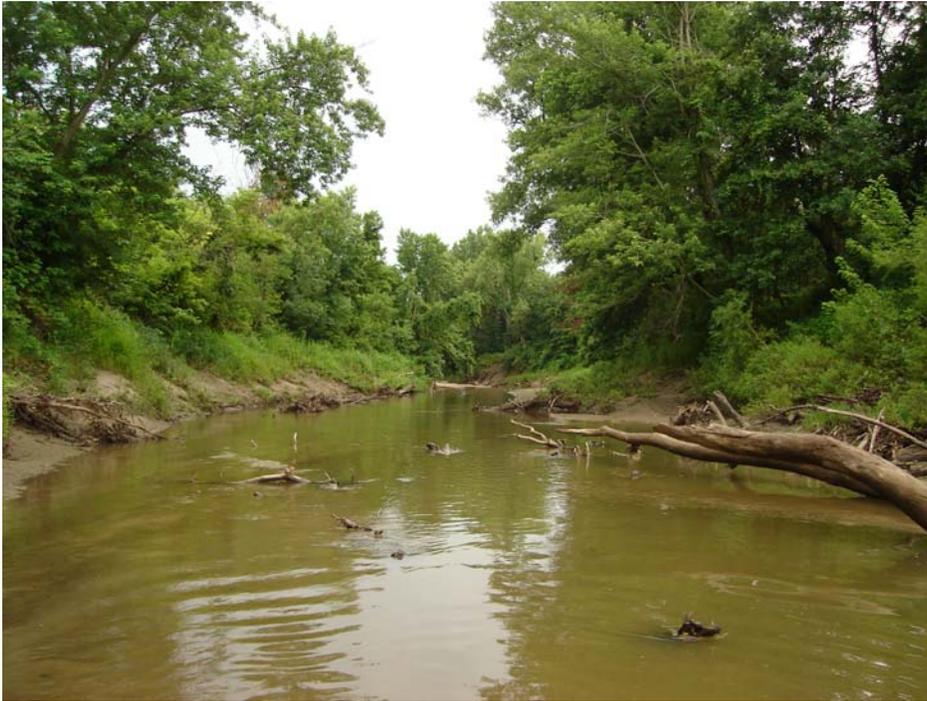
Figure 4. Muddy Creek Site 2 Downstream View

The stream banks at Site 2 are steeply sloping and are covered with low-growing brush (Figures 4 and 5). Riparian areas are vegetated by the upland deciduous forest complex and row crop agriculture. The stream channel was observed to be mostly sand with some mud.

Mean depth along a 1,350 ft. assessment reach was 0.50 ft. as determined from 10 transects (Appendix B). The maximum depth observed at this location was 2.14 ft. Flow was measured as 15.89 cfs.

MEC staff did not observe any direct or indirect evidence of WBCR at Site 2. MEC staff concludes that WBCR is neither an existing nor an attainable use at this site based on limited access to the stream imposed by no roads, steep slopes, absence of observed WBCR uses, and shallow conditions.

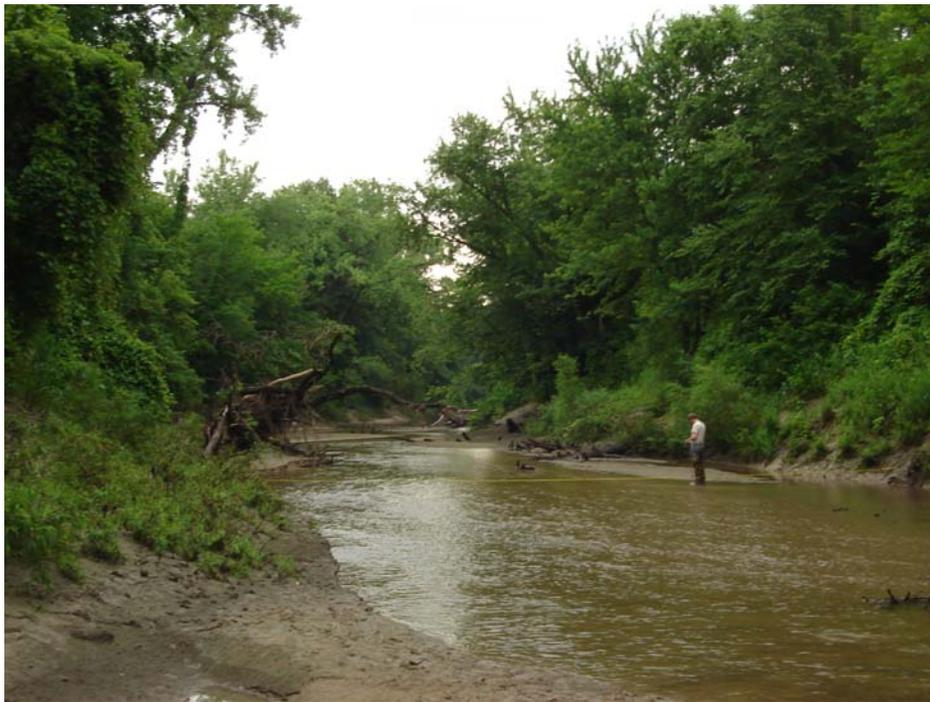
Figure 7. Muddy Creek Site 3 Upstream View

The riparian area consists of larger trees, thick brush, and some grassy areas (Figures 6 and 7). The stream banks at Site 3 are steep and covered with brush and downed trees (Figure 7). Stream substrate consisted of mostly sand with some mud and clay.

Mean depth along a 1,200 ft. assessment reach was 0.72 feet as determined from 11 transects (Appendix B). The maximum depth observed at this location was 2.15. Measured streamflow was 15.93 cfs at this site.

MEC staff did not observe any direct or indirect evidence of WBCR at Site 2. MEC staff concludes that WBCR is neither an existing nor an attainable use at this site based on limited access to the stream imposed by no roads, steep slopes, absence of observed WBCR uses, and low flow shallow conditions.
