Use Attainability Analysis

WBID 0721 Collier Creek

Submitted by
SES, Inc.

Field Data Sheets for Recreation Use Stream Surveys
Data Sheet A - Water Body Identification
 (For water body being surveyed)

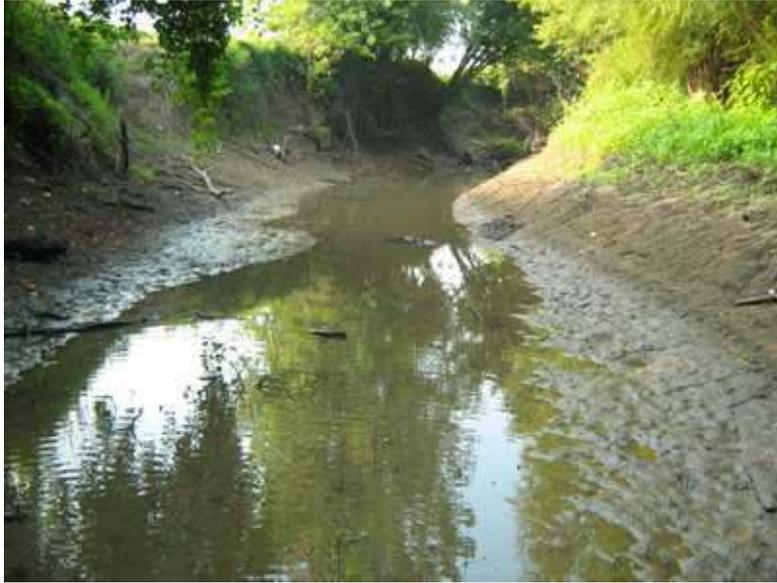
Site# 1 Photo ID# 2, Upstream

WBID 721
 Site # 1

Site Location (e.g. road crossing) between sites #2 and #3

Swimming	Skin Diving	SCUBA diving	Tubing
Water Skiing	Wind Surfing	Kayaking	Boating
Wading	Rafting	Hunting	Trapping
Fishing	<u>None of the Above</u>	Other

Depth (m)	
Transect 9	0.05	
Substrate:	0.10	
silt	0.10	
Water Clarity:	0.10	
clear	0.10	
Channel Feature:	0.05	
pool	0.10	
Channel Width:	0.05	
5 yards	0.05	
0.08	0.05	
Transect 10	0.05	
Substrate:	0.10	
silt	0.20	
Water Clarity:	0.20	
clear	0.20	
Channel Feature:	0.20	
pool	0.20	
Channel Width:	0.15	
5 yards	0.10	
0.18	0.05	
Transect 11	0.05	
Substrate:	0.05	
silt	0.10	
Water Clarity:	0.10	
clear	0.10	
Channel Feature:	0.10	
pool	0.15	
Channel Width:	0.10	
5 yards	0.10	
0.10	0.10	
Site Median	0.10	Site Maximum
		0.30

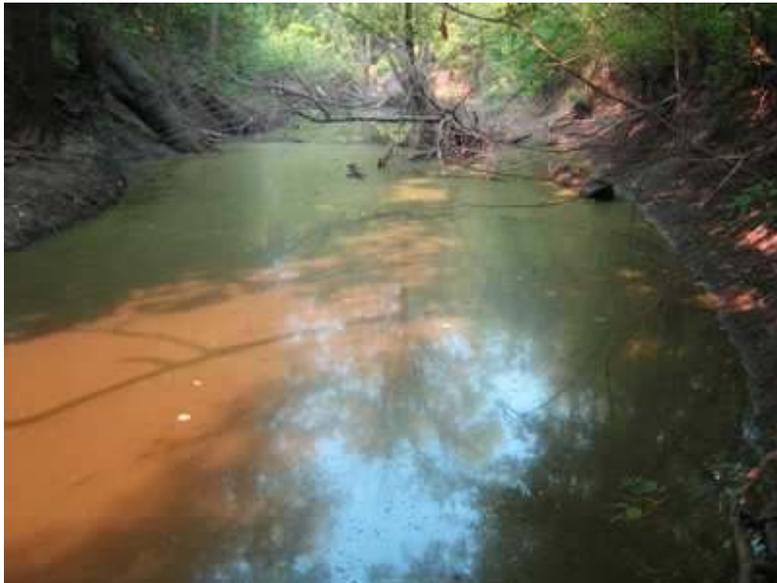
Site# 2 Photo ID# 4, Upstream

WBID 721
 Site # 2

Site Location (e.g. road crossing) downstream site #1

Swimming	Skin Diving	SCUBA diving	Tubing
Water Skiing	Wind Surfing	Kayaking	Boating
Wading	Rafting	Hunting	Trapping
Fishing	<u>None of the Above</u>	Other

Depth (m)	
Transect 9	1.00	
Substrate:	1.00	
silt	1.00	
Water Clarity:	1.00	
none	1.00	
Channel Feature:	1.00	
pool	1.00	
Channel Width:	1.00	
8 yards	1.00	
1.00	1.00	
Transect 10	1.00	
Substrate:	1.00	
silt	1.00	
Water Clarity:	1.00	
none	1.00	
Channel Feature:	1.00	
pool	1.00	
Channel Width:	1.00	
8 yards	1.00	
1.00	1.00	
Transect 11	1.00	
Substrate:	1.00	
silt	1.00	
Water Clarity:	1.00	
none	1.00	
Channel Feature:	1.00	
pool	1.00	
Channel Width:	1.00	
8 yards	1.00	
1.00	1.00	
Site Median	1.00	Site Maximum
		1.00

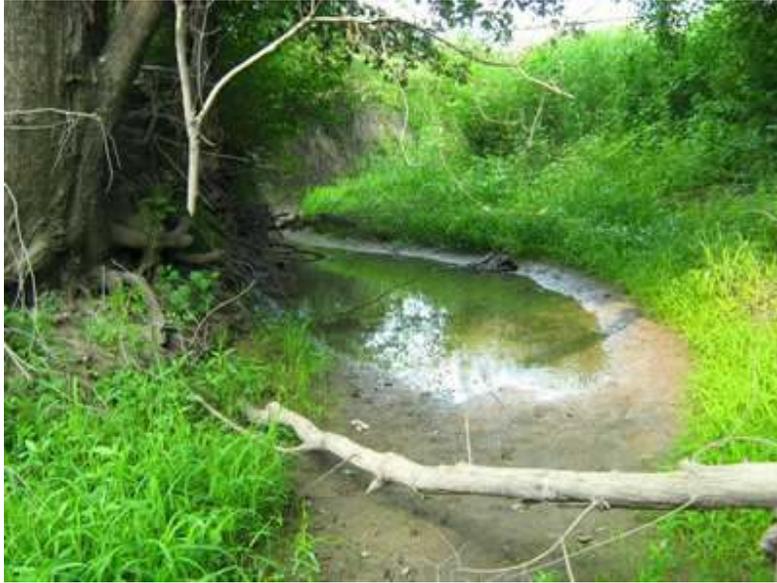
Site# 3 Photo ID# 5, Upstream

WBID 721
 Site # 3

Site Location (e.g. road crossing) Hwy 94

Swimming	Skin Diving	SCUBA diving	Tubing
Water Skiing	Wind Surfing	Kayaking	Boating
Wading	Rafting	Hunting	Trapping
Fishing	<u>None of the Above</u>	Other

Depth (m)
Transect 9	0.00
Substrate:	0.00
silt	0.00
Water Clarity:	0.00
N/A	0.00
Channel Feature:	0.00
N/A	0.00
Channel Width:	0.00
3 yards	0.00
0.00	0.00
Transect 10	0.00
Substrate:	0.00
silt	0.00
Water Clarity:	0.00
N/A	0.00
Channel Feature:	0.00
N/A	0.00
Channel Width:	0.00
3 yards	0.00
0.00	0.00
Transect 11	0.10
Substrate:	0.10
silt	0.15
Water Clarity:	0.15
some	0.15
Channel Feature:	0.20
pool	0.15
Channel Width:	0.15
2 yards	0.10
0.15	0.10
Site Median	0.00
Site Maximum	0.20
