Use Attainability Analysis

WBID 0883 Gabriel Creek

Submitted by
SES, Inc.

Date Received: September 10, 2007

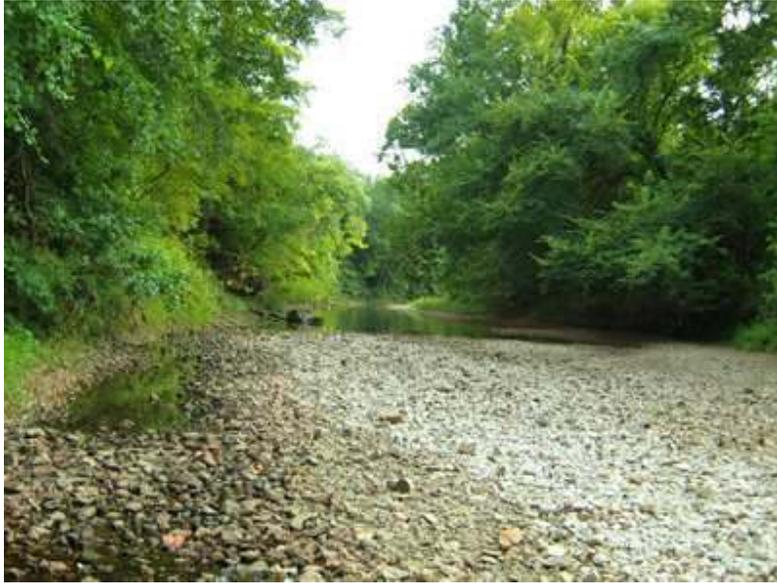
Site# 1 Photo ID# 11, Upstream

WBID # 883 **Site #** 1
Mark # 37 **Dissolved Oxygen (ppm)** 4.8
Upstream Views Physical Dimensions: Is there any water present at this view? y
 If so, is there an obvious current? y

% of Channel Feature				
Riffle	27				
Run	18				
Pool	55

14% Cobble	68% Gravel	% Sand	% Silt
% Mud/Clay	18% Bedrock

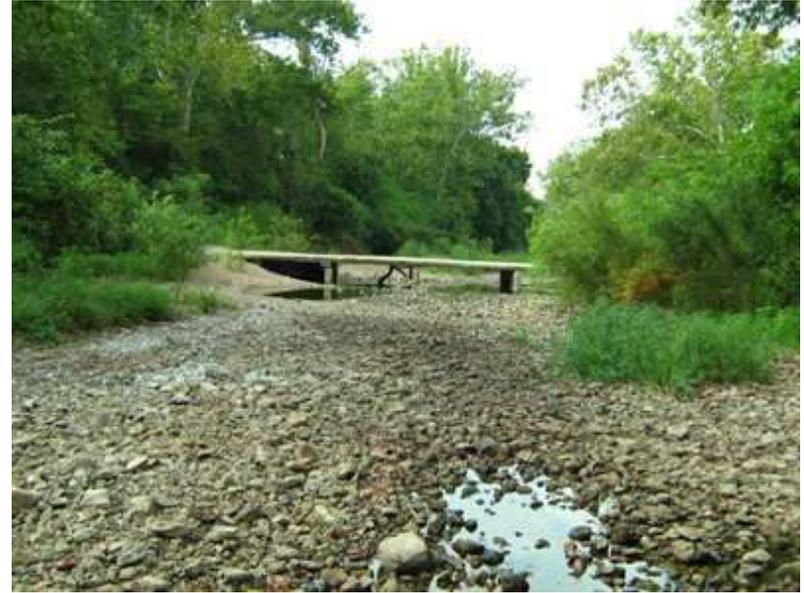
Site# 1 Photo ID# 10, Downstream

Downstream View's Physical Dimensions: Is there any water present at this view? y
 If so, is there an obvious current? n

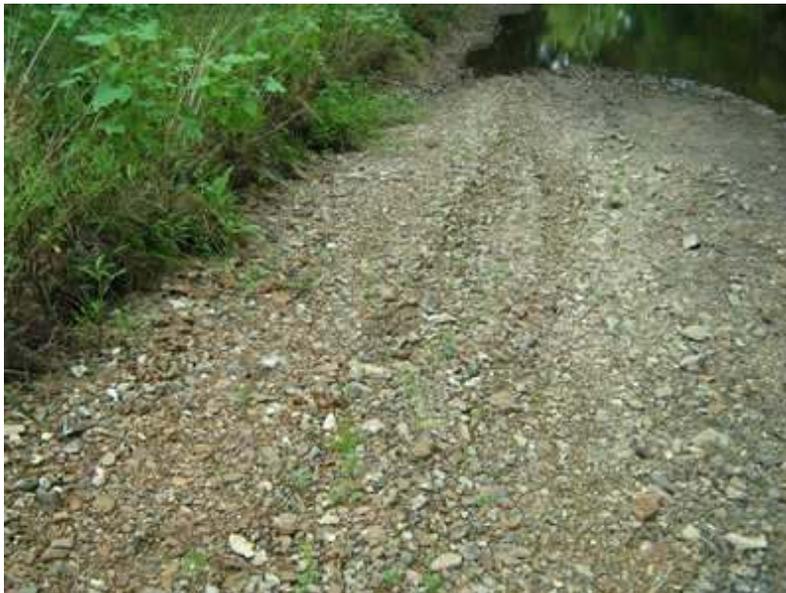
Site# 1 Photo ID# 12, RV/ATV tracks

Roads	Rope swings	Foot paths/prints	Dock/platform
Livestock Watering	<u>RV/ATV Tracks Pic #12</u>	Camping Sites	Fire pit/ring
NPDES Discharge	Fishing Tackle	Other:

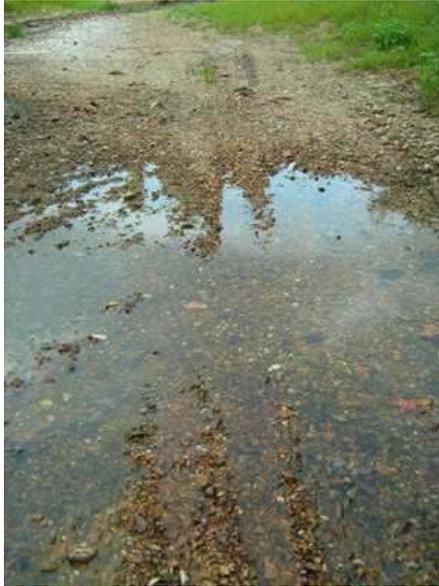
Site# 3 Photo ID# 16, RV/ATV tracks

Roads	Rope swings	Foot paths/prints	Dock/platform
Livestock Watering	<u>RV/ATV Tracks Pic #16</u>	Camping Sites	<u>Fire pit/ring Pic #15</u>
NPDES Discharge	Fishing Tackle	Other:

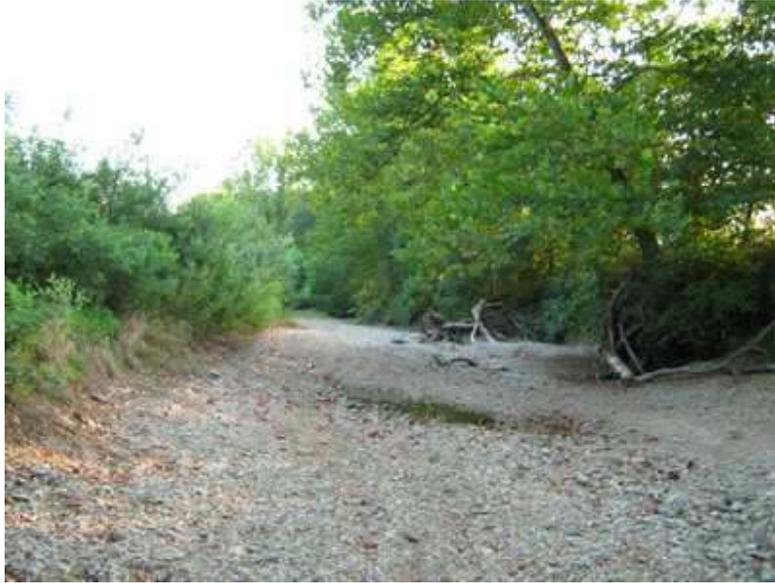
Site# 5 Photo ID# 22, Upstream

WBID # 883 **Site #** 5
Mark # 41 **Dissolved Oxygen (ppm)** 1.8
Upstream Views Physical Dimensions: Is there any water present at this view? n

Riffle					
Run	55				
Pool	45

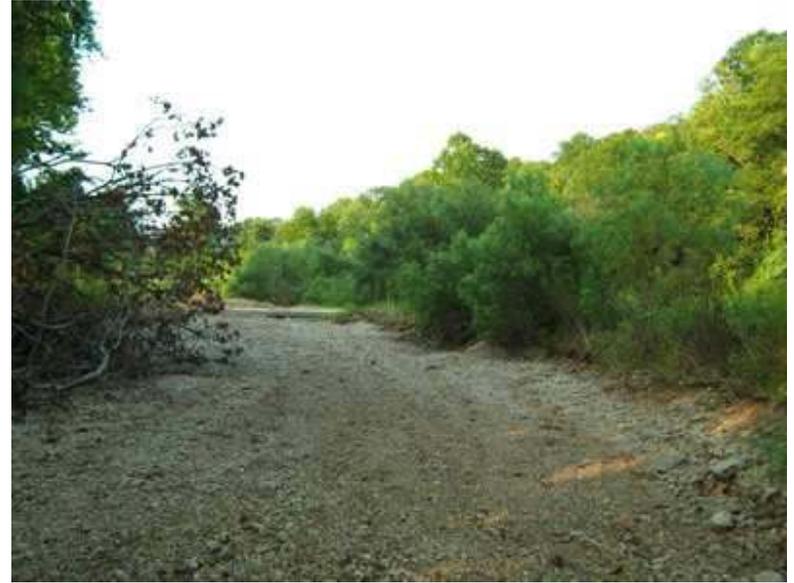
Site# 5 Photo ID# 21, Downstream

Downstream View's Physical Dimensions: Is there any water present at this view? n

Odor Sewage Musky Chemical **None** Other
 Color Clear **Green** Gray Milky Other
 Bottom Deposit Sludge Solids Fine Sed. **None** Other
 Surface Deposit **Oil** Scum Foam None Other

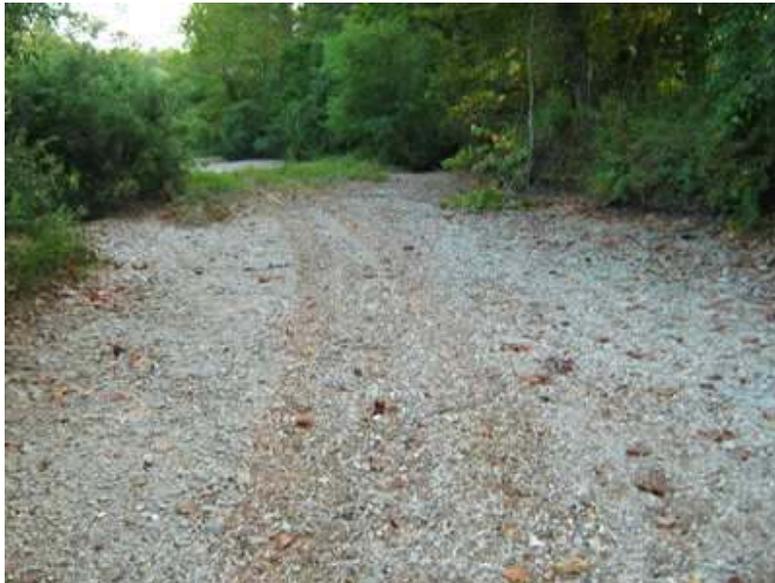
Site# 5 Photo ID# 23, RV/ATV tracks

Roads	Rope swings	Foot paths/prints	Dock/platform
Livestock Watering	<u>RV/ATV Tracks</u> <u>picture 23</u>	Camping Sites	Fire pit/ring
NPDES Discharge	Fishing Tackle	Other:

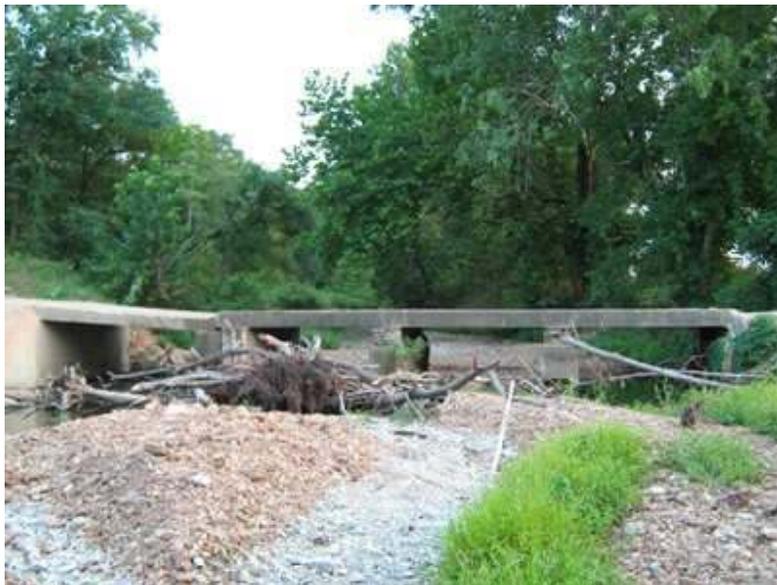
Site# 7 Photo ID# 28, Upstream

WBID # 883 **Site #** 7
Mark # 43 **Dissolved Oxygen (ppm)** n/a
Upstream Views Physical Dimensions: Is there any water present at this view? n

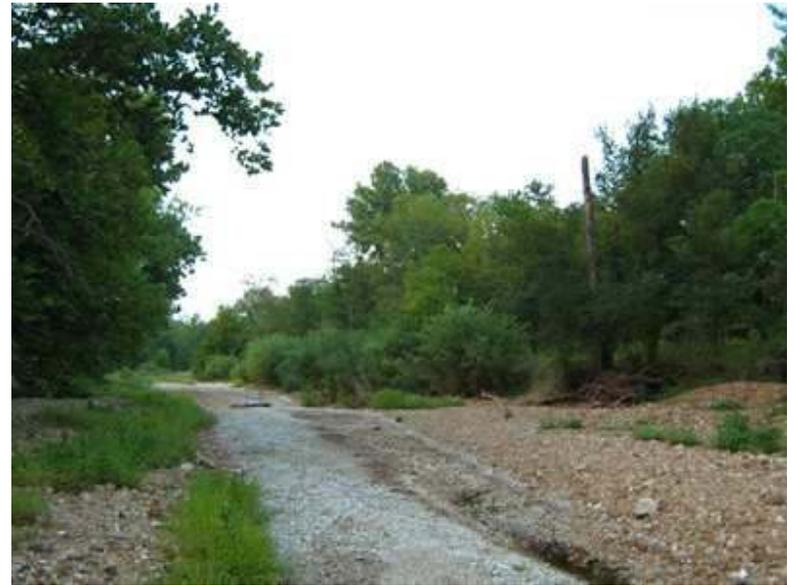
Site# 7 Photo ID# 27, Downstream

Downstream View's Physical Dimensions: Is there any water present at this view? n
