Use Attainability Analysis

WBID 0993 Blythes Creek

Submitted by
SES, Inc.

Date Received: June 3, 2007

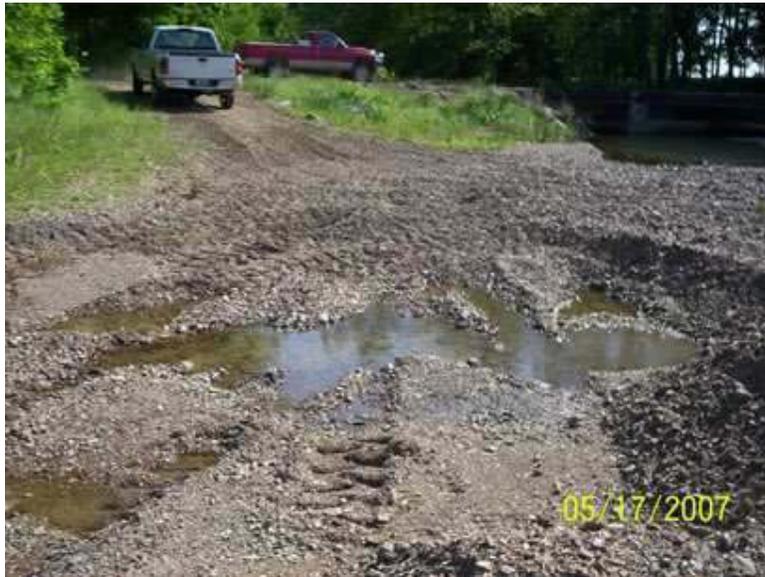
Site# 1 Photo ID# 89, Roads

Roads See Picture #89	Rope swings	Foot paths/prints	Dock/platform
Livestock Watering	RV/ATV Tracks	Camping Sites	Fire pit/ring
NPDES Discharge	Fishing Tackle	Other:
