Use Attainability Analysis

WBID 1030 Sugar Branch

Submitted by
SES, Inc.

Field Data Sheets for Recreation Use Stream Surveys
Data Sheet A - Water Body Identification
 (For water body being surveyed)

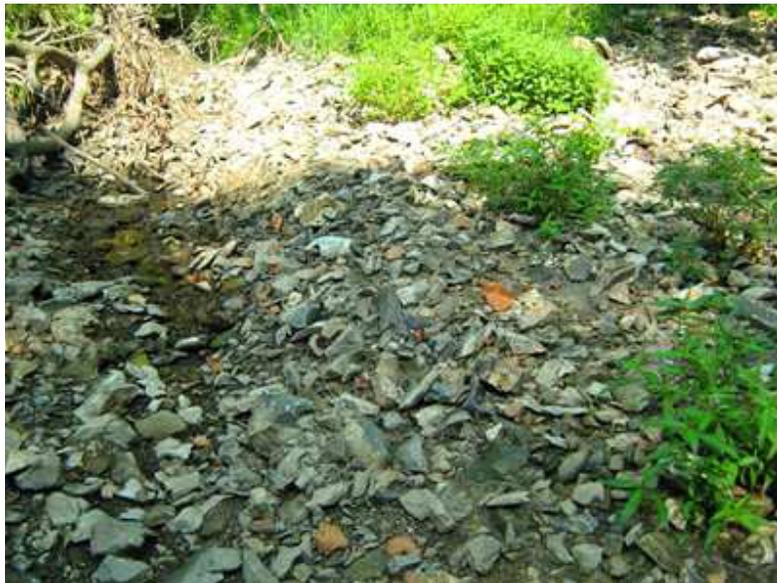
Site# 2 Photo ID# 2, Upstream

WBID # 1030 **Site #** 2
Mark # 1 **Dissolved Oxygen (ppm)** 5
Upstream Views Physical Dimensions: Is there any water present at this view? no

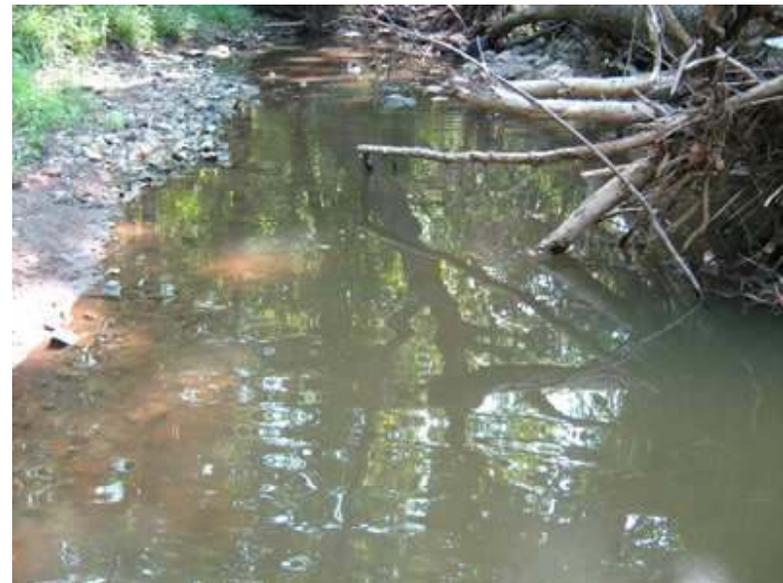
Site# 2 Photo ID# 1, Downstream

Downstream View's Physical Dimensions: Is there any water present at this view? yes

If so, is there an obvious current? no

Vegetation along banks and on gravel bars. No floating aquatic vegetation.

Odor	Sewage	Musky	Chemical	<u>None</u>	Other
Color	Clear	Green	Gray	Milky	<u>Other</u> <u>brown murky</u>
Bottom Deposit	Sludge	Solids	Fine Sed.	<u>None</u>	Other
Surface Deposit	<u>Oil</u>	Scum	Foam	None	Other

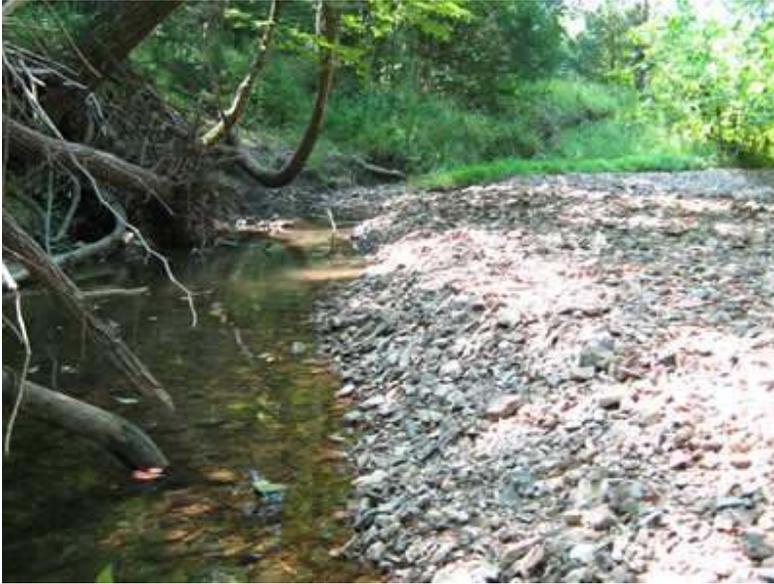
Site# 3 Photo ID# 4, Upstream

WBID # 1030 **Site #** 3
Mark # 2 **Dissolved Oxygen (ppm)** 6.1
Upstream Views Physical Dimensions: Is there any water present at this view? yes

If so, is there an obvious current? no

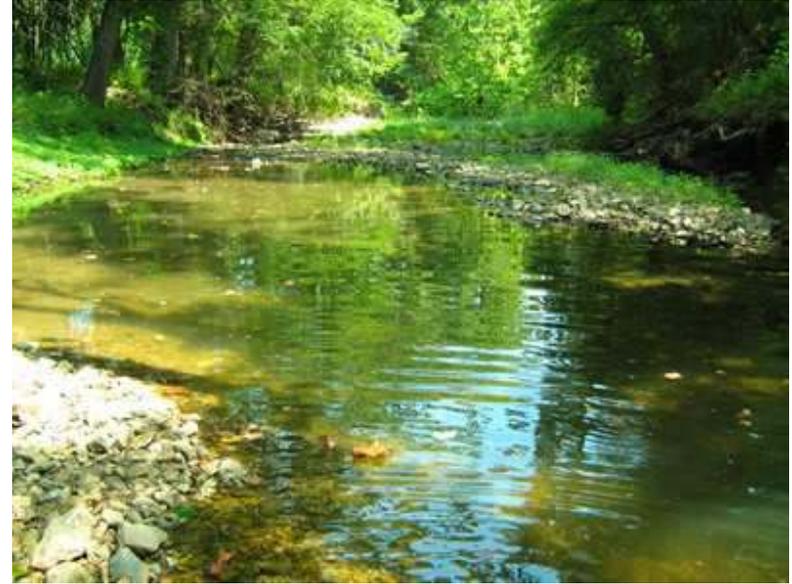
Site# 3 Photo ID# 3, Downstream

Downstream View's Physical Dimensions: Is there any water present at this view? yes

If so, is there an obvious current? yes

aquatic vegetation along bank and gravel bars. No aquatic vegetation or significant algal growth in water

Odor Sewage Musky Chemical **None** Other
 Color **Clear** Green Gray Milky Other
 Bottom Deposit Sludge Solids Fine Sed. **None** Other
 Surface Deposit Oil Scum Foam **None** Other
