Use Attainability Analysis

WBID 1349 Stinking Creek

Submitted by
Olsson Associates

Field Data Sheets for Recreational Use Stream Surveys

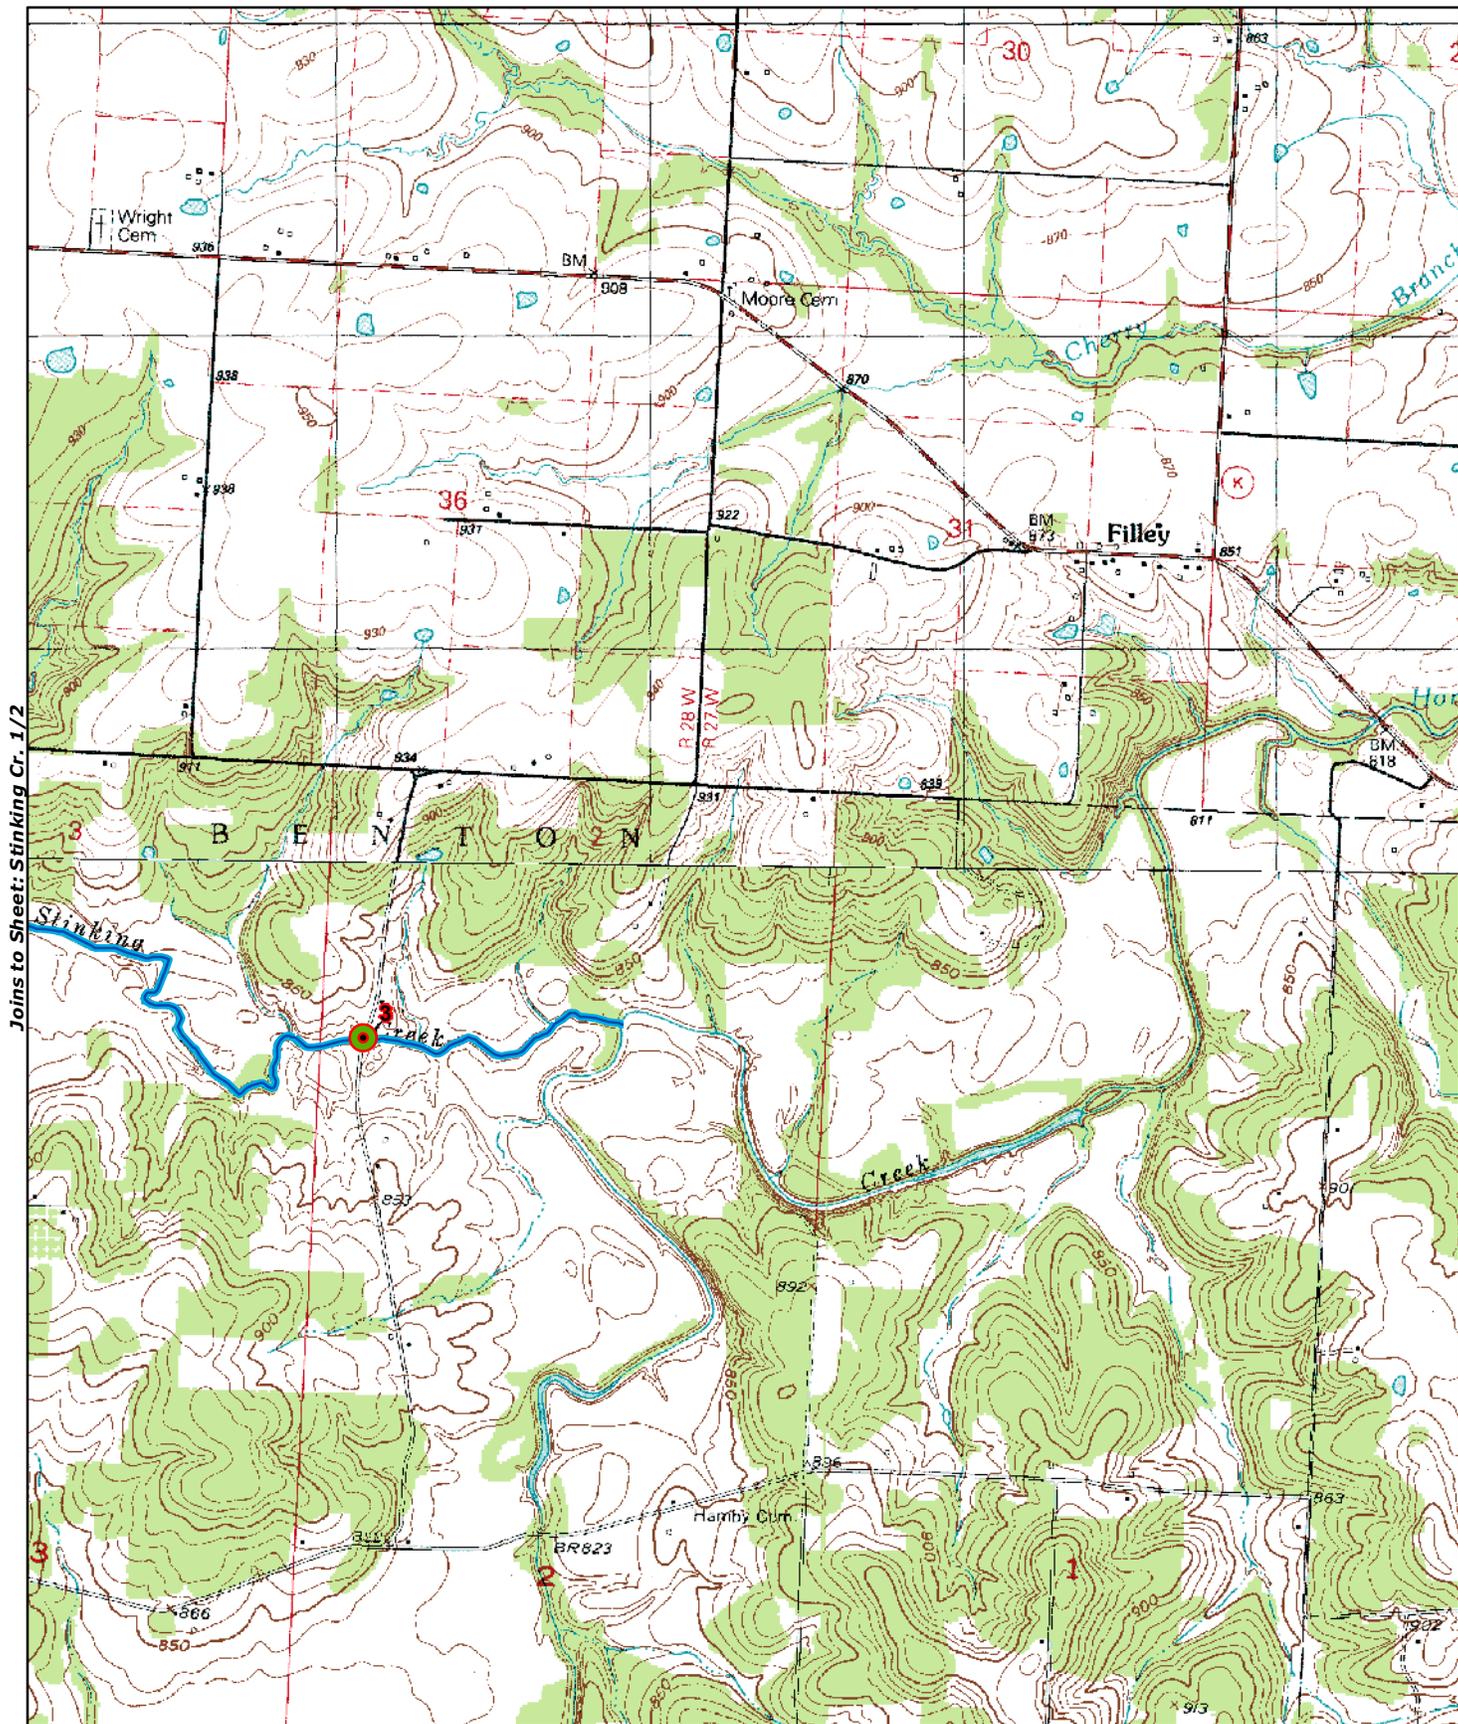
Map Sheet: 2/2
County: Cedar

Joins to Sheet: Stinking Cr. 1/2

Stream: Stinking Cr.
WBID: 1349

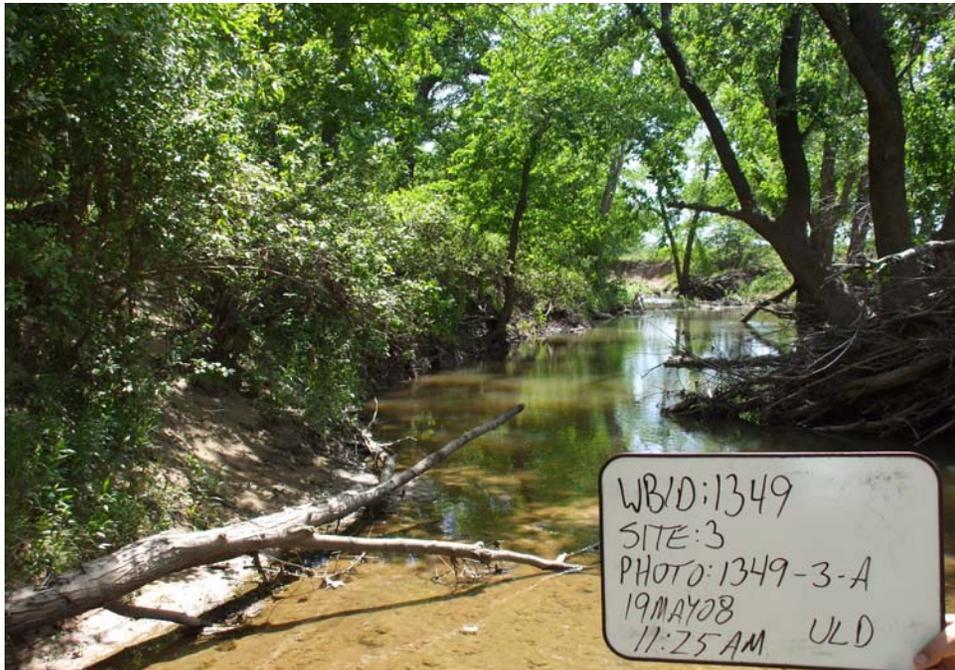
WBID:1349
SITE:3
PHOTO:1349-3-A
19MAY08 ULD
11:25 AM

Photo ID#	Photo Purpose	Photo ID#	Photo Purpose	Photo ID#	Photo Purpose
1349-3-A	Upstream looking down				
Photo ID#	Photo Purpose	Photo ID#	Photo Purpose	Photo ID#	Photo Purpose
1349-3-B	Downstream looking up				
Photo ID#	Photo Purpose	Photo ID#	Photo Purpose	Photo ID#	Photo Purpose
1349-3-C	Bridge
