Use Attainability Analysis

WBID 1552 Cedar Creek

Submitted by  
SES, Inc.

## Field Data Sheets for Recreational Use Stream Surveys

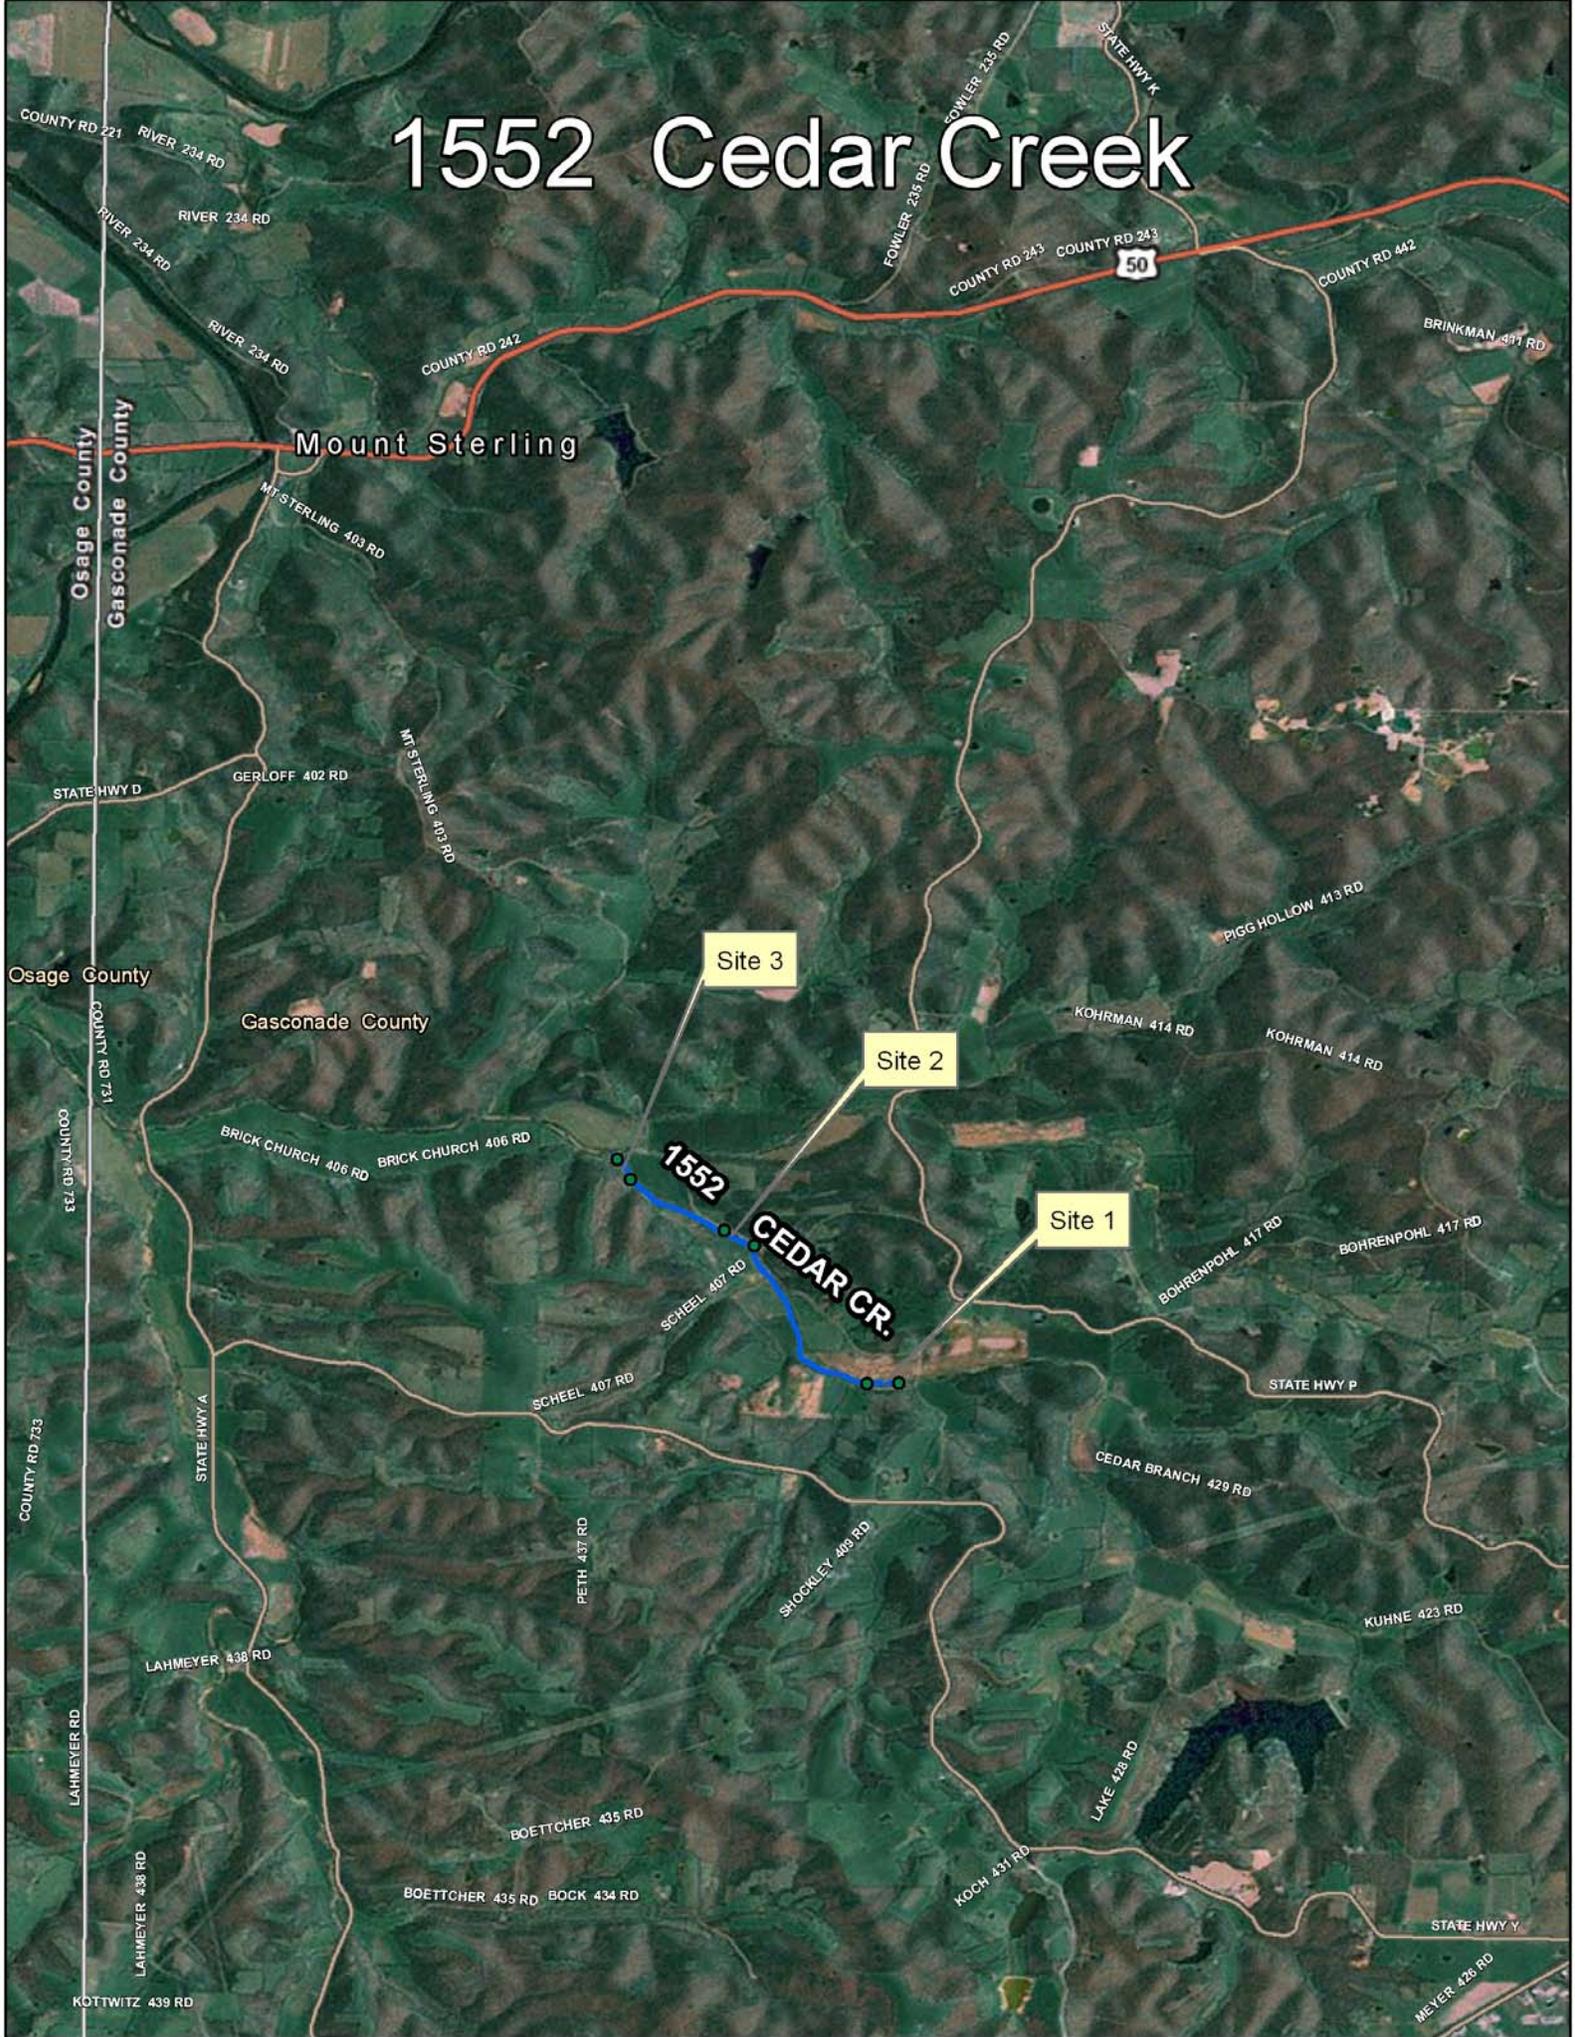
# 1552 Cedar Creek

Site 3

Site 2

Site 1

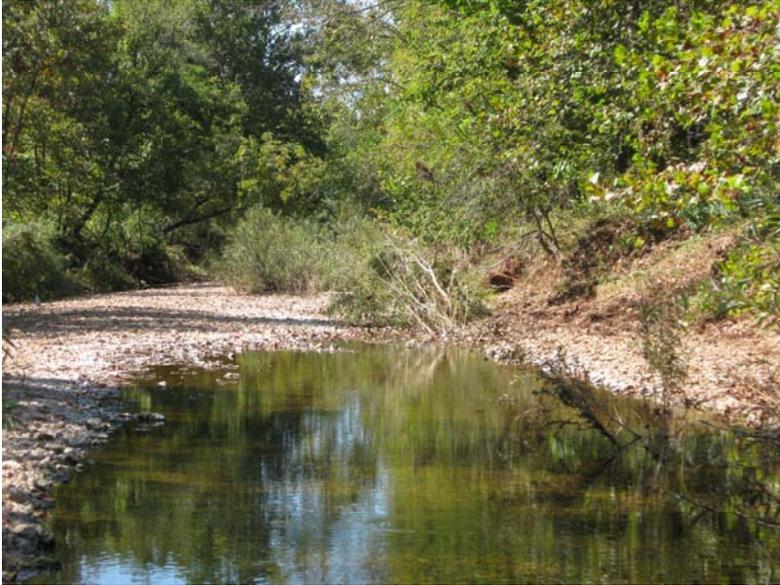
**Site# 1 Photo ID# 26, Downstream**

10% Cobble	80% Gravel	10% Sand	% Silt	% Mud/Clay	% Bedrock
------------	------------	----------	--------	------------	-----------

Algae on 100% of substrate.

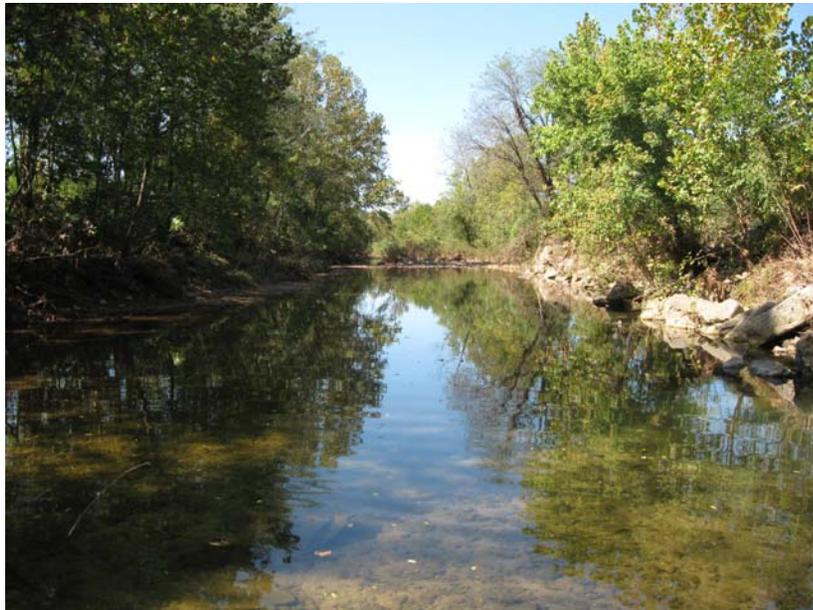
**Site# 2 Photo ID# 28, Downstream**

% Cobble	90% Gravel	10% Sand	% Silt	% Mud/Clay	% Bedrock
----------	------------	----------	--------	------------	-----------

algae on 30% of substrate.

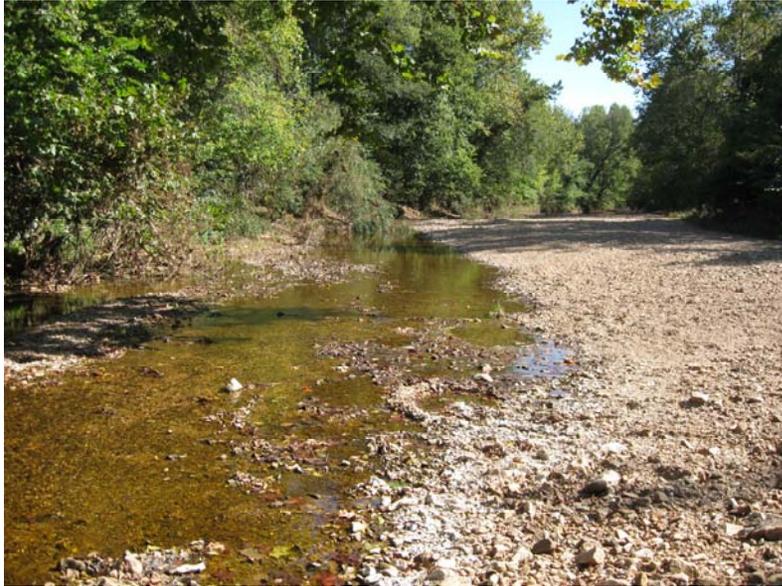
**Site# 3 Photo ID# 30, Upstream**

% Cobble	60% Gravel	40% Sand	% Silt	% Mud/Clay	% Bedrock
----------	------------	----------	--------	------------	-----------

Algae on 50% of substrate.
----------------------------

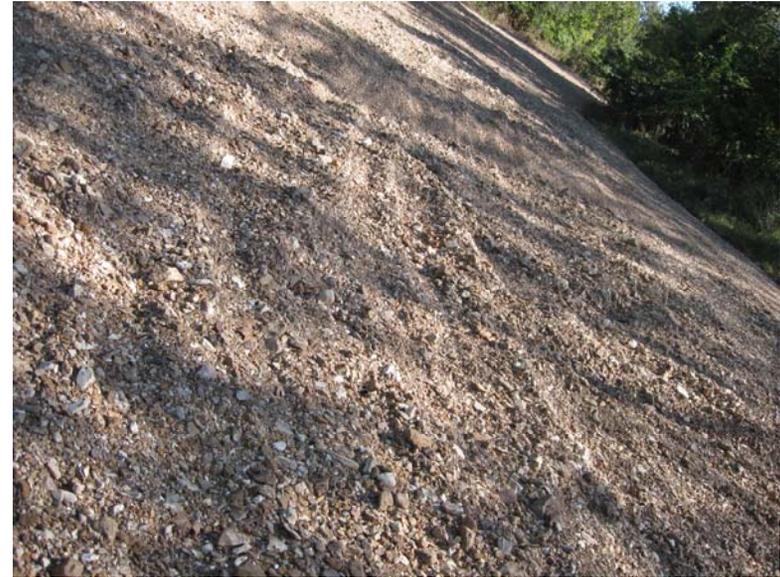
**Site# 3 Photo ID# 31, "Vehicle Tracks"**

<input checked="" type="checkbox"/> Roads	<input type="checkbox"/> Foot paths/prints	<input type="checkbox"/> Dock/platform	<input type="checkbox"/> Camping Sites	<input type="checkbox"/> Rope swings
<input type="checkbox"/> RV / ATV Tracks	<input type="checkbox"/> Fire pit/ring	<input type="checkbox"/> NPDES Discharge	<input type="checkbox"/> Fishing Tackle	<input type="checkbox"/> Livestock Watering
<input type="checkbox"/> None of the above	Comments / Other:
