Use Attainability Analysis

WBID 1679 Slaughter Branch

Pickett Ray and Silver

Missouri Department of Natural Resources  
Water Protection Program

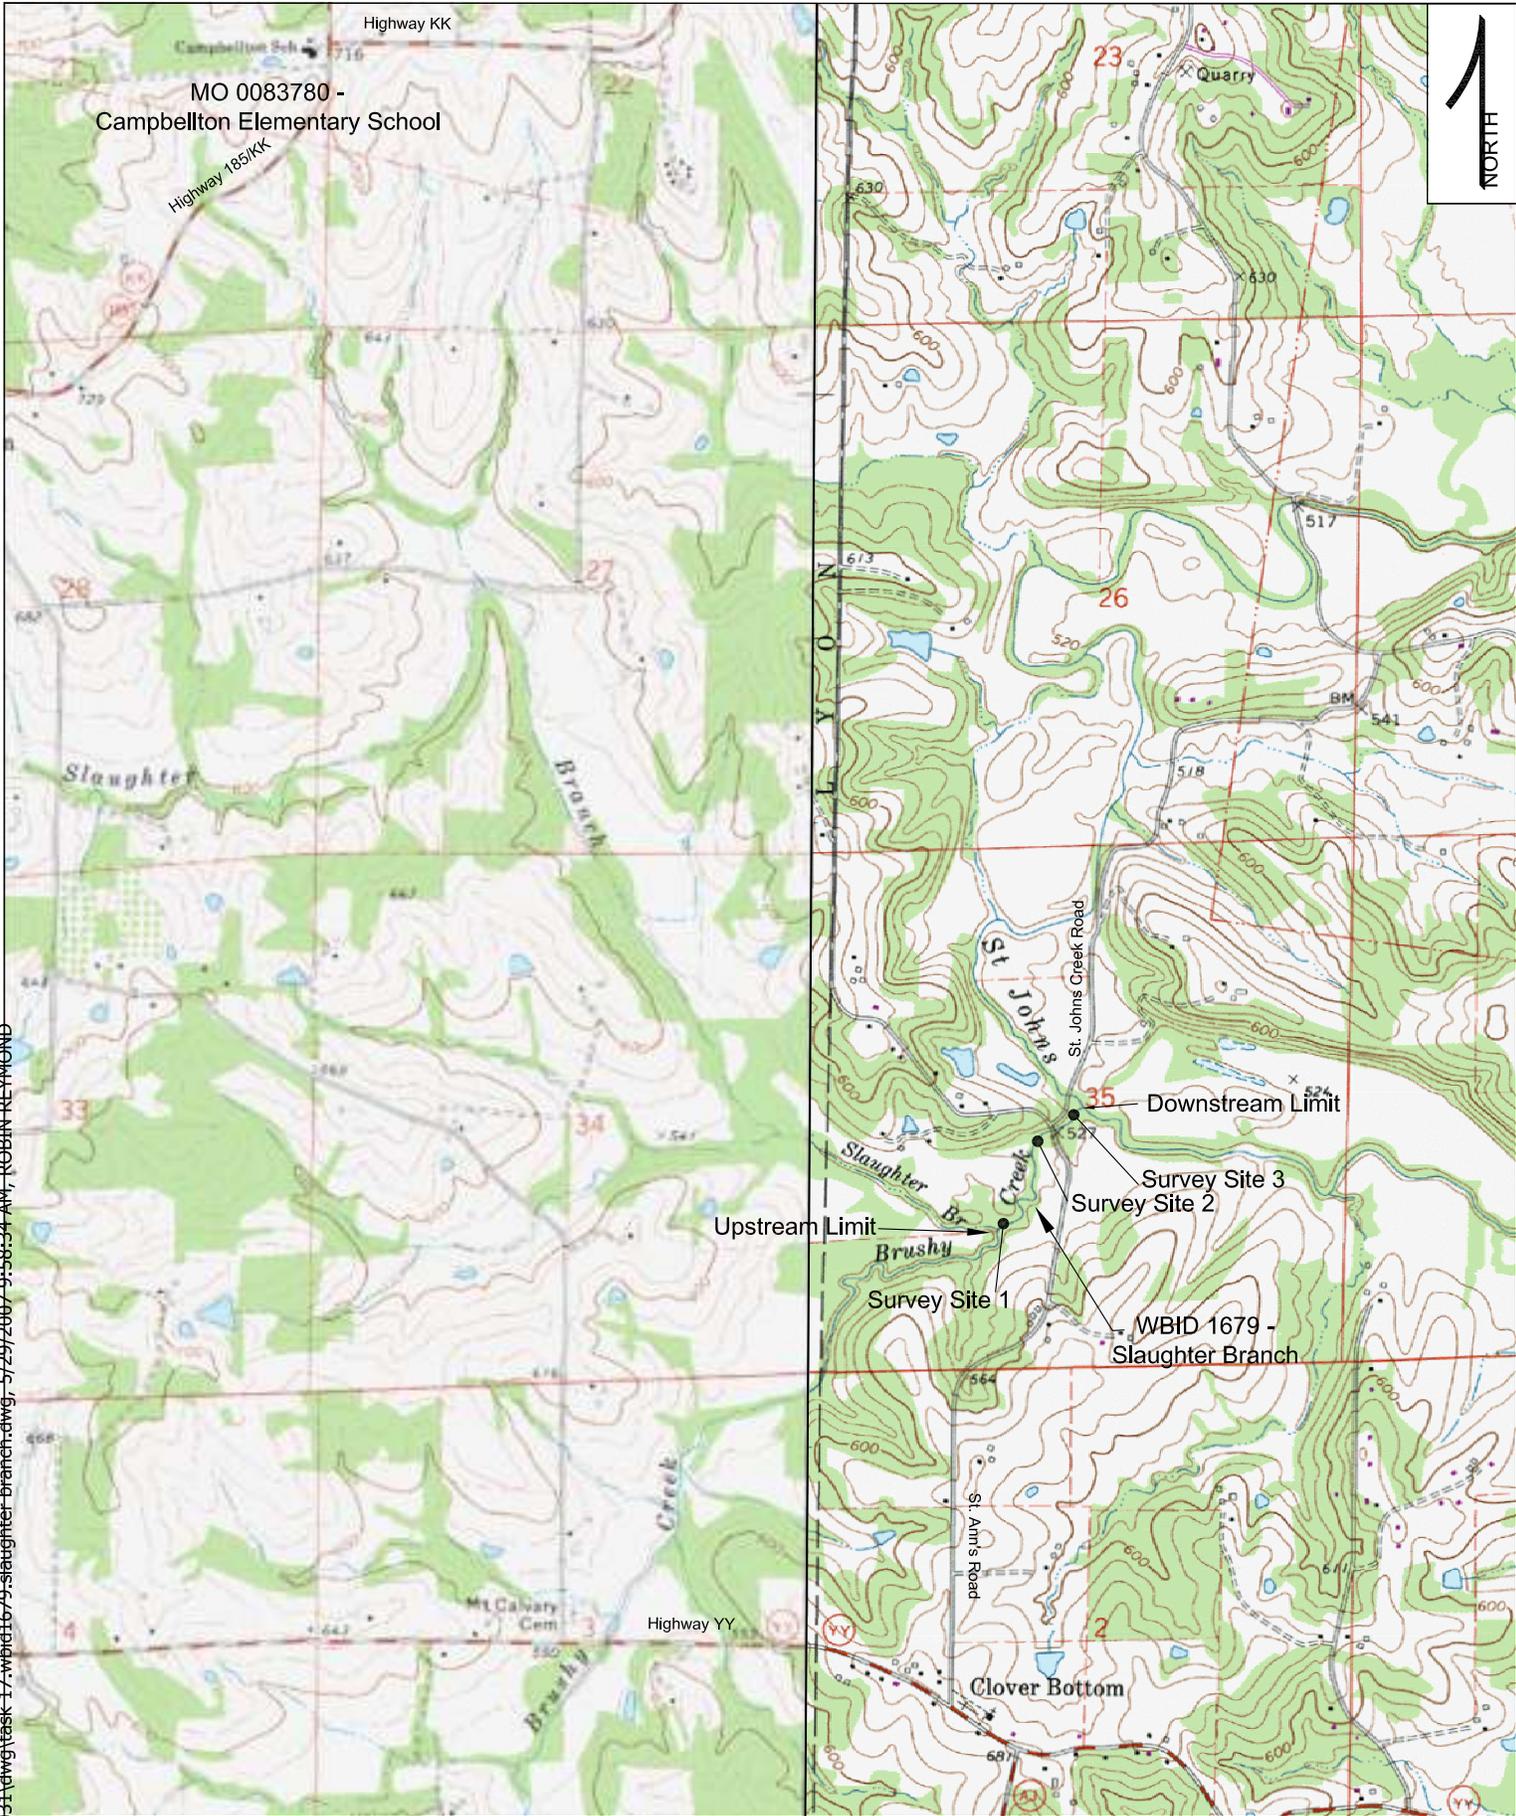
WBID #: 1679  
Name: Slaughter Branch  
County: Franklin  
USGS Location Map

Survey Site 1

Survey Site 2

Survey Site 3

WBID 1679 -  
Slaughter Branch

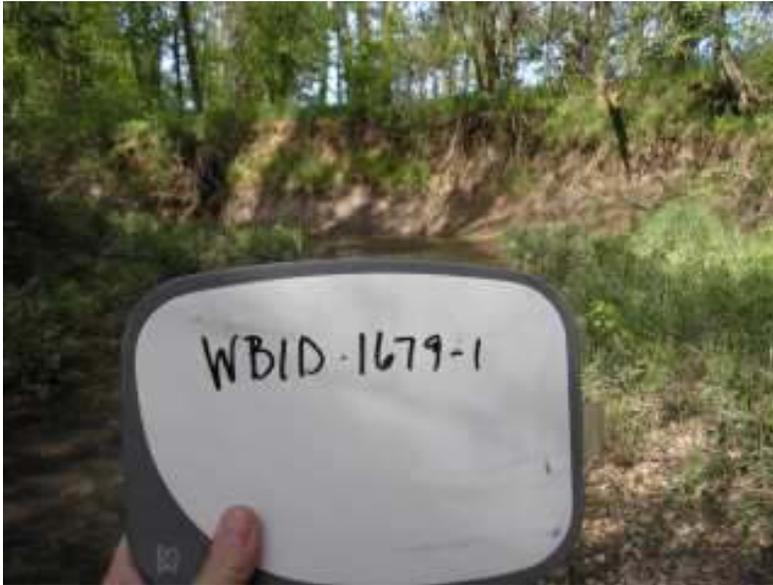
**Site# 1 Photo ID# Transect 1, Upstream**

Channel Feature	Distance from access (m)	Width (m)	Length (m)	Median Depth (m)	Max. Depth (m)
RIFFLE 30%					
RUN 40%					
POOL 30%

30 % Cobble	25 % Gravel	15 % Sand	15 % Silt	% Mud/Clay	15 % Bedrock
-------------	-------------	-----------	-----------	------------	--------------

Small patches of bur reed

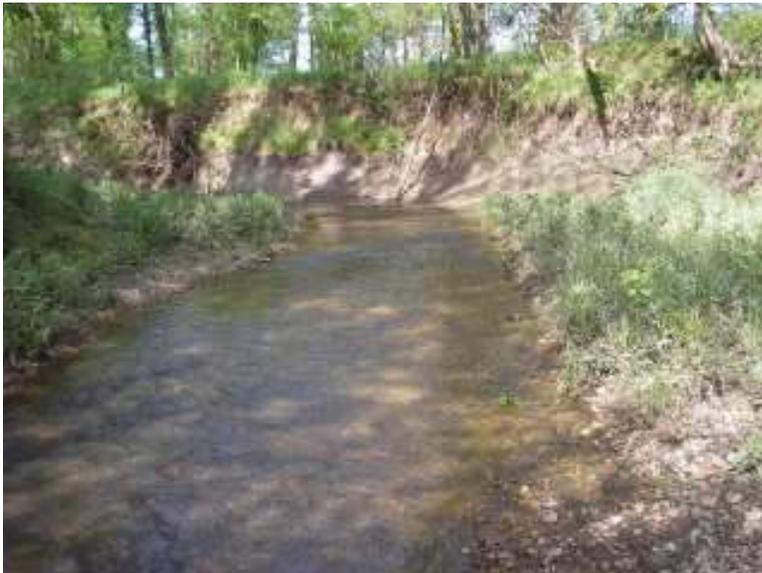
**Site# 2 Photo ID# Transect 1, Upstream**

Channel Feature	Distance from access (m)	Width (m)	Length (m)	Median Depth (m)	Max. Depth (m)
RIFFLE					
RUN 100%					
POOL

% Cobble	% Gravel	% Sand	75	% Silt	25	% Mud/Clay	% Bedrock
----------	----------	--------	----	--------	----	------------	-----------

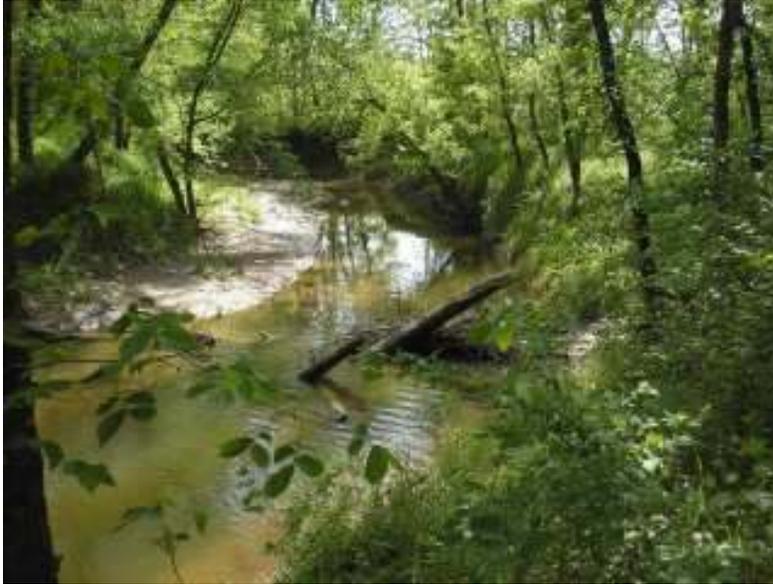
**Site# 3 Photo ID# Transect 1, Upstream**

Channel Feature	Distance from access (m)	Width (m)	Length (m)	Median Depth (m)	Max. Depth (m)
RIFFLE					
RUN 100%					
POOL

% Cobble	% Gravel	% Sand	75	% Silt	25	% Mud/Clay	% Bedrock
----------	----------	--------	----	--------	----	------------	-----------
