Use Attainability Analysis

WBID 2393 Little Flat Creek

SES, Inc.

Missouri Department of Natural Resources

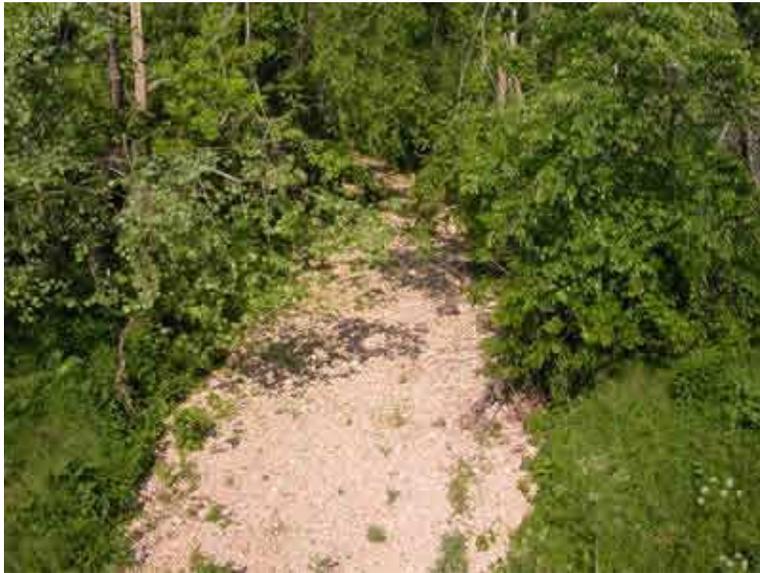
Site# 1 Photo ID# 105, Downstream

% Cobble	% Gravel	% Sand	% Silt
50	50		
% Mud/Clay	% Bedrock

Vegetation scattered in dry stream.

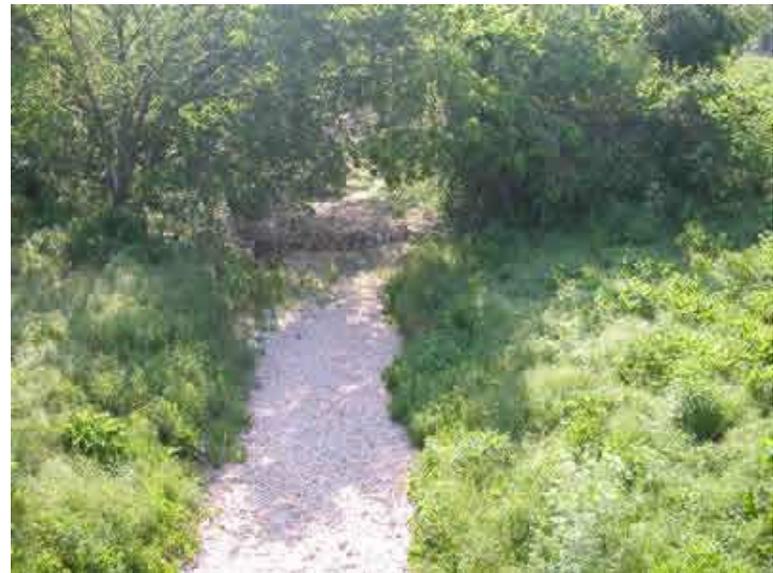
Site# 1 Photo ID# 104, Upstream

WBID # 2393 **Site #** 1
Mark # 53 **Dissolved Oxygen (ppm)** N/A
Upstream Views Physical Dimensions: Is there any water present at this view? no
 If so, is there an obvious current? no

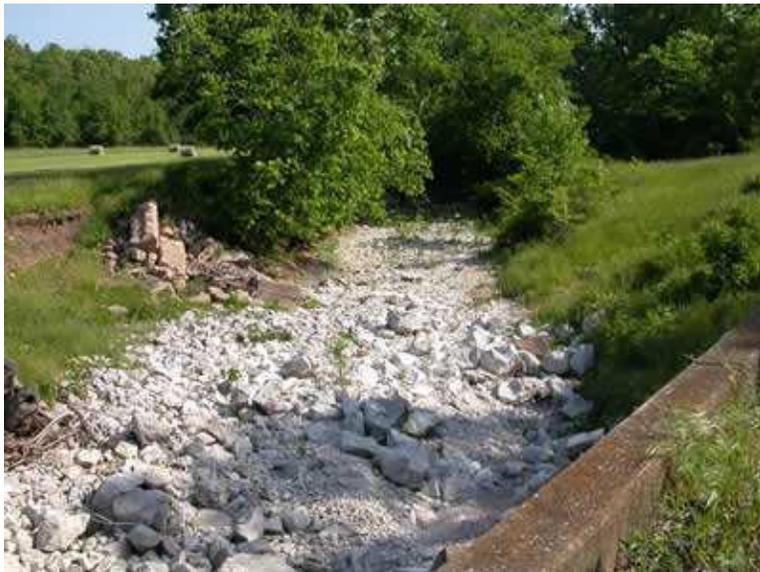
Site# 2 Photo ID# 107, Downstream

Vegetation scattered throughout dried stream bed.

*** NOTES:** Creek goes underground and flows only once a year, according to local. Needs at least 6 inches of rainfall.

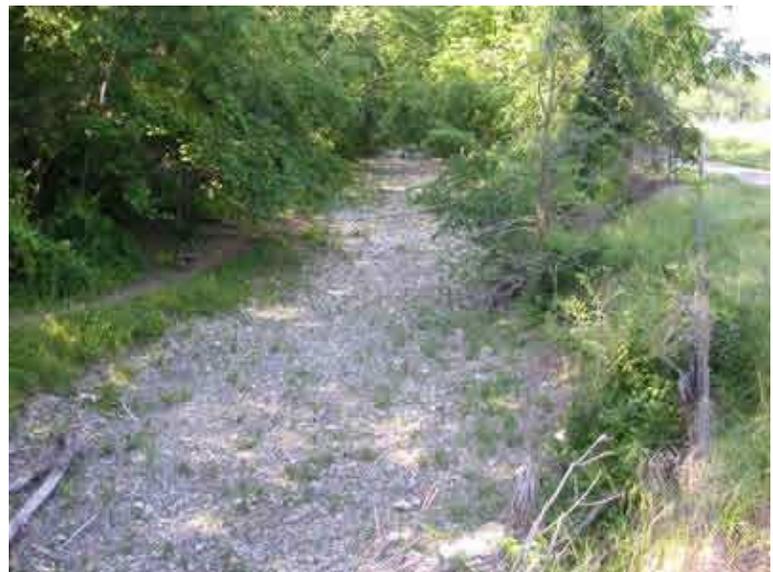
Site# 2 Photo ID# 106, Upstream

WBID # 2393 **Site #** 2
Mark # 54 **Dissolved Oxygen (ppm)** N/A
Upstream Views Physical Dimensions: Is there any water present at this view? no
 If so, is there an obvious current? no

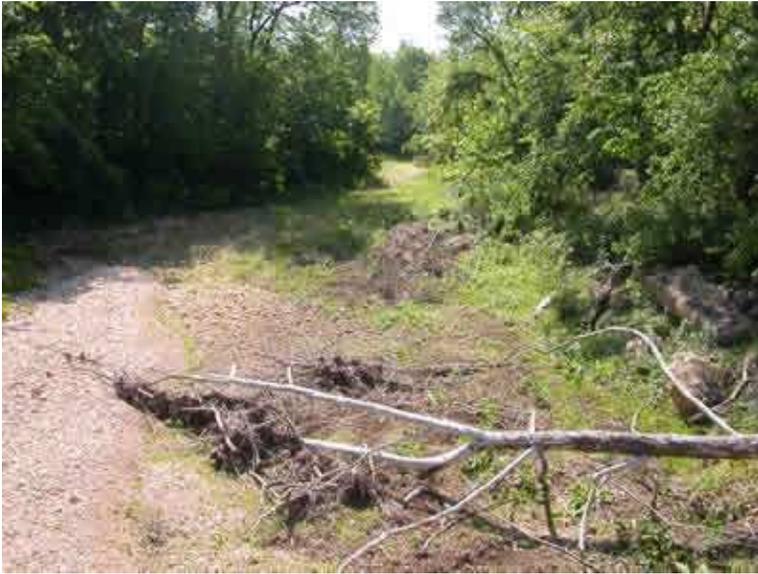
Site# 3 Photo ID# 109, Downstream

Vegetation scattered throughout dried stream bed.

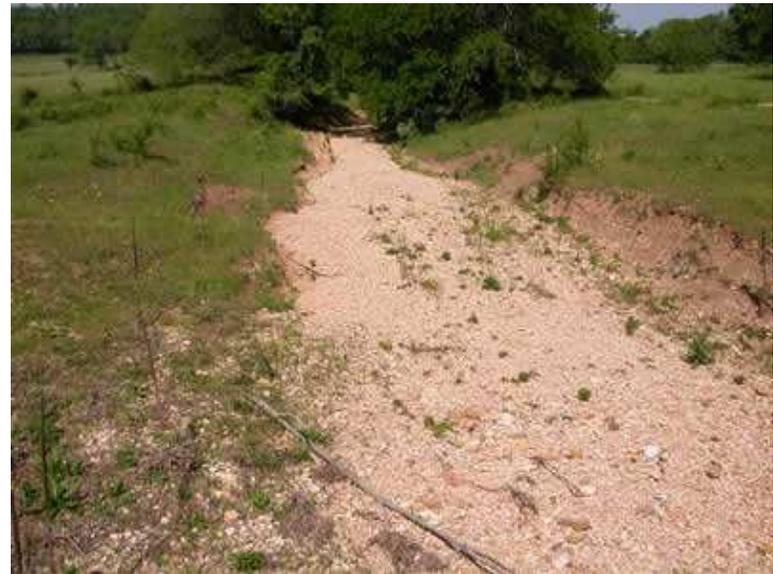
Site# 3 Photo ID# 108, Upstream

WBID # 2393 **Site #** 3
Mark # 56 **Dissolved Oxygen (ppm)** N/A
Upstream Views Physical Dimensions: Is there any water present at this view? no
 If so, is there an obvious current? no
