Use Attainability Analysis
for
Waterbody Identification # 3105
Lateral Main Ditch # 2

Conducted by:
Environmental Resources Coalition

To:
Missouri Department of Natural Resources
Water Protection Program

Submitted: December 22, 2005

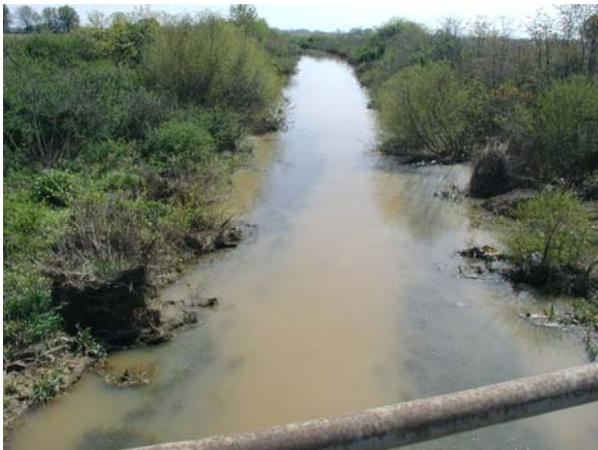
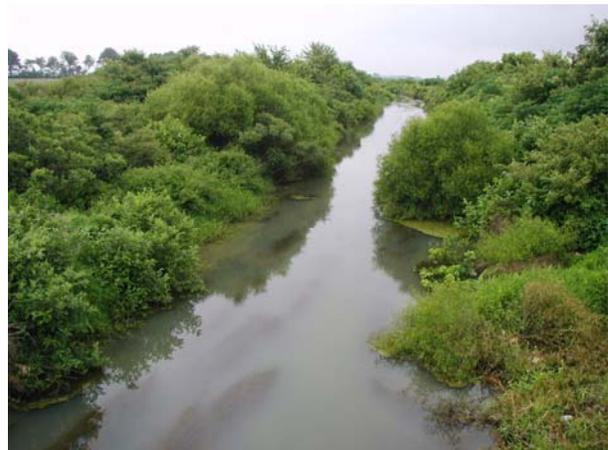
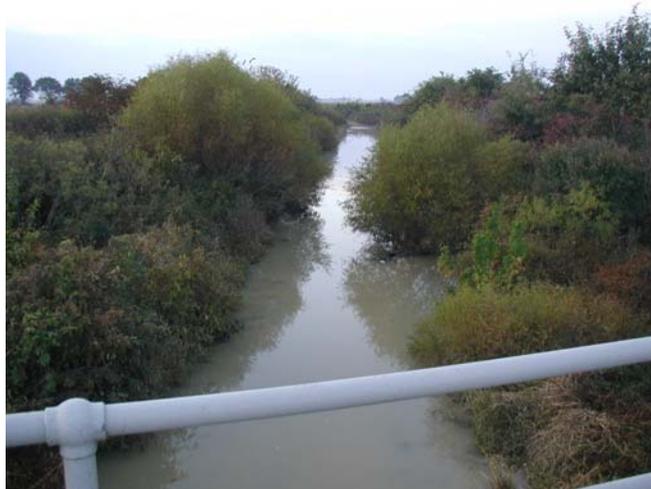
Downstream Views

Site #1: Site # 1 of Lateral Main Ditch # 2 is located on Highway 114, is the uppermost site of the reach, and is approximately two mile upstream of where the city of Dexter's Waste Water Treatment Facility enters the waterbody. Farm fields surround this site. The site water was turbid during all visits. Trash was visible on banks and in the stream bed.

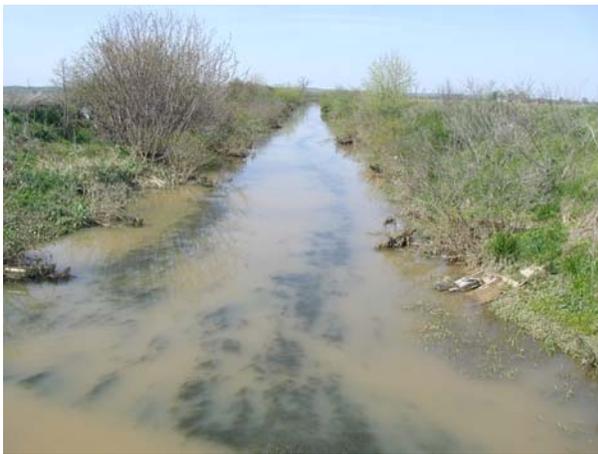
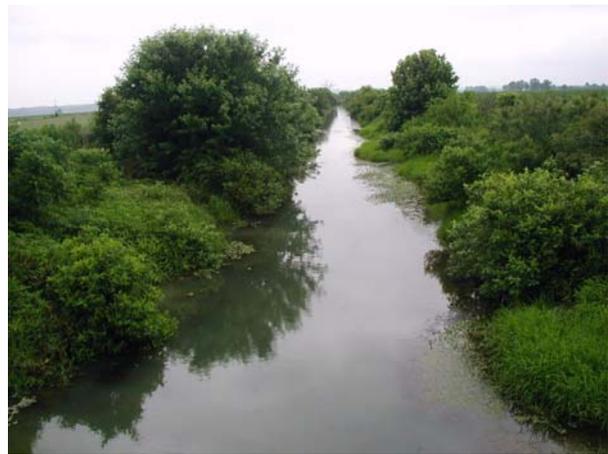
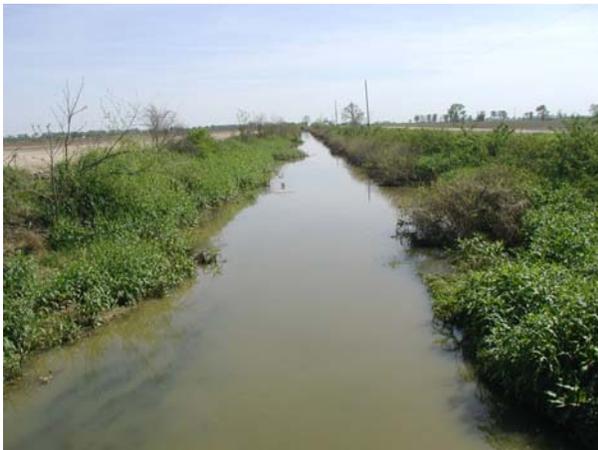
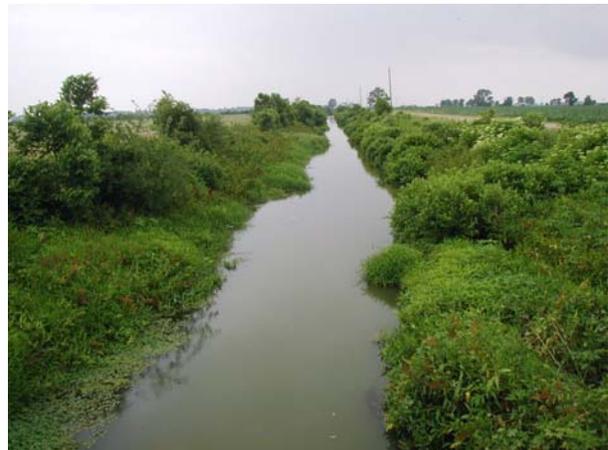
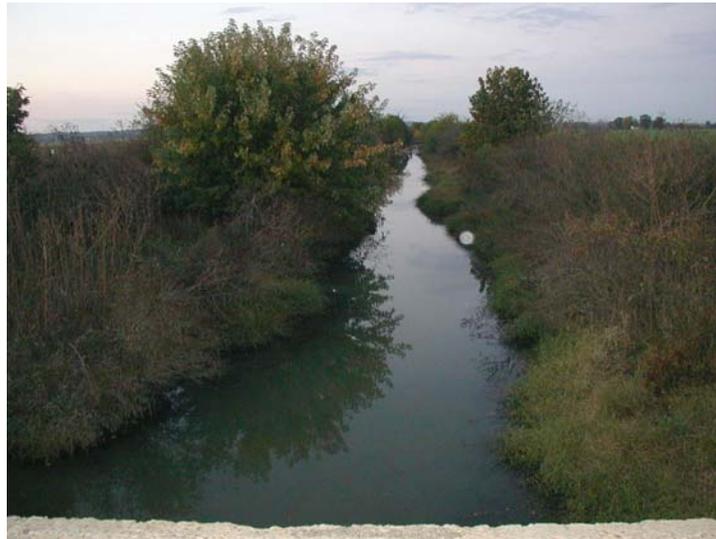
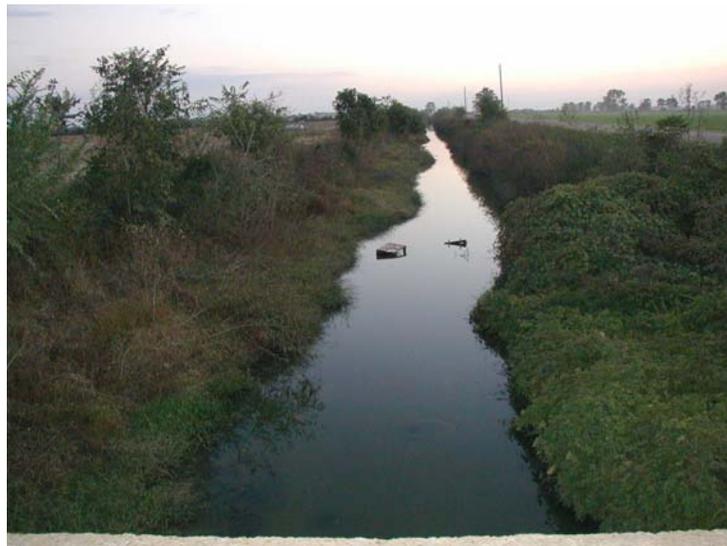
Site # 2 - Intersection of County Road 717 and 732

Site #2: Site # 2 of Lateral Main Ditch # 2 is located at the intersection of County Road 717 and 732 and has steep banks. Agriculture farm fields surround this site. Dexter's WWTF outflow enters the waterbody by much smaller ditch just upstream of the bridge. The bed of the ditch contains tires and other large discarded items. During our assessment, the water consistently had a sewage odor and remained very turbid.

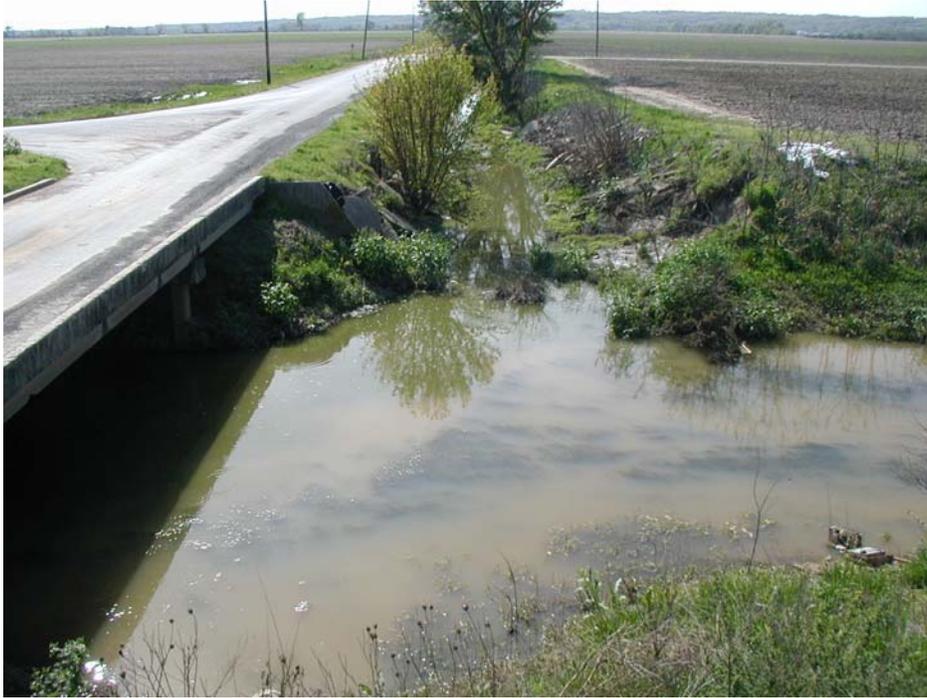
Tributary ditch where the City of Dexter's WWTF discharge enters the waterbody (WB # 3105)

Note: A small tributary ditch (pictured above) discharges a green plume of water and mixes with Lateral Main Ditch # 2.

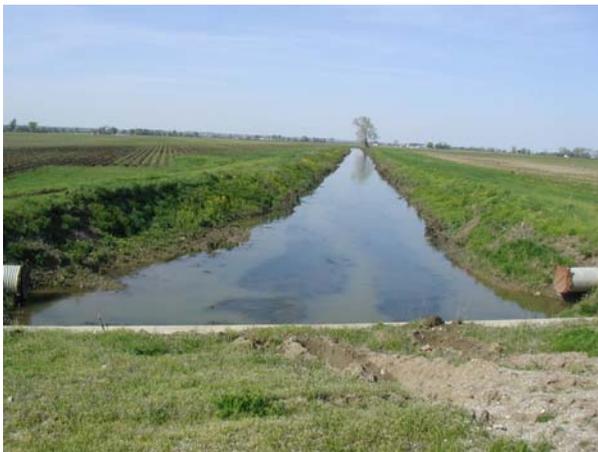
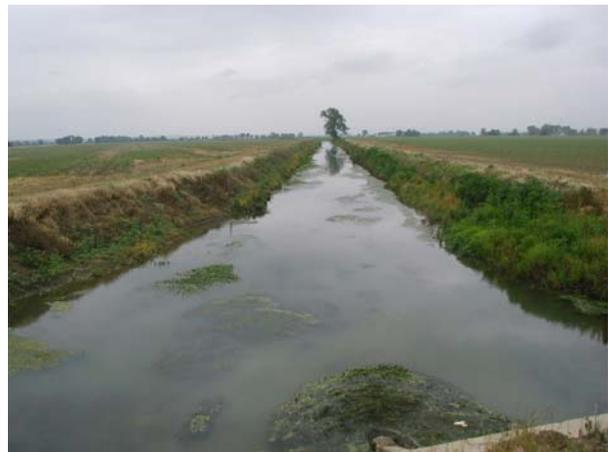
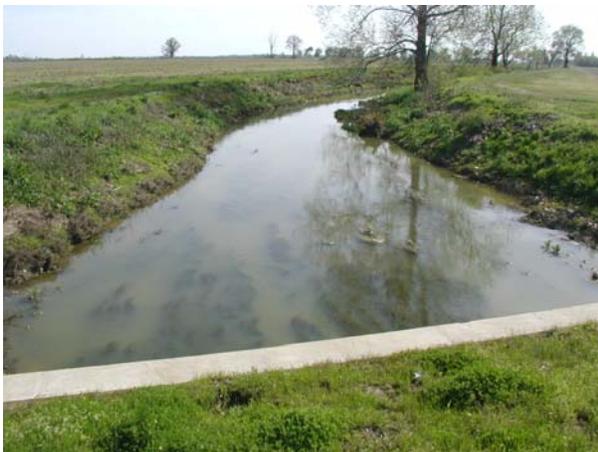
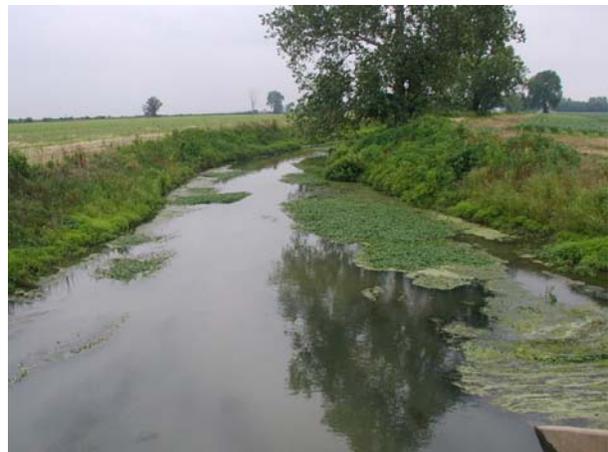
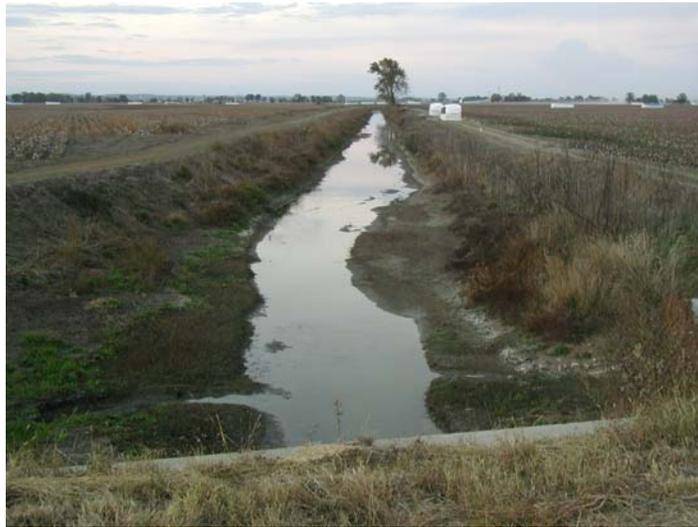
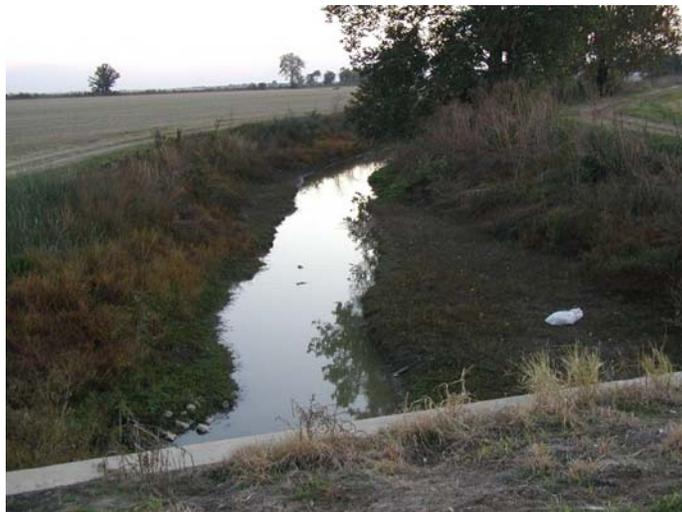
Site # 3 - Highway D

Site #3: Site # 3 of Lateral Main Ditch # 2 is located at Hwy D. Farm fields surround the area. Banks are very steep and the waterbody is hard to access. Numerous field drainage pipes are visible at this site.

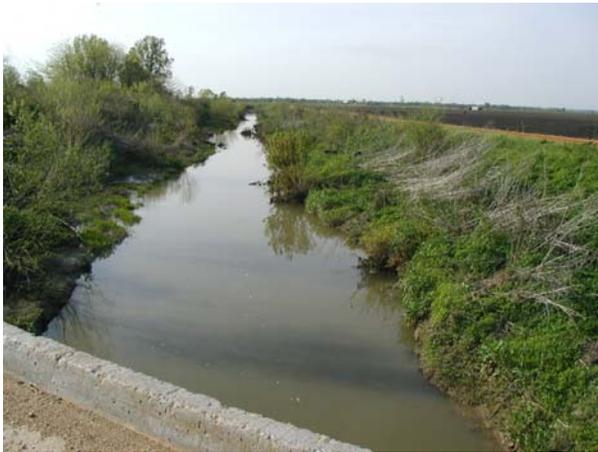
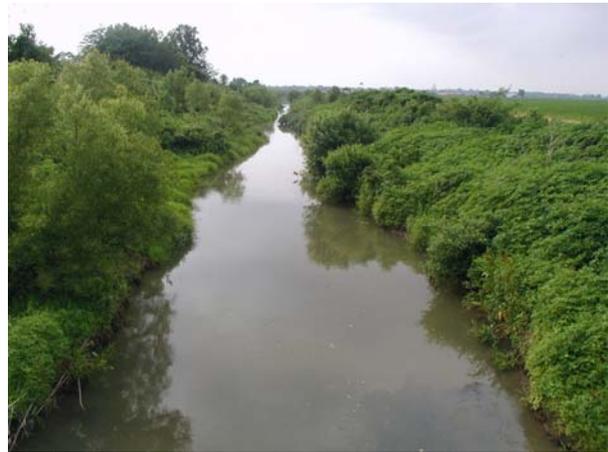
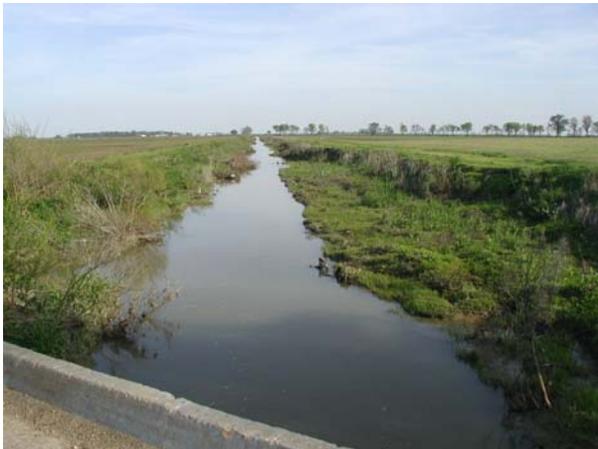
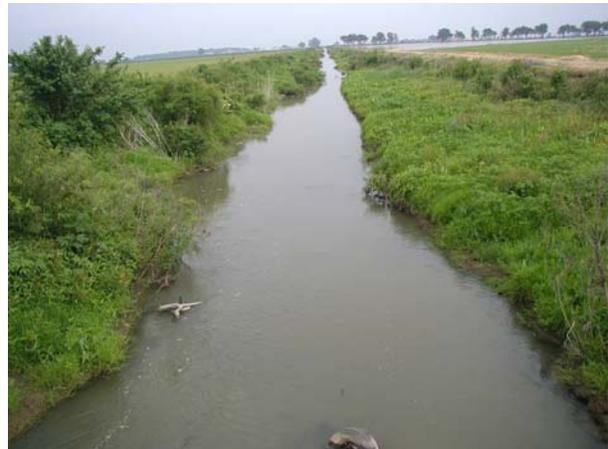
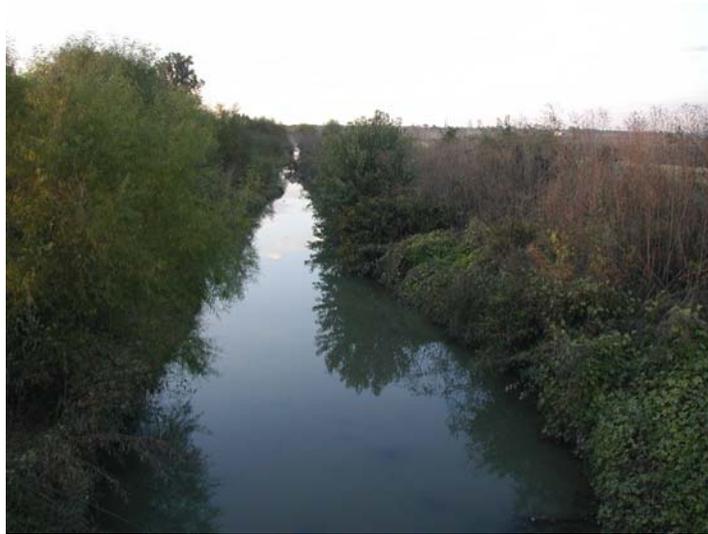
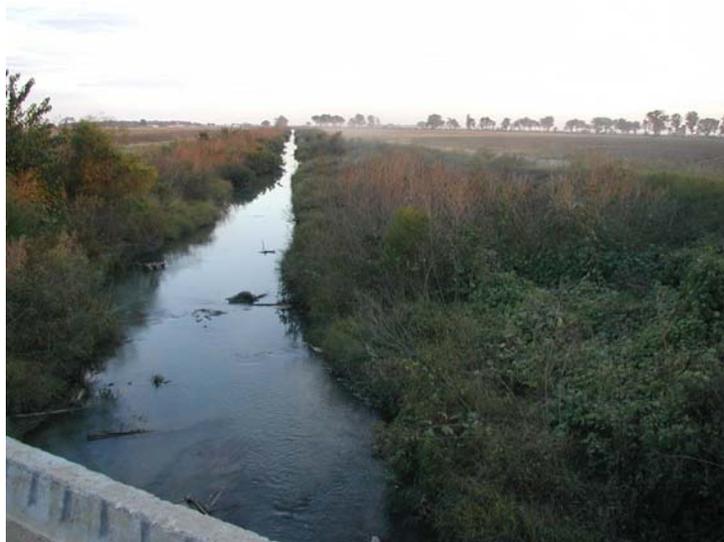
Site # 4 - Junction of County Roads 784 and 709

Site #4: Site # 4 of Lateral Main Ditch # 2 is located at the intersection of County Road 784 and 709. Farm fields surround the area. Appliances, trash, drainage pipes, tires and snakes can be seen when visiting the site. The site is approximately one and one half miles downstream of the Bernie WWTF outfall. The water at this location was consistently turbid and green, with an oily film and foam on the surface. Banks are steep and slightly brush covered. Data collected from this site on 04/15/05 was omitted due to a lost field assessment sheet.

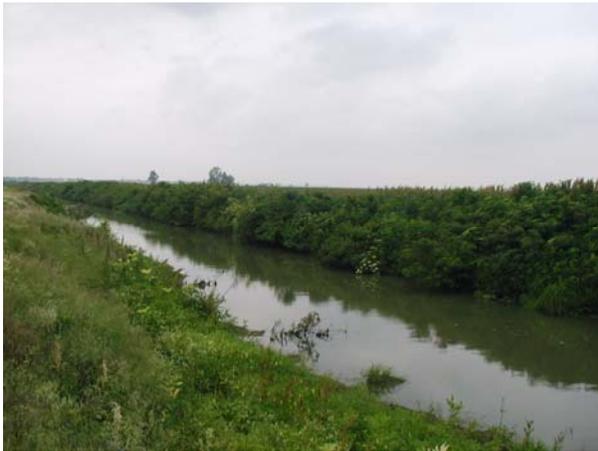
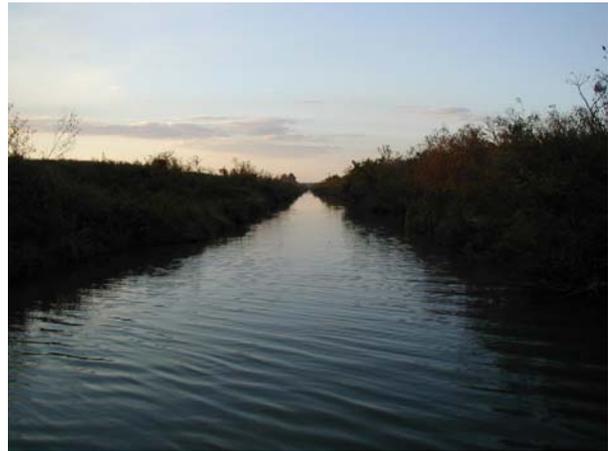
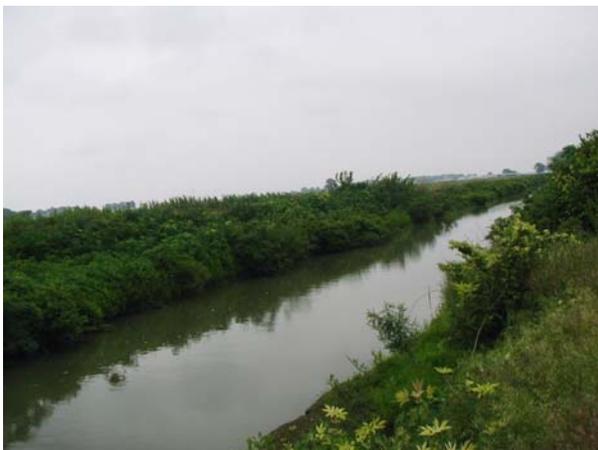
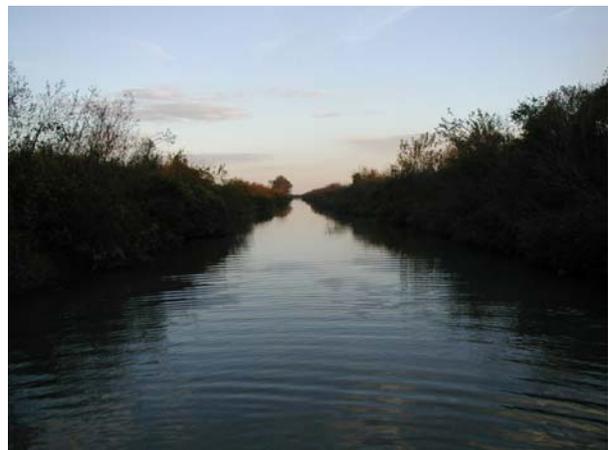
Site # 5 - County Road 784 - approximately two-thirds of a mile downstream of Site #4

Site #5: Site # 5 of Lateral Main Ditch # 2 is located two-thirds of a mile downstream of Site # 4 and just under two-thirds of a mile above the end of the classified segment. Farm fields entirely surround the stream at this location. The banks are very steep (12-16 feet) and brush covered. This was a newly created assessment site on 06/02/05.
