St. John's Ditch
Recreational Use Attainability Analysis

August 2005

Prepared by:
MEC WATER RESOURCES, INC.
1000 North College Avenue, Suite 4
Columbia, Missouri 65201

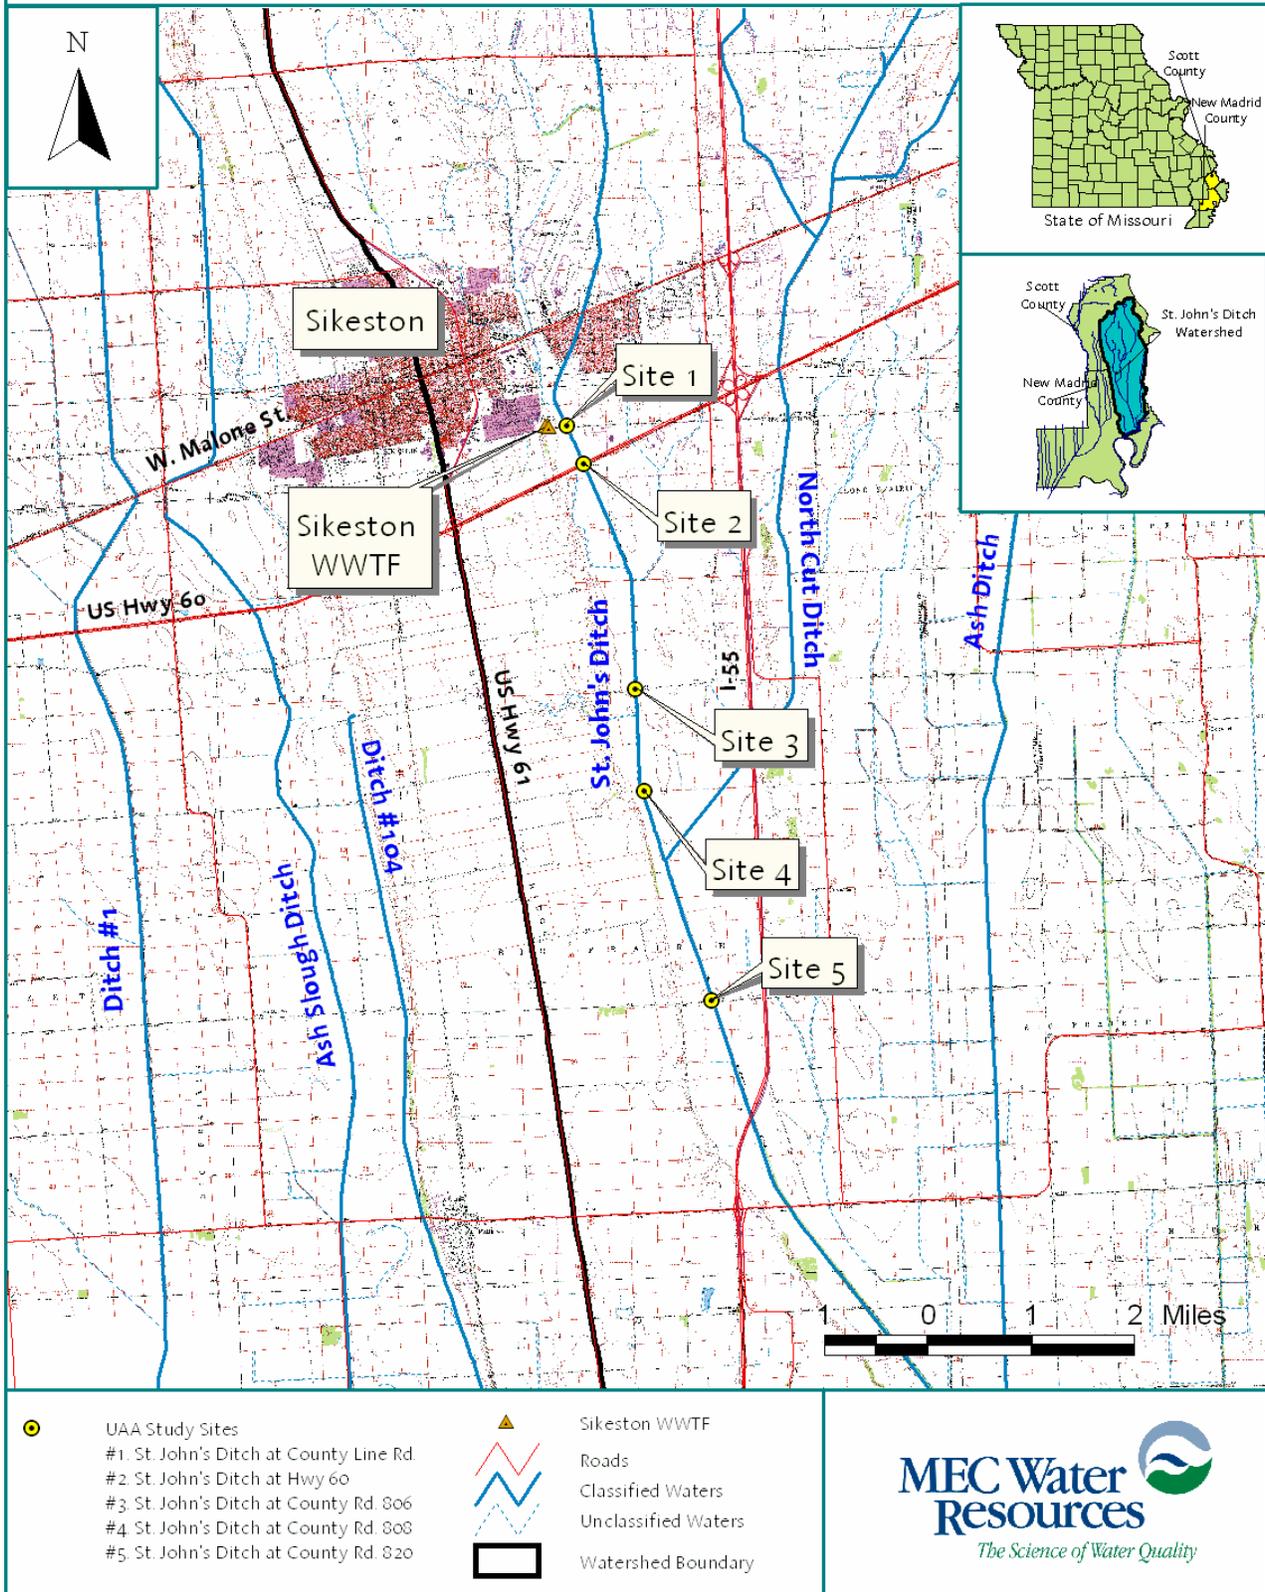
Figure 1. St. John's Ditch Study Area and Sites

Five sites (Figure 1) within classified sections of St. John's Ditch were assessed on August 4, 2005, using methods described in Section IV. The five sites were located at County Line Road Bridge Crossing (Site 1), Highway 60 Bridge Crossing (Site 2), County Road 806 Bridge Crossing (Site 3), County Road 808 Bridge Crossing (Site 4), and County Road 820 Bridge Crossing (Site 5). Surveys were conducted during presumed low-flow conditions as evidenced by precipitation data from Sikeston Power Station, Sikeston, Missouri (Table 1). Streamflow measurements taken in St. John's Ditch the day of the survey further support low-flow assumptions (Table 2).

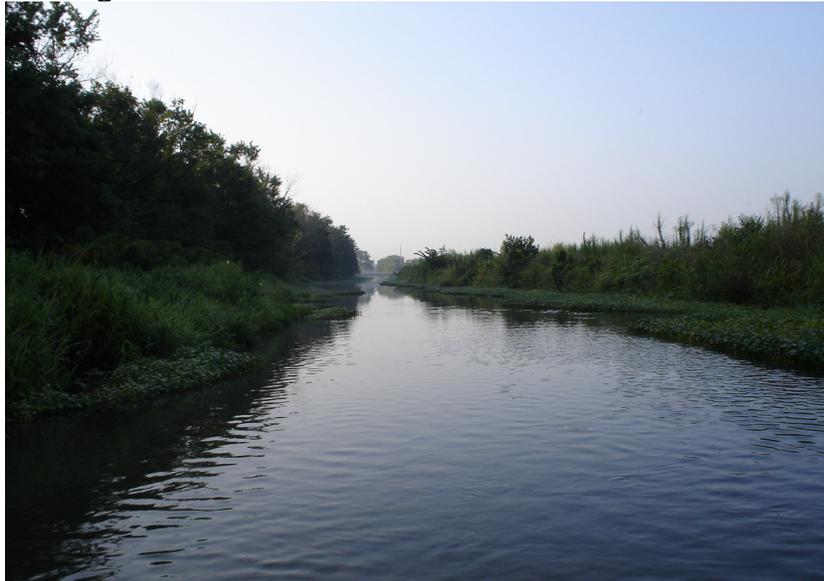
Figure 2 St. John's Ditch Site 1 Downstream View

The riparian area near the County Line Road bridge crossing is primarily vegetated by deciduous trees and brush, with row crops nearby. The banks are steep and mostly covered with grass and small shrubs (Figures 2 and 3). Channel substrate is predominately sand.

Mean depth along a 1,000 ft. assessment reach was 1.09 ft. as determined from 10 transects (Appendix B). The maximum depth observed at this location was 2.20 ft. MEC staff measured streamflow as 31.26 cubic feet per second (cfs).

There was no evidence of WBCR use observed at Site 1. In addition, no individuals were seen or found to be available for interviews near the bridge during the survey.

MEC staff concludes that WBCR is neither an existing nor an attainable use at this site based on limited access to the stream and the absence of observed recreational uses, and low-flow, shallow conditions.

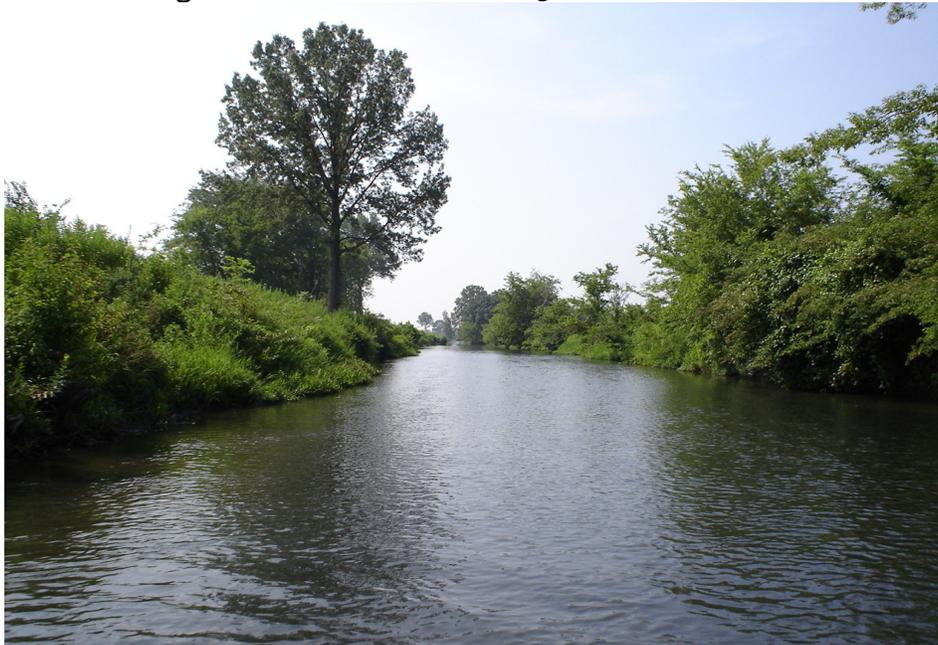
Figure 6. St. John's Ditch Site 3 Downstream View

The riparian area near the County Road 806 bridge crossing consists of low growing brush and grasses, with some mature deciduous trees and row crops (Figures 6 and 7). The stream banks are steep sloping and covered with brush and grasses. Stream substrate consisted of mostly sand with some silt.

Mean depth along a 1,000 ft. assessment reach was 0.92 feet as determined from 10 transects (Appendix B). The maximum depth observed at this location was 2.20. Measured streamflow was 35.24 cfs at this site.

MEC staff did not observe any direct or indirect evidence of WBCR at Site 3. No individuals were seen or found to be available for interviews near the bridge crossing at the time of the survey.

MEC staff concludes that WBCR is neither an existing nor an attainable use at this site based on limited access to the stream and the absence of observed recreational uses, and low-flow, shallow conditions.

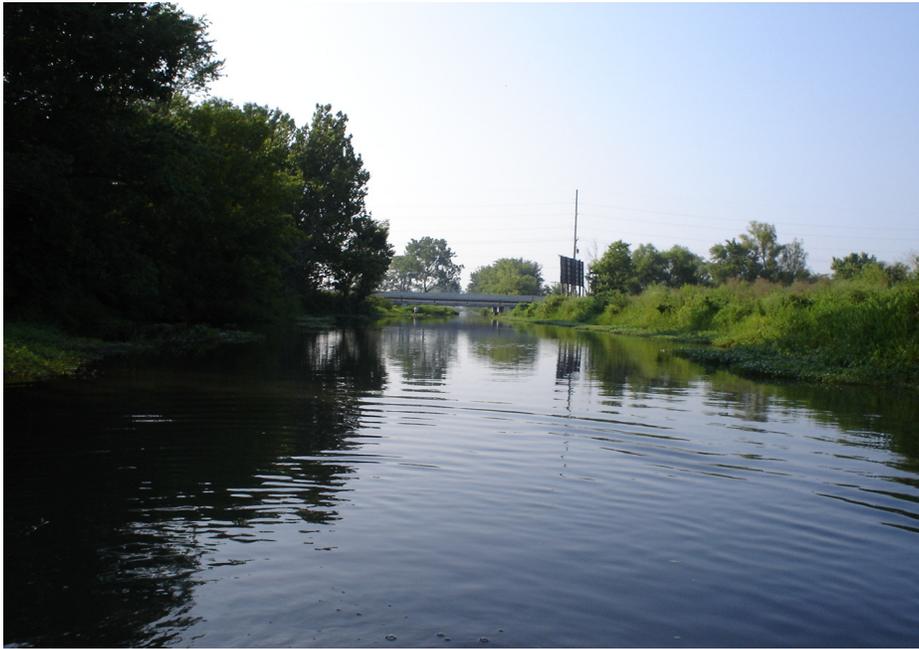
Figure 4. St. John's Ditch Site 2 Downstream View

Stream banks near the Highway 60 bridge crossing are steep sloping and heavily vegetated (Figures 4 and 5). Riparian areas immediately adjacent to the stream are primarily vegetated by forest and brush, with row crops nearby. The stream channel was observed to be mostly sand with little silt.

Mean depth along a 1,200 ft. assessment reach was 0.95 ft. as determined from 10 transects (Appendix B). The maximum depth observed at this location was 2.00 ft. Stream flow was measured as 33.36 cfs during the survey.

MEC staff did not observe any direct or indirect evidence of WBCR at Site 2. No individuals were seen or found to be available for interviews near the bridge crossing at the time of the survey.

MEC staff concludes that WBCR is neither an existing nor an attainable use at this site based on limited access to the stream and the absence of observed recreational uses, and low-flow, shallow conditions.

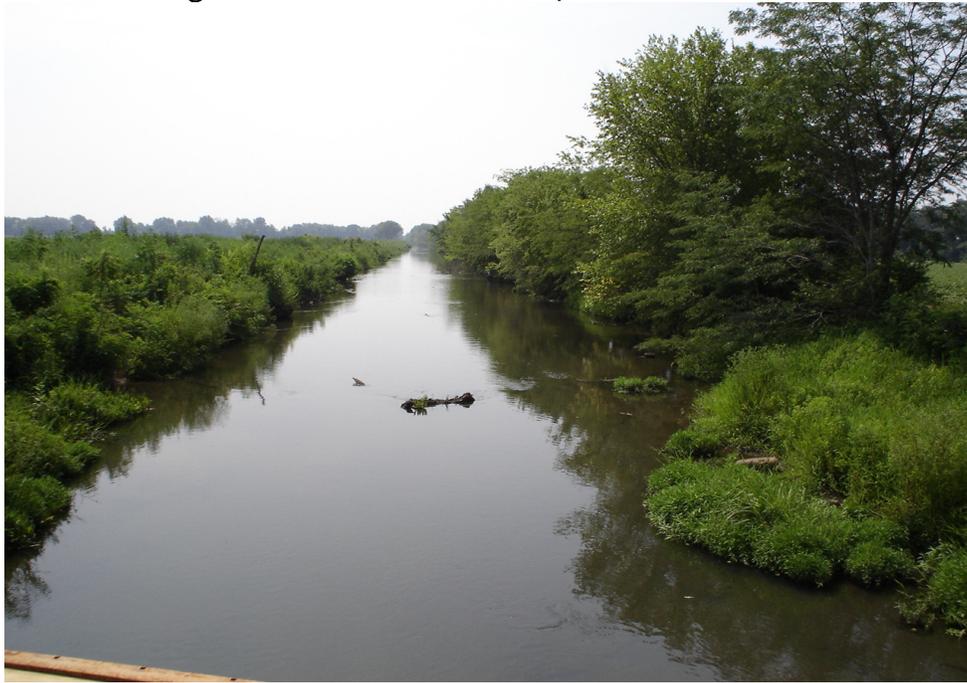
Figure 8. St. John's Ditch Site 4 Downstream View

Stream banks near the road are steep sloping and heavily vegetated (Figures 8 and 9). Riparian areas immediately adjacent to the stream are primarily vegetated by forest and brush while grassland and row crops are also nearby.

Mean depth along a 1,000 ft. assessment reach was 0.79ft based on 10 transects (Appendix B). The maximum observed depth was 2.20 ft. Measured streamflow was 35.26 cfs during the survey.

MEC staff did observe gravel and dirt roads near the stream along with drainage tiles leading into the stream; however they did not observe any direct or indirect evidence of WBCR at this site. No individuals were seen or found to be available for interviews near the bridge crossing at the time of the survey.

MEC staff concludes that WBCR is neither an existing nor an attainable use at Site 4 based on limited access to the stream and the absence of observed recreational uses, and low-flow, shallow conditions.

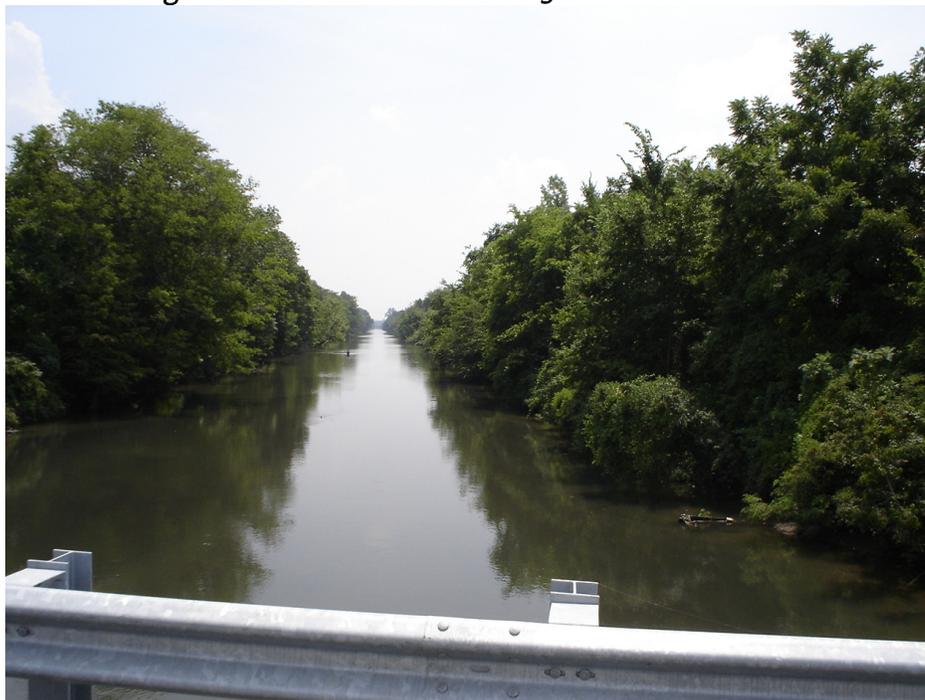
Figure 10. St. John's Ditch Site 5 Downstream View

Stream banks near the County Road 820 bridge crossing are heavily vegetated and steep (Figures 10 and 11).The riparian areas immediately adjacent to the stream consist of hardwood trees, brush and row crops.

Mean depth along a 1700 ft. assessment reach was 1.25ft. based on 10 transects (Appendix B). The maximum observed depth was 2.10 ft. Measured streamflow was 31.25 cfs during the survey.

MEC staff did observe a gravel road near the stream; however they did not observe any direct or indirect evidence of WBCR at Site 5. No individuals were seen or were available for interviews near the bridge crossing at the time of the survey.

MEC staff concludes that WBCR is neither an existing nor an attainable use at this site based on limited access to the stream and the absence of observed recreational uses, and low-flow, shallow conditions.
