Use Attainability Analysis

WBID 3284 Vance Branch

Submitted by
Olsson Associates

October 14, 2008

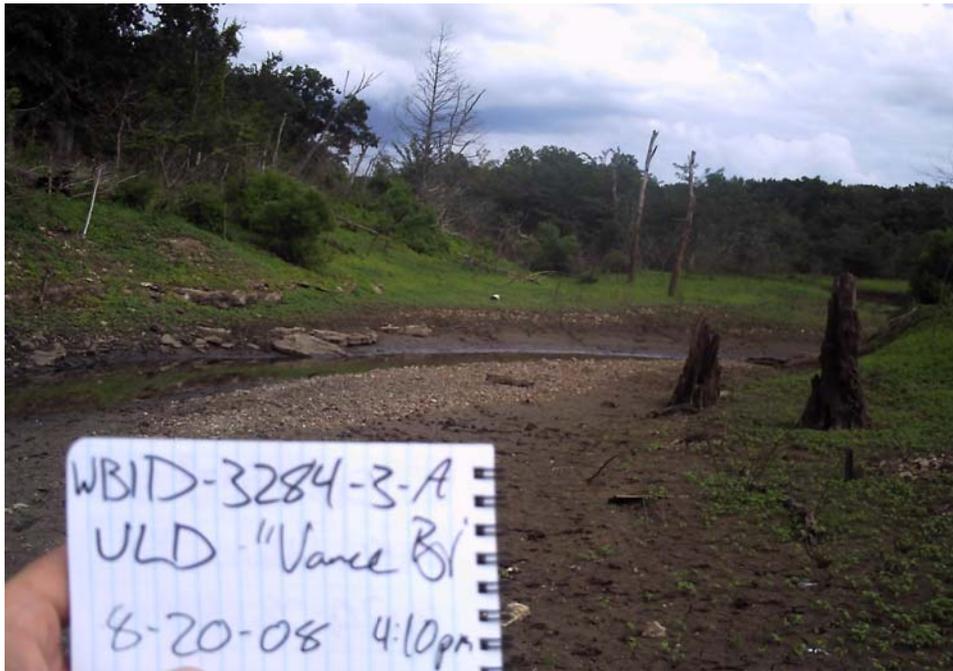
Photo ID#	Photo Purpose	Photo ID#	Photo Purpose	Photo ID#	Photo Purpose
3284-3-A	Upstream looking down				
Photo ID#	Photo Purpose	Photo ID#	Photo Purpose	Photo ID#	Photo Purpose
3284-3-B	Downstream looking up				
Photo ID#	Photo Purpose	Photo ID#	Photo Purpose	Photo ID#	Photo Purpose

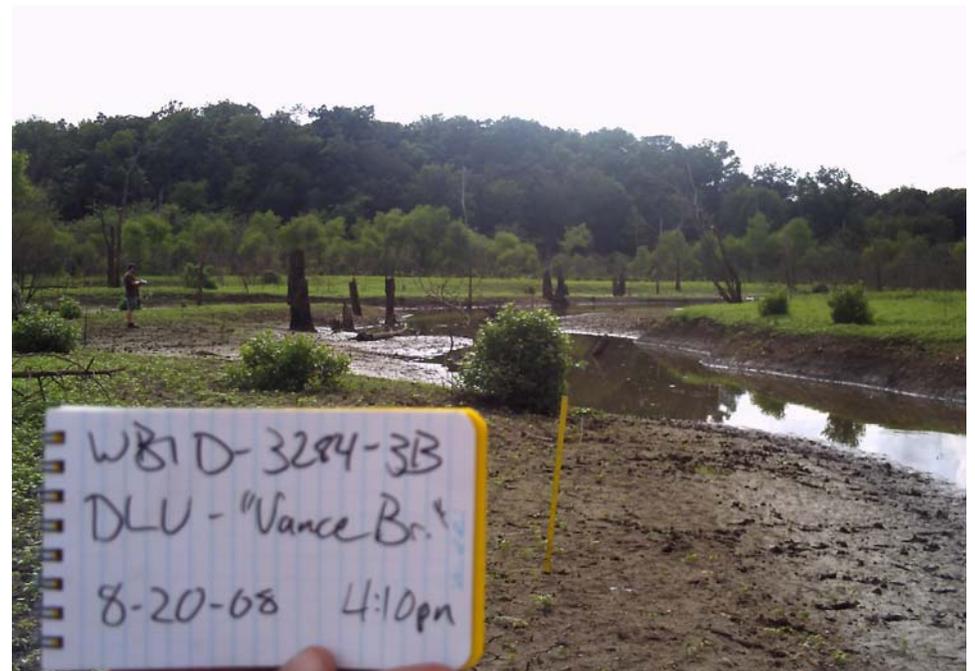
Truman Lake @ downstream end of transect. See photo 3284-3-C
