Use Attainability Analysis

WBID 3623 Rocky Branch

Submitted by
MEC/ERC

October 24, 2008

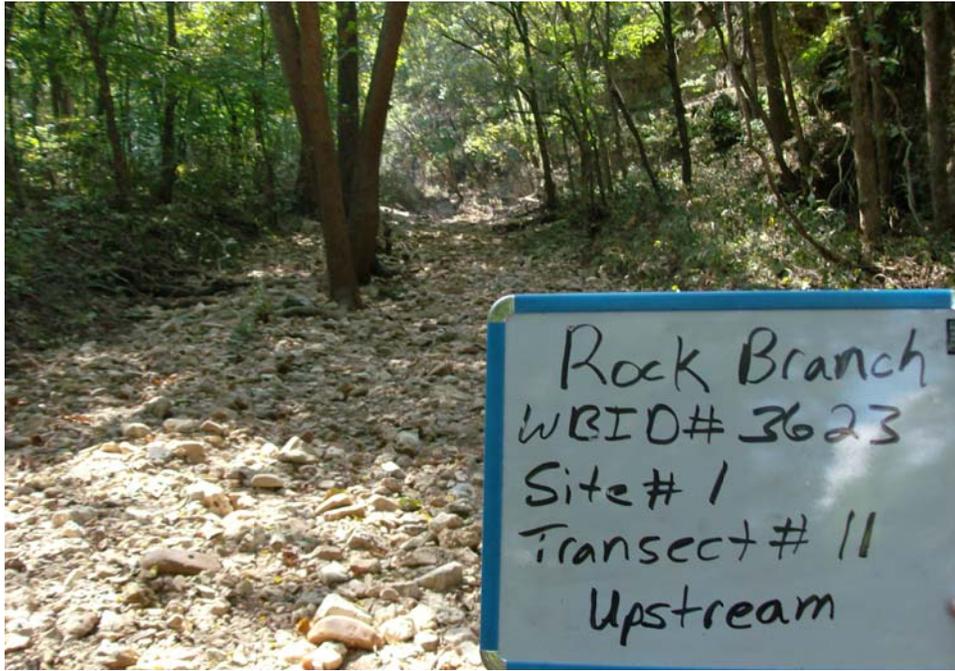
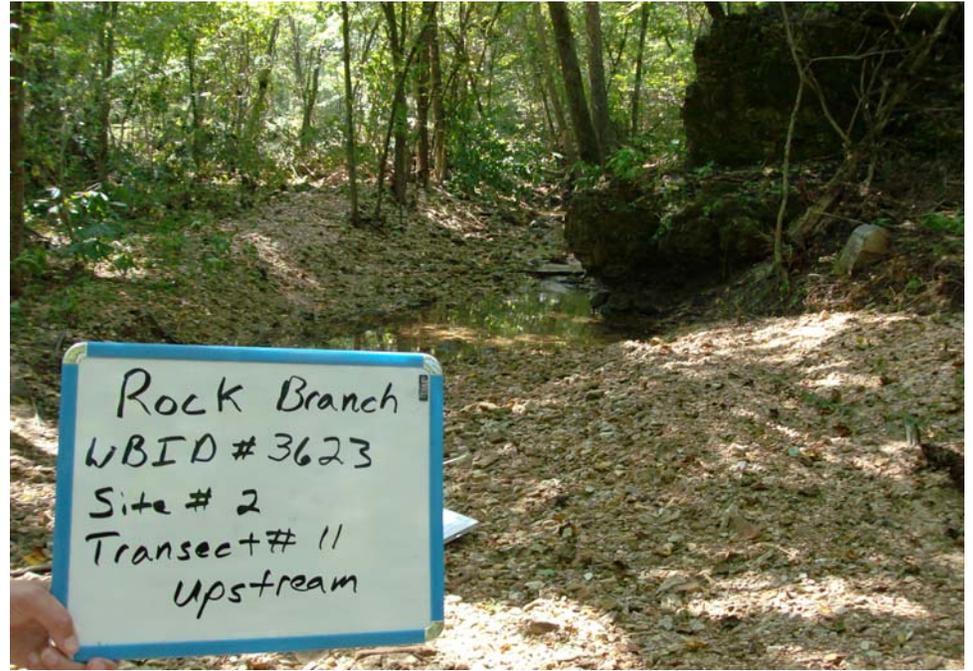
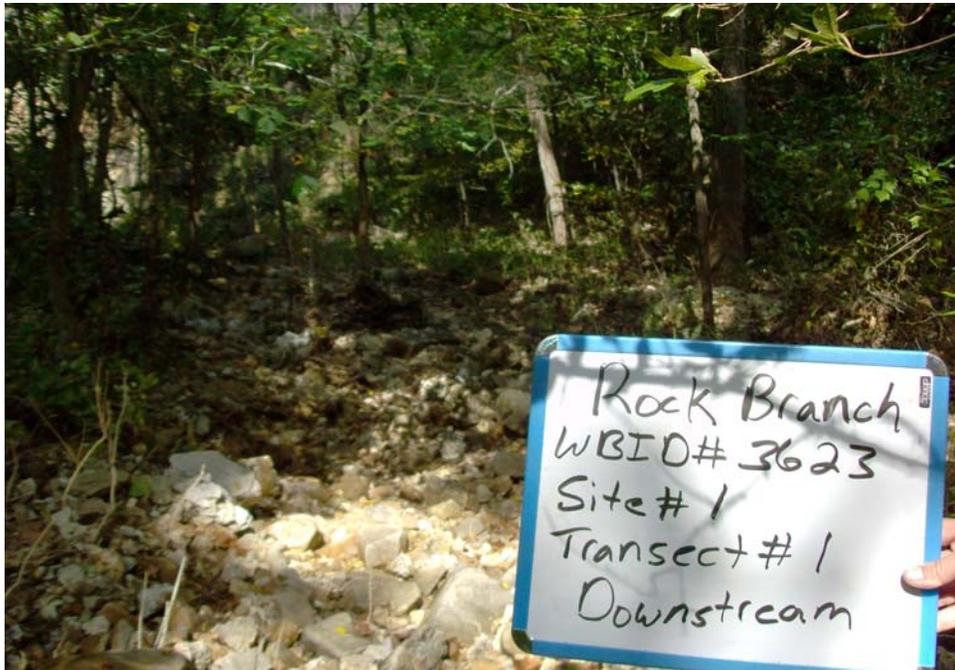
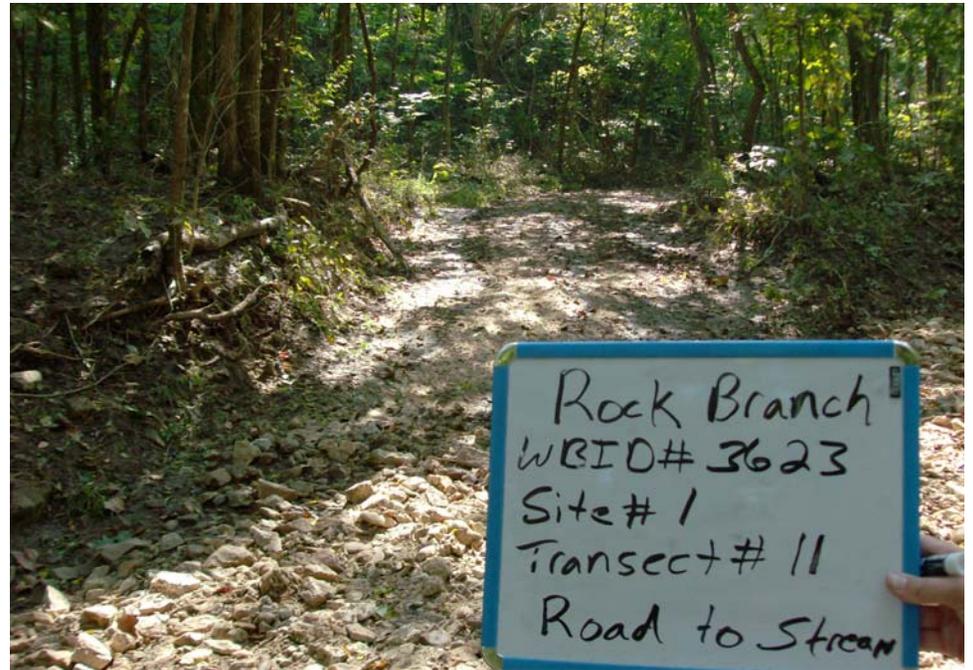
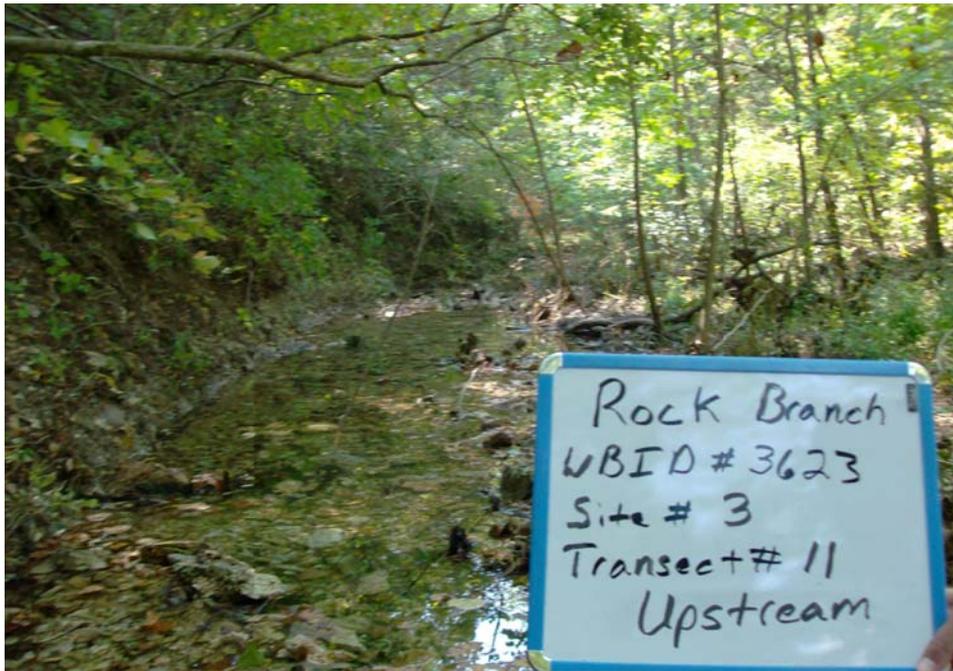
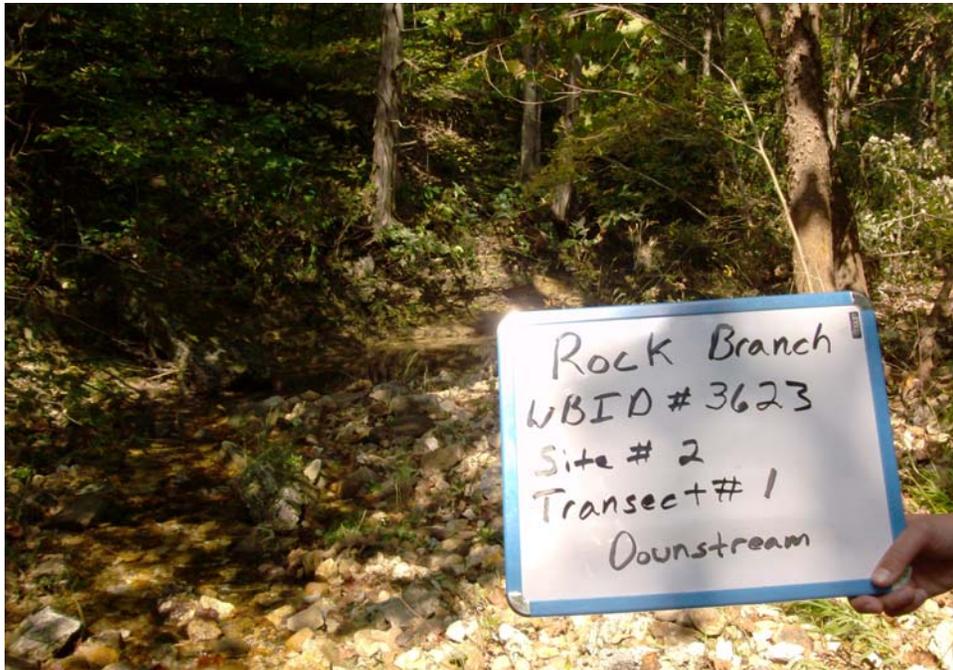
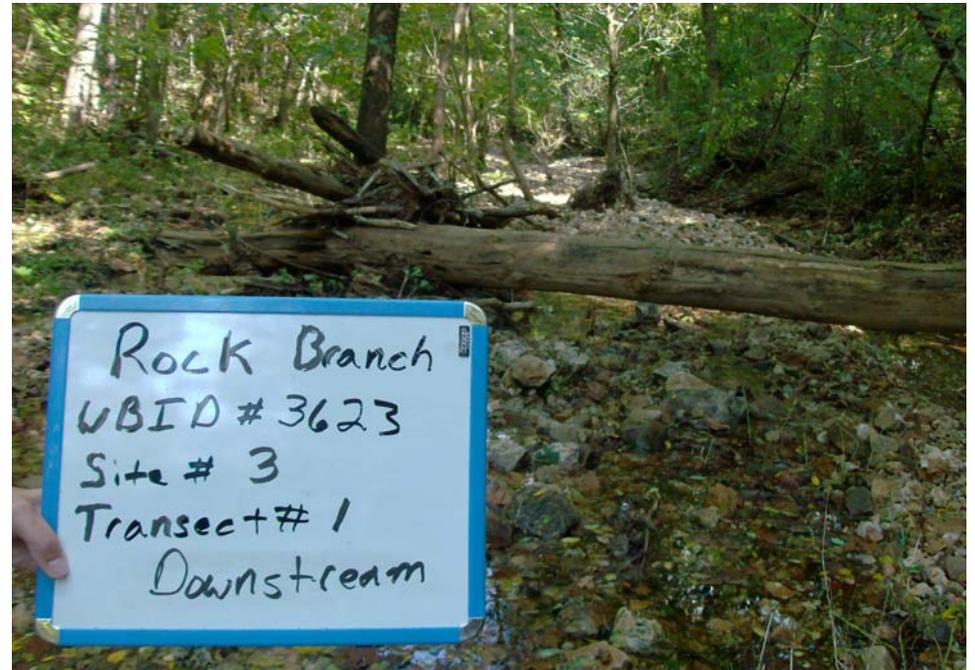
Photo ID#	Photo Purpose	Photo ID#	Photo Purpose	Photo ID#	Photo Purpose
<u>124</u>	<u>transect I Downstream</u>	<u>125</u>	<u>transect II upstream</u>	<u>126</u>	<u>transect II Road to stream</u>
Photo ID#	Photo Purpose	Photo ID#	Photo Purpose	Photo ID#	Photo Purpose
Photo ID#	Photo Purpose	Photo ID#	Photo Purpose	Photo ID#	Photo Purpose

Photo ID#	Photo Purpose	Photo ID#	Photo Purpose	Photo ID#	Photo Purpose
<u>119</u>	<u>transect 11 upstream</u>	<u>120</u>	<u>transect 1 downstream</u>		
Photo ID#	Photo Purpose	Photo ID#	Photo Purpose	Photo ID#	Photo Purpose
Photo ID#	Photo Purpose	Photo ID#	Photo Purpose	Photo ID#	Photo Purpose

Photo ID#	Photo Purpose	Photo ID#	Photo Purpose	Photo ID#	Photo Purpose
<u>122</u>	<u>transect 11 upstream</u>	<u>123</u>	<u>transect 1 downstream</u>		
Photo ID#	Photo Purpose	Photo ID#	Photo Purpose	Photo ID#	Photo Purpose
Photo ID#	Photo Purpose	Photo ID#	Photo Purpose	Photo ID#	Photo Purpose
