**NATIONAL REGISTER OF HISTORIC PLACES  
INVENTORY -- NOMINATION FORM**

HISTORIC Sappington, Joseph house  
AND/OR COMMON

STREET & NUMBER 10734 Clearwater Drive NOT FOR PUBLICATION  
CITY, TOWN Affton CONGRESSIONAL DISTRICT #3 Hon. Richard A. Gephardt  
STATE MO CODE 29 COUNTY St. Louis CODE 189

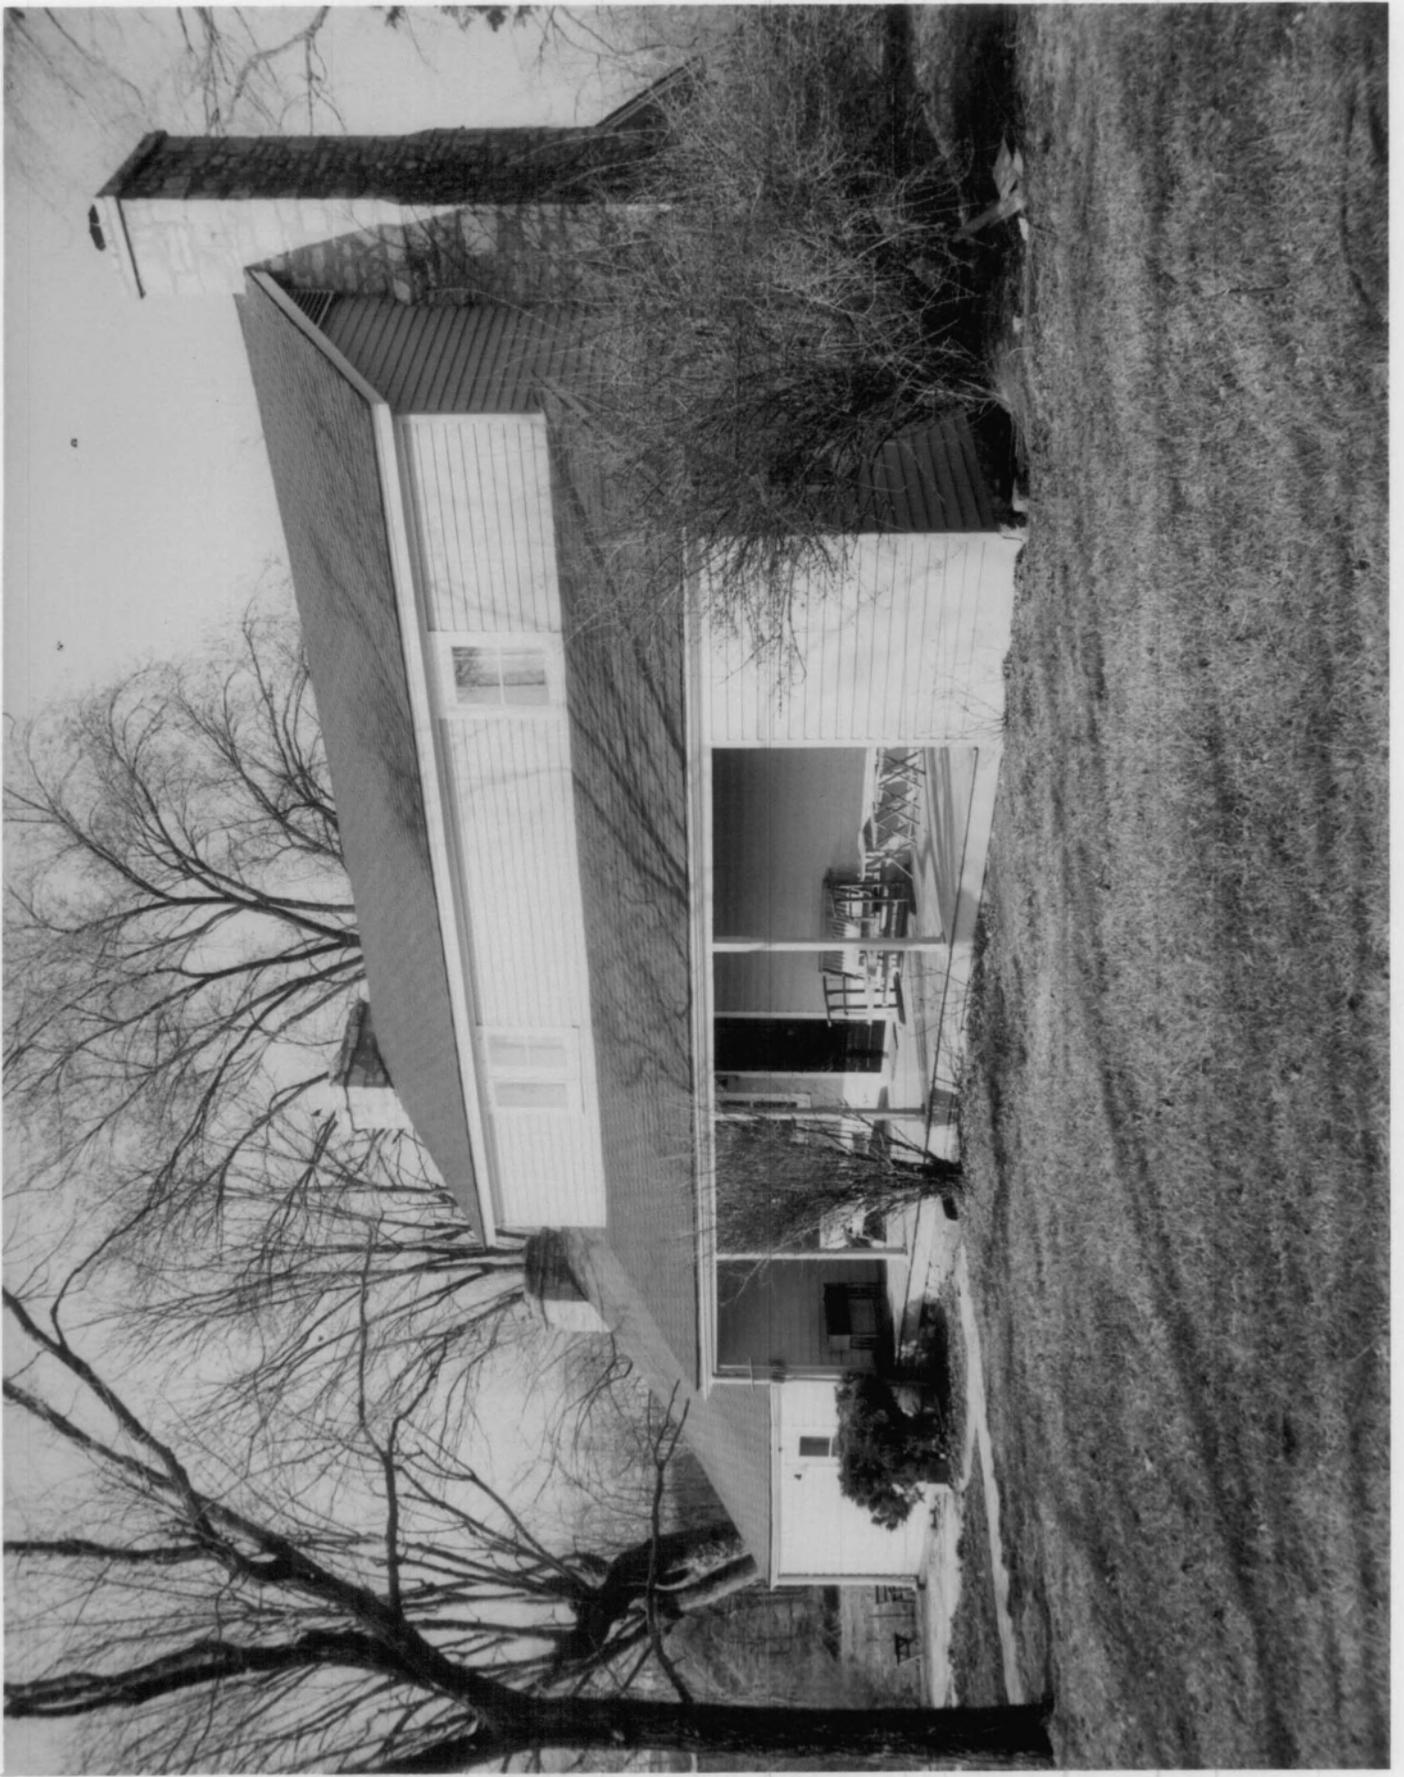
Joseph Sappington House  
10734 Clearwater Drive  
Photo credited to Esley Hamilton,  
December 1979  
Negative filed at St. Louis Co. Pks.  
& Rec. Dept.  
View of house from southeast  
Photo Number Two of Five

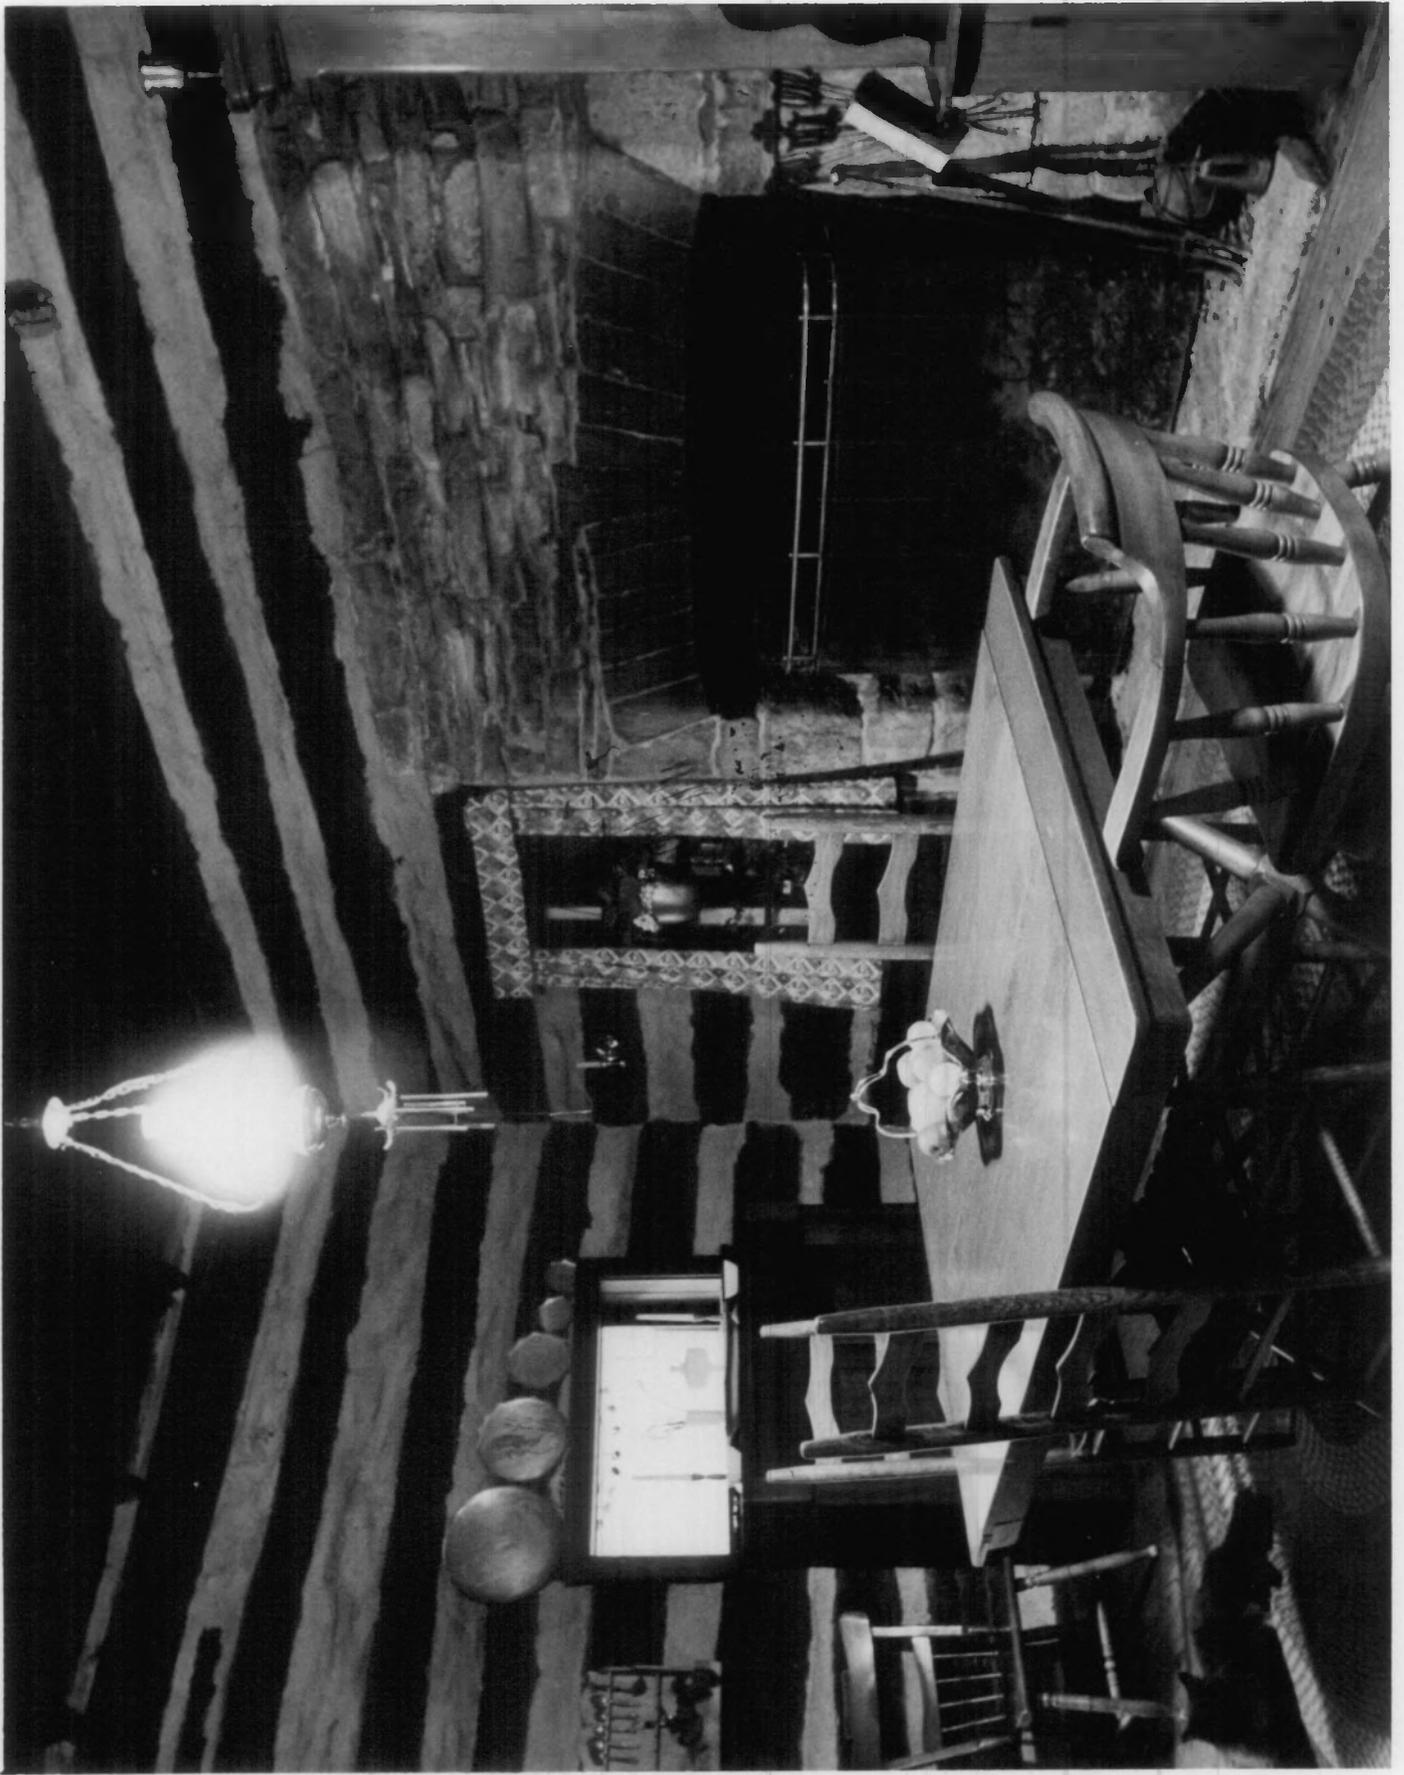
Joseph Sappington House  
10734 Clearwater Drive  
Photo credited to James Lubbock, 1978  
Negative filed at site  
View from the south room looking northwest  
Photo Number Four of Five

JOSEPH SAPPINGTON HOUSE -- DINING ROOM (SOUTH ROOM), LOOKING NORTHWEST. ROCKWORK IS EXTERIOR OF

← LIVING ROOM (KITCHEN)

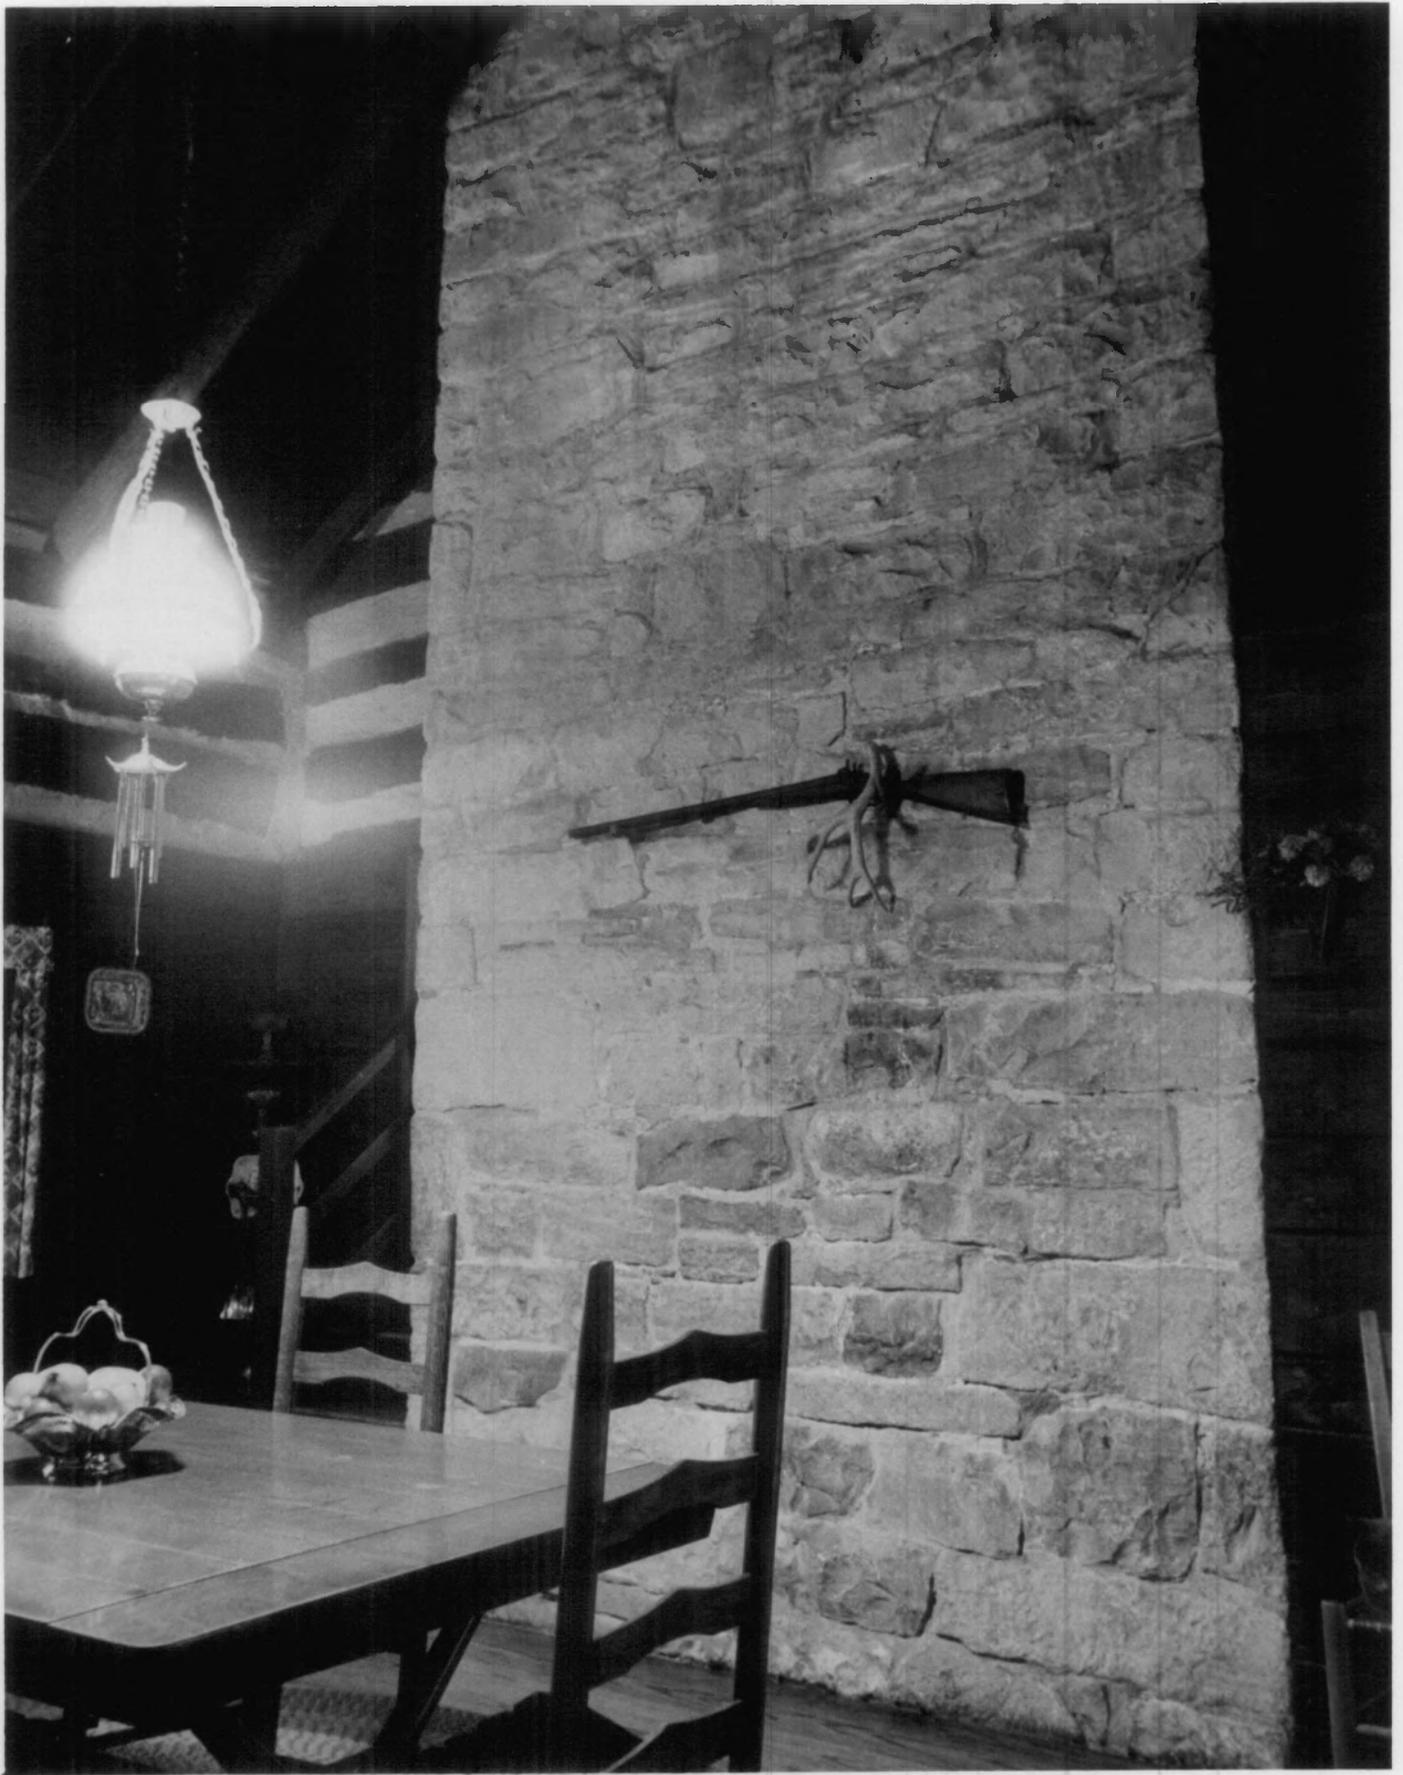
Joseph Sappington House  
10734 Clearwater Drive  
Photo credited to James Lubbock, 1978  
Negative filed at site  
View of center room looking south  
Photo Number Five of Five

partly on wood lathe, partly on wire, and an elaborate false front of grey and pink stones obscured the original outline of the fireplace, the only one then exposed. The north room had more modern sand plastering over wire lathe. All these surfaces were removed, revealing that the logs beneath had been whitewashed many times before being covered. These logs were cleaned and finished with a light coat of Minwax. The north and south fireplaces had lost their hearths, their fireboxes and had been filled with rubble, and holes had been knocked in their chimneys, presumably to accommodate stovepipes. These holes were filled and the hearths rebuilt with stone from the creek immediately to the south, which was evidently the source of the original stone. Previous crude patching of the masonry of the fireplaces was corrected and the fireboxes were tuckpointed with fireclay.

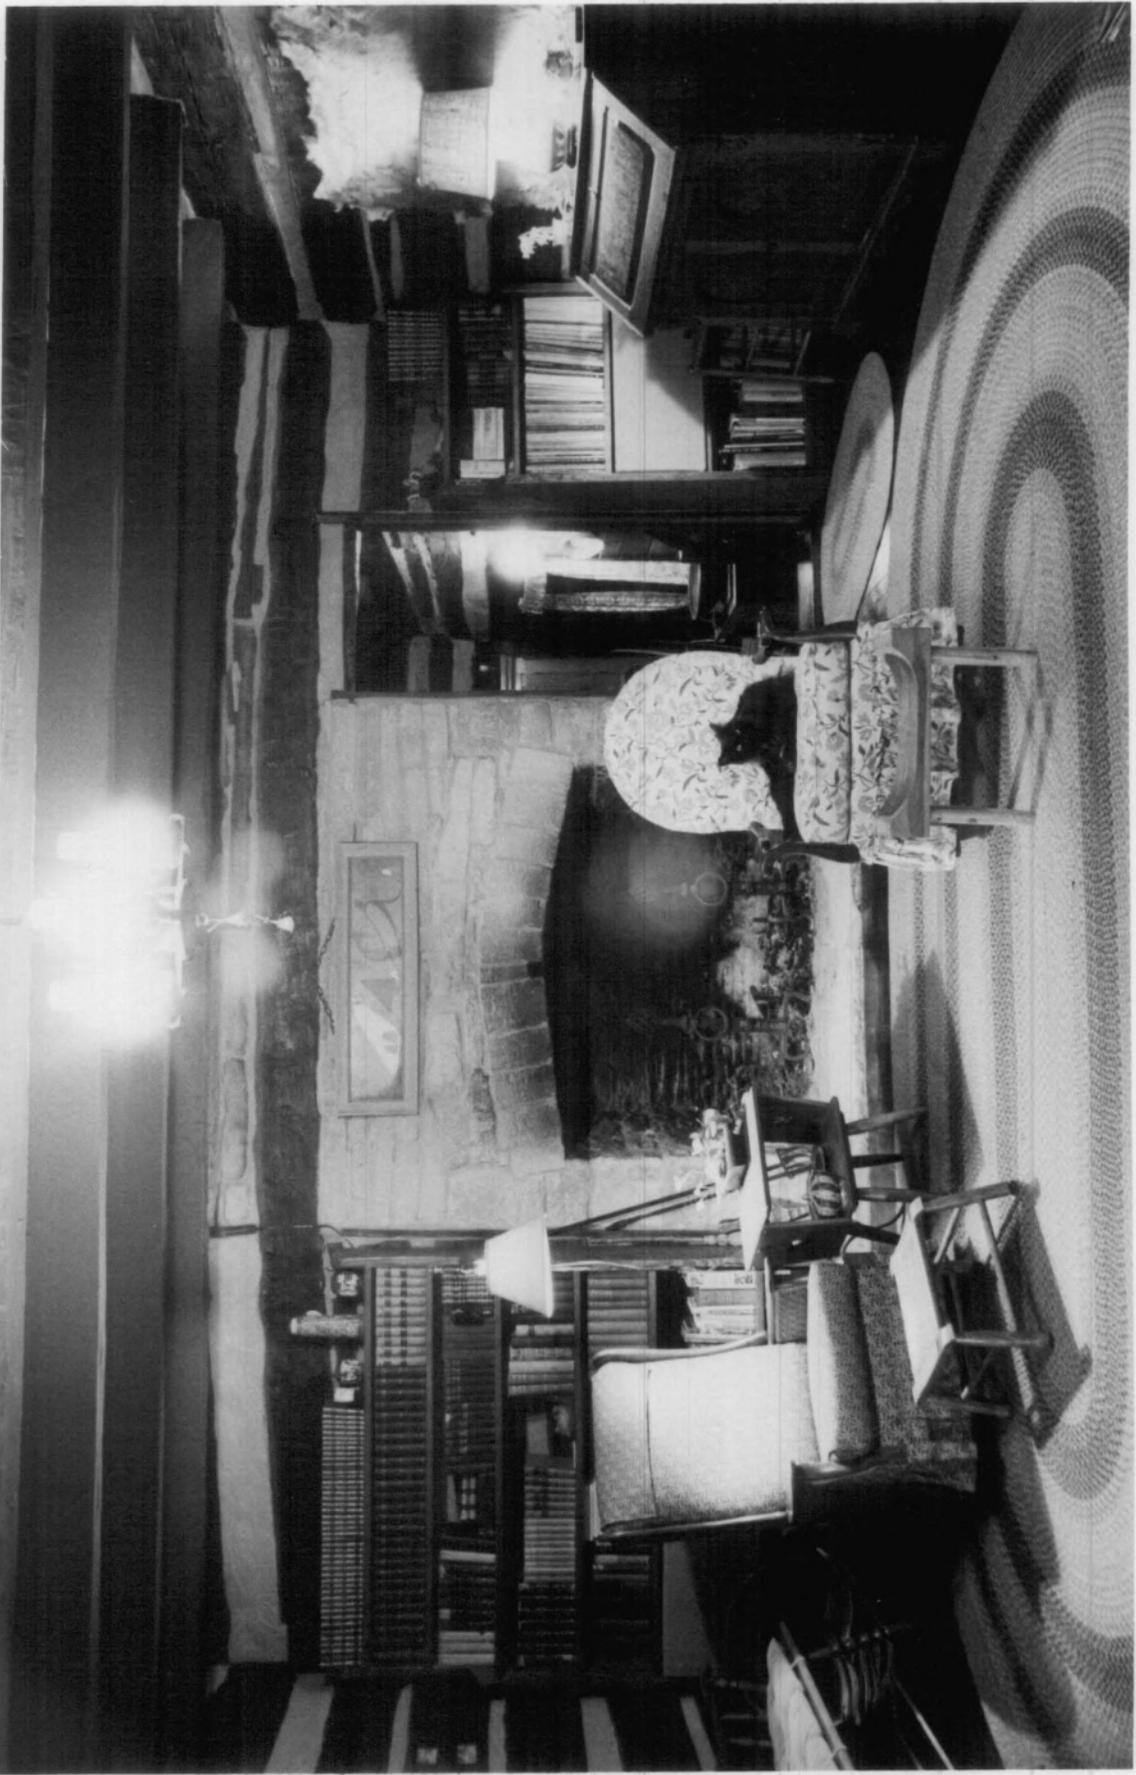
Joseph Sappington House  
10734 Clearwater Dr., St. Louis, MO 63123  
Photographer: James Lubbock, Feb., 1981  
Neg. Loc.: 10734 Clearwater Dr.  
View of N. room looking E, showing boxed  
stairway.  
Photo Number Six

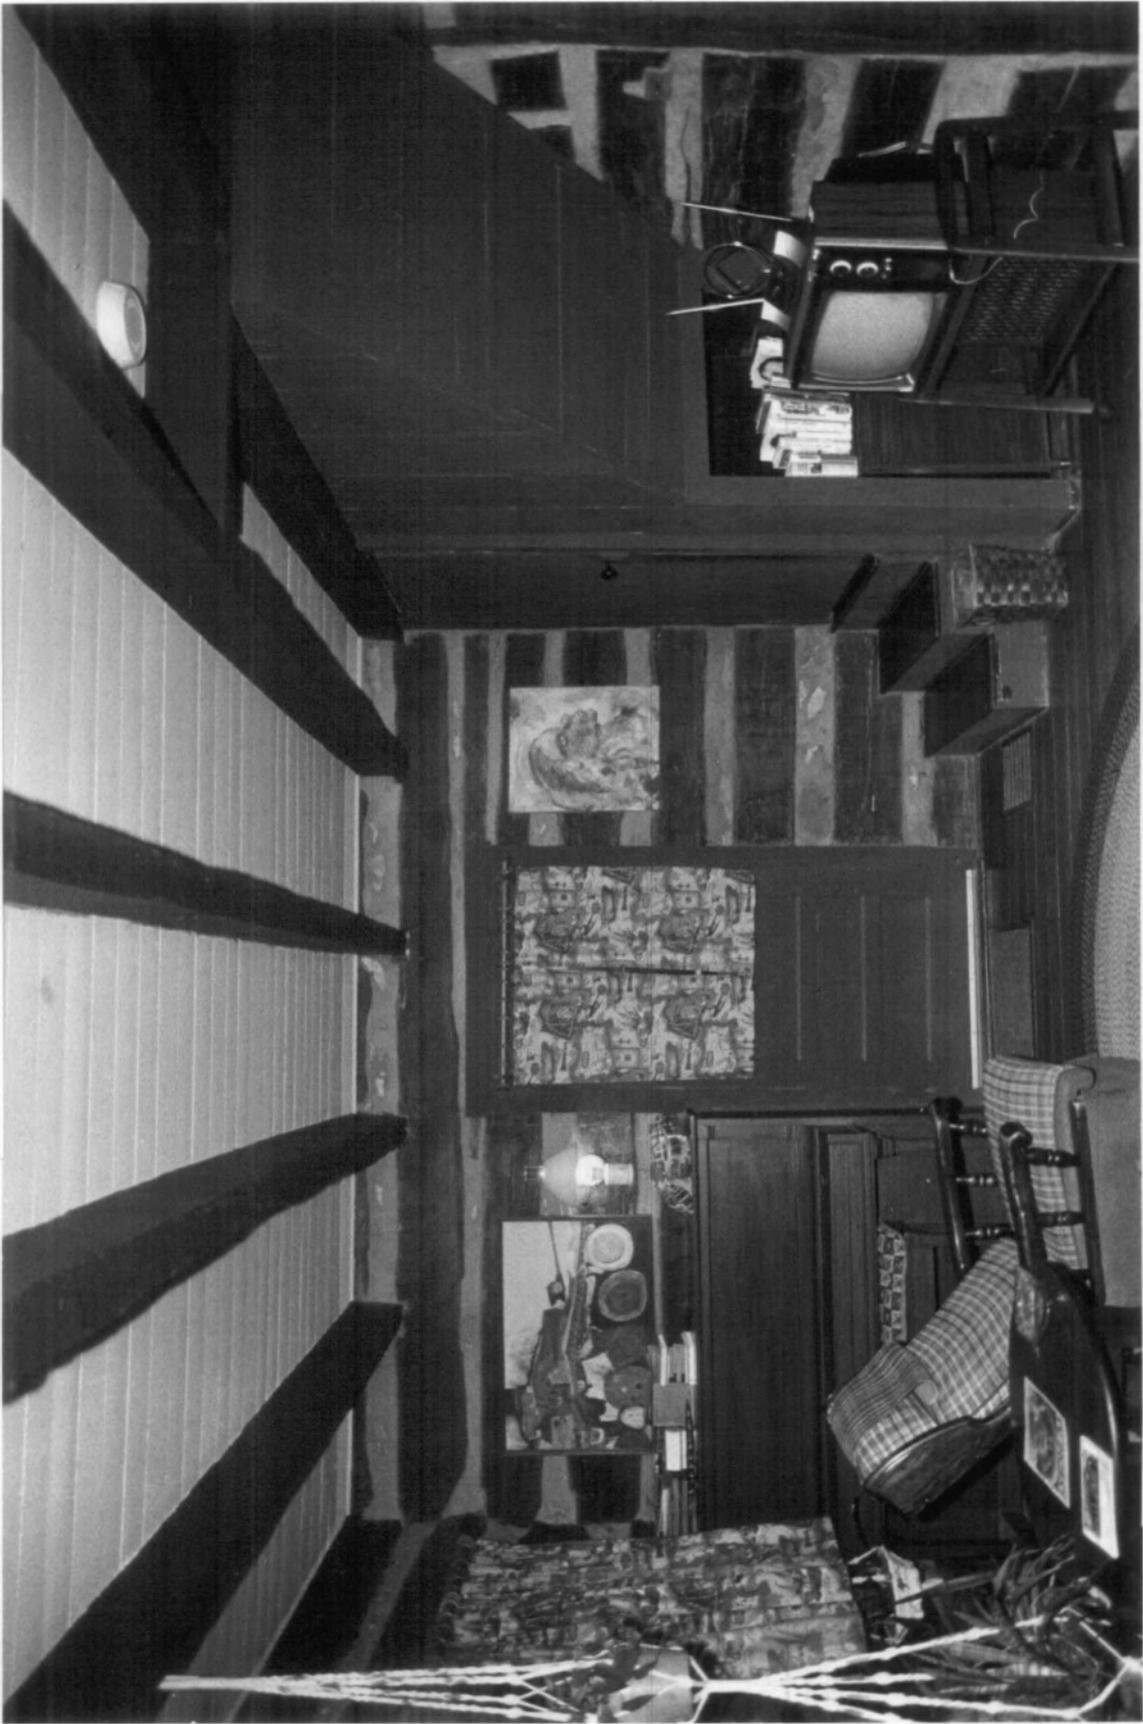
Joseph Sappington House  
10734 Clearwater Dr., St. Louis, MO 63123  
Photographer: James Lubbock, Feb., 1981  
Neg. Loc.: 10734 Clearwater Dr.  
View of center room ceiling, looking E. Offset  
in beams indicates that boxed stairway was once  
here.  
Photo Number Seven

Internal evidence suggests that the house was built in three or more phases and that the center room, heated by the chimney at the south end of the main block, is oldest. The logs in this room terminate at the corners rather than tying into the adjacent rooms. An offset in the northeast corner of the ceiling beams suggests that the boxed staircase, now located in the north room, was originally located here. The center and north rooms also differ in their ceilings and floors. The ceiling boards (which are the floor of the room above) are wider and beaded on one edge in the center room, narrower and unbeaded in the north room. The floors of the first floor are supported by log joists, but those under the center room have been stripped of bark, while those under the north room are still bark-covered.

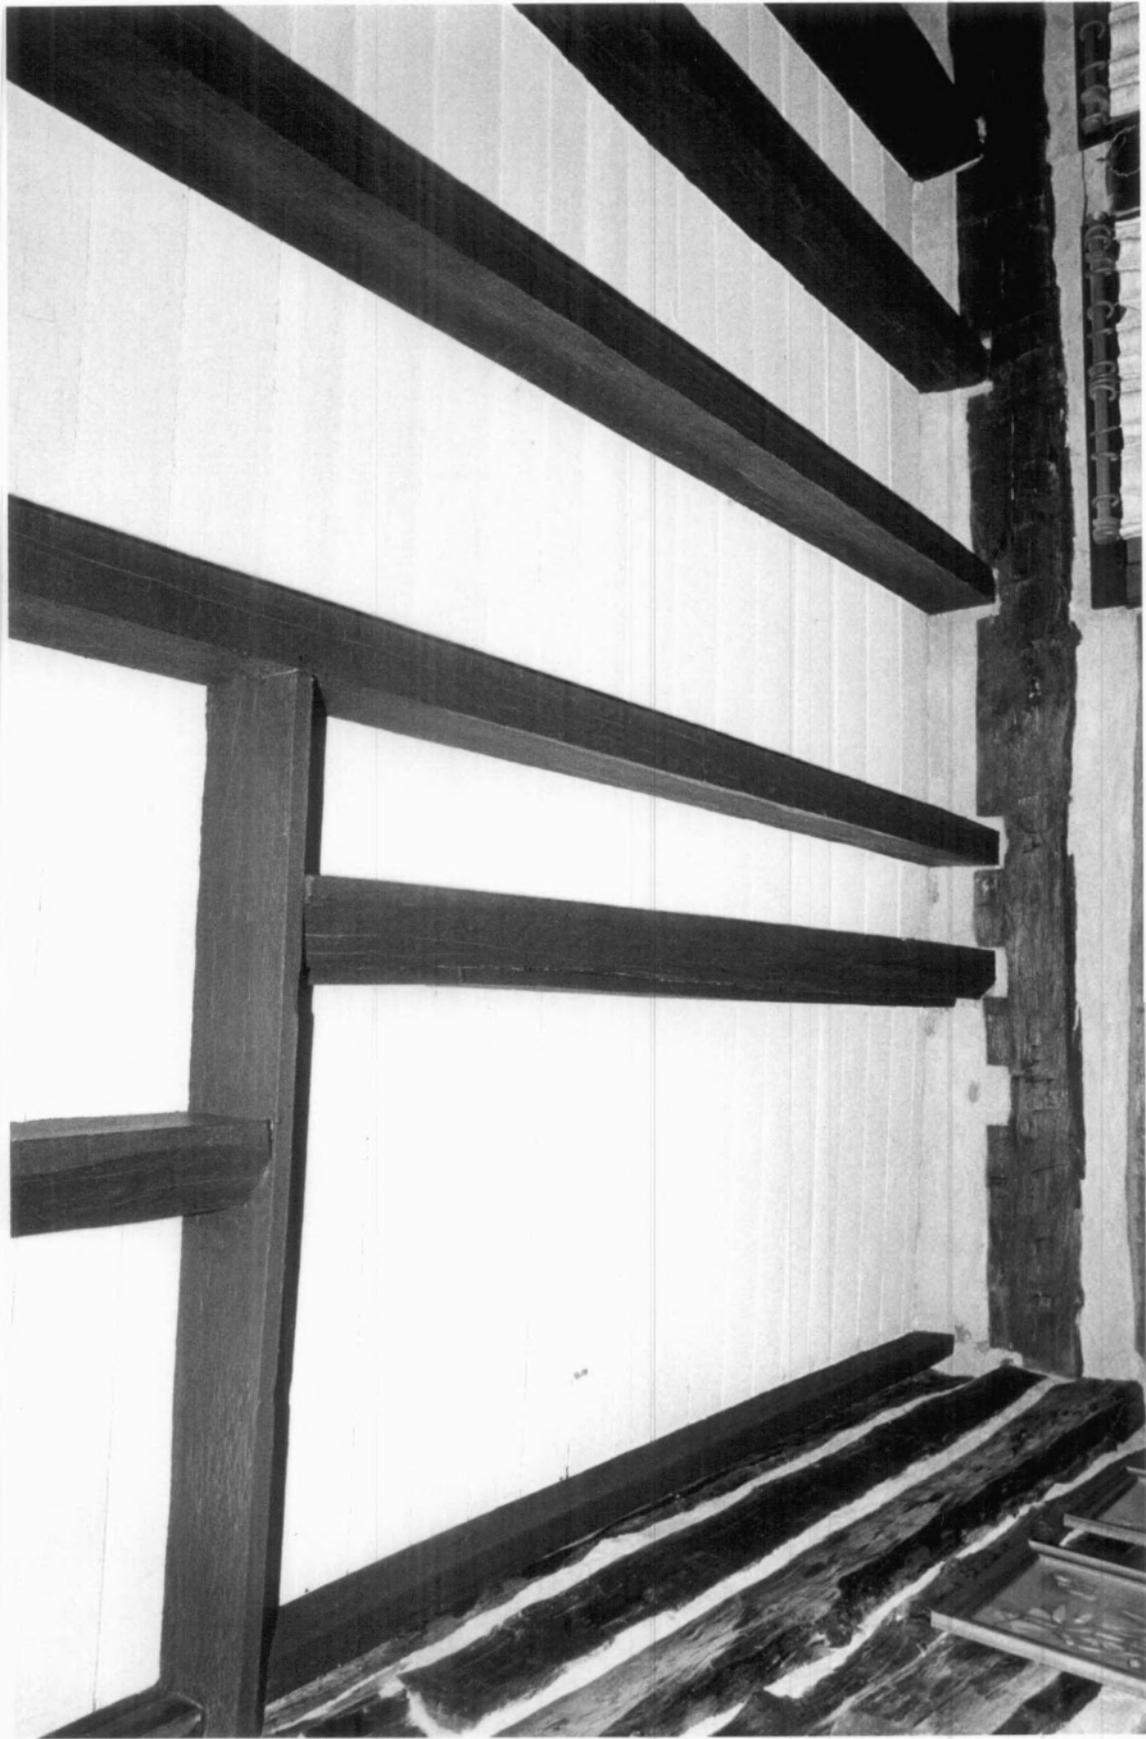
Photo Number Eight

View of NW corner of center room. Note that  
all logs end at this point, suggesting that N  
room beyond is later addition.

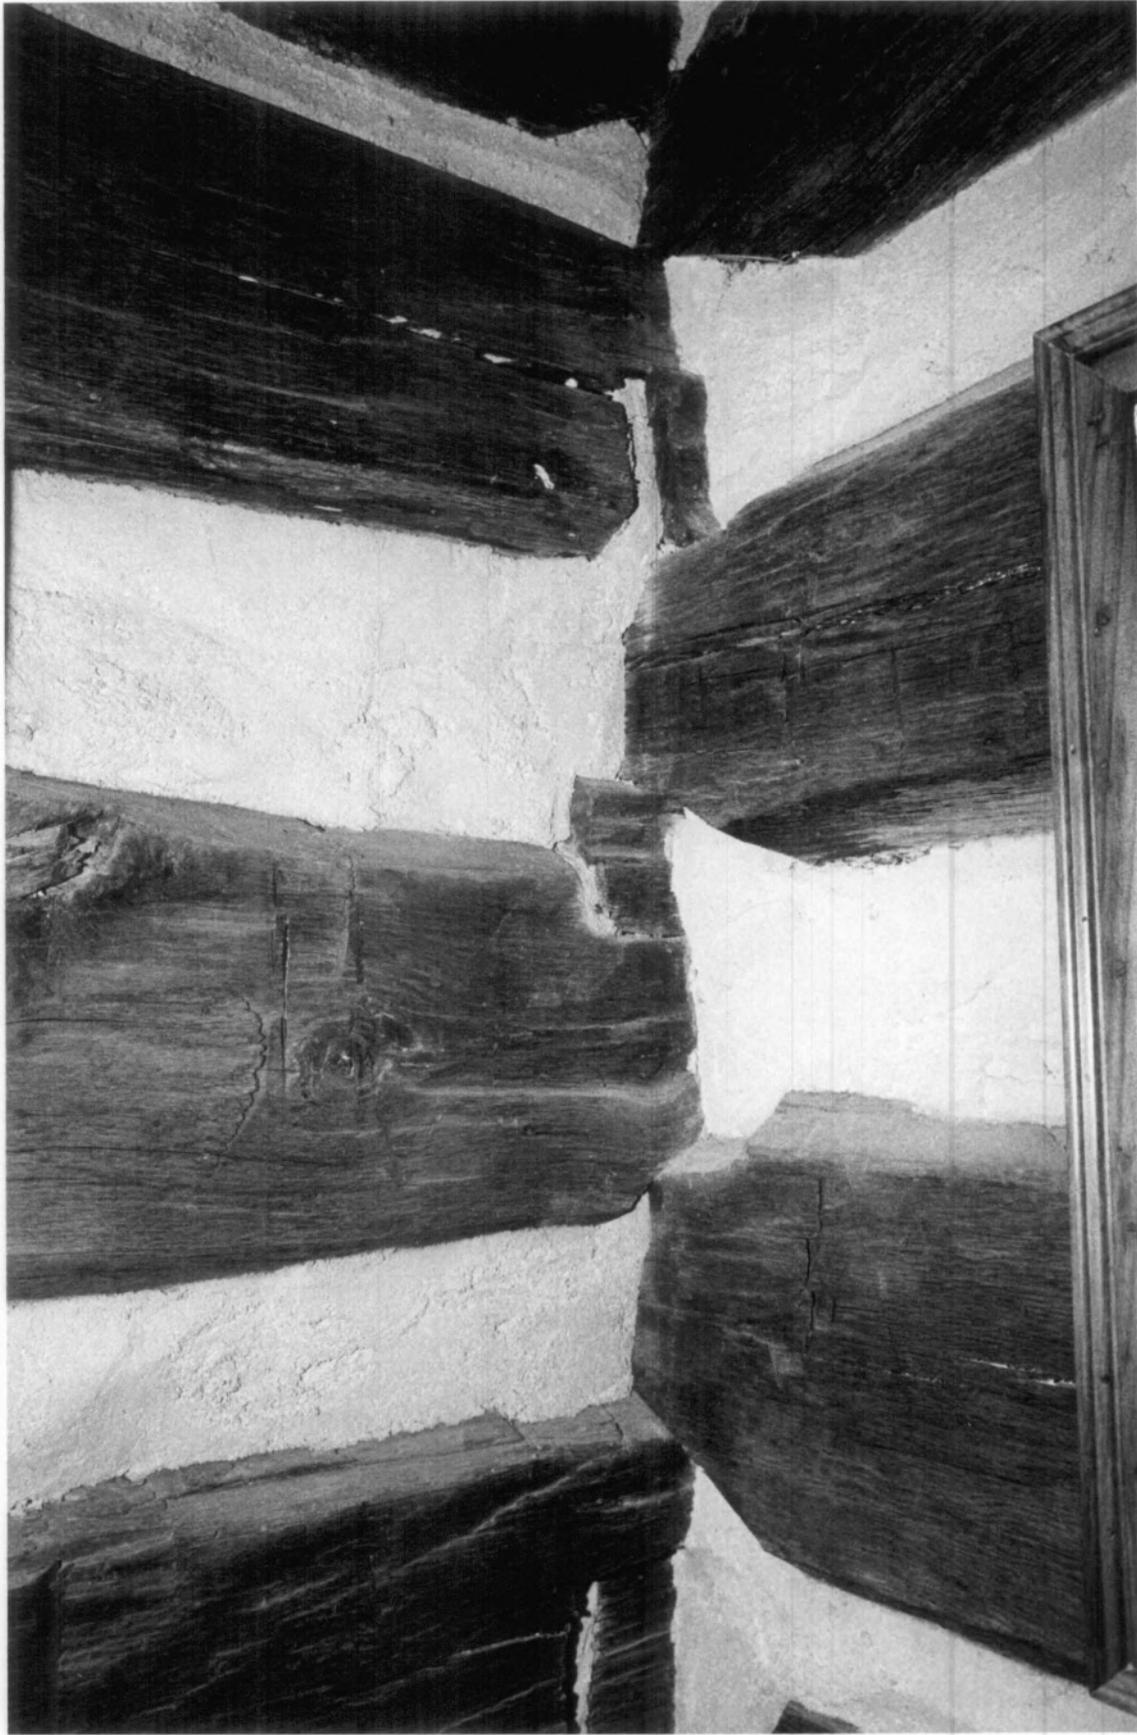
Joseph Sappington House  
10734 Clearwater Dr., St. Louis, MO 63123  
Photographer: James Lubbock, Feb., 1981  
Neg. Loc.: 10734 Clearwater Dr.  
View of log ends showing remains of original  
whitewash.  
Photo Number Nine

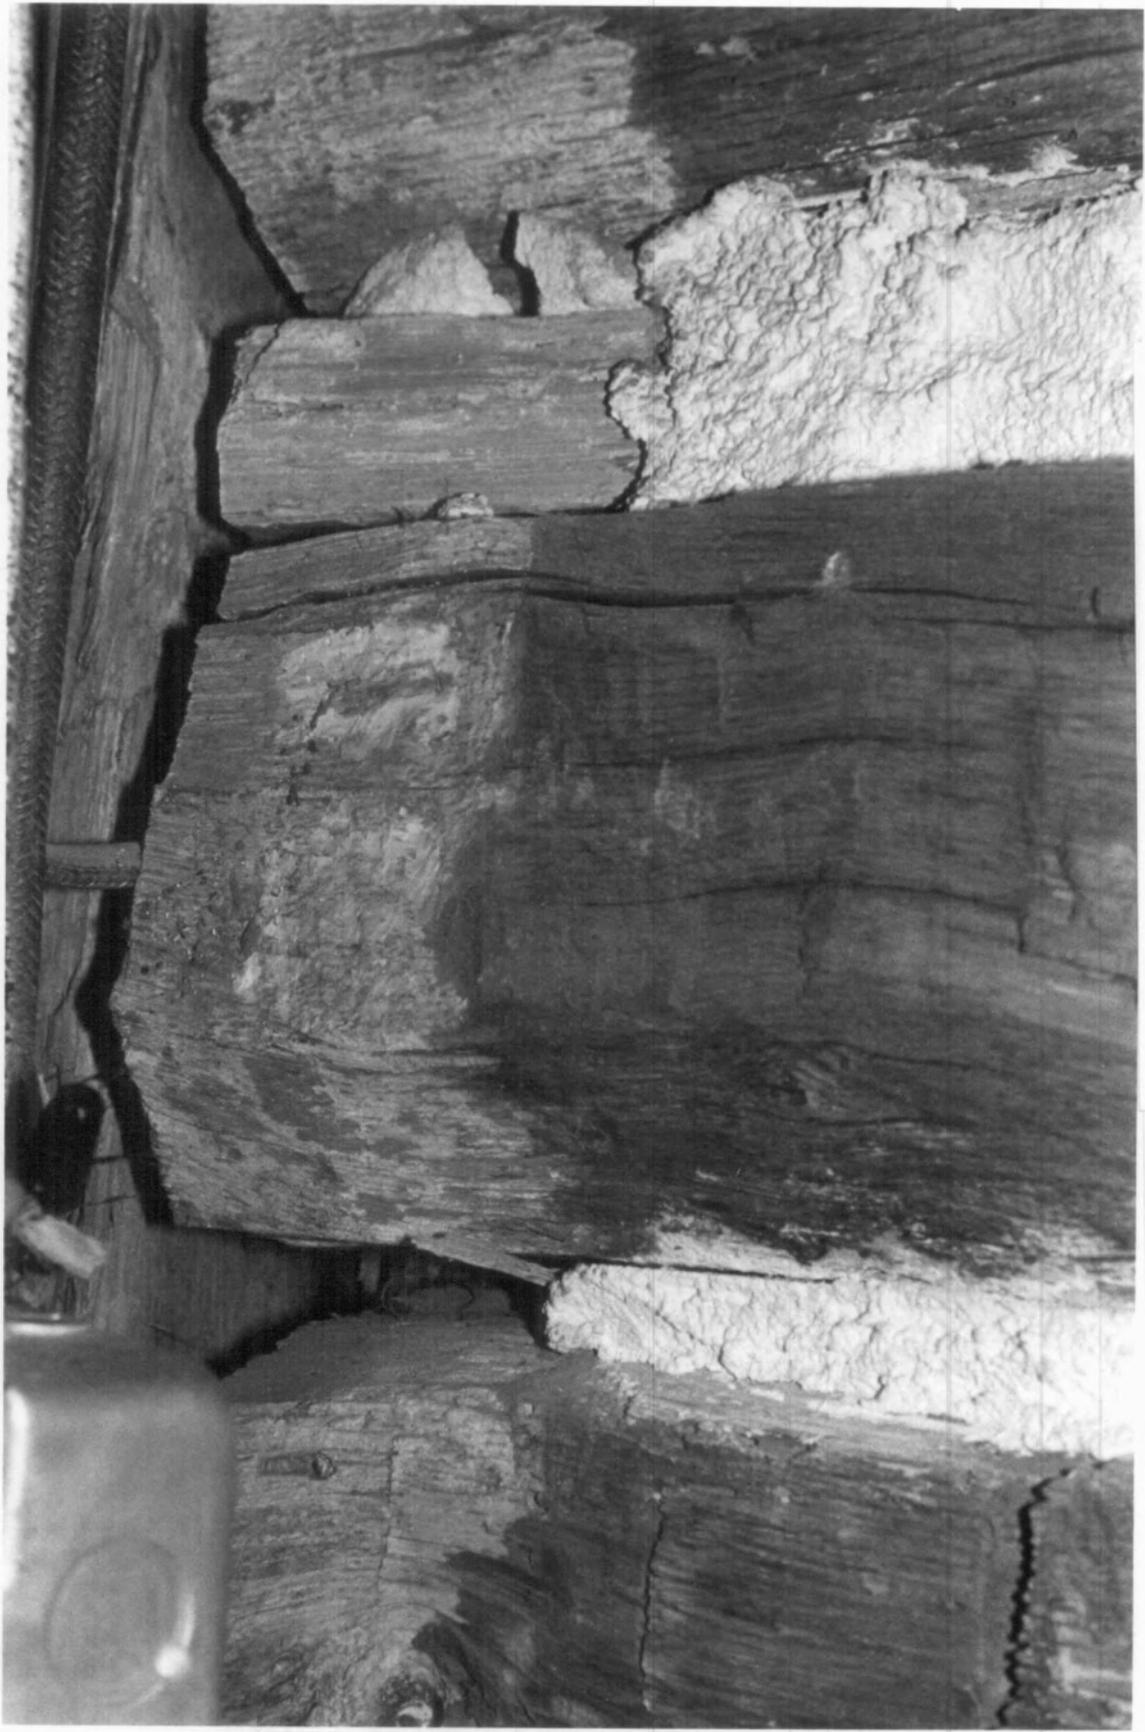
Joseph Sappington House  
10734 Clearwater Dr., St. Louis, MO 63123  
Photographer: James Lubbock, Feb., 1981  
Neg. Loc.: 10734 Clearwater Dr.  
View into a hidden corner of N room, showing  
wire lath used in late-19th or early-20th-  
century plastering of original logs.  
Photo Number Ten

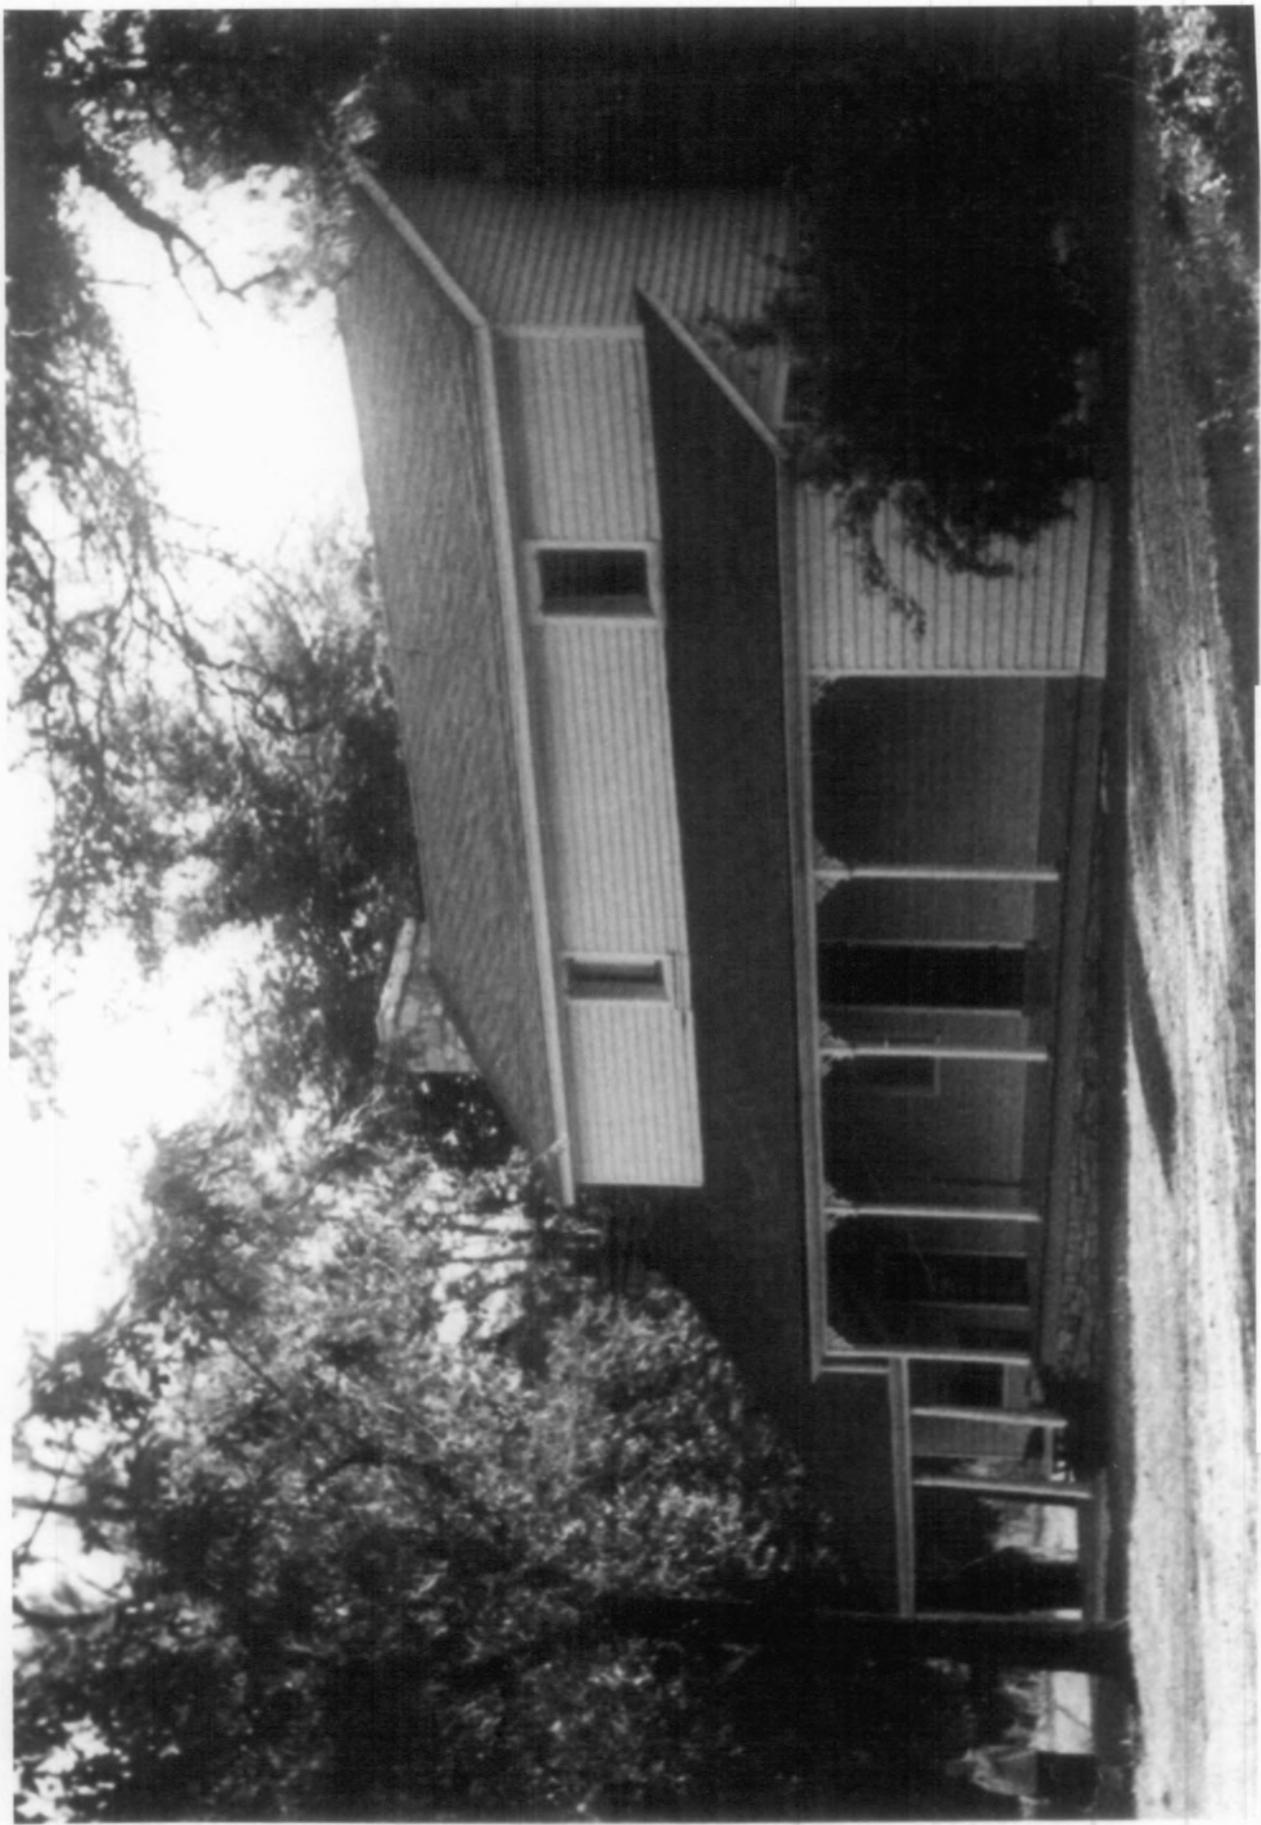
Photo Number Twelve

View of house from SW, before west porch was  
enclosed.

The house itself is a two-story structure facing east, with large squared rubble chimneys at the ends and a one-story wing to the south with a third chimney on its south end. The house is built of logs, but like most such pioneer structures it was weatherboarded as soon as prosperity and availability permitted. The many coats of paint on the present boards suggest that they are the originals. A one-story shed-roof porch of five bays extends across the east front of the house; the north bay was enclosed at some early time. A similarly proportioned one-story porch running across the west side of the house was also enclosed in 1953, as was a shorter porch on the east side of the south wing.<sup>1</sup>
