Survey number: CL-AS-015-001		2. SURVEY NAME: Boardinghouse Historic Resource Inventory	
3. COUNTY: CLAY		4. ADDRESS (STREET NO. 403 )	STREET (NAME) Benton Avenue
5. CITY: Excelsior Springs	Vicinity <input type="checkbox"/>	6. UTM	OR LAT: 39.341072 7. TOWNSHIP/RANGE/SECTION LONG: -94.21933 T: 52 R: 30 S: 1
8. HISTORIC NAME (IF KNOWN): Crystal Lithium (Lithia) Springs/ Crystal Minera		9. PRESENT/OTHER NAME (IF KNOWN): Crystal Lithia Pavilion	
10. OWNERSHIP <input type="checkbox"/> PRIVATE <input checked="" type="checkbox"/> PUBLIC		11A. HISTORIC USE (IF KNOWN): HEALTH CARE: Resort Facility	
		11B. CURRENT USE: RECREATION & CULTURE/outdoor recrea

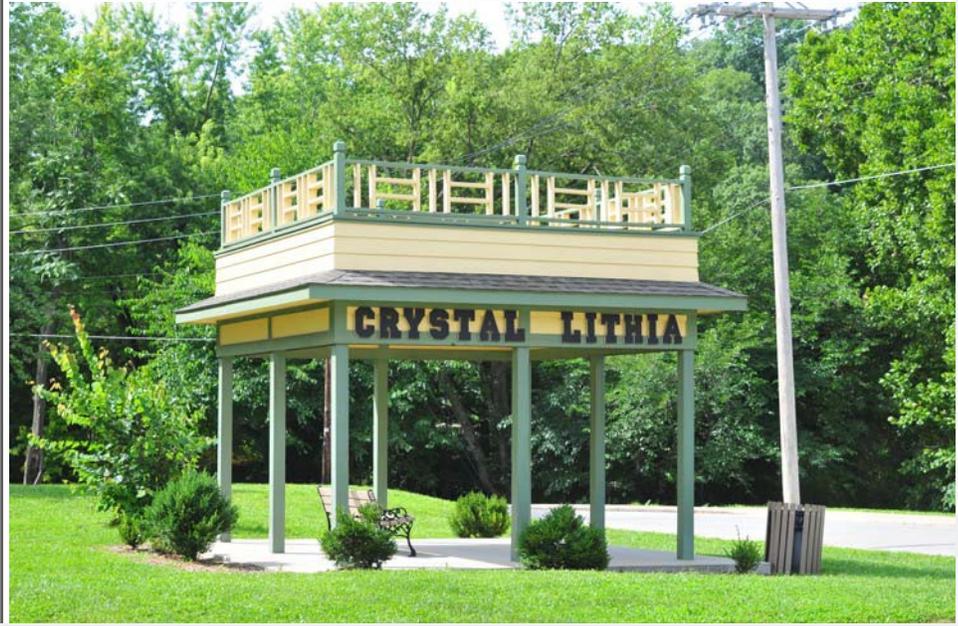
PHOTOGRAPHER Brad Finch, F-Stop Photography	DATE 8/21/2014	DESCRIPTION: North and east elevations, view southwest.

<p>41. (CONT.) DESCRIPTION OF PRIMARY RESOURCE. EXPAND BOX AS NECESSARY, OR ADD CONTINUATION PAGE</p> <p>The square pavilion has a concrete foundation and wood construction. Wood posts support wood deck clad in wood siding. Asphalt pent roofs project on each side. Beneath this, a wood panel architrave reads "Crystal Lithia" on the north and west elevations. Above the pent roof, a wood rail with an open, geometric design encircles the deck. The design of the pavilion imitates the historic form.</p>
<p>40. (CONT.) DESCRIPTION OF ENVIRONMENT AND OUTBUILDINGS. EXPAND BOX AS NECESSARY, OR ADD CONTINUATION PAGE</p> <p>The pavilion is located at the center of the open, irregular lot. Small shrubs surround the concrete platform. A grassy lawn fills the remainder of the lot.</p>
<p>21. (CONT.) HISTORY AND SIGNIFICANCE. EXPAND BOX AS NECESSARY, OR ADD CONTINUATION PAGE</p> <p>The Crystal Lithium Spring is listed among the medicinal waters in Excelsior Springs in advertisements as early as 1907, but was operating earlier. In the 1908 Excelsior Springs Blue Book, it is listed as one of 14 "Medical Drinking Water" companies, and one of the 15 known calcium bicarbonate waters (lithia) that operated in town. The spring was owned and operated by Mr. &amp; Mrs. J.M. Courtney through 1917. An enclosed springhouse was built midway on the lot, and sometime before 1913, an open air pavilion was constructed in the southeast corner of the property. The springhouse was demolished in August 1974, and in 2009, a replica of the pavilion was reconstructed on the site (although not in the original location). [Mineral Water Resources of Excelsior Springs Survey - 2011]</p>

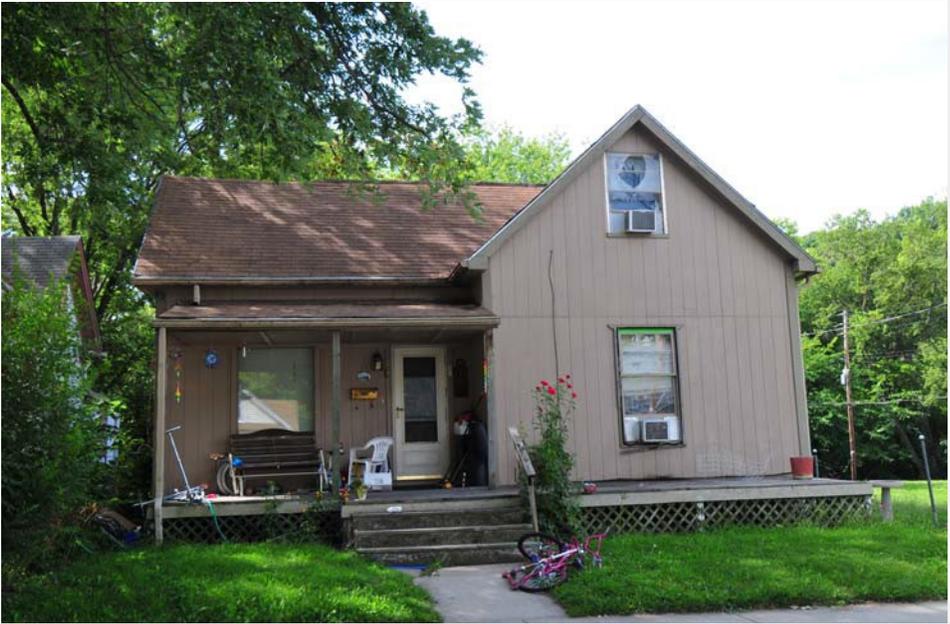
PHOTOGRAPHER	Brad Finch, F-Stop Photography	DATE	8/21/2014	DESCRIPTION:	North elevation, view south.

<p>41. (CONT.) DESCRIPTION OF PRIMARY RESOURCE. EXPAND BOX AS NECESSARY, OR ADD CONTINUATION PAGE</p> <p>The one-and-one-half-story Gable-Front-and-Wing house has a stone foundation, vertical fiberboard siding and an asphalt shingle roof. A large truncated hip wing projects from the south elevation. A wood deck spans the primary (north) elevation. A porch with square wood posts covers the east portion of the deck, in front of the wing. This elevation has three bays. A fixed window fills Bay 1; a single door fills Bay 2; single windows fill each story of the gable-front in Bay 3. Historic one-over-one wood windows pierce each elevation. This house is similar in form to 411 Benton Avenue and 413 Benton Avenue.</p>
<p>40. (CONT.) DESCRIPTION OF ENVIRONMENT AND OUTBUILDINGS. EXPAND BOX AS NECESSARY, OR ADD CONTINUATION PAGE</p> <p>The house is set back from the street at the center of the open lot. Mature trees define the east and south boundaries. A concrete sidewalk and wood stairs access the porch. A large one-story L-shaped outbuilding is located at the rear of the lot. It has metal panel walls, and a standing seam gable-front metal roof.</p>

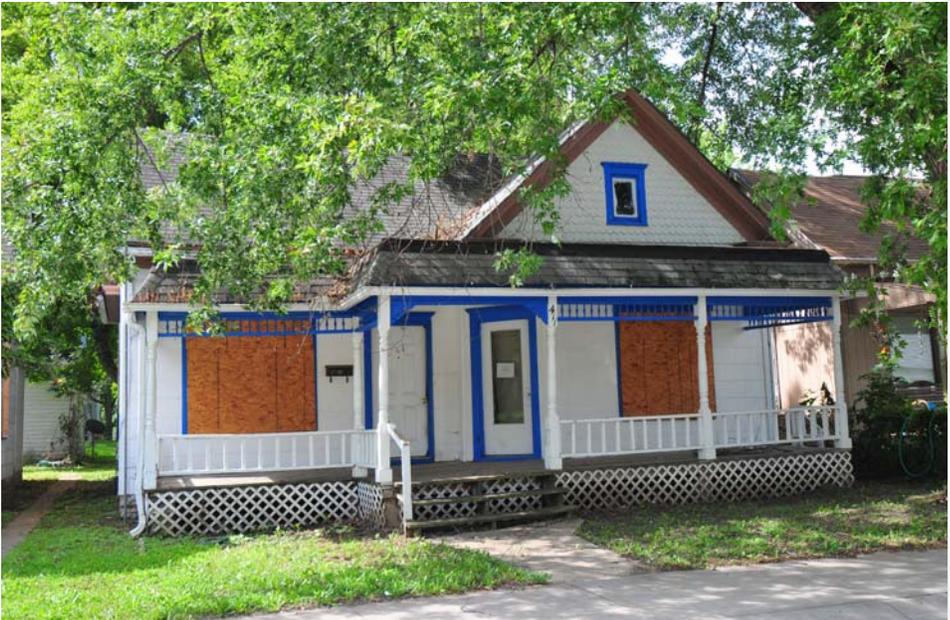
PHOTOGRAPHER	Brad Finch, F-Stop Photography	DATE	8/21/2014	DESCRIPTION:	North elevation, view south.

The one-and-one-half-story Folk Victorian house has a stone foundation, asbestos siding and an asphalt shingle cross-gable roof. Historic wood fishscale shingles fill the gable end. A large truncated hip wing projects from the south elevation. A porch with turned columns and a wood rail spans the primary (north) elevation. This elevation has four bays. Window openings fill Bays 1 and 4; single doors fill Bays 2 and 3. A fixed window pierces the gable. Particle board panels cover window openings on each elevation. This house is similar in form to 407 Benton Avenue and 413 Benton Avenue.

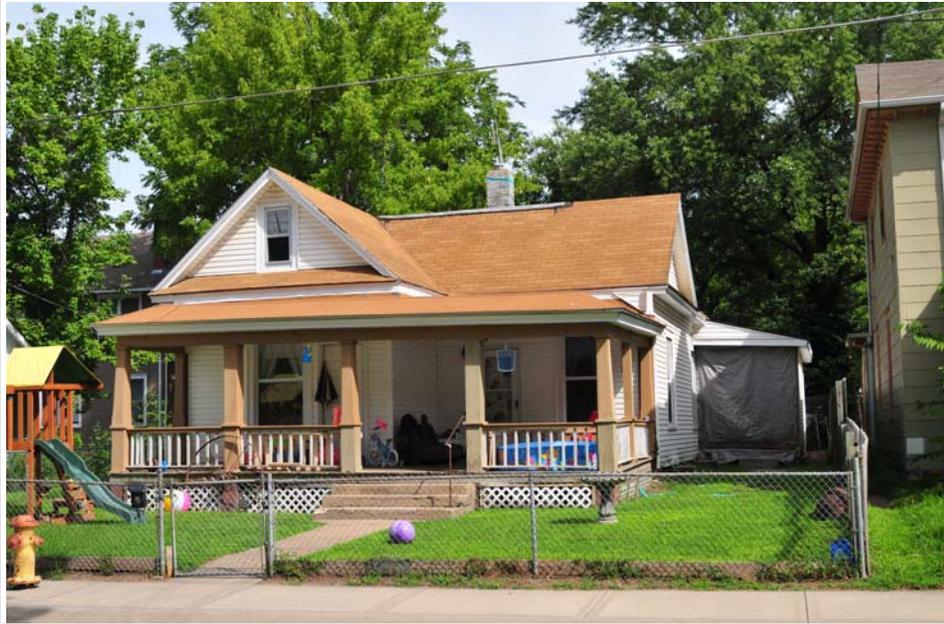
PHOTOGRAPHER	Brad Finch, F-Stop Photography	DATE	8/21/2014	DESCRIPTION:	South and east elevations, view northwest.
--------------	--------------------------------	------	-----------	--------------	--------------------------------------------

The one-and-one-half-story Gable-Front-and-Wing house has a stone foundation, vinyl siding and an asphalt shingle roof. A large hipped wing projects from the northeast corner of the house. A gabled chimney rises from the center of the roof. A porch with square wood columns and a wood picket rail spans the primary (south) elevation. This elevation has four bays. Single windows fill Bays 1 and 4; single doors fill Bays 2 and 3. A single window pierces the gable end. Replacement one-over-one vinyl windows pierce each elevation.

The house retains its historic form and porch configuration. The house has non-historic siding and the windows replaced within their historic openings with a 1/1 configuration. The house retains sufficient historic character to be contributing to a potential historic district.

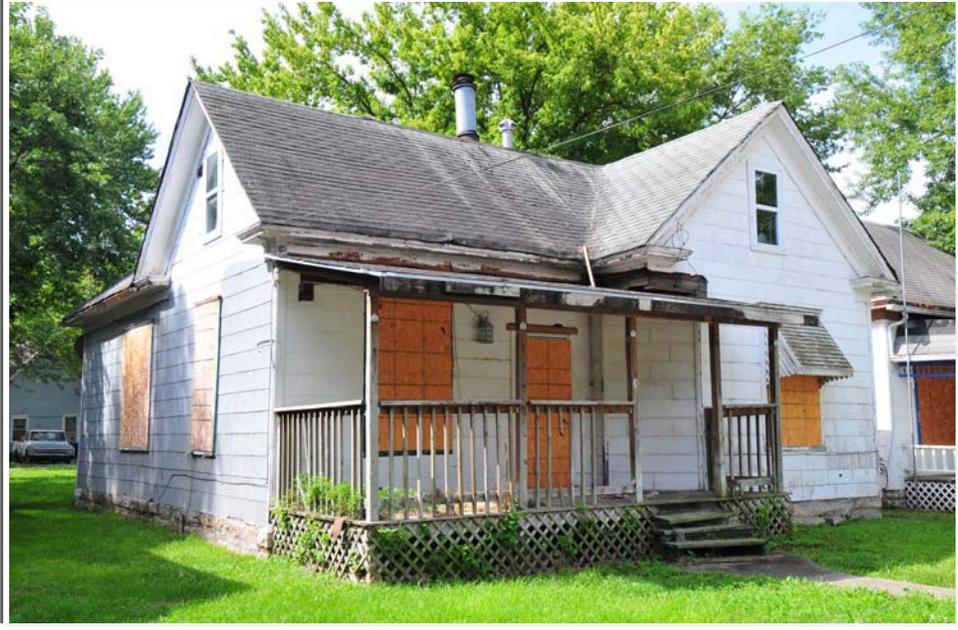
PHOTOGRAPHER	Brad Finch, F-Stop Photography	DATE	8/21/2014	DESCRIPTION:	North and east elevations, view southwest.
--------------	--------------------------------	------	-----------	--------------	--------------------------------------------

The one-and-one-half-story Gable-Front-and-Wing house has a stone foundation, asbestos siding and an asphalt shingle roof. A large truncated hip wing projects from the south elevation. A porch with square wood columns and a wood picket rail projects from the primary (north) elevation of the wing. This elevation has three bays. Window openings fill Bays 1 and 3; a single door fills Bay 2. A historic one-over-one wood window pierces the gable. Particle board panels cover window openings on each elevation. This house is similar in form to 407 Benton Avenue and 411 Benton Avenue.

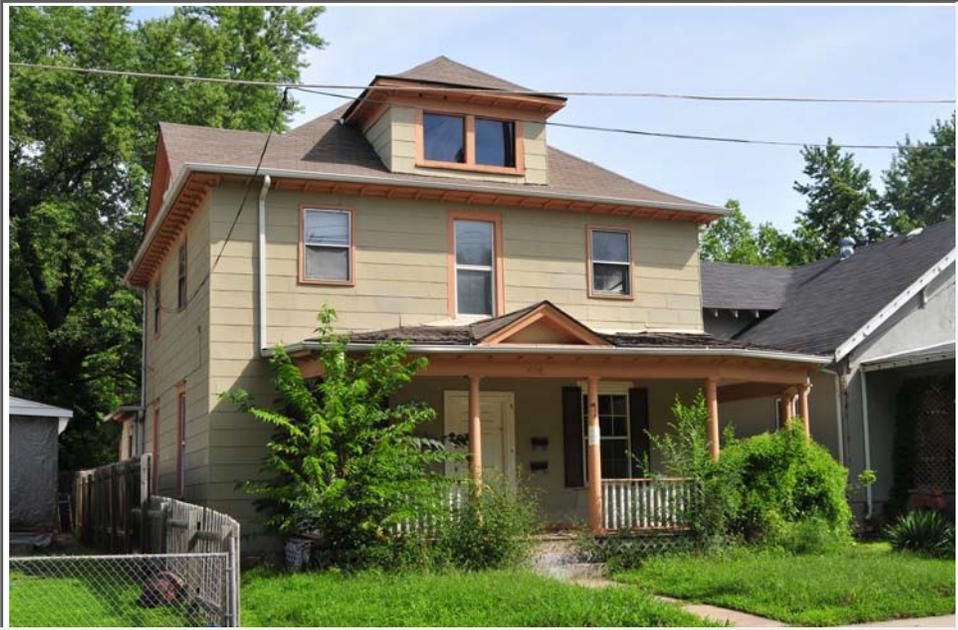
PHOTOGRAPHER Brad Finch, F-Stop Photography	DATE 8/21/2014	DESCRIPTION: South and west elevations, view northeast.

<p>41. (CONT.) DESCRIPTION OF PRIMARY RESOURCE. EXPAND BOX AS NECESSARY, OR ADD CONTINUATION PAGE</p> <p>The two-story-and-on e-half-story house has a stone foundation, asbestossiding and an asphalt shingle roof with lower cross-gables. A hipped dormer rises from the south slope of the roof. Curved brackets ornament all eaves. A one-story wing spans the north elevation. A side-wrap porch projects from the south and east elevations. It has round wood columns, a wood picket rail and a pediment center over the entrance. The primary (south) elevation has three bays. On the first story, single non-historic six-over-six vinyl windows fill Bays 1 and 3; a door fills Bay 2. A single historic one-over-one wood window fill each bay on the second story.</p>
<p>40. (CONT.) DESCRIPTION OF ENVIRONMENT AND OUTBUILDINGS. EXPAND BOX AS NECESSARY, OR ADD CONTINUATION PAGE</p> <p>The house is set back from the street at the center of the lot. Mature trees dot the property. A wood fence lines the east boundary. A concrete sidewalk and stairs access the porch.</p>

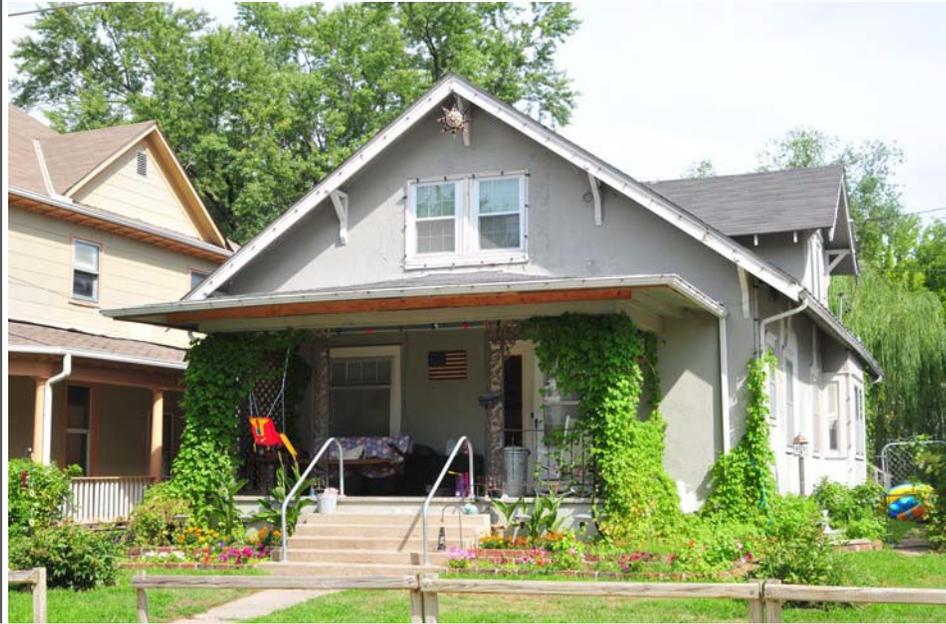
PHOTOGRAPHER	Brad Finch, F-Stop Photography	DATE	8/21/2014	DESCRIPTION:	South and east elevations, view northwest.
--------------	--------------------------------	------	-----------	--------------	--------------------------------------------

The one-and-one-half-story Craftsman house has a parged foundation, stucco cladding and an asphalt shingle, gable-front roof. Gabled dormers rise from the east and west slopes of the roof. Simple wood brackets adorn the eaves. A porch with scrolled metal posts and a metal rail projects from the center of the primary (south) elevation. This elevation has two bays. A historic wood cottage window fills Bay 1; a single door with sidelights fills Bay 3. Paired non-historic six-over-six vinyl windows pierce the gable end. Historic wood windows pierce the secondary elevations.

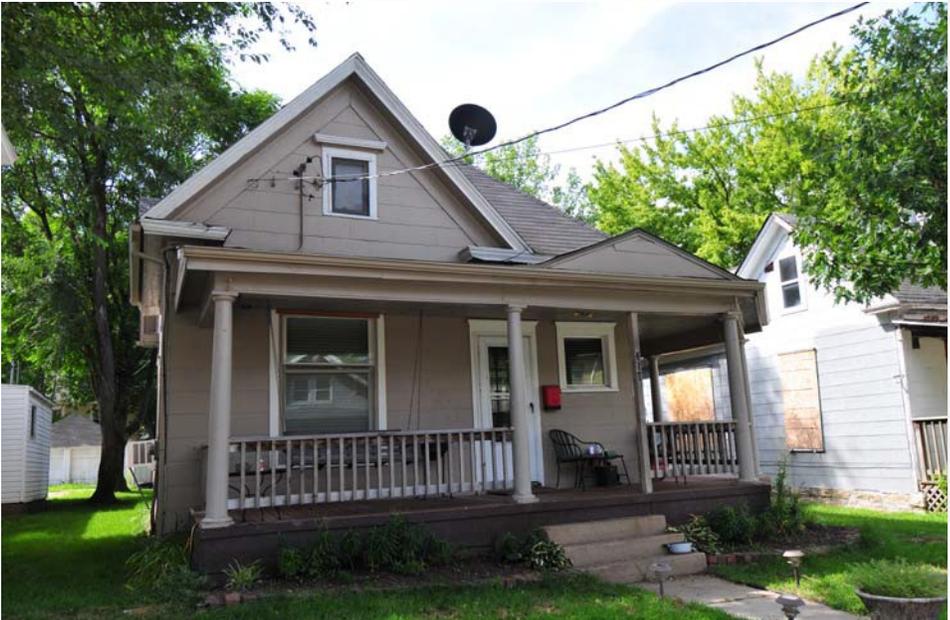
PHOTOGRAPHER	Brad Finch, F-Stop Photography	DATE	8/21/2014	DESCRIPTION:	North elevation, view south.

<p>41. (CONT.) DESCRIPTION OF PRIMARY RESOURCE. EXPAND BOX AS NECESSARY, OR ADD CONTINUATION PAGE</p> <p>The one-and-one-half-story house has a stone foundation, asbestos siding and an asphalt shingle roof with lower cross gables. Gabled wings with eave returns project from the north, east and west elevations. A hip wing projects from the south elevation. A side-wrap porch with an angled corner spans the primary (north) and west elevations. It has round wood columns and a wood picket rail. The primary elevation has four bays. A single window fills bay 1; single doors fill Bays 2 and 4; a small fixed window fills Bay 3. A small fixed window pierces the gable end above Bay 1. Historic one-over-one wood windows pierce each elevation.</p>
<p>40. (CONT.) DESCRIPTION OF ENVIRONMENT AND OUTBUILDINGS. EXPAND BOX AS NECESSARY, OR ADD CONTINUATION PAGE</p> <p>The house is set back from the street at the center of the lot. Mature trees dot the property. A concrete sidewalk and stairs access the porch. A prefabricated metal shed with a gambrel roof is located at the rear of the property. The non-historic shed would be non-contributing to a potential historic district.</p>

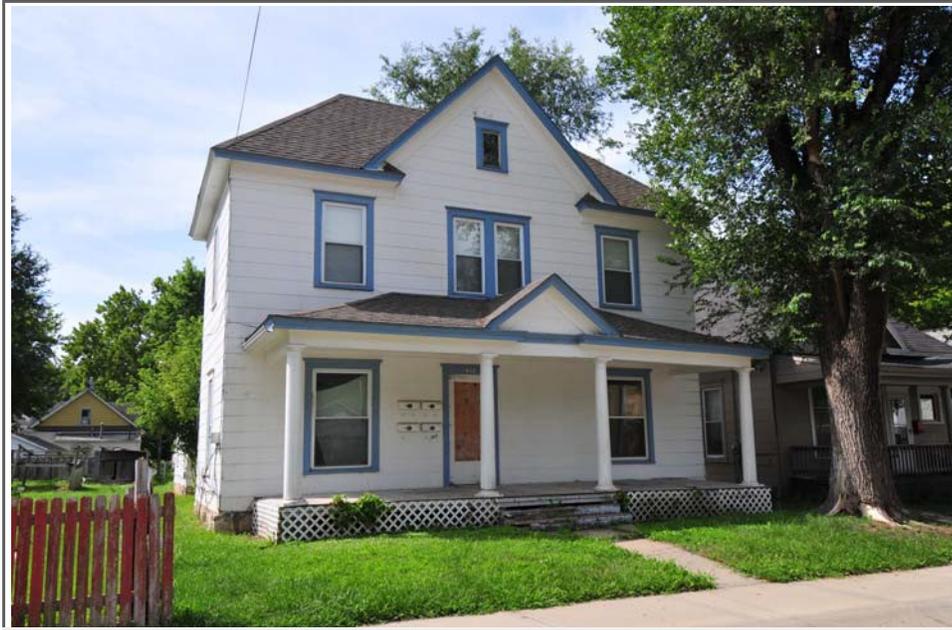
PHOTOGRAPHER	Brad Finch, F-Stop Photography	DATE	8/21/2014	DESCRIPTION:	North and east elevations, view south.
--------------	--------------------------------	------	-----------	--------------	----------------------------------------

41. (CONT.) DESCRIPTION OF PRIMARY RESOURCE. EXPAND BOX AS NECESSARY, OR ADD CONTINUATION PAGE  
 The two-story house has a stone foundation, asbestos siding and an asphalt shingle hip roof with a center cross gable. Multiple large one-story hipped wings project from the south elevation. A brick chimney rises from the south slope of the roof. A porch with round wood columns and a center gable spans the primary (north) elevation. This elevation has three bays. Bays 1 and 3 have a single window on each story; Bay 2 has an offset door on the first story, paired windows on the second story, and a small fixed window in the gable end. Historic one-over-one wood windows pierce each elevation.

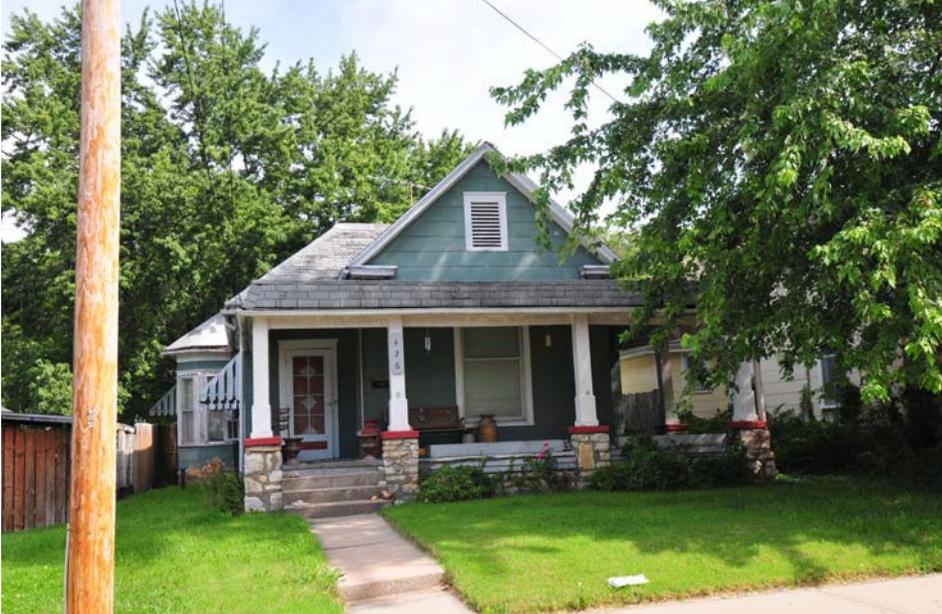
PHOTOGRAPHER Brad Finch, F-Stop Photography	DATE 8/21/2014	DESCRIPTION: South elevation, view north.

<p>41. (CONT.) DESCRIPTION OF PRIMARY RESOURCE. EXPAND BOX AS NECESSARY, OR ADD CONTINUATION PAGE</p> <p>The one-story Queen Anne house has a stone foundation, asbestos siding and an asphalt shingle truncated hip roof. A gabled wing projects from the south elevation. A hip wing projects from the west elevation. A brick chimney rises from the center of the roof. A side-wrap porch with limestone piers and square wood columns spans the primary (south) and east elevations. This elevation has three bays. Single doors fill Bays 1 and 3; a single window fills Bay 2. Historic one-over-one wood windows pierce each elevation.</p>
<p>40. (CONT.) DESCRIPTION OF ENVIRONMENT AND OUTBUILDINGS. EXPAND BOX AS NECESSARY, OR ADD CONTINUATION PAGE</p> <p>The house is set back from the street at the center of the lot. A wood fence encloses the rear portion of the property. A concrete sidewalk and stairs access the porch.</p>

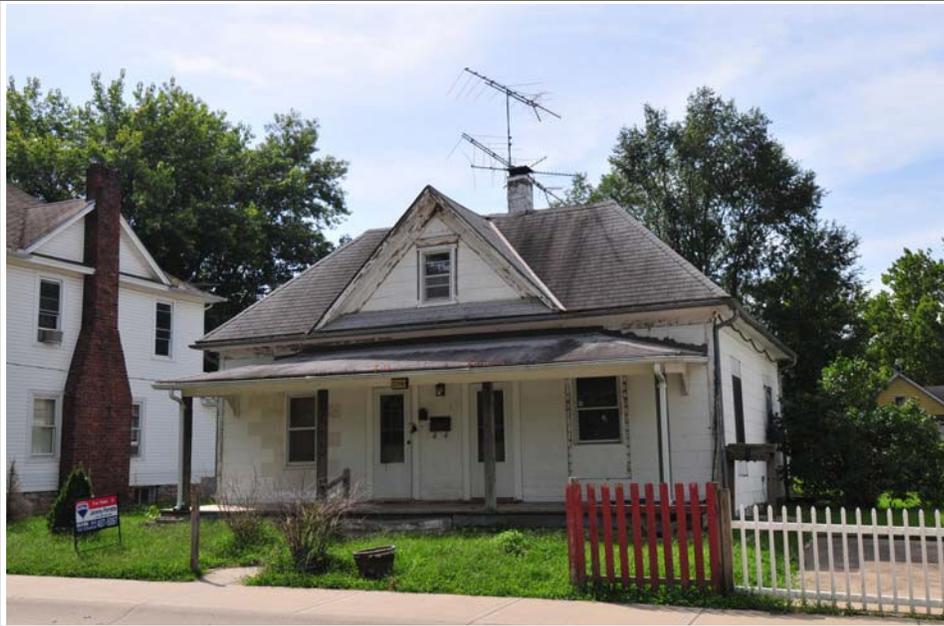
PHOTOGRAPHER	Brad Finch, F-Stop Photography	DATE	8/21/2014	DESCRIPTION:	North and west elevations, view southeast.
--------------	--------------------------------	------	-----------	--------------	--------------------------------------------

The one-and-one-half-story house has a stone foundation and an asphalt shingle truncated hip roof with a center cross gable. Historic wood siding is visible beneath asbestos siding. A gabled wing with shed additions projects from the south elevation. A parged chimney rises from the center of the roof. A porch with square wood posts spans the primary (north) elevation. This elevation has four bays. A single historic one-over-one wood window fills Bay 1; single doors fill Bays 2 and 3; a small single replacement one-over-one vinyl window in a larger, infilled opening fills Bay 4. A single historic one-over-one wood window pierces the gable end.

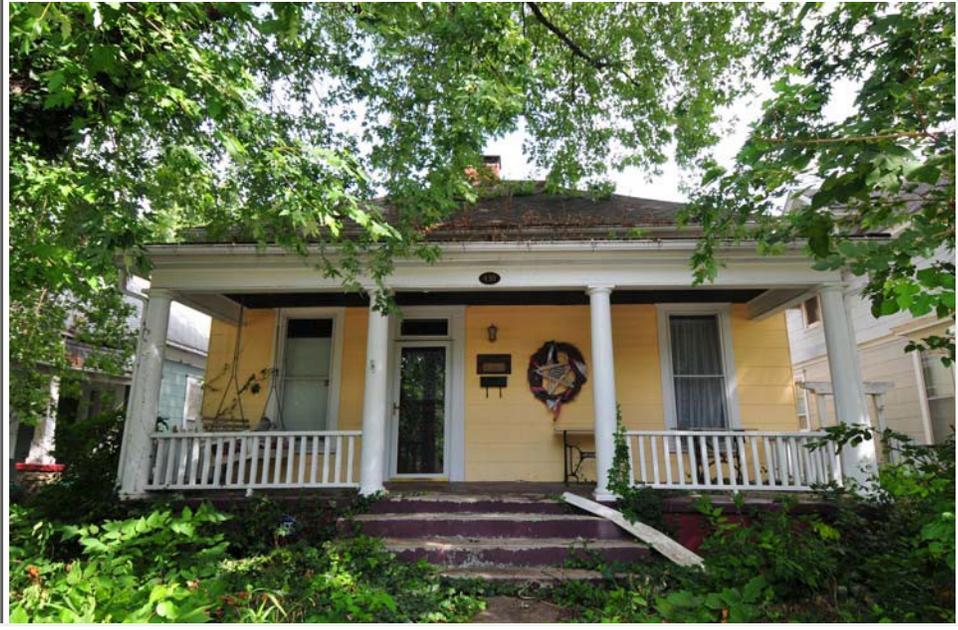
PHOTOGRAPHER	Brad Finch, F-Stop Photography	DATE	8/21/2014	DESCRIPTION:	South elevation, view north.
--------------	--------------------------------	------	-----------	--------------	------------------------------

41. (CONT.) DESCRIPTION OF PRIMARY RESOURCE. EXPAND BOX AS NECESSARY, OR ADD CONTINUATION PAGE  
 The one-story Classical Revival house has a stone foundation, asbestos siding and an asphalt shingle truncated hip roof. A hipped wing projects from the north elevation. A brick chimney rises from the center of the roof. A porch with round wood columns and a wood picket rail spans the primary (south) elevation. This elevation has three bays. Tall, narrow single windows fill bays 1 and 3. A single door with a transom fills Bay 2. Historic one-over-one wood windows pierce each elevation.

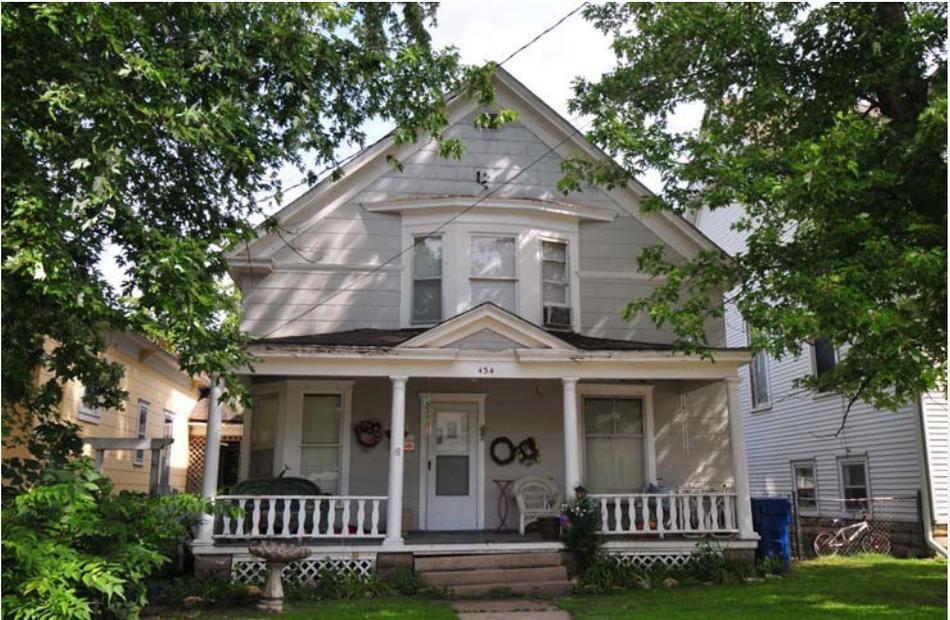
PHOTOGRAPHER	Brad Finch, F-Stop Photography	DATE	8/21/2014	DESCRIPTION:	South elevation, view north.

41. (CONT.) DESCRIPTION OF PRIMARY RESOURCE. EXPAND BOX AS NECESSARY, OR ADD CONTINUATION PAGE
The one-and-one-half-story Gable-Front house has a stone foundation, asbestos siding and an asphalt shingle roof. A one-story addition spans the (rear) north elevation. A brick chimney rises from the ridge. A porch with a center pediment, round columns and a cut-out wood railing spans the primary (south) elevation. This elevation has three bays. Bay 1 has a canted corner with a single window on each side; Bay 2 has a single door; Bay 3 has a single window. An angled bay window projects from the center of the second story. Single one-over-one wood windows pierce each elevation.

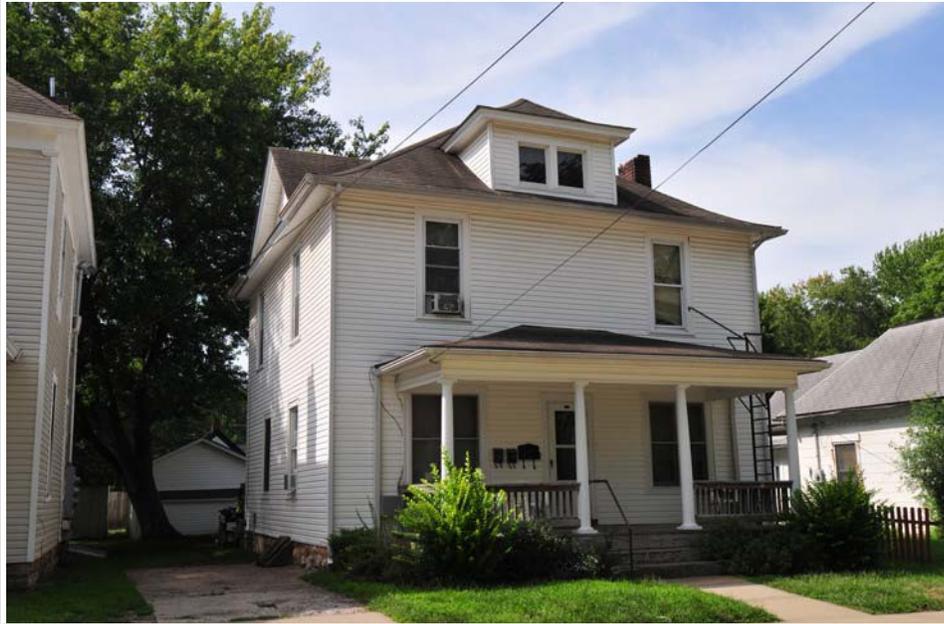
PHOTOGRAPHER	Brad Finch, F-Stop Photography	DATE	8/21/2014	DESCRIPTION:	North and east elevations, view southwest.
--------------	--------------------------------	------	-----------	--------------	--------------------------------------------

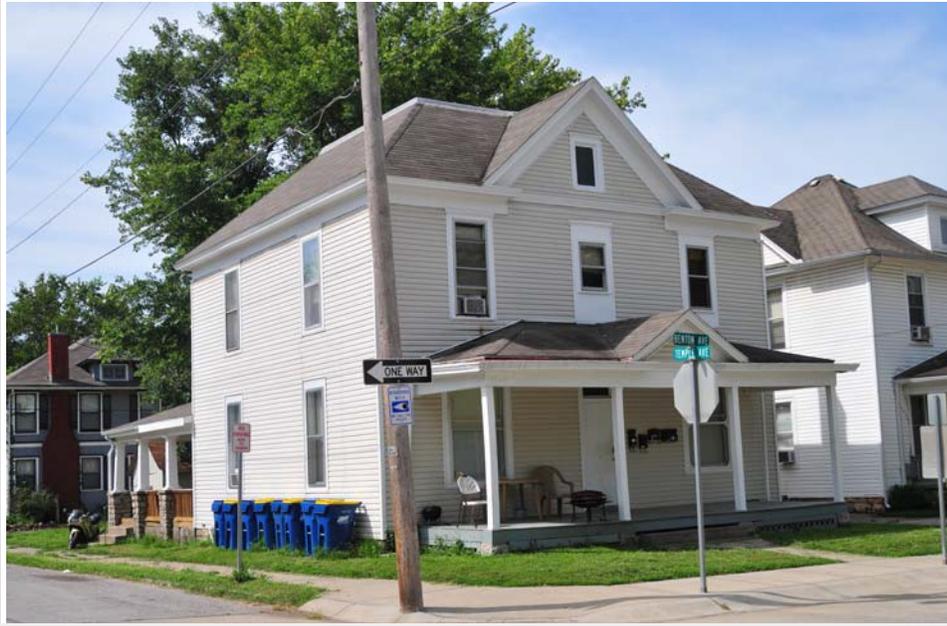
PHOTOGRAPHER Brad Finch, F-Stop Photography      DATE 8/21/2014      DESCRIPTION: North and east elevations, view southwest.

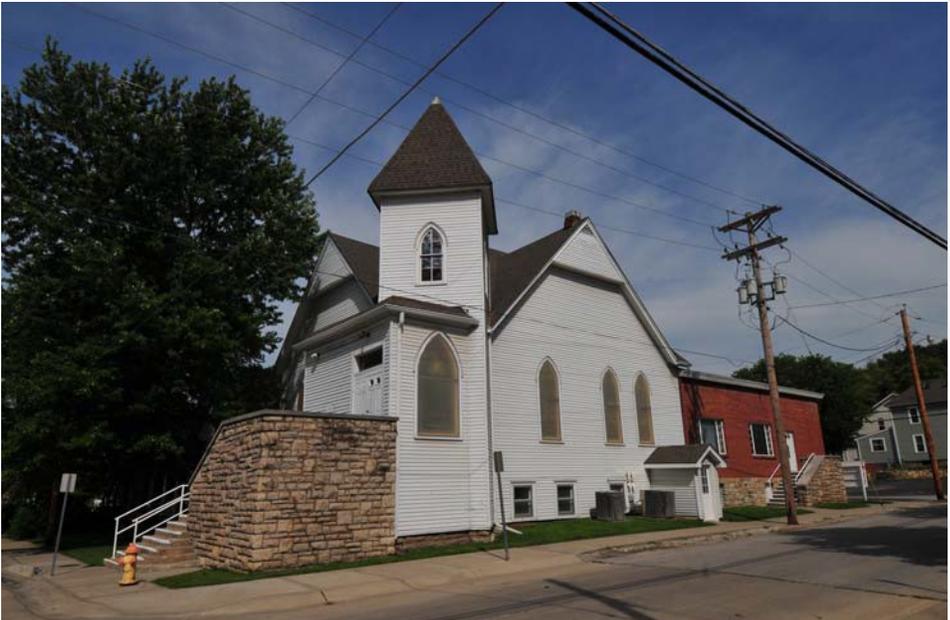
PHOTOGRAPHER	Brad Finch, F-Stop Photography	DATE	8/21/2014	DESCRIPTION:	South elevation, view north.

<p>41. (CONT.) DESCRIPTION OF PRIMARY RESOURCE. EXPAND BOX AS NECESSARY, OR ADD CONTINUATION PAGE</p> <p>The Gothic Revival church has a raised stone foundation, aluminum siding and an asphalt shingle cross-gable roof. Located on a corner, the primary elevations face south and east. The first story is raised nearly one level above grade. A two-story hip roof tower rises at the southeast corner. A single four-over-four lancet arch stained glass window pierces each side at the second story. A one-story vestibule projects from the south side of the tower. Paired doors with a transom access the south elevation of the vestibule; a historic lancet arch stained glass window pierces the east elevation. Three single historic lancet arch stained glass windows pierce each elevation of the church. A large historic flat-roof brick addition spans the north elevation. Historic windows pierce each elevation of the addition.</p>

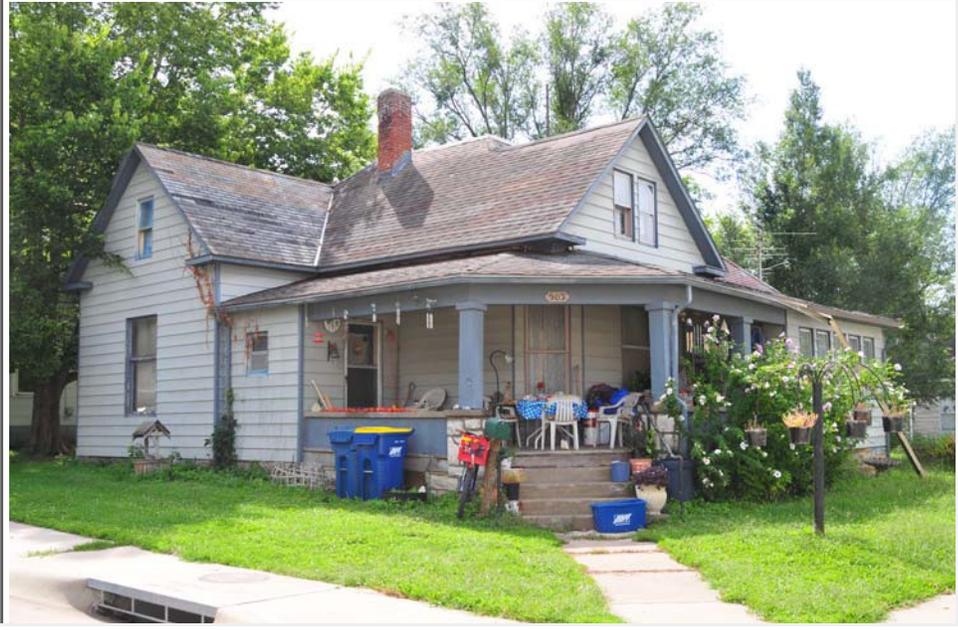
PHOTOGRAPHER Brad Finch, F-Stop Photography	DATE 8/21/2014	DESCRIPTION: North and west elevations, view southeast.
---------------------------------------------	----------------	---------------------------------------------------------

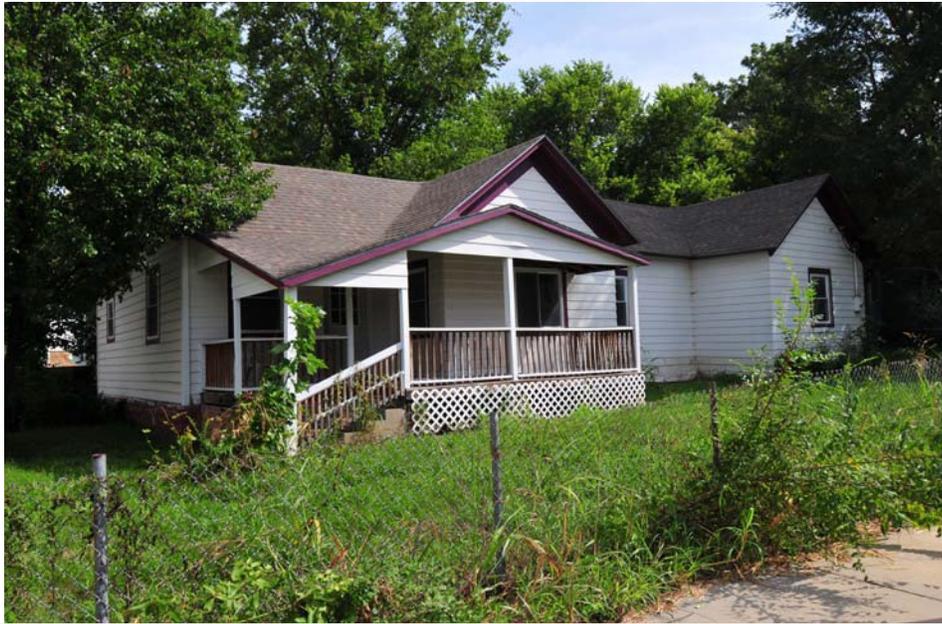
PHOTOGRAPHER	Brad Finch, F-Stop Photography	DATE	8/21/2014	DESCRIPTION:	South and west elevations, view northeast.
--------------	--------------------------------	------	-----------	--------------	--------------------------------------------

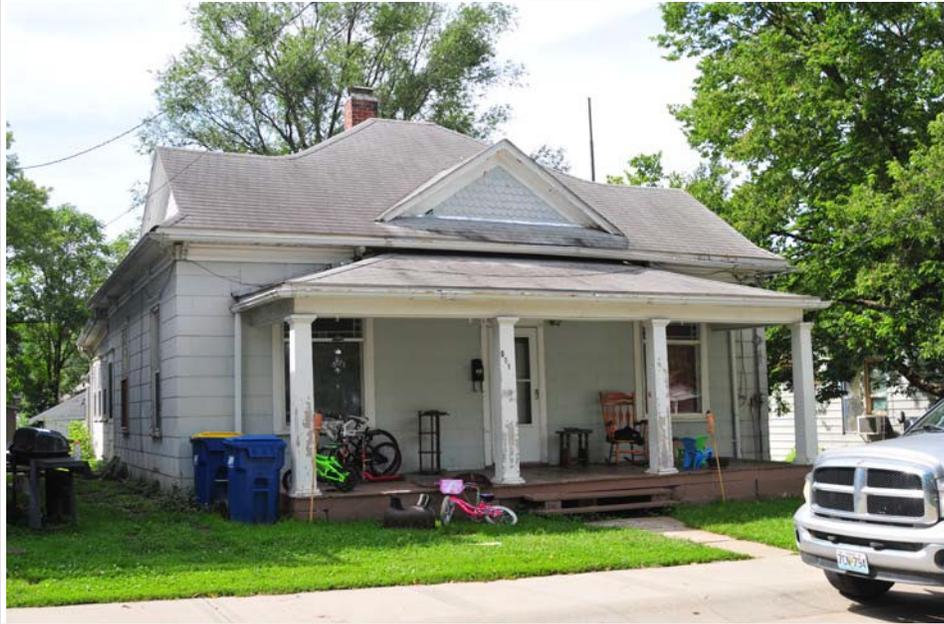
PHOTOGRAPHER	Brad Finch, F-Stop Photography	DATE	8/21/2014	DESCRIPTION:	North and east elevations, view southwest.
--------------	--------------------------------	------	-----------	--------------	--------------------------------------------

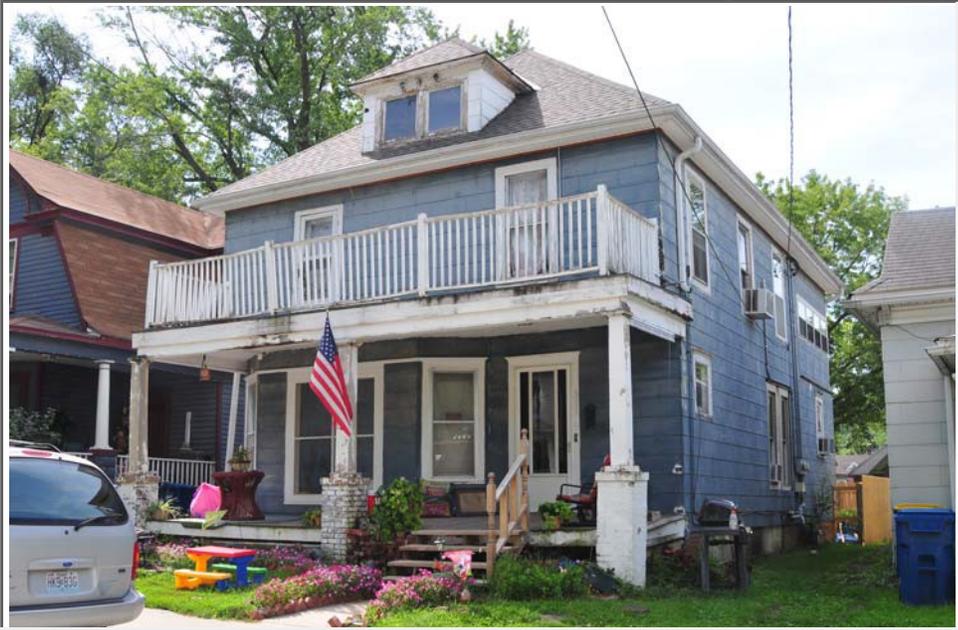
PHOTOGRAPHER Brad Finch, F-Stop Photography	DATE 8/21/2014	DESCRIPTION: North and west elevations, view southeast.

<p>41. (CONT.) DESCRIPTION OF PRIMARY RESOURCE. EXPAND BOX AS NECESSARY, OR ADD CONTINUATION PAGE</p> <p>The two-and-one-half-story American Foursquare house has a brick foundation, asbestos siding and an asphalt shingle pyramidal roof. A two-story gabled wing projects from the south elevation. A hipped dormer rises from the north slope of the roof. A two-story porch spans the primary (north) elevation. It has brick piers with square wood columns on the first story and a wood picket rail on the second story. The primary elevation has two bays. On the first story, Bay 1 has an angled bay window with paired windows on the front and single windows on the sides; Bay 2 has a single door. On the second story, single windows fill each bay. Paired historic fixed wood windows pierce the dormer. Historic one-over-one wood windows pierce each elevation.</p>
<p>40. (CONT.) DESCRIPTION OF ENVIRONMENT AND OUTBUILDINGS. EXPAND BOX AS NECESSARY, OR ADD CONTINUATION PAGE</p> <p>The house is set back from the street at the center of the lot. Mature trees dot the property. A wood fence encloses the rear portion of the lot. A concrete sidewalk and wood stairs access the porch.</p>

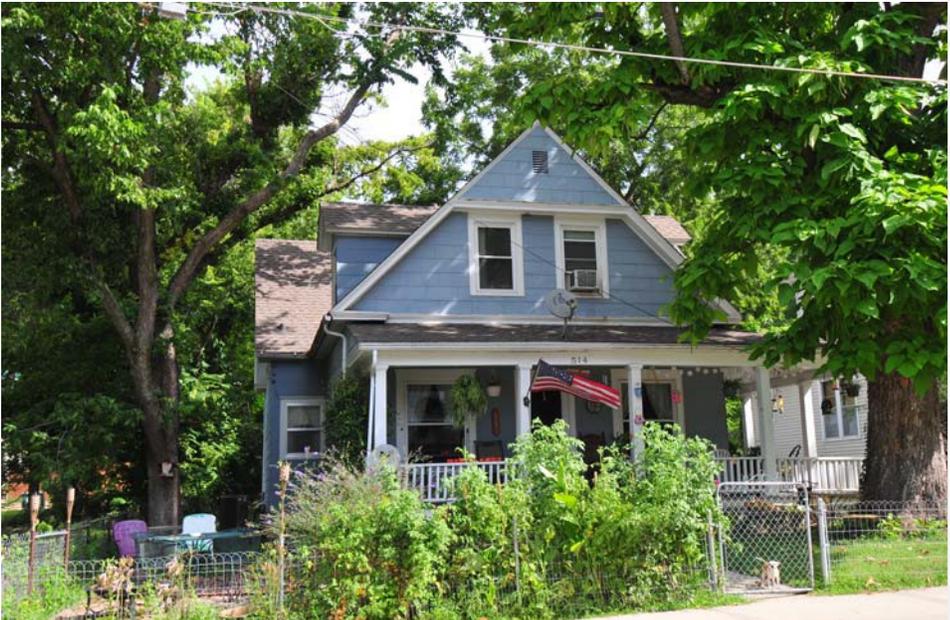
PHOTOGRAPHER	Brad Finch, F-Stop Photography	DATE	8/21/2014	DESCRIPTION:	South elevation, view north.

<p>41. (CONT.) DESCRIPTION OF PRIMARY RESOURCE. EXPAND BOX AS NECESSARY, OR ADD CONTINUATION PAGE</p> <p>The one-and-one-half-story Cross-Gable house has a stone foundation, asbestos siding and an asphalt shingle roof. Gabled dormers rise from the east and west slopes of the roof. An addition projects from the north elevation. A porch with limestone piers, square wood columns and a wood picket rail spans the primary (south) and east elevations. This elevation has five bays. Single windows fill Bays 1, 2 and 4; single doors fill Bays 3 and 5. Two single windows pierce the gable end. Historic one-over-one wood windows pierce fill each window opening on this elevation.</p>
<p>40. (CONT.) DESCRIPTION OF ENVIRONMENT AND OUTBUILDINGS. EXPAND BOX AS NECESSARY, OR ADD CONTINUATION PAGE</p> <p>The house is set back from the street at the center of the lot. Mature trees dot the property. A wire and chain link fence encloses the front portion of the lot. A concrete sidewalk and stairs access the porch.</p>

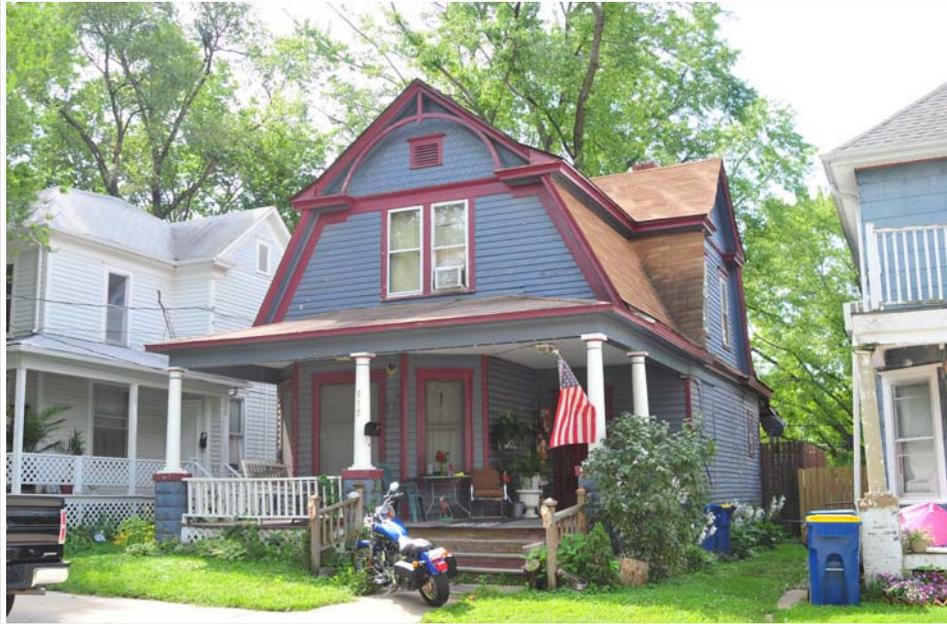
PHOTOGRAPHER	Brad Finch, F-Stop Photography	DATE	8/21/2014	DESCRIPTION:	North and west elevations, view southeast.
--------------	--------------------------------	------	-----------	--------------	--------------------------------------------

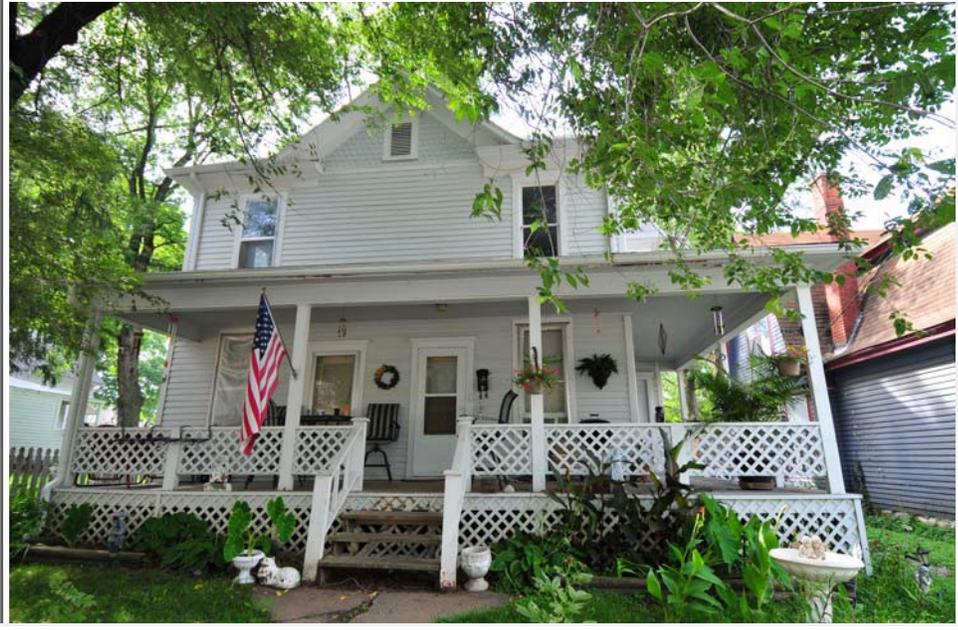
PHOTOGRAPHER Brad Finch, F-Stop Photography	DATE 8/21/2014	DESCRIPTION: North elevation, view south.
---------------------------------------------	----------------	-------------------------------------------

<p>41. (CONT.) DESCRIPTION OF PRIMARY RESOURCE. EXPAND BOX AS NECESSARY, OR ADD CONTINUATION PAGE</p> <p>The two-story Queen Anne house has a stone foundation, historic wood siding and an asphalt shingle hip roof with lower cross gables. Historic wood fishscale shingle fill the peaks of the cross gables. A one-story wing projects from the south elevation. A side-wrap porch with square wood columns and a lattice rail spans the primary (north) and east elevations. This elevation has five bays on the first story. Single windows fill Bays 1 and 4; single doors fill Bays 2, 3 and 5. Single windows pierce Bays 1 and 4 on the second story. Historic one-over-one wood windows fill each window opening on this elevation.</p>
<p>40. (CONT.) DESCRIPTION OF ENVIRONMENT AND OUTBUILDINGS. EXPAND BOX AS NECESSARY, OR ADD CONTINUATION PAGE</p> <p>The house is set back from the street at the center of the lot. Mature trees dot the property. A wood picket fence defines the east boundary. A wire fence encloses the rear portion of the lot. A concrete sidewalk and wood stairs access the porch.</p>

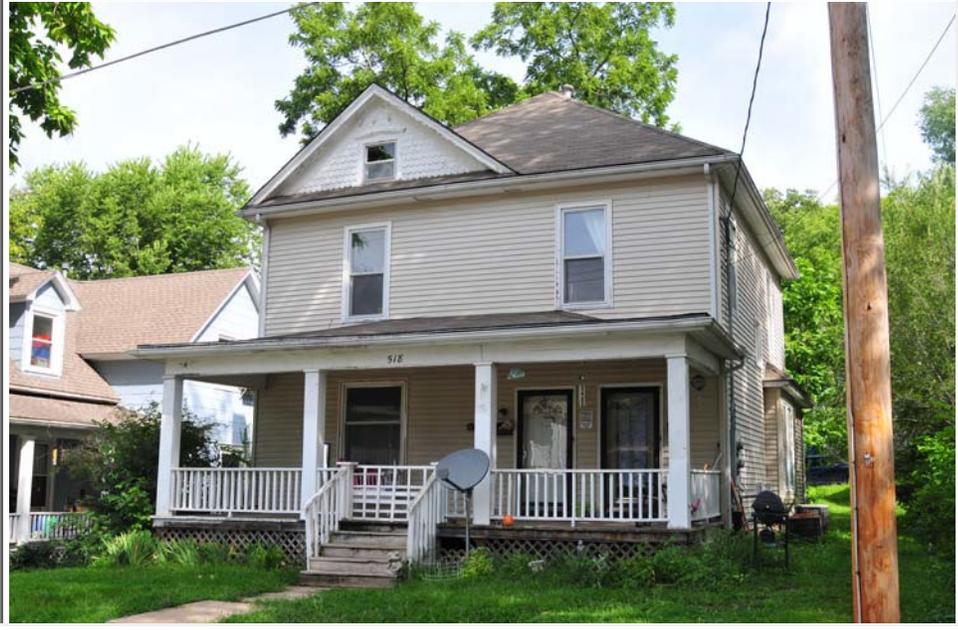
PHOTOGRAPHER Brad Finch, F-Stop Photography	DATE 8/21/2014	DESCRIPTION: South and east elevations, view northwest.
---------------------------------------------	----------------	---------------------------------------------------------

41. (CONT.) DESCRIPTION OF PRIMARY RESOURCE. EXPAND BOX AS NECESSARY, OR ADD CONTINUATION PAGE  
 The two-story Queen Anne house has a stone foundation, vinyl siding and an asphalt shingle hip roof with a lower cross gable. The gable has fish scale shingles and a single window. A one-story addition spans the north elevation. A brick chimney rises from the west slope of the roof. A porch with square wood columns and a wood picket rail spans the primary (south) elevation. This elevation has three bays. A single window fills Bay 1; single doors fill Bays 2 and 3. Two single windows pierce the second story. Historic one-over-one wood windows fill each opening on this elevation. This house has been sub-divided into apartments.

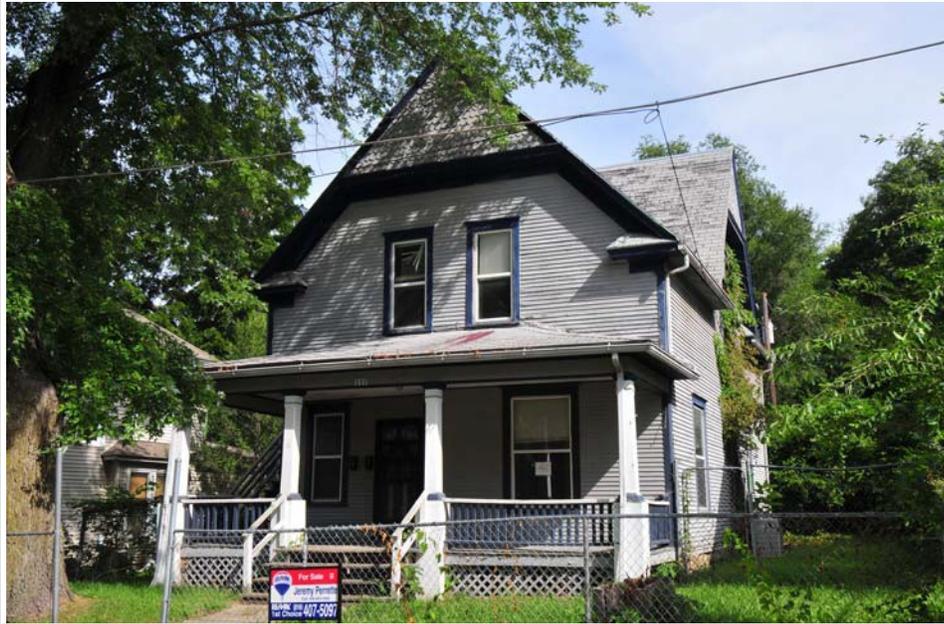
PHOTOGRAPHER	Brad Finch, F-Stop Photography	DATE	8/21/2014	DESCRIPTION:	South and east elevations, view northwest.
--------------	--------------------------------	------	-----------	--------------	--------------------------------------------

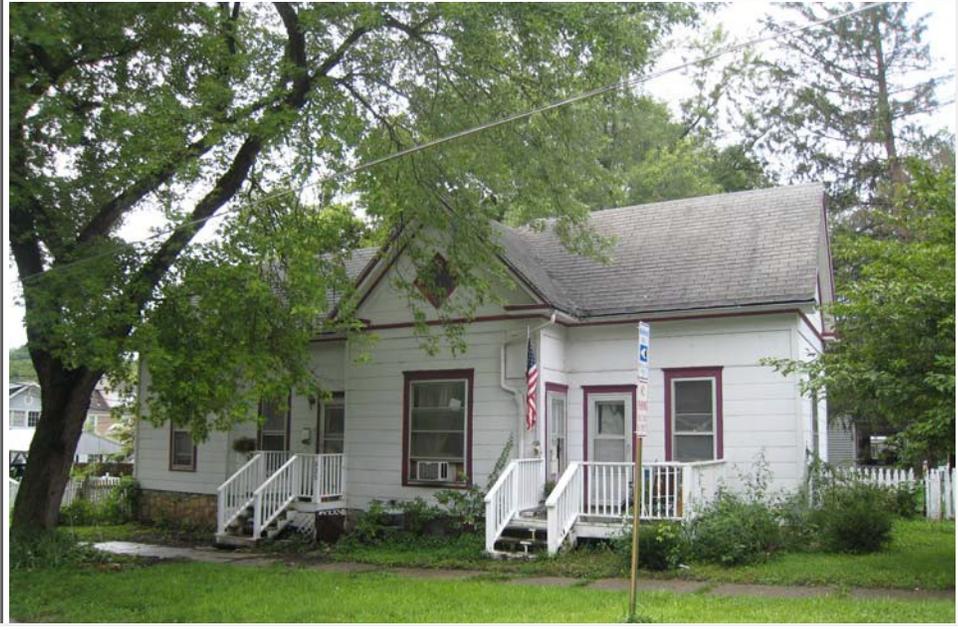
PHOTOGRAPHER	Brad Finch, F-Stop Photography	DATE	8/21/2014	DESCRIPTION:	East and north elevations, view west.
--------------	--------------------------------	------	-----------	--------------	---------------------------------------

41. (CONT.) DESCRIPTION OF PRIMARY RESOURCE. EXPAND BOX AS NECESSARY, OR ADD CONTINUATION PAGE  
 The one-story Cross-Gable house has a stone foundation, asbestos siding and an asphalt shingle roof. A one-story addition projects from the west elevation. A brick chimney rises from the south slope of the roof. Located on a corner, the primary elevations face north and east. The north elevation has two bays. A single door fills the recessed Bay 1; a single window fills Bay 2. The east elevation has six bays. Single windows fill Bays 1, 2, 4 and 6; single doors fill Bays 3 and 5. Separate wood stoops with wood picket rails access the entrances in Bays 3 and 5. Fixed diamond windows pierce the gable ends on each elevation. Historic one-over-one wood windows fill each window opening on these elevations. This house has been sub-divided into apartments. A side-wrap porch on the north and west elevations was removed sometime between 1994 and 2014.

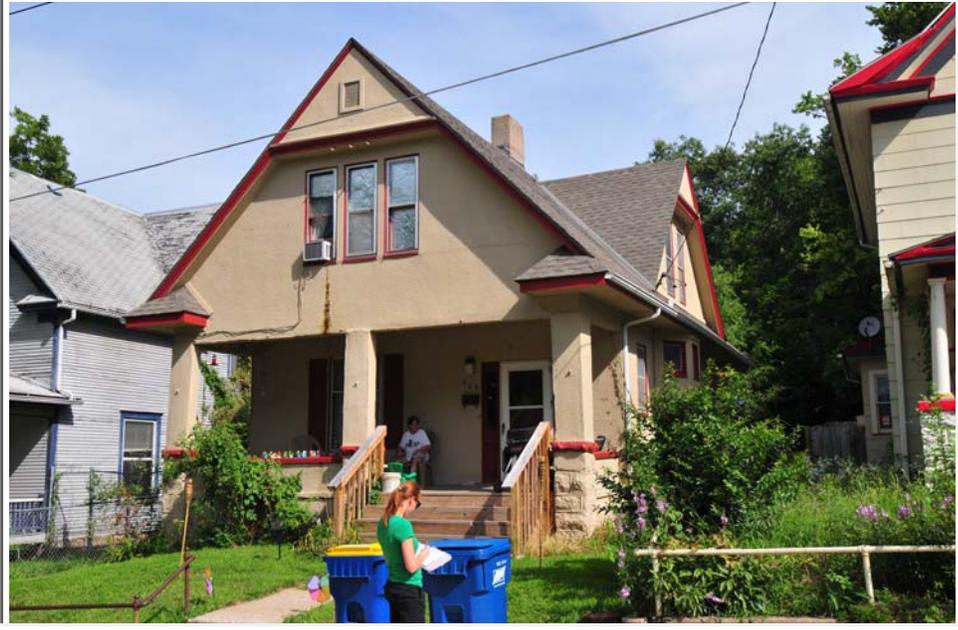
PHOTOGRAPHER Brad Finch, F-Stop Photography	DATE 8/21/2014	DESCRIPTION: South and east elevations, view northwest.
---------------------------------------------	----------------	---------------------------------------------------------
