Survey number: CL-AS-015-001		2. SURVEY NAME: Boardinghouse Historic Resource Inventory	
3. COUNTY: CLAY		4. ADDRESS (STREET NO. 403 )	STREET (NAME) Benton Avenue
5. CITY: Excelsior Springs	Vicinity <input type="checkbox"/>	6. UTM	OR LAT: 39.341072 7. TOWNSHIP/RANGE/SECTION LONG: -94.21933 T: 52 R: 30 S: 1
8. HISTORIC NAME (IF KNOWN): Crystal Lithium (Lithia) Springs/ Crystal Minera		9. PRESENT/OTHER NAME (IF KNOWN): Crystal Lithia Pavilion	
10. OWNERSHIP <input type="checkbox"/> PRIVATE <input checked="" type="checkbox"/> PUBLIC		11A. HISTORIC USE (IF KNOWN): HEALTH CARE: Resort Facility	
		11B. CURRENT USE: RECREATION & CULTURE/outdoor recrea

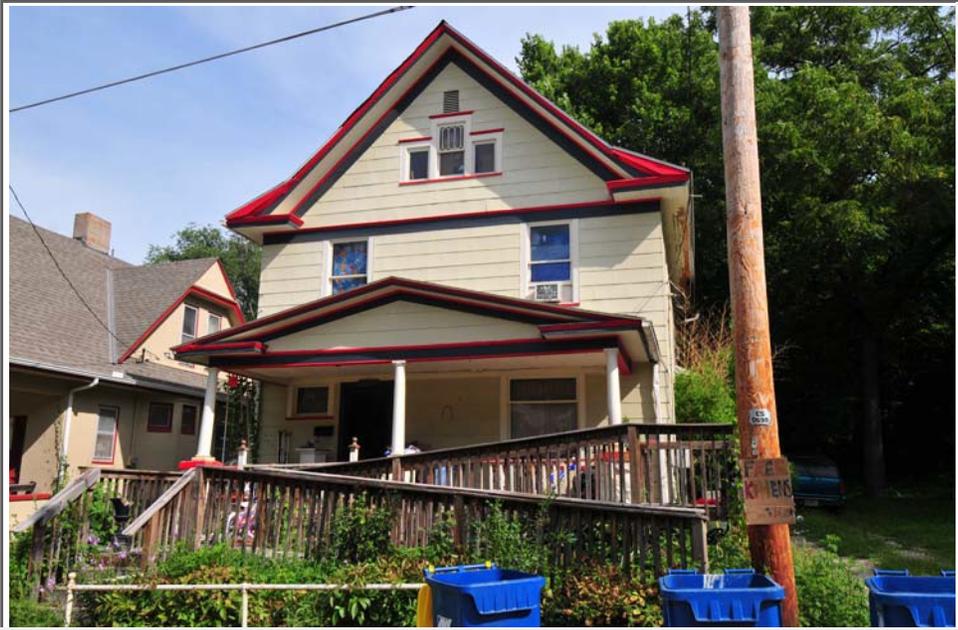
PHOTOGRAPHER Brad Finch, F-Stop Photography	DATE 8/21/2014	DESCRIPTION: South elevation, view north.

<p>41. (CONT.) DESCRIPTION OF PRIMARY RESOURCE. EXPAND BOX AS NECESSARY, OR ADD CONTINUATION PAGE</p> <p>The two-and-one-half-story Gable-Front house has a stone foundation, asbestos siding and an asphalt shingle gable-front roof with flared eaves. It has some Prairie Style elements. A one-story wing spans the north elevation. A porch with limestone piers, round wood columns and a wood picket rail spans the primary (south) elevation. This elevation has two bays. On the first story, a single door and a small fixed window fill Bay 1; a single window fills Bay 2. Single windows fill each bay on the second story. A stylized Palladian window pierces the gable peak. Historic one-over-one wood windows fill each window opening on this elevation.</p>
<p>40. (CONT.) DESCRIPTION OF ENVIRONMENT AND OUTBUILDINGS. EXPAND BOX AS NECESSARY, OR ADD CONTINUATION PAGE</p> <p>The house is set back from the street at the center of the lot. Mature trees fill the rear of the lot. A dirt driveway extends along the east side of the lot. A large, non-historic wood wheelchair ramp and stairs access the porch. An outbuilding at the northwest corner of the lot has a front-gable asphalt shingle roof. The outbuilding is located at the rear of the property and difficult to see from the public right-of-way. A complete assessment of its potential eligibility and property type was not possible at this time.</p>

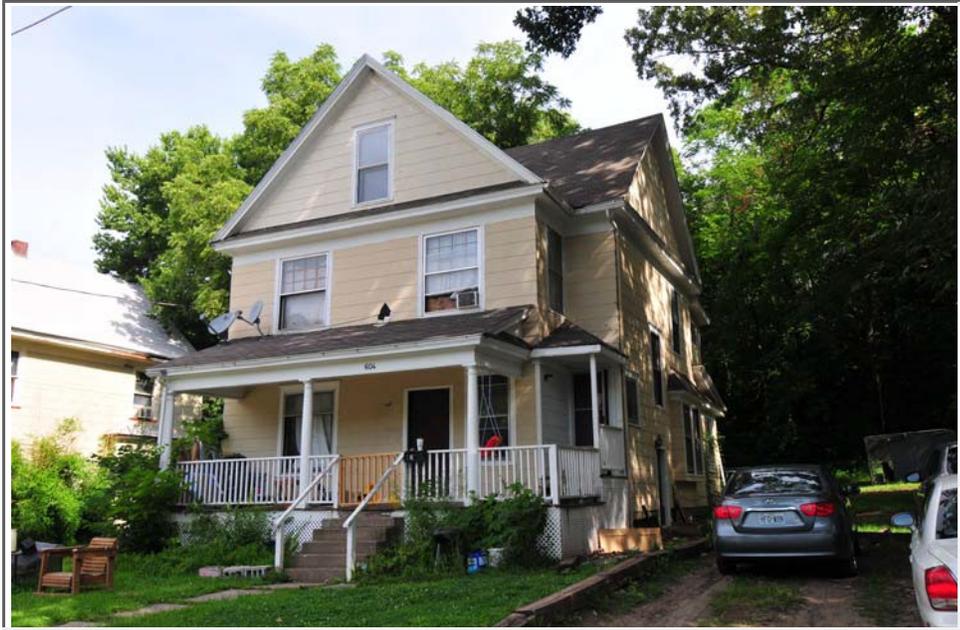
PHOTOGRAPHER Brad Finch, F-Stop Photography	DATE 8/21/2014	DESCRIPTION: South and east elevations, view northwest.

<p>41. (CONT.) DESCRIPTION OF PRIMARY RESOURCE. EXPAND BOX AS NECESSARY, OR ADD CONTINUATION PAGE</p> <p>The two-and-one-half story house has a stone foundation, asbestos siding and an asphalt shingle, side gable roof with a center cross gable. A one-story wing extends across the north elevation. A brick chimney rises from the south slope of the roof. A porch with round wood columns and a wood picket rail spans the primary (south) elevation. The first story has four bays. Single historic one-over-one wood windows fill Bays 1 and 3; single doors fill Bays 2 and 4. Two single historic twelve-over-one wood windows pierce the second story. A single historic one-over-one wood window pierces the gable peak.</p>
<p>40. (CONT.) DESCRIPTION OF ENVIRONMENT AND OUTBUILDINGS. EXPAND BOX AS NECESSARY, OR ADD CONTINUATION PAGE</p> <p>The house is set back from the street at the center of the lot. Mature trees fill the rear of the lot and line the east boundary. A dirt driveway extends along the east side of the house. A concrete sidewalk and concrete steps access the porch.</p>

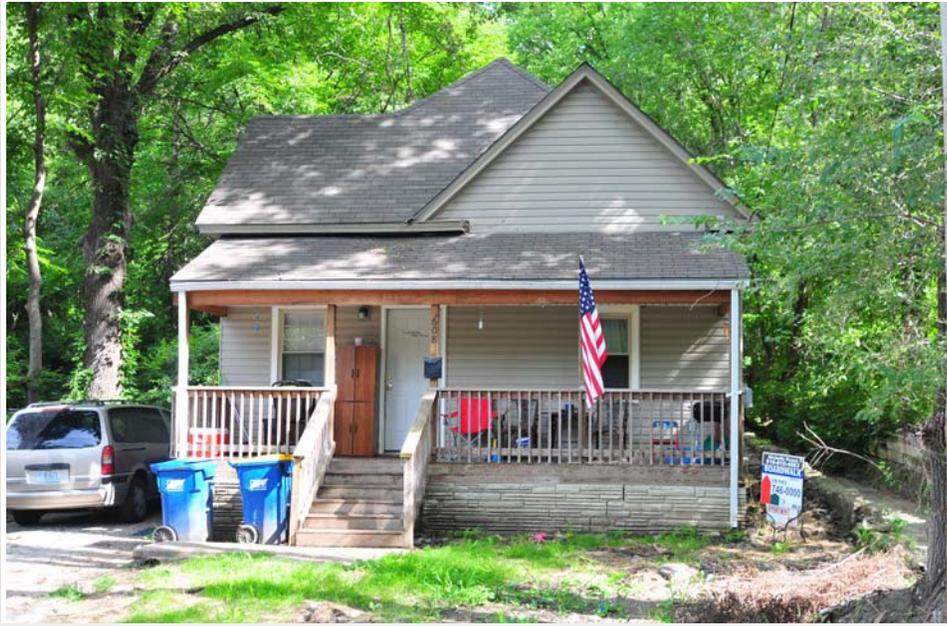
PHOTOGRAPHER Brad Finch, F-Stop Photography	DATE 8/21/2014	DESCRIPTION: South elevation, view north.
---------------------------------------------	----------------	-------------------------------------------

41. (CONT.) DESCRIPTION OF PRIMARY RESOURCE. EXPAND BOX AS NECESSARY, OR ADD CONTINUATION PAGE  
 The one-story Hip with Cross-Gable Form house has a stone foundation, vinyl siding and an asphalt shingle hip roof with lower cross gables. A porch with non-historic wood posts and a wood picket rail spans the primary (south) elevation. It has synthetic stone skirting. This elevation has three bays. Single non-historic nine-over-nine and one-over-one vinyl windows fill Bays 1 and 3; a single non-historic vinyl door fills Bay 2. Changes since the 1994 survey include the application of vinyl siding, covering a square window in the gable end and opening the enclosed porch with the wood railing and posts.

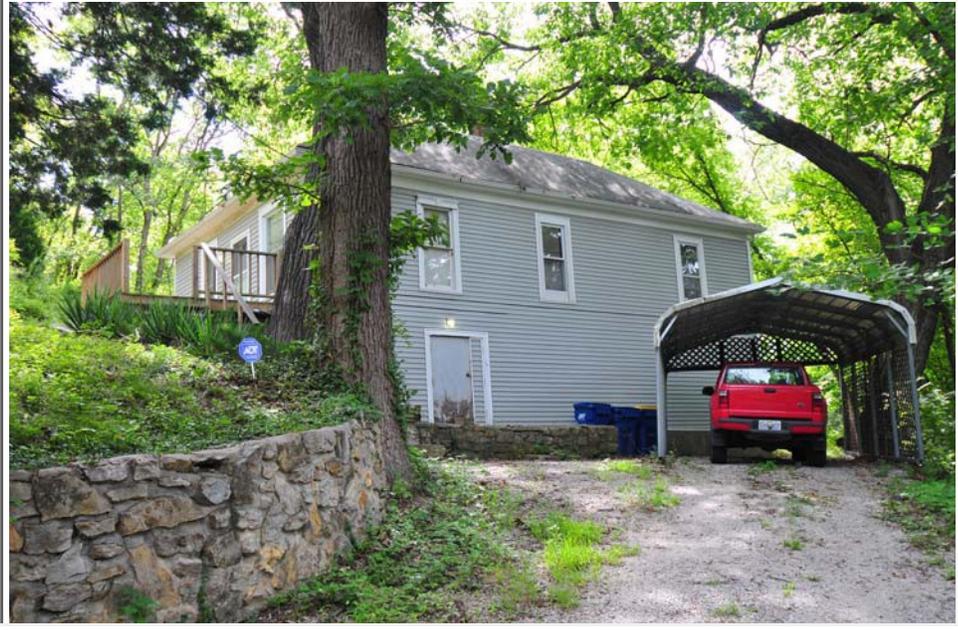
PHOTOGRAPHER	Brad Finch, F-Stop Photography	DATE	8/21/2014	DESCRIPTION:	North and west elevations, view southeast.
--------------	--------------------------------	------	-----------	--------------	--------------------------------------------

41. (CONT.) DESCRIPTION OF PRIMARY RESOURCE. EXPAND BOX AS NECESSARY, OR ADD CONTINUATION PAGE  
 The one-story Pyramidal Hip Form house has a stone foundation, vinyl siding and an asphalt shingle truncated hip roof. The basement level is fully exposed on the west and south elevations. A hipped wing projects from the east elevation. A wood deck with a wood rail projects from the primary (north) elevation. The west elevation faces the street. This elevation has three bays. Single windows fill Bays 1 and 3; a single door fills Bay 2. Historic one-over-one wood windows and replacement one-over-one vinyl windows fill each window opening on this elevation. Changes since the 1994 Survey, include the application of vinyl siding, enclosing two openings at the basement level, and the replacement deck.

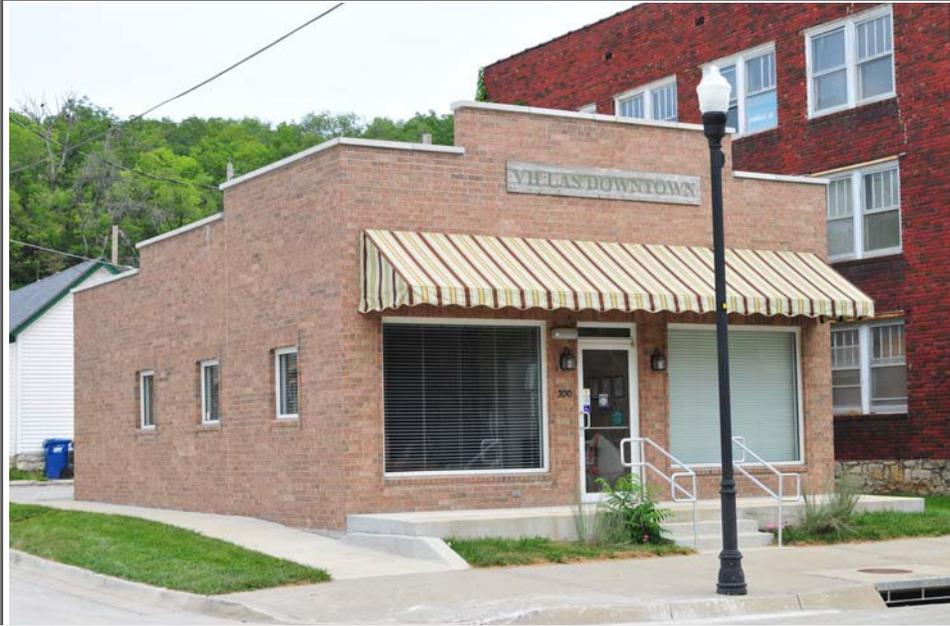
PHOTOGRAPHER Brad Finch, F-Stop Photography	DATE 8/21/2014	DESCRIPTION: South and west elevations, view northeast.
---------------------------------------------	----------------	---------------------------------------------------------

41. (CONT.) DESCRIPTION OF PRIMARY RESOURCE. EXPAND BOX AS NECESSARY, OR ADD CONTINUATION PAGE  
 The one-story one-part commercial block building has a concrete foundation, brick cladding and a flat roof with a stepped parapet. A concrete stoop spans the primary (south) elevation. This elevation has three symmetrical bays covered by a single fabric awning. Fixed windows fill Bays 1 and 3; a single glazed aluminum frame door fills Bay 2.

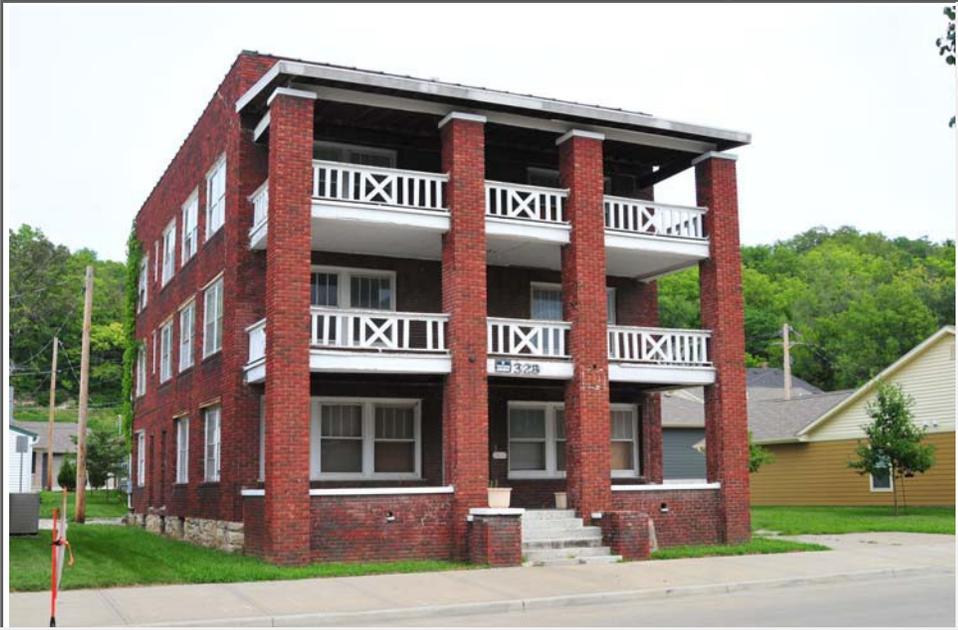
PHOTOGRAPHER Brad Finch, F-Stop Photography	DATE 8/21/2014	DESCRIPTION: South and west elevations, view northeast.

<p>41. (CONT.) DESCRIPTION OF PRIMARY RESOURCE. EXPAND BOX AS NECESSARY, OR ADD CONTINUATION PAGE</p> <p>The three-story colonnaded apartment building has a stone foundation, brick cladding and a flat roof. A three-story porch with brick columns projects from the primary (south) elevation. Balconies on the second and third stories have historic wood railings. The first story has brick kneewalls with limestone caps; the second and third stories have a wood picket rail with an "X" in the center of each bay. This elevation has three symmetrical bays. In Bays 1 and 3, the first story has a band of three historic vertical three-over-one double-hung wood windows; the second and third stories have paired historic vertical four-over-one double-hung wood windows. A single door fills each story in Bay 2.</p>
<p>40. (CONT.) DESCRIPTION OF ENVIRONMENT AND OUTBUILDINGS. EXPAND BOX AS NECESSARY, OR ADD CONTINUATION PAGE</p> <p>The building nearly fills the lot. Concrete steps with brick cheekwalls access the porch.</p>

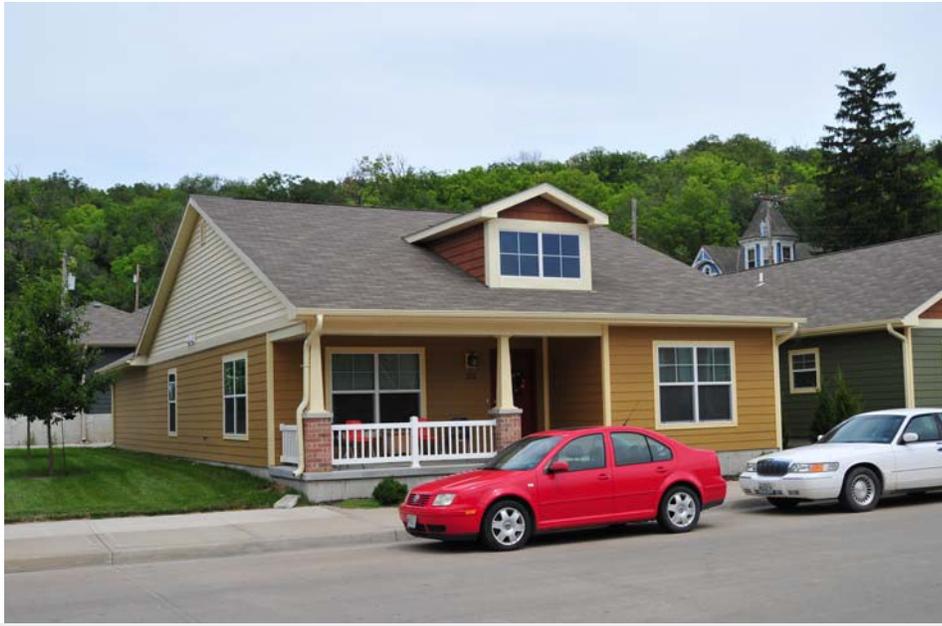
PHOTOGRAPHER Brad Finch, F-Stop Photography	DATE 8/21/2014	DESCRIPTION: South and west elevations, view northeast.
---------------------------------------------	----------------	---------------------------------------------------------

The one-and-one-half-story New Traditional Craftsman house has a concrete foundation, fiberboard siding and an asphalt shingle side-gable roof. A gabled dormer with wood shingles rises from the north slope of the roof. A one-story addition projects from the north elevation. A recessed porch with brick piers, tapered wood columns and a vinyl picket rail fills the west side of the primary (south) elevation. This elevation has three bays. Paired windows fill the recessed Bay 1 and Bay 3; a single door fills the recessed Bay 2. Paired fixed four-light windows pierce the dormer. Four-over-one double-hung vinyl windows pierce each elevation.

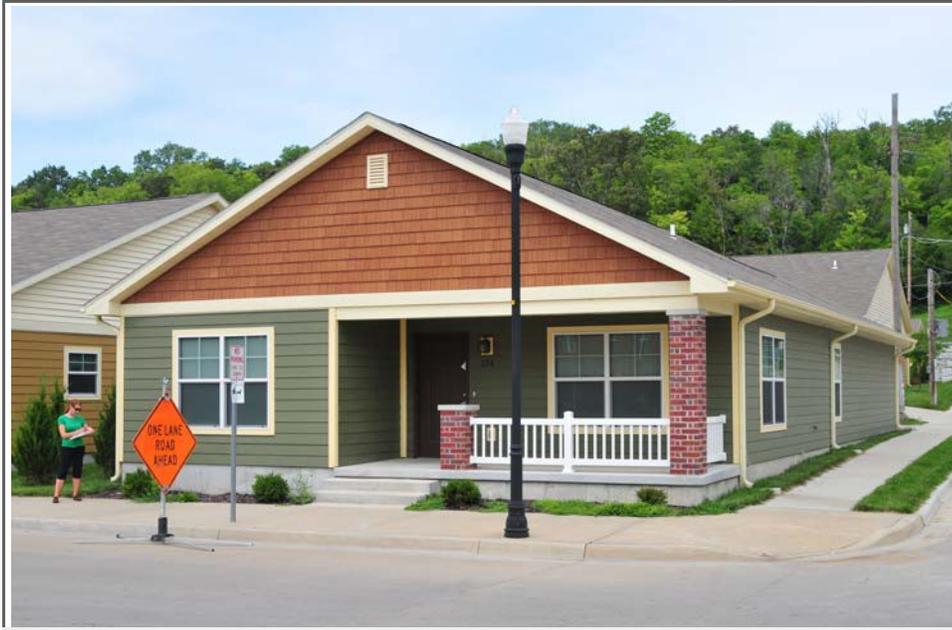
PHOTOGRAPHER Brad Finch, F-Stop Photography	DATE 8/21/2014	DESCRIPTION: South and east elevations, view northwest.

<p>41. (CONT.) DESCRIPTION OF PRIMARY RESOURCE. EXPAND BOX AS NECESSARY, OR ADD CONTINUATION PAGE</p> <p>The one-story New Traditional Craftsman house has a concrete foundation, fiberboard siding and an asphalt shingle gable-front roof. Wood shingle clad the gable end. A cross-gable addition projects from the north elevation. A recessed porch with a brick column and pier and vinyl picket rail fills the east side of the primary (south) elevation. This elevation has three bays. Paired windows fill Bay 1 and the recessed Bay 3; a single door fills the recessed Bay 2. Four-over-one double-hung vinyl windows pierce each elevation.</p>
<p>40. (CONT.) DESCRIPTION OF ENVIRONMENT AND OUTBUILDINGS. EXPAND BOX AS NECESSARY, OR ADD CONTINUATION PAGE</p> <p>The house nearly fills the corner lot. Concrete stairs access the porch.</p>
<p>21. (CONT.) HISTORY AND SIGNIFICANCE. EXPAND BOX AS NECESSARY, OR ADD CONTINUATION PAGE</p> <p>This building was constructed in 2013. The former building on this site was listed as 336 East Broadway Avenue. It was built c. 1922 on land platted in 1881. The 1926 Sanborn map shows it as a rooming house. The City Directories list the Paul Shepard at the address in 1917 and again in 1922. The 1940 phone book lists Mrs. Ethel Jean Forman at the address. The 2-story rooming house had a limestone foundation, plywood siding and a low-pitched hipped roof. The 3/4, off-center, double tiered porch was recessed, and supported by two square posts at the first and second stories. It had a simple wooden balustrade. The steps to the porch were centered on the main facade, as is the main entrance. Ribbons of three windows were located on the first and second stories in the west bay. A 1-story building with a full length porch was attached to the rear of the main building. [Boardinghouse Historic District Survey, 1994]</p>

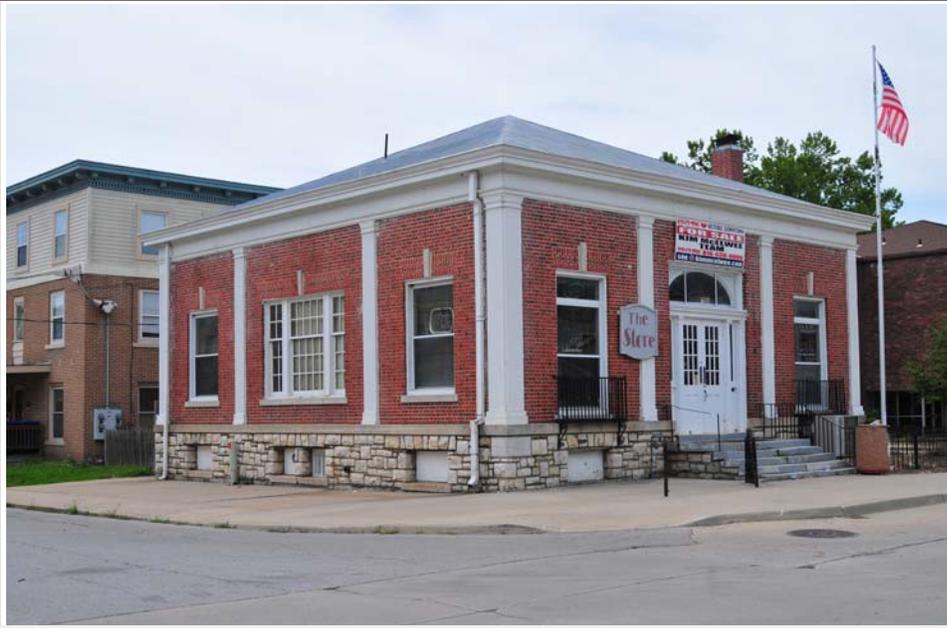
PHOTOGRAPHER Brad Finch, F-Stop Photography      DATE 8/21/2014      DESCRIPTION: North and east elevations, view southwest.

41. (CONT.) DESCRIPTION OF PRIMARY RESOURCE. EXPAND BOX AS NECESSARY, OR ADD CONTINUATION PAGE  
 The one-story Classical Revival building has a stone foundation, brick walls and an asphalt shingle pyramidal roof. An exterior brick chimney rises on the west elevation. A simple carved wood cornice ornaments the roofline on each elevation. The building has three symmetrical bays on each elevation. Square, fluted pilasters with simple capitals rise from the limestone water table to the cornice between each bay and at each corner. On the primary (north) elevation the main entrance fills Bay 2. It has paired wood panel doors with twelve-light glazing in the upper half and sidelights with round Ionic pilasters on each side. Above the doors is a leaded glass fanlight in a carved wood frame. Bays 1 and 3 have a single historic one-over-one double-hung wood window with a transom and wrought iron balconette. On the east and west elevations, Bay 2 has a band of three historic multi-light double-hung wood windows; Bays 1 and 3 have single historic one-over-one double-hung wood windows. All openings on each elevation have limestone sills and brick lintels with exaggerated limestone keystones.

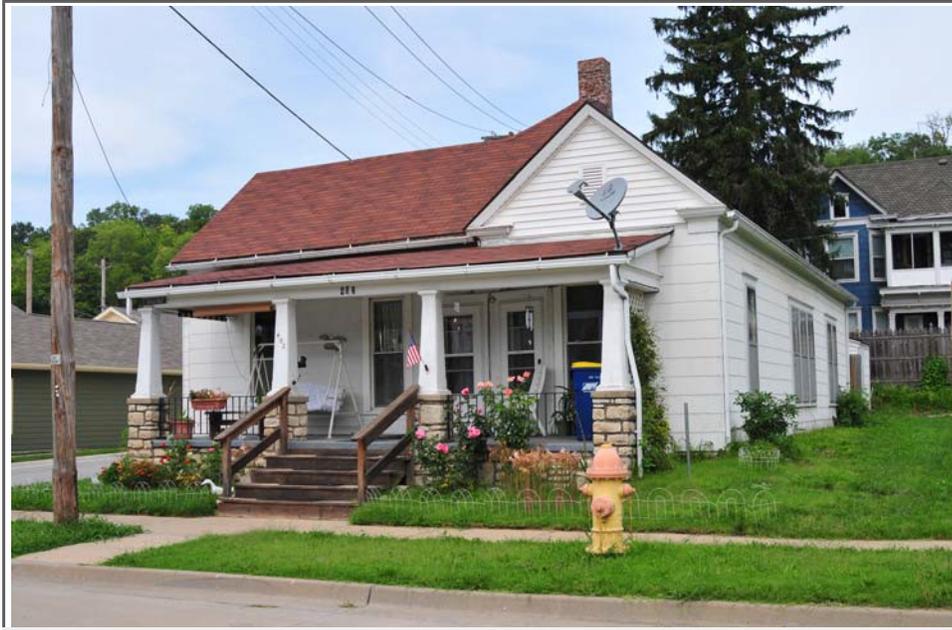
PHOTOGRAPHER Brad Finch, F-Stop Photography	DATE 8/21/2014	DESCRIPTION: South and east elevations, view northwest.
---------------------------------------------	----------------	---------------------------------------------------------

The one-story house has a stone foundation, asbestos siding and an asphalt shingle hip roof with lower cross gables. It has a Queen Anne form with Craftsman elements. Three gabled wings project from the west elevation. A brick chimney rises from the center of the ridge. A porch with limestone pilasters, tapered square wood columns and a metal rail projects from the primary (south) elevation. This elevation has five bays. Single one-over-one double-hung vinyl windows fill Bays 1, 2 and 5; single doors with replacement storm doors fill Bay 3 and the canted Bay 4. Historic wood windows are extant on the secondary elevations. Alterations since the 1994 Survey include the replacement of fishscale shingles in the gable end with vinyl siding.

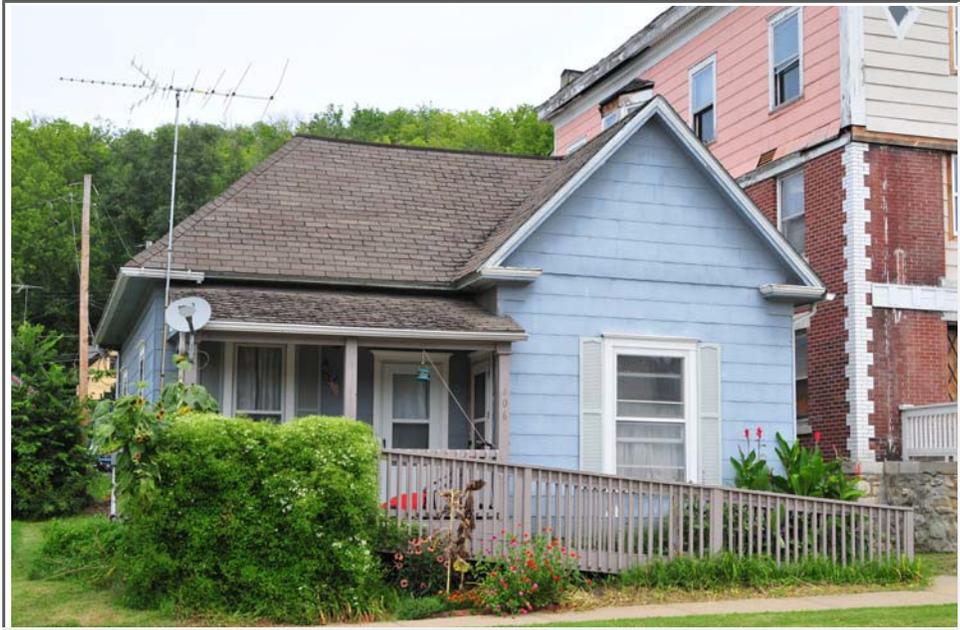
PHOTOGRAPHER Brad Finch, F-Stop Photography	DATE 8/21/2014	DESCRIPTION: South and west elevations, view north.

<p>41. (CONT.) DESCRIPTION OF PRIMARY RESOURCE. EXPAND BOX AS NECESSARY, OR ADD CONTINUATION PAGE</p> <p>The one-story house has a stone foundation, asbestos siding and an asphalt shingle truncated hip roof. A hipped wing projects from the north elevation. A gabled wing projects from the east side of the primary (south) elevation. A porch with wood columns and a wood picket rail projects from the west side. This elevation has three bays. Single one-over-one double-hung vinyl windows fill Bays 1 and 3; a single door with a replacement storm door fills Bay 2. A separate door accesses the west elevation of the wing, beneath the porch. Historic wood windows are extant on the secondary elevations. Alterations since the 1994 survey include the wood posts on the porch and the wheelchair ramp.</p>
<p>40. (CONT.) DESCRIPTION OF ENVIRONMENT AND OUTBUILDINGS. EXPAND BOX AS NECESSARY, OR ADD CONTINUATION PAGE</p> <p>The house is set back slightly from the street toward the front of the small lot. A large wood ramp with a picket rail access the porch.</p>

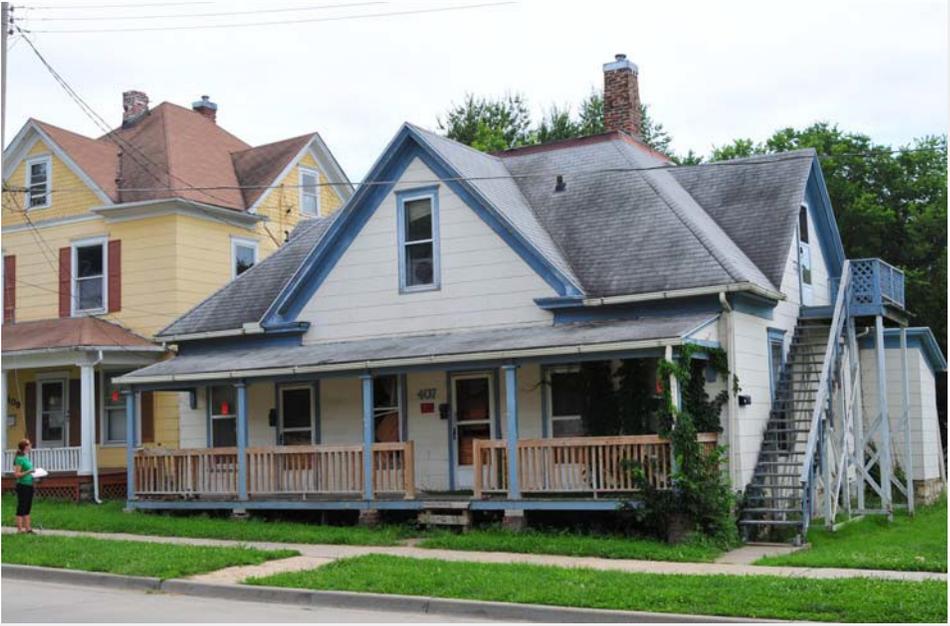
PHOTOGRAPHER Brad Finch, F-Stop Photography	DATE 8/21/2014	DESCRIPTION: North and west elevations, view southeast.

<p>41. (CONT.) DESCRIPTION OF PRIMARY RESOURCE. EXPAND BOX AS NECESSARY, OR ADD CONTINUATION PAGE</p> <p>The one-and-one-half-story Queen Anne apartment building has a stone foundation, asbestos siding and an asphalt shingle truncated hip roof with lower cross-gables on each elevation. A gabled wing projects from the south elevation. An exterior wood staircase on the west elevation accesses the second floor. A brick chimney rises from the center of the roof. A porch with square wood columns and a wood picket rail spans the primary (north) elevation. This elevation has six bays on the first story. Single windows fill Bays 1, 3 and 6; single historic wood panel doors fill Bays 2, 4 and 5. A single window pierces the gable end. Historic one-over-one double-hung wood windows fill each window opening on this elevation.</p>
<p>40. (CONT.) DESCRIPTION OF ENVIRONMENT AND OUTBUILDINGS. EXPAND BOX AS NECESSARY, OR ADD CONTINUATION PAGE</p> <p>The house is set back slightly from the street on the north side of the lot. Mature trees dot the property. A concrete sidewalk leads to the porch. A one-story shed with historic wood siding and a shed roof is located at the rear of the property. The historic garage retains integrity and would be contributing to a potential historic district.</p>

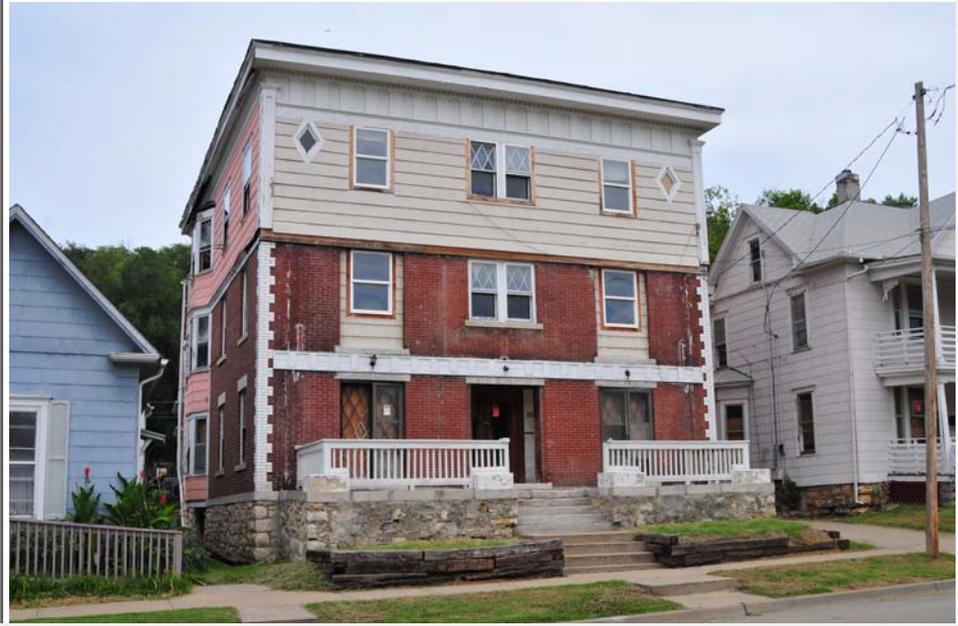
<p>PHOTOGRAPHER Brad Finch, F-Stop Photography</p>	<p>DATE 8/21/2014</p>	<p>DESCRIPTION: South and west elevations, view northeast.</p>

<p>41. (CONT.) DESCRIPTION OF PRIMARY RESOURCE. EXPAND BOX AS NECESSARY, OR ADD CONTINUATION PAGE</p> <p>The three-story apartment building has a stone foundation, brick cladding and a flat roof. Fiberboard clads the third story and a projecting angled bay window on the west elevation. White glazed brick quoins articulate the corners on the first and second stories; square wood panel pilasters define the third story corners. A wood cornice with a wide paneled frieze spans the south elevation; a band of dentil molding ornaments the roofline across each elevation. A concrete deck with a vinyl picket rail spans the primary (south) elevation. This elevation has three symmetrical bays. On the first story, Bays 1 and 3 have paired historic diamond-pane wood doors. Bay 2 and a single glazed historic wood door with a sidelight. Bays 1 and 3 have single replacement one-over-one double-hung windows set in larger openings, with fiberboard infill on the second story; and single replacement one-over-one double-hung windows flanked on the outside by diamond-shaped windows on the third story. Bay 2 has paired historic diamond pane-over-one double-hung wood windows on the second and third stories. Alterations since the 1994 survey include the removal of the two-story Classical Revival porch. It had two-story four Doric columns with a prominent frieze and wood picket rails across the first and second stories.</p>

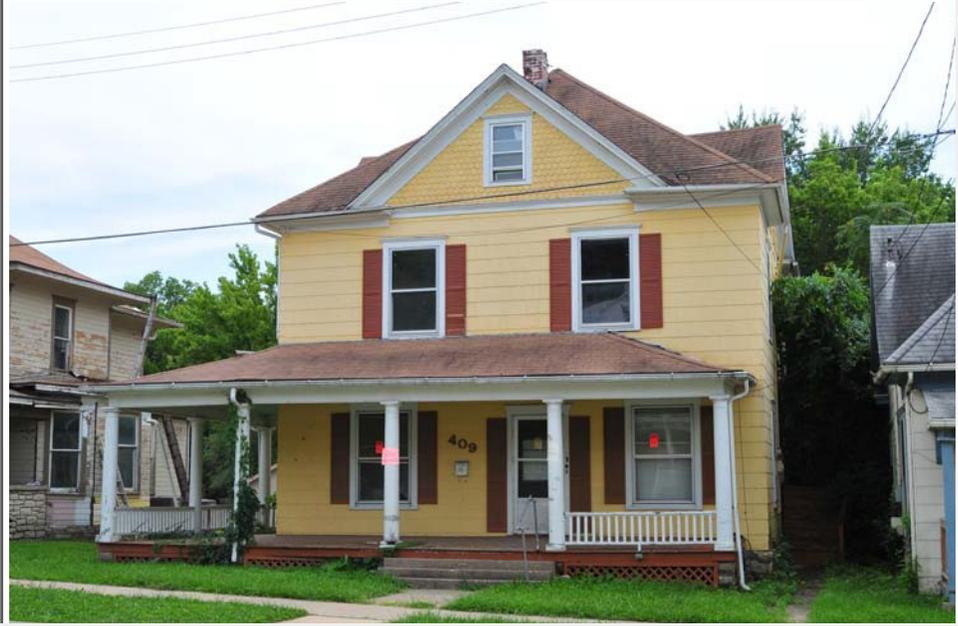
PHOTOGRAPHER Brad Finch, F-Stop Photography	DATE 8/21/2014	DESCRIPTION: North elevation, view south.

<p>41. (CONT.) DESCRIPTION OF PRIMARY RESOURCE. EXPAND BOX AS NECESSARY, OR ADD CONTINUATION PAGE</p> <p>The two-and-one-half-story house has a stone foundation, asbestos siding and an asphalt shingle roof with lower cross-gables on each elevation. The Colonial Revival style house has Victorian elements. Historic fishscale shingles clad each of the gables. A one-story wing projects from the south elevation. A brick chimney rises from the north slope of the roof. A side-wrap porch with round wood columns and a wood picket rail spans the primary (north) and east elevations. The north elevation has three bays on the first story. Single windows fill Bays 1 and 3; a single door fills the offset Bay 2. Two single windows pierce the second story. A single window pierces the gable. Historic one-over-one double-hung wood windows fill each window opening on this elevation.</p>
<p>40. (CONT.) DESCRIPTION OF ENVIRONMENT AND OUTBUILDINGS. EXPAND BOX AS NECESSARY, OR ADD CONTINUATION PAGE</p> <p>The house is set back from the street at the north side of the lot. Mature trees dot the rear of the property. A concrete sidewalk and stairs access the house. A one-story shed with vertical wood siding and an asphalt shingle gable-front roof is located at the rear of the property. The historic garage retains integrity and would be contributing to a potential historic district.</p>

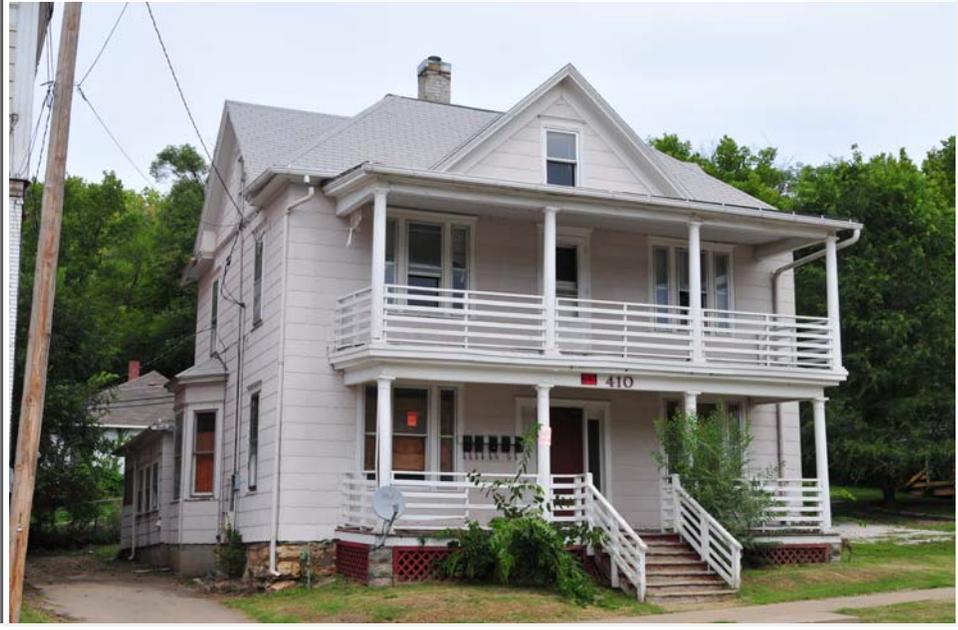
PHOTOGRAPHER Brad Finch, F-Stop Photography	DATE 8/21/2014	DESCRIPTION: South and west elevations, view northeast.
---------------------------------------------	----------------	---------------------------------------------------------

41. (CONT.) DESCRIPTION OF PRIMARY RESOURCE. EXPAND BOX AS NECESSARY, OR ADD CONTINUATION PAGE  
 The two-and-one-half-story Queen Anne apartment building has a stone and CMU foundation, asbestos siding and an asphalt shingle truncated hip roof. Lower cross-gables rise from the east, south and west slopes of the roof. A hipped wing projects from the east elevation. A brick chimney rises from the center. A two-story porch with round wood columns projects from the center of the primary (south) elevation. A horizontal wood railing encloses the porch at each story. This elevation has three symmetrical bays. Bays 1 and 3 have single windows flanked by narrower windows on the first and second stories; Bay 2 has a single door with sidelights on the first story and a single door on the second story. A single window pierces the gable end. Historic one-over-one double-hung wood windows fill each window opening on this elevation. Alterations since the 1994 survey include the replacement of a wood picket rail with the horizontal wood railing.

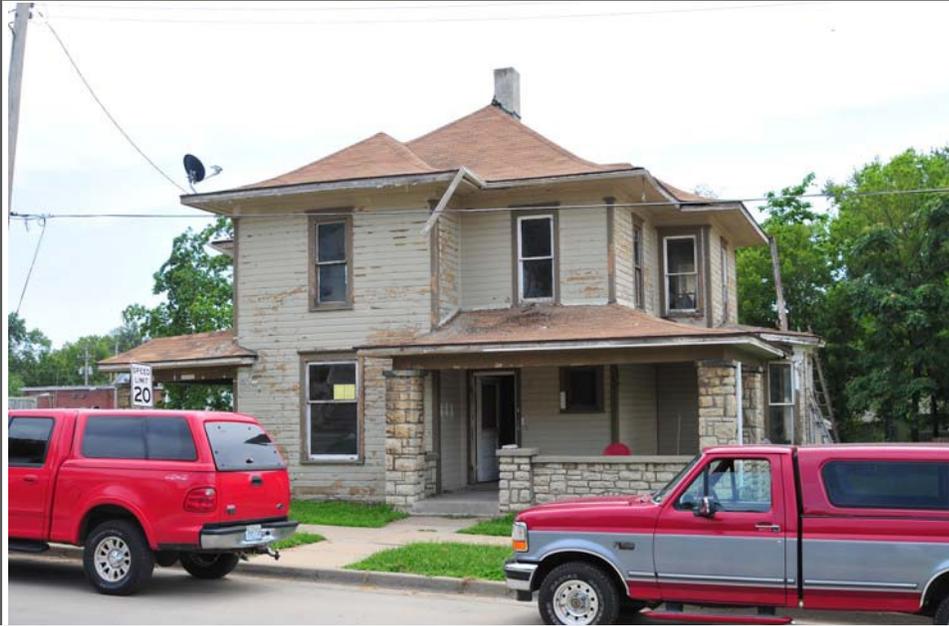
PHOTOGRAPHER Brad Finch, F-Stop Photography      DATE 8/21/2014      DESCRIPTION: North and west elevations, view southeast.

41. (CONT.) DESCRIPTION OF PRIMARY RESOURCE. EXPAND BOX AS NECESSARY, OR ADD CONTINUATION PAGE  
 The two-story house has a stone foundation, historic wood siding and an asphalt shingle bellcast hip roof. The house has a Queen Anne style form with a Prairie style roof with flared roof and wide overhanging eaves. Hipped additions projects from each elevation. A brick chimney rises from the center of the roof. Two porches with limestone piers and kneewalls front the primary (north) elevation, on each side of the projecting wing. One runs along the east elevation of the wing. The other wraps the north and west elevations of the house. The north elevation has four bays. Single doors fill each story of the recessed Bay 1; single windows fill each story of Bay 2; a single door and a fixed window fill the first story of Bay 3; single windows pierce the second story of Bays 3 and 4. Historic one-over-one wood windows fill each window opening on this elevation.

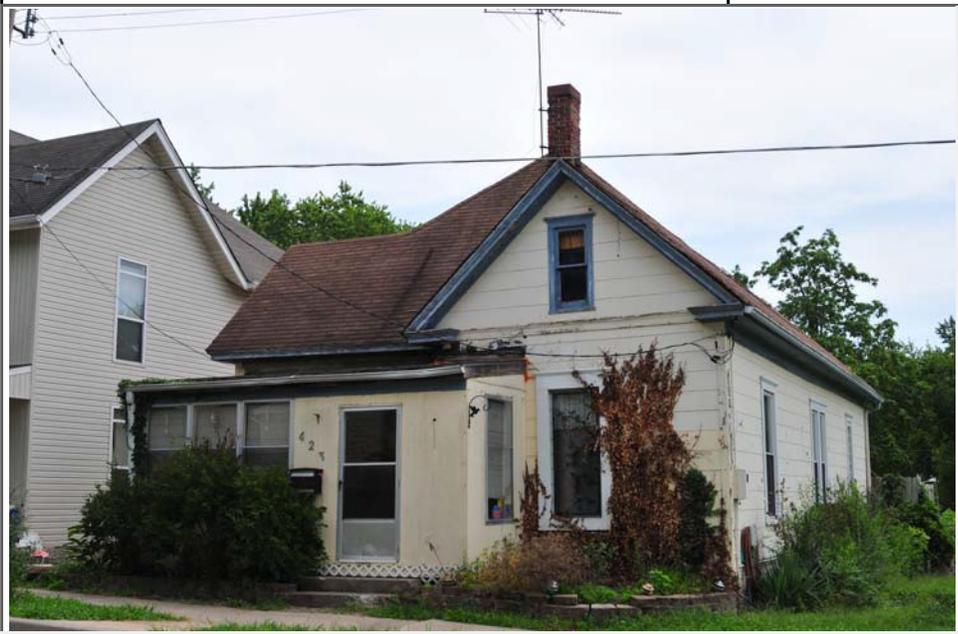
PHOTOGRAPHER Brad Finch, F-Stop Photography	DATE 8/21/2014	DESCRIPTION: North and west elevations, view southeast.

<p>41. (CONT.) DESCRIPTION OF PRIMARY RESOURCE. EXPAND BOX AS NECESSARY, OR ADD CONTINUATION PAGE</p> <p>The one-and-one-half-story house has a stone foundation, asbestos siding and an asphalt shingle roof. Gabled wings project from the north, east and south elevations. A brick chimney rises from the center of the roof. A non-historic enclosed porch with fiberboard cladding projects from the east side of the primary (north) elevation. This elevation has three bays. Bay 1 has a band of three replacement one-over-one aluminum storm windows; Bay 2 has a single door; Bay 3 has a single replacement fixed window. A single historic one-over-one wood window pierces the gable. Changes since the 1994 survey include the enclosure of the porch. It previously had square wood columns with a wood picket rail.</p>
<p>40. (CONT.) DESCRIPTION OF ENVIRONMENT AND OUTBUILDINGS. EXPAND BOX AS NECESSARY, OR ADD CONTINUATION PAGE</p> <p>The house is set back from the street on the north side of the lot. Concrete stairs access the porch. A one-story outbuilding with fiberboard cladding and an asphalt shingle gable-front roof is located at the rear of the property. The garage is non-historic and would be non-contributing to a potential historic district.</p>

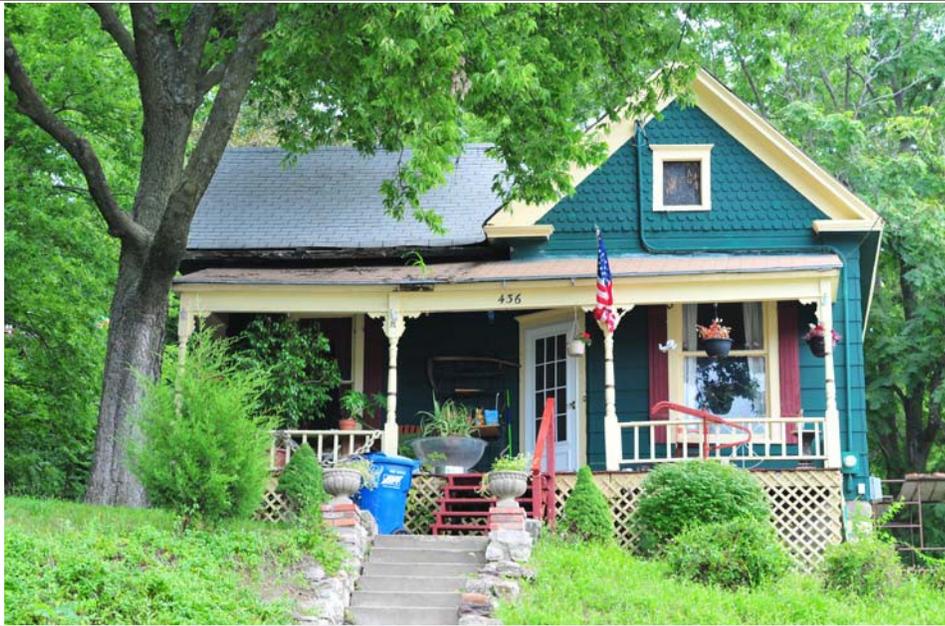
PHOTOGRAPHER Brad Finch, F-Stop Photography	DATE 8/21/2014	DESCRIPTION: West elevation, view east.
---------------------------------------------	----------------	-----------------------------------------

41. (CONT.) DESCRIPTION OF PRIMARY RESOURCE. EXPAND BOX AS NECESSARY, OR ADD CONTINUATION PAGE  
 The one-and-one-half-story Folk Victorian house has a stone foundation, fiberboard siding and an asphalt shingle side-gable roof. A gabled wing with fishscale shingles in the peak projects from the west elevation. Hipped wings project from the east elevation. A porch with turned wood columns and a wood railing. This elevation has three bays. Single historic one-over-one double-hung wood windows fill Bays 1 and 3; a single door fills the angled Bay 2. A single historic fixed wood window pierces the gable end. The house is similar in form to the adjacent house at 103 Temple Avenue. Alterations since the 1994 survey include the application of fiberboard siding.

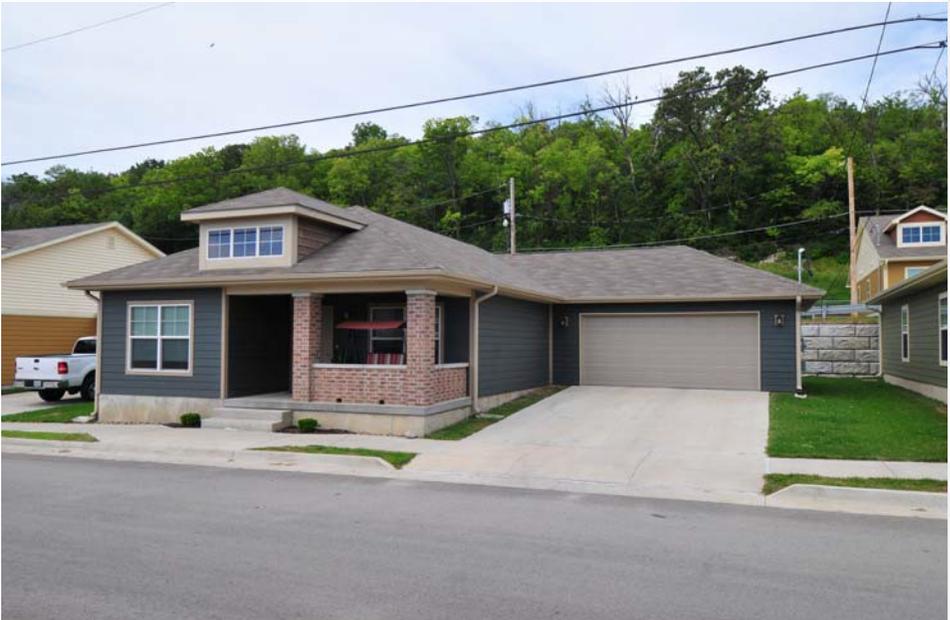
PHOTOGRAPHER Brad Finch, F-Stop Photography	DATE 8/21/2014	DESCRIPTION: South and east elevations, view northwest.

41. (CONT.) DESCRIPTION OF PRIMARY RESOURCE. EXPAND BOX AS NECESSARY, OR ADD CONTINUATION PAGE  
 The one-and-one-half-story New Traditional Craftsman house has a concrete foundation, fiberboard siding and an asphalt shingle hip roof. An attached two-car garage projects from the east elevation. A hip dormer clad in wood shingles rises from the south slope of the roof. A recessed porch with brick piers and kneewalls fills the southeast corner. The primary (south) elevation has three bays. Paired four-over-one vinyl windows fill Bay 1 and the recessed Bay 3. A single door fills the recessed Bay 2. A band of three four-light vinyl windows pierce the dormer.

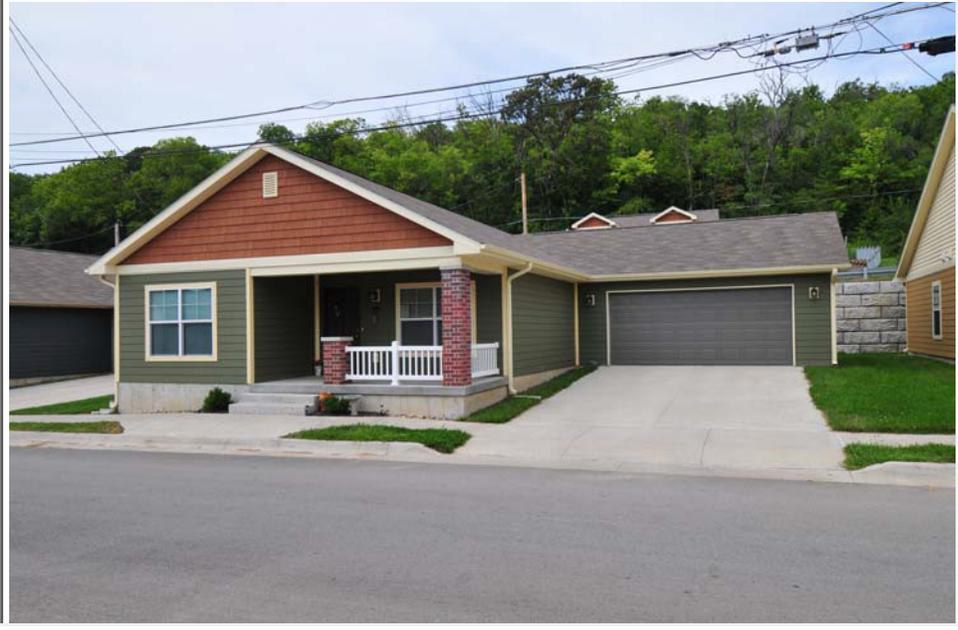
PHOTOGRAPHER Brad Finch, F-Stop Photography	DATE 8/21/2014	DESCRIPTION: South and east elevations, view northwest.
---------------------------------------------	----------------	---------------------------------------------------------

41. (CONT.) DESCRIPTION OF PRIMARY RESOURCE. EXPAND BOX AS NECESSARY, OR ADD CONTINUATION PAGE  
 The one-story New Traditional Craftsman house has a concrete foundation, fiberboard siding and an asphalt shingle gable-front roof. Wood shingles clad the gable-end. An attached two-car garage projects from the east elevation. A recessed porch with brick columns and a vinyl picket rail fills the southeast corner. The primary (south) elevation has three bays. Paired four-over-one vinyl windows fill Bay 1 and the recessed Bay 3. A single door fills the recessed Bay 2.

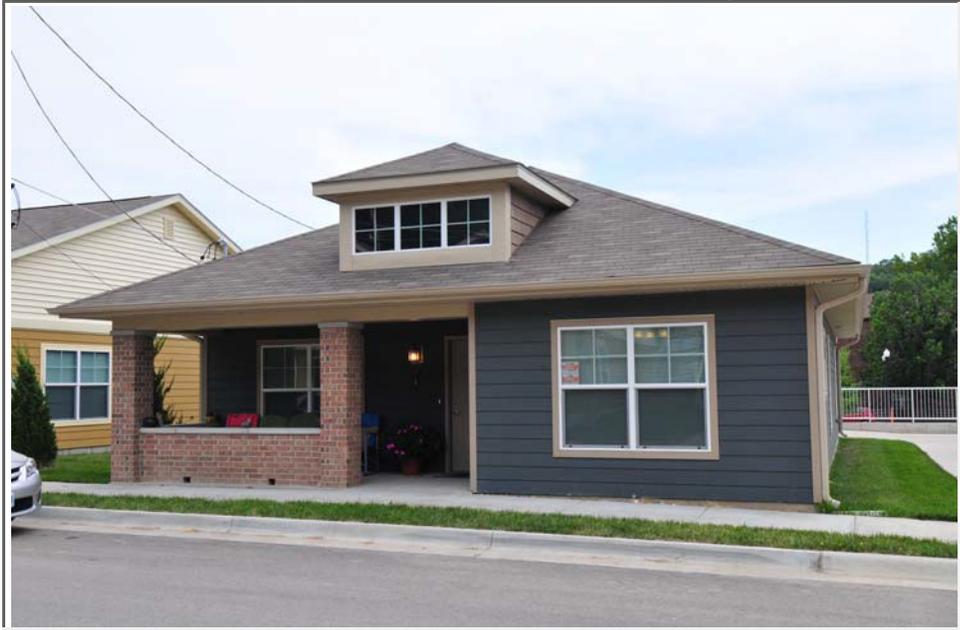
PHOTOGRAPHER Brad Finch, F-Stop Photography	DATE 8/21/2014	DESCRIPTION: North elevation, view south.

<p>41. (CONT.) DESCRIPTION OF PRIMARY RESOURCE. EXPAND BOX AS NECESSARY, OR ADD CONTINUATION PAGE</p> <p>The one-and-one-half-story New Traditional Craftsman house has a concrete foundation, fiberboard siding and an asphalt shingle hip roof. An attached two-car garage projects from the south elevation. A hipped dormer rises from the north slope of the roof. A recessed porch with brick columns and kneewall fills the northeast corner. The primary (north) elevation has three bays. Paired four-over-one vinyl windows fill the recessed Bay 1 and Bay 3. A single door fills the recessed Bay 2. A band of three four-light vinyl windows pierce the dormer.</p>
<p>40. (CONT.) DESCRIPTION OF ENVIRONMENT AND OUTBUILDINGS. EXPAND BOX AS NECESSARY, OR ADD CONTINUATION PAGE</p> <p>The house abuts the public sidewalk on the north elevation. A concrete driveway runs along the west side of the property.</p>
<p>21. (CONT.) HISTORY AND SIGNIFICANCE. EXPAND BOX AS NECESSARY, OR ADD CONTINUATION PAGE</p> <p>This lot was vacant in the 1994 Survey. Sanborn Maps from 1942 show that a two-story dwelling, 333 East Excelsior Street, previously occupied this parcel. A building appears on a 1970 aerial photograph. The building was demolished between 1970 and 1994.</p>

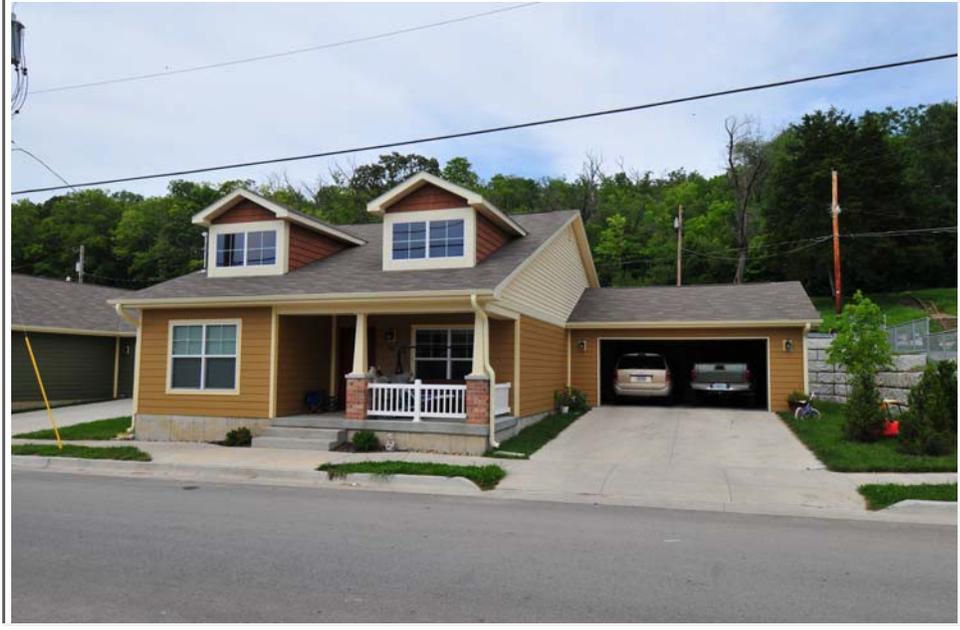
PHOTOGRAPHER Brad Finch, F-Stop Photography	DATE 8/21/2014	DESCRIPTION: South and east elevations, view northwest.
---------------------------------------------	----------------	---------------------------------------------------------

41. (CONT.) DESCRIPTION OF PRIMARY RESOURCE. EXPAND BOX AS NECESSARY, OR ADD CONTINUATION PAGE  
 The one-and-one-half-story New Traditional Craftsman house has a concrete foundation, fiberboard siding and an asphalt shingle side-gable roof. An attached two-car garage projects from the east elevation. Two gabled dormers clad in wood shingles rise from the south slope of the roof. A recessed porch with brick piers, tapered square wood columns and a vinyl picket rail fills the southeast corner. The primary (south) elevation has three bays. Paired four-over-one vinyl windows fill Bay 1 and the recessed Bay 3. A single door fills the recessed Bay 2. Paired four-light vinyl windows pierce each dormer.

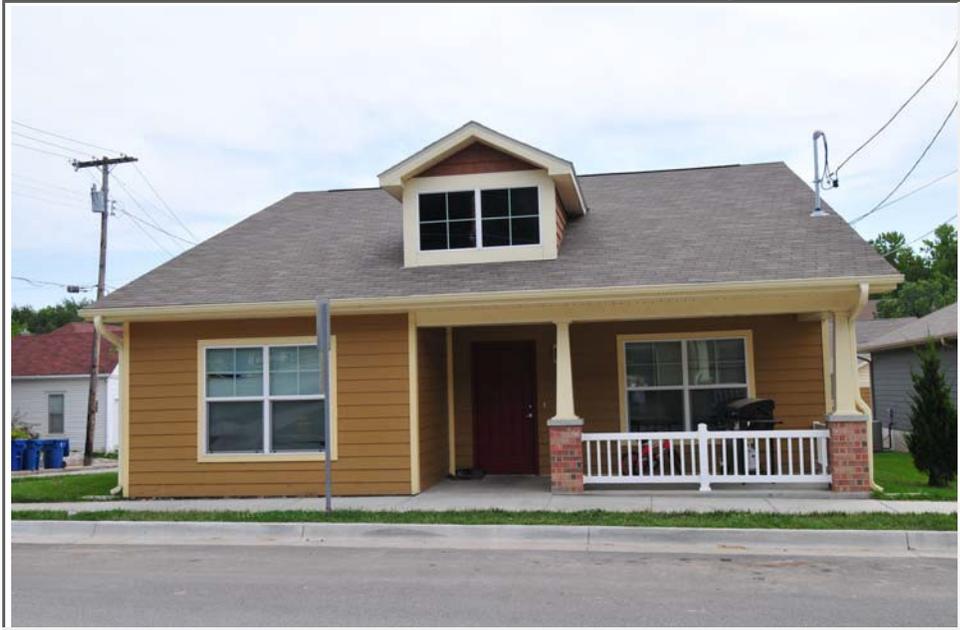
PHOTOGRAPHER Brad Finch, F-Stop Photography	DATE 8/21/2014	DESCRIPTION: North elevation, view south.

<p>41. (CONT.) DESCRIPTION OF PRIMARY RESOURCE. EXPAND BOX AS NECESSARY, OR ADD CONTINUATION PAGE</p> <p>The one-and-one-half-story New Traditional Craftsman house has a concrete foundation, fiberboard siding and an asphalt shingle side-gable roof. An attached two-car garage projects from the south elevation. A gabled dormer clad in wood shingles rises from the north slope of the roof. A recessed porch with brick piers, tapered square wood columns and a vinyl picket rail fills the northwest corner. The primary (north) elevation has three bays. Paired four-over-one vinyl windows fill Bay 1 and the recessed Bay 3. A single door fills the recessed Bay 2. Paired four-light vinyl windows pierce the dormer.</p>
<p>40. (CONT.) DESCRIPTION OF ENVIRONMENT AND OUTBUILDINGS. EXPAND BOX AS NECESSARY, OR ADD CONTINUATION PAGE</p> <p>The house sits on a corner lot. It abuts the public sidewalk on the north elevation. A concrete driveway accesses the garage from the east side of the property.</p>

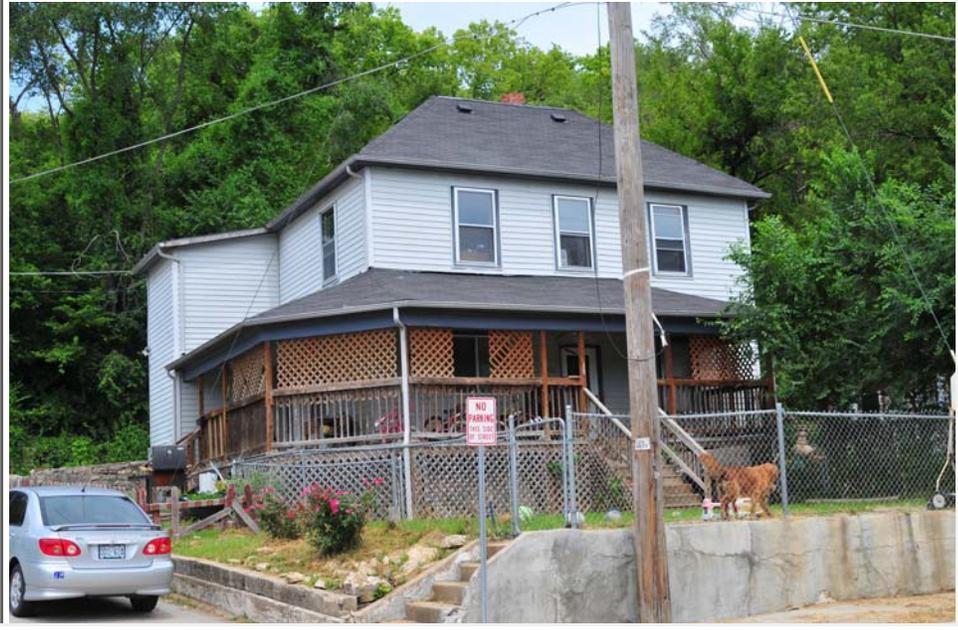
PHOTOGRAPHER Brad Finch, F-Stop Photography	DATE 8/21/2014	DESCRIPTION: South and west elevations, view northeast.
---------------------------------------------	----------------	---------------------------------------------------------

41. (CONT.) DESCRIPTION OF PRIMARY RESOURCE. EXPAND BOX AS NECESSARY, OR ADD CONTINUATION PAGE  
 The two-story Pyramidal Hip Form house has a stone foundation, vinyl siding and an asphalt shingle truncated hip roof. A two-story wing projects from the west elevation. A brick chimney rises from the center of the roof. A side-wrap porch with square wood columns and a wood picket rail spans the primary (south) and west elevations. The south elevation has three bays. On the first story, a replacement sliding window fills Bay 1; a single door fills Bay 2; a single replacement one-over-one vinyl window Bay 3. Single replacement one-over-one double-hung vinyl windows fill each bay on the second story. Alterations since the 1994 survey include the replacement porch supports and railing.
