Survey number: CL-AS-015-001		2. SURVEY NAME: Boardinghouse Historic Resource Inventory	
3. COUNTY: CLAY		4. ADDRESS (STREET NO. 403 )	STREET (NAME) Benton Avenue
5. CITY: Excelsior Springs	Vicinity <input type="checkbox"/>	6. UTM	OR LAT: 39.341072 7. TOWNSHIP/RANGE/SECTION LONG: -94.21933 T: 52 R: 30 S: 1
8. HISTORIC NAME (IF KNOWN): Crystal Lithium (Lithia) Springs/ Crystal Minera		9. PRESENT/OTHER NAME (IF KNOWN): Crystal Lithia Pavilion	
10. OWNERSHIP <input type="checkbox"/> PRIVATE <input checked="" type="checkbox"/> PUBLIC		11A. HISTORIC USE (IF KNOWN): HEALTH CARE: Resort Facility	
		11B. CURRENT USE: RECREATION & CULTURE/outdoor recrea

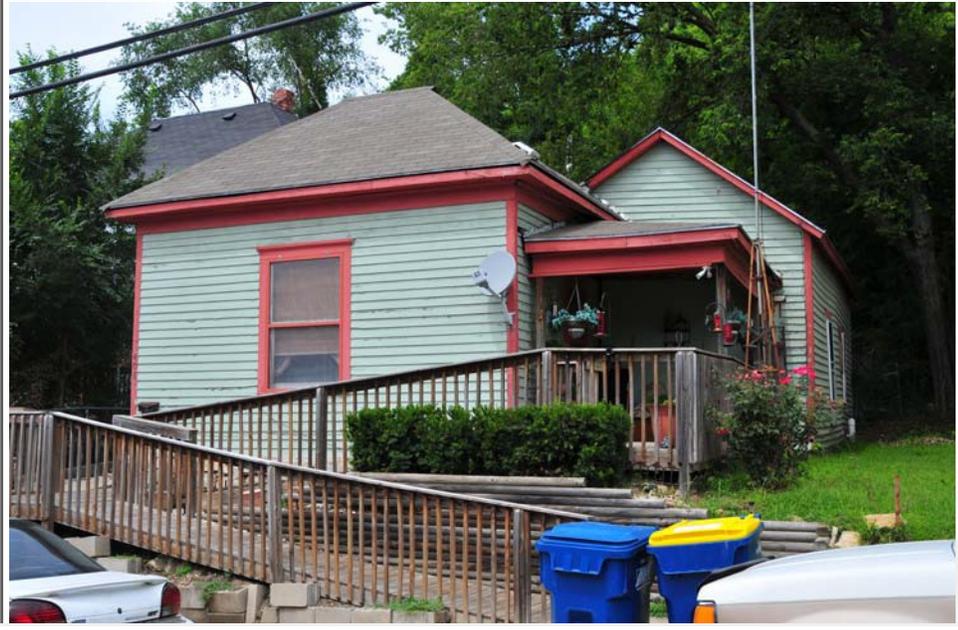
PHOTOGRAPHER Brad Finch, F-Stop Photography	DATE 8/21/2014	DESCRIPTION: South and east elevations, view northwest.
---------------------------------------------	----------------	---------------------------------------------------------

41. (CONT.) DESCRIPTION OF PRIMARY RESOURCE. EXPAND BOX AS NECESSARY, OR ADD CONTINUATION PAGE  
 The one-story house has a stone foundation, wood siding and an asphalt shingle roof. The irregular form consists of a prominent pyramidal block with a rear, gable-front block projecting from the northeast corner. A porch with square wood posts and a wood picket rail fills the interior, southeast corner of the blocks. The primary (south) elevation has a single historic one-over-one double-hung wood window that pierces the pyramidal wing. A single door accesses the east elevation of the wing, beneath the porch. Alterations since 1994 include the removal of aluminum siding, the opening of the enclosed porch and the addition of the wheelchair ramp.

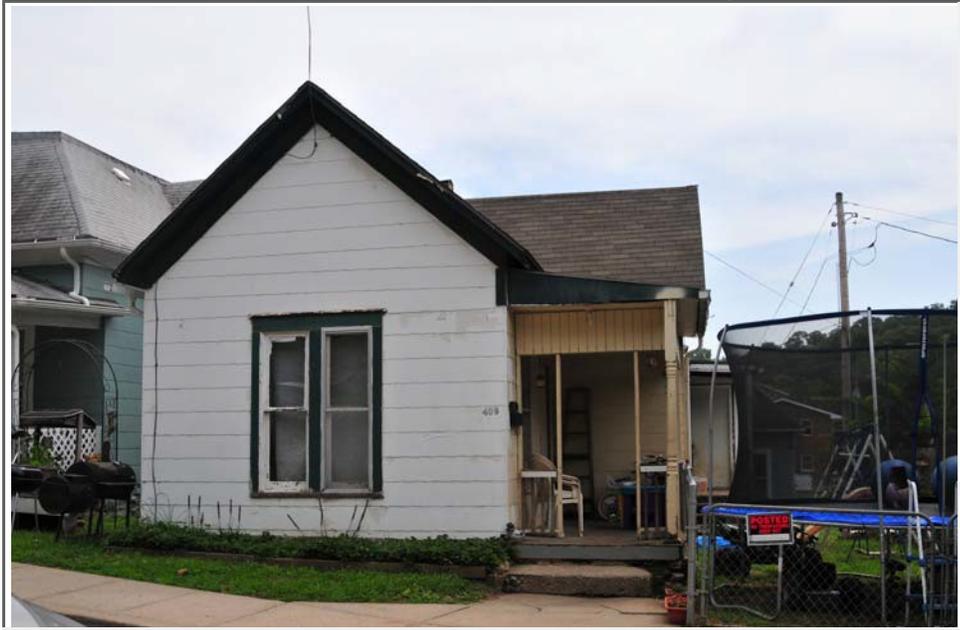
PHOTOGRAPHER Brad Finch, F-Stop Photography	DATE 8/21/2014	DESCRIPTION: North elevation, view south.

<p>41. (CONT.) DESCRIPTION OF PRIMARY RESOURCE. EXPAND BOX AS NECESSARY, OR ADD CONTINUATION PAGE</p> <p>The one-story Cross-Gable house has a stone foundation, asbestos siding and an asphalt shingle roof. A shed addition with a brick chimney projects from the southwest corner. A porch with turned wood columns and a wood picket rail fills the northwest corner of the intersecting gables. Two bays organize the primary (north) elevation. Paired historic one-over-one wood windows pierce the front gable. A single replacement door fills the deeply recessed Bay 2 in the addition. A single door beneath the porch accesses the west elevation of the front gable. Alterations since the 1994 survey include the removal of wood lattice from the porch and the replacement door in Bay 2.</p>
<p>40. (CONT.) DESCRIPTION OF ENVIRONMENT AND OUTBUILDINGS. EXPAND BOX AS NECESSARY, OR ADD CONTINUATION PAGE</p> <p>The house is slightly set back from the street on the east side of the lot. A chain link fence encloses the west side. A concrete sidewalk accesses the porch.</p>

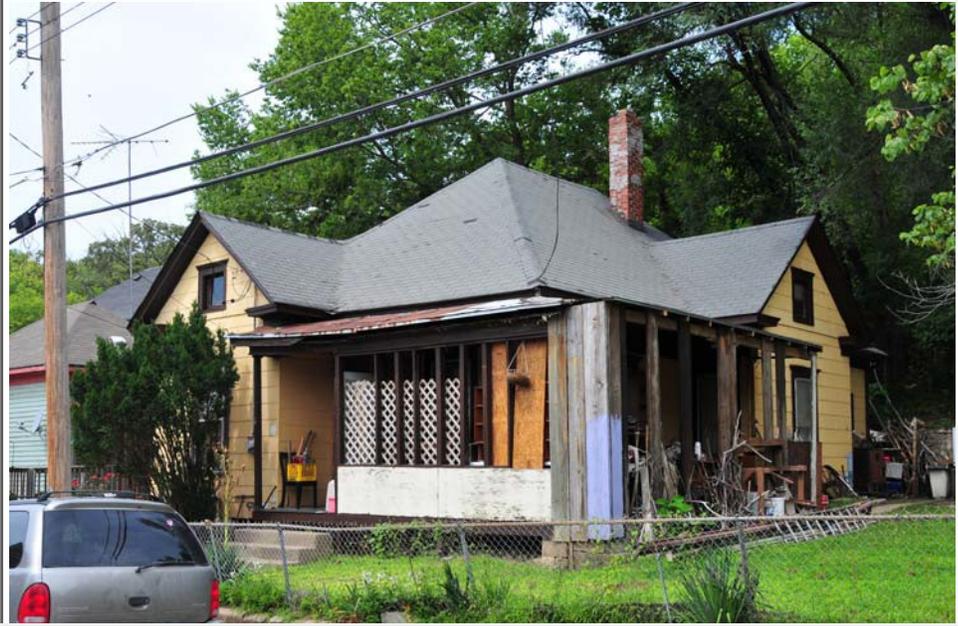
PHOTOGRAPHER Brad Finch, F-Stop Photography	DATE 8/21/2014	DESCRIPTION: South and east elevations, view northwest.

<p>41. (CONT.) DESCRIPTION OF PRIMARY RESOURCE. EXPAND BOX AS NECESSARY, OR ADD CONTINUATION PAGE</p> <p>The one-and-one-half-story house has a stone foundation, asbestos siding and an asphalt shingle hip roof with lower cross-gables. Gabled wings project from the east and south elevations. A hipped wing projects from the north elevation. A brick chimney rises from the east slope of the roof. A side-wrap porch with square wood columns and a wood rail projects from the primary (south) and east elevations. The south elevation has four bays. Single historic one-over-one double-hung wood windows fill Bays 1, 3 and 4; a single door fills Bay 2. Alterations since the 1994 survey include the removal of wood lattice from the porch.</p>
<p>40. (CONT.) DESCRIPTION OF ENVIRONMENT AND OUTBUILDINGS. EXPAND BOX AS NECESSARY, OR ADD CONTINUATION PAGE</p> <p>The house is set back from the street on the west side of the lot. A chain link fence encloses an open lawn on the east side of the lot. A stone retaining wall defines the north boundary. Mature trees dot the rear of the property. A concrete sidewalk and concrete stairs access the porch.</p>

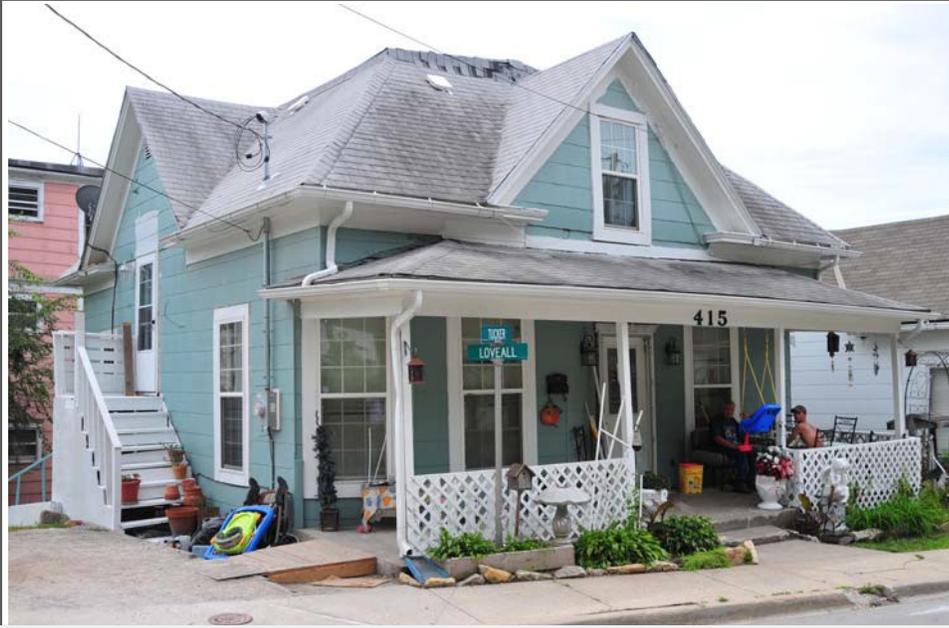
PHOTOGRAPHER	Brad Finch, F-Stop Photography	DATE	8/21/2014	DESCRIPTION:	North and east elevations, view southwest.
--------------	--------------------------------	------	-----------	--------------	--------------------------------------------

The one-and-one-half-story house has a stone foundation, asbestos siding and an asphalt shingle truncated hip roof with lower cross-gables. The house has a Queen Anne form, but the historic elements have been removed. A wood staircase rises on the east elevation. A porch with square wood columns and a lattice rail spans the primary (north) elevation. This elevation has four bays. Single non-historic multi-light double-hung vinyl windows fill the angled Bay 1 and Bays 2 and 4; a single door fills Bay 3. A single non-historic multi-light double-hung vinyl window pierces the gable end. Alterations since the 1994 survey include the replacement windows and the addition of the lattice railing.

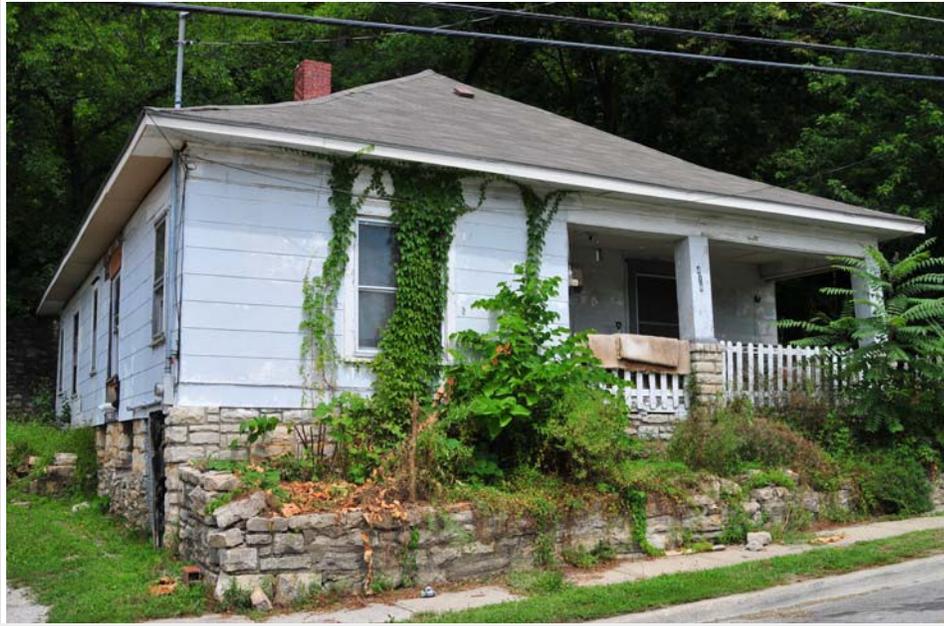
PHOTOGRAPHER	Brad Finch, F-Stop Photography	DATE	8/21/2014	DESCRIPTION:	South and west elevations, view northeast.
--------------	--------------------------------	------	-----------	--------------	--------------------------------------------

The one-story Pyramidal Hip Form house has a stone foundation, asbestos siding and an asphalt shingle, bellcast hip roof. A brick chimney rises from the west slope of the roof. An inset porch with limestone piers, square columns and a wood picket fence rail fills the southeast corner of the house. The primary (south) elevation has three bays. Single replacement one-over-one vinyl windows fill Bay 1 and recessed Bay 3; a single door fills recessed Bay 2. Historic one-over-one wood windows pierce the secondary elevations. Changes since the 1994 survey include the replacement vinyl windows on the south elevation.

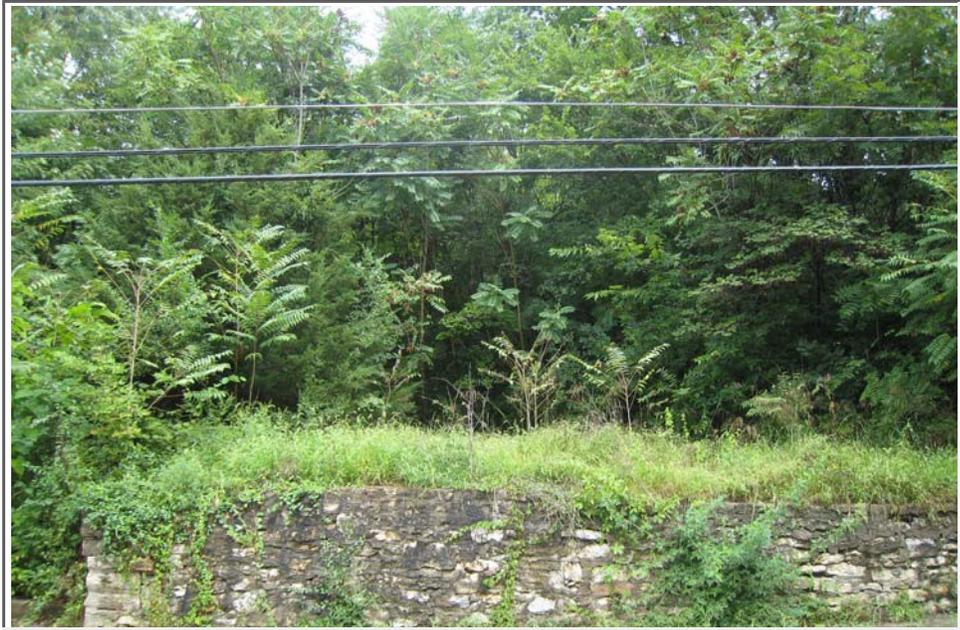
PHOTOGRAPHER Lauren Rieke	DATE 9/3/2014	DESCRIPTION: Vacant lot, view north.

<p>41. (CONT.) DESCRIPTION OF PRIMARY RESOURCE. EXPAND BOX AS NECESSARY, OR ADD CONTINUATION PAGE</p>
<p>40. (CONT.) DESCRIPTION OF ENVIRONMENT AND OUTBUILDINGS. EXPAND BOX AS NECESSARY, OR ADD CONTINUATION PAGE                  A wooded area fills the sloping vacant lot. A stone retaining wall defines the south boundary.</p>
<p>21. (CONT.) HISTORY AND SIGNIFICANCE. EXPAND BOX AS NECESSARY, OR ADD CONTINUATION PAGE                  The parcel was not surveyed in the Boardinghouse Historic District Survey, 1994. Sanborn Maps from 1942 show a one-story dwelling, 426 East Excelsior Street, previously occupied this parcel. It was demolished at an unknown date.</p>
<p>ELIGIBILITY STATEMENT:                  Because a building historically occupied this property, the vacant lot would be non-contributing to a potential historic district.</p>
<p>22. (CONT.) SOURCES OF INFORMATION. EXPAND BOX AS NECESSARY, OR ADD CONTINUATION PAGE                  PREVIOUS SURVEY NAME:                  Sanborn Fire and Insurance Maps, 1942.</p>

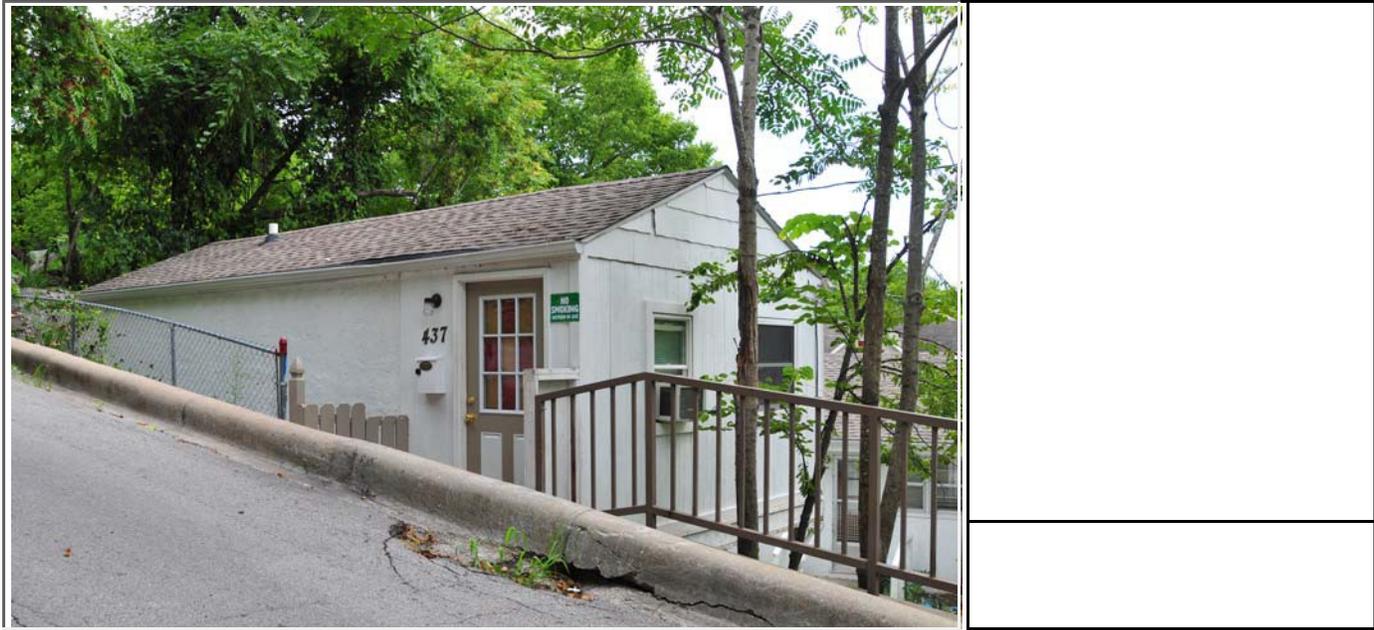
PHOTOGRAPHER	Brad Finch, F-Stop Photography	DATE	8/21/2014	DESCRIPTION:	North and west elevations, view southeast.
--------------	--------------------------------	------	-----------	--------------	--------------------------------------------

41. (CONT.) DESCRIPTION OF PRIMARY RESOURCE. EXPAND BOX AS NECESSARY, OR ADD CONTINUATION PAGE  
 The one-story house is raised one-story above grade on concrete footings with square wood posts to match the grade of the road. The east portion of the house sits atop a rear wing of the adjacent resource at 420-424 East Broadway. It has stucco and asbestos cladding and an asphalt shingle side-gable roof. The primary (north) elevation has a single door on the west side that accesses a former porch. Replacement one-over-one double-hung vinyl windows pierce the west elevation. The siding at the west end encloses a full-width porch. Alterations since the 1994 survey include the addition of siding to enclose the porch.

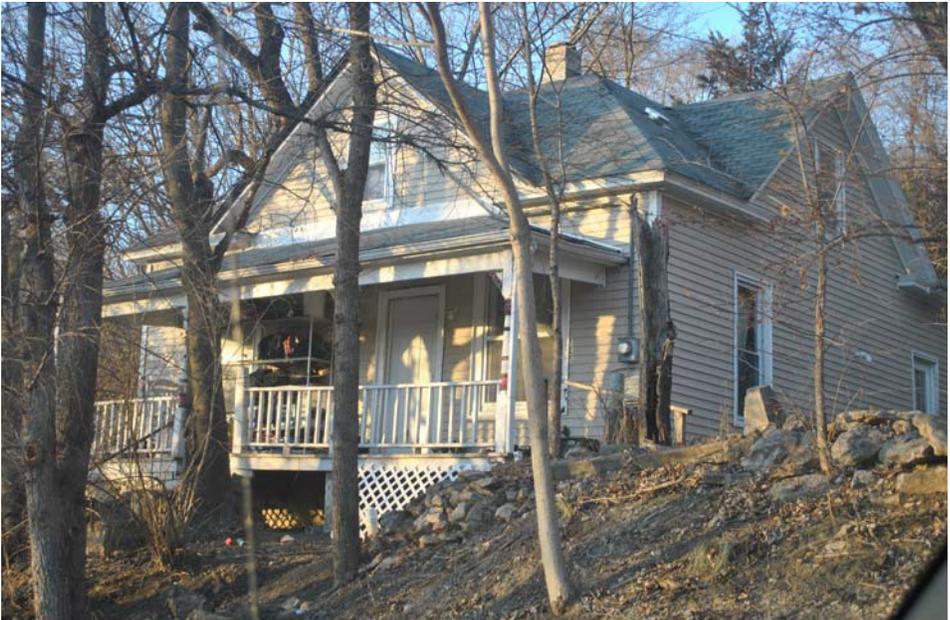
PHOTOGRAPHER	Brad Finch, F-Stop Photography	DATE	8/21/2014	DESCRIPTION:	South elevation, view north.

<p>41. (CONT.) DESCRIPTION OF PRIMARY RESOURCE. EXPAND BOX AS NECESSARY, OR ADD CONTINUATION PAGE</p> <p>The one-and-one-half-story Folk Victorian house has a stone foundation, vinyl siding and an asphalt shingle truncated pyramidal roof with lower cross-gables. A porch with turned wood columns and a wood picket rail spans the primary (south) elevation. This elevation has four bays. Single windows fill Bays 1 and 4; single doors fill Bays 2 and 3. Historic one-over-one wood windows pierce each elevation.</p>
<p>40. (CONT.) DESCRIPTION OF ENVIRONMENT AND OUTBUILDINGS. EXPAND BOX AS NECESSARY, OR ADD CONTINUATION PAGE</p> <p>The house is set up on a hill on the steeply sloping lot. Mature trees surround the house and obscure its view from the street. Concrete steps with stone cheekwalls access the porch. A limestone retaining wall defines the south boundary. A gravel driveway accesses the house from east side of the lot.</p>

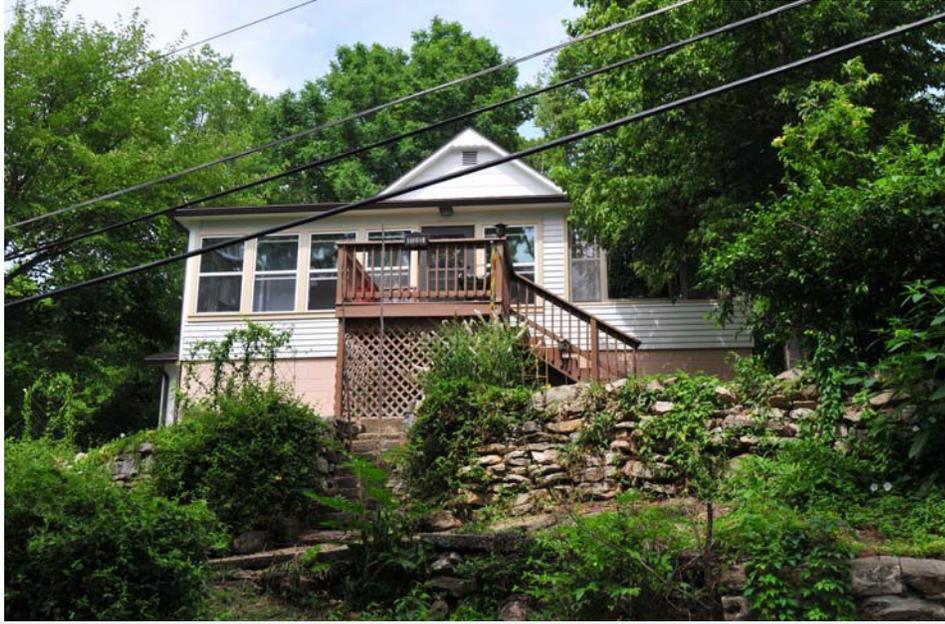
PHOTOGRAPHER Brad Finch, F-Stop Photography	DATE 8/21/2014	DESCRIPTION: South elevation, view north.
---------------------------------------------	----------------	-------------------------------------------

41. (CONT.) DESCRIPTION OF PRIMARY RESOURCE. EXPAND BOX AS NECESSARY, OR ADD CONTINUATION PAGE  
 The one-story Cross-Gable house has a CMU foundation, and an asphalt shingle roof. Wood clads an enclosed porch on the south elevation; asbestos shingles clad the gable end. Shed-roof additions project from the north elevation. An enclosed porch spans the primary (south) elevation. A wood deck with a wood picket rail and wood stairs projects from the center of the porch. The south elevation has two bays. Bay 1 has a continuous band with four windows, a single door and a single window. Bay 2 has a large picture window flanked on each side by a single window. All windows on this elevation are replacement one-over-one double-hung vinyl windows.

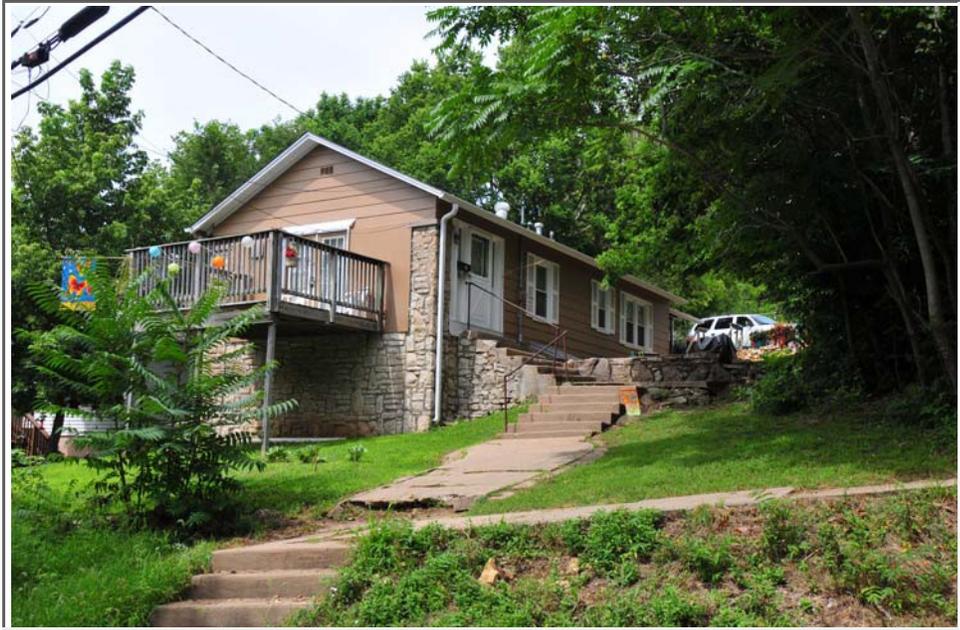
PHOTOGRAPHER Brad Finch, F-Stop Photography	DATE 8/21/2014	DESCRIPTION: South and east elevations, view northwest.

<p>41. (CONT.) DESCRIPTION OF PRIMARY RESOURCE. EXPAND BOX AS NECESSARY, OR ADD CONTINUATION PAGE</p> <p>The one-story Side-Gable house has a rubble stone foundation, fiberboard siding and an asphalt shingle roof. A recessed porch with stone columns on the south elevation has been enclosed with opaque panels. A wood deck with a wood rail projects from this enclosed porch. The primary (east) elevation has four bays. A single door fills Bay 1; single windows with shutters fill Bays 2 and 3; paired windows with shutters fill Bay 4. Replacement one-over-one double-hung vinyl windows fill each window opening on this elevation.</p>
<p>40. (CONT.) DESCRIPTION OF ENVIRONMENT AND OUTBUILDINGS. EXPAND BOX AS NECESSARY, OR ADD CONTINUATION PAGE</p> <p>The house is set back from the street at the center of the lot. The lot slopes down to the south, exposing the basement level on the south and west elevations. A concrete sidewalk and stairs access the main entrance. A separate paved driveway accesses the house from the north side of the lot.</p>

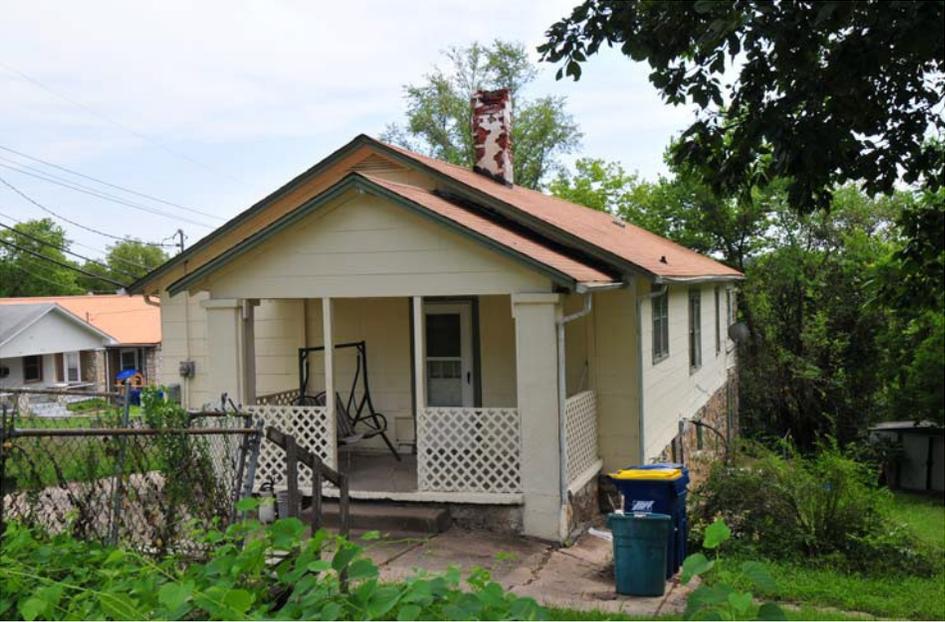
PHOTOGRAPHER	Brad Finch, F-Stop Photography	DATE	8/21/2014	DESCRIPTION:	East elevation, view west.

<p>41. (CONT.) DESCRIPTION OF PRIMARY RESOURCE. EXPAND BOX AS NECESSARY, OR ADD CONTINUATION PAGE</p> <p>The one-story house has a stone foundation, asbestos siding and an asphalt shingle gable roof. A brick chimney rises from the west slope of the roof. A porch projects from the primary (north) elevation. Square posts support the gabled porch roof. This elevation has one bay containing a single historic wood door. The side elevations have single windows with historic wood one-over-one sashes.</p>
<p>40. (CONT.) DESCRIPTION OF ENVIRONMENT AND OUTBUILDINGS. EXPAND BOX AS NECESSARY, OR ADD CONTINUATION PAGE</p> <p>The house is set back from the street at the center of the corner lot. The terrain slopes down to the south, exposing the basement level on the east, south and west elevations. A concrete driveway accesses the east side of the property. A concrete sidewalk accesses the porch on the north elevation. Wood stairs with a wood rail access the deck on the east elevation. A prefabricated shed is located at the rear of the lot.</p>

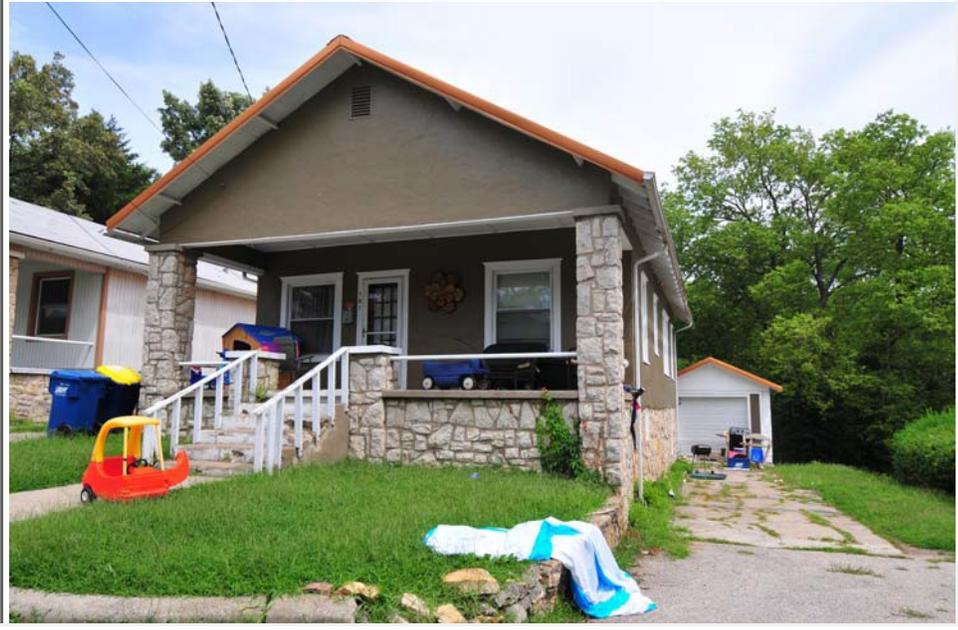
PHOTOGRAPHER Brad Finch, F-Stop Photography	DATE 8/21/2014	DESCRIPTION: West and south elevations, view northeast.
---------------------------------------------	----------------	---------------------------------------------------------

41. (CONT.) DESCRIPTION OF PRIMARY RESOURCE. EXPAND BOX AS NECESSARY, OR ADD CONTINUATION PAGE  
 The one-story Craftsman house has a stone foundation, stucco cladding and an asphalt shingle gable-front roof with wide overhanging eaves. A recessed porch with limestone columns and a simple pipe rail spans the primary (west) elevation. This elevation has three bays. Single historic one-over-one double-hung wood windows fill Bays 1 and 3; a single door fills the offset Bay 2. This house is identical in form to 103 North Francis Street.

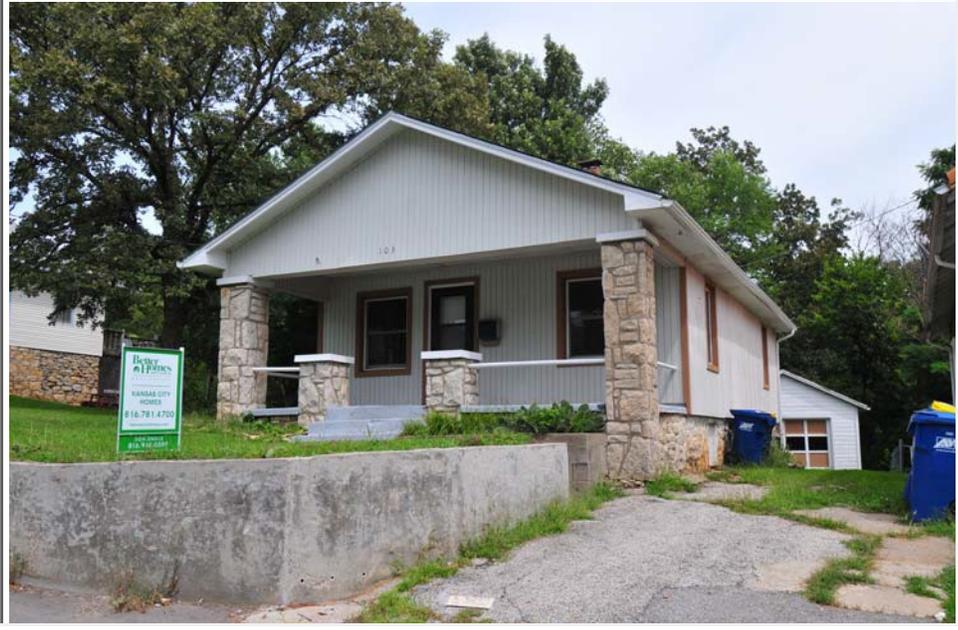
PHOTOGRAPHER Brad Finch, F-Stop Photography	DATE 8/21/2014	DESCRIPTION: West and south elevations, view northeast.
---------------------------------------------	----------------	---------------------------------------------------------

41. (CONT.) DESCRIPTION OF PRIMARY RESOURCE. EXPAND BOX AS NECESSARY, OR ADD CONTINUATION PAGE  
 The one-story house has a stone foundation, fiberboard siding and an asphalt shingle gable roof. A brick chimney rises from the center of the ridge. A recessed porch with limestone columns and a simple pipe rail spans the primary (west) elevation. This elevation has three bays. Single one-over-one-wood windows fill Bays 1 and 3; a single door fills the offset Bay 2. This house is identical in form to 101 North Francis Street.

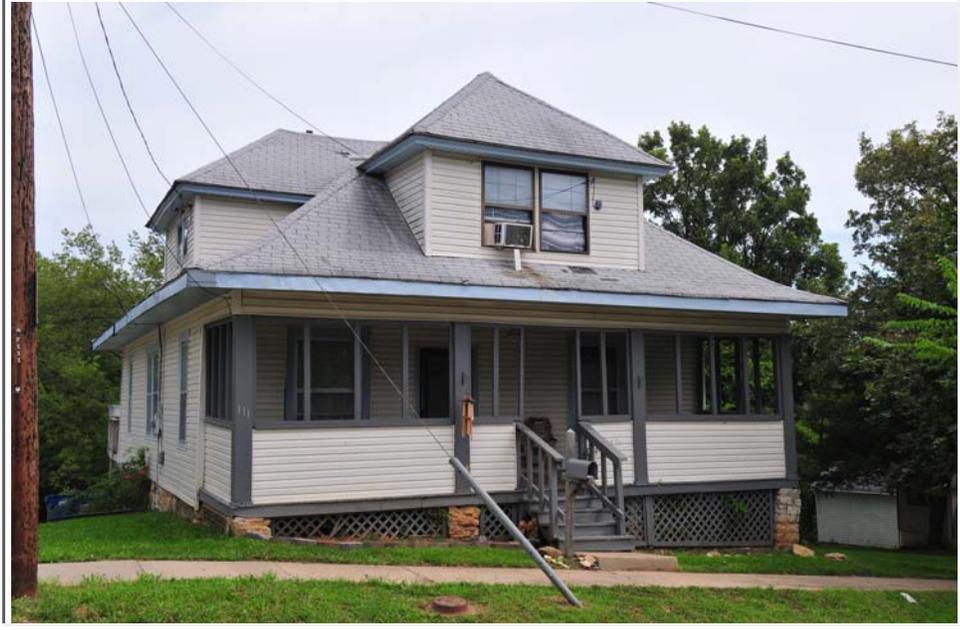
PHOTOGRAPHER Brad Finch, F-Stop Photography	DATE 8/21/2014	DESCRIPTION: West and north elevations, view southeast.
---------------------------------------------	----------------	---------------------------------------------------------

41. (CONT.) DESCRIPTION OF PRIMARY RESOURCE. EXPAND BOX AS NECESSARY, OR ADD CONTINUATION PAGE  
 The one-and-one-half-story Pyramidal Hip Form house has a stone foundation, vinyl siding and an asphalt shingle bellcast hip roof. Hip domers rise from the north, south and west slopes of the roof. A recessed porch with square wood columns and vinyl-clad kneewalls spans the primary (west) elevation. This elevation has three bays. Single historic one-over-one double-hung wood windows fill Bays 1 and 3; a single door fills the offset Bay 2. Paired replacement windows pierce the dormer.

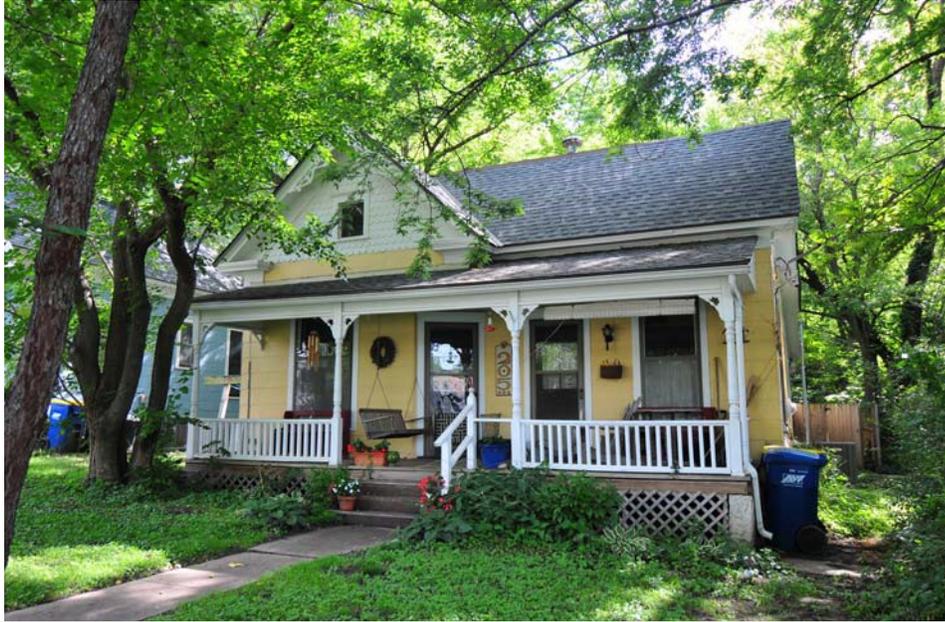
PHOTOGRAPHER	Brad Finch, F-Stop Photography	DATE	8/21/2014	DESCRIPTION: West elevation, view east.
--------------	--------------------------------	------	-----------	-----------------------------------------

41. (CONT.) DESCRIPTION OF PRIMARY RESOURCE. EXPAND BOX AS NECESSARY, OR ADD CONTINUATION PAGE  
 The one-story Folk Victorian house has a stone foundation, asbestos siding and an asphalt shingle cross-gable roof. Historic one-story wings project from the rear (east) elevation. Fishscale shingles and decorative trim ornament the gable end on the west elevation. A full-width porch with turned wood columns and picket rail spans the primary (west) elevation. This elevation has four bays. Single historic one-over-one wood windows fill Bays 1 and 2; single doors fill the angled Bay 2 and Bay 3. A single historic fixed wood window pierces the gable end.

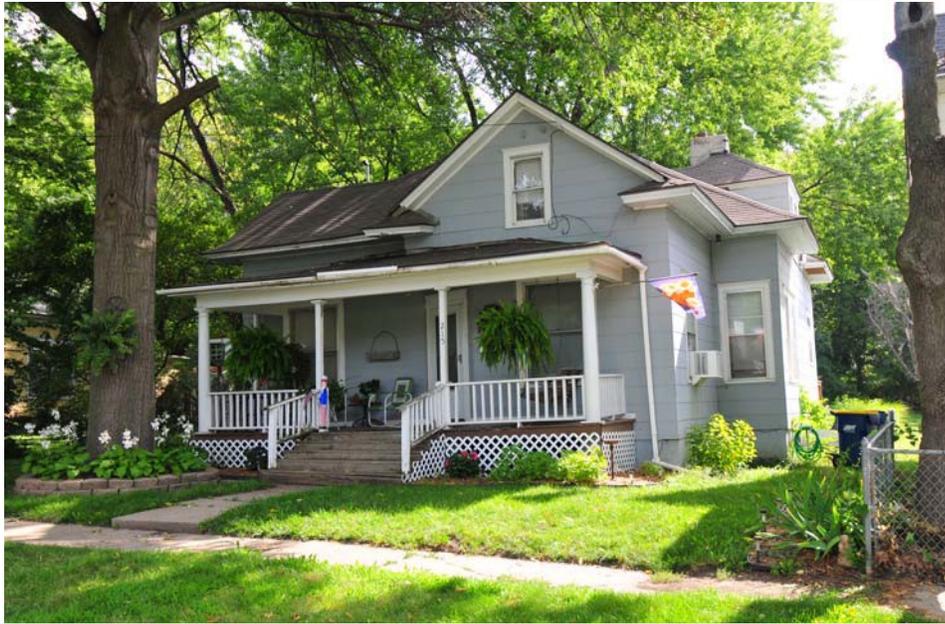
PHOTOGRAPHER Brad Finch, F-Stop Photography	DATE 8/21/2014	DESCRIPTION: West and south elevations, view northeast.
---------------------------------------------	----------------	---------------------------------------------------------

41. (CONT.) DESCRIPTION OF PRIMARY RESOURCE. EXPAND BOX AS NECESSARY, OR ADD CONTINUATION PAGE  
 The one-and-one-half story house has a concrete foundation, asbestos siding and an asphalt shingle hip roof with lower cross gables. Gabled wings with eave returns project from the north and west elevations. Multiple wings project from the east elevation. A full-width porch with round columns and a wood picket rail spans the primary (west) elevation. This elevation has four bays. Single windows fill Bays 1, 3 and 4. A single door fills the angled Bay 2. A single window pierces the gable end. Historic one-over-one double-hung wood windows fill each window opening.

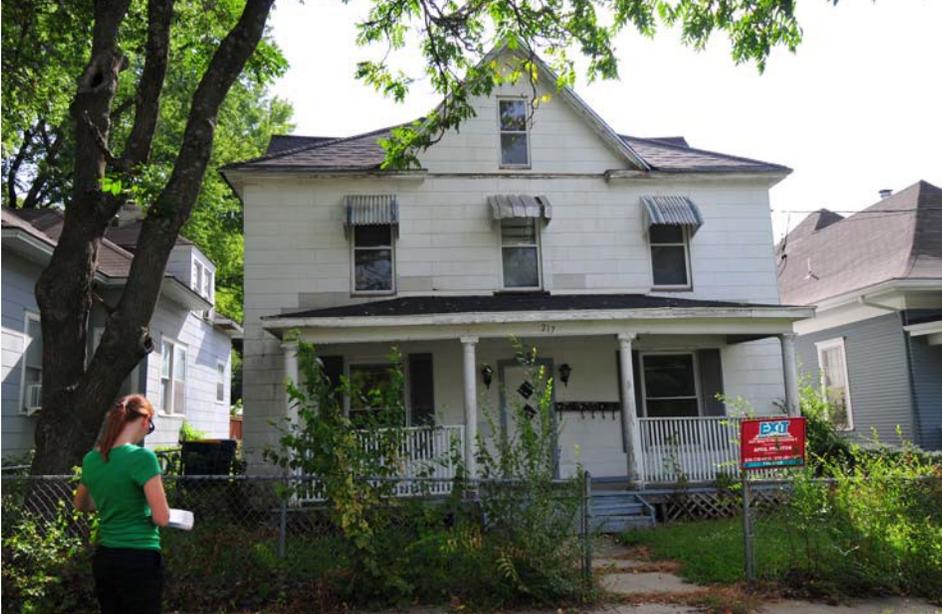
PHOTOGRAPHER Brad Finch, F-Stop Photography	DATE 8/21/2014	DESCRIPTION: West elevation, view east.

<p>41. (CONT.) DESCRIPTION OF PRIMARY RESOURCE. EXPAND BOX AS NECESSARY, OR ADD CONTINUATION PAGE</p> <p>The two-and-one-half-story Pyramidal Hip Form house has a concrete foundation, asbestos siding and an asphalt shingle hip roof with lower cross gables. A hip addition and an attached two-car garage project from the east elevation. A porch with round columns and a wood picket rail projects from the primary (west) elevation. This elevation has three bays. An entrance with a wood door fills Bay 2 on the first story. Single historic one-over-one double-hung wood windows fill each remaining bay on both stories and the gable end. pierce each elevation. Alterations since the 1994 survey include the addition of the wood picket rail.</p>
<p>40. (CONT.) DESCRIPTION OF ENVIRONMENT AND OUTBUILDINGS. EXPAND BOX AS NECESSARY, OR ADD CONTINUATION PAGE</p> <p>The house is set back from the street at the center of the lot. Mature trees and shrubs dot the property. A chain link fence defines the north, west and south boundaries. A concrete sidewalk and wood stairs access the porch.</p>

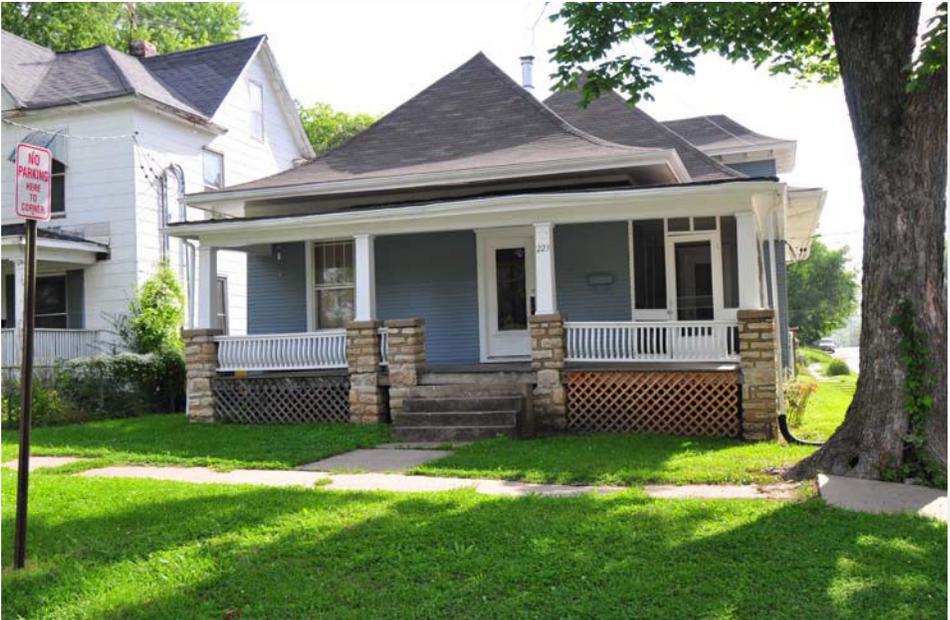
PHOTOGRAPHER	Brad Finch, F-Stop Photography	DATE	8/21/2014	DESCRIPTION:	West elevation, view east.

<p>41. (CONT.) DESCRIPTION OF PRIMARY RESOURCE. EXPAND BOX AS NECESSARY, OR ADD CONTINUATION PAGE</p> <p>The one-story Queen Anne house has a stone foundation, historic wood siding and an asphalt shingle bellcast hip roof. A side-wrap porch with limestone piers, square wood columns and a wood picket rail spans the primary (west) and south elevations. The south portion of the porch is screened. This elevation has three bays. A historic three-over-one double-hung wood window fills Bay 1; a historic wood door fills Bay 2; a wood screen door accesses the screened porch in Bay 3.</p>
<p>40. (CONT.) DESCRIPTION OF ENVIRONMENT AND OUTBUILDINGS. EXPAND BOX AS NECESSARY, OR ADD CONTINUATION PAGE</p> <p>The house is set back from the street at the center of the lot. A wood fence encloses a portion of the property behind the house. A concrete sidewalk and stairs access the porch. A carport with wood posts and a flat metal roof is located at the rear of the property. The structure is non-historic and would be non-contributing.</p>

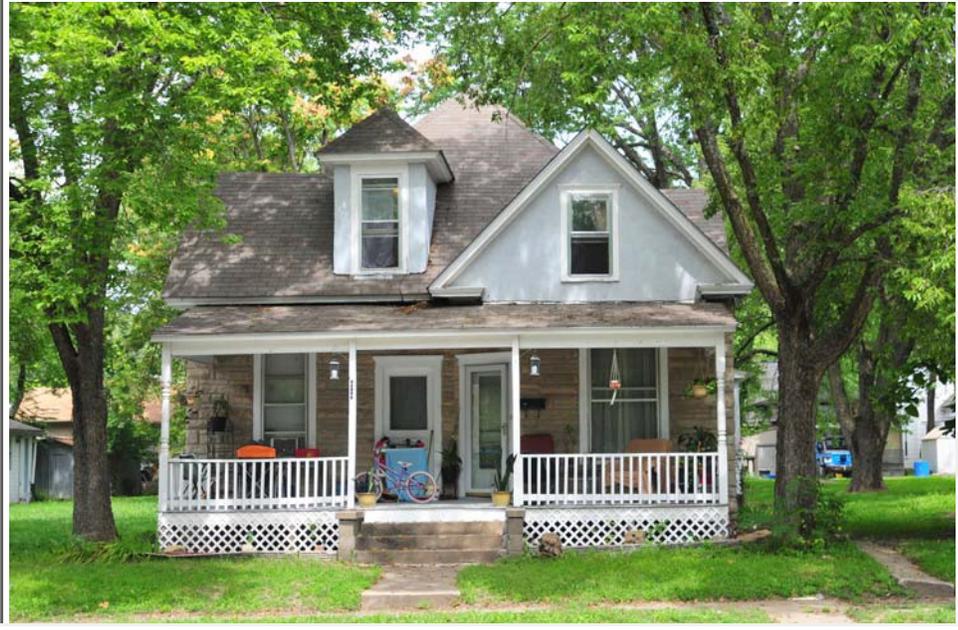
PHOTOGRAPHER Brad Finch, F-Stop Photography	DATE 8/21/2014	DESCRIPTION: South elevation, view north.
---------------------------------------------	----------------	-------------------------------------------

The one-and-one-half-story Queen Anne house has a stone foundation and an asphalt shingle pyramidal hip roof with lower cross-gables. Cast stone clad the primary (south) elevation; stucco clad the secondary elevations. Hipped dormers rise from the south and east slopes of the roof. A gabled wing projects from the north elevation. A brick chimney rises from the west slope of the roof. A porch with square wood columns and turned wood columns and a wood picket rail spans the primary (south) elevation. This elevation has four bays. Single windows fill Bays 1 and 4; single historic wood doors fill Bay 2 and the angled Bay 3. Single windows pierce the dormer and the gable end. Historic one-over-one double-hung wood windows fill each window opening on this elevation. Alterations since the 1994 survey include the removal of a chimney on the south slope of the roof and the addition of square wood columns and wood railing on the porch.

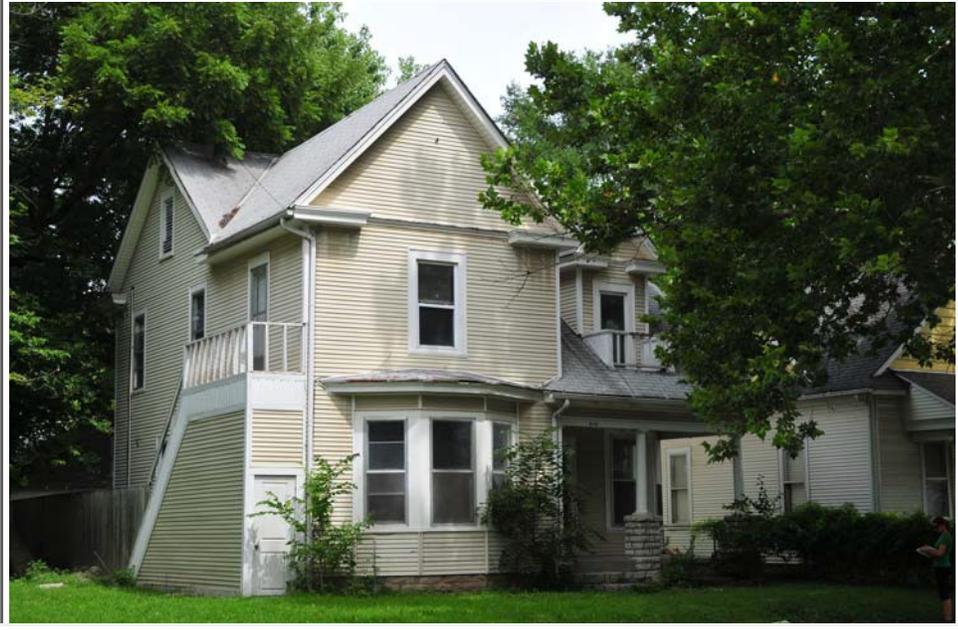
PHOTOGRAPHER	Brad Finch, F-Stop Photography	DATE	8/21/2014	DESCRIPTION:	South and west elevations, view northeast.
--------------	--------------------------------	------	-----------	--------------	--------------------------------------------

The two-story Cross-Gable house has a stone foundation, vinyl siding and an asphalt shingle roof. A gabled dormer with an inset balcony rises from the south slope of the roof above the Wing. A recessed porch with limestone piers and round wood columns fills the east side of the primary (south) elevation, in front of the wing. This elevation has three bays. An angled bay window with a single historic one-over-one double-hung wood window on each side fills Bay 1 on the first story, and a single one-over-one double-hung vinyl window pierces the second story; a single door fills Bay 2; a single historic one-over-one double-hung wood window fills Bay 3. A single replacement one-over-one double-hung vinyl window pierces the dormer. A second door accesses the east side of the front-gable wing beneath the porch. This house has been subdivided into apartments. Alterations since the 1994 survey include the application of vinyl siding and replacement windows.

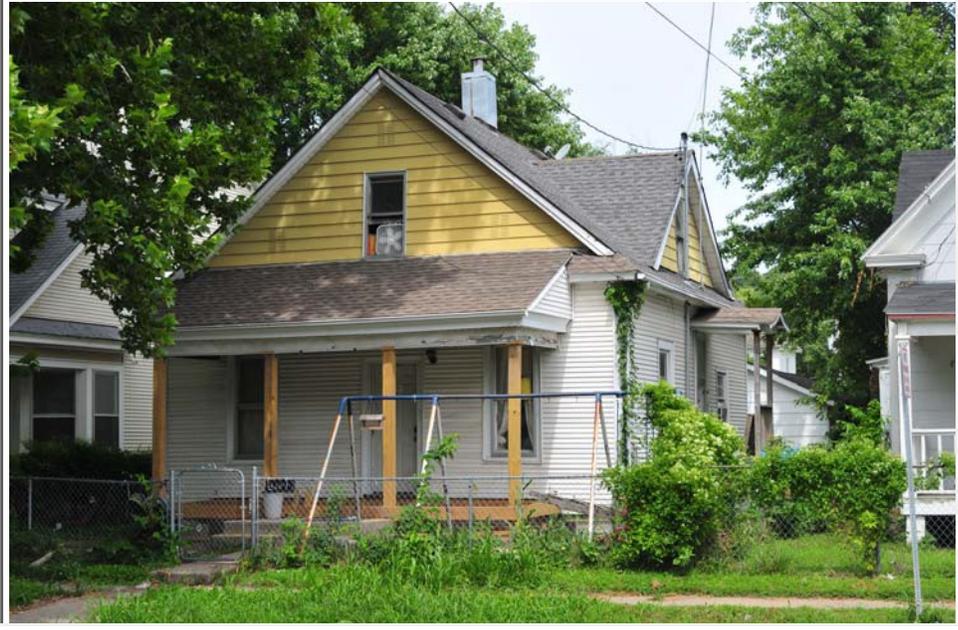
PHOTOGRAPHER Brad Finch, F-Stop Photography	DATE 8/21/2014	DESCRIPTION: South and east elevations, view northwest.
---------------------------------------------	----------------	---------------------------------------------------------

41. (CONT.) DESCRIPTION OF PRIMARY RESOURCE. EXPAND BOX AS NECESSARY, OR ADD CONTINUATION PAGE  
 The one-and-one-half-story Gable-Front house has a concrete foundation, vinyl siding and an asphalt shingle roof with lower cross gables. A chimney covered with metal flashing rises from the center of the ridge. A shed roof porch projects from the center of the primary (south) elevation. This elevation has three bays. Single windows fill Bays 1 and 3; a single door fills Bay 2. A single window pierces the gable end. Alterations since the 1994 survey include the application of vinyl siding on the first story and the removal of an enclosed porch.

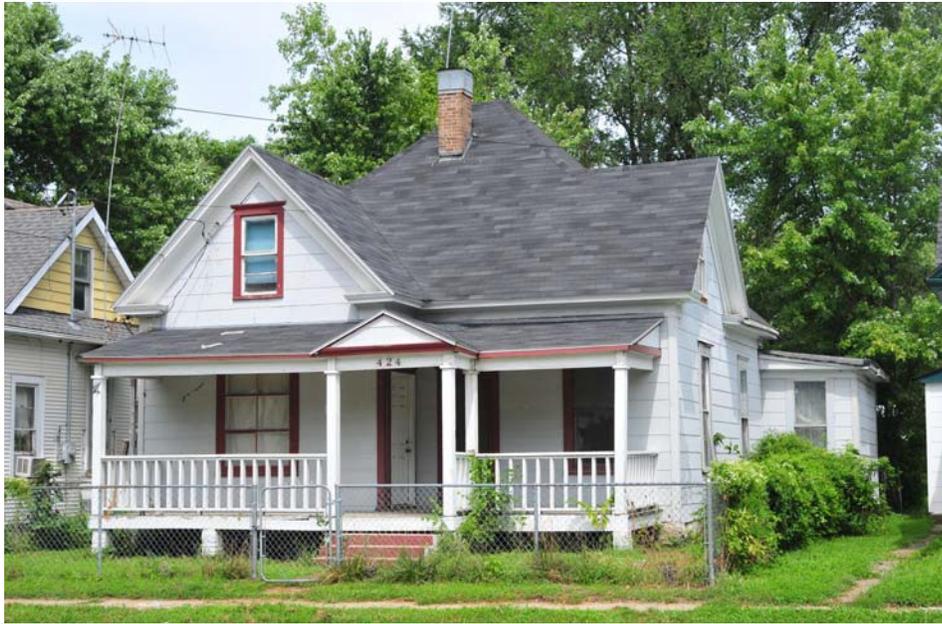
PHOTOGRAPHER	Brad Finch, F-Stop Photography	DATE	8/21/2014	DESCRIPTION:	South and east elevations, view northwest.
--------------	--------------------------------	------	-----------	--------------	--------------------------------------------

The one-and-one-half-story house has a stone foundation, asbestos siding and an asphalt shingle pyramidal hip roof. Lower cross-gables rise on the east, south and west elevations. A gabled addition projects from the north elevation. A brick chimney rises from the south slope of the roof. A porch with a center gable, square wood columns and a wood picket rail spans the primary (south) elevation. This elevation has three bays. Single historic one-over-one double-hung wood windows fill Bays 1 and 3; a single door fills the recessed Bay 2. A single historic one-over-one double-hung wood window pierces the gable end. A second door accesses the east side of the gable wing, beneath the porch. This house is similar in form to 426 Isley Boulevard.

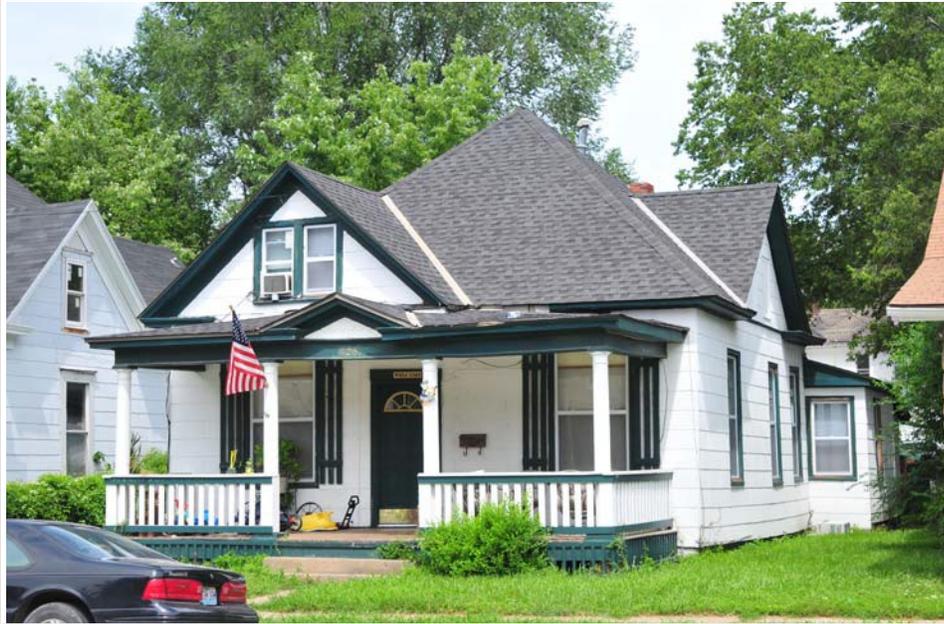
PHOTOGRAPHER	Brad Finch, F-Stop Photography	DATE	8/21/2014	DESCRIPTION:	South and east elevations, view northwest.
--------------	--------------------------------	------	-----------	--------------	--------------------------------------------

The one-and-a-half-story house has a CMU foundation, asbestos siding and an asphalt shingle pyramidal hip roof. Lower cross-gables rise on the east, south and west elevations. A gabled addition projects from the north elevation. A brick chimney rises from the north slope of the roof. A porch with a center gable, round wood columns and a wood picket rail spans the primary (south) elevation. This elevation has three bays. Single non-historic one-over-one double-hung vinyl windows fill Bays 1 and 3; a single door fills the offset Bay 2. Paired non-historic one-over-one double-hung vinyl windows pierce the gable end. This house is similar in form to 424 Isley Boulevard. Alterations since the 1994 survey include the removal of a secondary entrance on the south elevation, the replacement windows, and the addition of the wood picket rail.

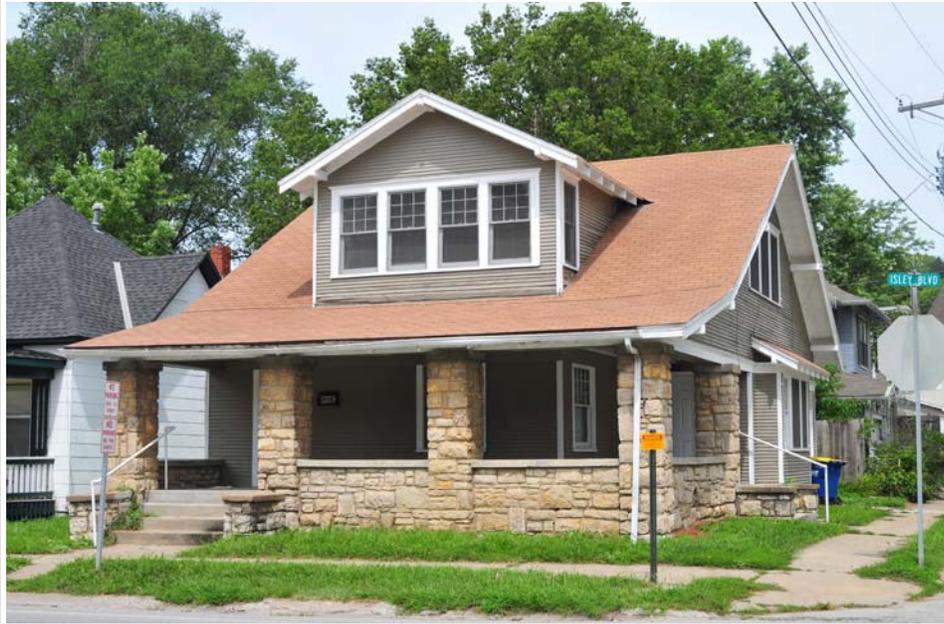
PHOTOGRAPHER Brad Finch, F-Stop Photography	DATE 8/21/2014	DESCRIPTION: South and east elevations, view northwest.
---------------------------------------------	----------------	---------------------------------------------------------

The one-and-a-half-story Craftsman house has a stone foundation, historic wood siding and an asphalt shingle side-gable roof with exposed rafter tails. A large gabled dormer rises from the south slope of the roof. A porch with limestone columns and kneewalls spans the primary (south) elevation. This elevation has three bays. Single doors fill Bay 1 and recessed bay 3; a single historic twelve-over-one double-hung wood window fills Bay 2. A band of four historic nine-over-one double-hung wood windows pierce the dormer. Alterations since the 1994 survey include a replacement door in Bay 3.

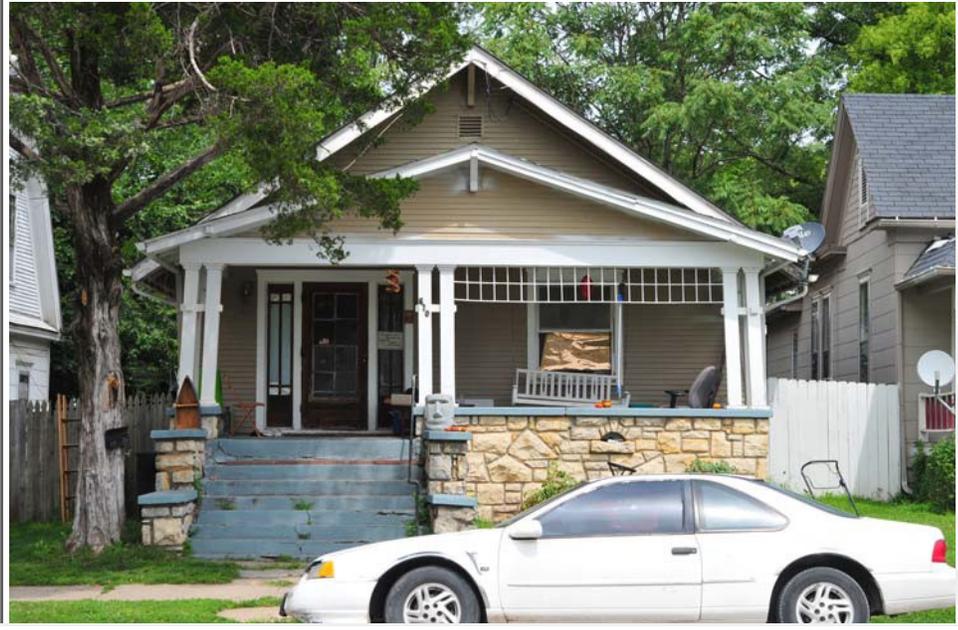
PHOTOGRAPHER Brad Finch, F-Stop Photography	DATE 8/21/2014	DESCRIPTION: South elevation, view north.
---------------------------------------------	----------------	-------------------------------------------

41. (CONT.) DESCRIPTION OF PRIMARY RESOURCE. EXPAND BOX AS NECESSARY, OR ADD CONTINUATION PAGE  
 The one-story Craftsman house has a stone foundation, historic wood siding and an asphalt shingle gable-front roof. Simple wood brackets ornament the wide overhanging eaves. A porch with limestone kneewalls and grouped square wood columns spans the primary (south) elevation. A band of non-historic wood grille spans the top of the porch opening. This elevation has two bays. Bay 1 has a single historic wood door with sidelights; Bay 2 has a single historic one-over-one double-hung wood window. Alterations since the 1994 survey include the removal of a portion of the non-historic wood grille.
