Survey number: CL-AS-015-001		2. SURVEY NAME: Boardinghouse Historic Resource Inventory	
3. COUNTY: CLAY		4. ADDRESS (STREET NO. 403 )	STREET (NAME) Benton Avenue
5. CITY: Excelsior Springs	Vicinity <input type="checkbox"/>	6. UTM	OR LAT: 39.341072 7. TOWNSHIP/RANGE/SECTION LONG: -94.21933 T: 52 R: 30 S: 1
8. HISTORIC NAME (IF KNOWN): Crystal Lithium (Lithia) Springs/ Crystal Minera		9. PRESENT/OTHER NAME (IF KNOWN): Crystal Lithia Pavilion	
10. OWNERSHIP <input type="checkbox"/> PRIVATE <input checked="" type="checkbox"/> PUBLIC		11A. HISTORIC USE (IF KNOWN): HEALTH CARE: Resort Facility	
		11B. CURRENT USE: RECREATION & CULTURE/outdoor recrea

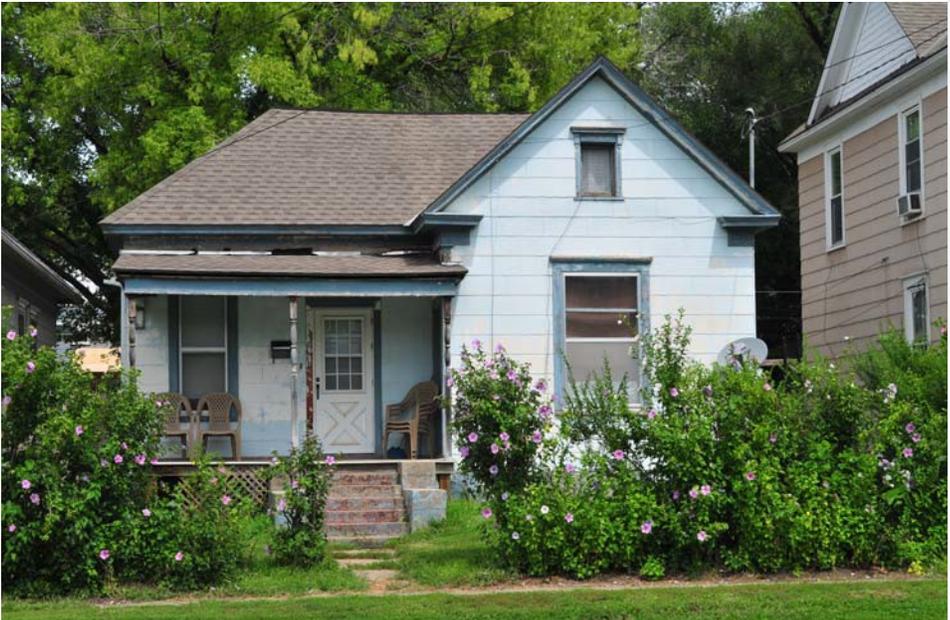
PHOTOGRAPHER	Brad Finch, F-Stop Photography	DATE	8/21/2014	DESCRIPTION:	South elevation, view north.

<p>41. (CONT.) DESCRIPTION OF PRIMARY RESOURCE. EXPAND BOX AS NECESSARY, OR ADD CONTINUATION PAGE</p> <p>The one-story Pyramidal Form house has a parged stone foundation, asbestos siding and an asphalt shingle truncated pyramidal roof. Gabled wings project from the north and south elevations. A porch with turned wood columns projects from the west side of the primary (south) elevation. This elevation has three bays. Single historic one-over-one double-hung wood windows fill Bays 1 and 3; a single door fills Bay 2. A small historic fixed wood window pierces the gable end. Alterations since the 1994 survey include the removal of a brick chimney from the center of the roof.</p>
<p>40. (CONT.) DESCRIPTION OF ENVIRONMENT AND OUTBUILDINGS. EXPAND BOX AS NECESSARY, OR ADD CONTINUATION PAGE</p> <p>The house is set back from the street on the south side of the lot. Mature shrubs and trees dot the property. A concrete sidewalk and stairs access the porch. A one-story garage with historic wood siding and an asphalt shingle gable-front roof is located at the rear of the property. The historic garage retains integrity and would be contributing to a potential historic district.</p>

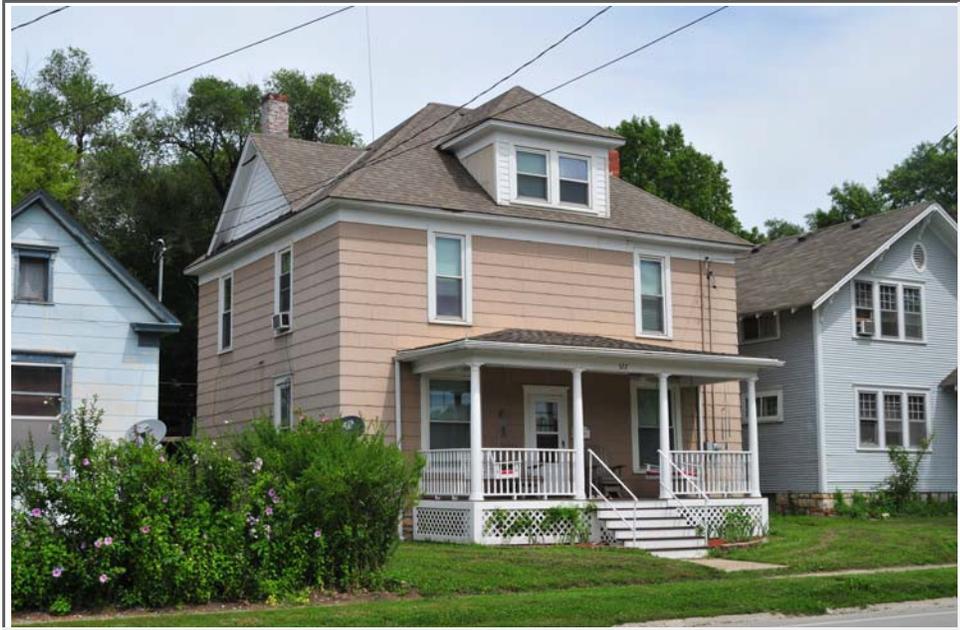
PHOTOGRAPHER Brad Finch, F-Stop Photography	DATE 8/21/2014	DESCRIPTION: South and west elevations, view northeast.

<p>41. (CONT.) DESCRIPTION OF PRIMARY RESOURCE. EXPAND BOX AS NECESSARY, OR ADD CONTINUATION PAGE</p> <p>The two-and-one-half-story American Foursquare house has a stone foundation, asbestos siding and an asphalt shingle hip roof with lower cross gables. Hipped dormers rise on the north and south slopes of the roof. Brick chimneys rise on the east and west slopes of the roof. A porch with round wood columns and a wood picket rail projects from the primary (south) elevation. This elevation has three bays. Single replacement one-over-one double-hung vinyl windows pierce each story in Bays 1 and 3; a single door pierces the first story of Bay 2; the second story is void of fenestration. Paired replacement one-over-one double-hung vinyl windows pierce the dormer. Changes since the 1994 survey include the addition of the wood picket rail on the porch.</p>
<p>40. (CONT.) DESCRIPTION OF ENVIRONMENT AND OUTBUILDINGS. EXPAND BOX AS NECESSARY, OR ADD CONTINUATION PAGE</p> <p>The house is set back from the street on the south side of the lot. Mature trees dot the rear of the property. A concrete sidewalk and wood stairs access the porch. Two outbuildings are located at the rear of the property. A one-story prefabricated shed has composite siding and an asphalt shingle gambrel roof. A carport has metal posts and a metal gable-front roof. Both are non-historic and would be non-contributing to a potential historic district.</p>

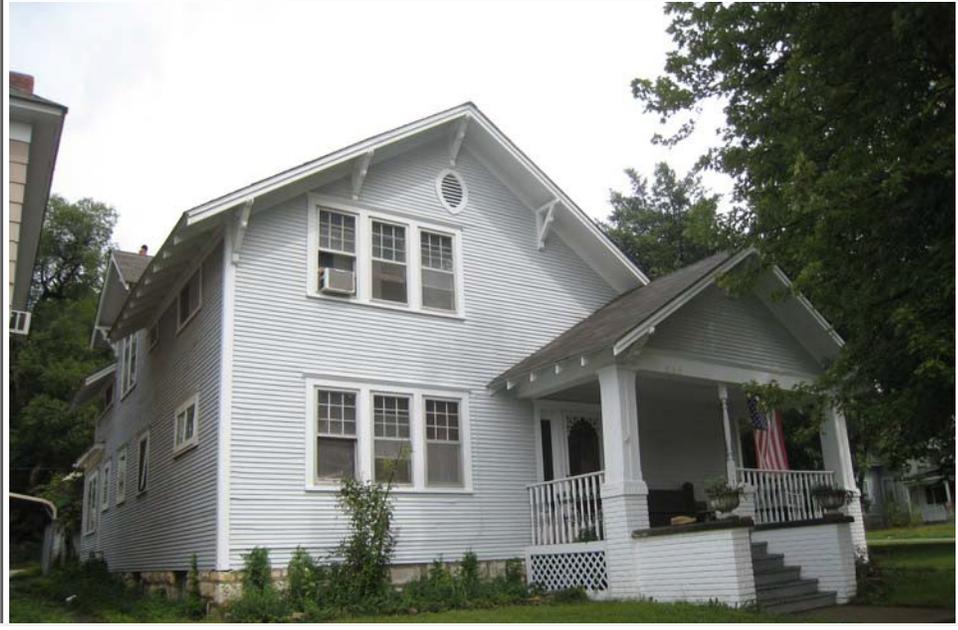
PHOTOGRAPHER	Brad Finch, F-Stop Photography	DATE	8/21/2014	DESCRIPTION:	South and west elevations, view northeast.
--------------	--------------------------------	------	-----------	--------------	--------------------------------------------

41. (CONT.) DESCRIPTION OF PRIMARY RESOURCE. EXPAND BOX AS NECESSARY, OR ADD CONTINUATION PAGE  
 The two-story house has a stone foundation, historic wood siding and an asphalt shingle, gable-front roof. Craftsman elements include exposed rafter tails and the porch supports. Cross gables rise on the east and west slopes of the roof. An exterior brick chimney rises on the east elevation. A gabled porch with brick piers, square wood columns and turned spindles projects from the east side of the primary (south) elevation. This elevation has two bays. A band of three historic nine-over-one double-hung wood windows fills each story in Bay 1; a single door with sidelights fills the first story in Bay 2.

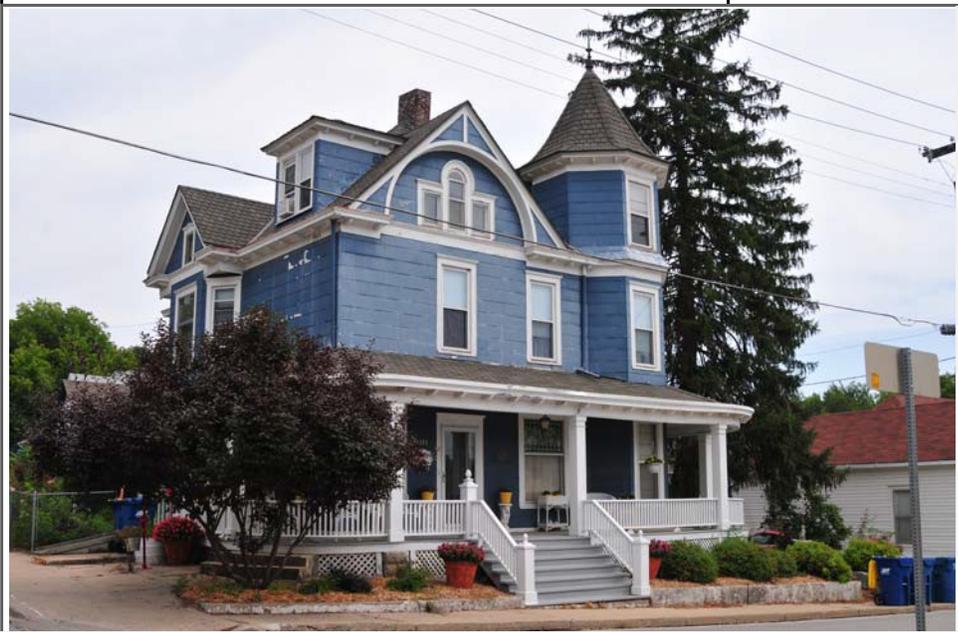
PHOTOGRAPHER Brad Finch, F-Stop Photography	DATE 8/21/2014	DESCRIPTION: West and north elevations, view southeast.

41. (CONT.) DESCRIPTION OF PRIMARY RESOURCE. EXPAND BOX AS NECESSARY, OR ADD CONTINUATION PAGE  
 The two-and-one-half-story Queen Anne house has a stone foundation, asbestos siding and an asphalt shingle pyramidal roof. A three-story polygonal tower rises in the southwest corner. Gabled angled bay windows project from the north and south elevations. A gabled wing projects from the east elevation. A hip dormer projects from the north slope of the roof. A brick chimney rises from the roof. Simple wood modillions ornament the roofline. A curved boxed eave ornaments the gable end on the west elevation. A wrap-around porch with new square wood columns and a wood picket rail projects from the north, west and south elevations. The primary (west) elevation has four bays. On the first story, a single window fills Bay 1; a single door fills Bay 2; a single window with a stained glass upper sash fills Bay 3; single windows pierce each side of the tower on each story in Bay 4. On the second story, single windows pierce Bays 2 and 3. A Palladian window with historic wood windows fills the gable. Unless otherwise noted, all windows are replacement one-over-one double-hung vinyl windows. Changes since the 1994 survey include new porch supports and railing.

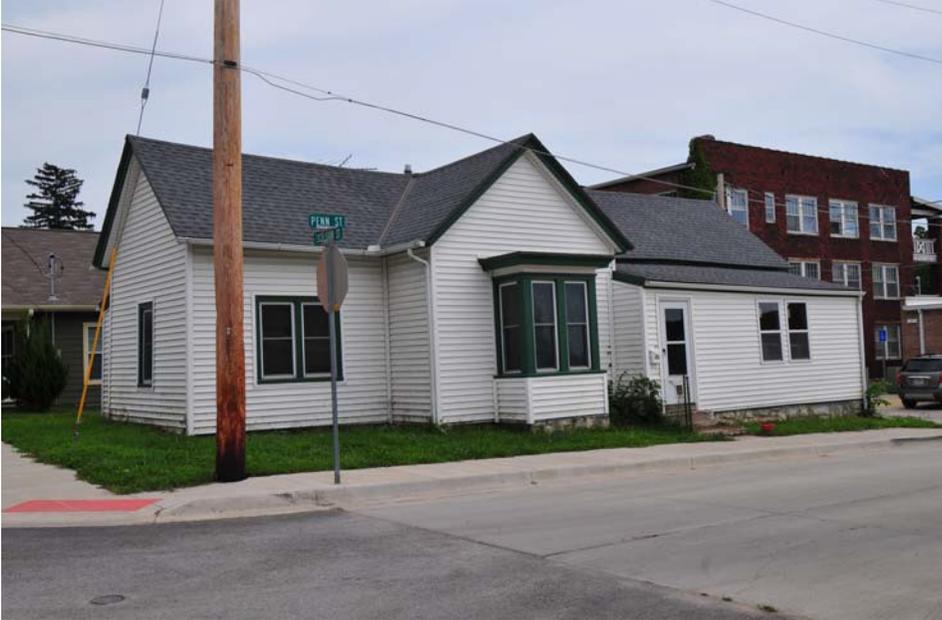
PHOTOGRAPHER Brad Finch, F-Stop Photography	DATE 8/21/2014	DESCRIPTION: West and north elevations, view southeast.

<p>41. (CONT.) DESCRIPTION OF PRIMARY RESOURCE. EXPAND BOX AS NECESSARY, OR ADD CONTINUATION PAGE</p> <p>The one-story Cross-Gable house has a stone foundation, vinyl siding and an asphalt shingle roof. Shed roof wings projects from the east and west elevations. The primary (west) elevation has four bays. Paired windows fill Bay 1; a square bay window fills Bay 2; a single door fills Bay 3; two single windows fill Bay 4. Replacement one-over-one double-hung vinyl windows fill each window opening. Alterations since the 1994 survey include the application of vinyl siding, the enclosure of the porch on the west elevation, and the removal of awnings from the windows.</p>
<p>40. (CONT.) DESCRIPTION OF ENVIRONMENT AND OUTBUILDINGS. EXPAND BOX AS NECESSARY, OR ADD CONTINUATION PAGE</p> <p>The house is set back from the street at the center of the corner lot. A paved driveway runs along the south side of the house. A concrete sidewalk and stairs access the front door.</p>

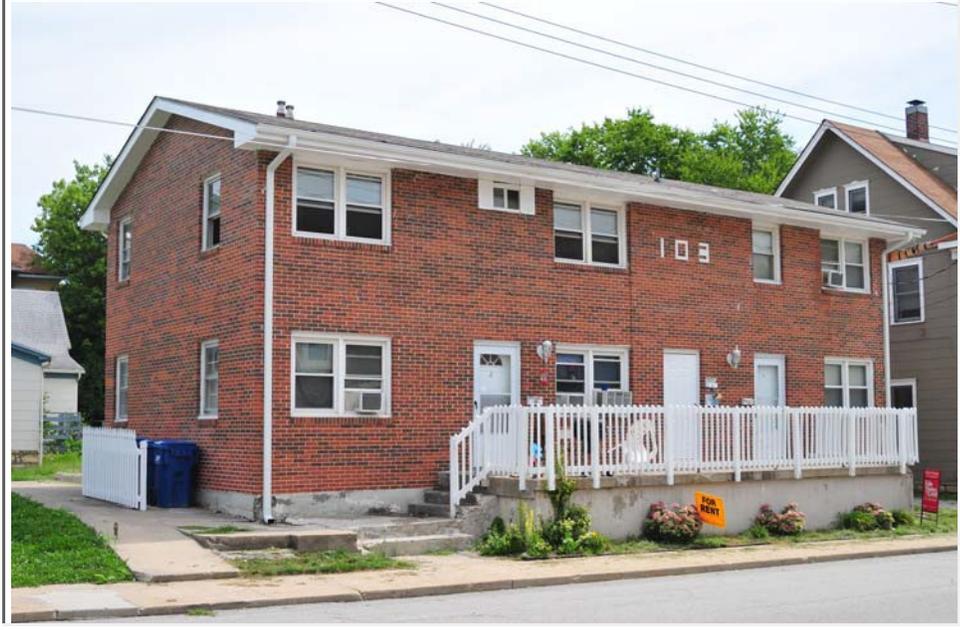
PHOTOGRAPHER Brad Finch, F-Stop Photography	DATE 8/21/2014	DESCRIPTION: West and north elevations, view southeast.
---------------------------------------------	----------------	---------------------------------------------------------

41. (CONT.) DESCRIPTION OF PRIMARY RESOURCE. EXPAND BOX AS NECESSARY, OR ADD CONTINUATION PAGE  
 The two-story apartment building has a concrete foundation, brick cladding and an asphalt shingle side-gable roof. A concrete deck projects from the south side of the primary (west) elevation. This elevation has six bays. Paired replacement one-over-one double-hung vinyl windows fill each story in Bays 1, 3, and 6; single doors fill the first story of Bays 2, 4, and 5. A small sliding window with shutters fills the second story of Bay 2; glazed white brick spelling "103" fills Bay 4; a single replacement one-over-one double-hung vinyl window fills Bay 5. Alterations since the 1994 survey include the installation of the replacement porch railing and vinyl windows.

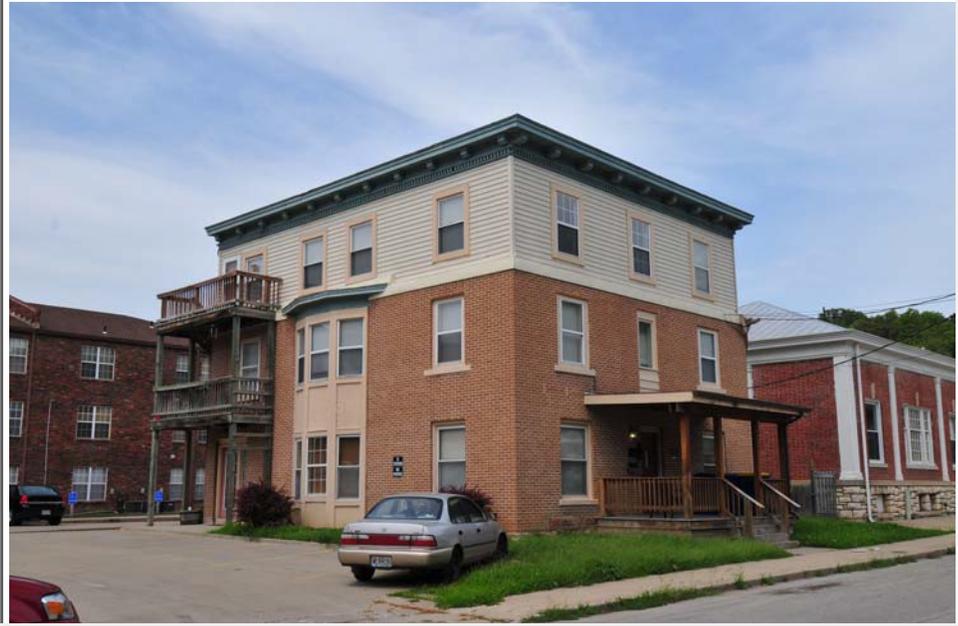
PHOTOGRAPHER Brad Finch, F-Stop Photography	DATE 8/21/2014	DESCRIPTION: East and south elevations, view northwest.

<p>41. (CONT.) DESCRIPTION OF PRIMARY RESOURCE. EXPAND BOX AS NECESSARY, OR ADD CONTINUATION PAGE</p> <p>The three-story apartment building has a stone foundation, brick cladding and a flat roof. Vinyl siding clad the third story. A decorative cornice with brackets and dentil molding ornaments the roofline. An angled bay window and three-story wood deck project from the south elevation. A porch with square wood columns and a wood picket rail projects from the center of the primary (east) elevation. This elevation has three bays. A single door fills Bay 2 on the first story and a small window with wood infill set in a historic door opening. Replacement one-over-one double-hung vinyl windows fill Bays 1 and 3 on the first and second stories. Replacement six-over-six double-hung vinyl windows fill each bay on the third story. This building appears to have been undergoing a remodel during the 1994 survey. Changes include the addition of the porch and three-story deck.</p>

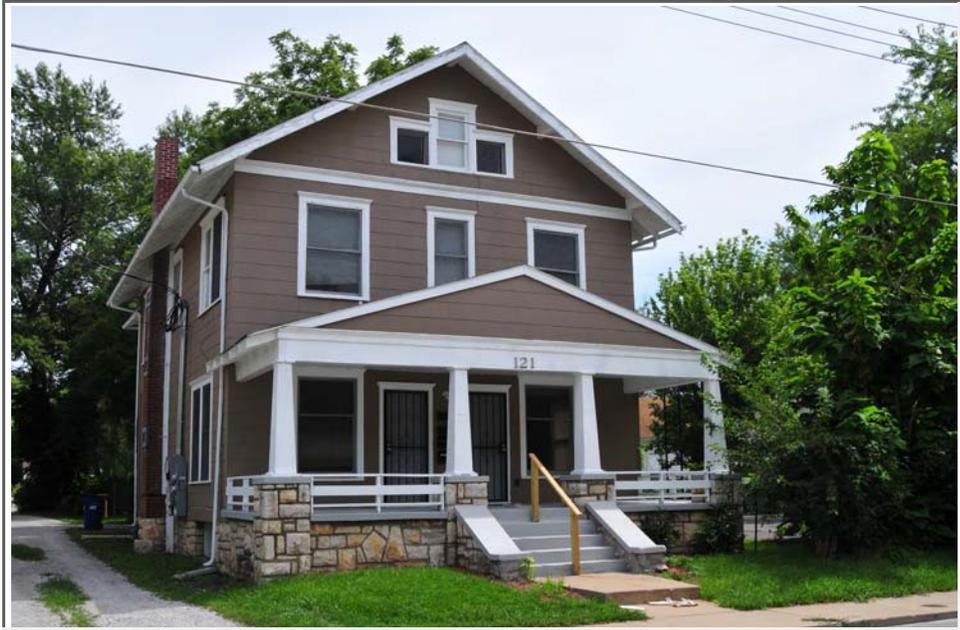
PHOTOGRAPHER Brad Finch, F-Stop Photography	DATE 8/21/2014	DESCRIPTION: West and north elevations, view southeast.

<p>41. (CONT.) DESCRIPTION OF PRIMARY RESOURCE. EXPAND BOX AS NECESSARY, OR ADD CONTINUATION PAGE</p> <p>The two-and-one-half-story Craftsman house has a stone foundation, asbestos siding and an asphalt shingle, gable-front roof with exposed rafter tails. A two-story wing spans the east elevation. An exterior brick chimney rises on the north elevation. A porch with limestone piers, tapered square wood columns and a wood railing spans the primary (west) elevation. This elevation has four bays. Single historic one-over-one wood windows fill each story of Bays 1 and 4; single doors fill Bays 2 and 3 on the first story; a single historic one-over-one wood window is centered above these bays on the second story. A historic stylized wood Palladian window pierces the gable end. This house has been subdivided into apartments.</p>
<p>40. (CONT.) DESCRIPTION OF ENVIRONMENT AND OUTBUILDINGS. EXPAND BOX AS NECESSARY, OR ADD CONTINUATION PAGE</p> <p>The house is set back from the street at the northwest corner of the double lot. Mature trees dot the perimeter of the property. An asphalt parking lot fills the south portion of the lot. A concrete sidewalk and stairs with stone cheekwalls access the porch.</p>

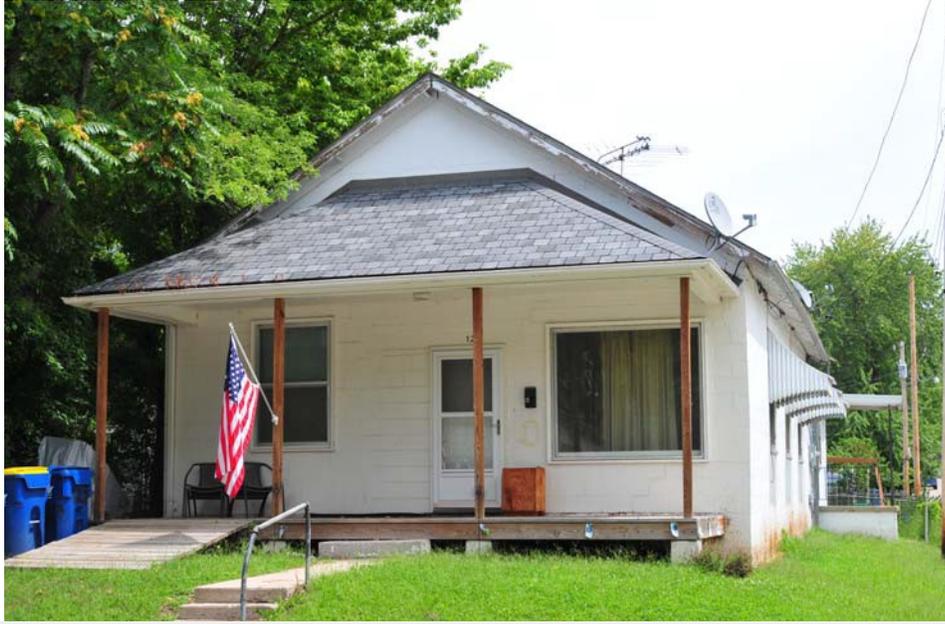
PHOTOGRAPHER Brad Finch, F-Stop Photography	DATE 8/21/2014	DESCRIPTION: West and south elevations, view northeast.
---------------------------------------------	----------------	---------------------------------------------------------

41. (CONT.) DESCRIPTION OF PRIMARY RESOURCE. EXPAND BOX AS NECESSARY, OR ADD CONTINUATION PAGE  
 The one-story Gable-Front house has a CMU foundation and walls and an asphalt shingle roof. A gabled wing projects from the east elevation. A porch with simple square wood posts projects from the primary (west) elevation. This elevation has three bays. A single historic one-over-one double-hung wood window fills Bay 1; a single replacement door fills Bay 2; a large historic wood picture window fills Bay 3. Changes since the 1994 survey include the new wood posts on the porch.

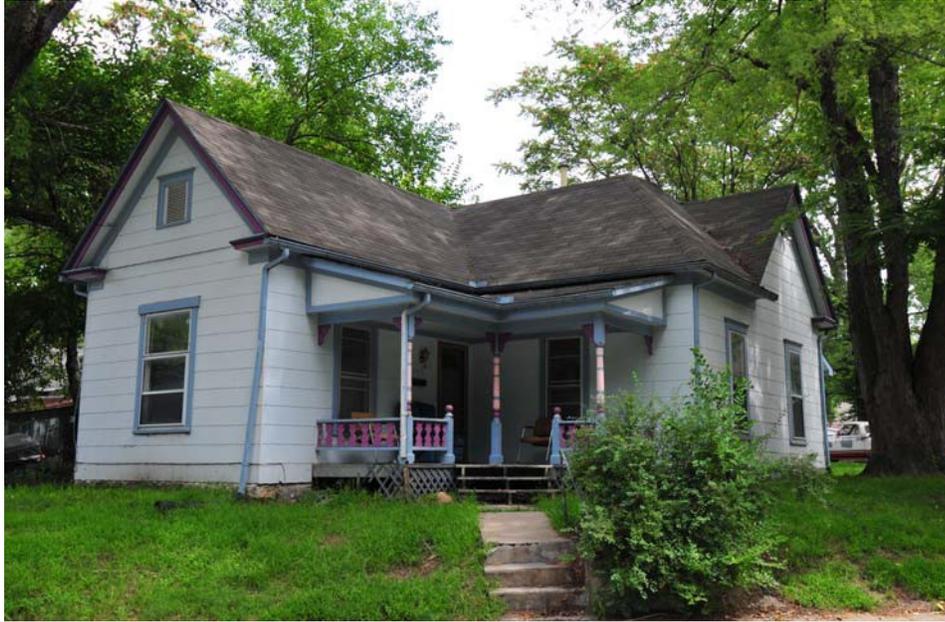
PHOTOGRAPHER	Brad Finch, F-Stop Photography	DATE	8/21/2014	DESCRIPTION:	West and south elevations, view northeast.
--------------	--------------------------------	------	-----------	--------------	--------------------------------------------

41. (CONT.) DESCRIPTION OF PRIMARY RESOURCE. EXPAND BOX AS NECESSARY, OR ADD CONTINUATION PAGE  
 The one-story Folk Victorian house has a stone foundation, asbestos siding and a cross-gable roof. A hipped wing projects from the interior corner of the intersecting gables. A porch with turned wood columns and a cut-out rail fills each side of this interior corner. The primary elevation faces west and has two bays with a single historic one-over-one double-hung wood window in each. The main entrance is located on the south elevation, beneath the porch.

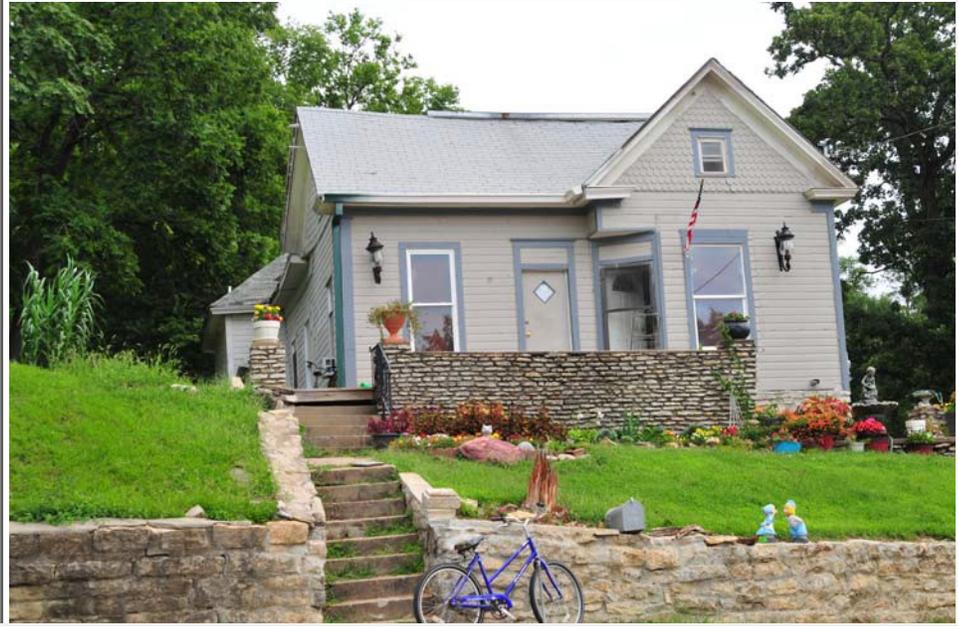
PHOTOGRAPHER Brad Finch, F-Stop Photography	DATE 8/21/2014	DESCRIPTION: West and north elevations, view southeast.
---------------------------------------------	----------------	---------------------------------------------------------

41. (CONT.) DESCRIPTION OF PRIMARY RESOURCE. EXPAND BOX AS NECESSARY, OR ADD CONTINUATION PAGE  
 The one-and-one-half-story Gable-Front-and-Wing house has a stone foundation, wood siding and an asphalt shingle roof. Historic wood fishscale shingles fill the peak of the gable ends. Multiple one- and two-story additions project from the east elevation. An open porch with limestone kneewalls projects from the Wing on the primary (west) elevation. This elevation has four bays. Single replacement one-over-one double-hung vinyl windows fill Bays 1 and 4; single replacement doors with infilled transoms fill Bay 2 and the canted Bay 3. This house has been sub-divided into apartments. The original form is similar to the adjacent house at 436 East Broadway. Changes since the 1994 survey include the removal of the shed roof and wood columns from the porch, and the removal of asbestos siding.

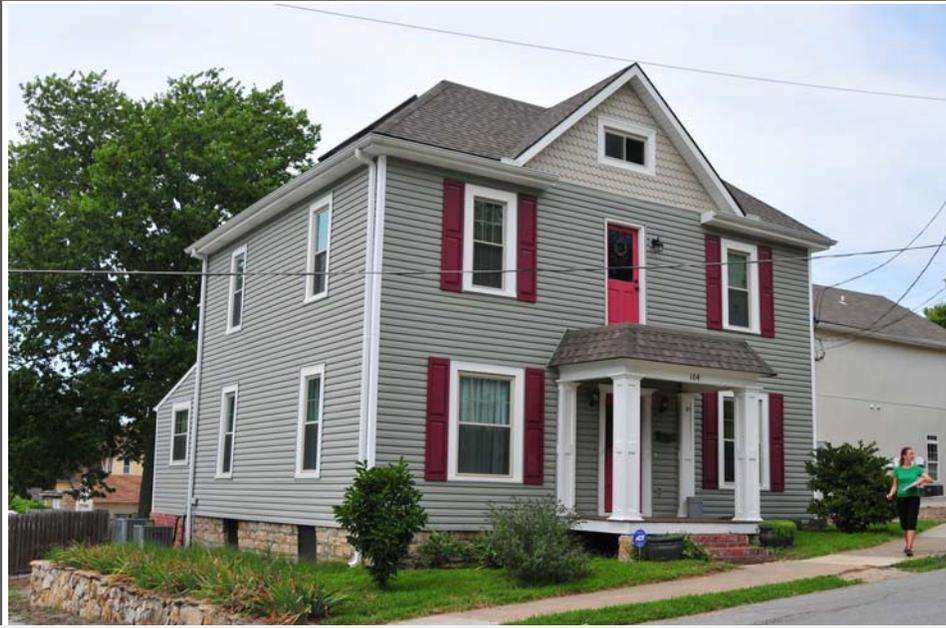
PHOTOGRAPHER	Brad Finch, F-Stop Photography	DATE	8/21/2014	DESCRIPTION:	East and south elevations, view northwest.
--------------	--------------------------------	------	-----------	--------------	--------------------------------------------

The two-and-one-half-story Pyramidal Form house has a stone foundation, vinyl siding and an asphalt shingle truncated pyramidal roof with a center cross gable. Fishscale shingles fill the gable end. Multiple one- and two-story additions project from the west elevation. A non-historic porch with square wood panel columns projects from the primary (east) elevation. This elevation has three bays. The first story of Bays 1 and 3 have a replacement eight-over-eight double-hung vinyl window. The second story has a replacement six-over-six double-hung vinyl window in these bays. Single doors fill each story of Bay 2. A sliding window pierces the gable end. Changes since the 1994 survey include the replacement porch and windows and the application of vinyl siding.

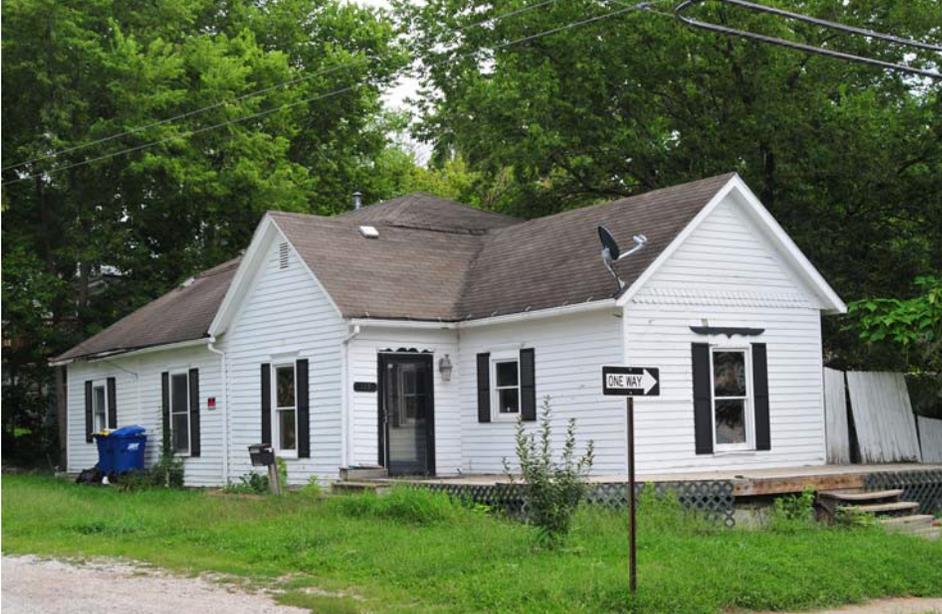
PHOTOGRAPHER Brad Finch, F-Stop Photography	DATE 8/21/2014	DESCRIPTION: West and north elevations, view southeast.

<p>41. (CONT.) DESCRIPTION OF PRIMARY RESOURCE. EXPAND BOX AS NECESSARY, OR ADD CONTINUATION PAGE</p> <p>The one-story Cross-Gable house has a stone foundation, historic wood siding and an asphalt shingle roof. A large hipped wing projects from the east elevation. A wood decksurrounds the projecting gabled wing on the primary (west) elevation. This elevation has three bays. A single door fills Bay 1; single historic one-over-one double-hung wood windows fill Bays 2 and 3. Replacement one-over-one vinyl windows pierce the secondary elevations. The hipped wing appears to have been constructed since the 1994 survey.</p>
<p>40. (CONT.) DESCRIPTION OF ENVIRONMENT AND OUTBUILDINGS. EXPAND BOX AS NECESSARY, OR ADD CONTINUATION PAGE</p> <p>The building is set back from the street at the center of the corner lot. Mature trees dot the property. A wood fence encloses the southeast portion of the lot. A concrete sidewalk and wood stairs access the porch.</p>

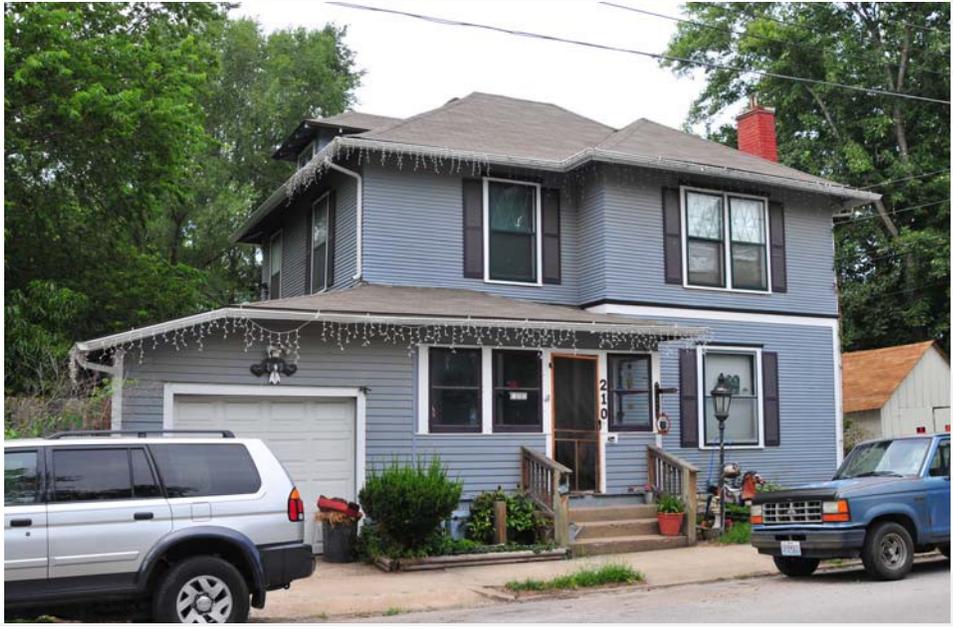
PHOTOGRAPHER Brad Finch, F-Stop Photography      DATE 8/21/2014      DESCRIPTION: East and south elevations, view northwest.

41. (CONT.) DESCRIPTION OF PRIMARY RESOURCE. EXPAND BOX AS NECESSARY, OR ADD CONTINUATION PAGE  
 The two-and-one-half-story house has a stone foundation, historic wood siding and an asphalt shingle pyramidal hip roof. A two-story hipped wing projects from the east elevation. Hipped dormers rise from the north and south slopes of the roof. An exterior brick chimney rises on the north elevation. A one-story hipped wing projects from the south side of the primary (east) elevation. This elevation has three bays. A one-car garage fills Bay 1 in the south half of the addition; an enclosed porch fills Bay 2 in the north half. A single historic one-over-one double-hung wood window fills Bay 3 on the main façade. On the second story, a single historic diamond-pane-over-one double-hung wood window fills Bay 2; paired historic diamond-pane-over-one double-hung wood windows fill Bay 3. Changes since the 1994 survey include the installation of the vehicular opening.

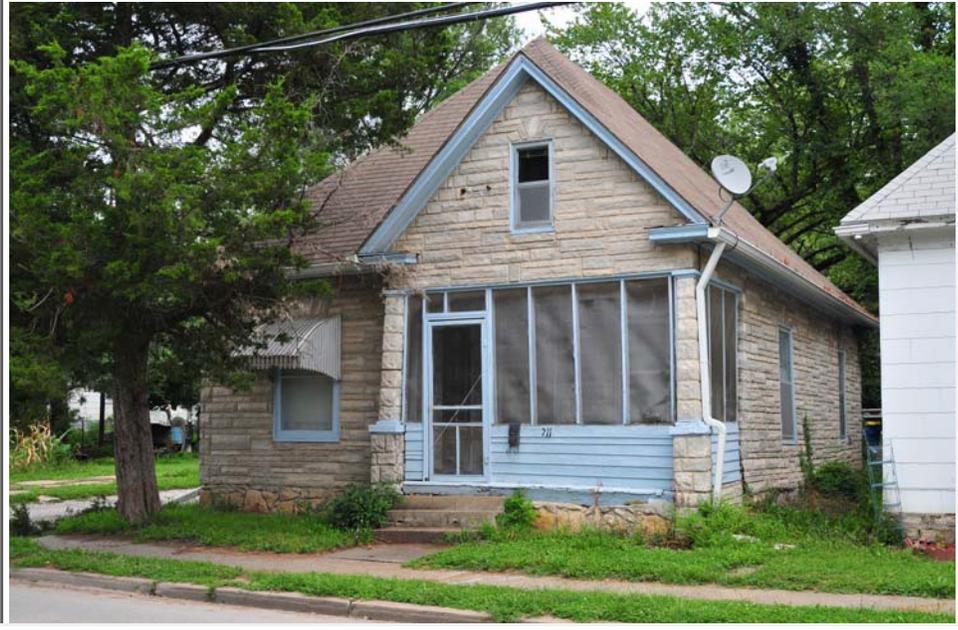
PHOTOGRAPHER Brad Finch, F-Stop Photography	DATE 8/21/2014	DESCRIPTION: West and south elevations, view northeast.
---------------------------------------------	----------------	---------------------------------------------------------

41. (CONT.) DESCRIPTION OF PRIMARY RESOURCE. EXPAND BOX AS NECESSARY, OR ADD CONTINUATION PAGE  
 The one-and-one-half-story Queen Anne house has a stone foundation, cast stone cladding and an asphalt shingle pyramidal hip roof with a lower cross-gable. An inset, screened porch fills the first story of the gabled wing on the primary (west) elevation. It has limestone piers and columns and historic wood kneewalls beneath the screens. This elevation has three bays. Single historic one-over-one double-hung wood windows fill Bays 1 and 3; a single door fills Bay 2. A single historic one-over-one double-hung wood window pierces the gable end.

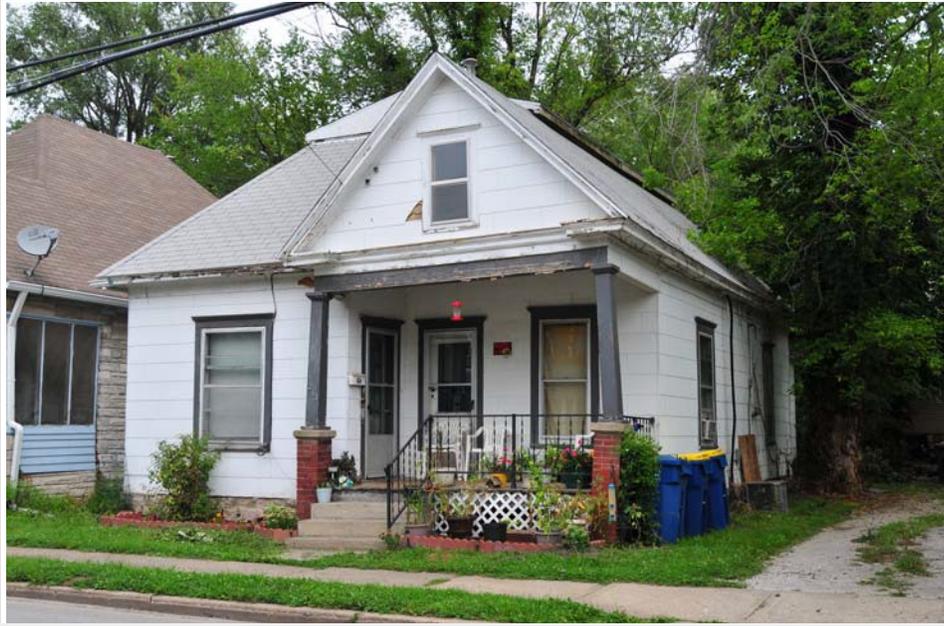
PHOTOGRAPHER	Brad Finch, F-Stop Photography	DATE	8/21/2014	DESCRIPTION: West and south elevations, view northeast.
--------------	--------------------------------	------	-----------	---------------------------------------------------------

The one-and-one-half-story house has a stone foundation, asbestos siding and an asphalt shingle truncated hip roof with a lower cross-gable. A brick chimney rises from the center of the roof. An inset porch fills the first story of the gabled wing on the primary (west) elevation. It has brick piers, square wood columns and a metal rail. This elevation has three bays. Single historic one-over-one double-hung wood windows fill Bays 1 and 3; a single door fills Bay 2. A single historic one-over-one double-hung wood window pierces the gable end.
