# Hazardous Waste Management Commission Report

April - June 2016

Quarterly Report

**MISSOURI**  
DEPARTMENT OF  
NATURAL RESOURCES

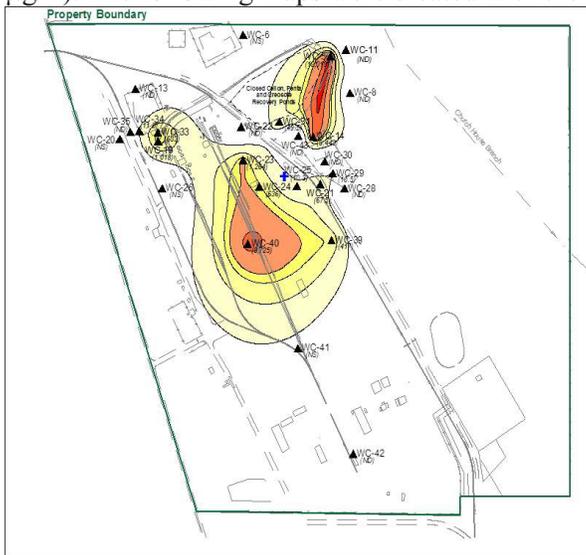
1992 Naphthalene Plume Map

The Ricker Plume Stability Analysis Method has been used to evaluate plume stability at a large wood treating facility. A contaminant-by-contaminant, well-by-well analysis was performed. The main contaminants of concern at the site were chlorophenols and polynuclear aromatic hydrocarbons (PAHs). For this analysis, naphthalene was selected as the compound most representative of the contaminant plume. The average concentration of naphthalene was tabulated from 1992 to 2004. Grid files were created for each well using Surfer software. These grid files were then used to create concentration contour maps.

The plume area was calculated using the volume calculation utility in Surfer. A grid volume report was created, which included the plume volume and the planar area. Values were entered for the aquifer thickness (30 feet), effective porosity (20% or 0.20) and contaminant clean-up level for naphthalene (10 µg/L). The plume center of mass was calculated in order to provide a better understanding of the overall plume shape while evaluating the stability of the plume. The grid files used to calculate the center of mass were filtered to include values greater than the specified contaminant clean-up level for naphthalene (10 µg/L). The following maps were created with the X and Y coordinates of the center of plume.

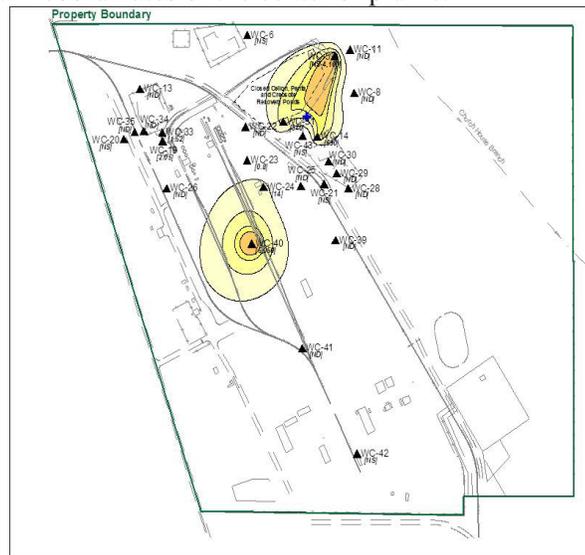
2004 Naphthalene Plume Map

The calculated naphthalene plume characteristics from 1992 to 2004 are shown in the table below.

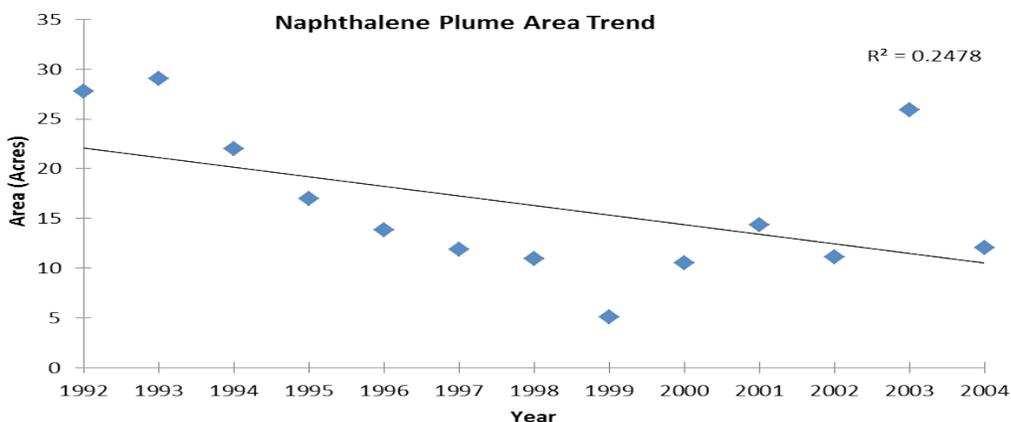
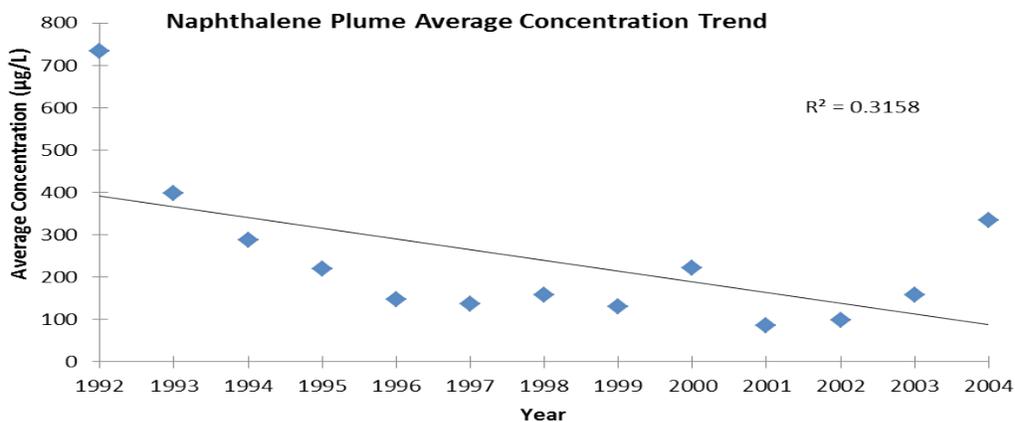
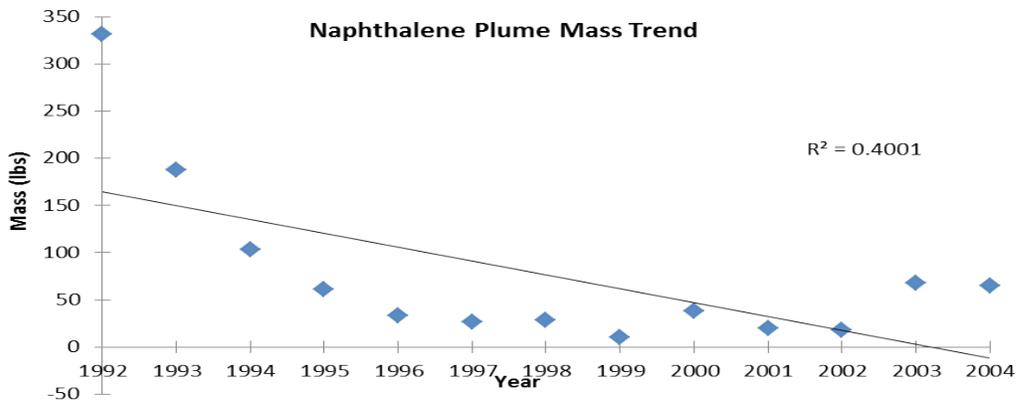
Trend graphs were created for the size of the impacted area versus the year, average naphthalene concentration versus the year, and dissolved mass of naphthalene versus the year. The trend analyses were conducted using the regression analysis utility in Excel. It appears the plume characteristics have a decreasing trend.

Summary of Linear Regression Analysis

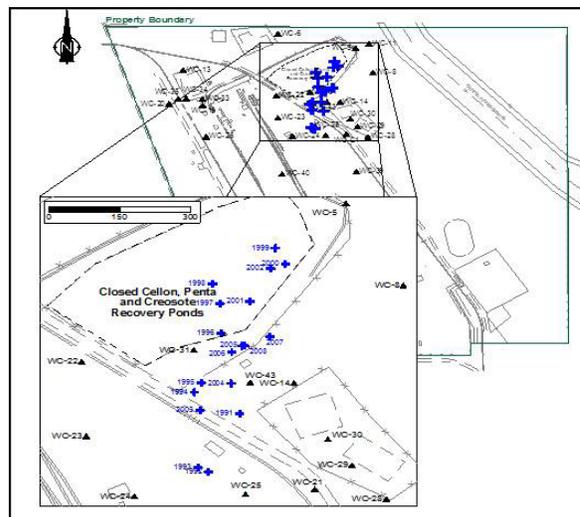
The center of the plume mass was also analyzed as a final means of evaluating the stability of the naphthalene plume. The figure below shows the location of the plume center of mass over several years. The plume center migrated approximately 558 ft upgradient from 1991 to 2000, 422 ft downgradient from 2000 to 2003, and 234 ft upgradient in 2004. It appears the naphthalene plume has not migrated significantly between 1992 and 2004.

Overall, the plume stability analysis indicates the naphthalene plume is stable. The trends show a significant decrease in concentration, area and mass.
