ATTACHMENT 10 - GRANBY SURVEY NOTES MAY 10-11, 2007

Abandoned Mining Area in Granby City Limits Southwest of Downtown Area

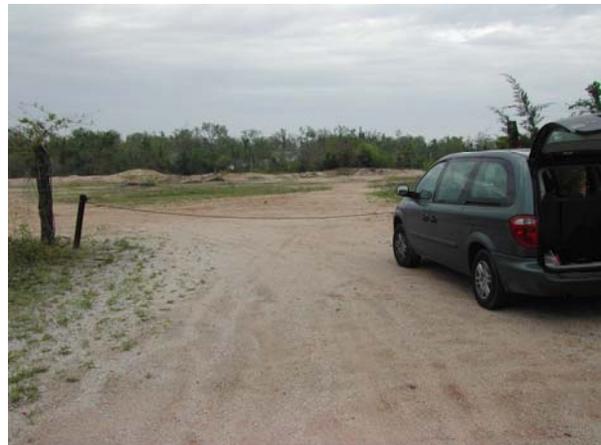
Photo G1

Van at entrance to city mining area.

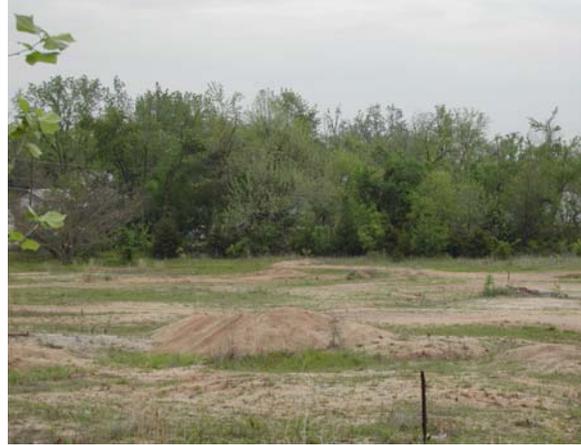
Photo G2

Cedar trees

#13 needles & berries Pb 0 / Zn 12.75

#14 needles & berries turned over Pb 0 / Zn 9.46

#5 Pb 1,022/ Zn 29,574

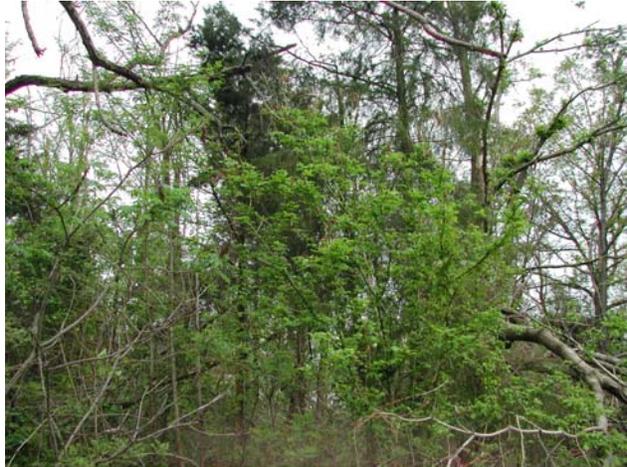
Photo G3

Tall stand of Cedar trees

#21 Needles & no berries Pb 0 / Zn 10.61

#22 Same turned over Pb 0 / Zn 5.13

#9 Pb 504 / Zn 4,622

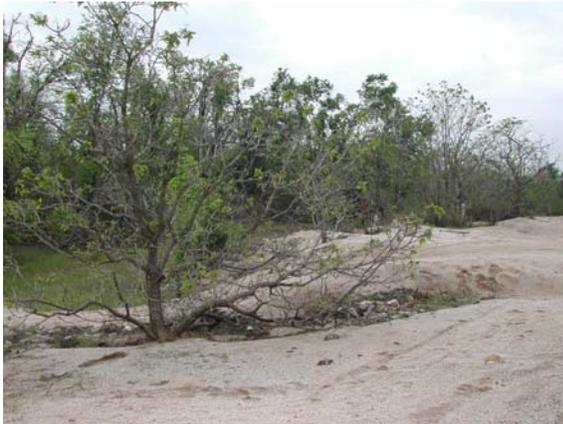
Photo G4

Catalpa Tree

#23 Single leaf Pb 0 / Zn 0

#24 Stacked leaves Pb 0 / Zn 6.25

#10 Pb 1,441 / Zn 25,040

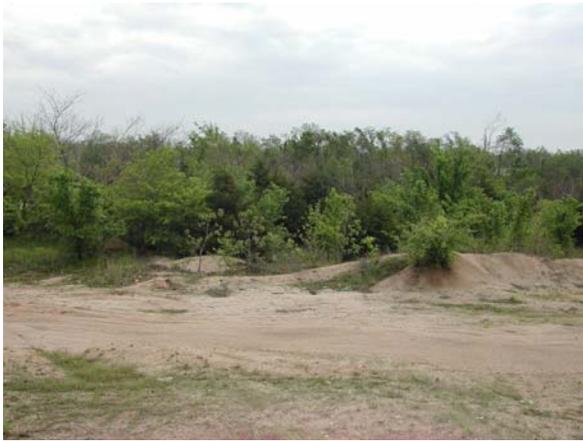
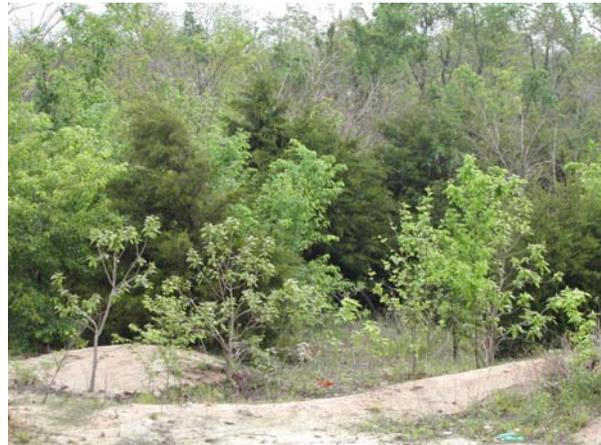
Photo G5 & 6

Several Cedar in middle of chat pile

#25 Needles & berries Pb 0 / Zn 13.63

#26 Same over Pb 0 / Zn 4.85

#11 Pb 373 / Zn 12,921

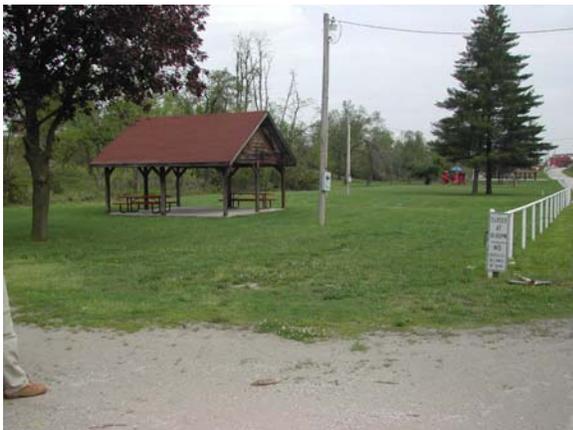
Photo G7

SPOT G9 - City Park near mine waste

Standard Grass

#27 Grass stacked Pb 0 / Zn 11.26

#28 Grass over Pb 0 / Zn 8.94

#14 Pb 0 / Zn 232

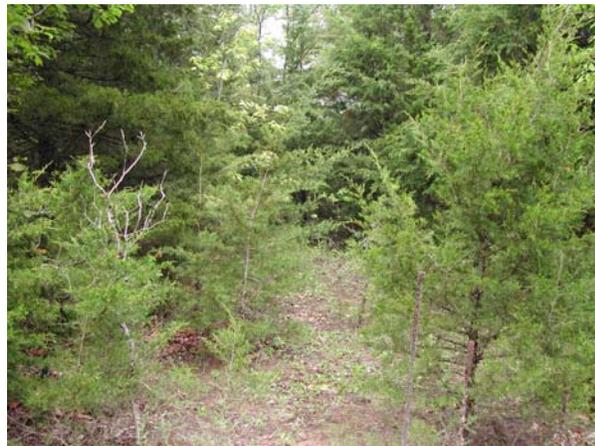
Photo G8

Stand of short and tall Cedar on edge of pond

#38 Pb 0 / Zn 3.53

#39 Pb 0 / Zn 4.54

#22 Pb 1,354 / Zn 13,950

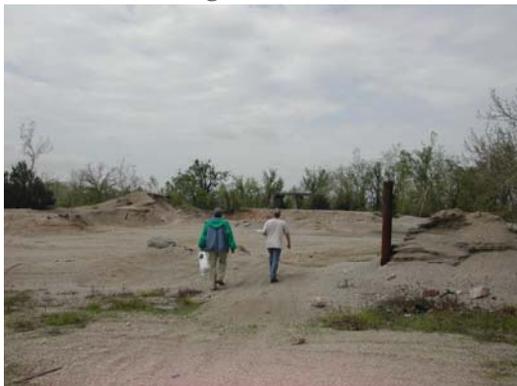
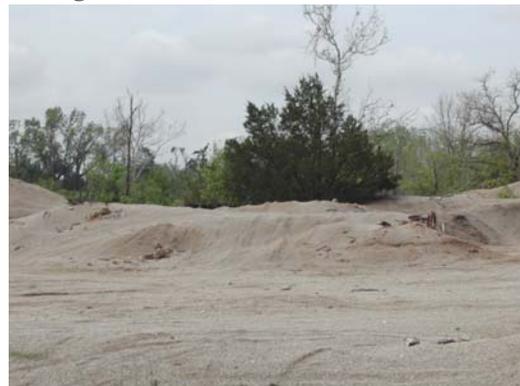
Photo G9 (Mining Structures) & 11 (Cedar to the left of mining structures)

Cedar tree in middle of southern portion of mining area.

#23 Pb 291 / Zn 16,934

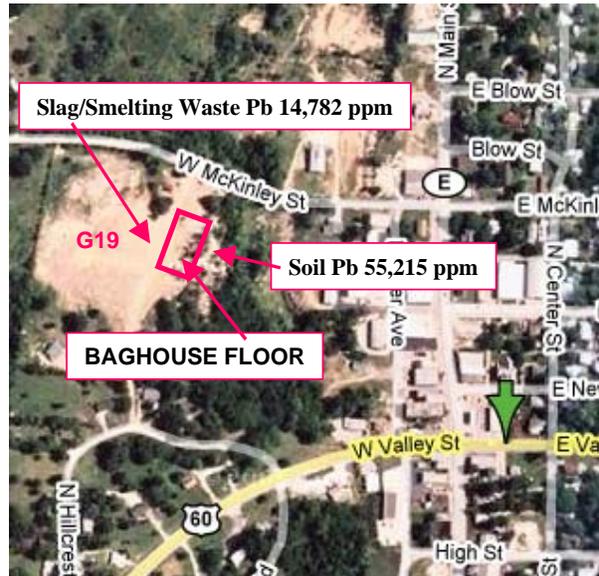
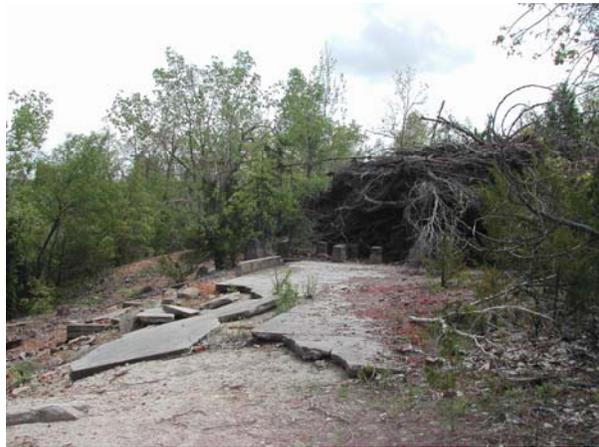
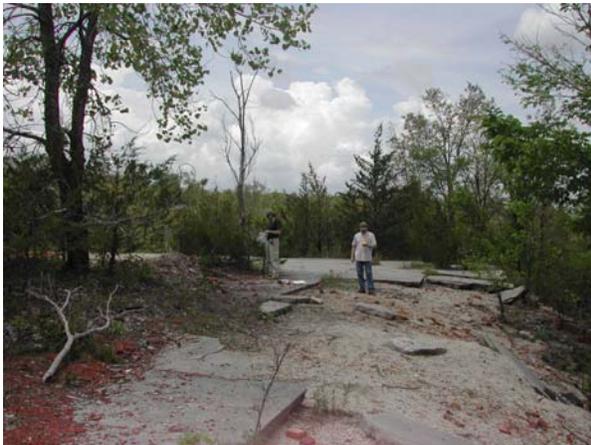
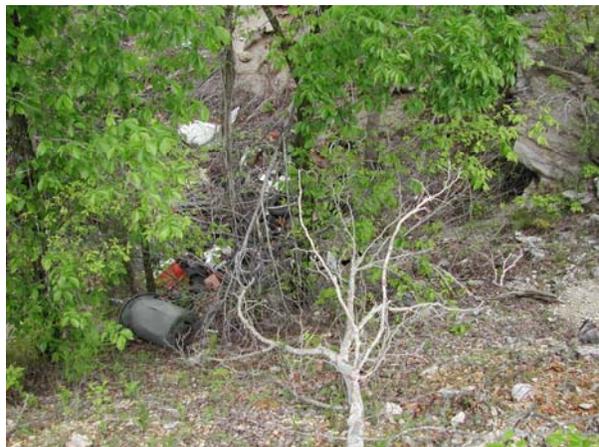
Possible clean fill on west side of smelter bag house floor.

Lead slag or smelting waste west of bag house on the surface, mixed with the clean cover. Streaks of slag were clearly visibly on the surface of the cover.

XRF 20070510 (ppm)
#28 Pb 14,782 / Zn 471

Undisturbed area on east side of smelter bag house floor.

Cedar tree about 13 ft west of soil area growing in cracks in concrete floor.

XRF 20070511 (ug/cm²)
#40 Pb 3.54 / Zn 14.34
#41 Pb 0 / Zn 16.22
#42 Pb 3.08 / Zn 8.52

XRF 20070510 (ppm)
#27 Pb 55,215 / Zn 67,637
Photo G12, 13, 14

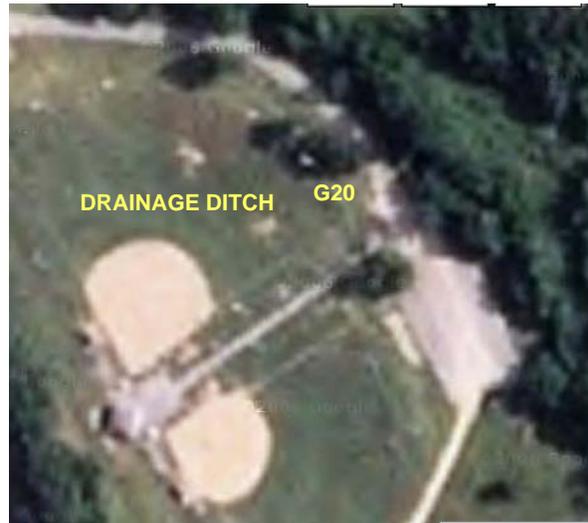
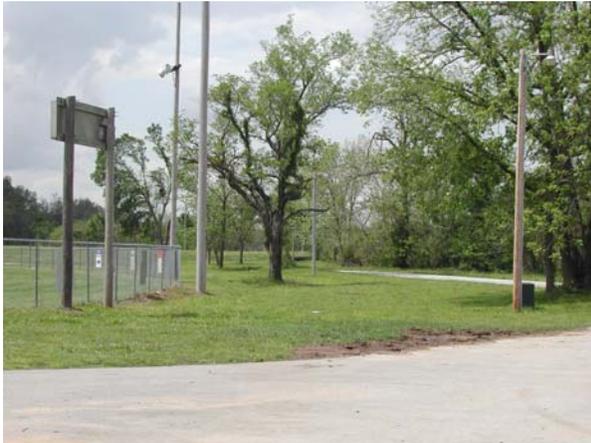
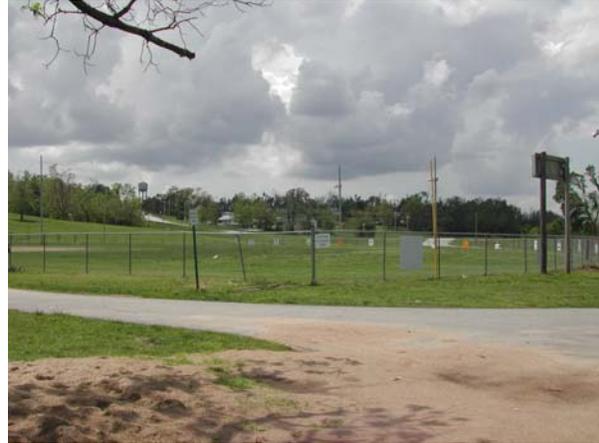
Photos G15, 16

Ball fields and athletic complex on east side of Granby.
No grass samples taken.

#29 Pb 106 / Zn 2,366

#30 Pb 208 / Zn 2,052
