# Westinghouse Electric Company Hematite Facility

## Well Inspection Report

<b>Well Number:</b> WS-15	<b>Date Installed:</b> Unknown	<b>Project Number:</b> SAHEM00136
<b>Coordinates (MO State Plane NAD83):</b> <b>    Northing/Easting</b>		<b>Elevation (TOC):</b>
N 865099.807	E 827623.158	432.70
<b>Total Depth</b> <b>(feet BTOC):</b> 26.38	<b>Riser Height</b> <b>(feet above pad):</b> 2.01	<b>Water Level</b> <b>(feet BTOC):</b> 17.14
<b>Well Construction</b> <b>Material:</b> PVC	<b>Well Casing</b> <b>Diameter (inches):</b> 2	<b>Screen Length</b> <b>(feet):</b> 10.0
<b>Hydrostratigraphic</b> <b>Zone:</b> Unconsolidated	<b>Inspected By:</b> R. Tubbs	<b>Date Inspected:</b> 8/18/2004

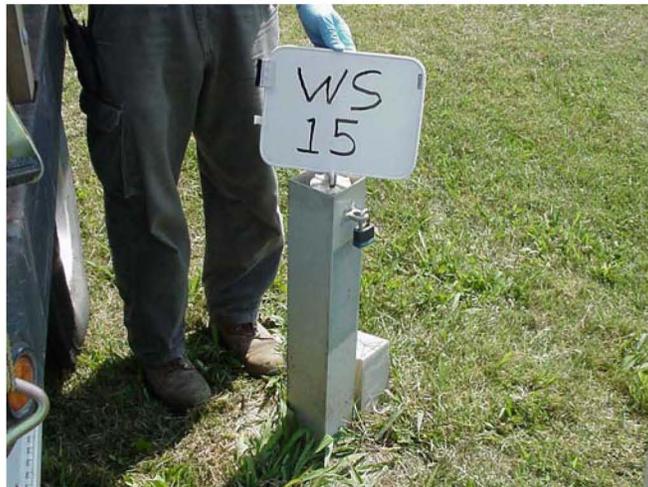
- Well condition noted as good
- Protective outer casing constructed of 4 inch square aluminum
- Well pad construction – 12 inch round concrete
- No guard posts in place
- Water-tight cap in place with dedicated bailer
- Well needs relabeling
- During redevelopment, well produced brown water
- Rehabilitation with mud dispersant recommended to remove additional fines accumulated around filter pack

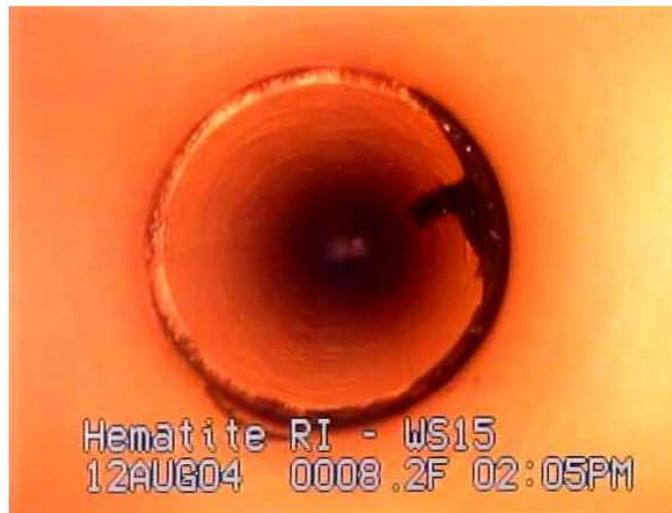
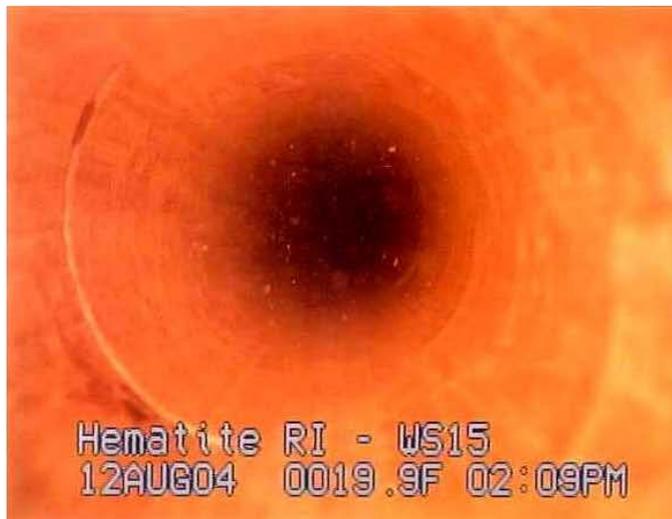
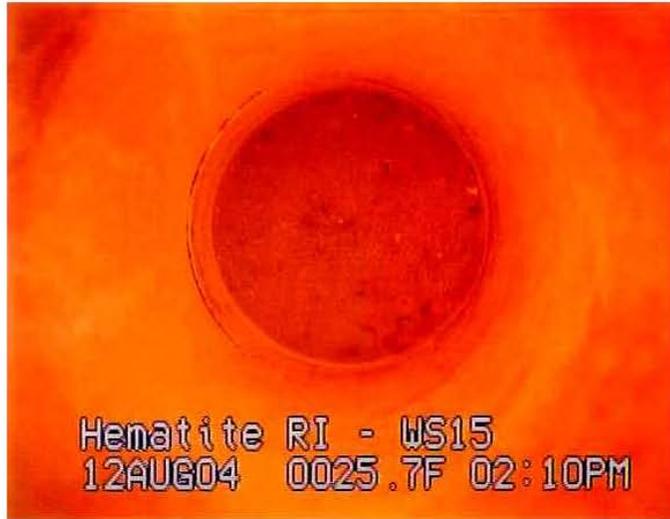
- Screen slots observed at approximately 16 feet below top of casing
- Total depth with camera 26.2 feet
- Glue from slip joint connection was identified at approximately 8.5 feet below top of casing
- Very little sediment present in bottom of well
