East Branch
Recreational Use Attainability Analysis

December 2005

Prepared by:
MEC WATER RESOURCES, INC.
1000 North College Avenue, Suite 4
Columbia, Missouri 65201

Recreational Use Attainability Analysis

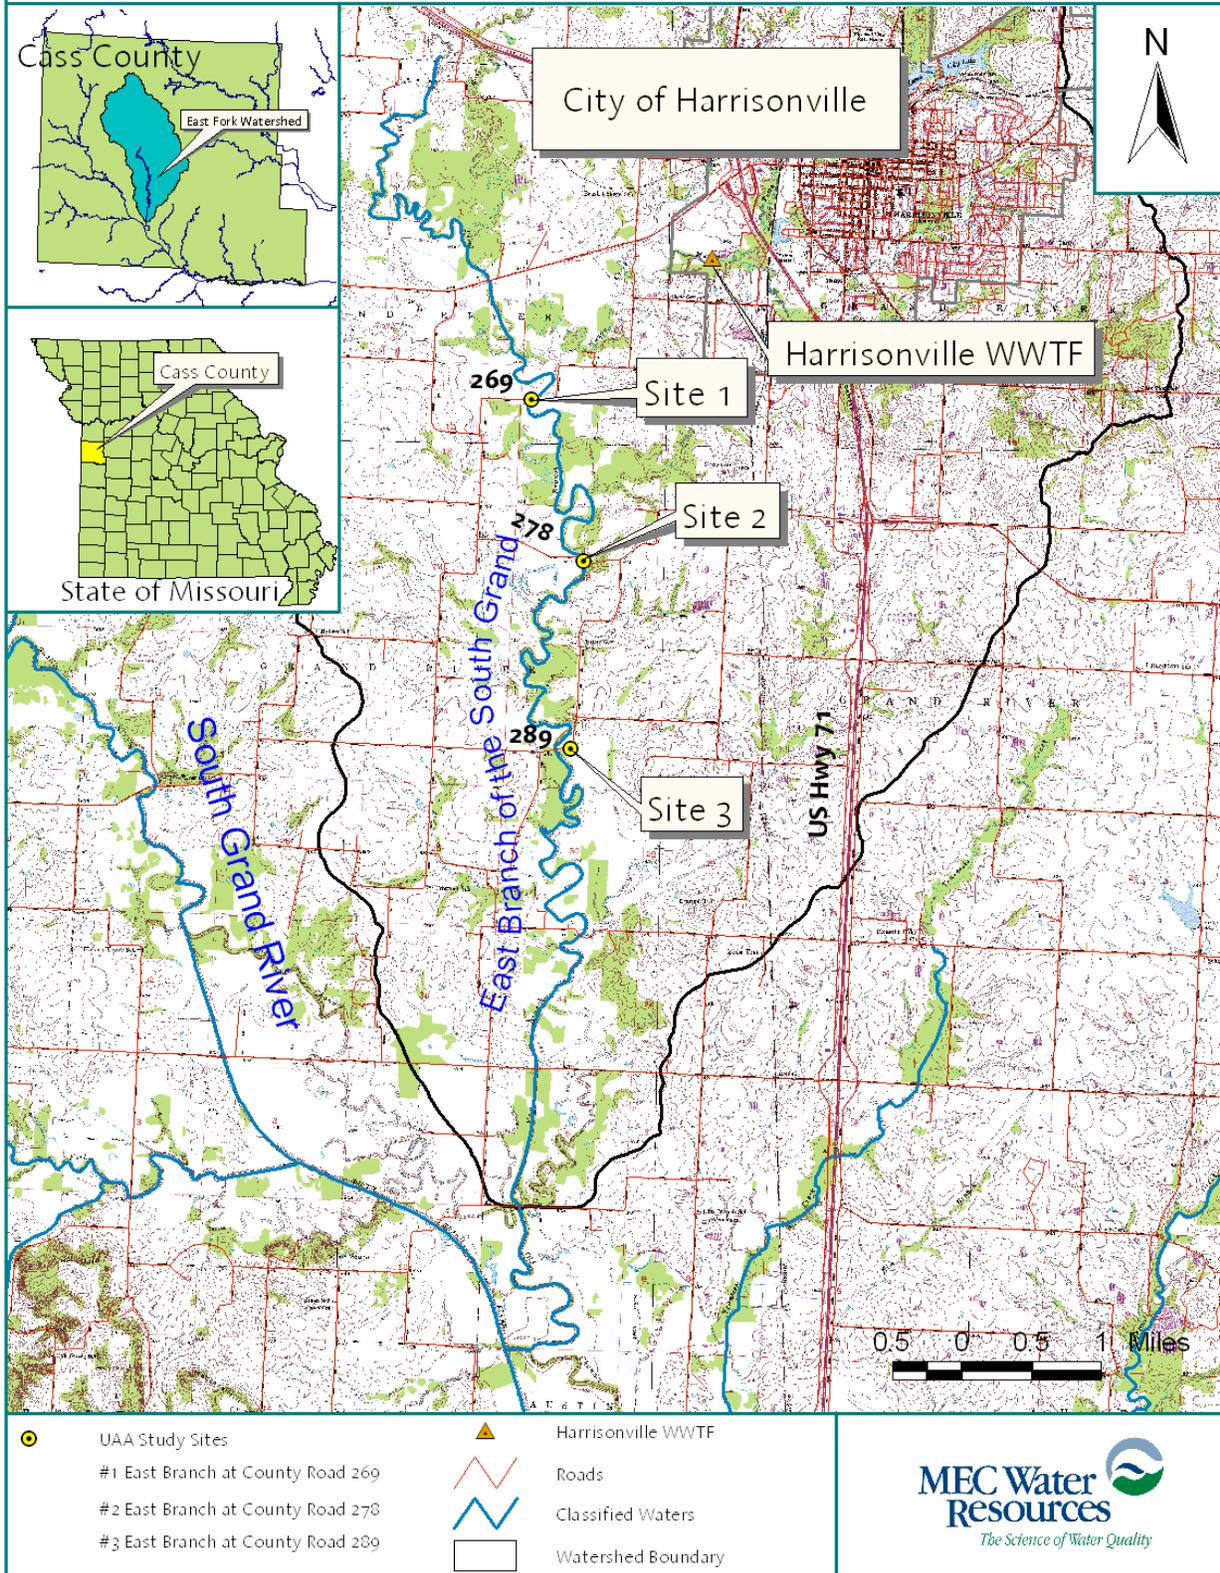
Figure 1. East Fork Study Area and Sites

East Branch (Figure 1) is a Class C water of the state and a tributary to the South Grand River near Harrisonville, Missouri (Blunt 2004). Uses currently designated for East Branch include Protection of Warm-Water Aquatic Life and Human Health – Fish Consumption, and Livestock and Wildlife Watering. The Category B Whole Body Contact Recreation use was added to East Branch in the September 2005 recommended revisions to 10 CSR 20-7.031.

Three sites (Figure 1) within classified sections of the East Branch of the South Grand River were assessed on October, 17, 2005, using methods described in Section IV: 1264_Site 1_County Road 269 Bridge Crossing, 1264_Site 2_County Road 278 Bridge Crossing, and 1264_Site 3_County Road 289 Bridge Crossing. Surveys were conducted during presumed low-flow conditions as evidenced by precipitation data from the Blue River USGS Gage Station 6893080 near Stanley, KS (Table 1).

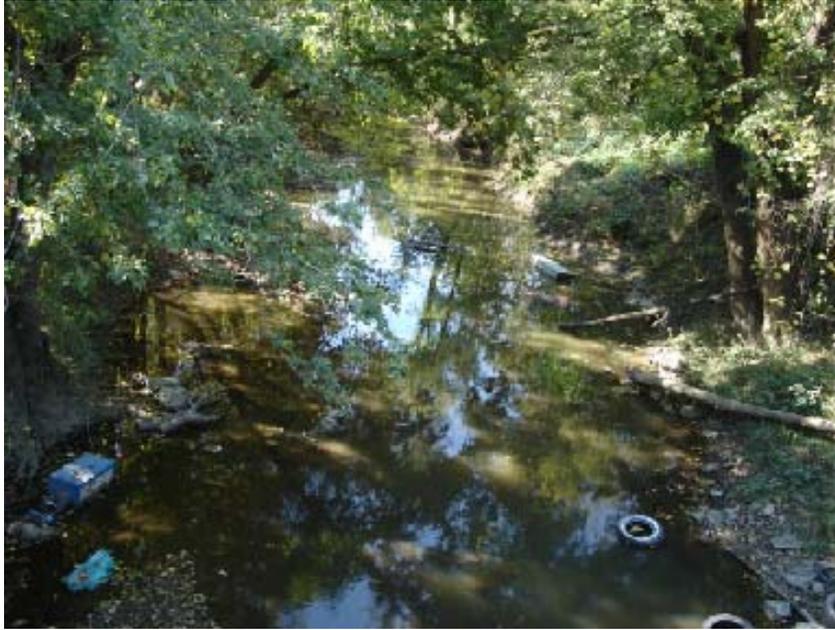
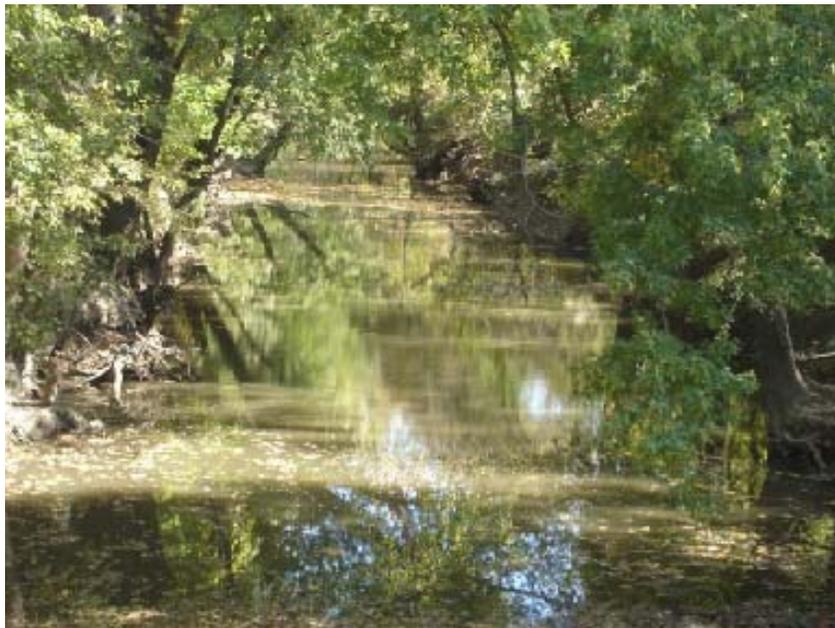
Site 1. County Road 269 Bridge Crossing (38.62940, -94.39337) 2.42 miles from WWTP.

The riparian areas near the County Road 269 bridge crossing consist of trees and shrubs with some grasses. Agriculture fields are also present nearby. Channel substrate was predominately sand with gravel and cobble present (Figures 2 and 3). Stream bank slopes are steep at this road crossing.

Mean depth along an 840 ft. assessment reach was 1.20 ft. as determined from 7 transects (Appendix B). The maximum depth observed at this location was 2.84 ft.

There was no evidence of WBCR use observed at Site 1. In addition, no individuals were seen or found to be available for interviews near the bridge during the survey.

MEC staff concludes that WBCR is neither an existing or an attainable use at this site based on limited access to the stream imposed by steep banks, the absence of observed recreational uses, and low-flow, shallow conditions.

The surveyed reaches of East Branch at Site 1 (County Road 269 Bridge Crossing) do not currently support WBCR uses due to the to depth criteria associated with ephemeral, intermittent, or low flow conditions set forth in MDNR UAA guidance. The surveyed reaches at Site 2 (County Road 269 Bridge Crossing) exceeded the WBCR maximum depth criteria and the mean depth criteria by 0.46 feet and 0.15 feet, respectively. The surveyed reaches at Site 3 (County Road 289 Bridge Crossing) were below the WBCR depth criteria. Based on reach depth measurements and lack of observed recreation use, it is recommended that WBCR be removed upstream of Site 2.

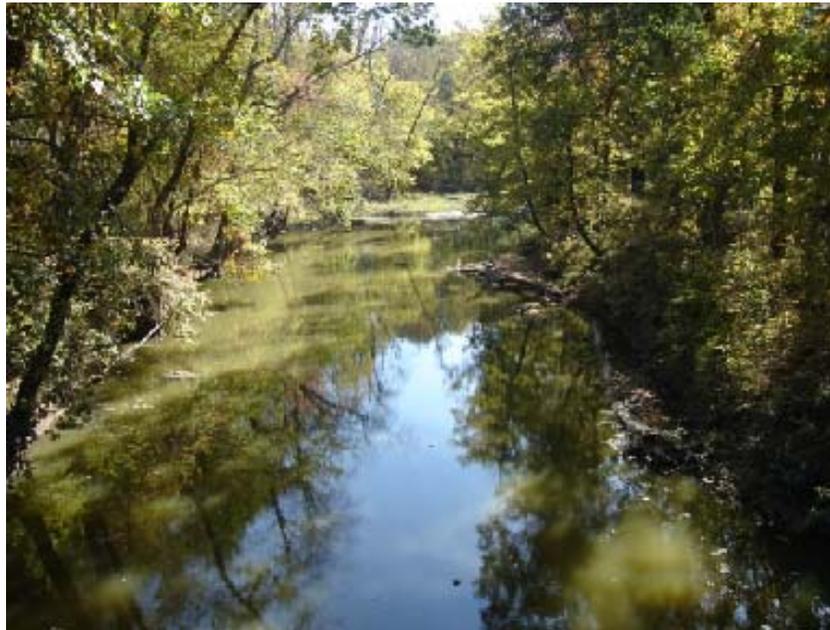
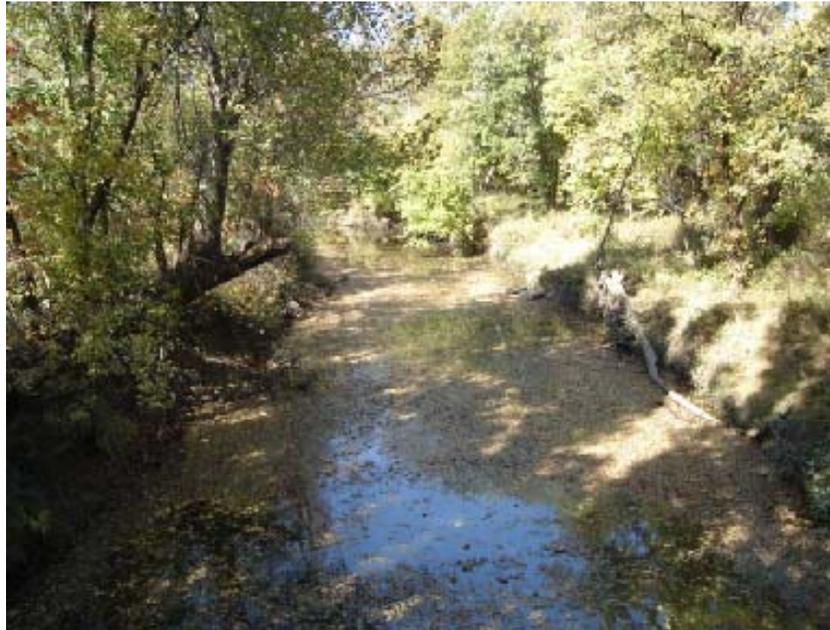
Site 2. County Road 278 Bridge Crossing (38.61278, -94.38615) 4.63 Miles from WWTF

The riparian area near the County Road 278 bridge crossing consists of low growing brush and grasses, with some mature deciduous trees and row crops (Figures 4 and 5). The stream banks are steeply sloping and covered with brush and grasses. Stream substrate consisted of bedrock and cobble with sand and silt present.

Mean depth along a 1,000 ft. assessment reach was 1.79 feet as determined from 9 transects (Appendix B). The maximum depth observed at this location was 3.74 ft.

MEC staff did not observe any direct or indirect evidence of WBCR at Site 2. A trot line was found from the bridge; however, no individuals were seen or found to be available for interviews near the bridge crossing at the time of the survey. Access to stream may be impeded by the presence of fencing.

MEC staff concludes that WBCR is an attainable use at this site based on maximum depth of over a meter within the surveyed reach and an average depth that is greater than a half meter.

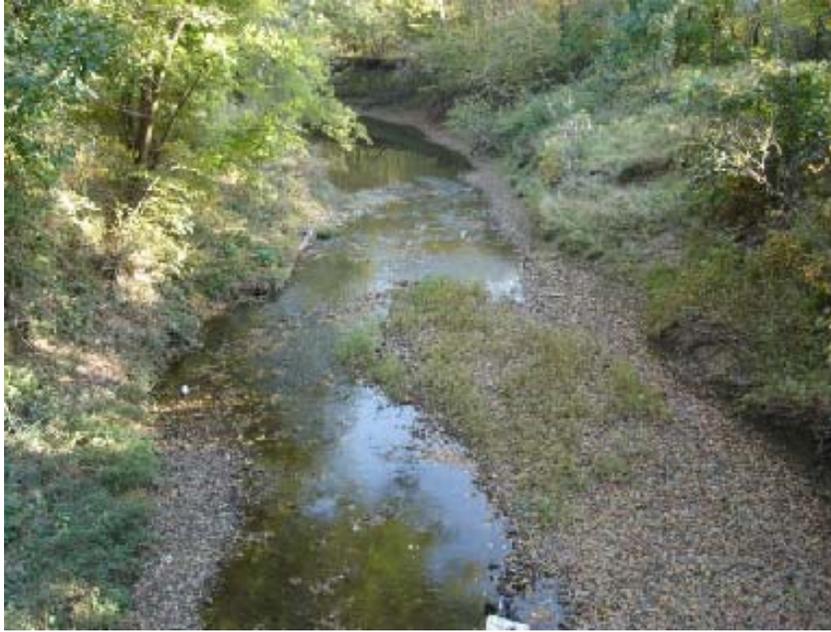
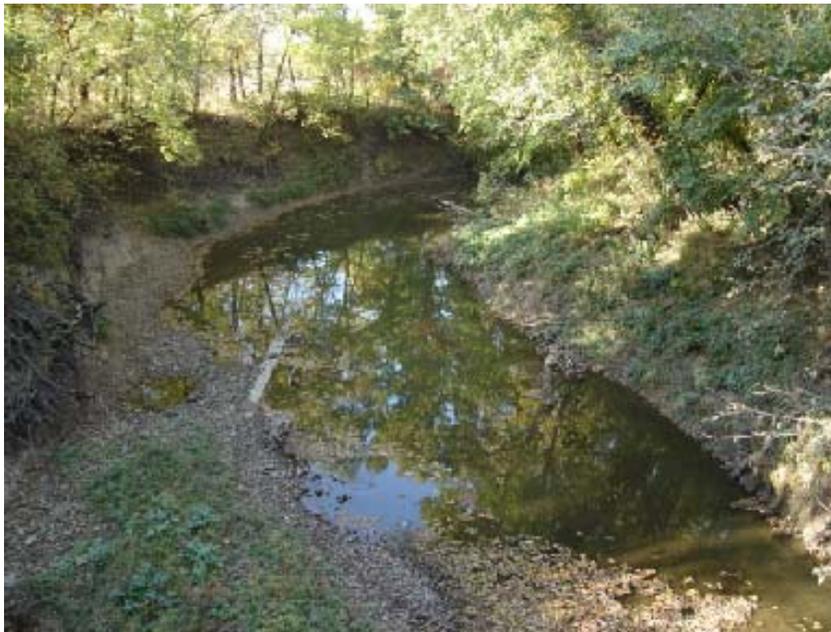
Site 3. County Road 289 Bridge Crossing (38.61287, -94.38585) 7.16 Miles from WWTF

Stream banks near the County Road 289 bridge crossing are steep sloping and vegetated with grasses and brush (Figures 6 and 7). Riparian areas immediately adjacent to the stream are primarily vegetated by trees and brush, with agriculture fields nearby. The stream channel was observed to consist of mud/clay, gravel, and sand.

Mean depth along a 600 ft. assessment reach was 1.15 ft. as determined from 14 transects (Appendix B). The maximum depth observed at this location was 3.21 ft.

MEC staff did not observe any direct or indirect evidence of WBCR at Site 3. No individuals were seen or found to be available for interviews near the bridge crossing at the time of the survey. MEC staff concludes that WBCR is not an existing use at the surveyed reach.
